**St Anne's Catholic School
3 Rockstone Place
Southampton
Hampshire**

Historic Building Recording and Watching Brief Report

CA Project: 770750

CA Report: 18322

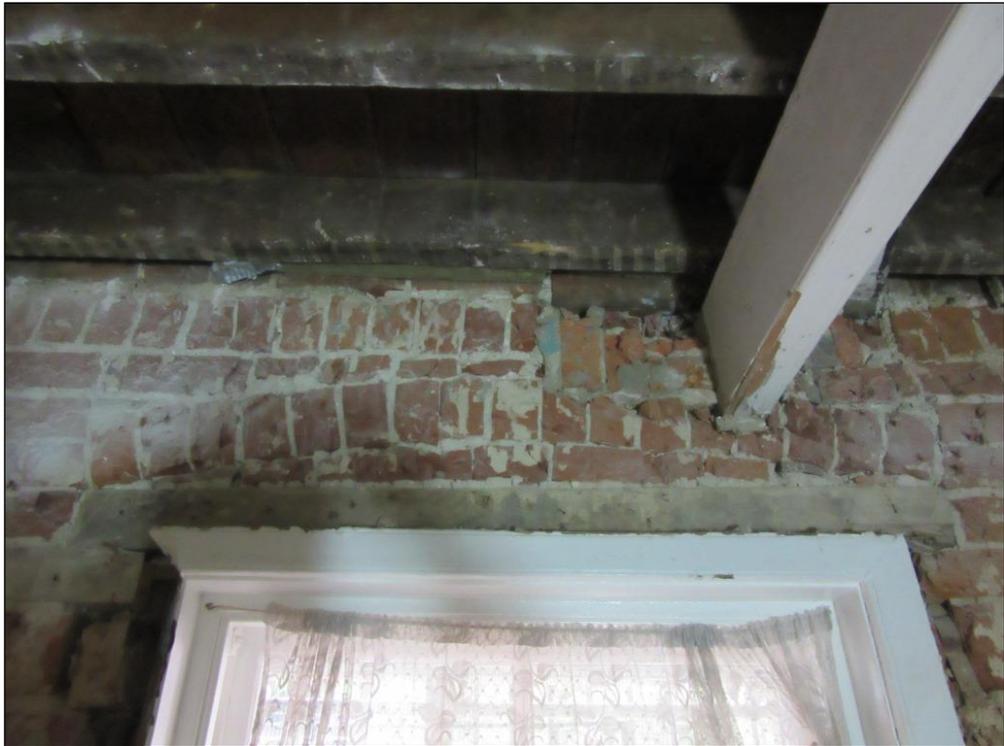
- 4.22. The features revealed comprise a segmental arch brick lintel over the window (Photograph 4), with a timber lintel directly over the window frame. The brick work surrounding the windows indicates that it has been altered at some time, with strips of concrete along the edge and timber framing used to hold the frame in place. This indicates that it is a later replacement. The boxing on the roof structure was removed, revealing a timber running the length of the ceiling. It cuts into the arch over the window and has an area of brick infilling indicating that it is a later insertion. The timber does not appear to retain any features and was most probably inserted for structural reasons.

Photograph 4 Exposed arch over window in south wall of Music Store

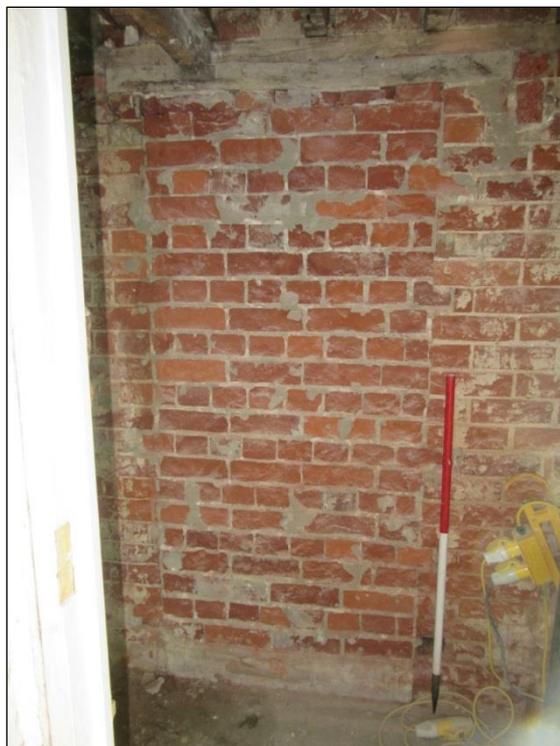
- 4.23. Three blocked in entrances were noted following the removal of the plaster. A square headed entrance with a roughly cut timber lintel was recorded in the east wall of the northern projection (Photograph 5).

Photograph 5 Blocked in opening in the north projection of Music Store

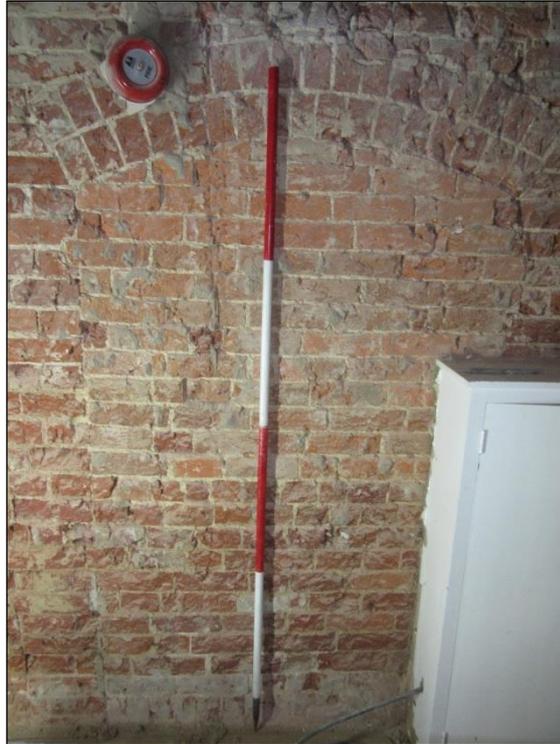
Photograph 6 Blocked in opening of east wall of Music Store

- 4.24. An opening with a segmental arch was noted in the centre of the east wall of the main section of the room (Photograph 6). The segmental arch was formed of two courses of bricks with the header set vertically. The north side of the opening could be identified to the base of the wall, but the southern side continued behind the electrical cupboard and could not be identified with complete certainty. The third blocked up opening was set in the north wall and was partially occupied by the modern doorway leading to Circulation (base of stairs) (Photograph 7). This opening also had a segmental arch head of bricks.

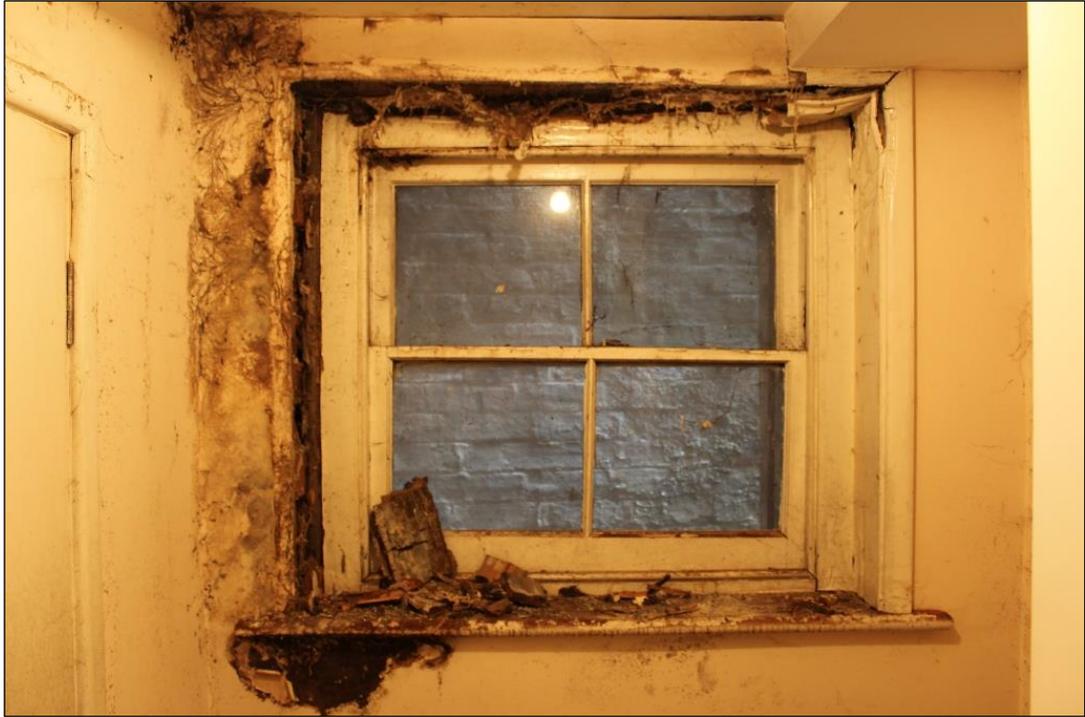
Photograph 8 Window in Circulation (west) with extensive mould along the edge

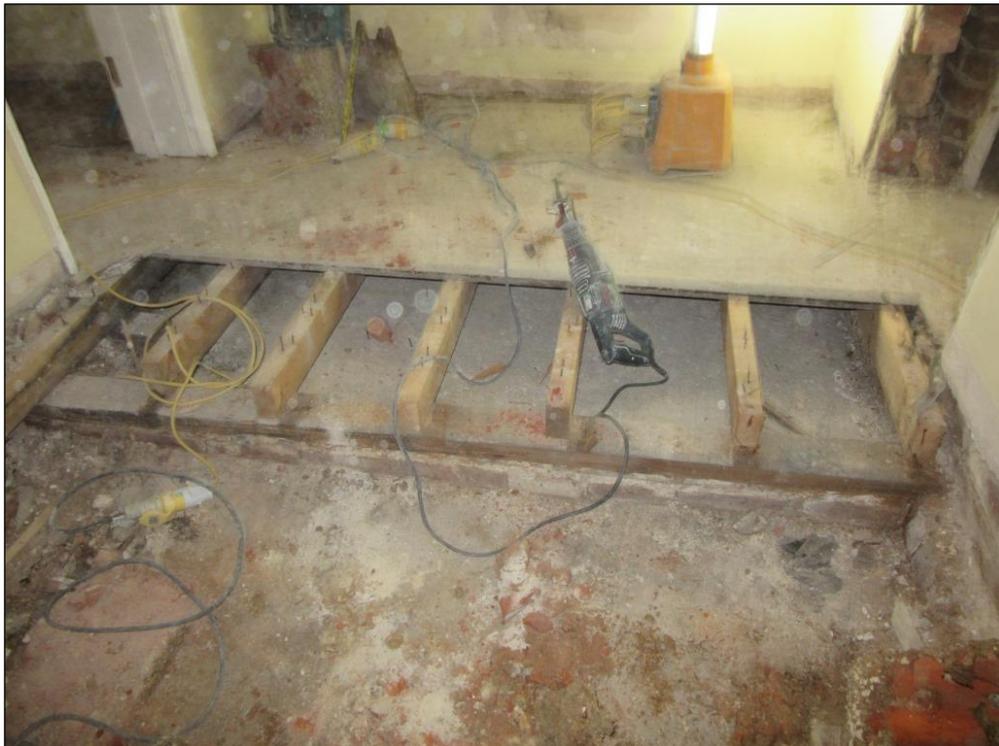
Photograph 11 Timber frame over concrete base flooring in Music Practice

- 4.37. The works in Music Practice comprised the removal of the floor which was formed of modern boarding over timber framing (Photograph 11). There was an area of concrete at the southern extent and north half of the floor, with the remainder of the

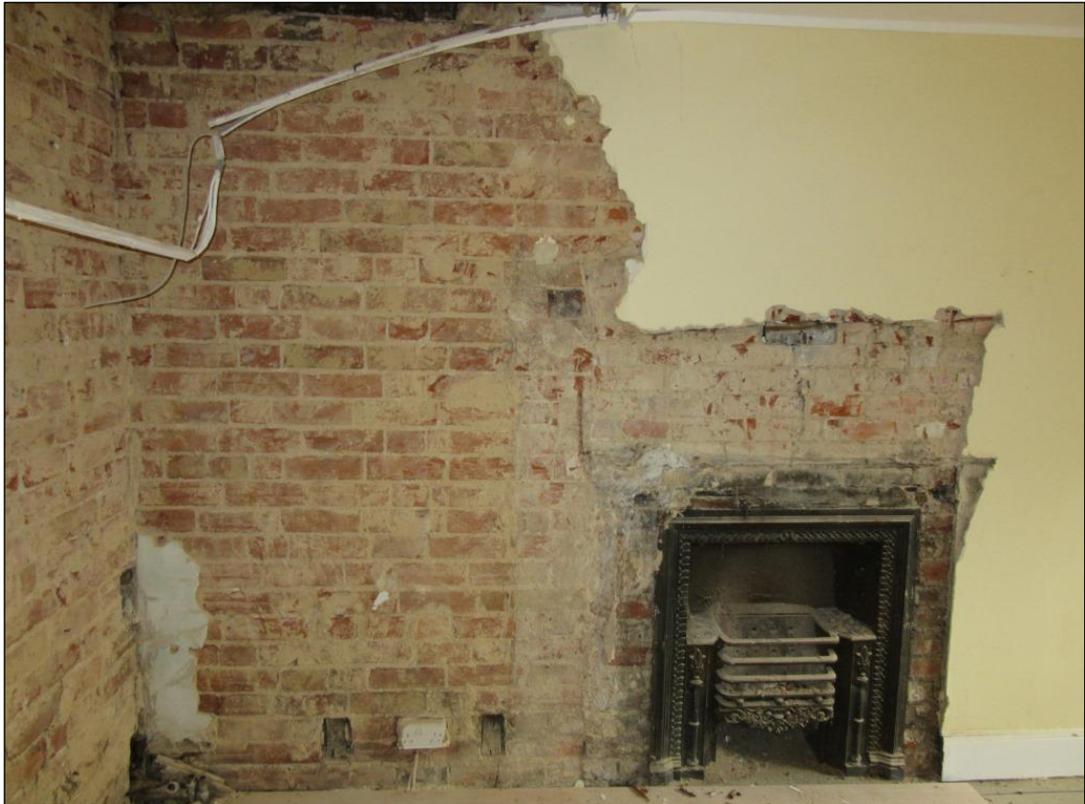
Photograph 14 West wall of ground floor Office following removal of plaster with exposed fireplace and ghosting on wall

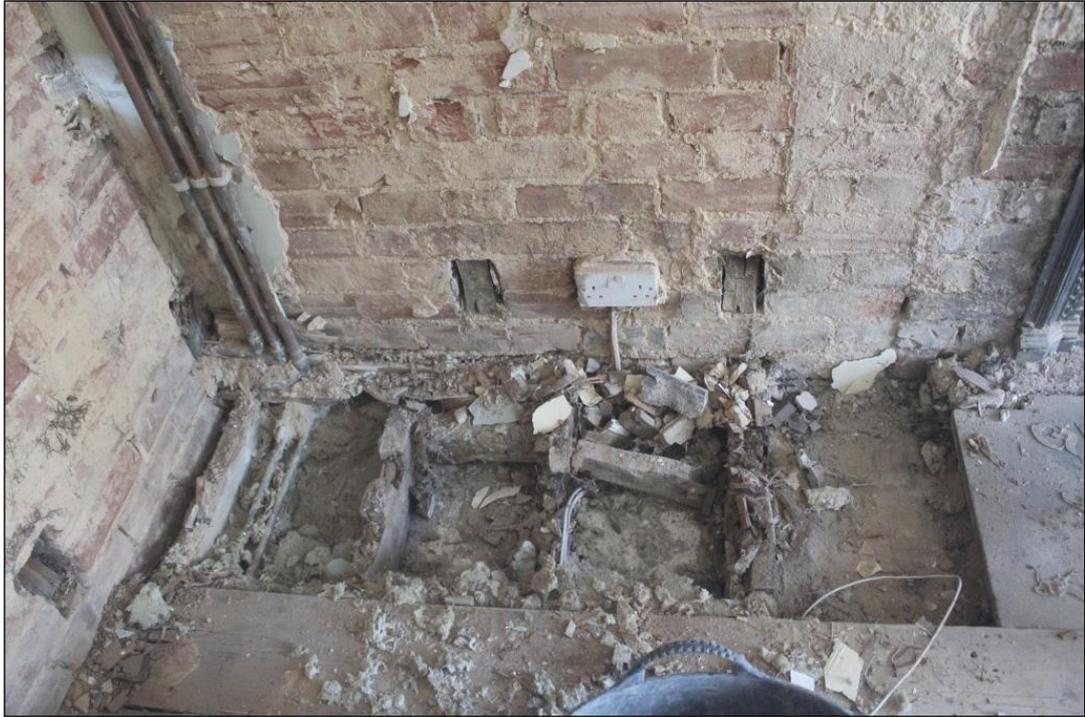
4.47. The floorboards in the south-west corner of the room had rotted and were removed exposing the supporting structure beneath. This structure was of parallel timber beams, which had rotted to varying degrees at the western extent (Photograph 15).

Photograph 15 Significantly damaged flooring joists in south-west corner of Office

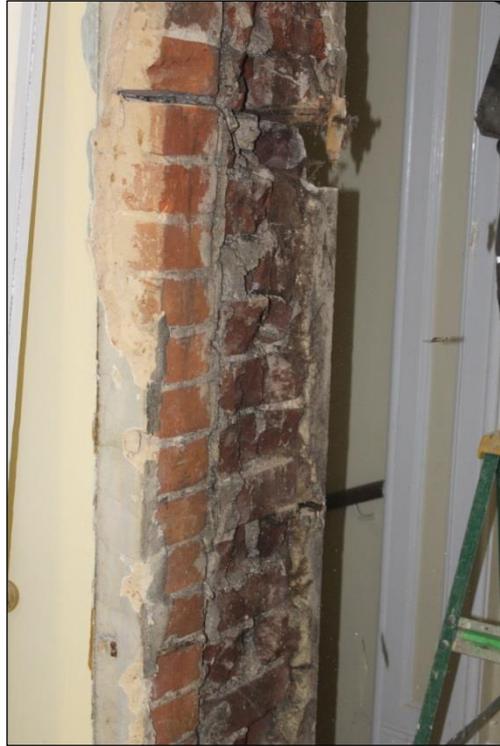
- 4.57. The adjoining wall of the Corridor and Music Practice 2 is formed of three courses of brick; the two to the west have a rough edge and are of a darker brick, matching that in the western extent of the building (Photograph 20). There is a narrow void between the central and east course, with the eastern course of brighter brick with a smooth edge lining the doorway. This indicates that the third course is a later addition, probably reflecting the extension to the east, with the rough edged brick representing the insertion of the doorway in the elevation.
- 4.58. The ceiling was removed in the north-west corner with the timbers showing the ends of the joists are rotted in the corner becoming surface damage further away.

Photograph 20 Detailed view of three course walling between Music Practice 2 and Corridor

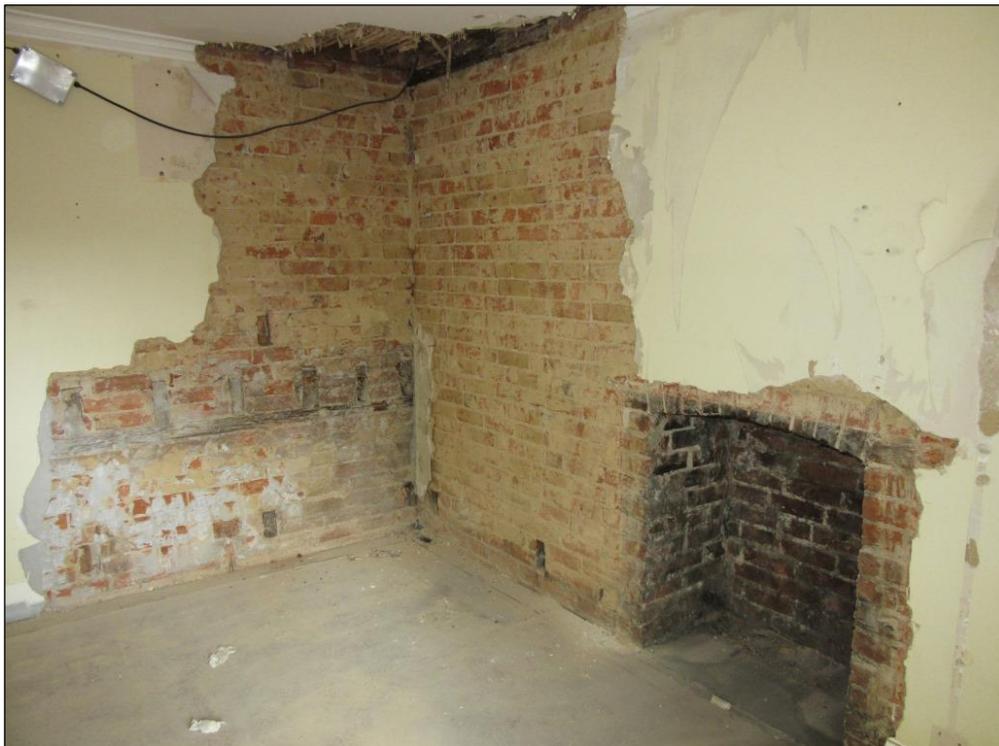
- 4.62. As with the ground-floor Office, the work was concentrated in the south-west corner of the room. In the south wall there were three rows of timbers exposed (Photographs 21). The lower row is for the attachment of the skirting boards in the SEN Office, with blocks placed at regular intervals and the upper row relating to the skirting board attachment in the adjacent Classroom 2, also of regularly spaced timber blocks. The middle row of timbers is formed of a horizontal timber continuing past the area of exposed brick work with a second row of timbers set vertically and at a smaller interval than the other rows. This central row of timbers related to the flooring structure for the adjacent Classroom 2.

Photograph 21 General view of SEN Office following works showing the timber flooring of adjacent room and fireplace

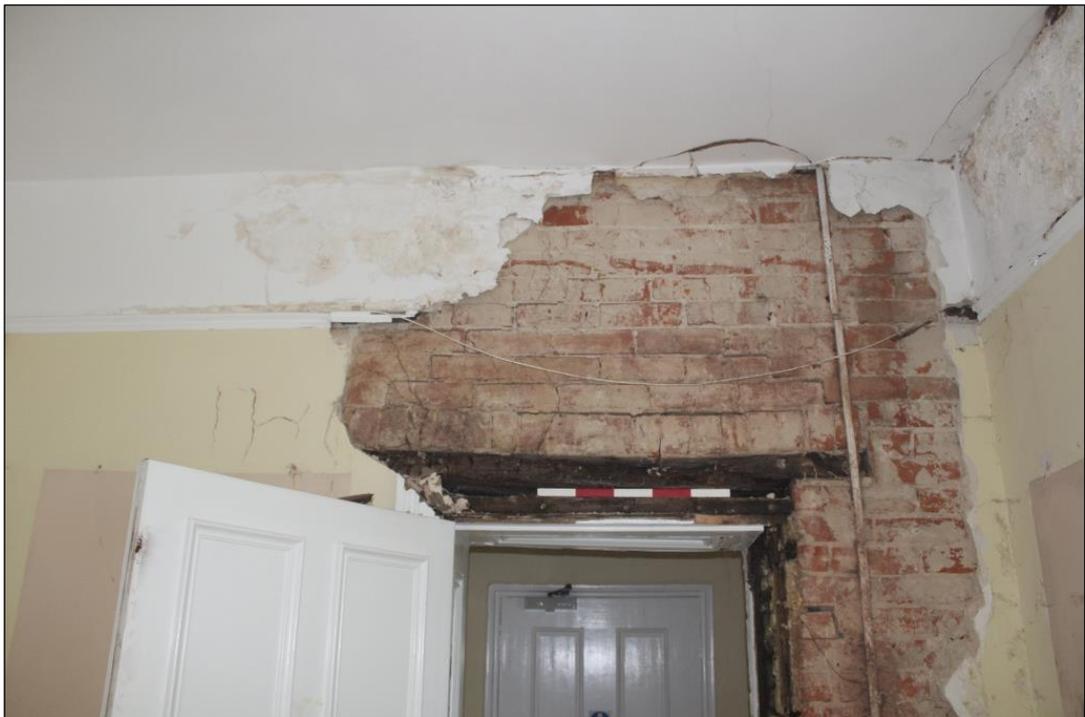
- 4.67. The works were concentrated in the north-west corner of the room and extended past the west window in the north wall, the framing of which had started to rot. Due to structural concerns with the west wall, it was not fully exposed but it was possible to determine that it is the same as the west wall of ground-floor Music Practice 2, in that the door had a timber lintel overhead and the walling was three courses thick with a void between the centre and east course (Photographs 22). Not all of the panelling was removed from the doorway as it was providing additional support to the shifting walling above the door.

Photograph 22 Exposed brickwork over doorway between first floor Classroom 1 and Circulation with shifting walling due to rotted timber lintel

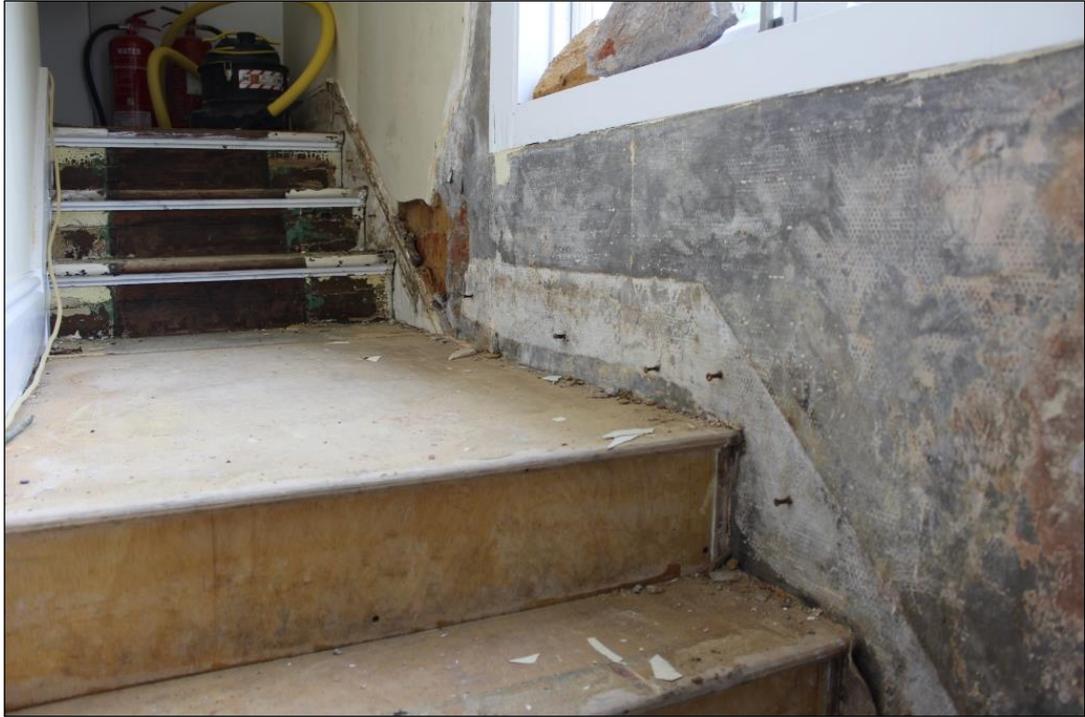
- 4.77. The carpet was removed from the stairs within the third-floor Circulation area, which revealed that the lower section of stairs was a later timber addition, most probably inserted in order to allow access to the modern fire escape. The lower stairs are formed of a timber framing with ply-boards over the top with the original staircase retained in place. The older (presumed original) staircase was set into the skirting board which provided it with support and had started to rot. As continued access was needed to the Comms Room and there was a concern that the removal of the damaged skirting board would make the stairs unstable, therefore this was left in place.

- 4.78. There were two forms of plaster over this section of wall, with the area beneath and adjacent to the modern fire escape of Portland cement and the remainder of lime with horse hair seen throughout the remainder of the building (Photographs 23).

Photograph 23 Third floor Circulation with modern timber stairs for access to fire escape, rotted skirting boards and Portland cement plaster
