# **Archaeological Works at St. John's Church, Alkmonton, Derbyshire**

**ARS Ltd Report 2019/62  
Oasis No. archaeol5-346570**

# **Archaeological Works at St John's Church, Alkmonton, Derbyshire**

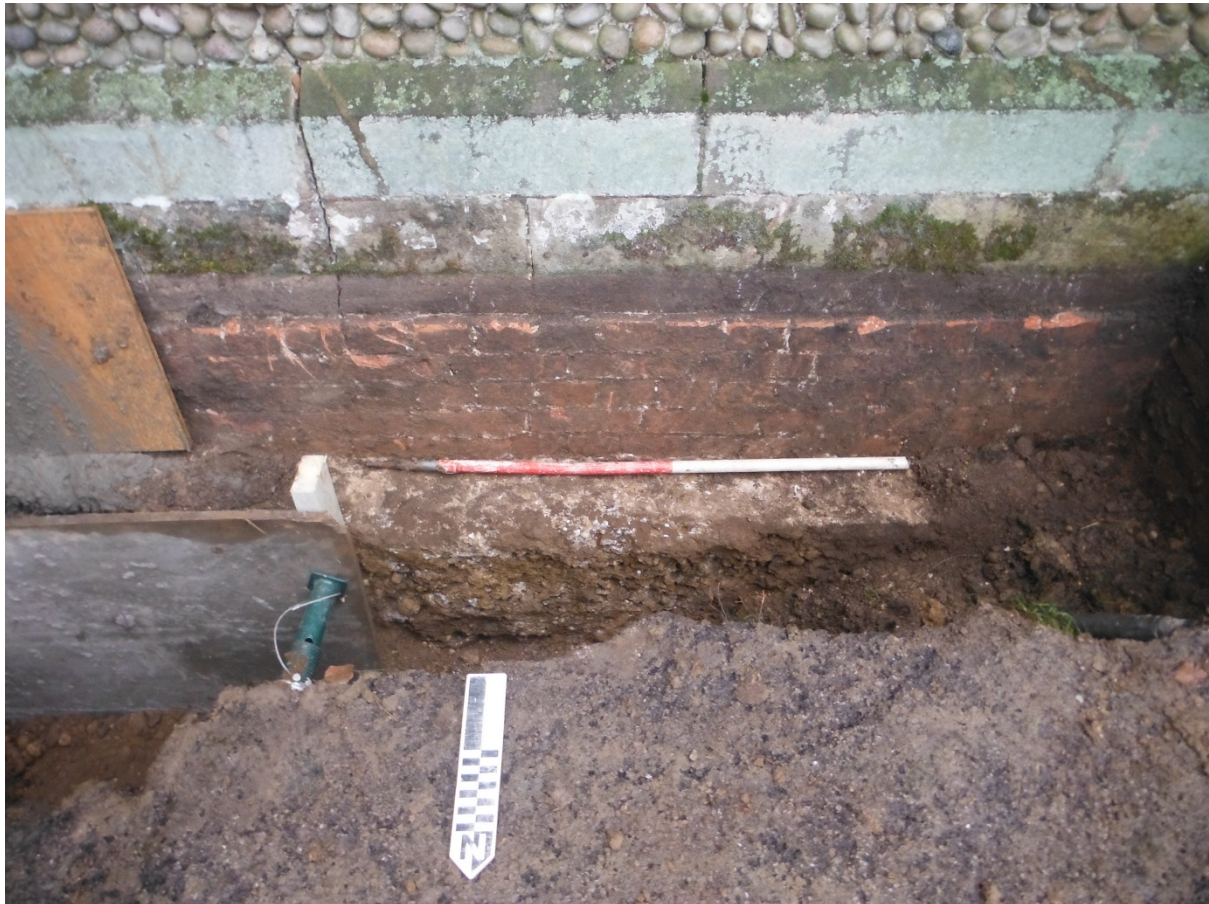
**Figure 4 Brick foundation (006) and concrete underpinning (005) of north wall of nave**

4.2.2 The foundation substructure of the outer north wall of the nave consists of three distinct construction layers (Figure 4). The first comprises a thick block of plain concrete (005) measuring 800mm deep and 5m thick, overlaid by five courses of handmade orangey bricks (006) laid on bed facing north, bonded with a whitish grey mortar. The brick work forms an English Bond and is overlain by two courses of finely dressed limestone (007) forming an ashlar bond with carefully chamfered dressed masonry. For measurements see Appendix 1.

5.2 The concrete underpinnings found beneath the foundations appears to be later additions, representing an attempt to enhance either the stability of the walls (necessary, presumably, because of ground subsidence) or their capacity to resist loading or both. The concrete underpinnings under the nave can be securely classified as a later addition, as Portland cement concrete was first used in Britain in the 1850s, postdating the initial construction of the church by a few years.

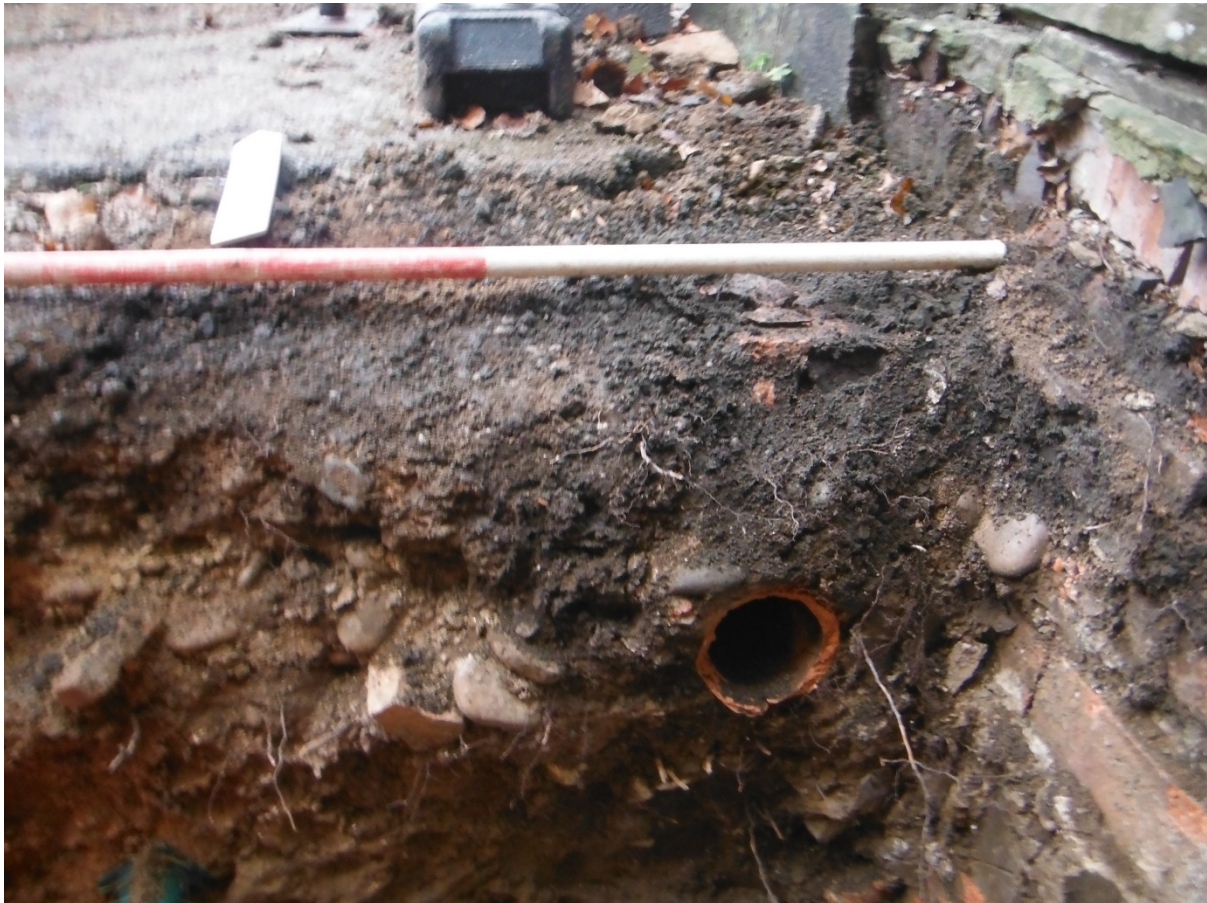
Figure 5 South facing section of trench [011] and drain [008]

4.2.3 The north church churchyard, as shown in Figure 5, comprises a sequence deposits above the subsoil. The natural clay geology (004) is overlaid by a yellowish brown stony sandy silt layer, identified as subsoil (003). On top of that a mixed layer (002) (composed of

loose spread of material including cobbles and bricks mixed with redeposited topsoil was encountered. The last layer is represented by an asphalt layer flooring (001).

4.2.4 At the east site of the underpinning (close to the boiler wall) a ceramic drain (009) was detected running north-east away from the church wall. The trench was cut through made ground (002), backfilled with redeposited topsoil (010) and overlaid by asphalt layer (001).

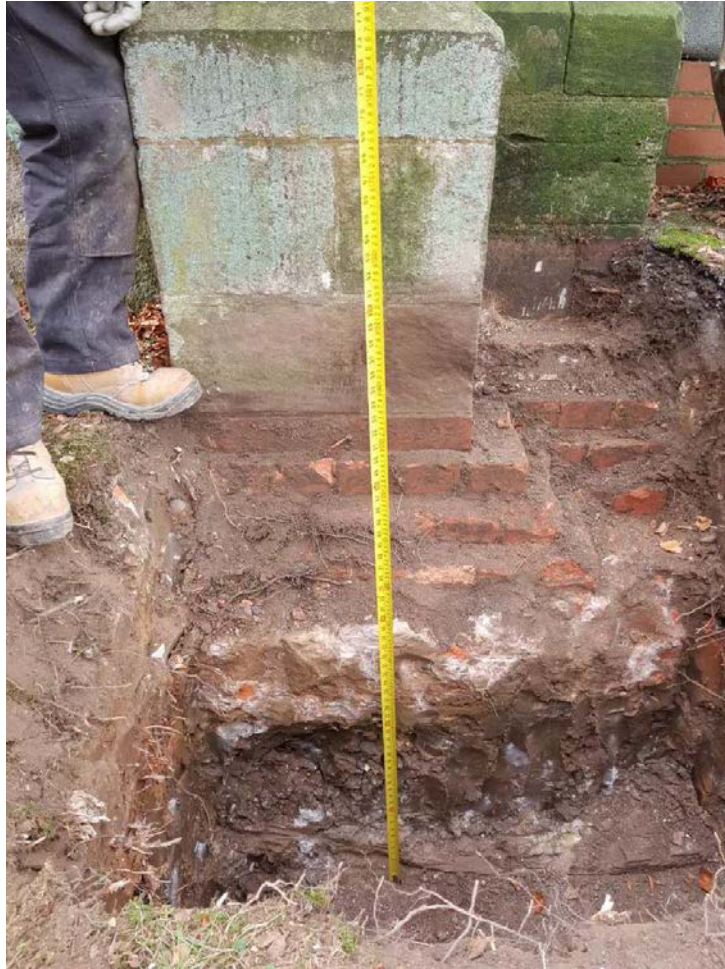
**Figure 6 Stepped brickwork and concrete underpinning foundation underneath the east wall © Paul Mendham Stonemasons Ltd**

4.3.1 The east underpinning trench was located by the east wall of the chancel (Figure 2). The trench had already been excavated and refilled with concrete by the time ARS archaeologist arrived on site. A photographic record collected by the construction team revealed that the foundation comprises concrete overlain by four courses of stepped brickwork in a stretcher bond underneath three courses of chamfered limestone ashlar blocks.

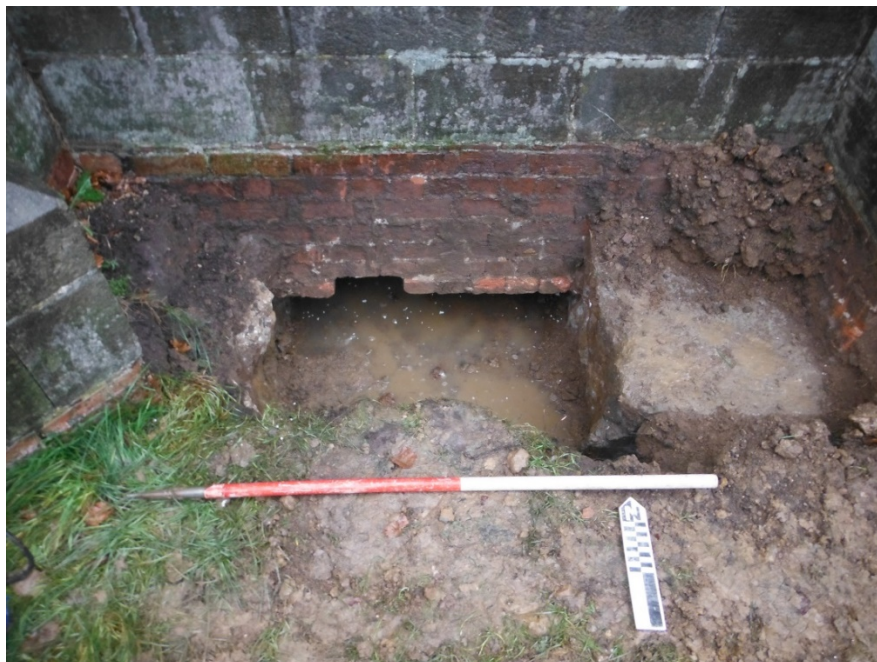
**Figure 7 South wall brick foundation**

4.3.2 Unlike the four courses stepped brickwork identified on the east wall of the chancel, the south wall comprises a seven-course foundation of hand-made bricks laid on bed facing south (014). The brickwork is bonded with a light grey mortar forming an English Bond and is superimposed by two courses of finely finished ashlar limestone blocks (015) (Figure 7 and section 1 in Figure 14).

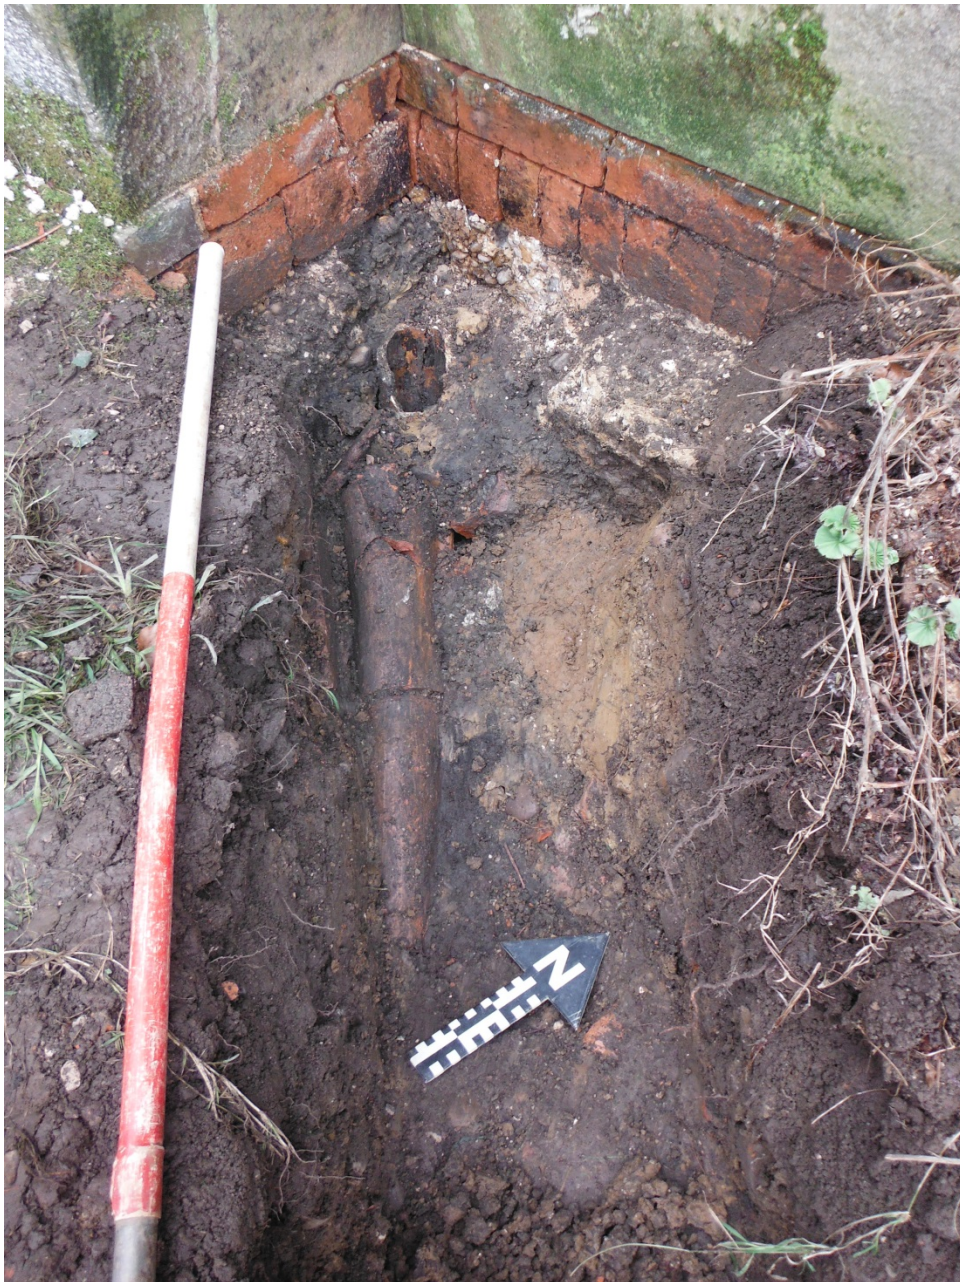
**Figure 9 Brick foundation (029) concrete underpinning (037) and water pipes (030) – (032)**

4.3.3 Immediately to the right of the church porch (south wall of nave), a concrete layer (037) overlaid by two courses of bricks (029) was revealed during the laying of the new storm drain (Figure 9 and Figure 8 plan 2). The lower course forms a header bond with bricks laid on edge while the upper forms a stretcher bond (Section 3 in Figure 8).

5.4 Brick foundation {029} represents an unusual bond for a load bearing wall. The 'on edge' construction opposed to the conventional 'on bed', identified on the north wall was possibly considered as a more appropriate construction technique for levelling the church due to the natural inclination of the land to the east.

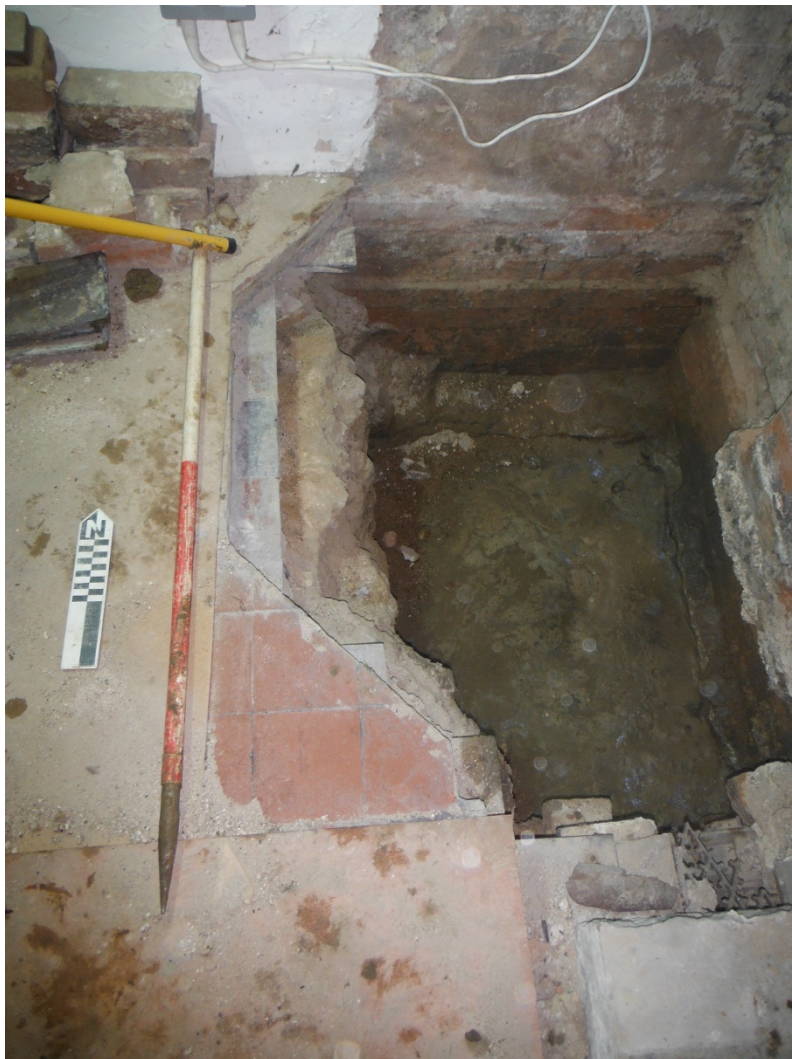
**Figure 10 Floors {023} and {025}**

4.4.2 The east facing section of the underpinnings revealed floors in two different levels. The lower floor {023}, comprising alternate blue and red rectangular floor tiles, was situated on top of a thick layer of concrete {022}. The higher-level floor {025} consisted of red rectangular tiles forming a simple straight lay pattern (Figure 10). Both floor levels were placed on thin (20mm) foundations, (026) and (024), consisting of concrete compound.

5.5 Two floors, {023} and {025} were encountered inside the church nave, indicating refurbishment works. The new floor shares stylistic similarities with the old (shape and the size of tiles). The new surface has a dissimilar design, consisting of squared red tiles, as opposed to the previous design of alternate dark blue and red tiles. (Figure 9).

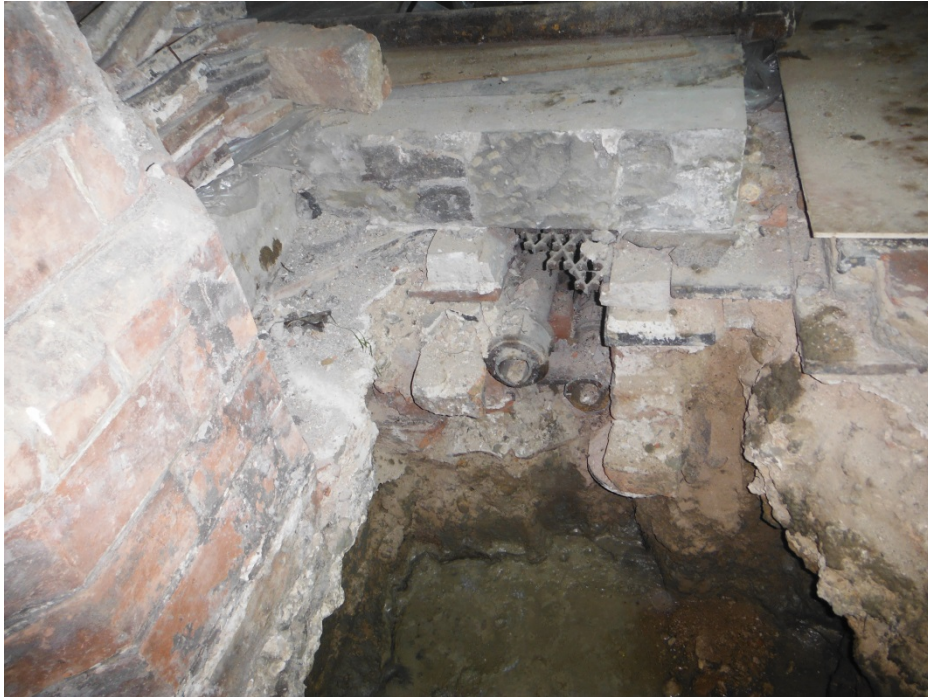
**Figure 11 Heating duct [020] system overlaid by the concrete floor of the chancel**

4.4.3 The north facing section revealed a heating system housed within a brick sited channel [020] covered with a metal grate (Figure 10 and plan 1 in Figure 14). The channel comprises three courses of bricks laid in stretcher bond and runs along the north-south axis of the church between the nave and the chancel. The heating system cuts through the primary floor of the nave (026) and it is overlaid by a thick concrete block forming the floor of the chancel.

5.6 Heating duct [020], running across the north-south axis of the church (between the nave and the chancel), post-dates the initial construction of the church since it is a later insertion (Figure 10). The system is sealed by the concrete floor of the chancel, which overlays the metal grate of the duct, suggesting that at a later stage the heating system was deactivated or decommissioned.

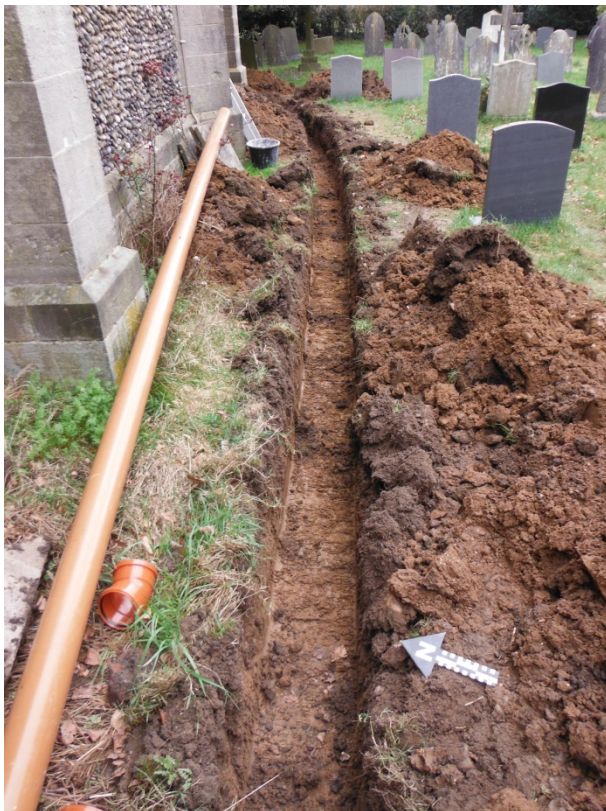
**Figure 12 Trench for new storm drain, looking east**

4.5.1 The trench for the new storm drain starts directly to the east of the church porch and it runs approximately 1 meter off the church wall along the south and east side (Figure 2). The excavation revealed multiple phases of drainage.

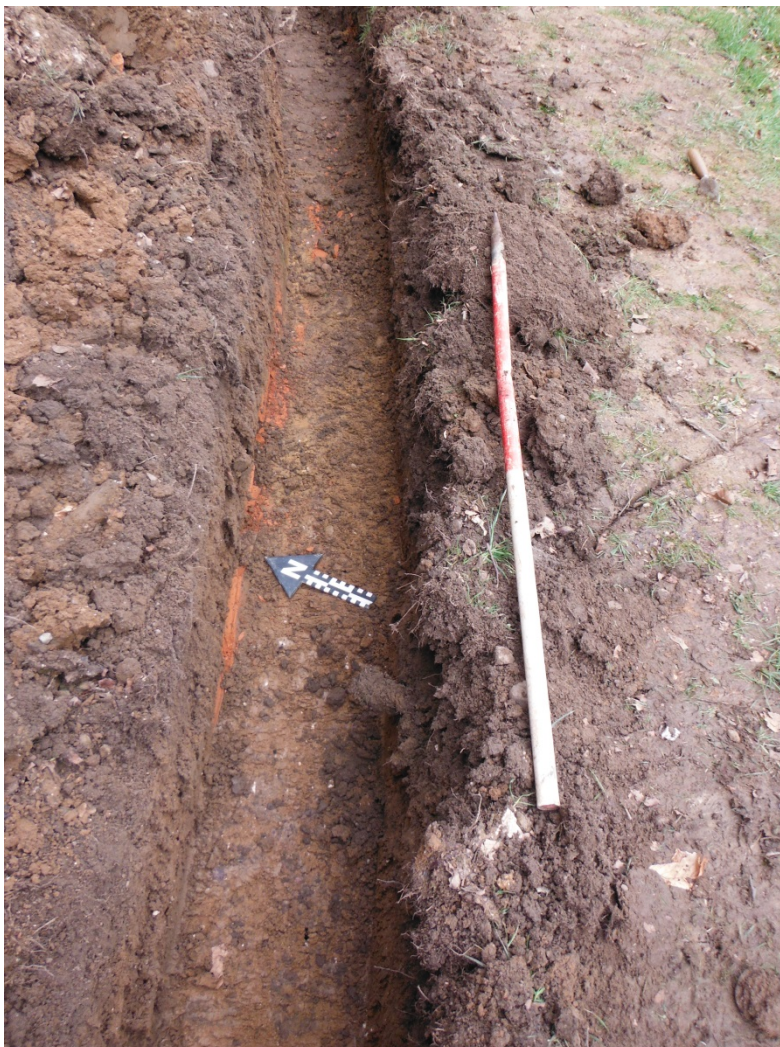
Figure 15 Drain (034) visible in the trench for the new storm drain, looking east

4.5.3 A third drain (034) was identified in the new trench on an east to west alignment. This poorly preserved drain was observed for a distance of 1.5m.
