LEVEL 2 HISTORIC BUILDING RECORD

The Toll House, Folly Bridge, Oxford, OX1 4LB

AHC REF: PM/9815

Date: October 2019

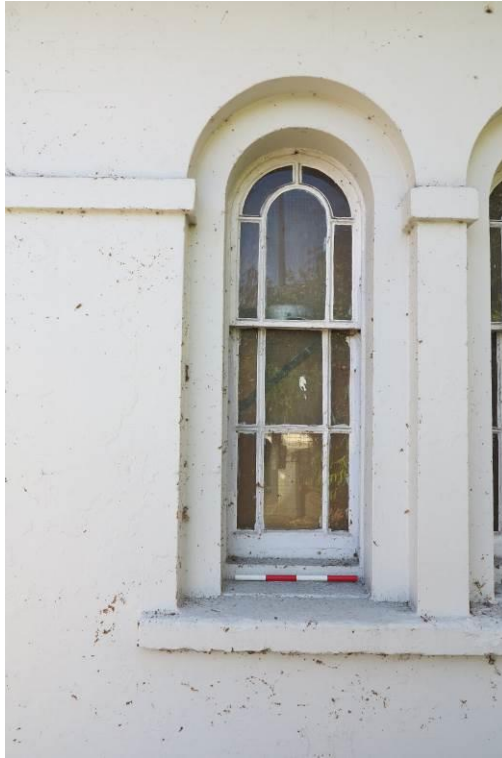
- 2.24 The northern elevation also incorporates a projecting gable and the paired, round-headed windows here retain their original un-horned sashes (some of the glass has been replaced with Georgian-wired glass) with marginal lights. Note the deep, stepped reveals to these windows and the plat-band that continues onto the jamb between the two.

Plate 7. Detail of window on northern elevation

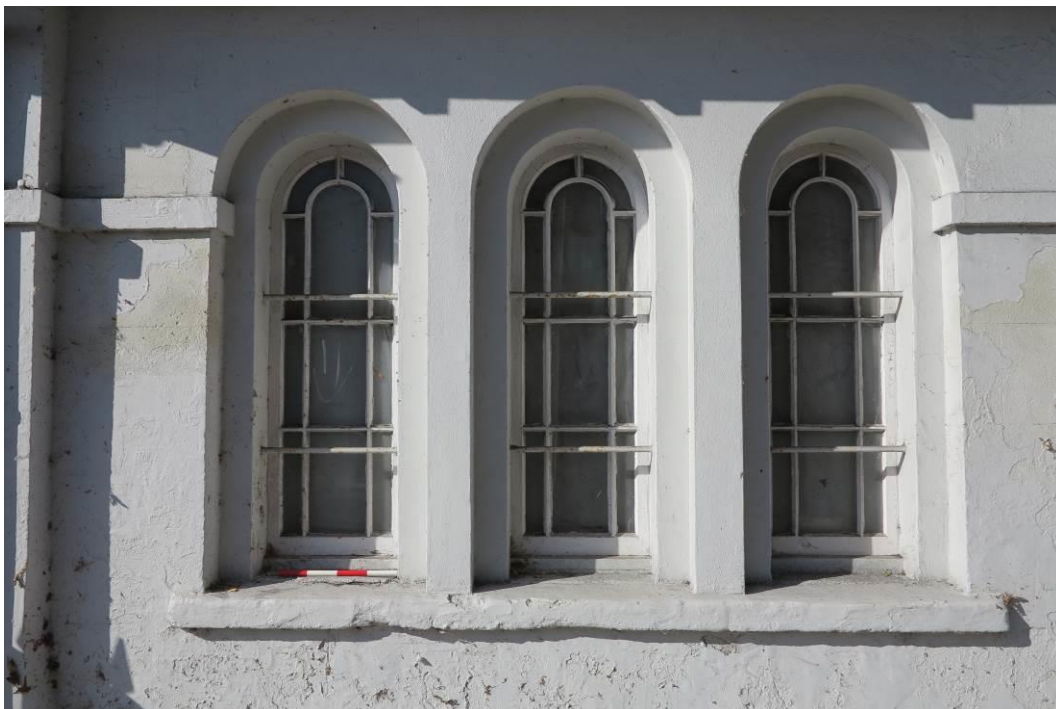
- 2.25 Compare this with the windows on the eastern elevation, where the deep reveals remain but the plat-band does not continue across the jambs, suggesting this has been rebuilt or refaced at some point.

Plate 8. Detail of windows on eastern elevation

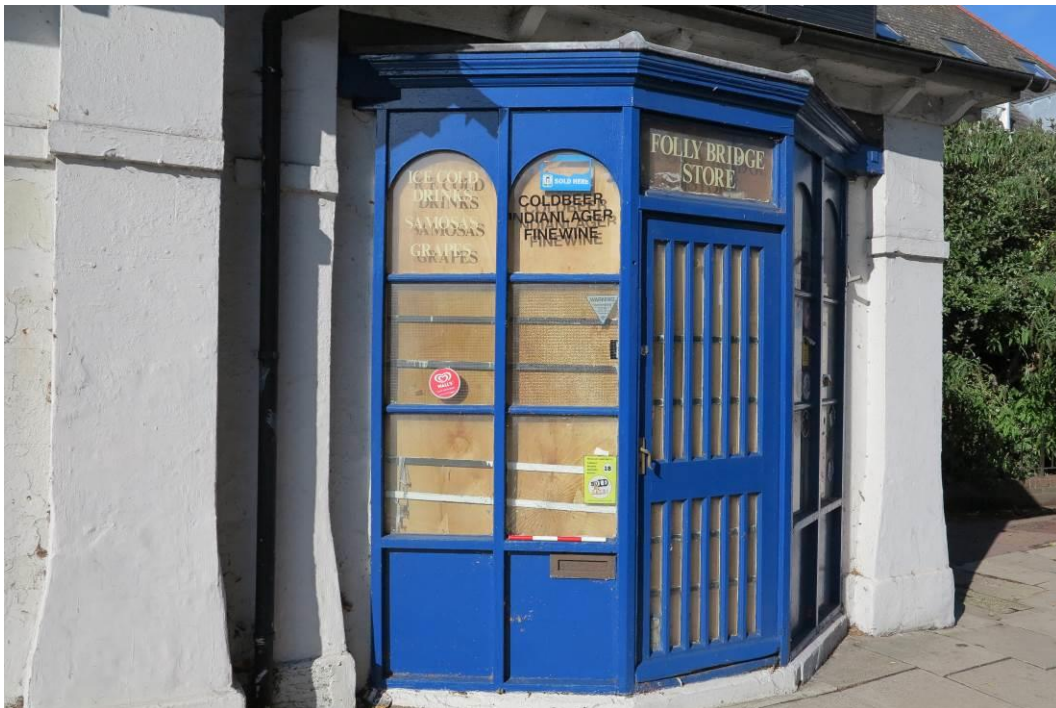
- 2.22 The bracketed eaves continue around the building and the bay to the south incorporates a timber shop frontage. This is a canted bay with round-headed windows and a central door. As noted above (and as shown on **Appendix 3**), this shop frontage was in place by the late 19th-/early 20th-century but it has clearly been renewed since.

Plate 10. Detail of shop frontage on eastern elevation

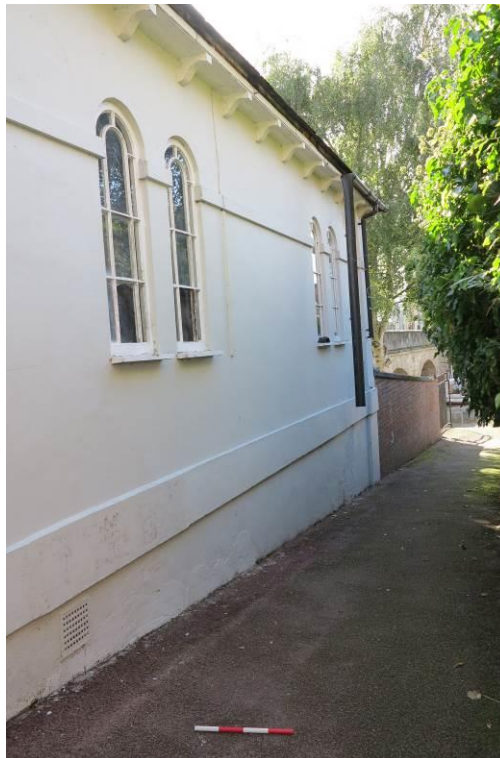
- 2.26 Also, note the western elevation, which the planning history indicates was rebuilt in the early 1980s (see paragraph 2.14 above), where the windows are set within very shallow reveals (and are boarded internally), with modern timber cills, and the moulded brackets to the eaves have a deeper profile than those elsewhere on the building.

Plate 11. General view of western elevation. Note the eaves brackets have a deeper profile than on the other elevations

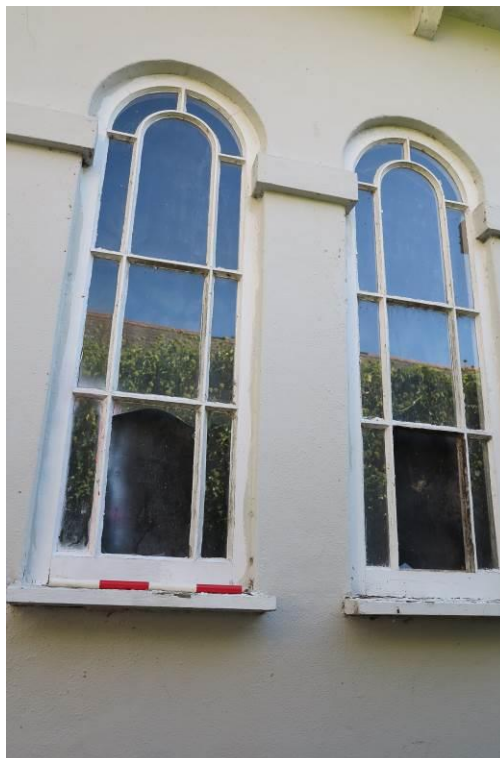
Plate 12. Detail of modern windows with shallow reveals on western elevation

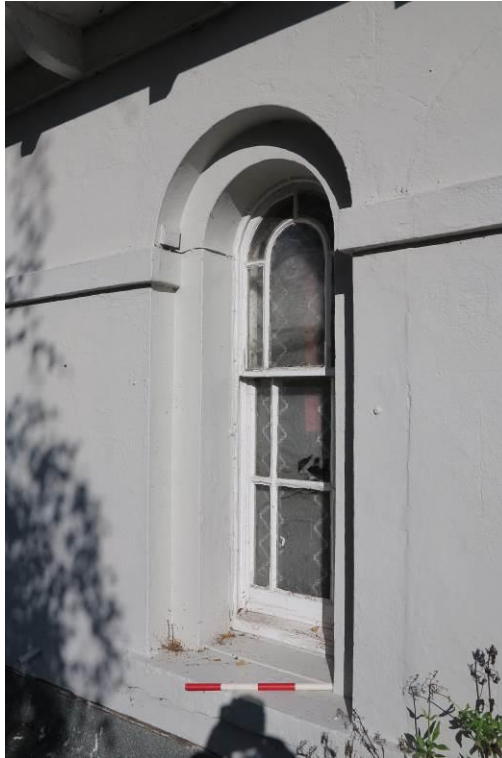
- 2.28 The original, unhorned sash window with marginal glazing remains in place and the location of an adjacent blocked window can clearly be seen in the stucco. The blocking of this window presumably relates to the insertion of the adjacent doorway, which must relate to the formation of the steps and boatshed in the late 20th century. The iron railings at the top of the stairs, shown on the late 19th-/early 20th-century plan at **Appendix 3**, have been adapted to incorporate a gateway but are otherwise identical to those found on the other side of the bridge.

Plate 15. Detail of window on southern elevation

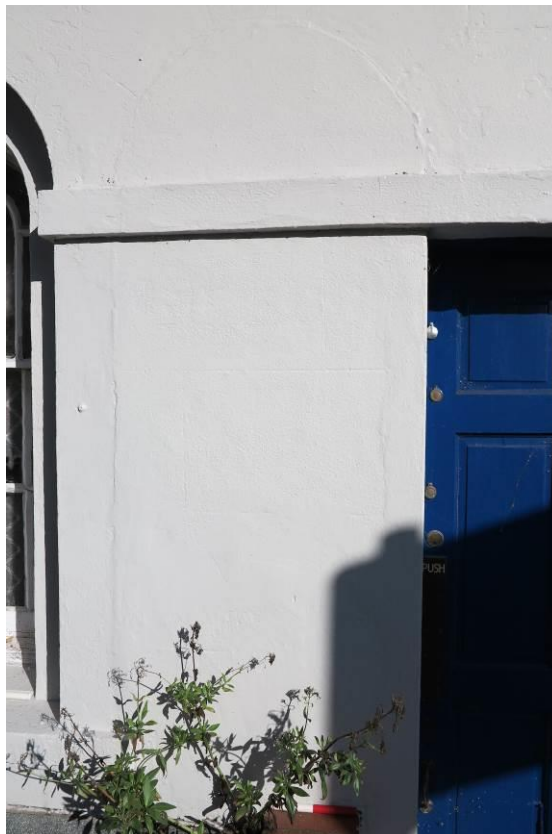
Plate 16. Blocked window opening on southern elevation

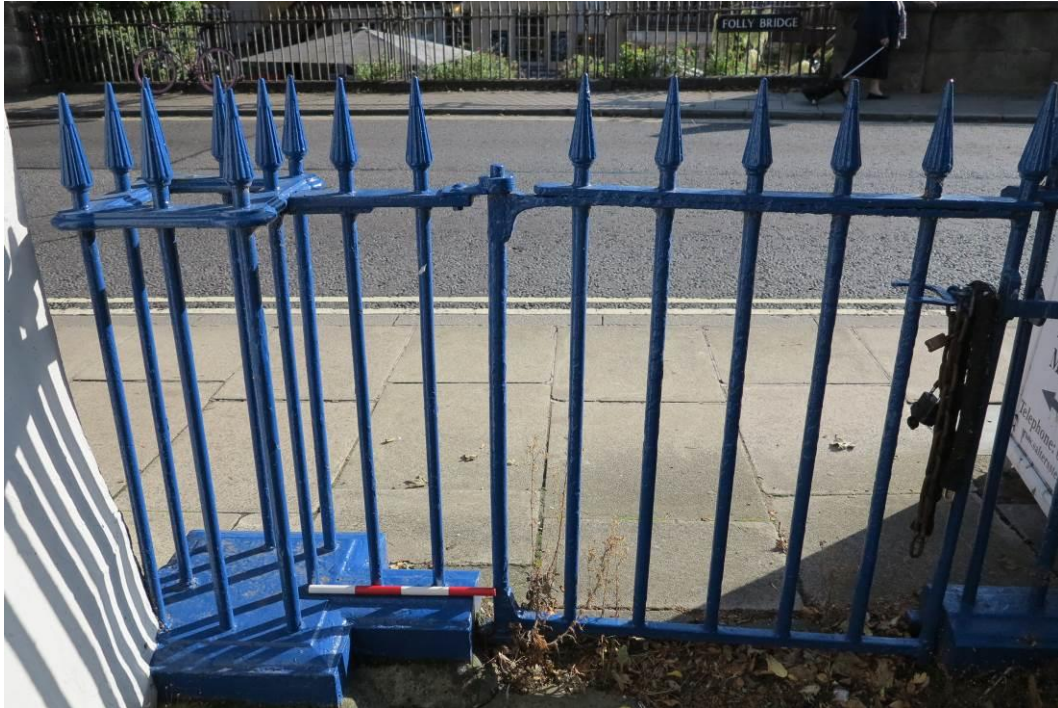
Plate 17. The bridge railings have been converted into a gateway, presumably when the steps were erected

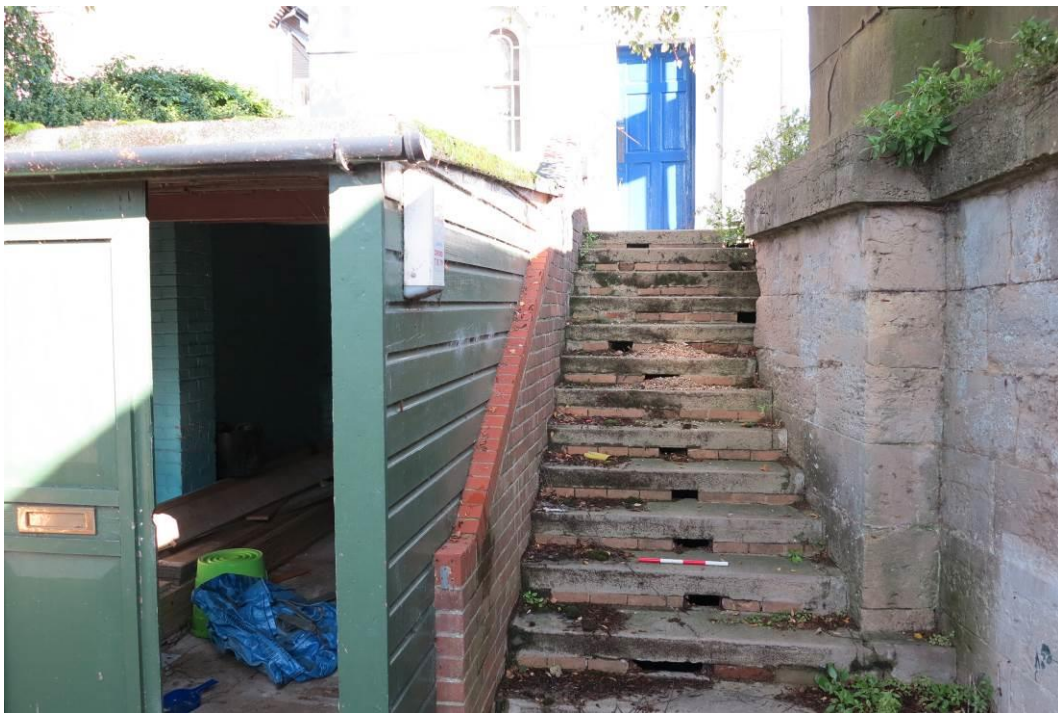
- 2.29 The steps are constructed in brick with concrete treads and are built against the stone wall of the bridge. The boatshed is constructed in match-boarded timber built onto the brick balustrade.

Plate 18. Late 20th-century steps in the yard with boathouse to the left

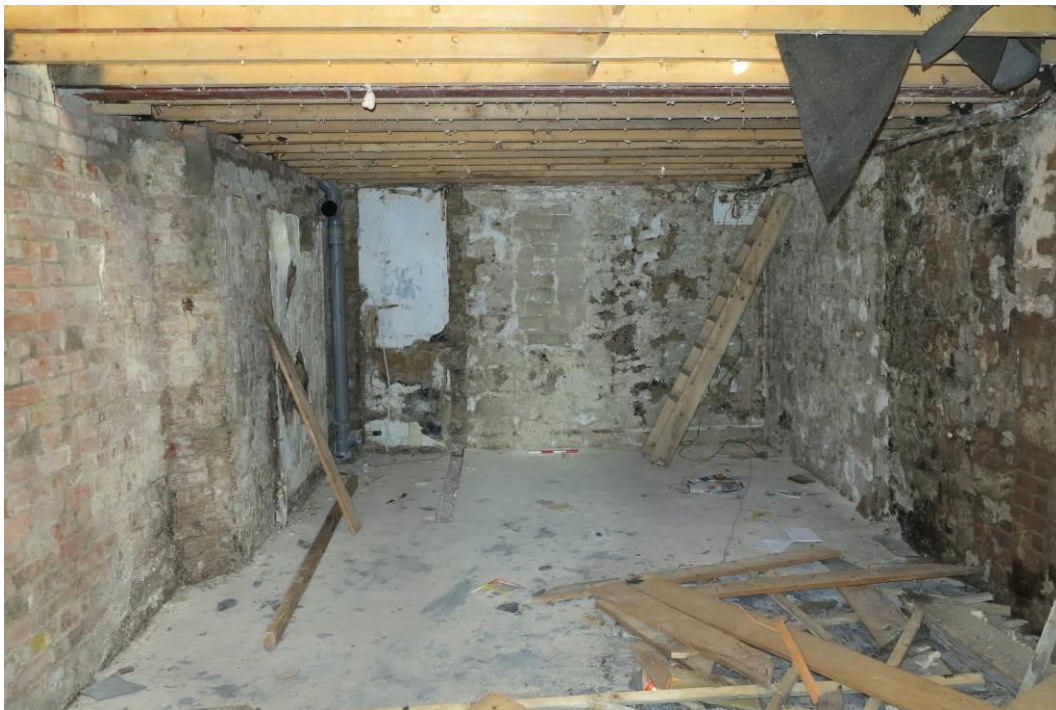
Plate 24. General view looking northwards, note the transition to stone construction level with change in wall thickness to the left

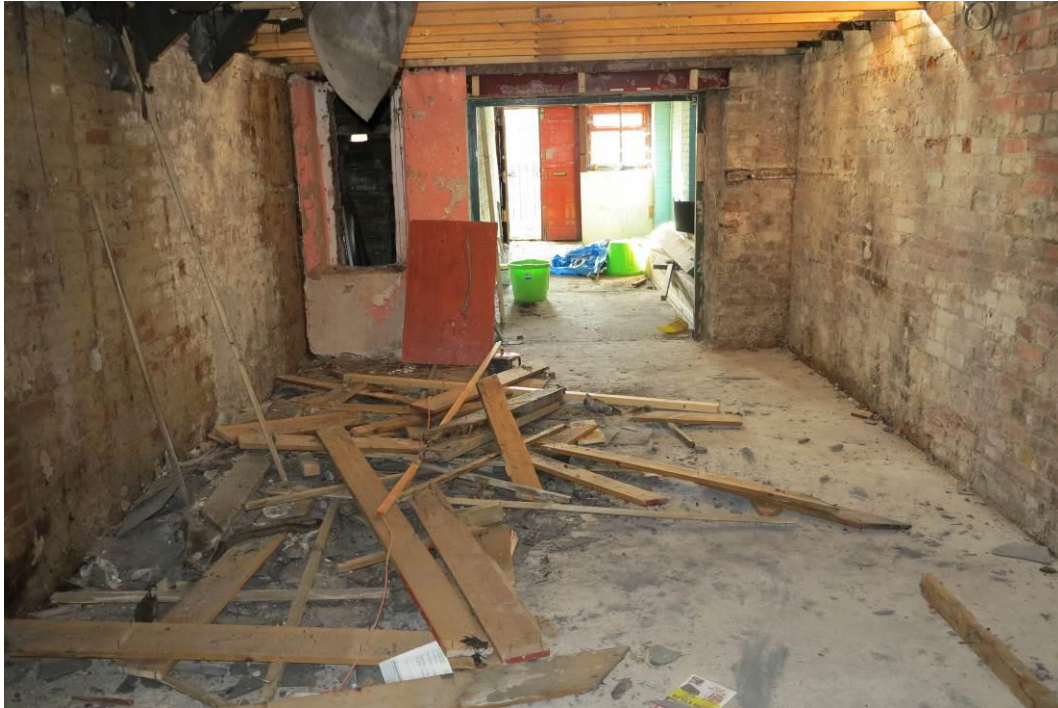
- 2.15 The steel lintel to the double-door opening on the southern elevation (now contained within the boatshed at basement level) is of the same character as the steels found within the main portion of the building, suggesting that they are contemporary with the creation of this opening and presumably relate to the rebuilding of the western elevation.

Plate 25. General view looking southwards. Note the steel lintel to the boatshed opening and, to the left of this, access to the under-stair area

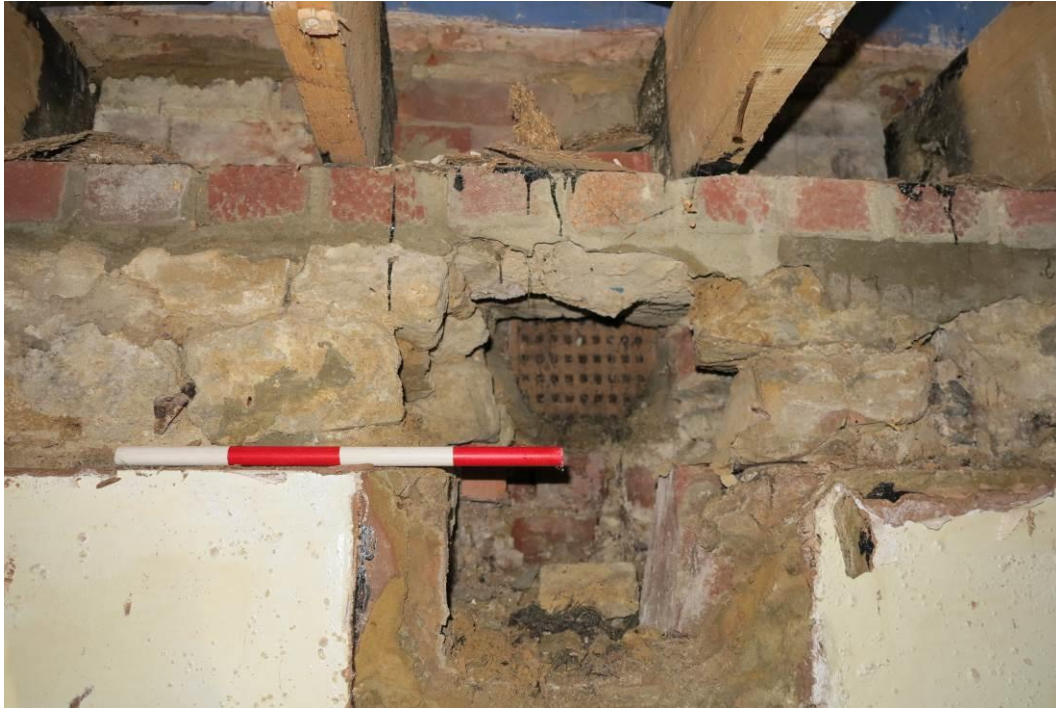
- 2.35 Although floorboards have been removed, the joists to the ground floor remain and are all modern, circular-sawn timbers resting on late 20th-century brickwork. The remaining ground-floor partition, which is constructed in concrete blockwork, is supported on a steel beam and no doubt dates from the 1980s' alterations.

Plate 27. Detail of rubblestone construction at the northern end of the basement. Note the modern joists above resting on a course of late 20th-century brickwork

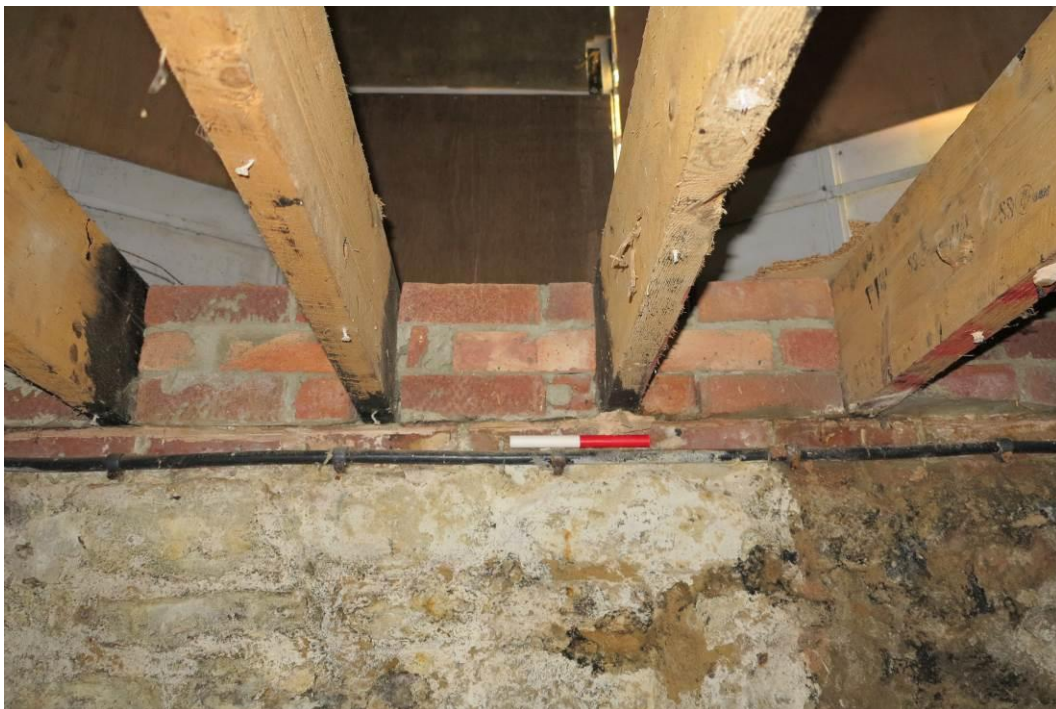
Plate 28. Modern joists to ground floor

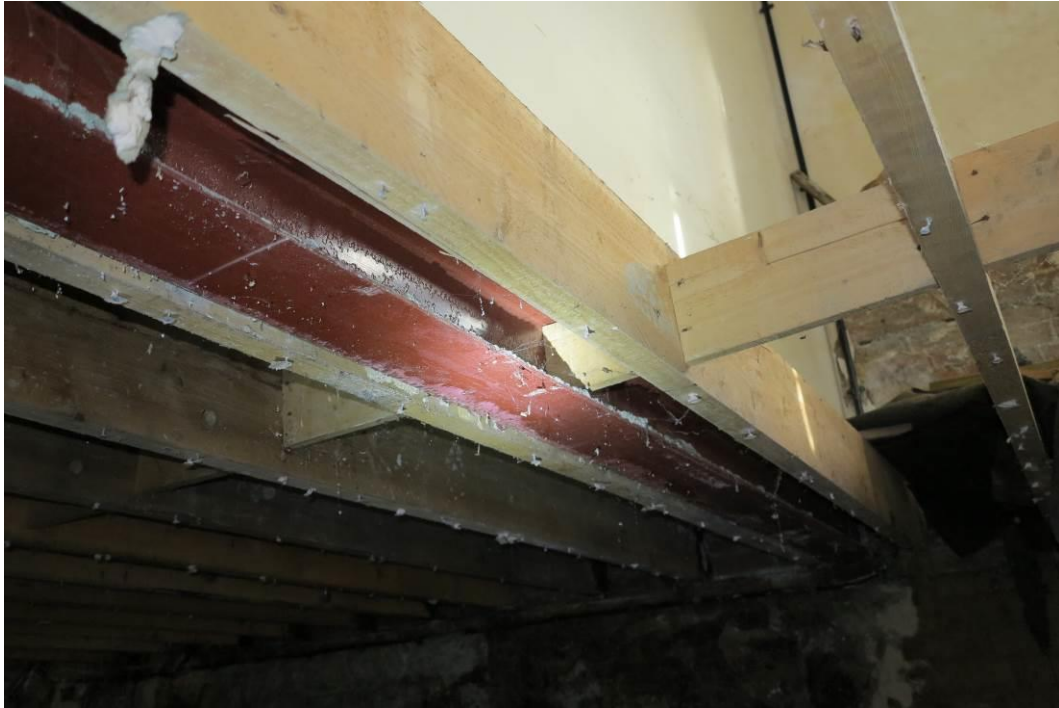
Plate 29. Steel beam supporting blockwork partition to ground floor

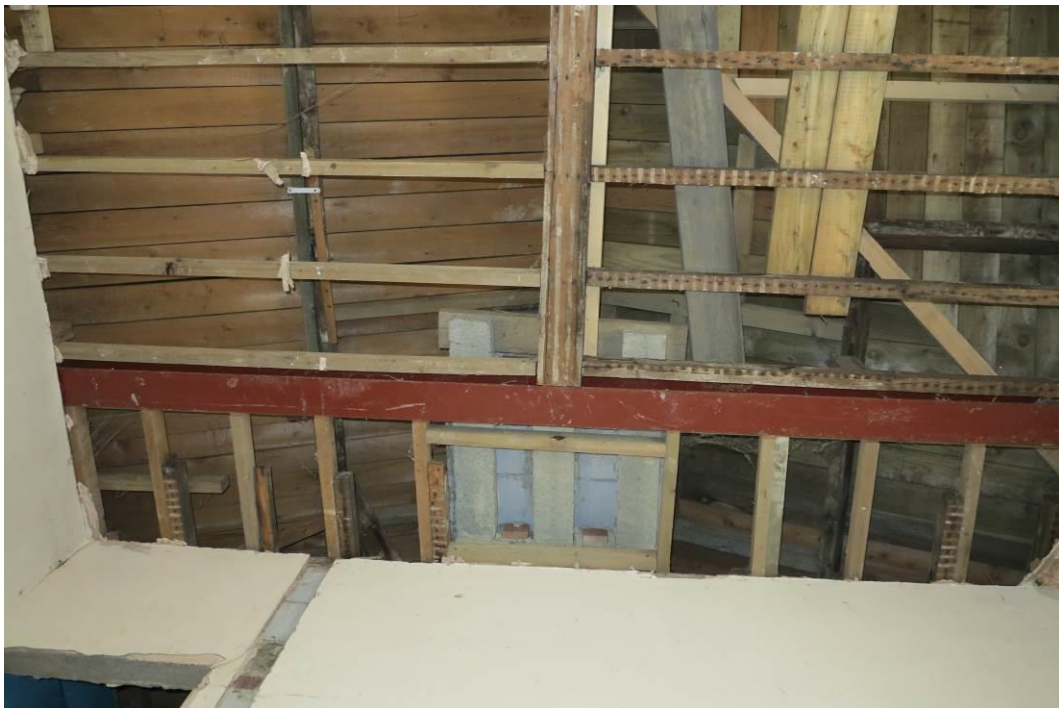
Plate 30. Blockwork partition to ground floor, from south. Note the steel beam above. The concrete slats to the north of the beam (bottom of image) support the truncated stack

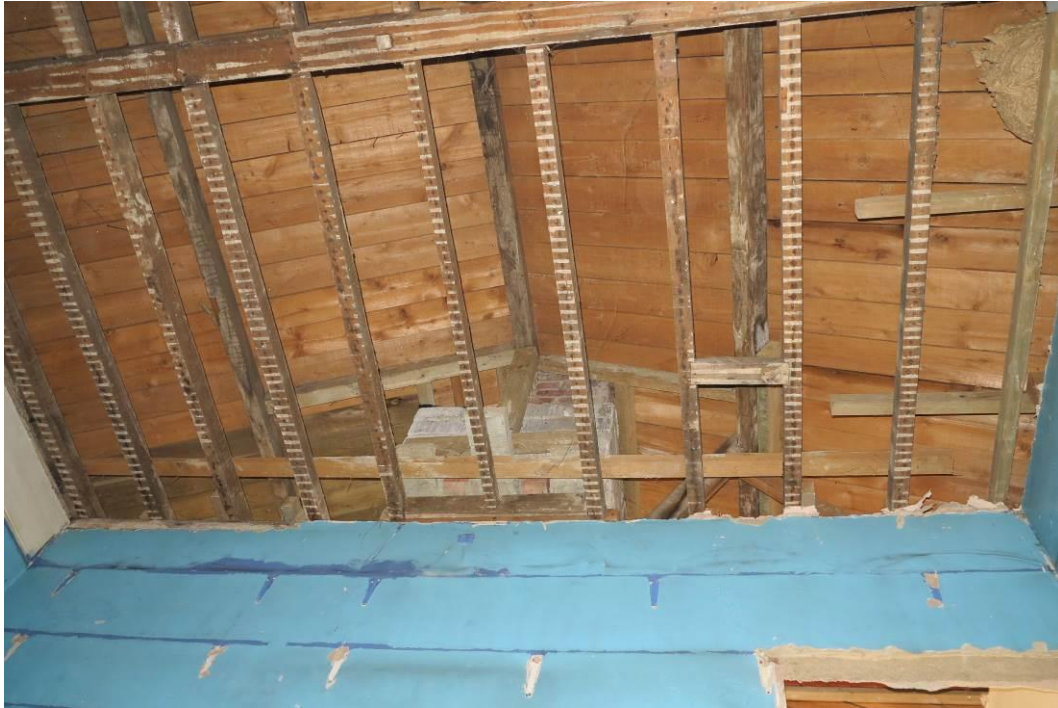
- 2.38 Other than this steel, the roof structure incorporates a mix of 19th-century and late 20th-century timbers, the latter of which have been 'bodged' around the retained element of the stack. Trusses are 'king posts' of the type commonly found from the late 18th-century onwards, with raking struts resting on a splayed base.

Plate 31. General view of roof structure and ceiling joists from northern side of partition. Note the 'bodged' timbers around the truncated stack

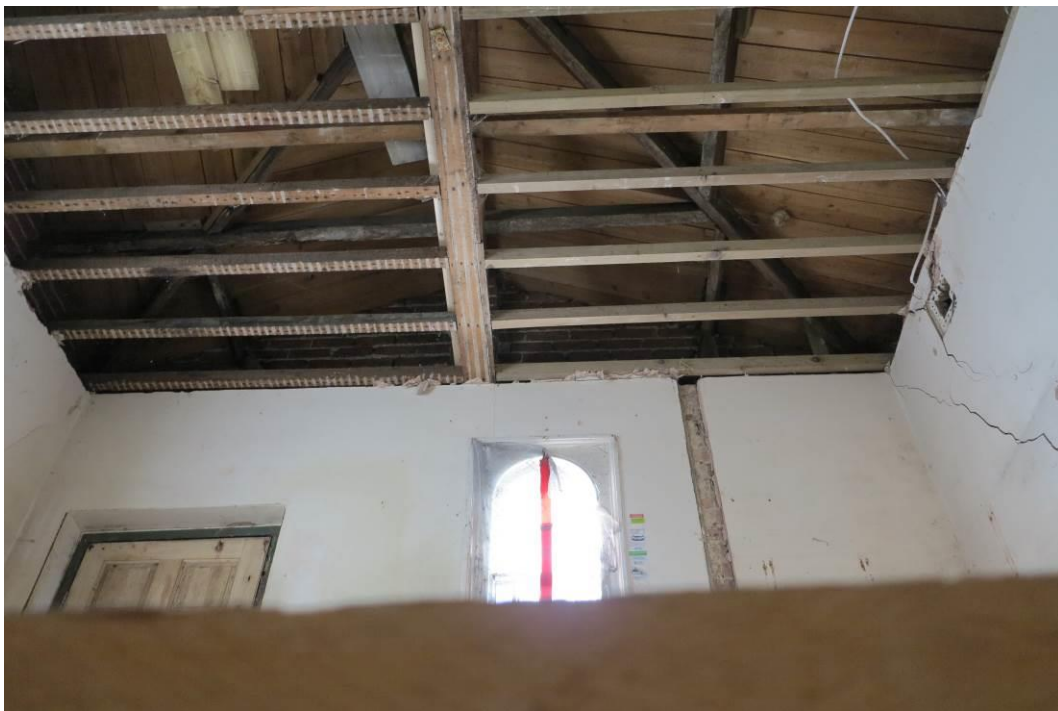
- 2.37 There is nothing of interest remaining at ground-floor level. The ceiling above has been removed and joists on the eastern side of the building appear to be of 19th-century date while those on the western side are modern, presumably relating to the rebuilding of the western elevation in the 1980s. The earlier timbers show lath marks. As mentioned at paragraph 2.36 above, there is a further steel at tie-beam level, to the south of the central partition.

Plate 32. General view of the southern room. Note the ceiling joists have been replaced on the western side of this area (right of image)

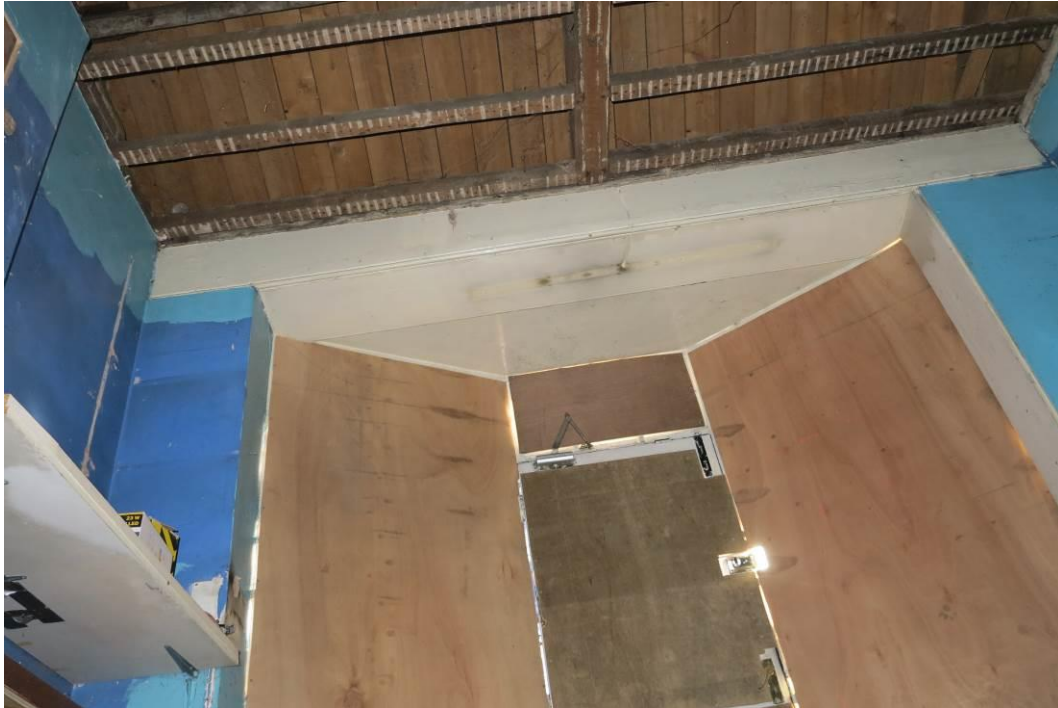
- 2.23 Indeed, the lintel is visible internally and appears to be a boxed-in steel (although it has not been possible to verify this, as it is only visible looking up from the basement), suggesting that the whole shop frontage may have been rebuilt in the late 20th century.

Plate 33. View of shop frontage on northern side of the eastern elevation from inside. What appears to be a boxed-in steel lintel suggests that the whole shop frontage may have been replaced in the 20th century
