Paved with Living Colour; Community Archaeological Investigations of the Godwin Tiles Factory

Report No. CHAC2013/02

Compiled By Christopher Atkinson *BA (Hons), MA*

December 2013

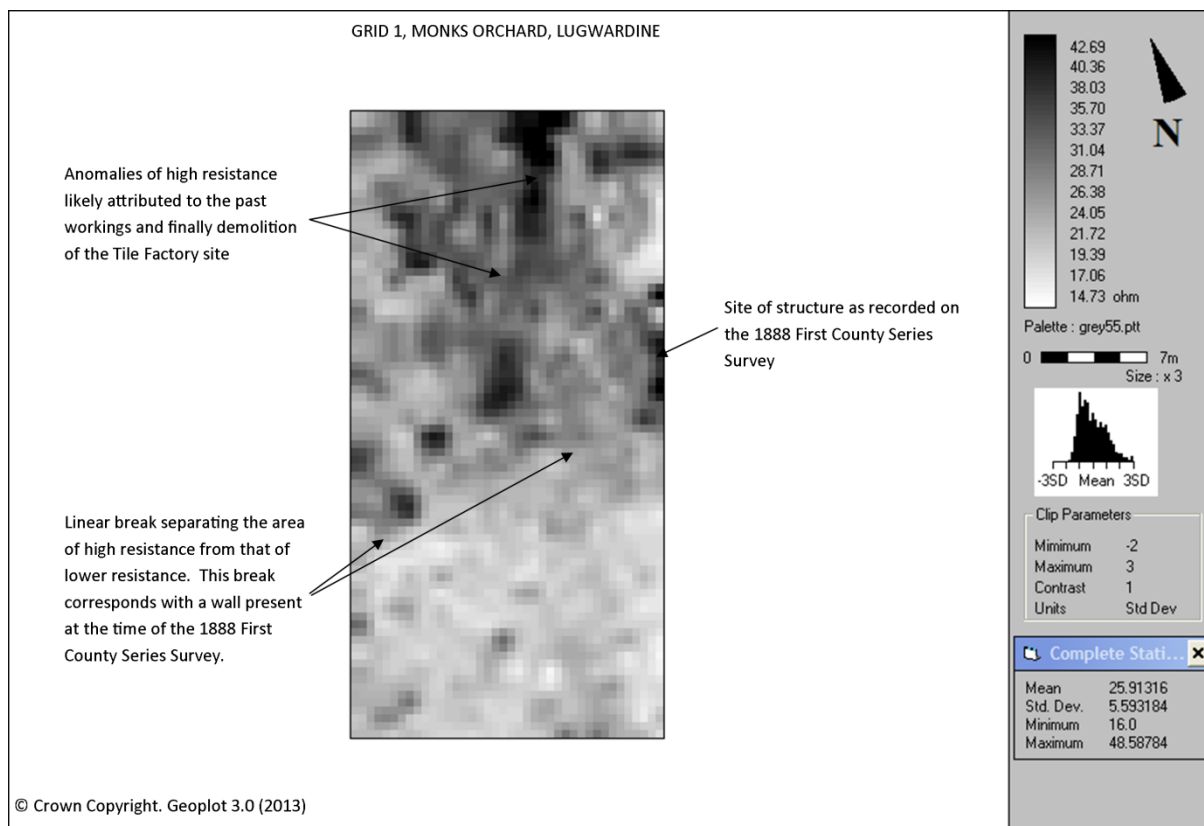
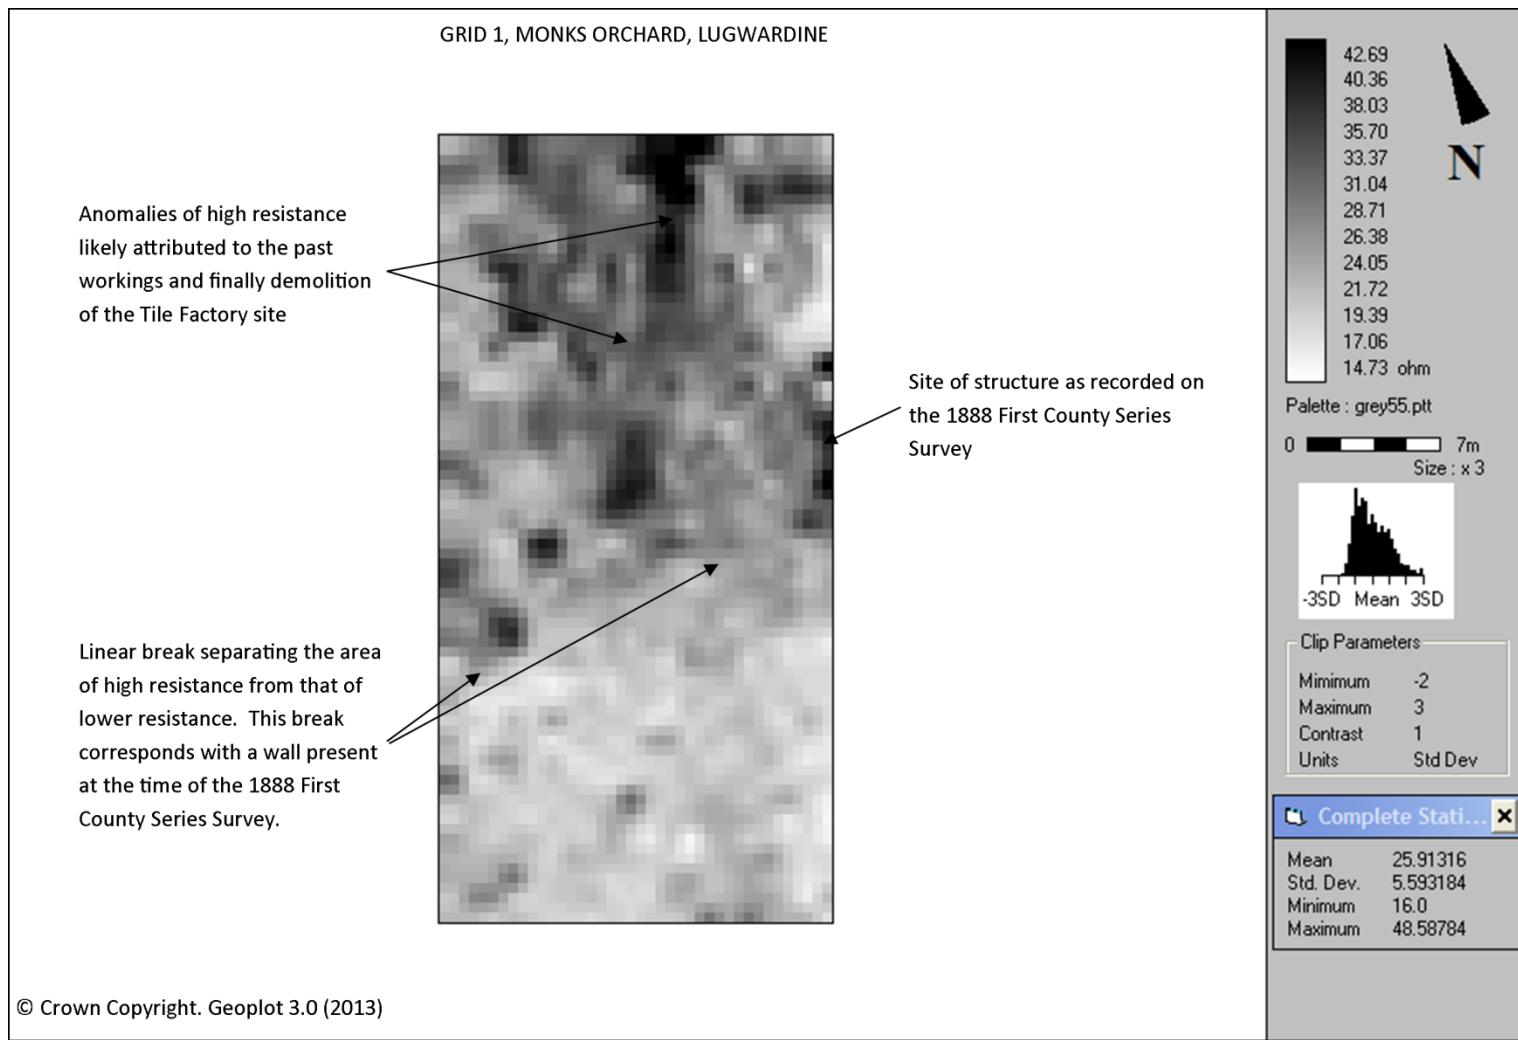
It is apparent from the results of the survey that following the closure of the factory in Lugwardine at around 1906 a substantial amount of demolition and landscaping work took place as highlighted by the multiple anomalies of high and low resistance across the north of the surveyed area (as represented by a concentration darker anomalies in figure 4). At the time of the survey the dense concentration of both nettles and thistles within the north of the survey area supports the idea of past ground disturbance.

Figure 4: Results of the resistance survey in Grid 1. © Crown Copyright. Geoplot 3.0 (2013)

Within the southern half of the survey area there is apparently less evidence for past ground disturbance (represented by the lighter coloured, uniform pattern). When these results are matched with the 1888 First County Series Survey (figure 2) it is clear that the lighter area of less resistance laid outside of the tile factory complex and within an orchard. The division between the two areas was marked by a wall, which although now removed its original position is marked by the break between the areas of high resistance in the north of Grid 1 and the areas of lower resistance to the south (figure 4).

An linear anomaly of high resistance within the east of the surveyed area marks the location of a structure present on the site at the time of the 1888 First County Series Survey (figure 2).

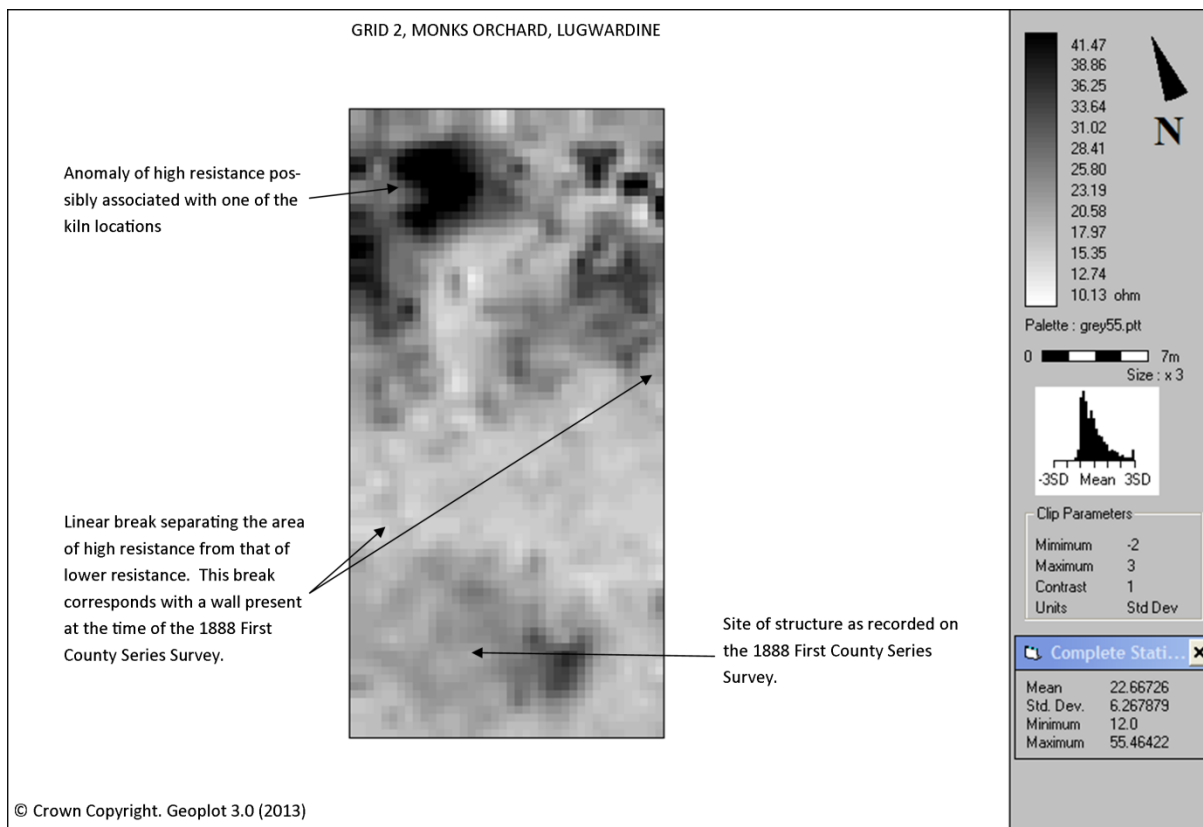
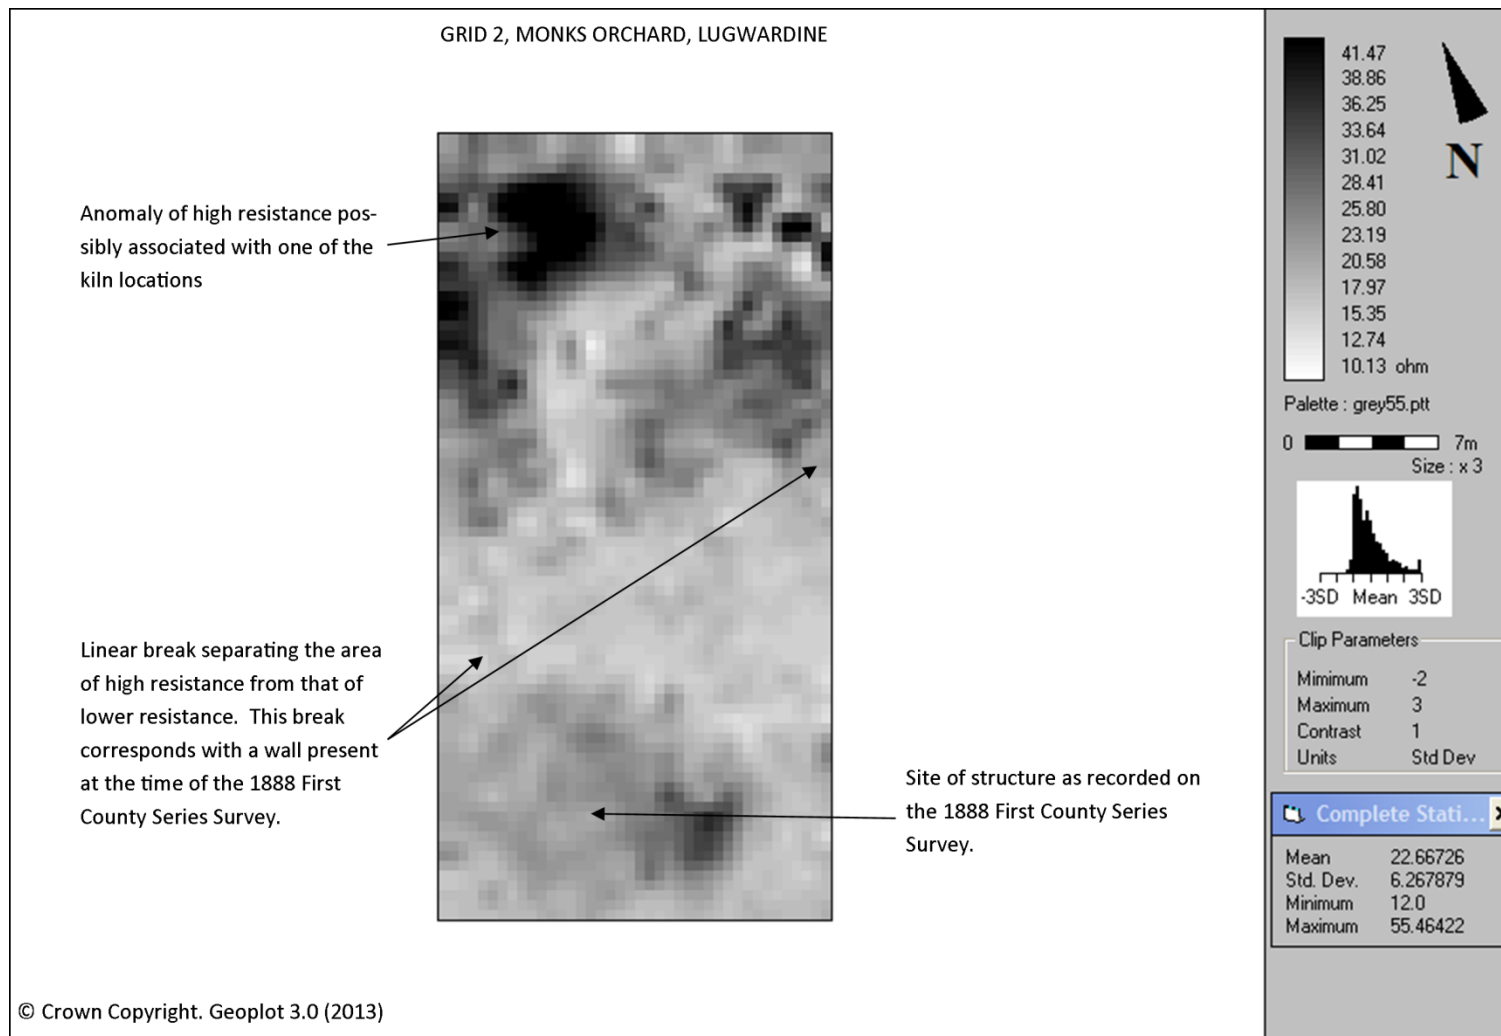
Grid 2 to the east of the lane was centred to identify the existence of features associated to the kiln and structure recognisable on the 1888 First County Series Survey (figure 2). The possible kiln site was represented by an area of high resistance on the northern fringe of the surveyed area. The identified anomaly measured approximately 5m diameter.

Within the south of the survey area the site of a structure (figure 2) is represented a number of subtle anomalies of high resistance that appear to mark the course of walls outlining a number of rooms. The subtleness of the anomaly may suggest the feature's foundations have been substantial removed.

Figure 5: Results of the resistance survey in Grid 2. © Crown Copyright. Geoplot 3.0 (2013)

As with the survey in Grid 1 the course of the original boundary separating the factory from an orchard associated with Porch Farm to the south (figure 2) is evident from the distinct linear break in the values of soil resistance. The concentrations of higher resistances are clearly linked to ground disturbance associated to the activity of the tile factory.

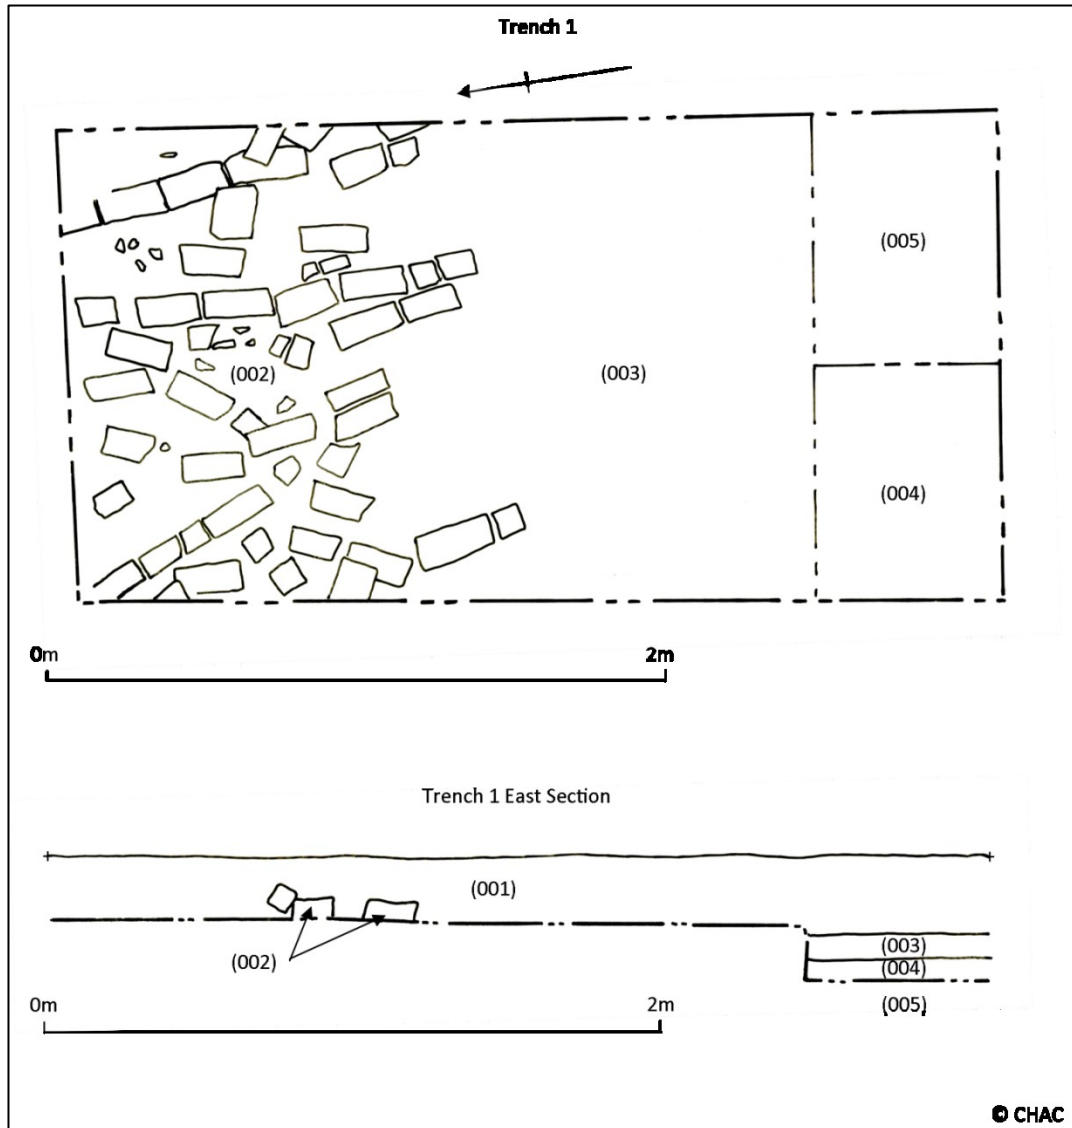
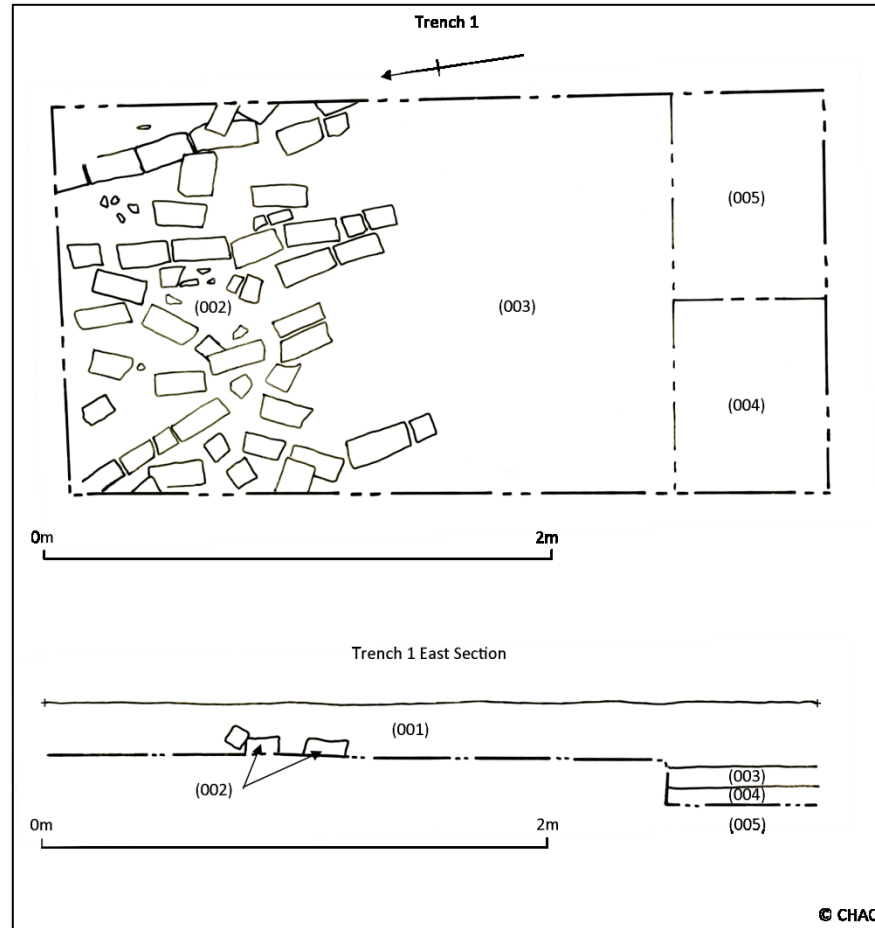
Figure 7: Plan and Section Plan of Trench 1 detailing the location of the brick surface (002). © CHAC

Directly beneath the topsoil was a laid brick surface consisting of vitrified engineer bricks; each of which measured 9.5cm wide x 21.5cm long x 7.2cm thick. The bricks lay side on (north-south orientation) and packed tightly with no evidence of

mortar having been used to bond them (figure 8). The partially revealed surface that extends beyond the trench to the north, east and west was truncated at three locations. Each truncation was spaced equidistant and orientated roughly north-south consisting of a void where the bricks had been upturned and dislodged. It is likely this was caused as a result of the attempted ploughing of the site (this was

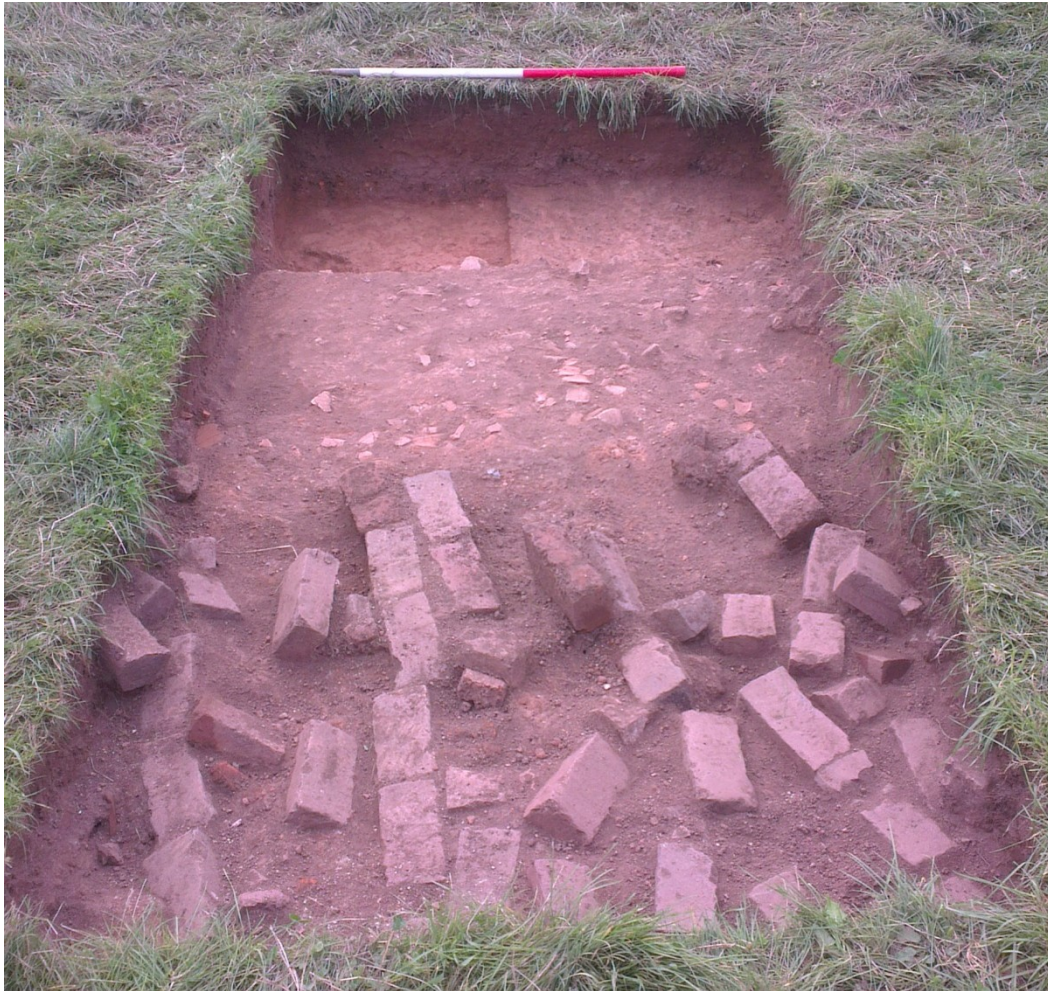
Figure 8: Trench 1 viewed from the north highlighting the extent of the laid brick surface (002). The clay subsoil (005) can be seen in the top left corner of the trench. © CHAC

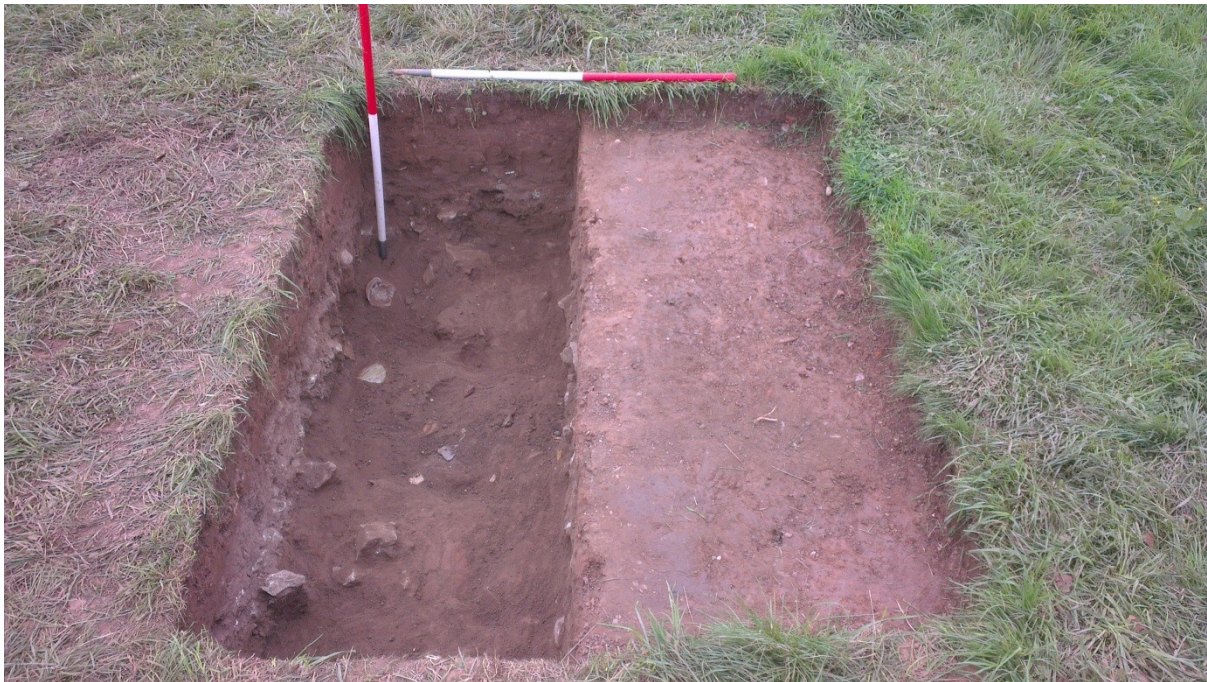
Figure 9: Trench 2 viewed from the north indicating the mixed clay/silt debris filled deposits (004 and 005). © CHAC

The horizon (003) measured between 12cm (north) and 18cm thick (south) and contained a high density of stone rubble within a silty matrix. The horizon appears to represent the later phase in a period of demolition/dumping on the site which also includes the underlying horizons (004) and (005).

Both horizon (004) and (005) were difficult to distinguish apart due to the similarities in artefacts present as well as similarly loose compaction of the dark brown silt matrix that supported the artefacts. The horizon (004) measured between 8cm thick (south) and 18cm (north). Definition between the two horizons was determined by

The volume of tile and crucible fragment retrieved from the small area would suggest the layers represent either the demolition of a structure or the dumping of waste material onto the site following the removal of the building identified on the 1888 First County Series Survey (figure 2).

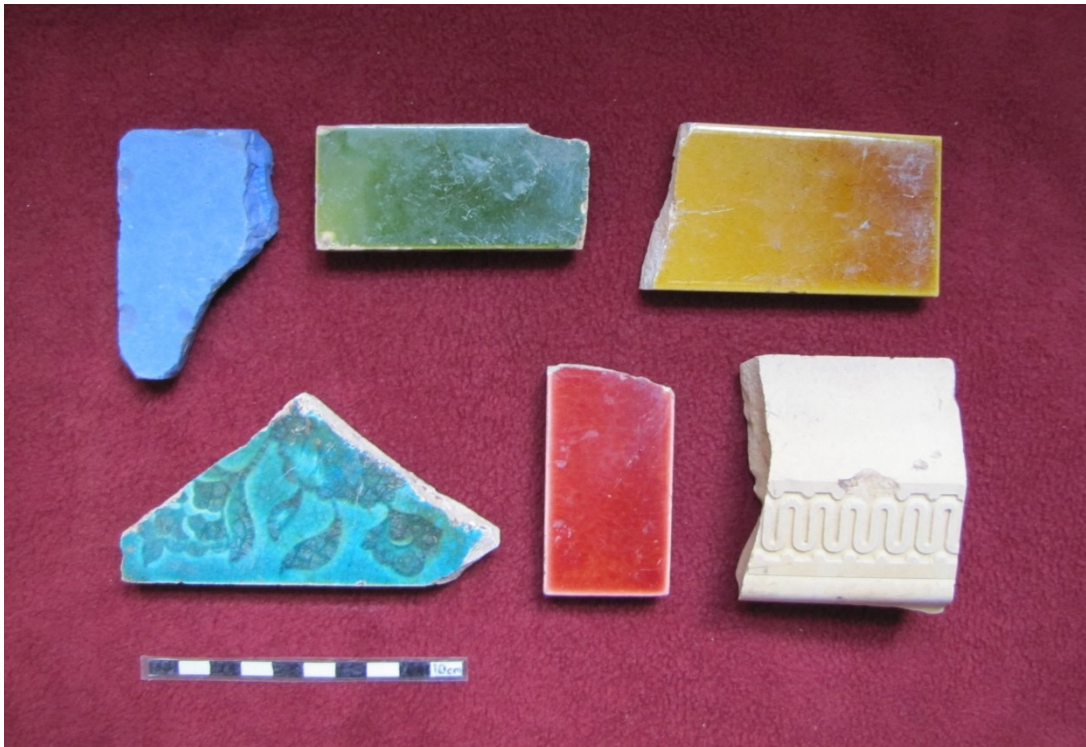
The majority of tiles encountered during the course of the excavation came from Trench 2. They consisted primarily of white clay border tiles and colourful floor and wall tiles of green, red and blue (figure 12).

Figure 12: Example of some of the tiles encountered during the excavation of Trench 2. © CHAC

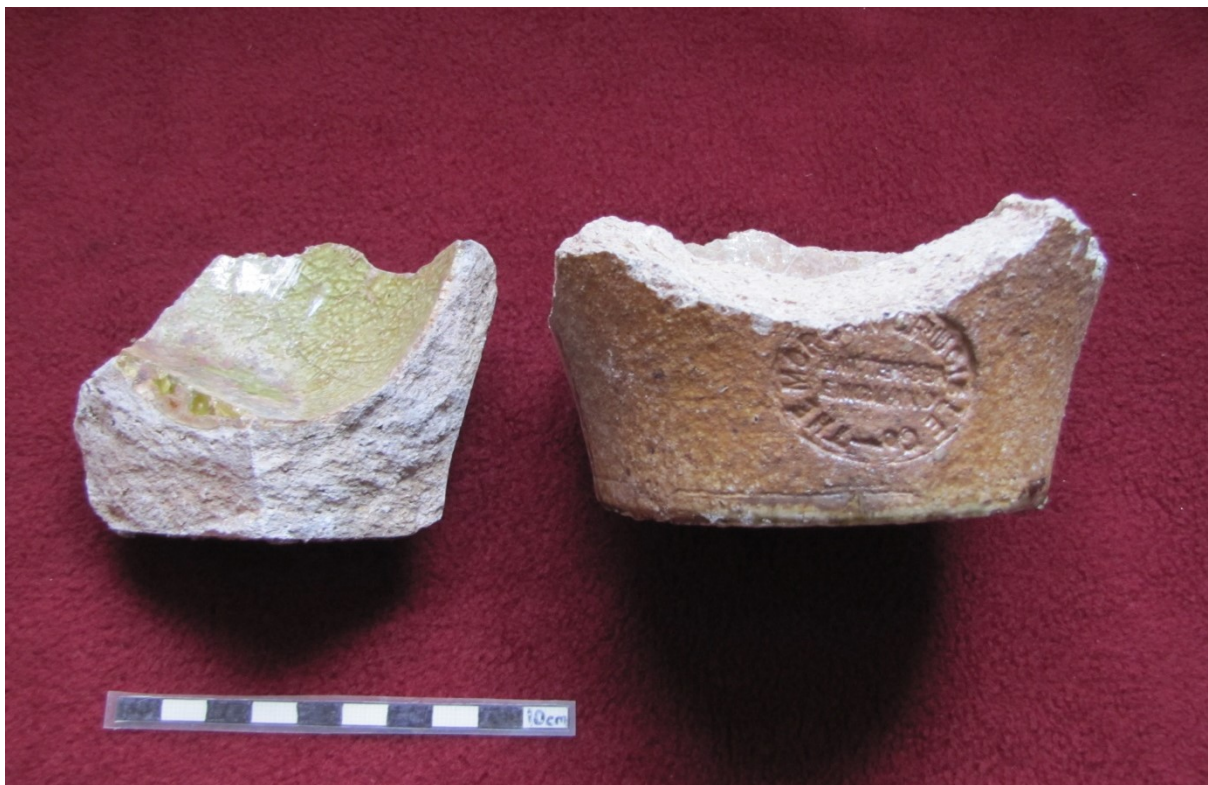
Associated with the tiles fragments within Trench 2 were multiple fragments of crucible. On two of the fragments the manufacturing stamp of The Morgan Crucible Company, Battersea, England survive (figure 13). Initially founded by the Morgan Brothers in 1856 to sell American-built crucibles, they quickly evolved to begin producing their own crucibles that served the needs not only of the Godwin Tiles but also the Royal Mint of England, India, France and Germany. Today the company continues to manufacture crucibles under trading name Morgan Advanced Materials (Morgan Advanced Material plc, 2014). The crucibles would have been essential as part of the lead-based glaze production method.

Figure 13: Example of the Morgan Crucible Company crucibles uncovered during the excavation. © CHAC

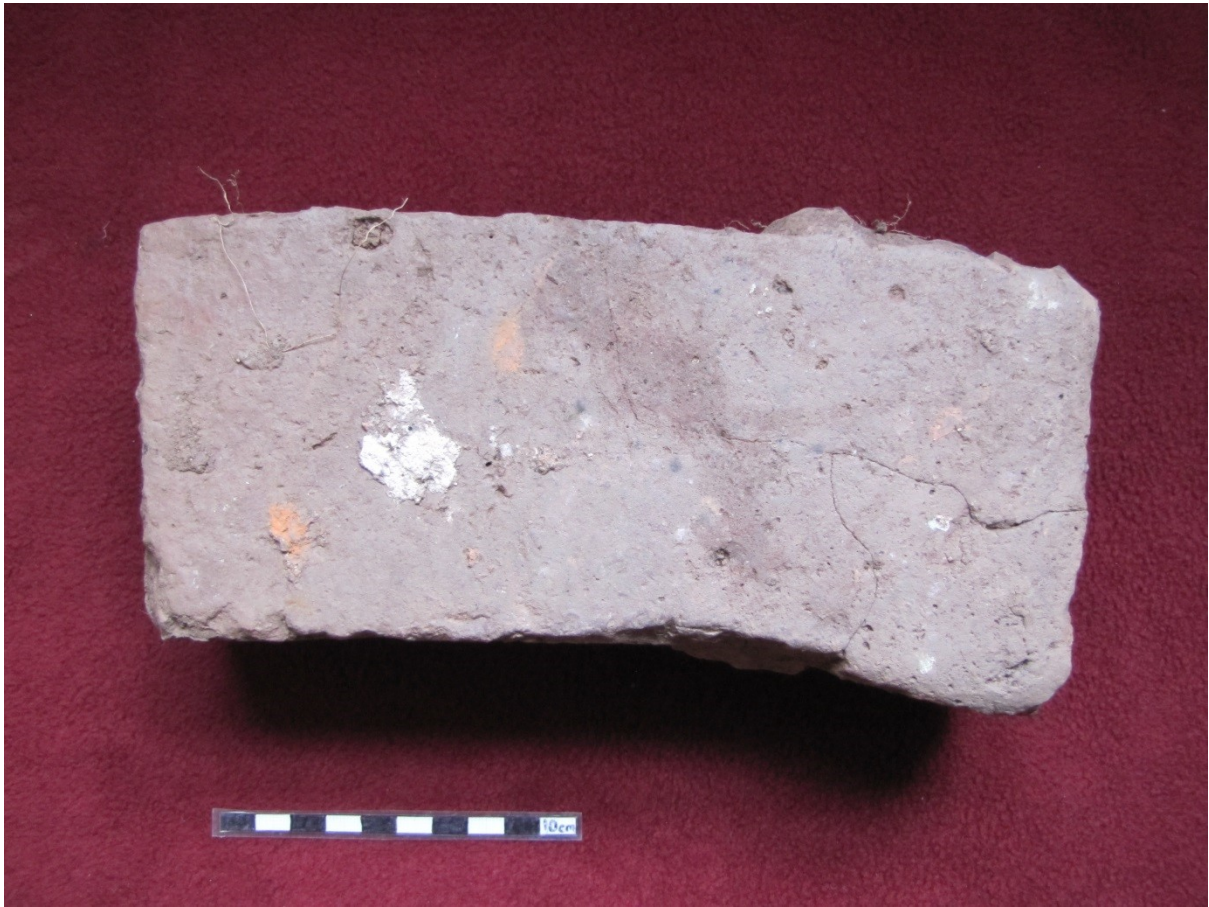
the kiln superstructure. Many of the bricks displayed characteristics of being vitrified causing them to have a bowed shaped appearance (figure 14).

Figure 14: Example of a vitrified engineering brick recovered from Trench 1. © CHAC
