1 BRIDGE STREET EVESHAM

AN INTERIM REPORT

JANUARY 1989

The City of Hereford Archaeological Unit
Town Hall,
Hereford

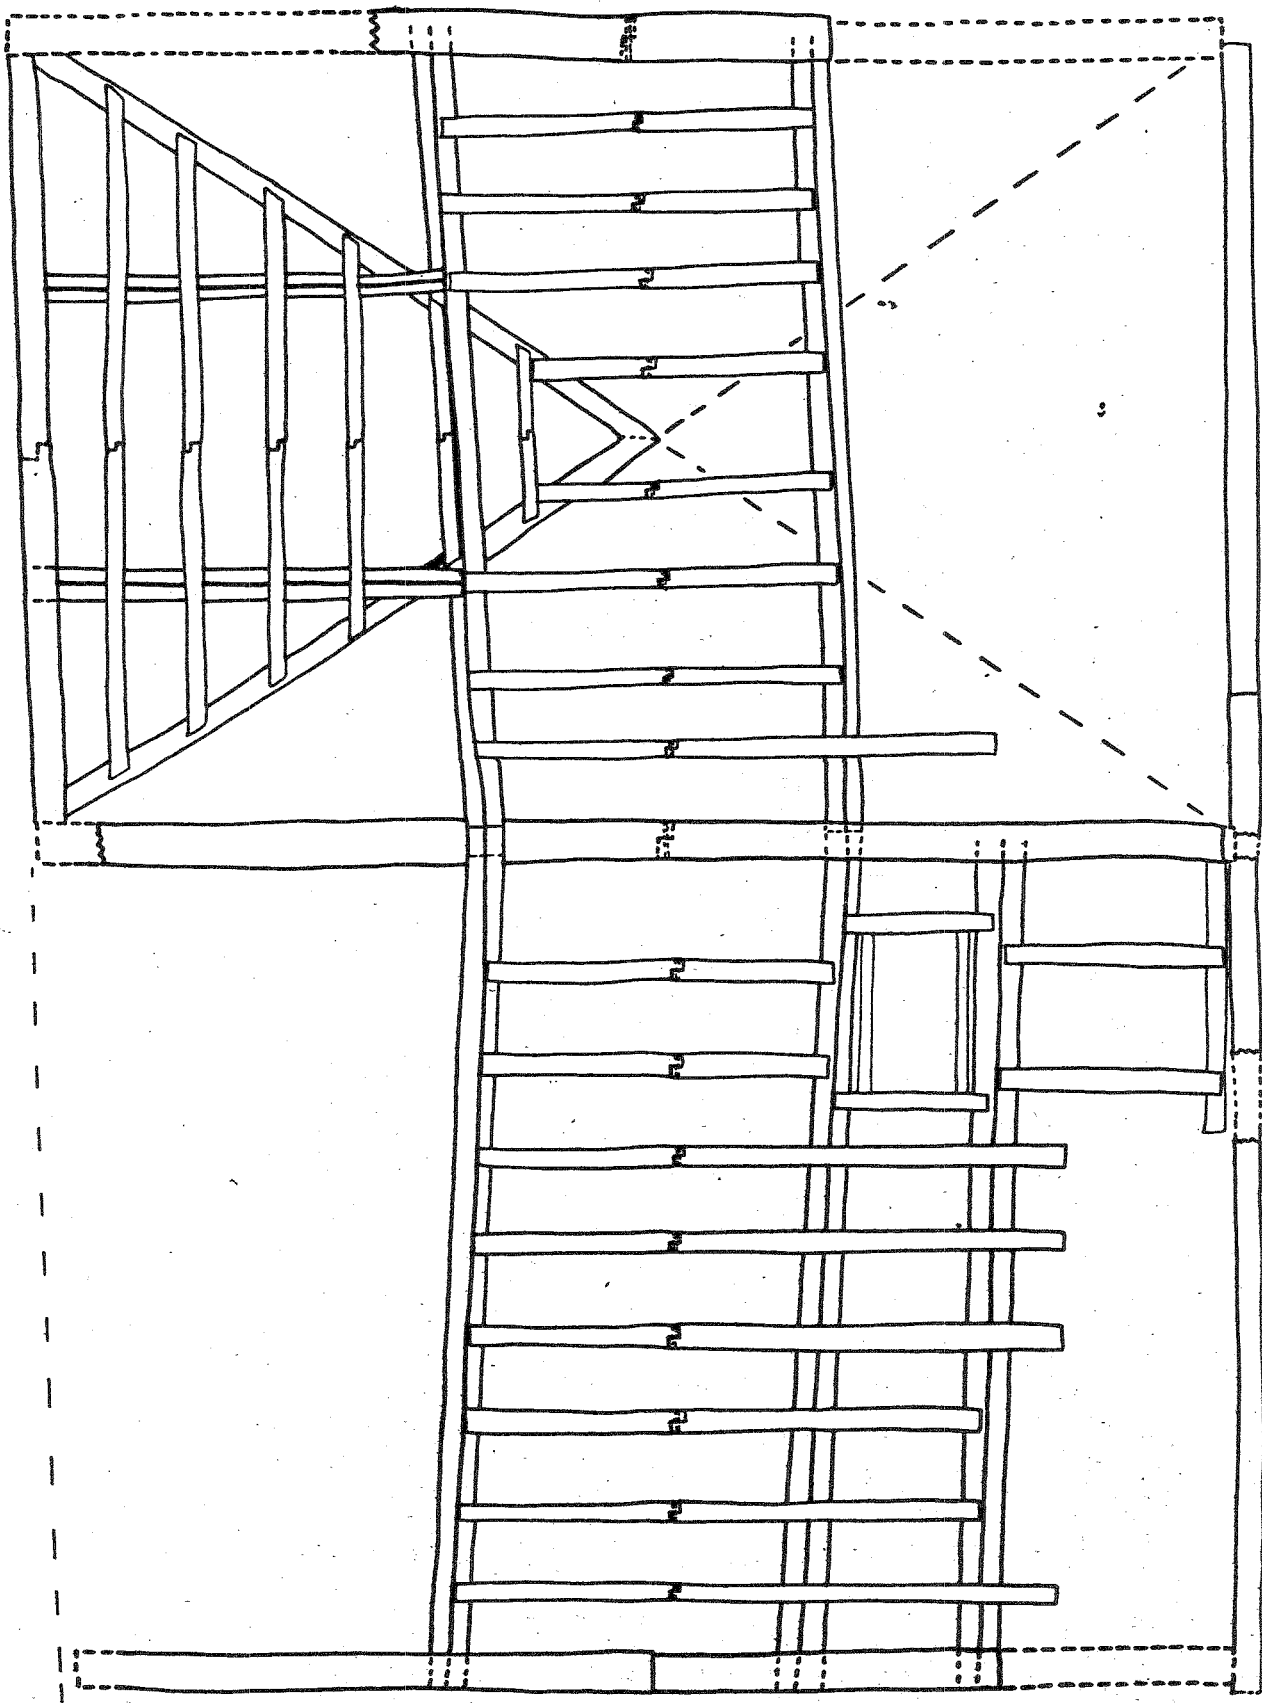
Roof plan showing survival of original rafters

The Roof

The double-collared gabled roof of building A was designed to be large enough to accommodate an attic floor above tie-beam level, and the lower collar of the intermediate truss is interrupted by the original framework of an opening between the two bays at this level. There are two purlins on the rear slope and a single purlin on the front. The two slopes of the roof are built differently. The east, or back, slope consists of continuous rafters resting on clasped purlins. The west, or front, slope has rafters from the roof apex tenoned into the butted purlin. This arrangement was designed to allow some headroom within the dormer gables. Many of the original rafters survive; they are coupled, being tenoned and pegged at the apex.

The dormer gable and the front slope of the roof are covered with slates; the back slope with modern plain tiles. The upper sections of the chimneys above the roof line have been demolished.

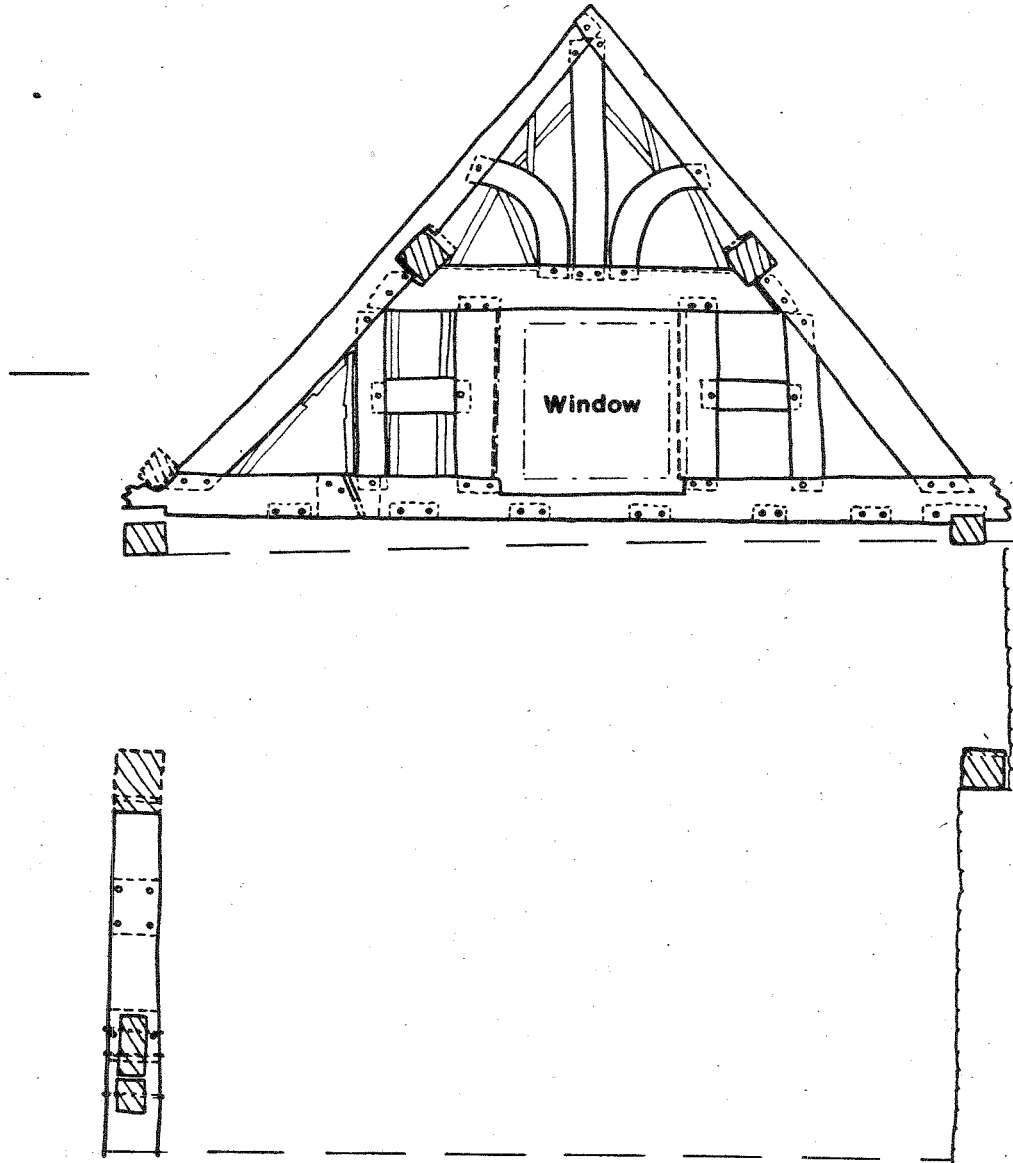
The surviving dormer gable is of full bay width with its wall plates and frames tenoned into the principal rafters of the north and intermediate trusses. The gable truss was clearly designed to incorporate a window between the tie beam and the collar. A king strut rises from the collar to the apex flanked by a pair of decorative curved braces. The ends of a single pair of purlins are clasped between the collar and the principal rafters. The other ends of the purlins originally rested on the main roof purlin but were not tenoned or pegged. They have slipped from their original positions and are now held by iron straps.

The northern bay was re-modelled in the 18th century when the facade was plastered over and the original windows were replaced. A new window was inserted in the original opening in the dormer gable, and two large balanced sashes were inserted at first floor level. The facade of the southern bay might have been re-modelled in the same style and at the same time but there is no surviving evidence of this as the frontage of this bay was completely rebuilt in the early 19th century. The dormer gable was then removed, along with all the west frame members, and a new, slightly taller, brick facade was built allowing the west slope of the roof of the bay to be raised. This new front had balanced sash windows on first and attic floors and a bay window on the ground floor. A similar bay window on the ground floor of the northern bay might have been added at about the same time.

West gable of north bay, east face
As surveyed

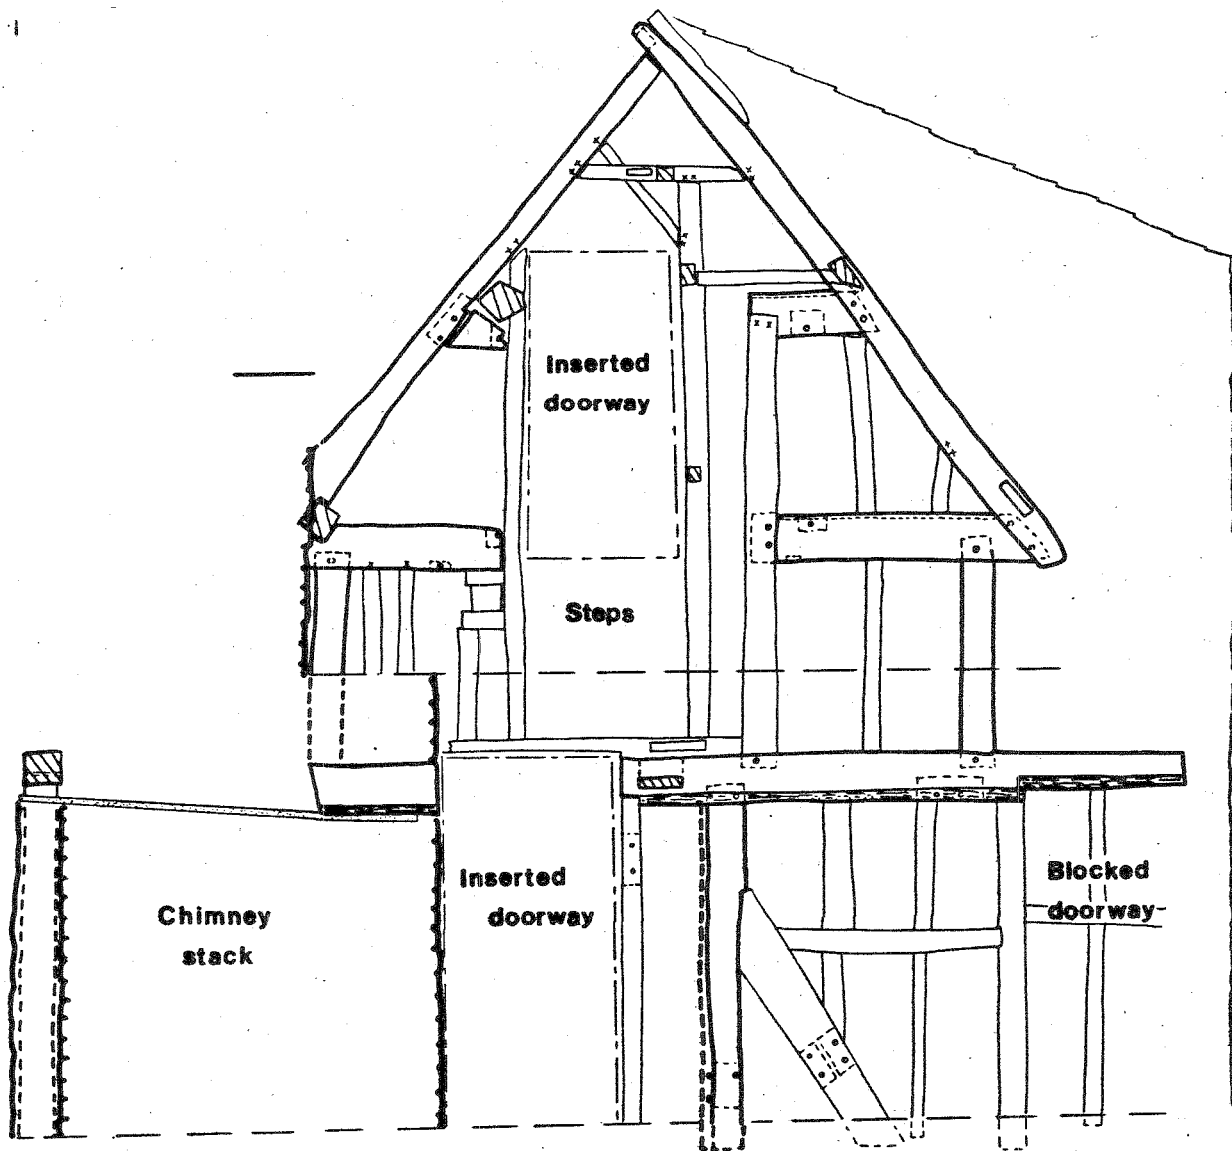
This frame has suffered some alteration due to the insertion of openings to building E and the addition of a chimney stack. It has been totally removed at ground floor level. In its original phase the truss consisted of a tie-beam, chamfered on its northern arris, and two collar beams. There were four struts between tie-beam and lower collar, and two struts between lower and upper collars. Below the truss, the eastern principal post survives but is mainly obscured by the inserted fireplace and a concrete render. A pair of side-braces rose from the principal posts to the tie-beam, but both have been removed. Only one of the original intermediate posts survives. This has a through mortice for a low rail at the same height as the rail in the intermediate truss.

When the south bay of building A became connected with the early 18th century range (Buildings D/E), several openings had to be cut into the frame to provide access. Two doorways were inserted at first floor level; the eastern doorway (not seen in the frame drawing) had a chamfered head on the south side of the tie-beam and the existing strut was cut back slightly on its eastern side to accommodate the opening. The western door head was also cut into the tie-beam. The western door post of the attic doorway still survives, morticed into the cut-through lower collar and nailed on to the upper collar.

Following the rebuilding of building E and the re-modelling of the south bay of building A, which are assumed to have happened during the early 19th century, the new floor levels meant that the doorways had to be re-cut at a higher level. On the attic floor the upper collar had to be cut through to cope with the higher doorway, and more of the lower collar was cut away because the new door was built off-centre to accommodate the new attic stairs in building E. On the first floor the western doorway was blocked and the eastern one re-cut at a higher level. The insertion of the chimney stack, which resulted in the removal of part of the eastern end of the frame, was probably part of the early 19th century work.

Building A: South frame, north face
As surveyed

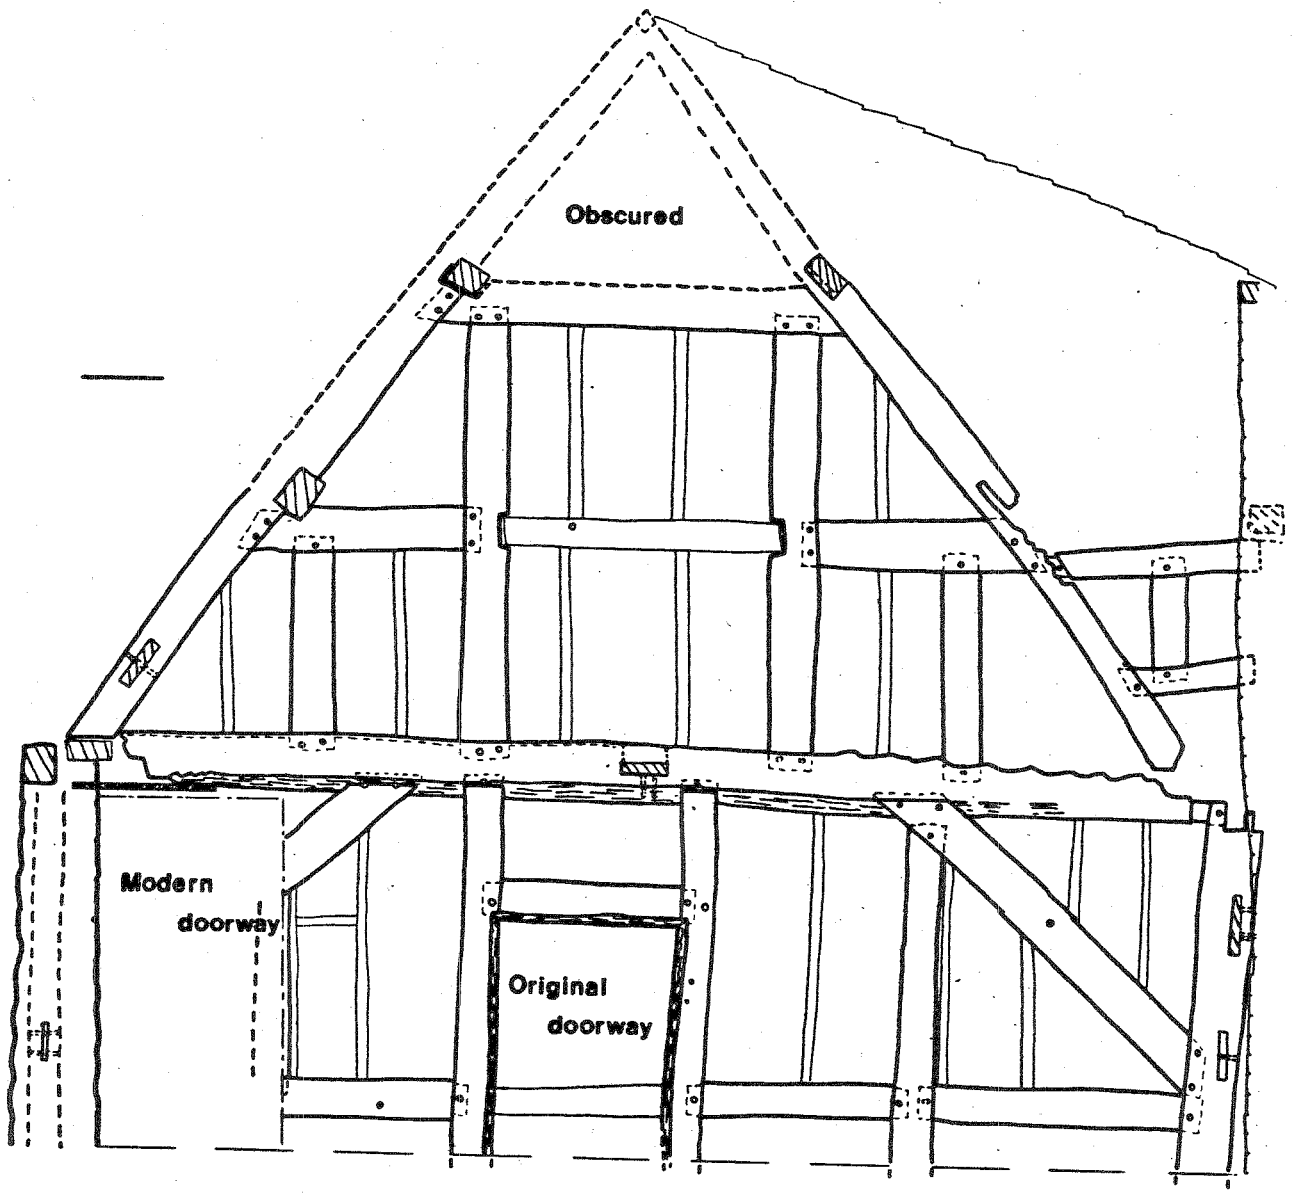
Despite several alterations this frame is substantially complete from just above the level of the first floor girding beam. The apex of the truss was inaccessible but is assumed to be intact. This was clearly designed as an intermediate frame and originally had openings at both first and attic floor levels; these were subsequently blocked following the division of the building and the changes in floor levels.

The ends of the tie-beam have perished and the remainder is plain-chamfered on both sides. The posts and braces below the tie-beam were tenoned into it after it had been chamfered, suggesting that it may have been re-used. Centrally placed pegged mortices in both sides of the tie-beam carried the tenons for the spine-beams. They are answered by similar mortices in the tie-beams of the northern and southern trusses.

Enough of the framing of the original first floor survives to suggest how it was built. Diagonal braces rose from the principal posts to the tie-beam, but apart from this none of the framing was symmetrical. The off-centre doorway is flanked by two posts which ran between the first floor girding beam and the tie-beam. An attempt was made to provide a measure of symmetry to each side of the doorway by inserting centrally-positioned posts from the girding beam to the diagonal braces. There is a low, interrupted rail, approximately one-third of the storey high. The side-frame of the dormer gable is tenoned into the slope of the west principal rafter.

After the first floor doorway was blocked the wall was replastered and an elaborate pattern of circular mock-timberwork was painted on its northern side, much of which remains. At a later date, a new doorway was inserted linking the first floor rooms at the new, higher level and cutting through the eastern brace. The ground-floor frame and the first floor girding beam were probably removed in the early 20th century.

Intermediate frame, north face
As surveyed

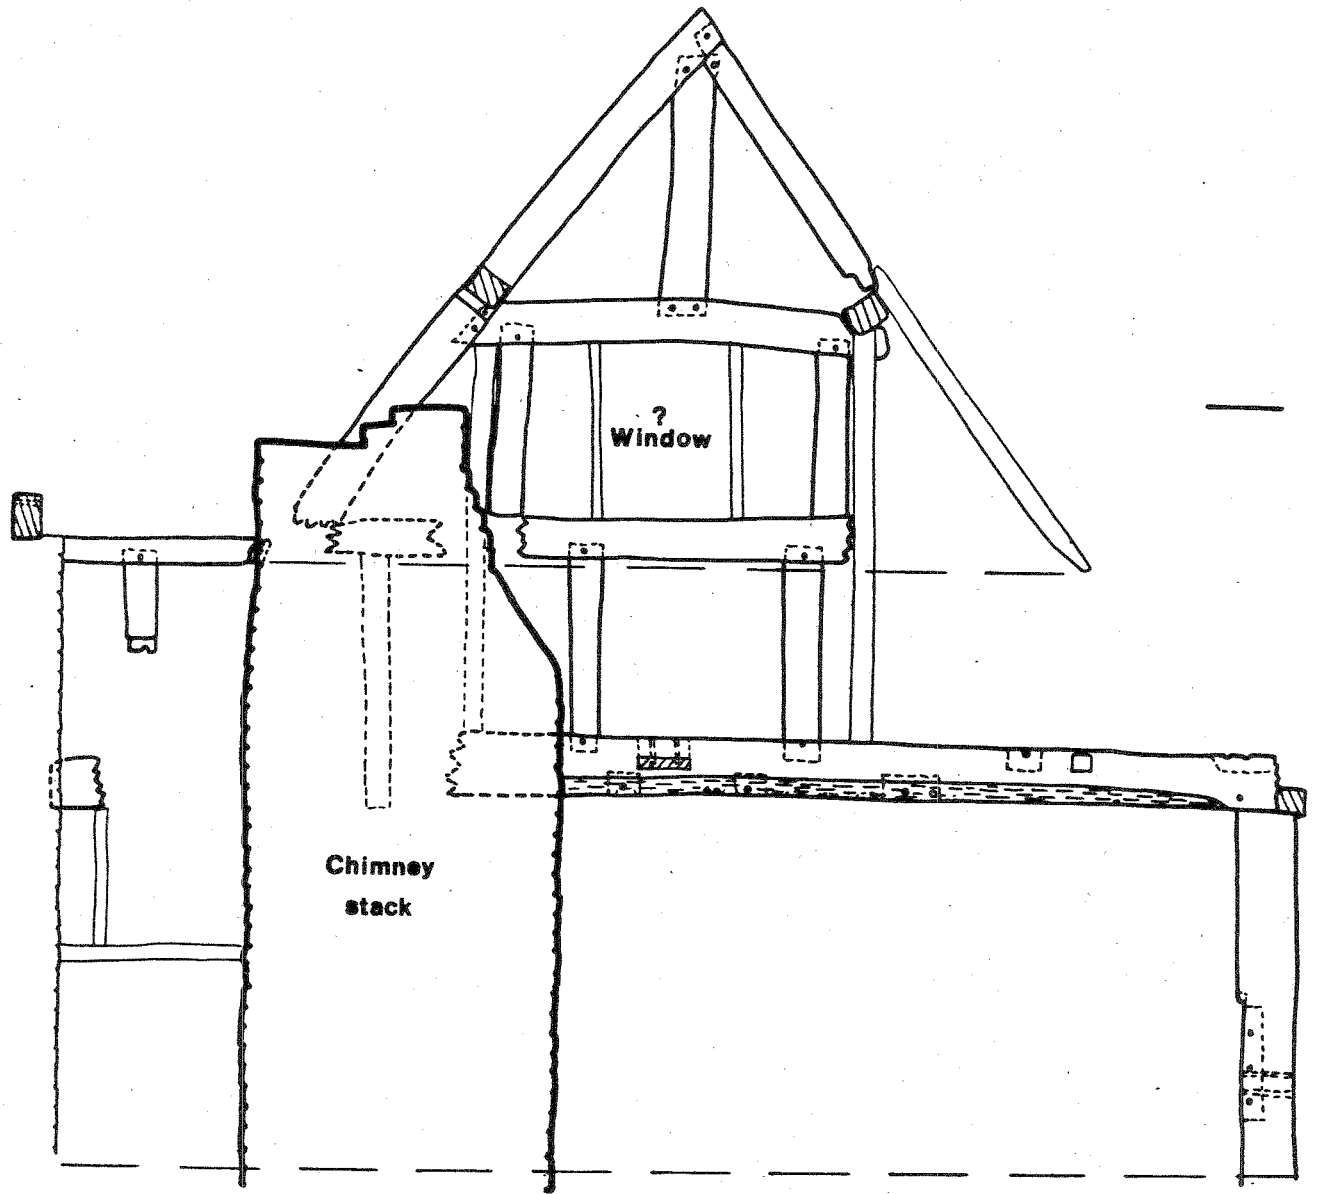
The surviving sections of this frame comprise the truss and the east principal post. This post is the only timber in the building which continues down to the ground floor.

The truss has a tie-beam, chamfered on its inner arris, and two collar beams. Two of the original four struts between the tie-beam and the lower collar are still in place and there are two struts between the lower and upper collars which may have provided the framing for a window. From the upper collar, a king strut rises to the underside of the apex of the principal rafters. The lower collar has been forced slightly to the north following the loss of the original attic floor and the insertion of a raised one.

The northern wall frame of the dormer gable is tenoned into the west principal rafter of the truss but this junction is in very poor condition. The western section of the tie-beam is also in a parlous state. The inserted chimney stack was built around the tie-beam at this point and has clearly caused many of the problems of damp and rot in this area.

The evidence from the surviving principal post and in the soffit of the tie-beam shows that this frame was originally similar to the south frame, with braces from post to tie-beam, a low mid-storey rail, and probably four vertical struts. There is no evidence of windows below the attic level suggesting that the building abutted an earlier but lower one. Just below the present ground floor ceiling the principal post has blocked mortices at the same height in its west and south faces, which show the position of the original first floor girding beams. There are lower mortice relating to the mid-rails of the ground floor. The post rests on flat stones.

Building A: North frame, south face
As surveyed

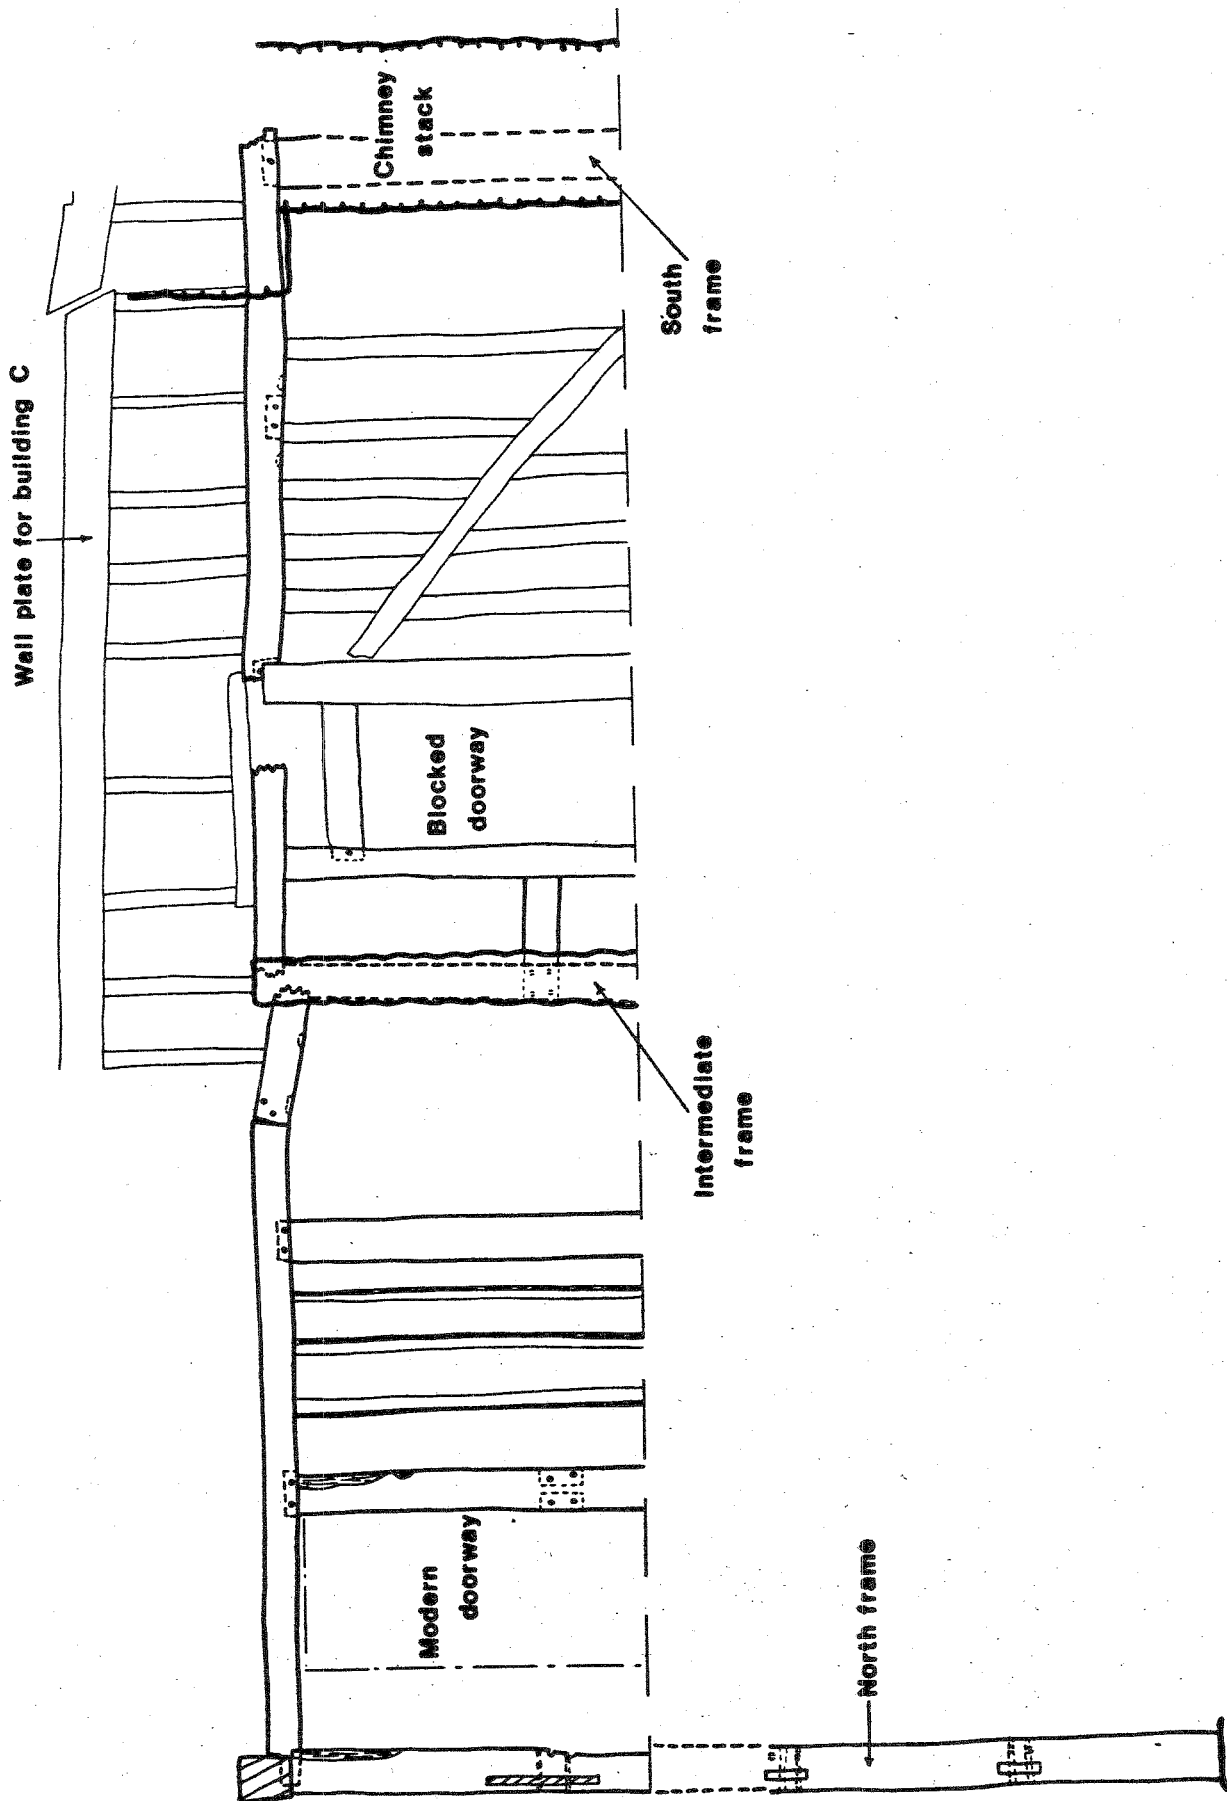
Apart from the north-east corner post, the east frame of building A was not immediately visible. Additional clearance revealed the main structure at first-floor level; it is assumed that it is totally lost below the level of the first-floor girding beam.

The post belonging to the intermediate frame and the south-eastern post are both encased in concrete and could not be examined in any detail. The wall plate, which has a poorly-constructed scarf joint close to the intermediate frame, is now in several parts. The frame could not be examined below the present first-floor level - parts of the girding beam could exist but if so are completely hidden.

The frame originally consisted of six panels, three in each bay, with rails some two-thirds of the way down between the wall plate and the first-floor girding beam. The wall plate was used to support the higher roof plate of building C in the early 19th century by inserting a series of struts. It was presumably at this time that the rails were removed and replaced by a series of struts in an attempt to provide the additional support. An inserted, blocked doorway may have led to a cupboard underneath the stairs in building C.

There is no evidence for any windows in this frame and it may well have been built against an existing building which would have had to be demolished before buildings B and C were erected.

East frame, west face
As surveyed

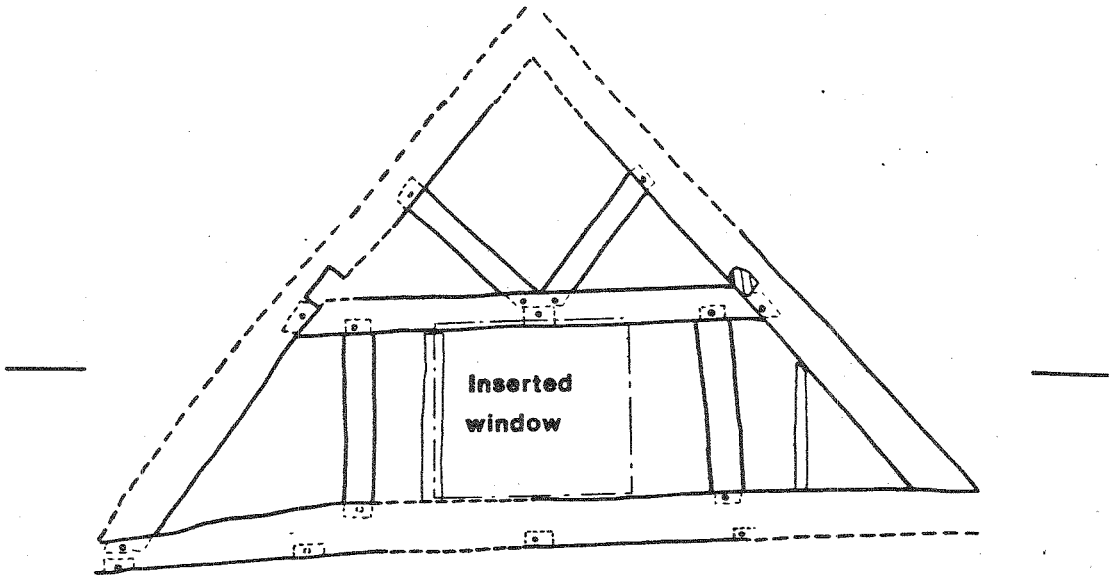
East frame, west face

This is a single bay, timber-framed extension to building A, with 2½ storeys under a coupled-rafter roof running at right angles to that of the main block. It was probably a service wing. Virtually all the timber frame beneath wall-plate level has either been replaced or encased in rendered brick.

This range must have been built after building A, probably in the second half of the 17th century. The rafters of building A were cut off at the upper purlin level and the lower purlin was removed to accommodate the roof of building B. The single pair of purlins are butted into the principals of the east gable truss and run through to the upper purlins of building A, where they are held in place by iron straps.

The gable truss is quite plain, and probably had three struts between tie-beam and collar. Above the collar, a pair of 'V' struts help support the principal rafters. This truss, and the roof itself, is virtually intact.

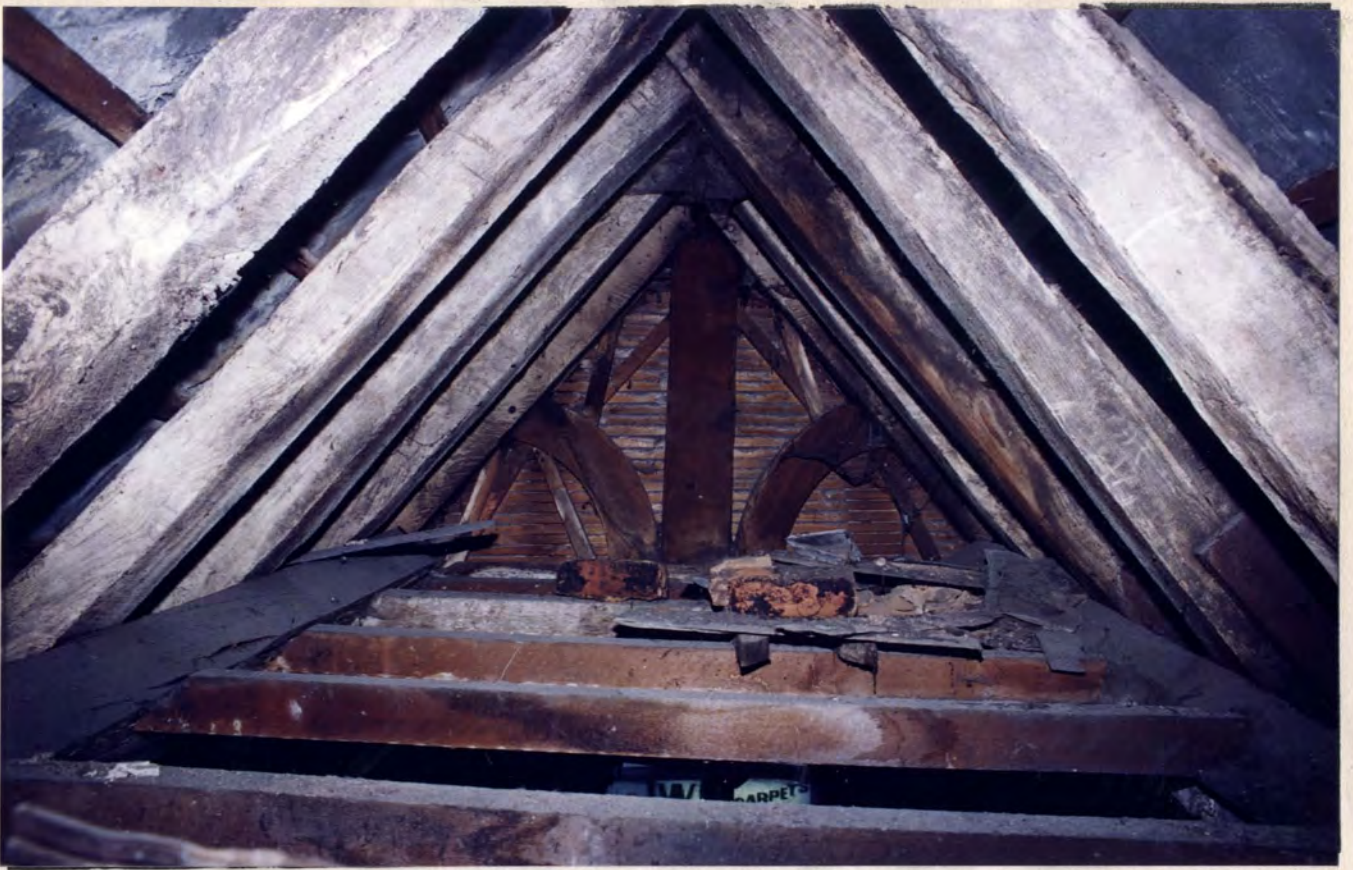
Building A: West gable, attic floor, east face,
showing the upper part of the truss

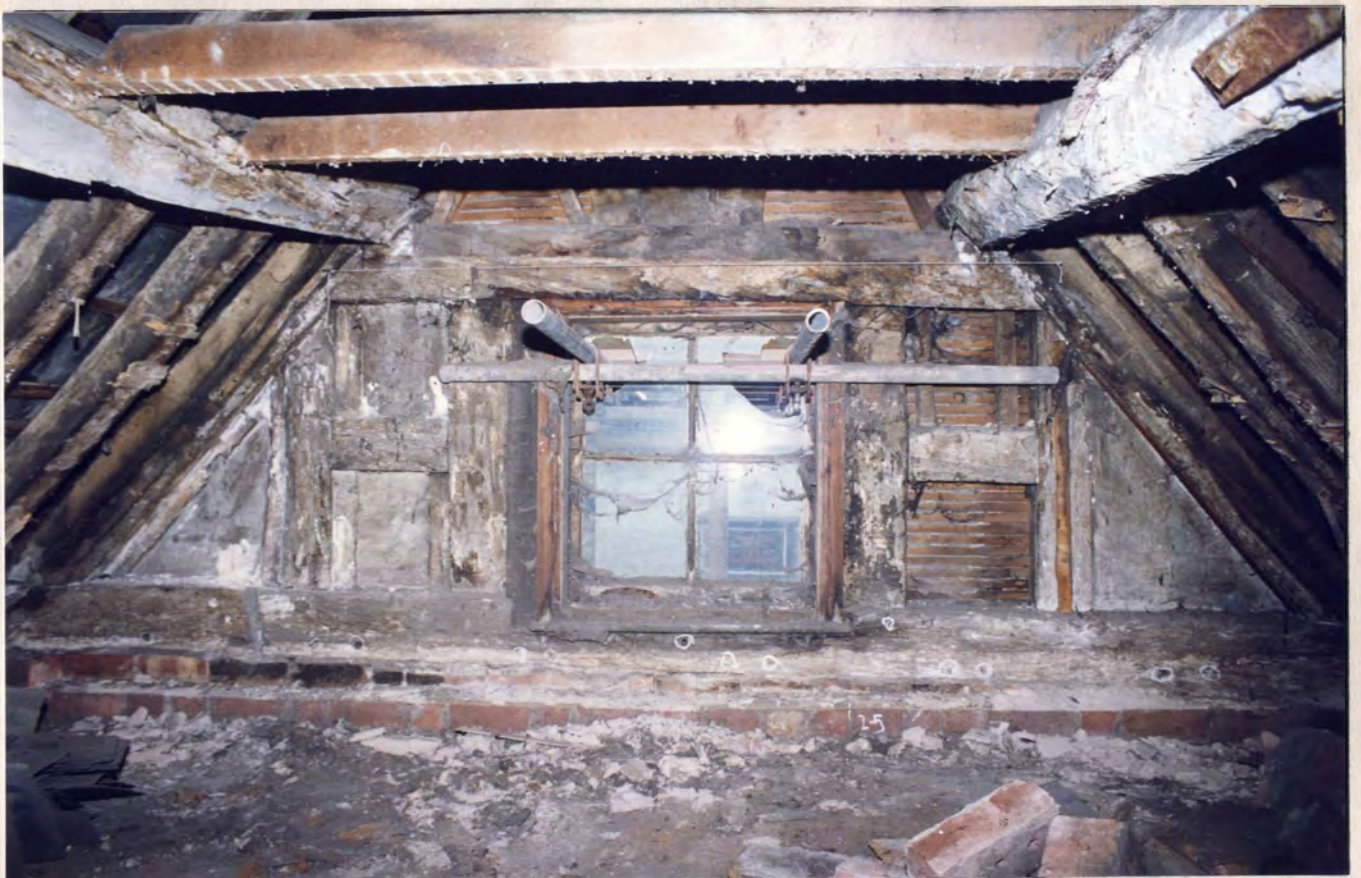
Building A: West gable, attic floor, east face
showing the lower part of the gable

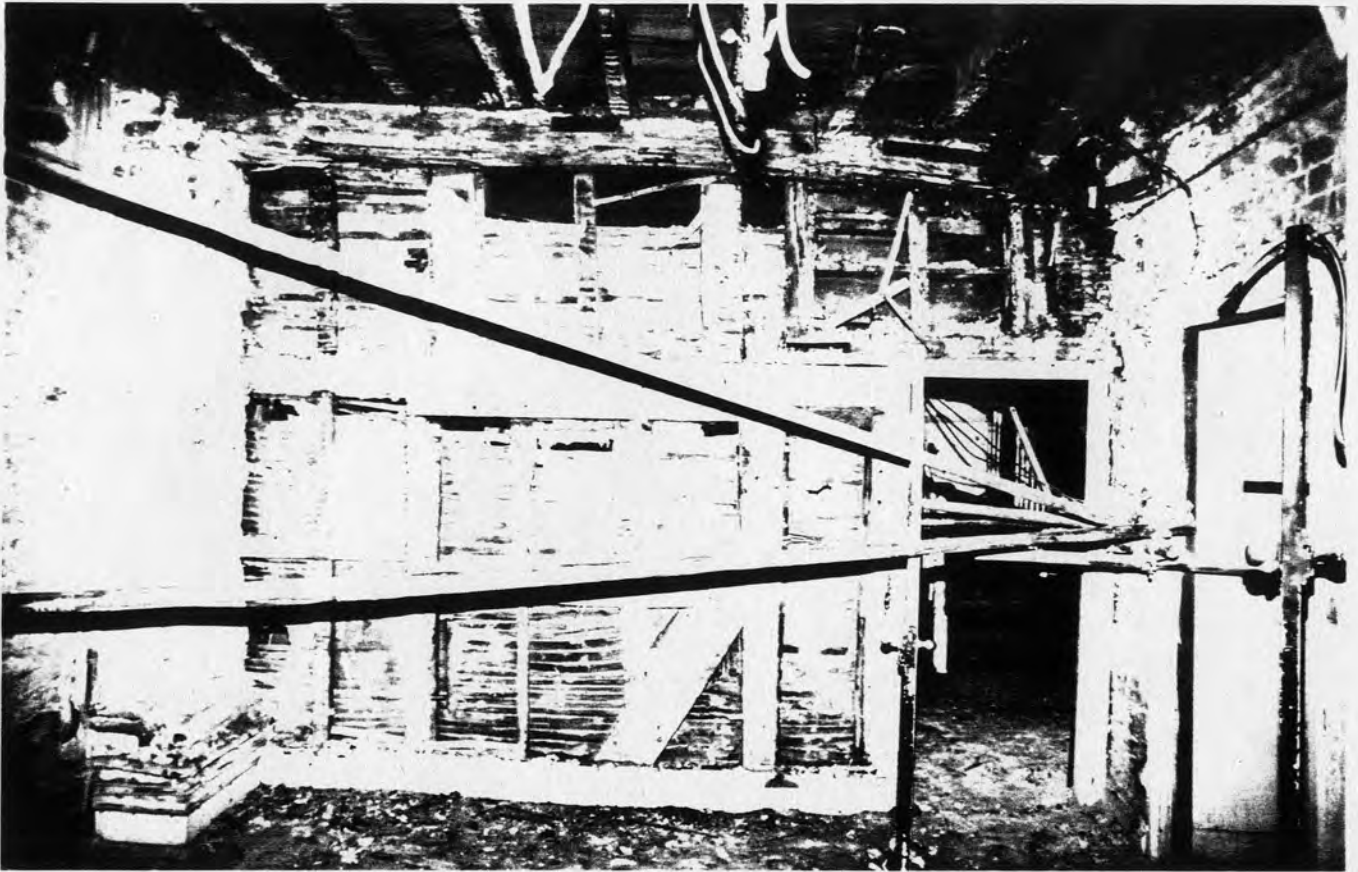
Building A: South frame, 1st floor, south face, showing inserted doorway

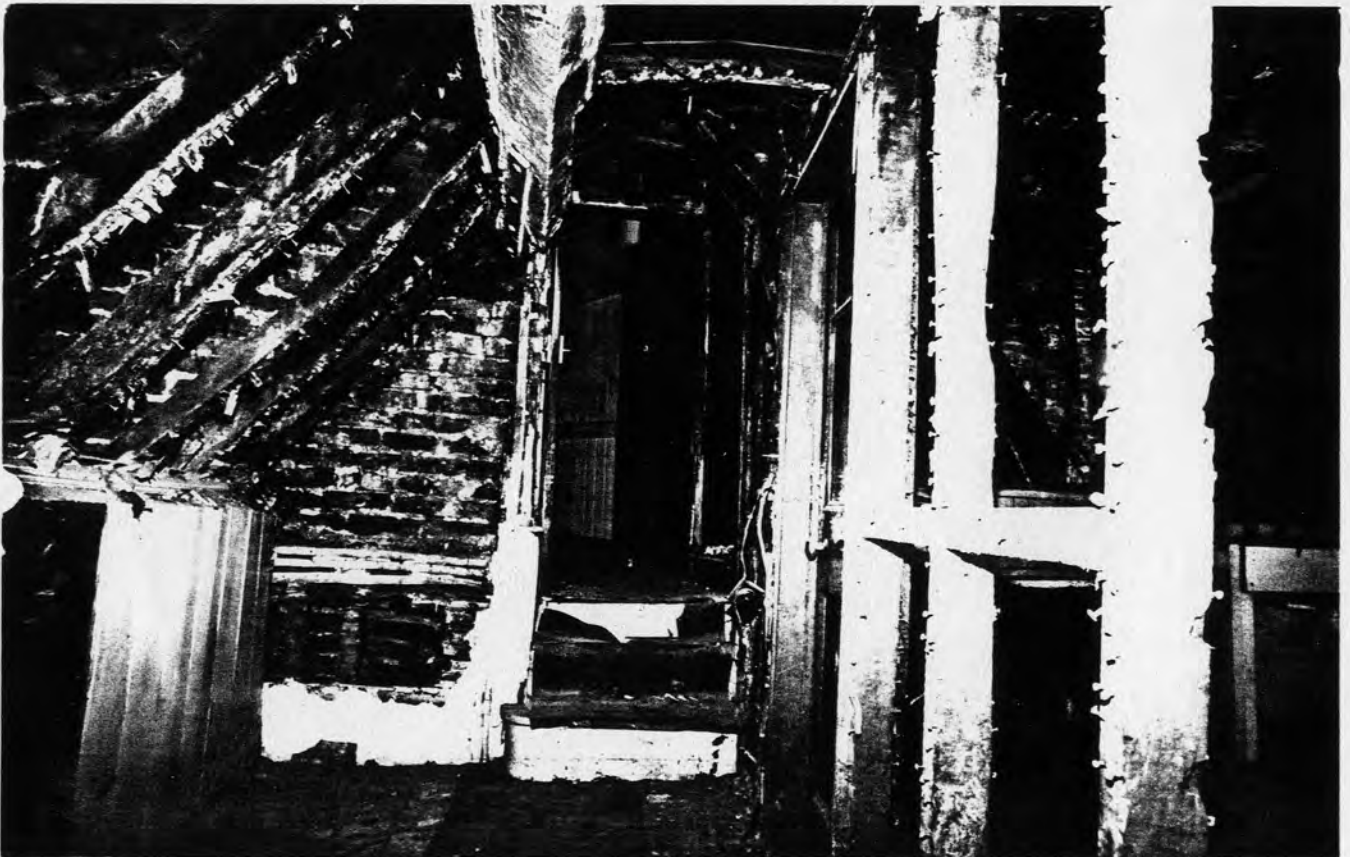
Building A: South frame, attic floor, north face, showing the inserted doorway and part of the original roof

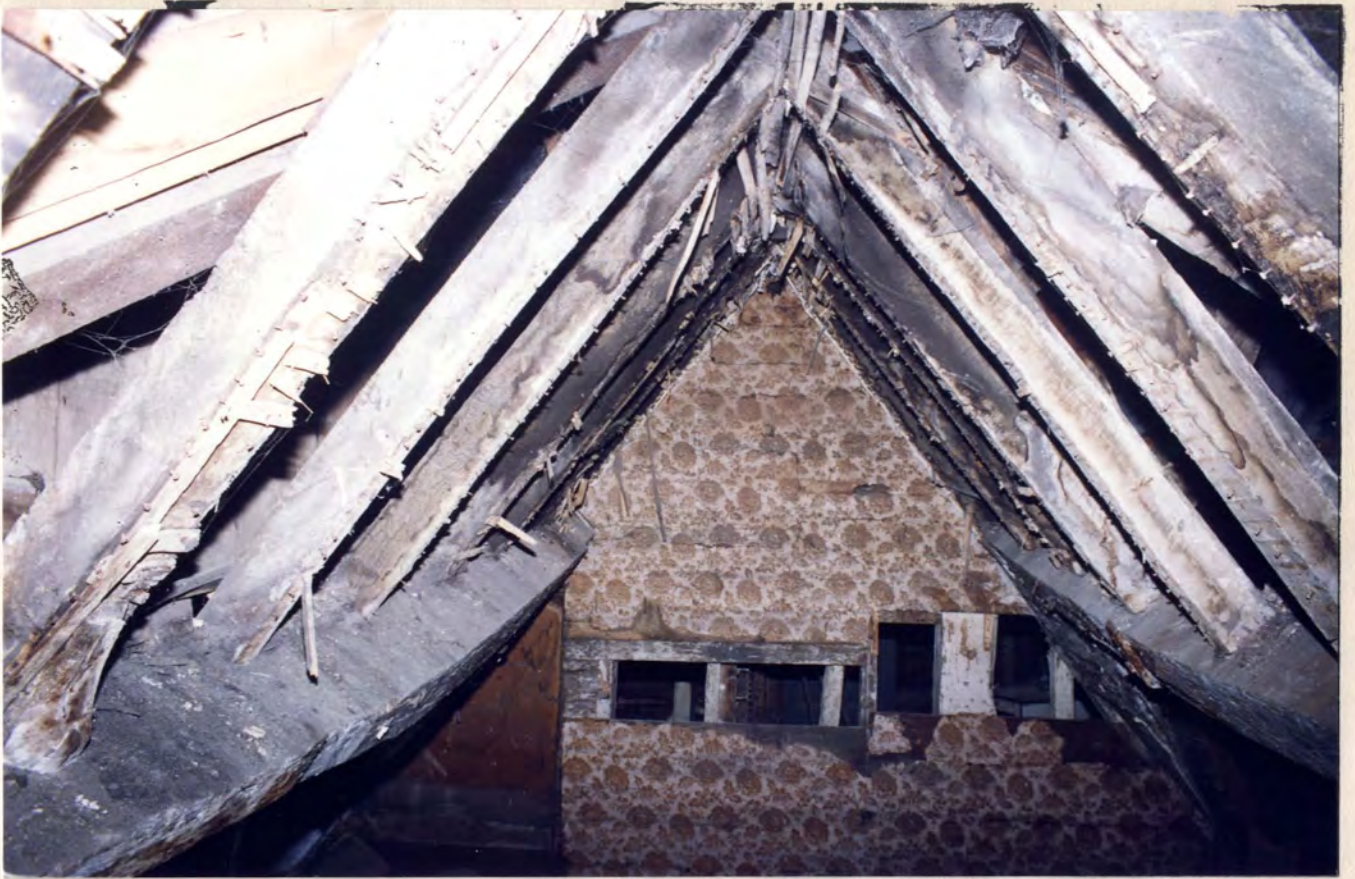
Building A: Intermediate frame, attic floor, south face, showing original purlins and rafters

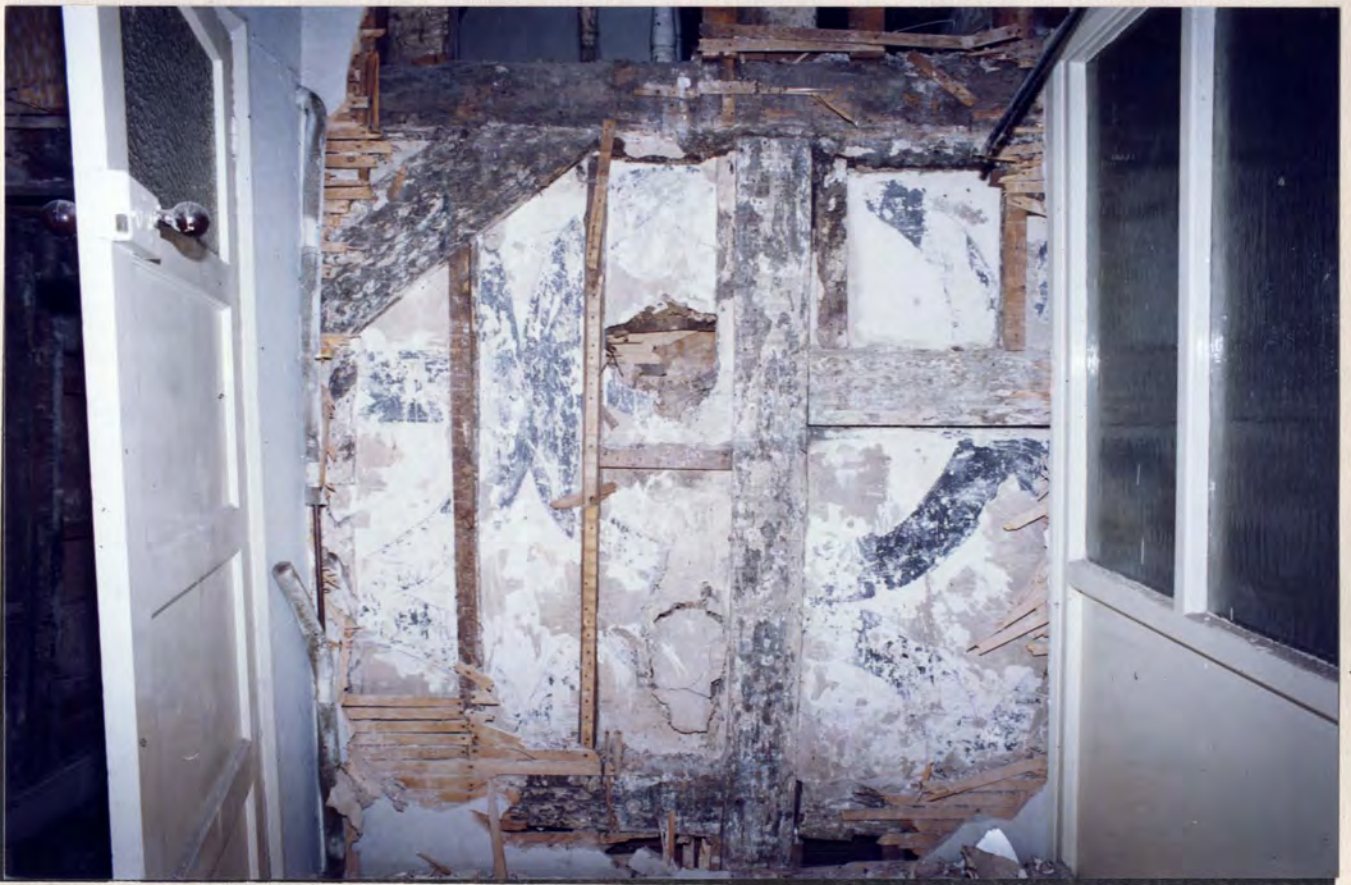
Building A: Intermediate frame, 1st floor, south face, showing tie beam and traces of wall paintings

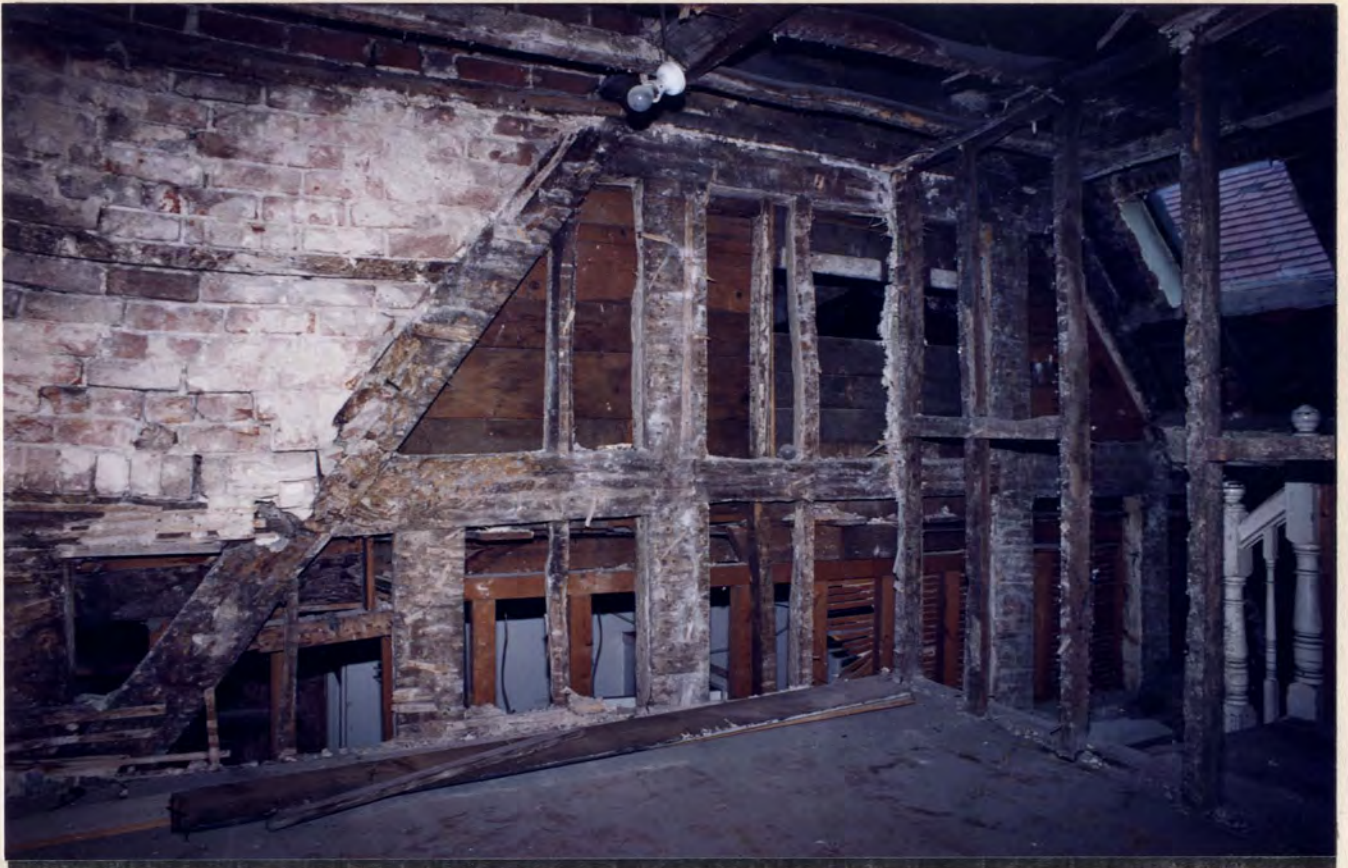
Building A: Intermediate frame, attic floor, south face,
showing central opening cut through lower collar
