1 BRIDGE STREET EVESHAM

AN INTERIM REPORT

JANUARY 1989

The City of Hereford Archaeological Unit
Town Hall,
Hereford

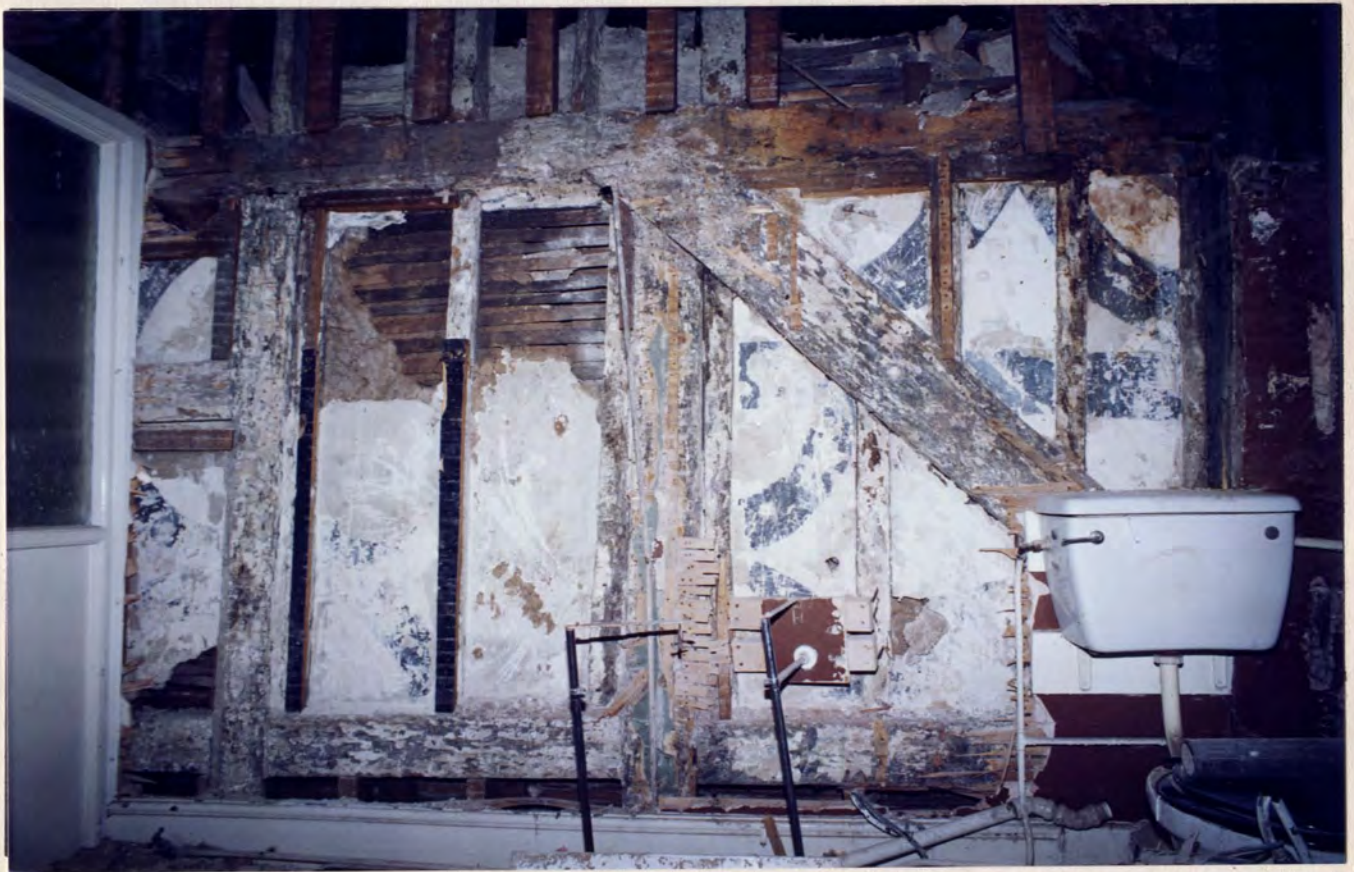
Building A: Intermediate frame, 1st floor, south face, showing
wall paintings across blocked doorway

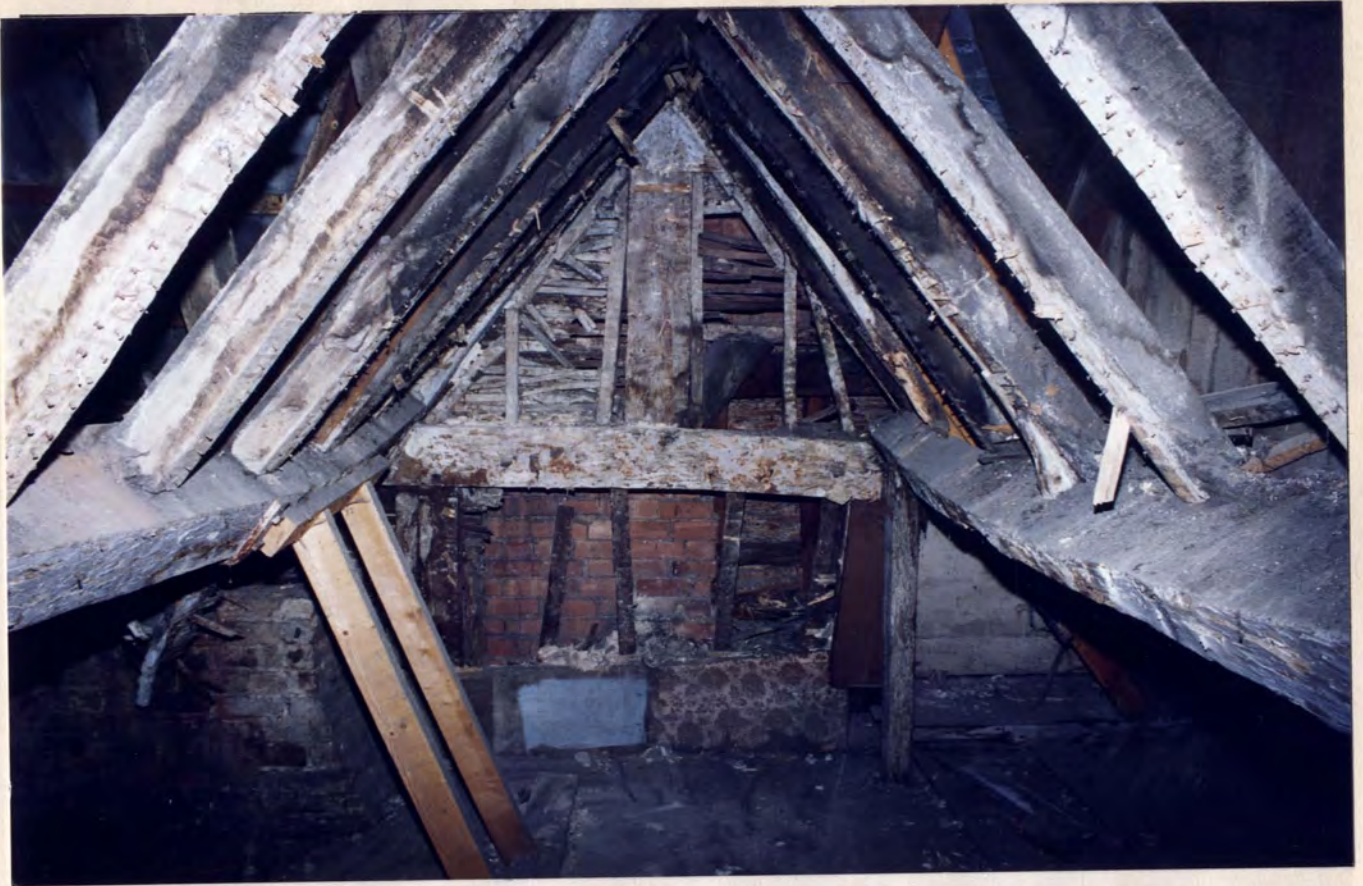
Building A: North frame, attic, south face, showing the upper part of the truss and original purlins and rafters

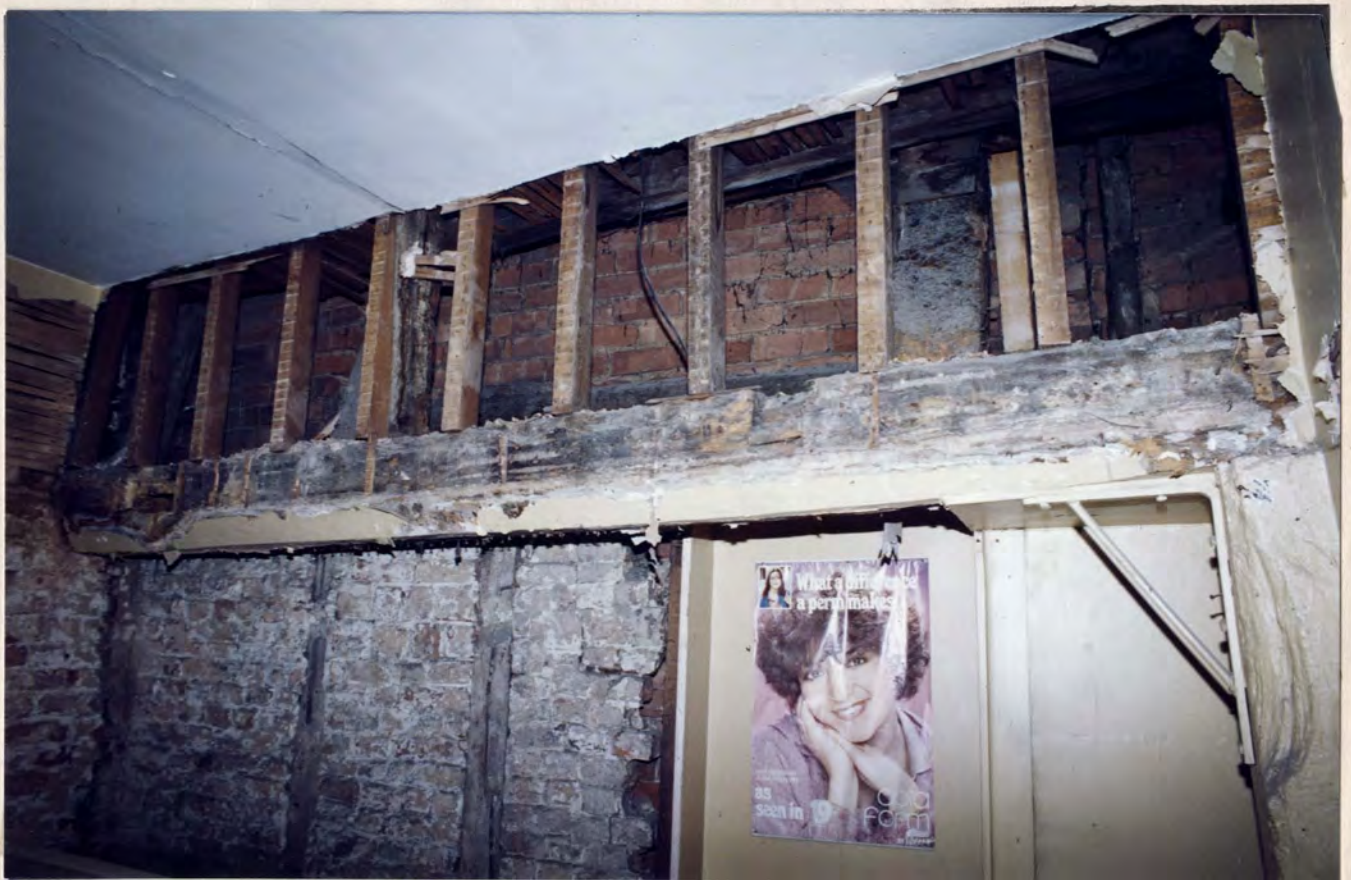
Building A: North frame, 1st floor, south face showing the tie-beam of the truss

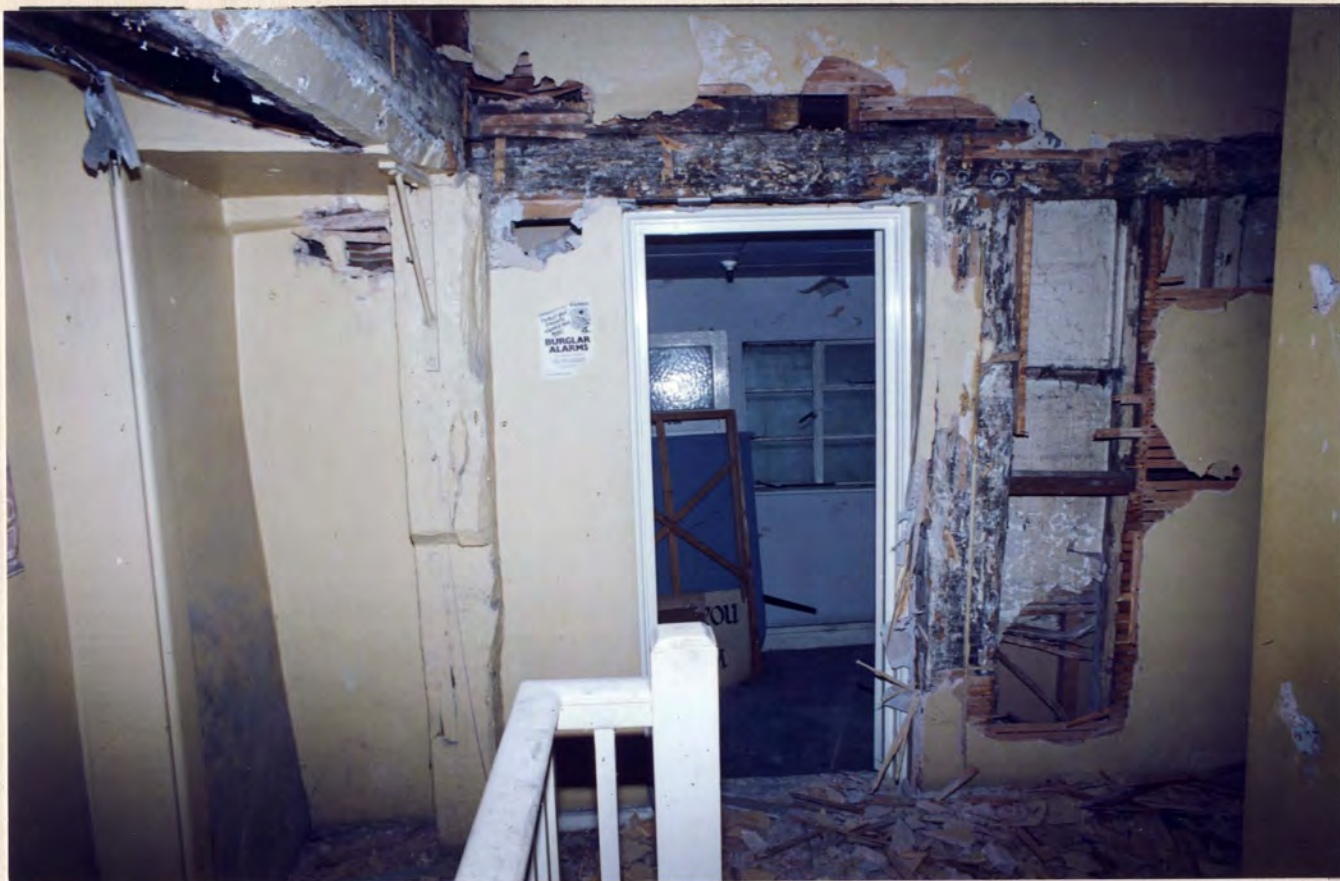
Building A: East frame, 1st floor, west face, showing the north-eastern corner post and the wall plate

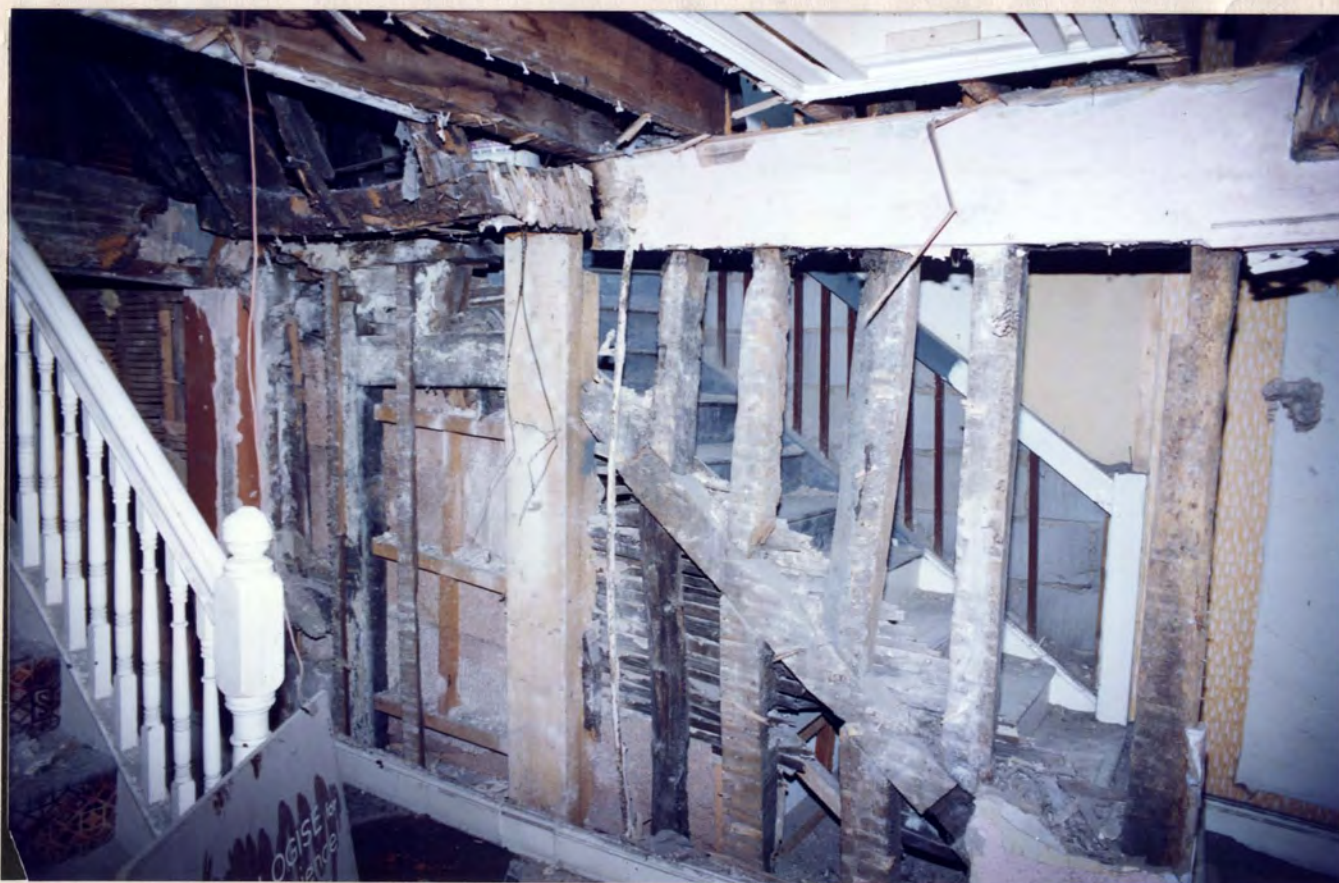
Building A: East frame, 1st floor, west face, showing part of surviving frame, and the staircase in building C

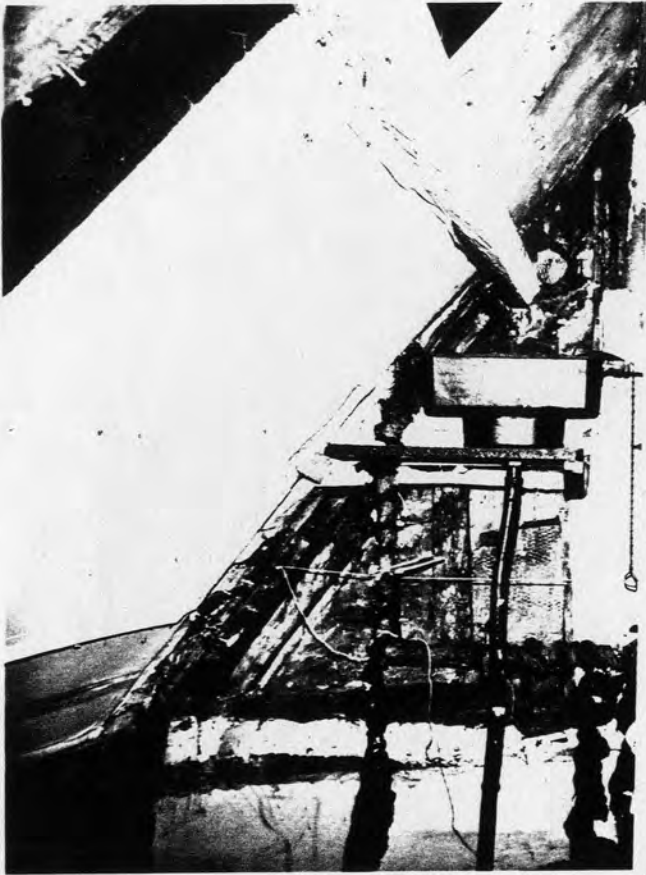
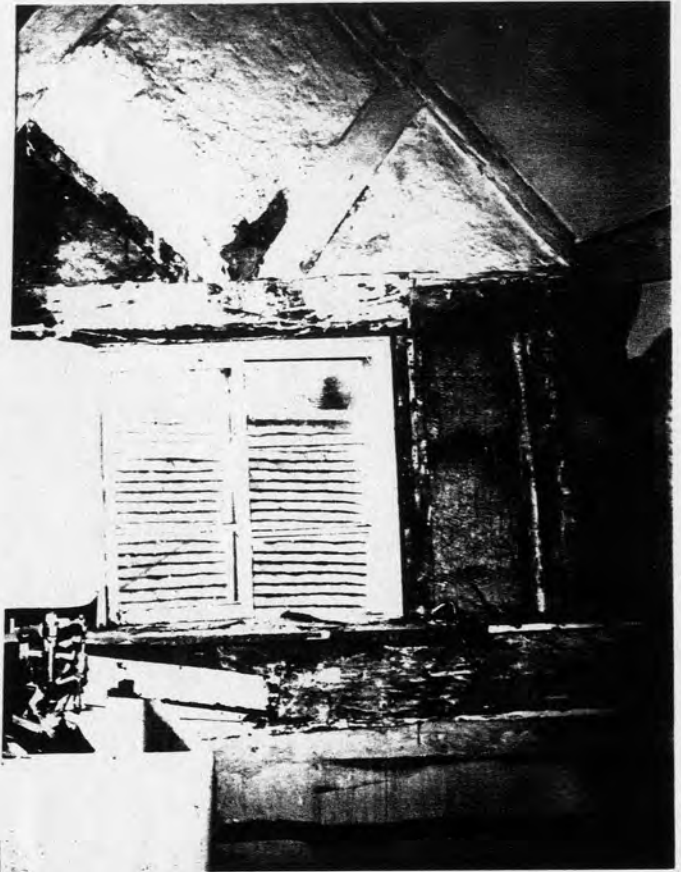
Building B: East frame, attic floor, west face,
showing surviving truss

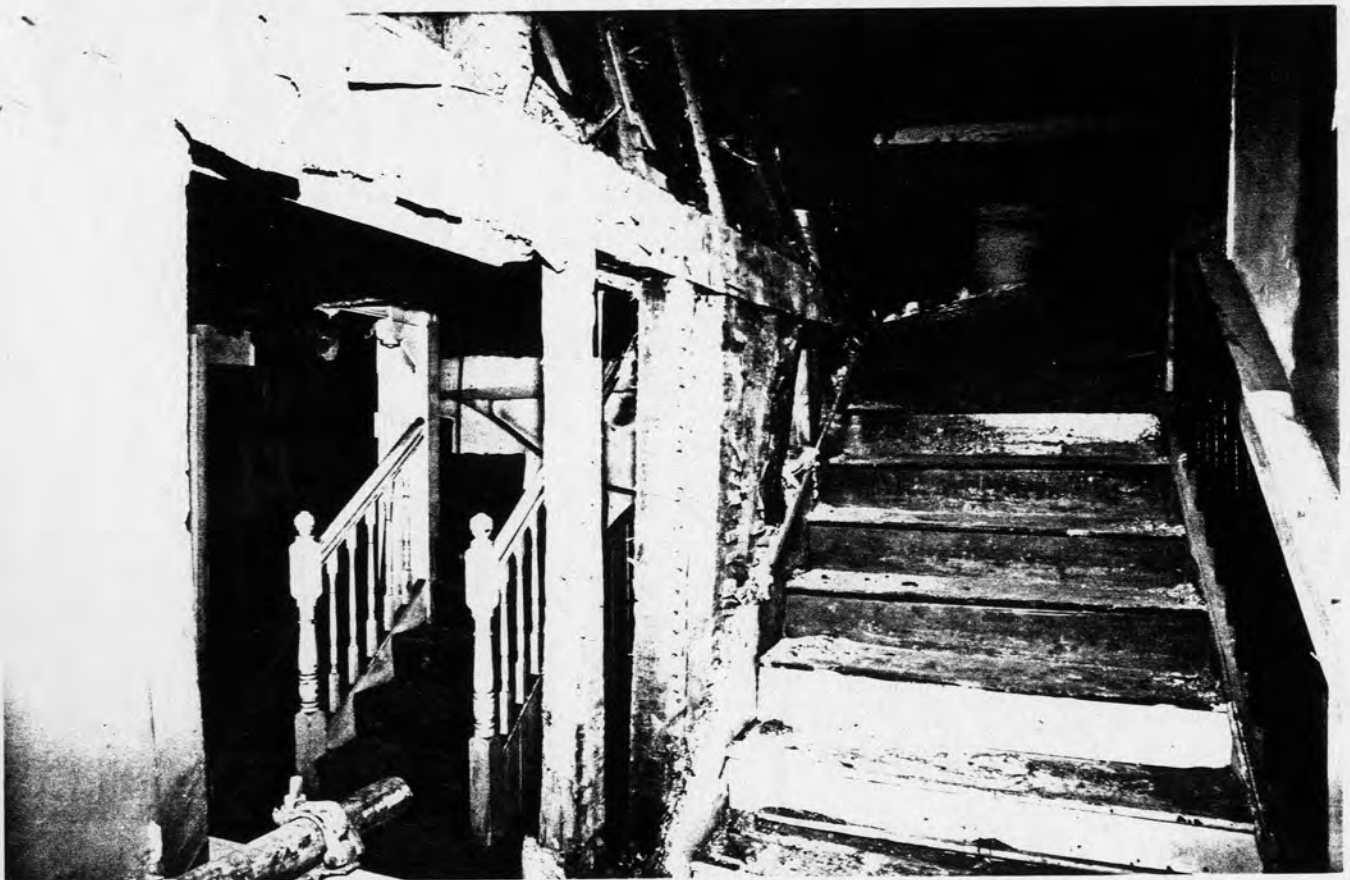
Building C is a wide, single bay, 2½ storey partly timber-framed range built to the rear of the southern bay of building A and next to building B. The building is poorly constructed, using many second-hand timbers. The gabled roof is aligned parallel to that of building A and there is a valley between the two roofs. The north gable truss is timber-framed, rendered externally, but the wall below the tie-beam is rendered on both sides and it was impossible to see what it is constructed of; the same is true of the east side wall. The upper part of the west wall is timber-framed and sits on the wall plate of building A.

Buildings A & C: The party wall from the south-east, showing
the wall plate of A and the raised wall of C

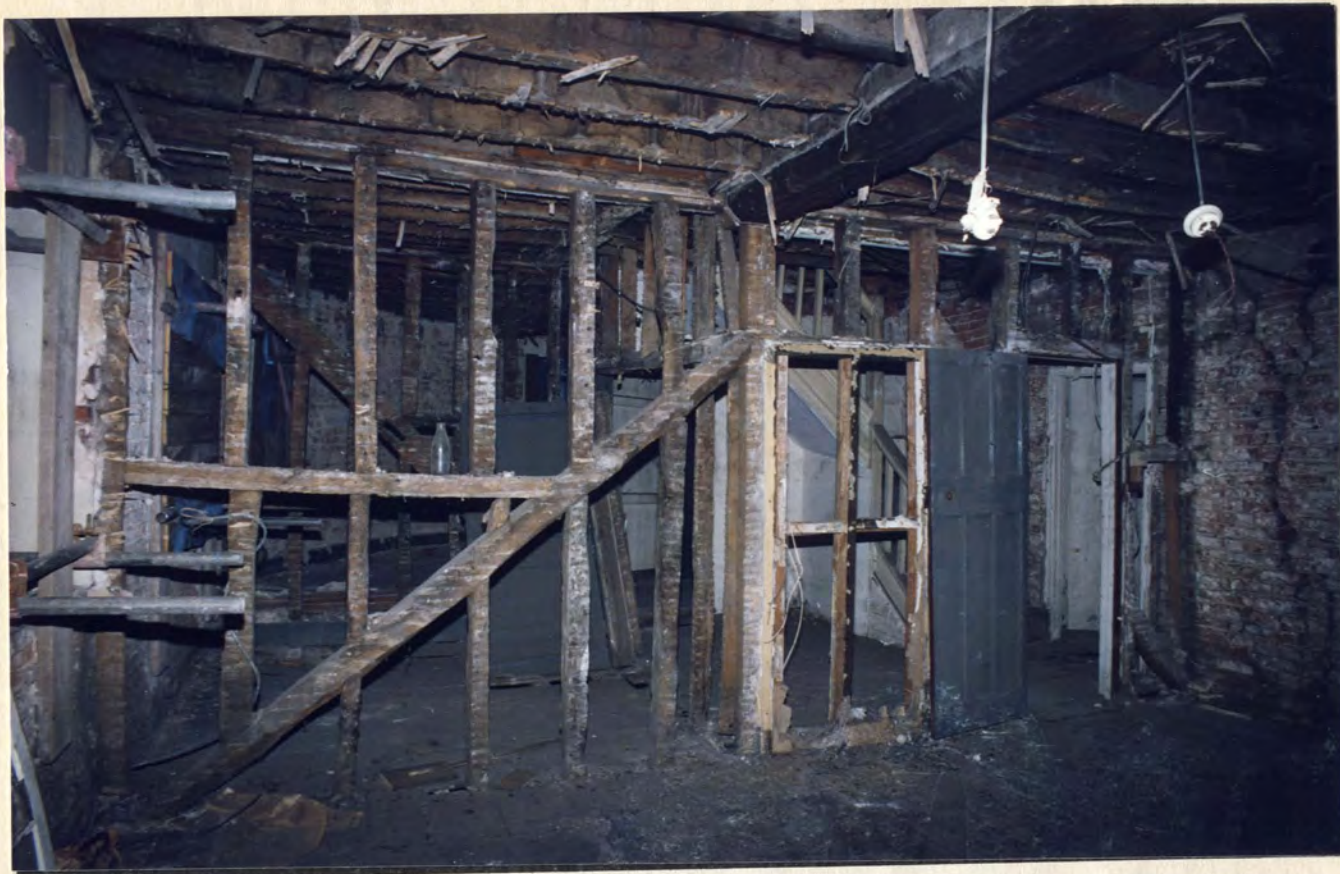
All the internal partitions are timber-framed and made up of re-used timbers. The section of the rear, or north, wall adjacent to building A was not built in brick like the rest of the outside walls. Instead, beams, running between the west gable wall and the rest of the north wall brickwork, were inserted to support the floors.

Building D: 2nd floor from the south, showing the poor quality timber dividing frames

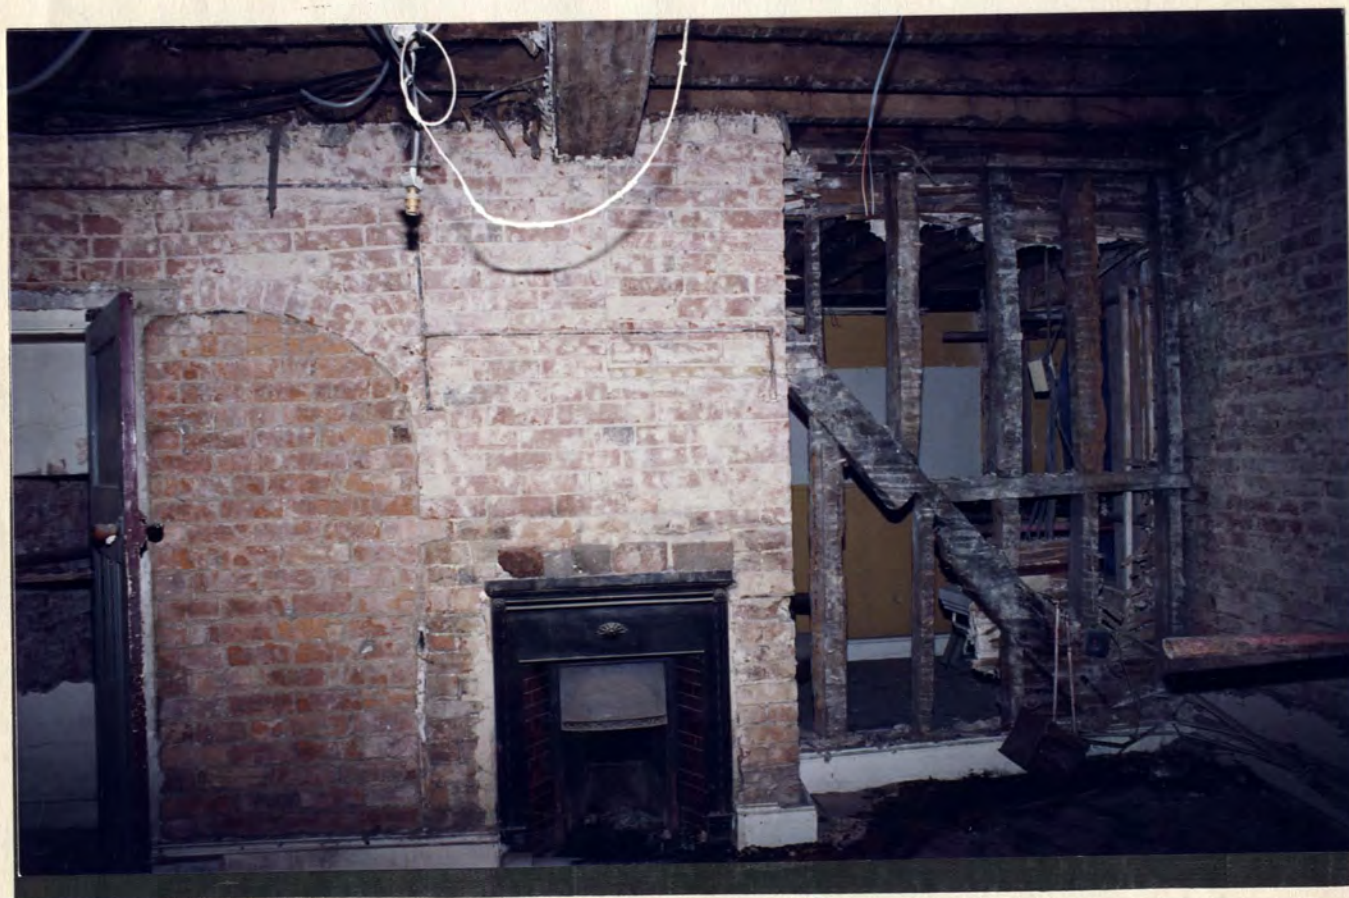
This building re-used elements of the early 18th century building but is effectively a different structure. The roof was lowered, with a lower pitch, off-centre ridge, and a convex, hipped end to match the corner facade. The north slope of this roof has recently been replaced. The floors had all to be reconstructed and a new, narrow staircase was inserted to provide access to the attic. The new first floor level was higher than that in Building D. Doorways were maintained between buildings A and E at first and second floor levels.

Building E: 1st floor from the north, showing the chimney stack and re-used timbers
