**BRICK WALLS FARM
GILBERT'S END
HANLEY SWAN
WORCESTERSHIRE**

*Archaeological
Building Analysis*

June 2002

Hereford Archaeology Series 534

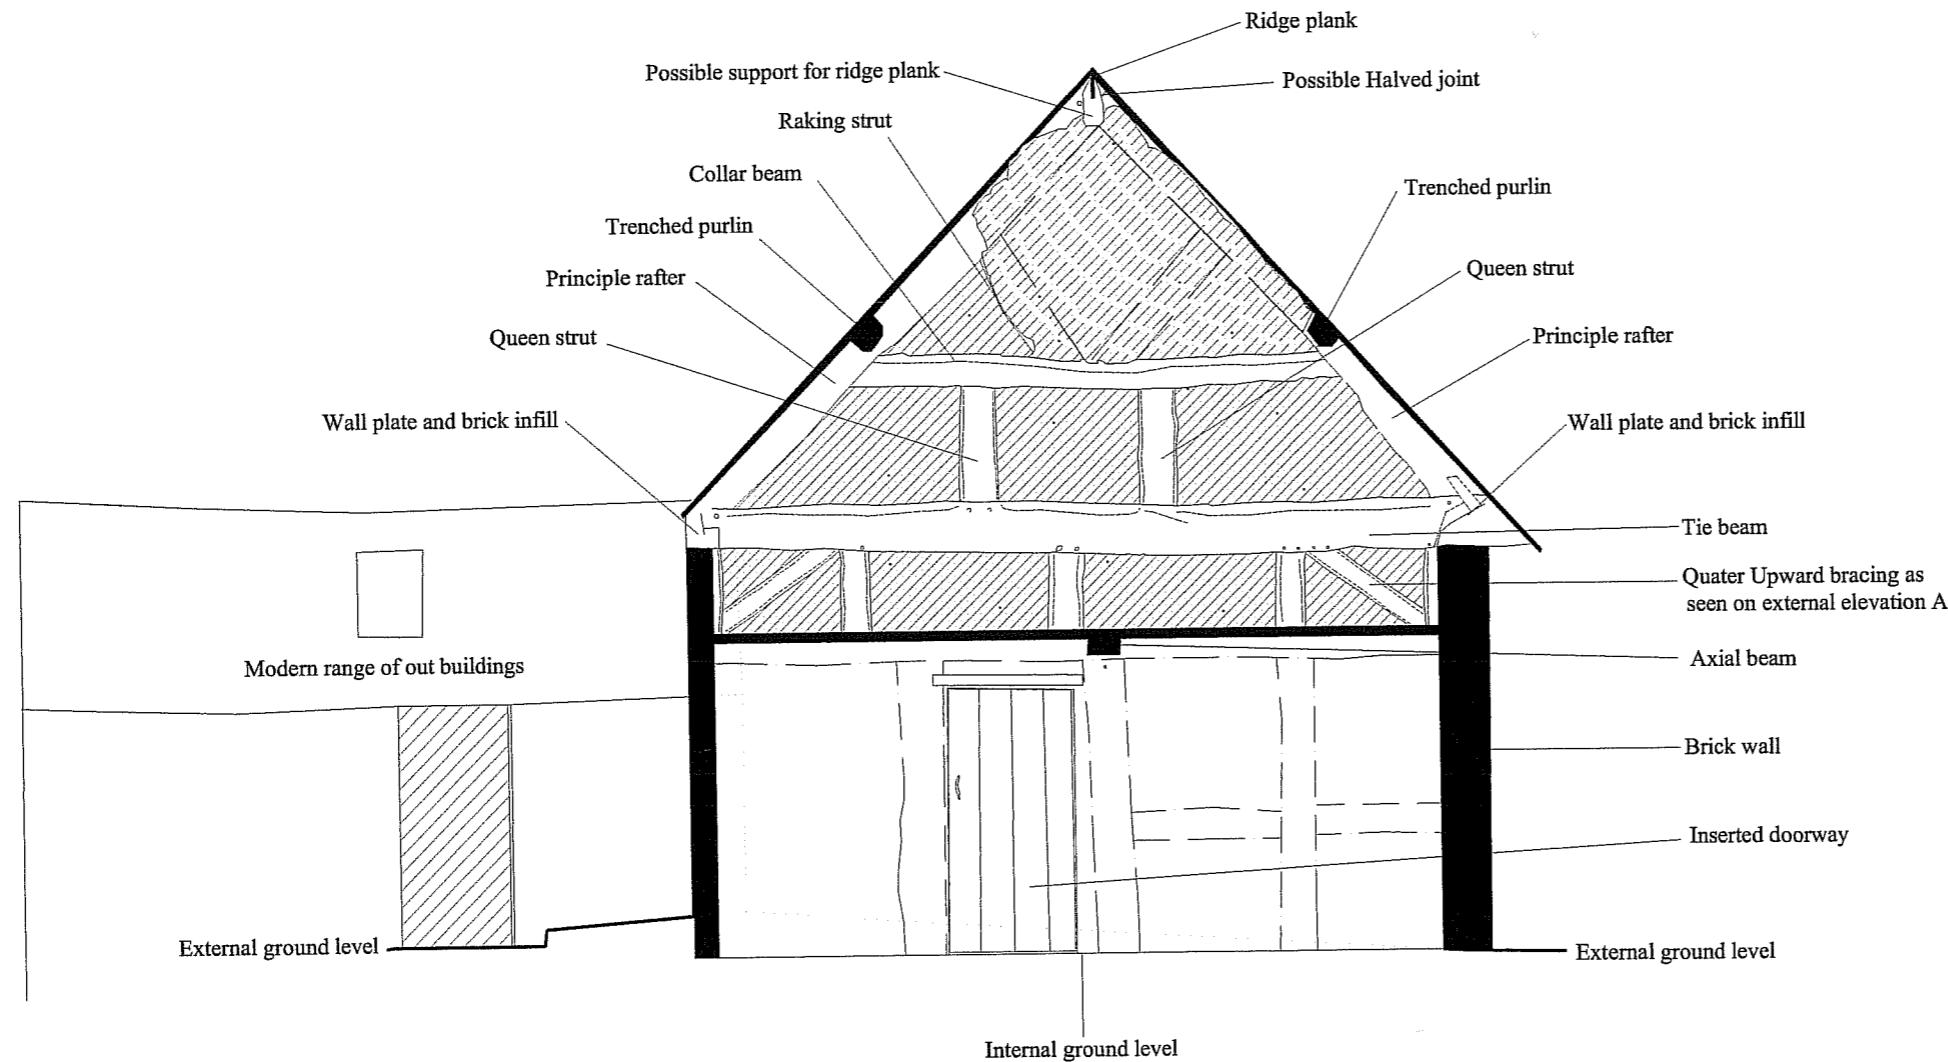
TRUSS SECTION

- Obscured beam details
- Plaster and Lime wash Obscuring beam details
- Plaster and Lime wash over brick infill

Due to the unsafe nature of the building this section is mainly based upon rectified photographs
 Most of the peg holes are totally obscured by successive white wash coverings

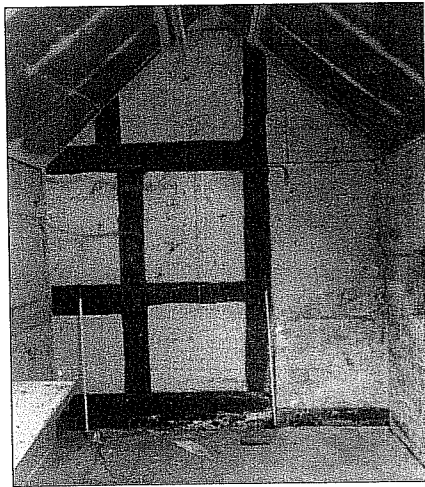
Internal detail showing timber framing detail of phase B building (PH1)

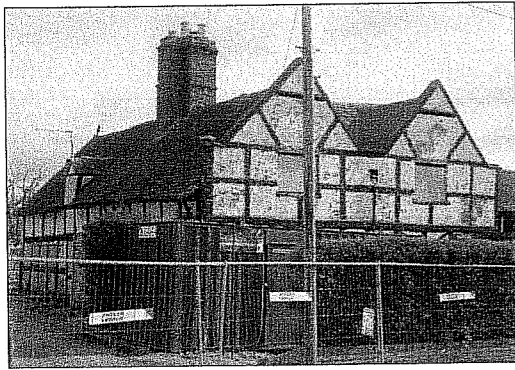
General view of Brickwalls, showing Brick fronted and painted gables (PH1)

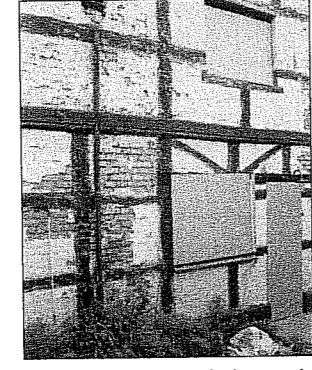
Detail of Inserted window and painted timber framing (PH2)

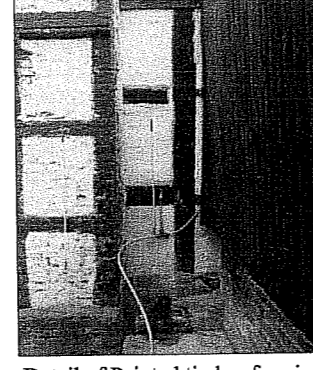
Detail of Painted timber framing on infill block in relation to timber framing of barn (PH3)

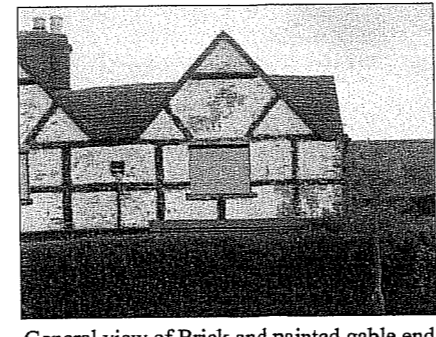
General view of Brick and painted gable end over infill block (PH4)

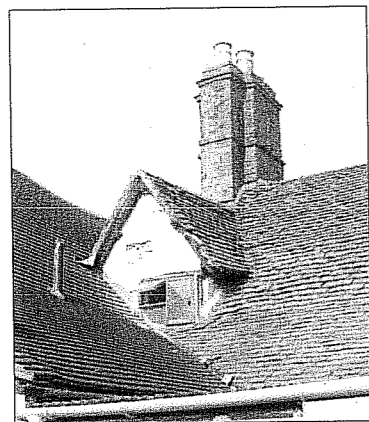
View illustrating Roof Line intersections and modified dormer window

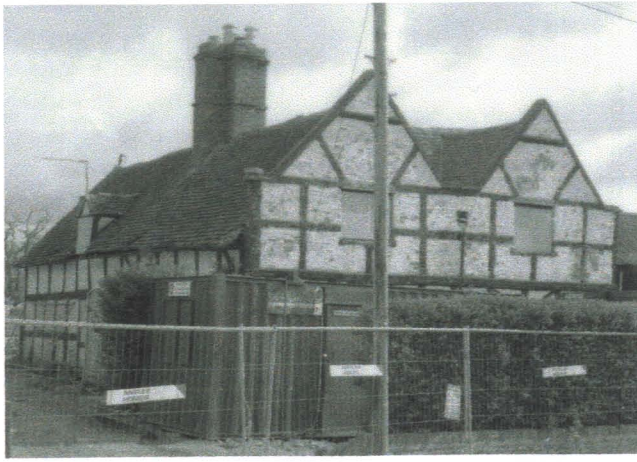
The timber-framed West Wing is the oldest surviving structure on the site, though evidently not medieval. Its south gable was effectively replaced by the later brick façade (*Plate 1*) but there is no evidence to indicate that the building ever continued further southwards. Indeed, the absence of any peg holes in its southern corner posts shows that it did not.

Plate 1 General view showing later brick facade.

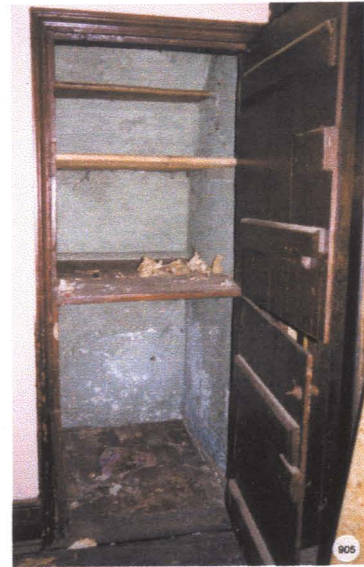
Apart from the surviving framing of its south window (*see below*), the main interest in the room is its doors. Made of deal, these are all ledged plank doors hung on strap hinges. Apart from the west doorway, there are also doorways to the west of the stack and through the east wall. In addition, there is a cupboard with a doorway recessed into the stack to the east of the fireplace (*Plate 2*).

Plate 2 Recessed cupboard
in central stack

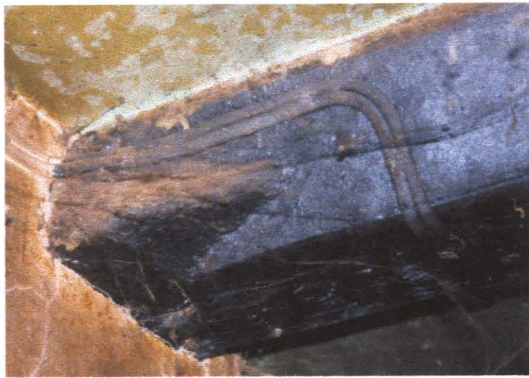
The northern room, the Kitchen, has a later-19th century quarry tiled floor and plain plastered walls. It is spanned by a single bridging beam with the same profile of broad chamfer as that across the southern room. This retains a single chamfer stop, at the west end – a broad broach stop of medieval character. However, as it is an elm beam it is unlikely that it is a reused medieval timber and it probably represents a very conservative design (*Plate 3*).

Plate 3 Beam and stop end detail.

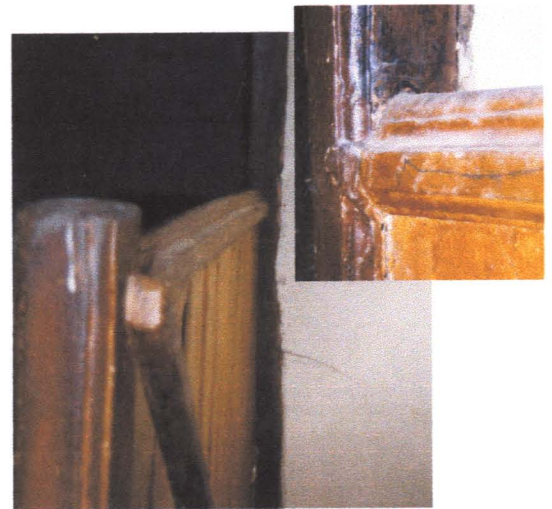
The 'boxing' of the stairs consists of vertical planks with moulded edges that continue upwards to form a solid balustrade for the narrow landing on the first-floor. This balustrade is topped by a moulded handrail – a bold ovolo flanked by cavetti (*Plate 4*).

Plate 4 Balustrade and moulded
Handrail.

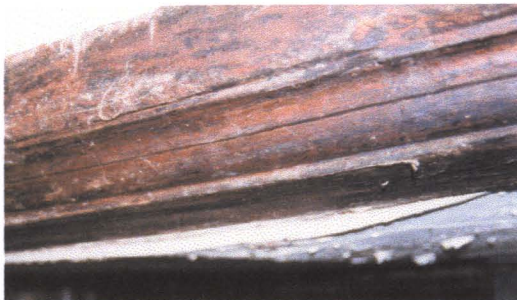
The moulding – of a cavetto and ovolo - on the beam is of the same general character as that on the handrail of the landing, and in the moulding of the window frame of the dormer gable (*Plate 5*).

Plate 5 Detail of moulding from window
frame in dormer window

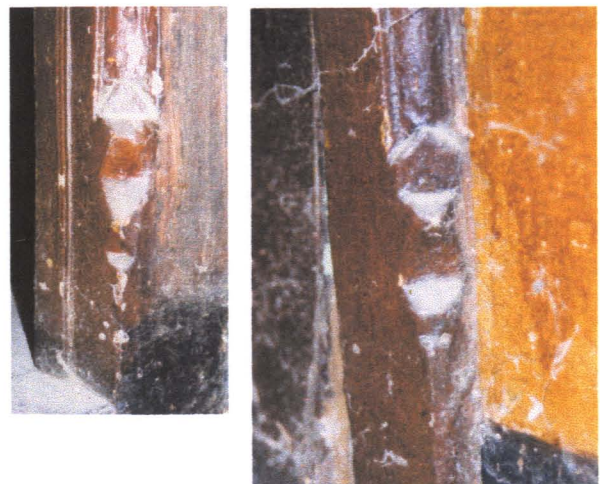
Plate 6 Details of the ornate stops on the
architrave of the upstairs rooms.
