# WITLEY COURT

The Archaeological Excavation of the Floor within the  
Veterinary's Room

**The Archaeological excavation of the Floor within the  
Veterinary's Room.**

**March 1998**

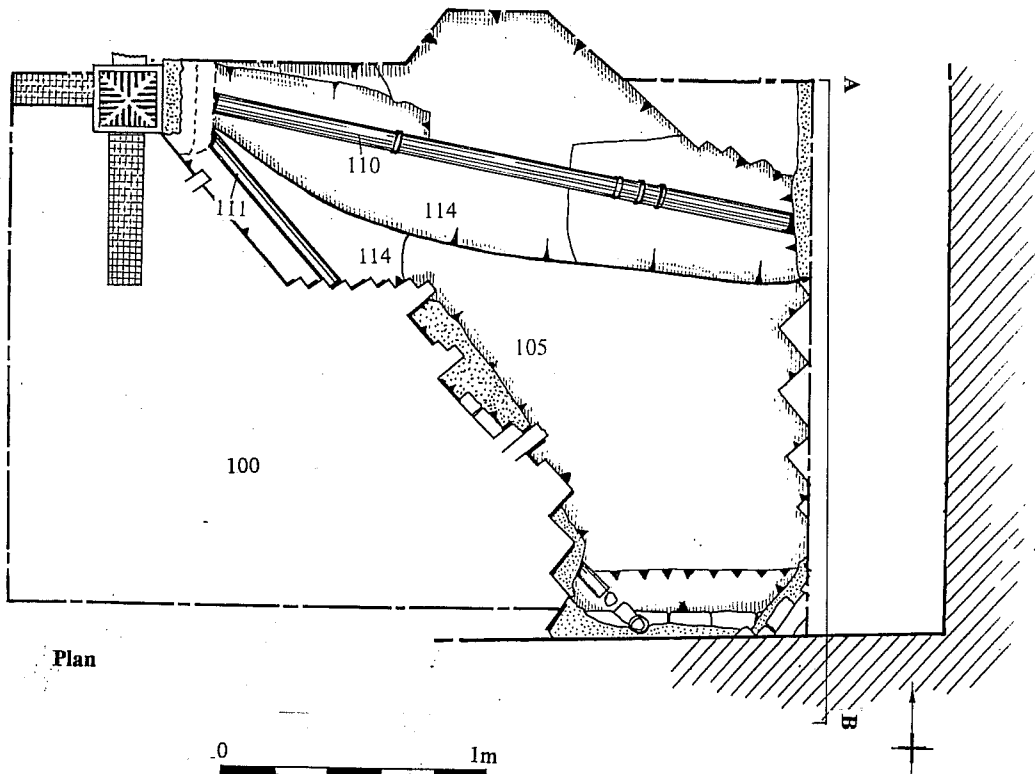
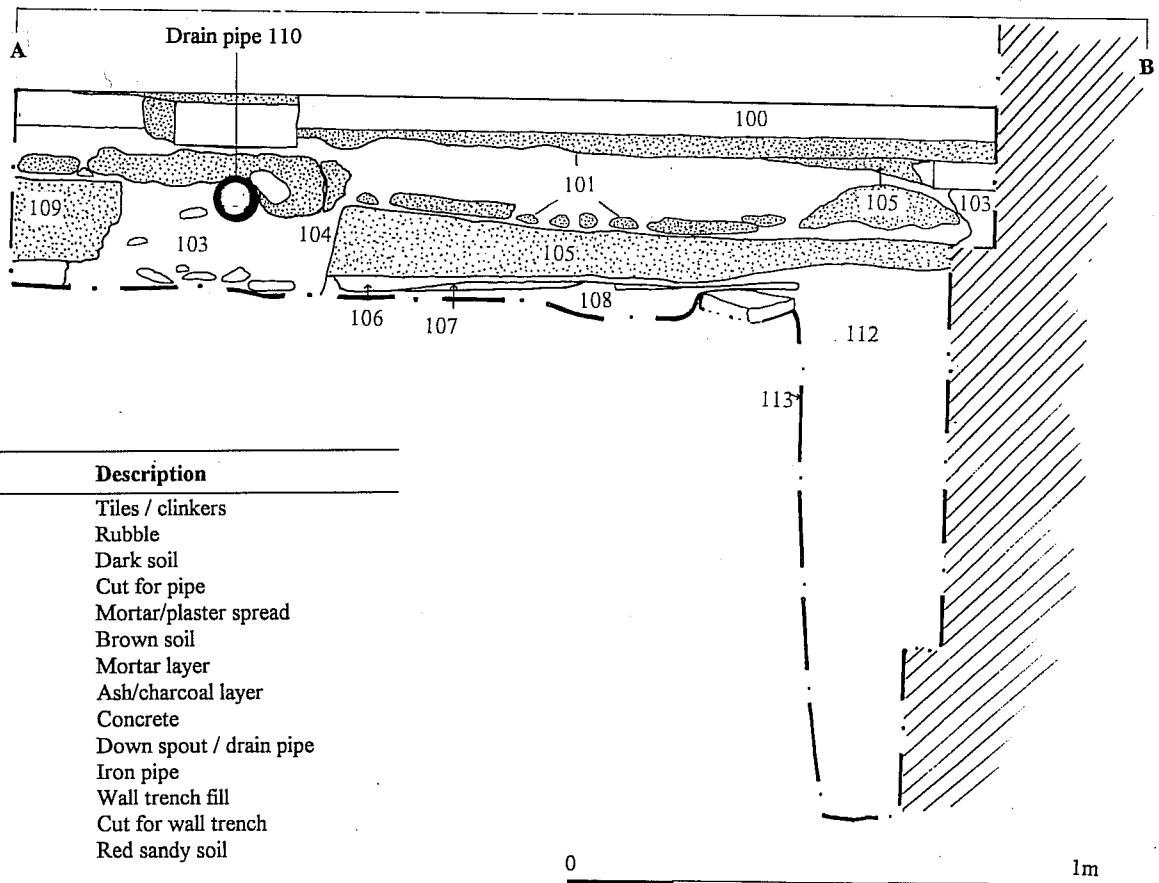
Fig. 2

An area approximately 2.5m x 1.0m had sunk to a depth of about 0.10m below the current floor level, immediately to the east of the central drainage trap. This area was gridded out and photographically recorded prior to the lifting of the tiles. The removal of the tiles revealed a void immediately below the clinkers approximately 0.25m in depth. At the bottom of the void was a deposit of mortar/cement which proved to be the base of the tiled floor which had slumped down and fallen away from the underside of the tiled surface.

After the removal of the clinkers, some excavation was necessary to establish the extent of slumping and its cause. Two linear cuts were encountered leading from the drainage trap, (at the western end of the trench), one running on an east/west axis (feature 10) and one on a north-west / south-east axis (feature 11). These cuts each contained a water pipe originating / terminating at the drainage trap in the middle of the floor. The pipe within feature 10 continued through the eastern wall of the building at which point there was a second trap. The second pipe (feature 11) may well have been originally connected to a sink on the south wall. Its fall was toward the trap in the centre of the room as would be expected. The fills of both pipe trenches were removed so that the pipes could be inspected for signs of damage. Upon inspection the pipe running east / west (10) was found to be a re-used downpipe (drainpipe) that was not actually connected or joined in any way to the trap end of the pipework, just butted up to it. Furthermore it too was falling towards the trap when it clearly should have

been running away to the outside. Whether this was bad workmanship, or the result of subsidence due of water seepage could not be ascertained. The central trap was also investigated. This revealed a salt glazed trap commencing approximately 260mm below the iron grill and inspection covers. The trap was found to be fractured and had been mended with a substantial cement fillet.

These works have illustrated that the subsidence below the floor, within the veterinary's room, was caused by repeated flooding and seepage from both the broken central drainage trap and the re-used length of down-pipe which was not properly connected. Both the broken central trap and the unconnected pipe will have contributed greatly to the subsidence of the floor, as both will have caused a lot of water to accumulate below the ground with nowhere to escape to except to sink into the soil. It is clear that the use of the room would have necessitated the constant washing down of the floor and other surfaces. It must be concluded that this drain was therefore in constant use until the building fell into decay. The lack of a roof over this room in more recent times must also have contributed to the problem.

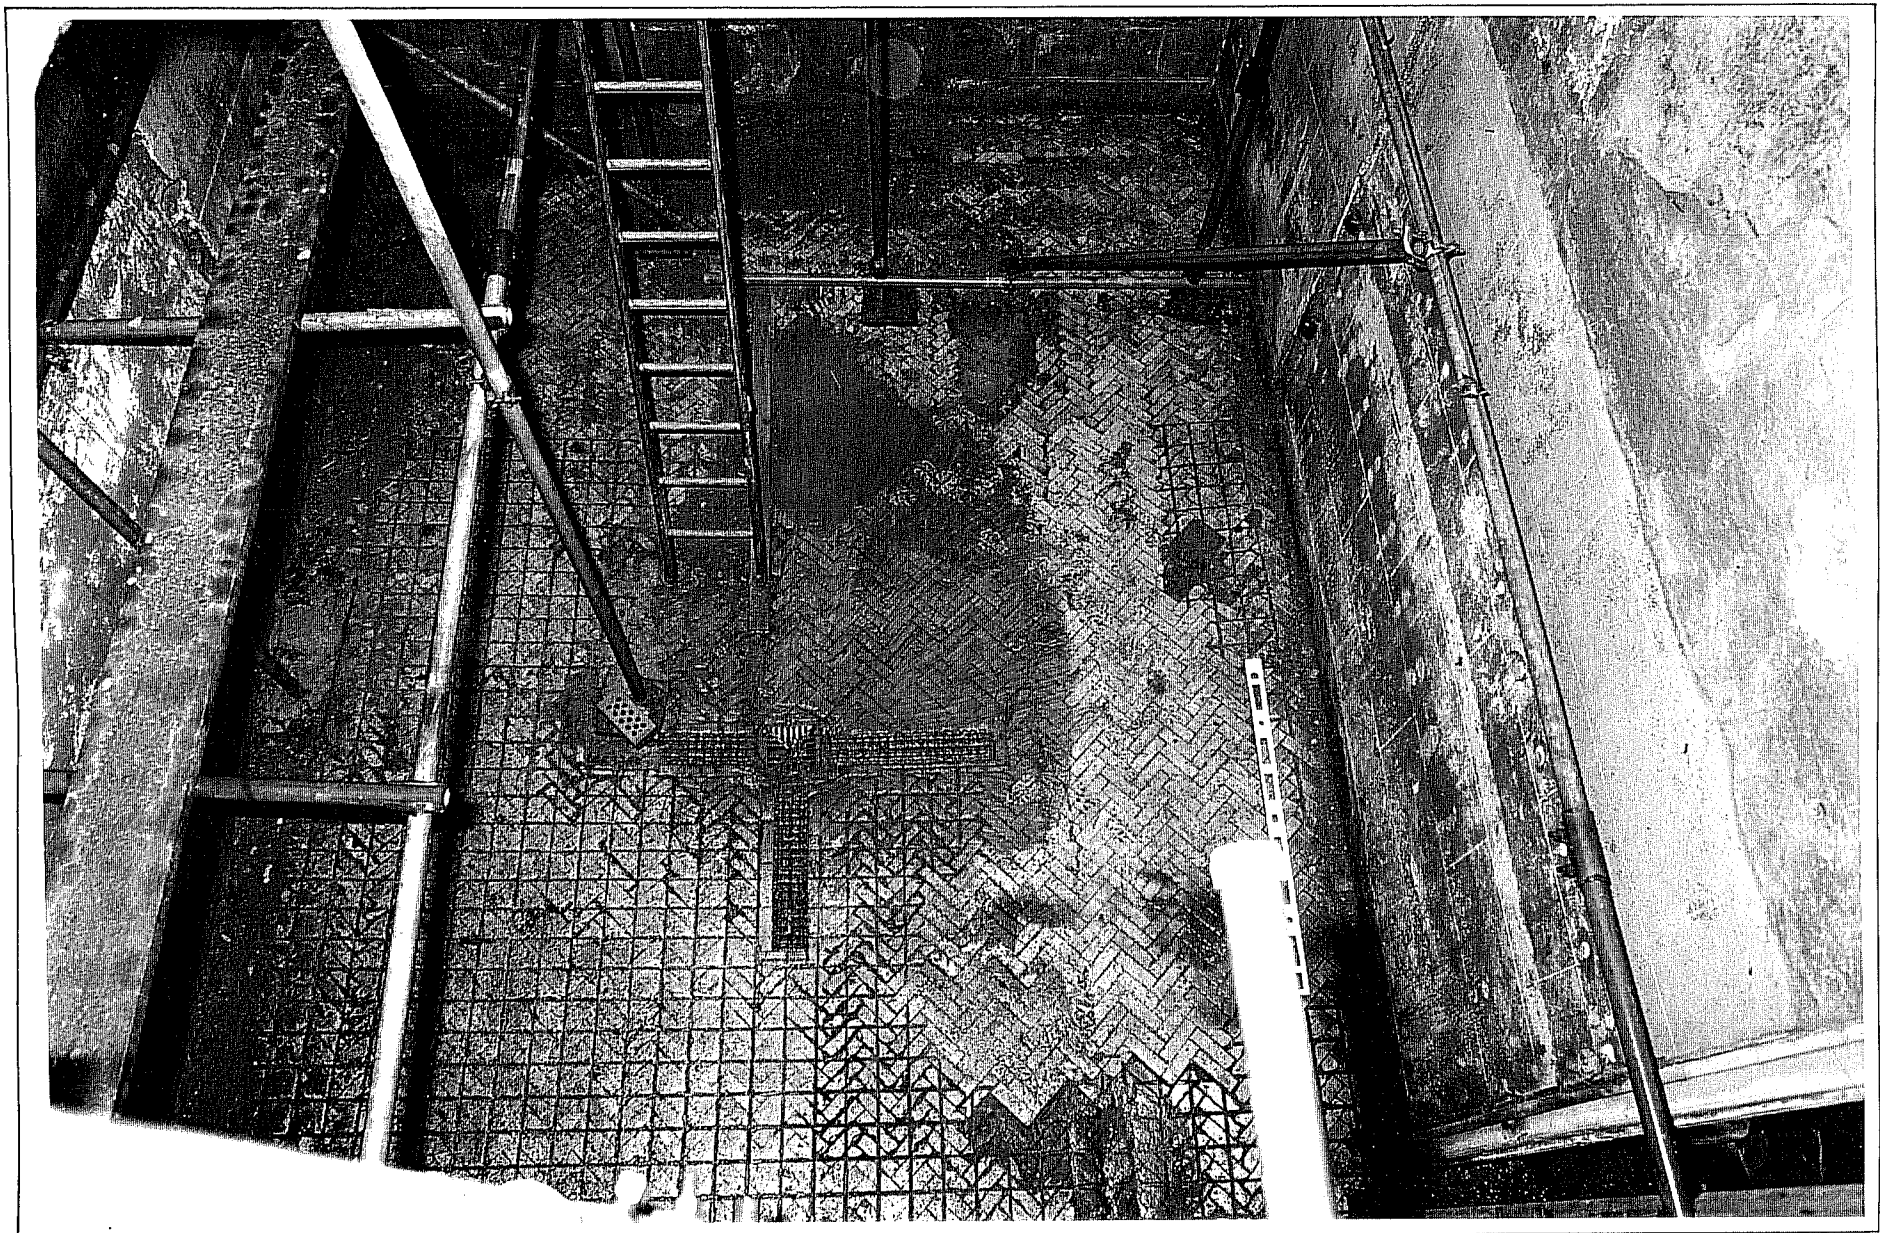
The floor showing the pattern of the clinkers, the iron drain and the concrete patching.
