*Comment on an Historic Building at
Butts Bank Farm, Broadwas, Worcestershire*

A report for Mr and Mrs Barnes

November 2006

Project: PJ 169

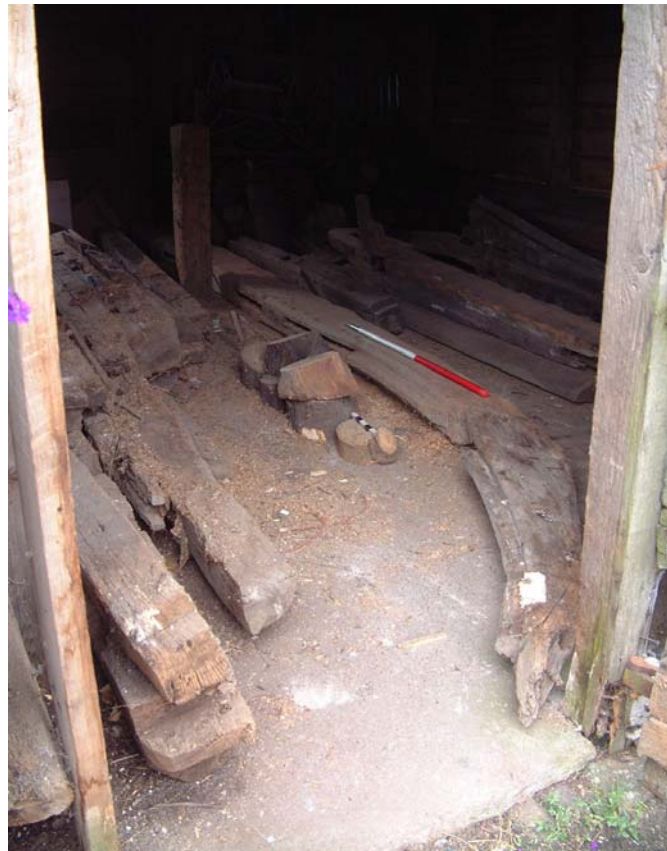
Plate 2: *The remaining cruck blade is unfortunately fractured (Scale 1 metre)*

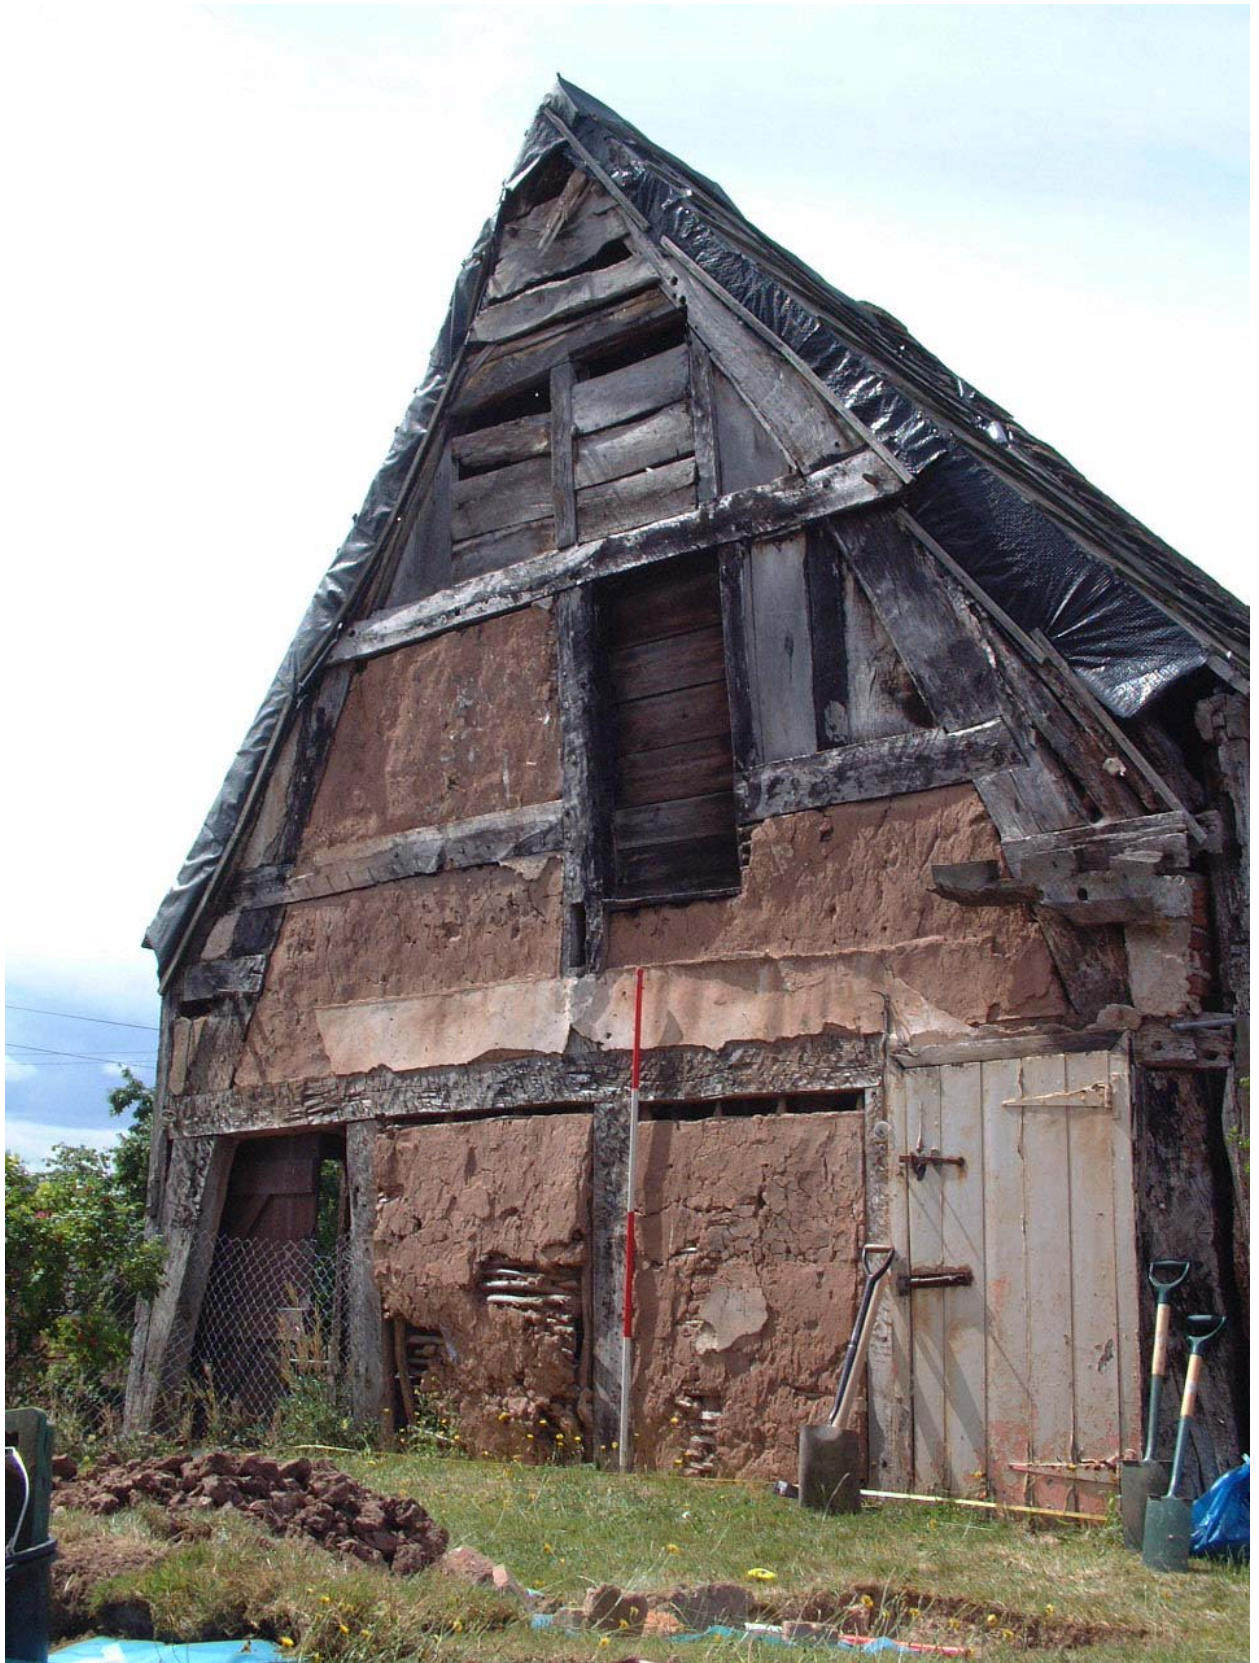
The structure is generally in poor condition and there are many indications of stress, movement and fracture of structural timbers. The remaining wattle and daub panels in the exposed eastern frame (C1) have been exposed to the elements for many years and degradation is clear. The daub is cracking and falling out and some of the wattle lattice, on which the daub is applied, has moved out of its securing holes and is in danger of collapsing outwards.

Plate 14: *Cruck frame C1 looking south-west. The door is the location of the earlier door between the domestic end and the byre (Scale 2 metres)*

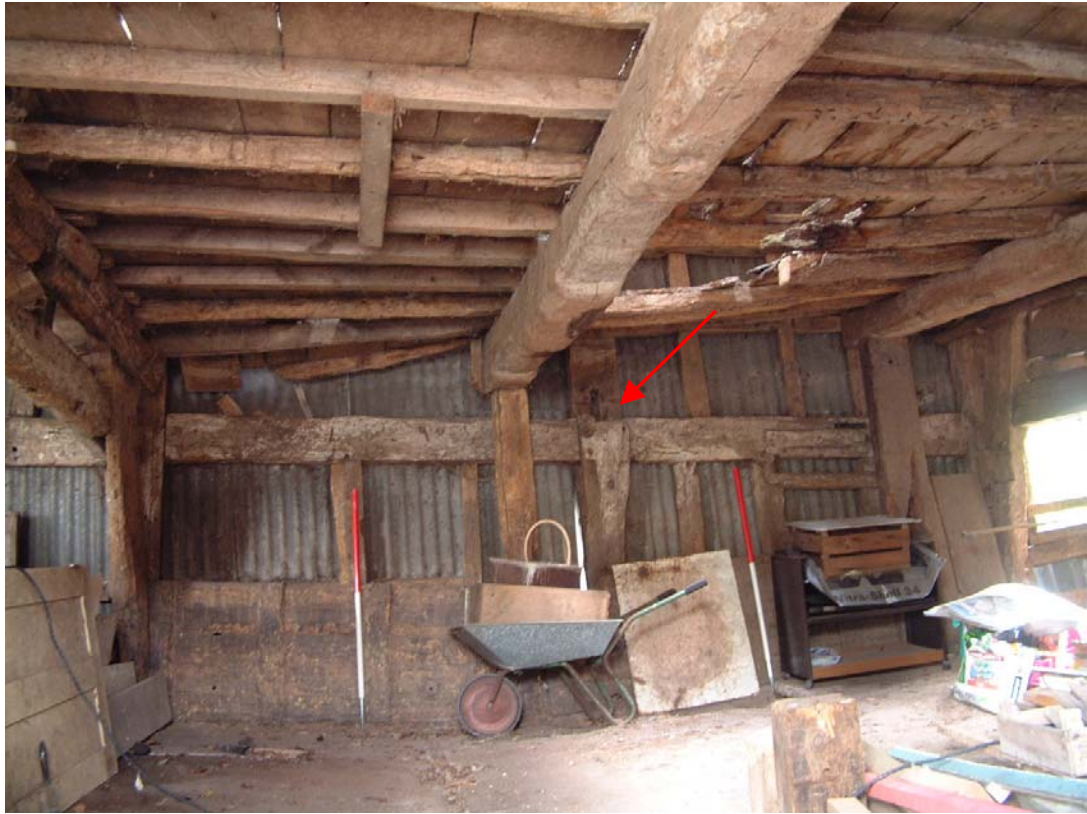
The cumulative problems caused by the split in the tiebeam of C2 is noticeable in bay 2, where there is a distinct lean of the southern frame to the south. The northern framing is in poor condition and the sill beam has totally rotted away.

Plate 17: *Southern framing of Bay 2. The bridging beam is inserted and originally was tenoned into the central post (arrowed)*

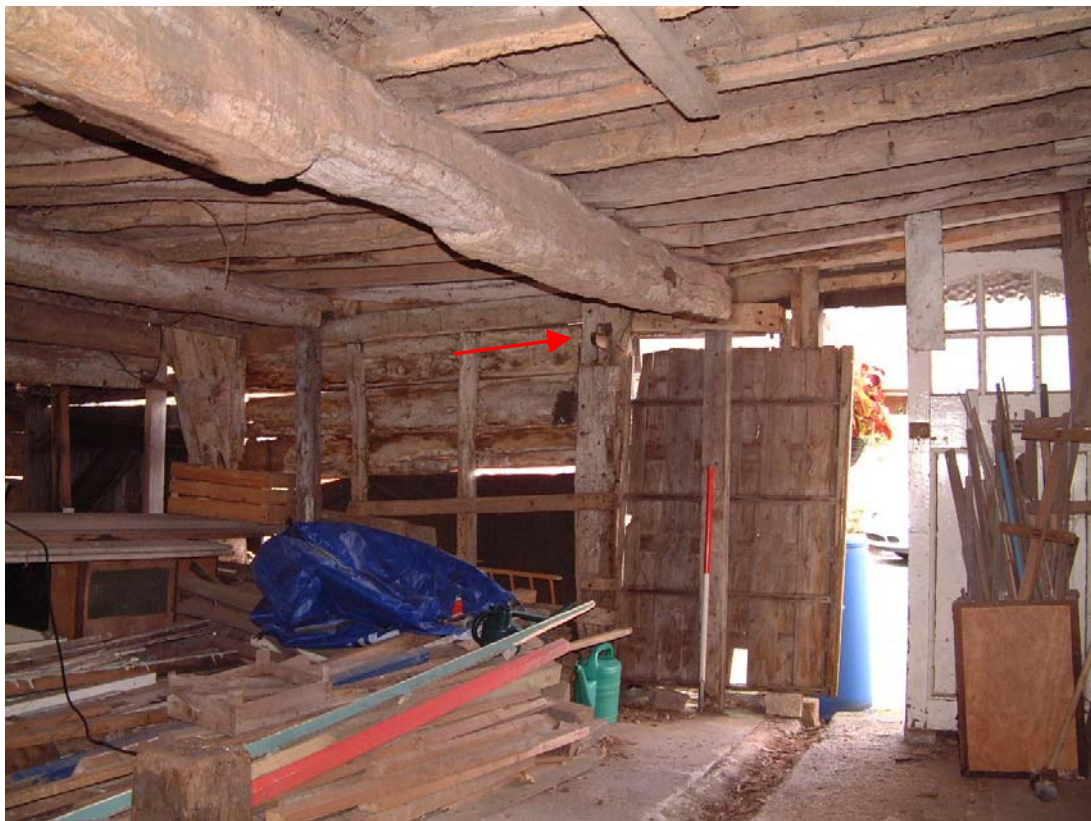
Plate 18: *The opposite northern framing of Bay 2, with the original location of the opposite end of the bridging beam arrowed*

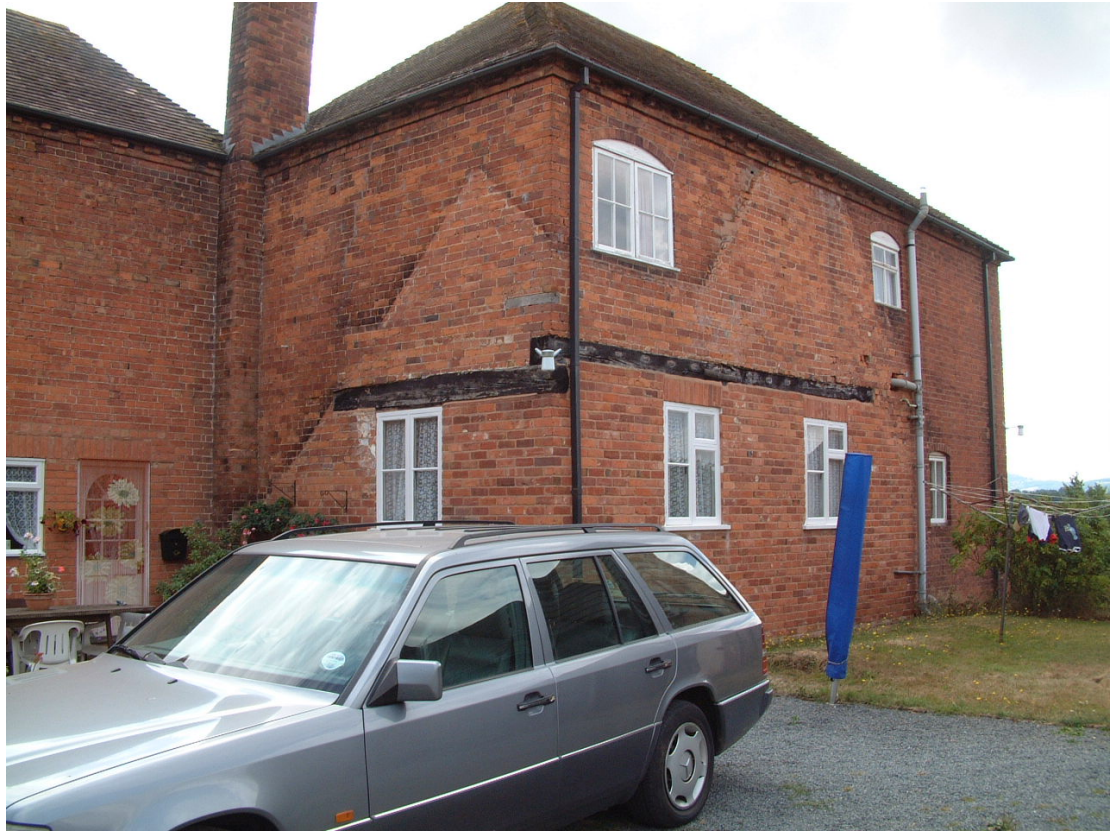
Plate 20: *Remaining timber-framing in the external walls of the present farmhouse; also note the shadow lines of the former rooflines.*
