*Archaeological Condition Assessment
of the Ha Ha at Kersoe Farm,
Elmley Castle, Worcestershire*

**Archaeological Condition Assessment
of the Ha Ha Wall at Kersoe Farm,
Elmley Castle, Worcestershire**

January 2008
© Mercian Archaeology

Project: PJ 204

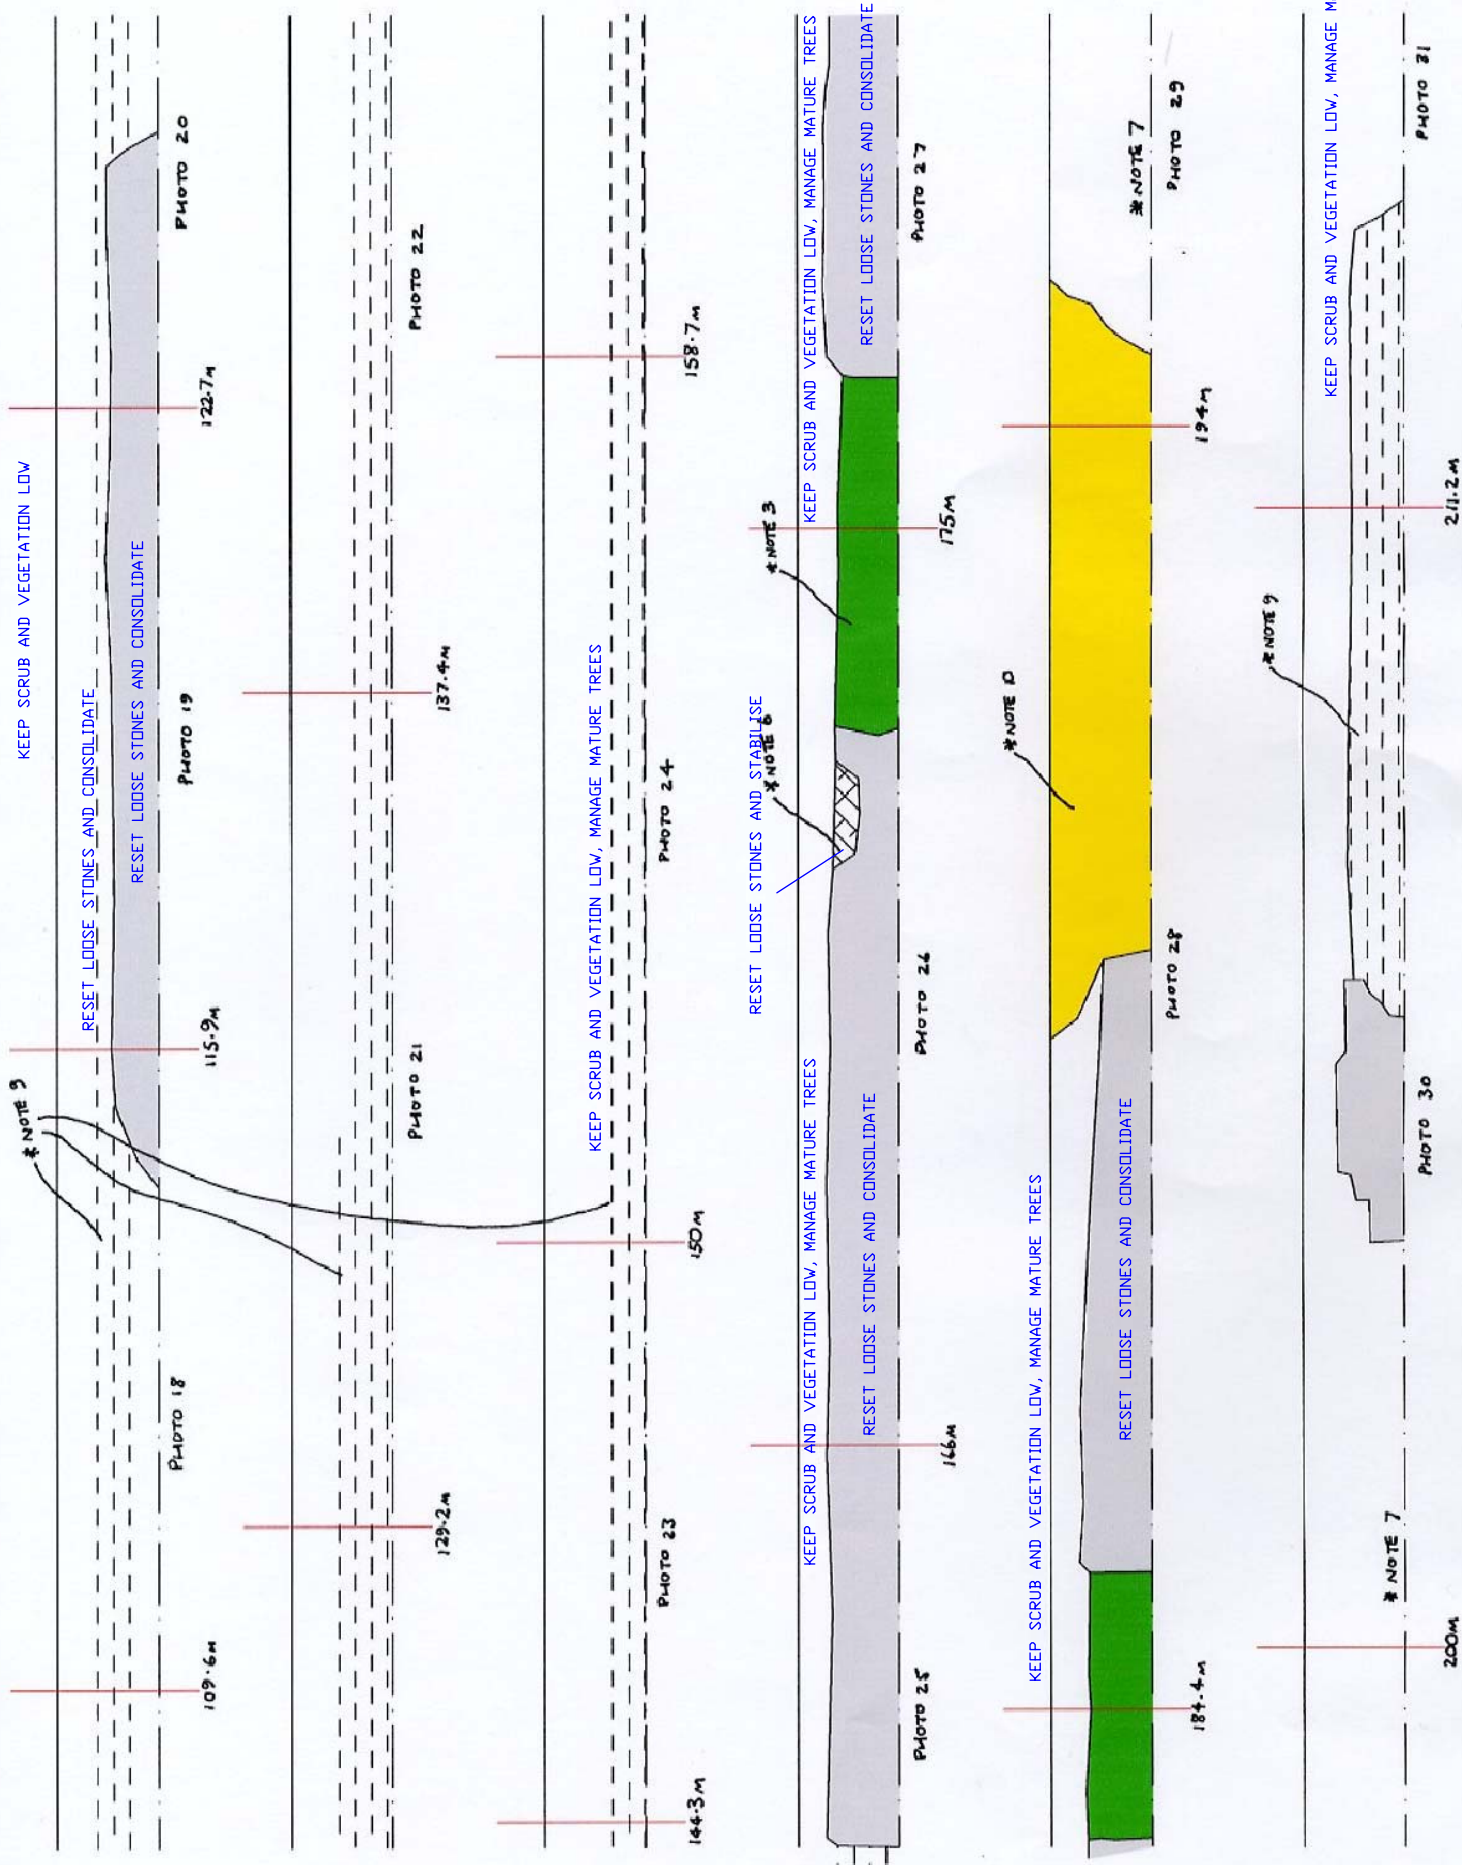
* NOTE 9

* NOTE 3

* NOTE 8

* NOTE 10

* NOTE 7

KEEP SCRUB AND VEGETATION LOW

RESET LOOSE STONES AND CONSOLIDATE

KEEP SCRUB AND VEGETATION LOW, MANAGE MATURE TREES

RESET LOOSE STONES AND STABILISE

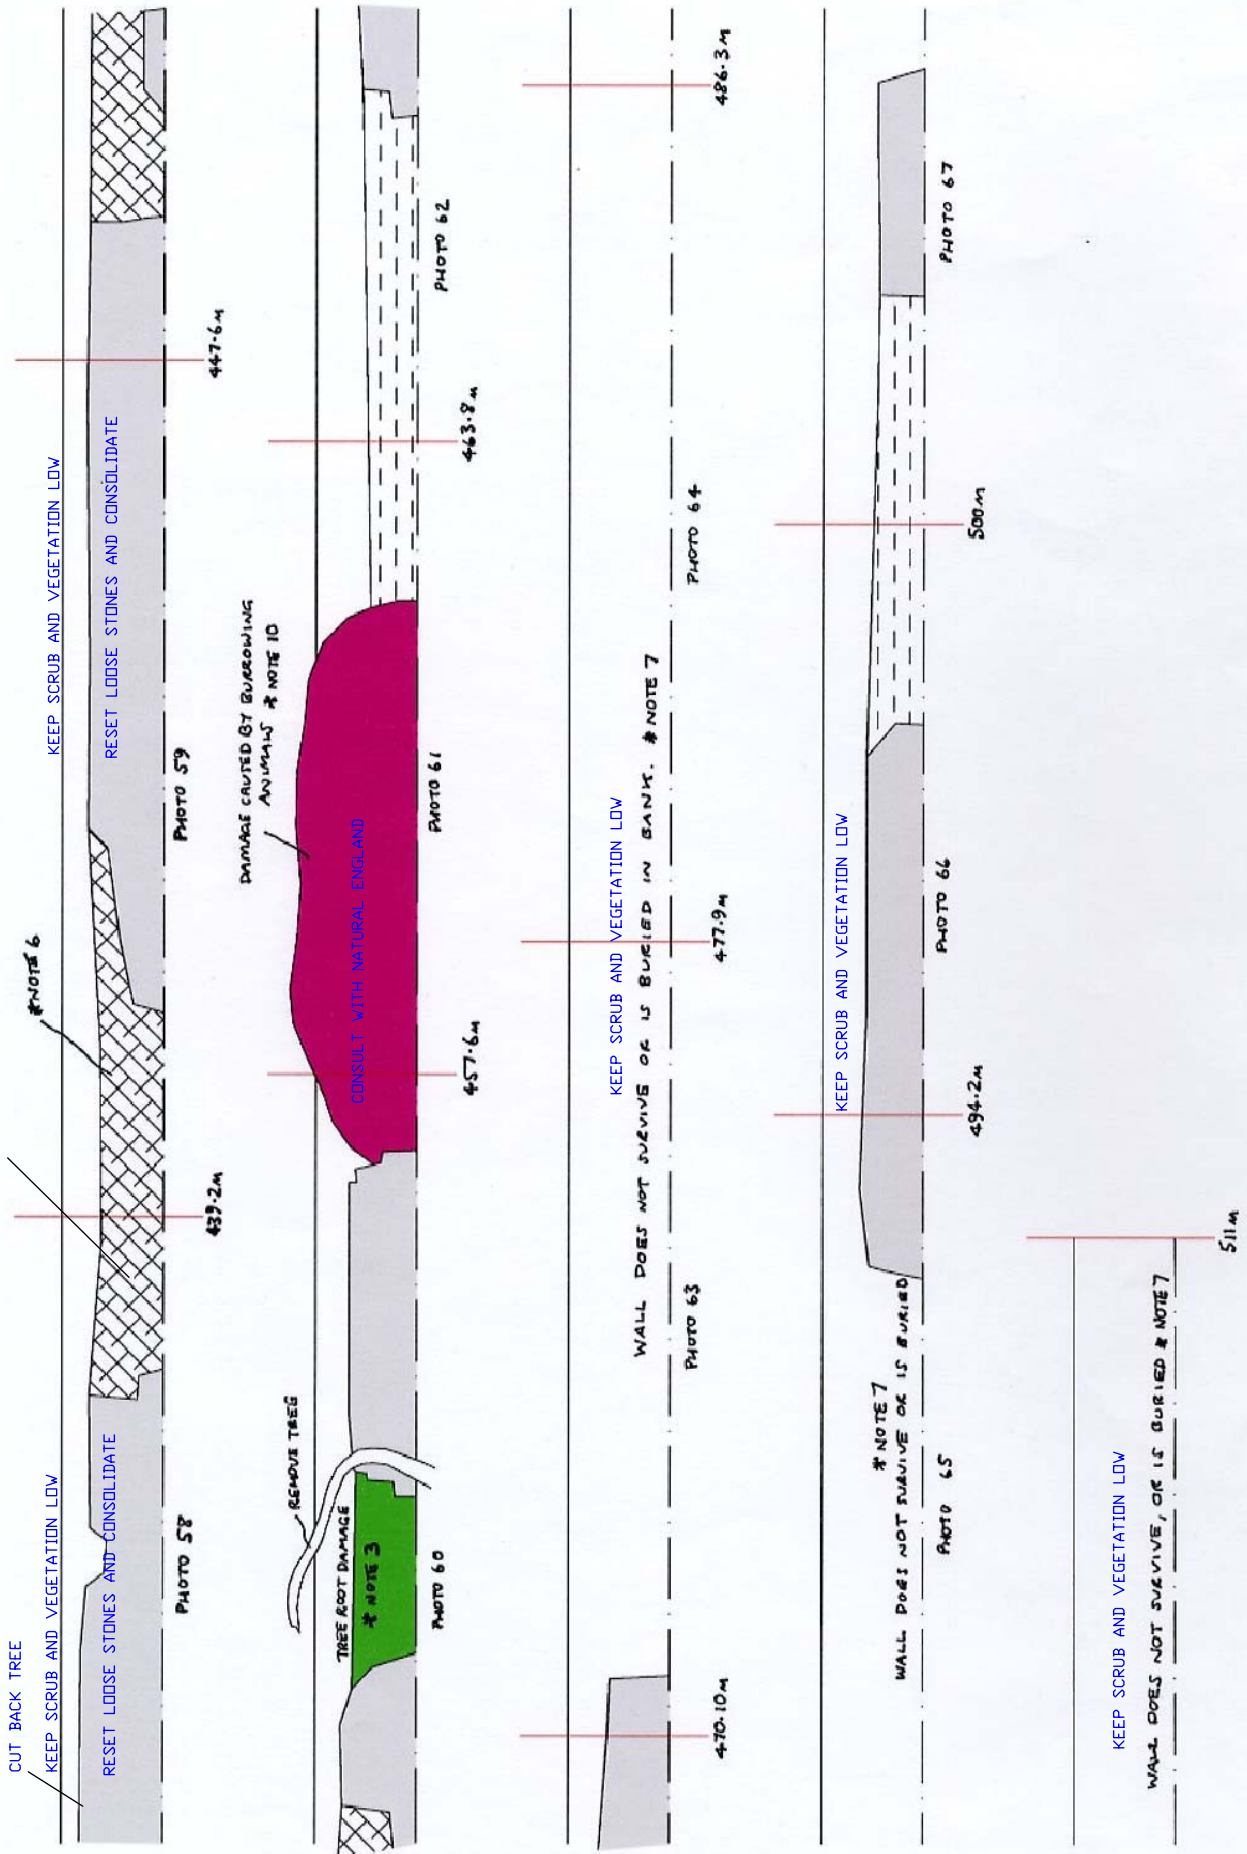
TREE ROOT DAMAGE
NOTE 3

DAMAGE CAUSED BY BURROWING ANIMALS # NOTE 10

WALL DOES NOT SURVIVE OR IS BURIED IN BANK. # NOTE 7

NOTE 7
WALL DOES NOT SURVIVE OR IS BURIED

WALL DOES NOT SURVIVE, OR IS BURIED # NOTE 7

CUT BACK TREE
KEEP SCRUB AND VEGETATION LOW

KEEP SCRUB AND VEGETATION LOW

RESET LOOSE STONES AND CONSOLIDATE

REMOVE TREES

CONSULT WITH NATURAL ENGLAND
