*An Historic Building Recording at  
Boat House Farm, Eastham, Worcestershire*

# A Historic Building Recording at Boat House Farm, Eastham, Worcestershire

*A report for Mr and Mrs Jones*

**Project: PJ 106**

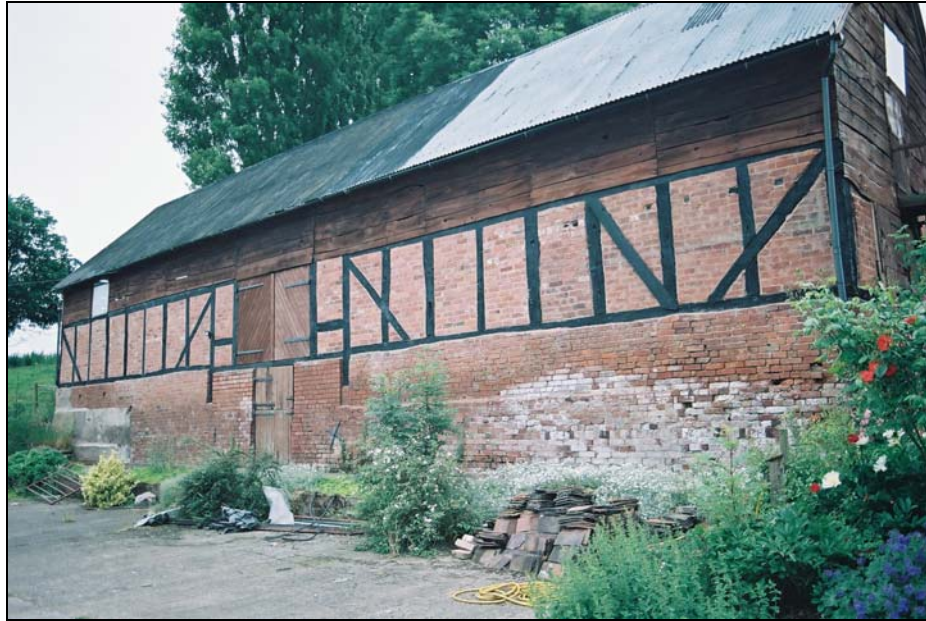
## Plate 1

*North elevation of the barn*

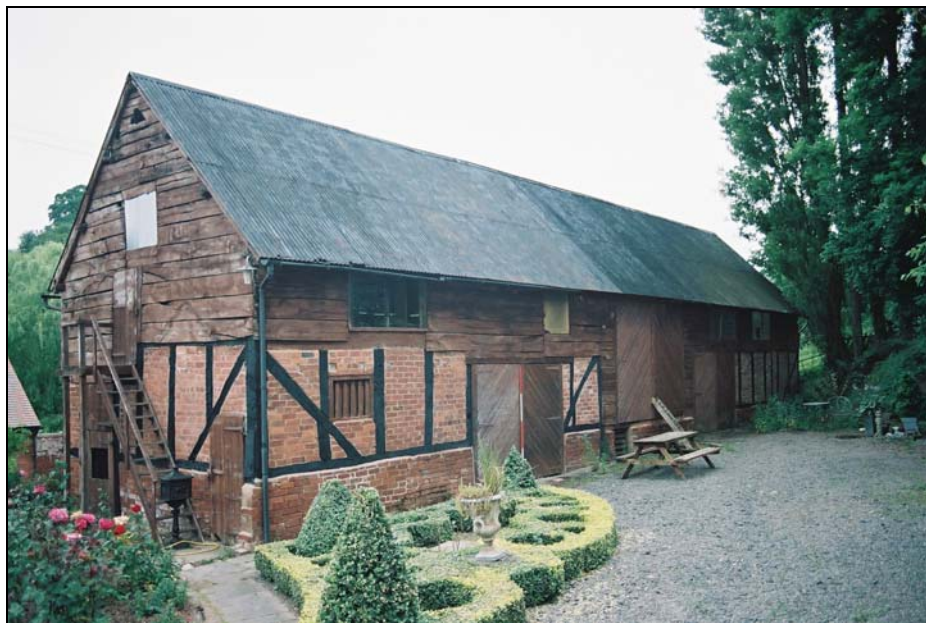
## Plate 2

*South elevation of the barn*

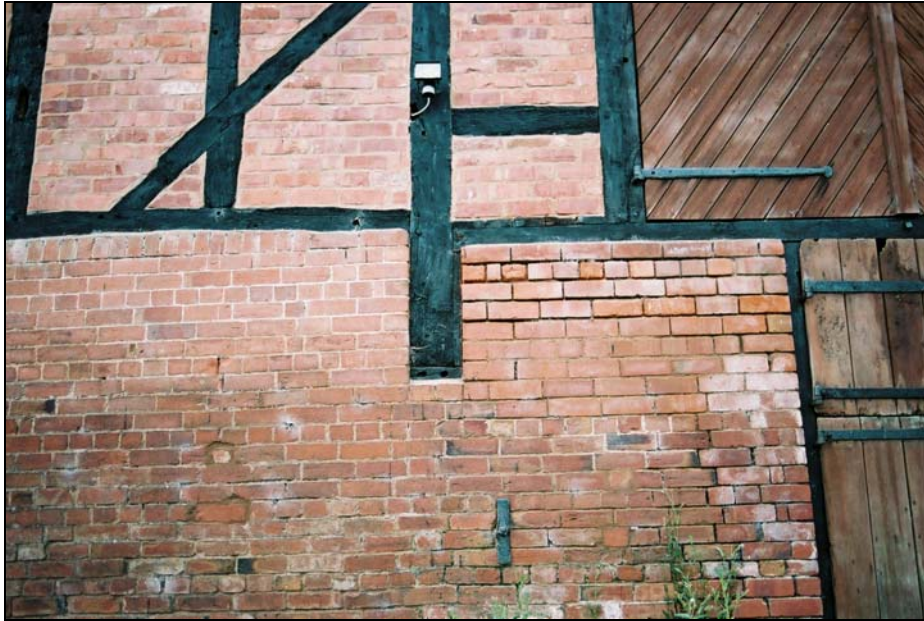
## Plate 3

Bay 3 is the central bay (Plate 9). It originally would have been at ground level with full height cart doors to both north and south elevations. Today, the floor has been raised by around 80 centimetres to the level of the windbreak axial sill beams and a room built below (now a wood store, Plate 10). The land on the north side has been excavated away to accommodate the new basement room. The position of the original sill beam on this side can be seen in Plate 3.

*Post of the cart bay standing on the remains of the original sill beam, highlighting the extent of under-building on this side*

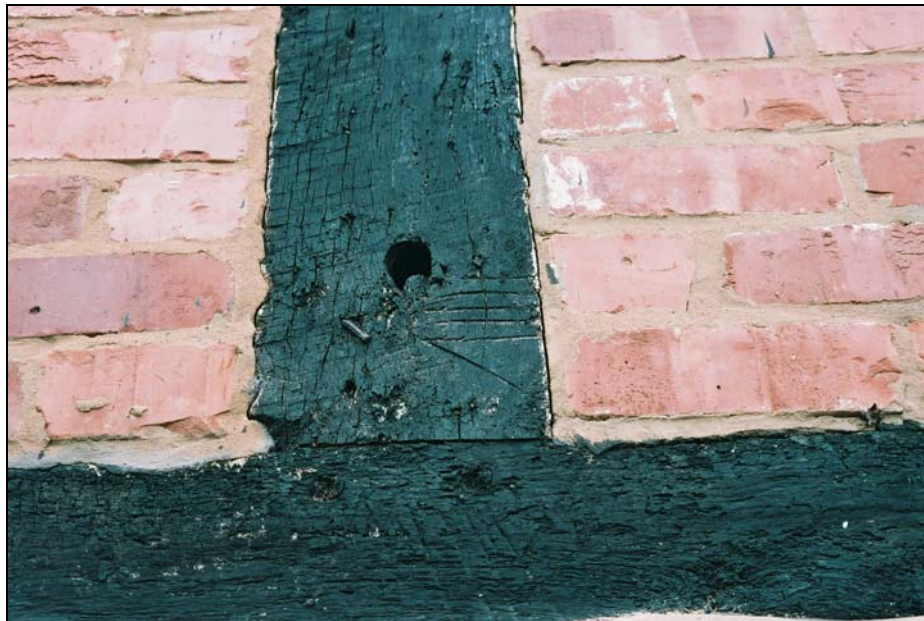
## Plate 4

*Scribed carpenter's marks on a rail on north elevation of the barn*

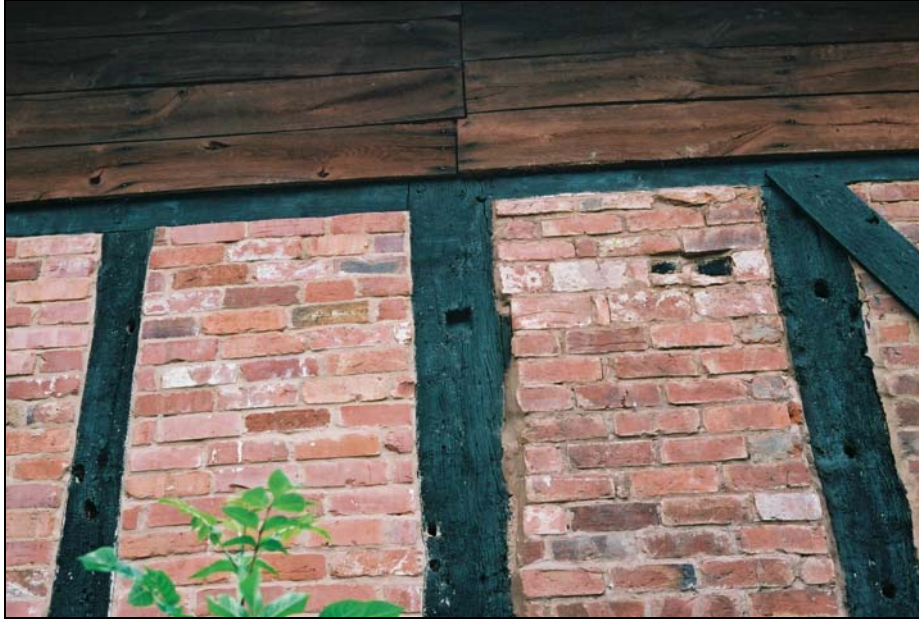
## Plate 5

*Detail of frame showing a 'scotch' (notch in post for a supporting strut during the construction process). The diagonal strut (right) is clearly false and is nailed onto the frame*

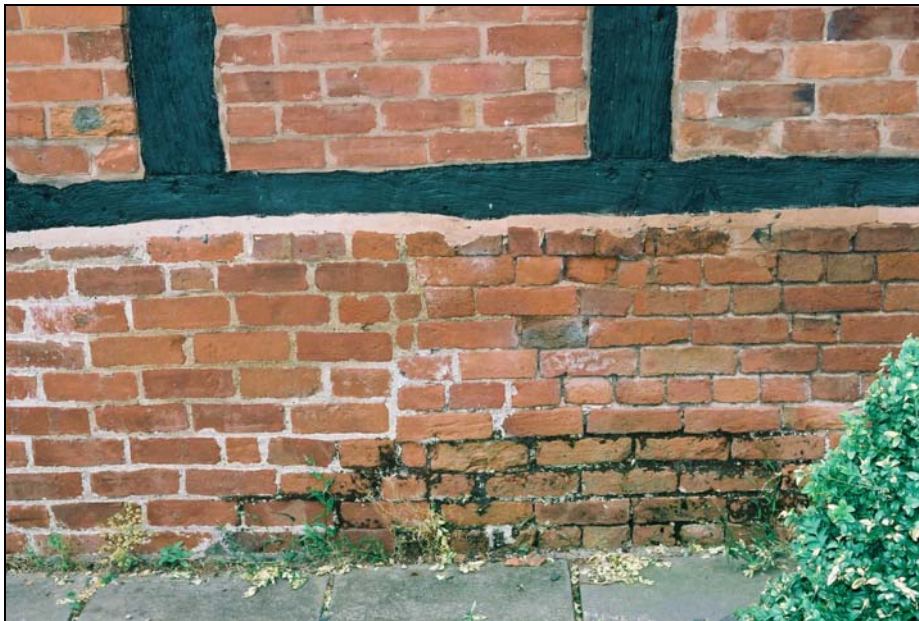
## Plate 6

*South elevation. The original brick plinth (right) and larger bricks of the plinth rebuild (left). The post of Truss T2 is the one on the right.*

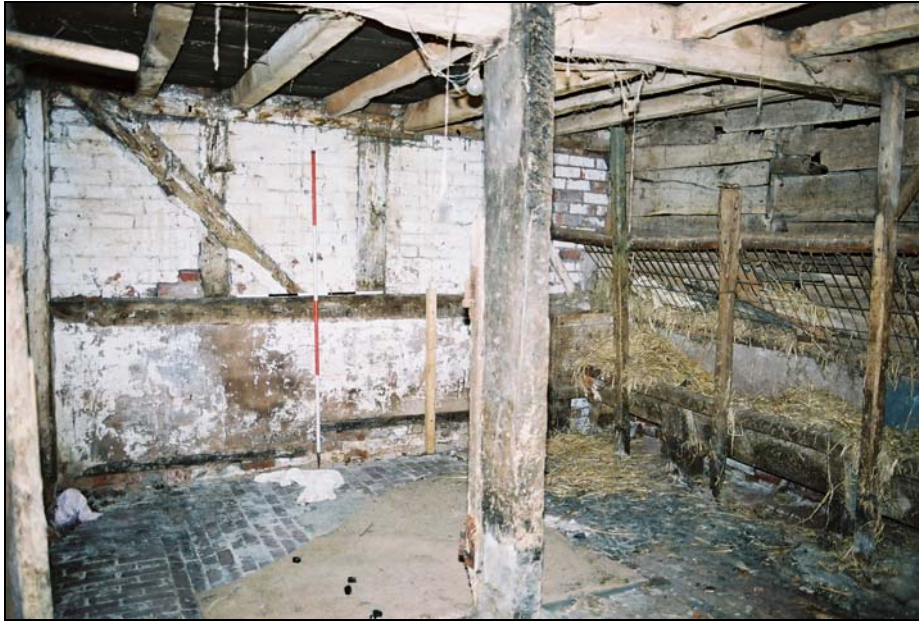
## Plate 7

The floor of the cowhouse is partly cobbled and part repaired in brick (Plate 7). It is likely that the cobbled floor was added when the bay was converted to house animals, probably in the 19<sup>th</sup> century. The original floor may have been rammed earth, although there is no visible evidence for this. The wall framing, as throughout the barn, is rectangular panelled with corner downward braces. There is further discussion of the frame below.

*Bay 1 (lower) showing the inserted hayloft above and the part cobbled floor*

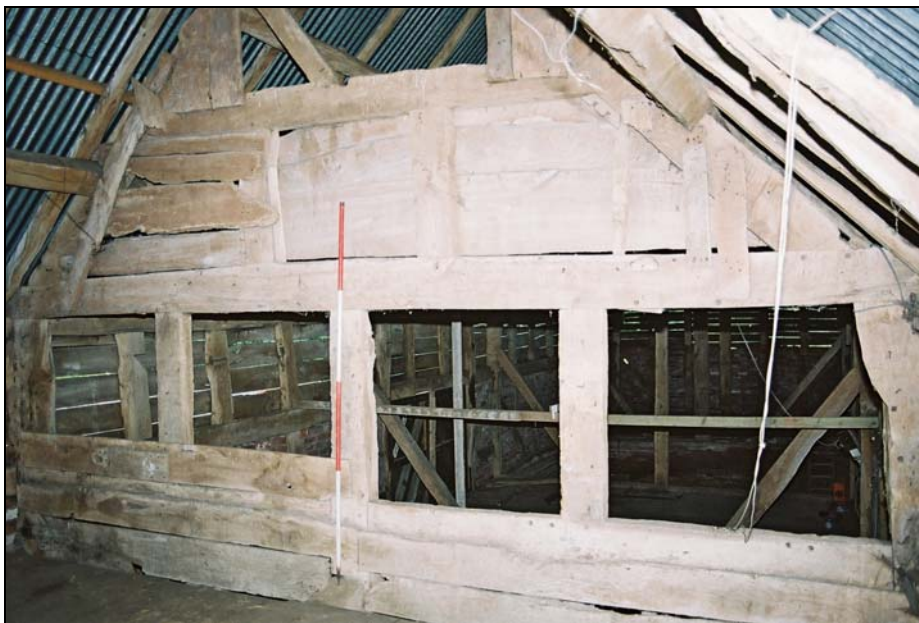
## Plate 8

*Truss T2 from the hayloft looking through along the barn to the east.*

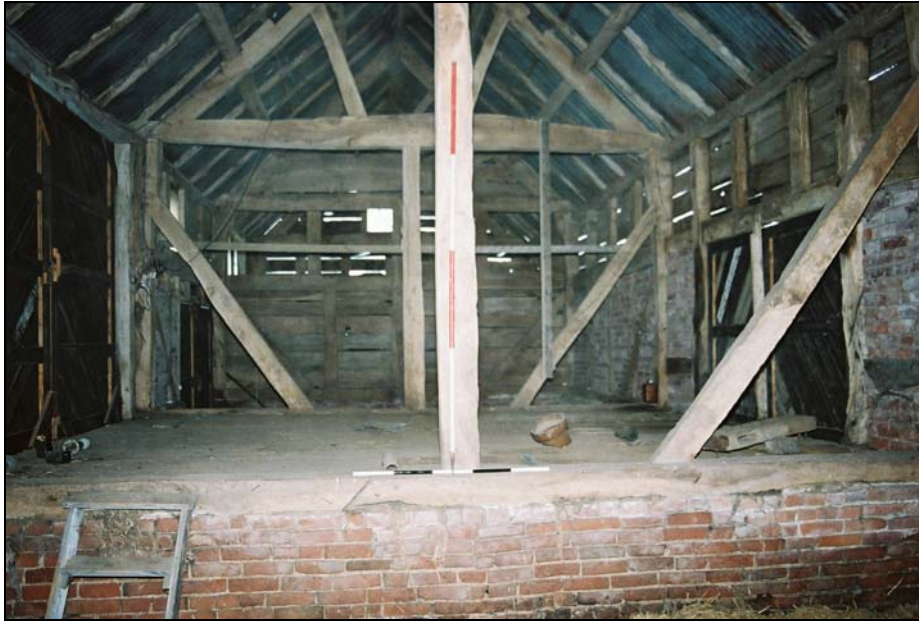
## Plate 9

*Bay3, originally the threshing bay, but now raised up and a room inserted below on the ground floor (see Plate 10)*

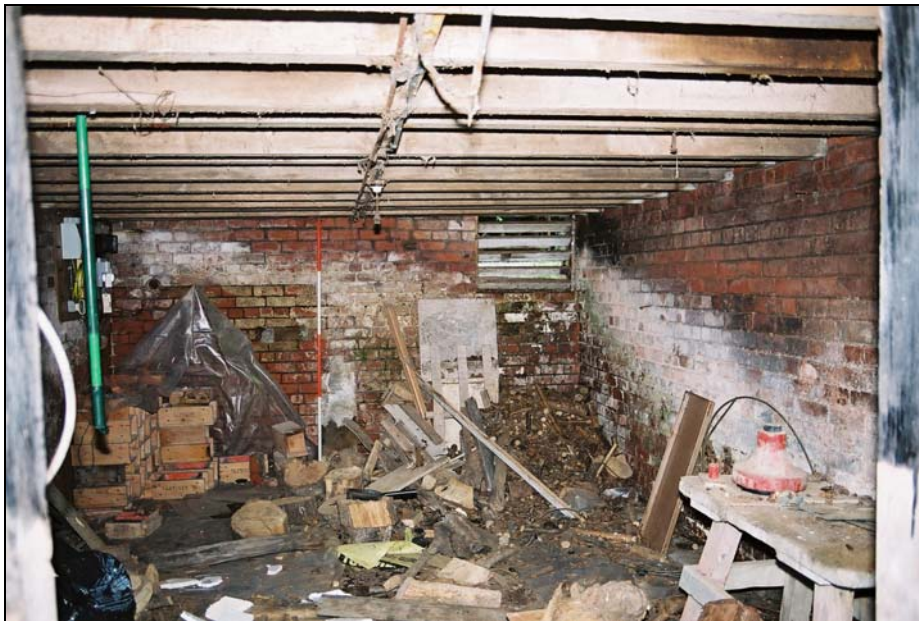
## Plate 10

*Room below the threshing bay (see Plate 9)*

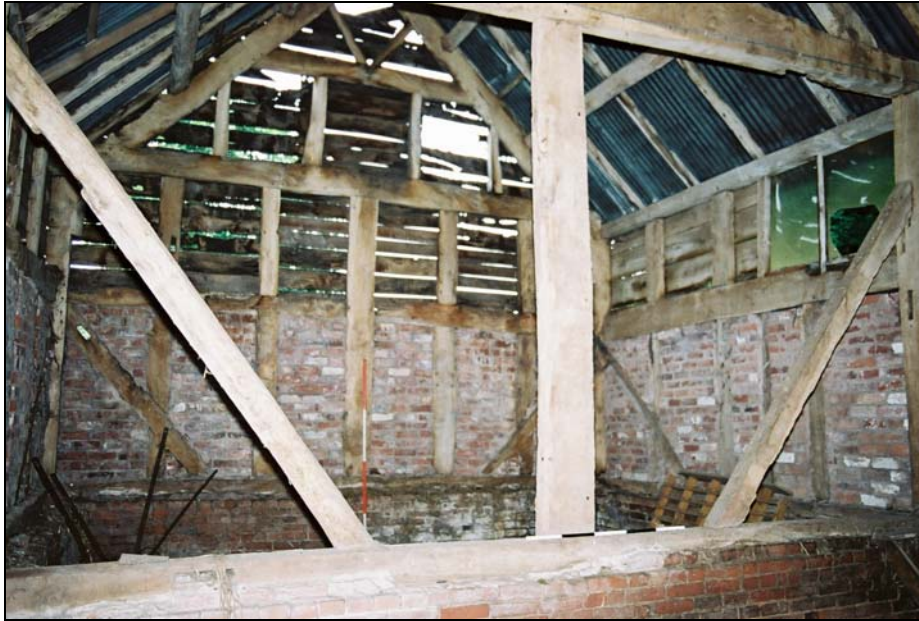
## Plate 11

Truss T6 forms the eastern gable end of the barn (Plate 11). The outside was not available for close inspection as the barn butts onto an adjoining property boundary. Internally, the truss is similar in form to Truss T1 at the opposite end of the barn. There are stave holes in both principals but not in the tiebeam or collar. This is likely to indicate re-use of timbers from elsewhere.

*Truss T6 and Bay 5 from Bay 4*

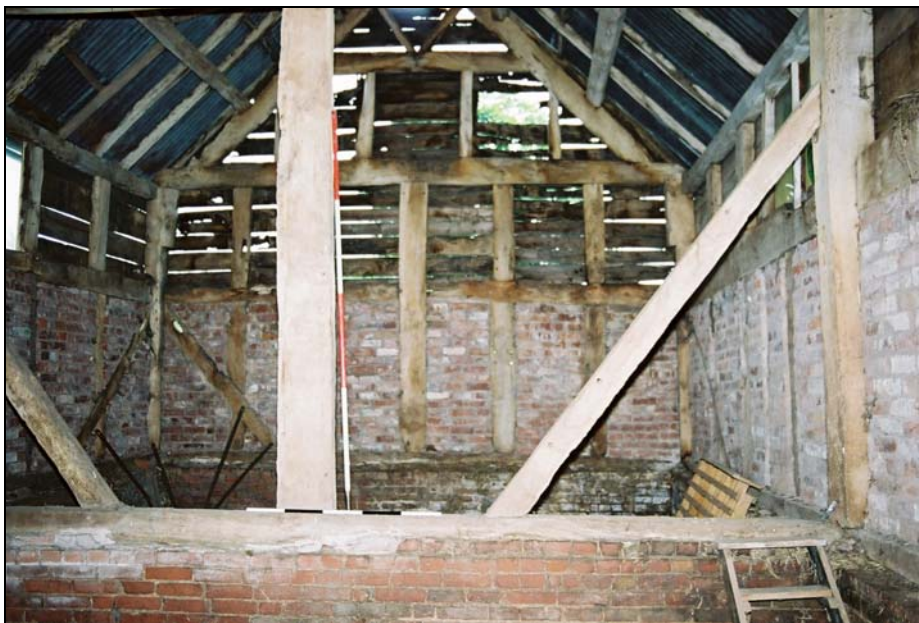
## Plate 12

Truss 3 has a pair of raking queen struts from tiebeam to principals with no collar (Plate 12). Trusses T4, and T5 are of the same style of construction. These too have the principals set around 12 centimetres in from the end of the tiebeam. The posts are braced down to an axial sill beam with long straight braces and there is a supporting central post. The sill beam is set onto a brick plinth some 80 centimetres high. This would have provided a windbreak and divided the barn into separate storage areas. The braces helped secure the outer frames against the outward force of piled up straw / crop. There are chiselled carpenter's marks on the face of the truss members, facing into Bay 3.

*View along the barn to the east showing Truss 5 and Truss T6*

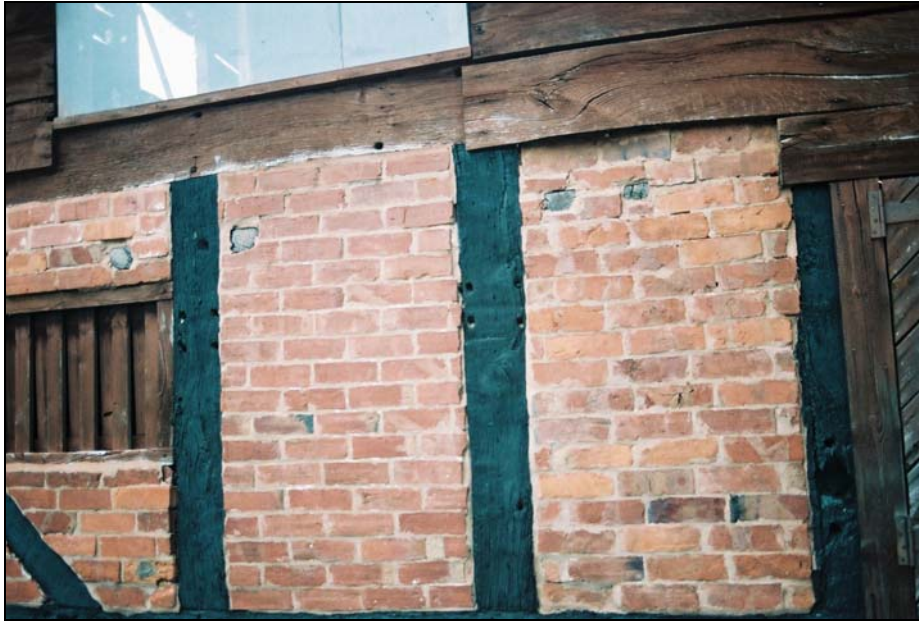
## Plate 13

*Unused peg holes on studs in Bay 2, indicating the position of a former rail forming square panelling*

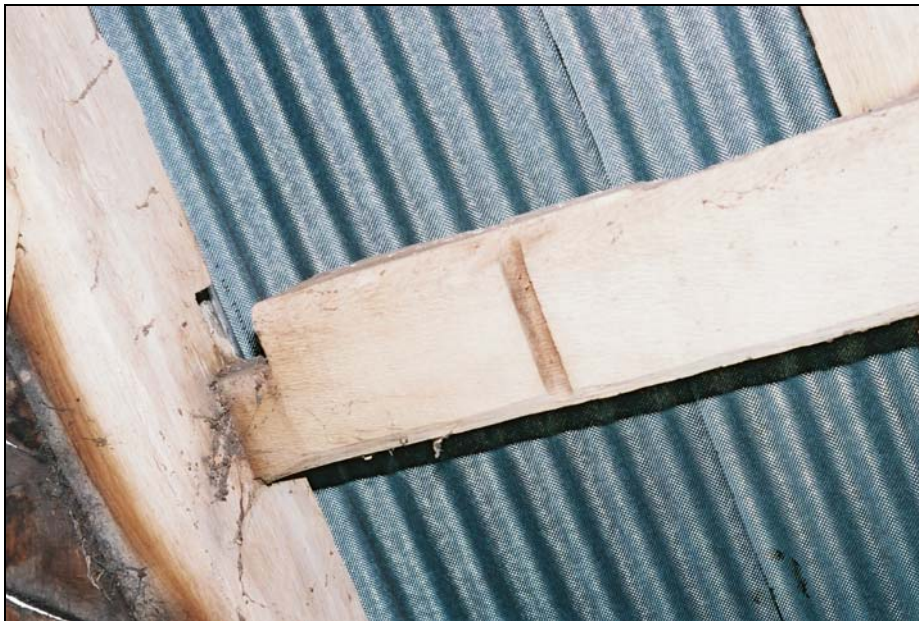
## Plate 14

*This purlin has been made from a re-used timber. Note the remains of the peg hole; showing the timber has been cut along its length*

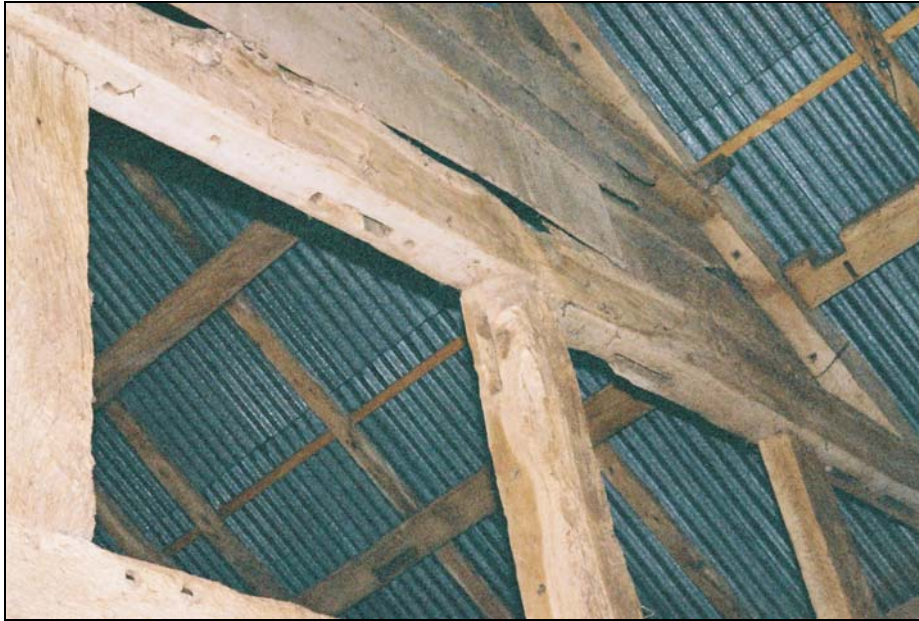
## Plate 15

The tie-beam, collar and principals all have stave holes on their undersides to take staves for the vertical component of latticework panel infills (Plate 15). A couple of staves remain in situ above the collar (Plate 16). There are also unused mortises and pegholes on the truss members suggesting that the truss was once framed in square panels and was likely to have been an end truss and frame. Further evidence is provided by chiselled carpenter's marks on the west face of the truss members. It was usual practice for the carpenter's marks on inner trusses to face towards the threshing or cart bay (Bay 3 in this case) and the end frames would have the carpenter's marks on the opposite external face. The groove to take the bottoms of the staves on the sill beam does not extend across to the southern post, which may suggest that there was a narrow annexe attached to the outside of the frame on the southwest corner.

*Un-used mortises and stave holes in Truss T2 suggesting this was probably originally the external western end truss*

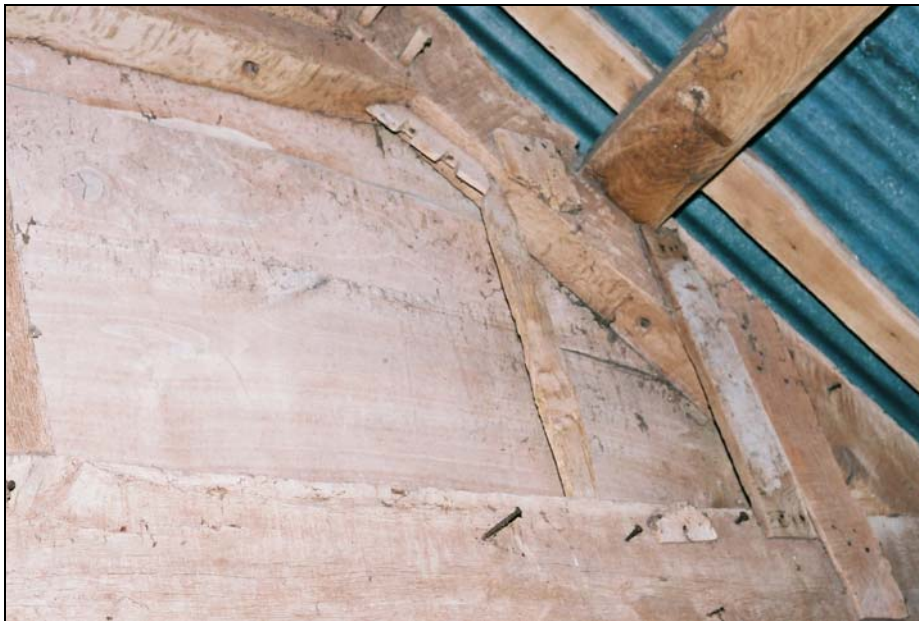
## Plate 16

*A stave can be seen in-situ between the principal and the tie-beam on Truss T2. Note the empty stave holes to either side*
