***Historic Building Appraisal of a  
Barn Adjacent to Old Farm,  
Eastham, Worcestershire***

*A report for Mr & Mrs Inge*

June 2007

**Project: PJ 188**

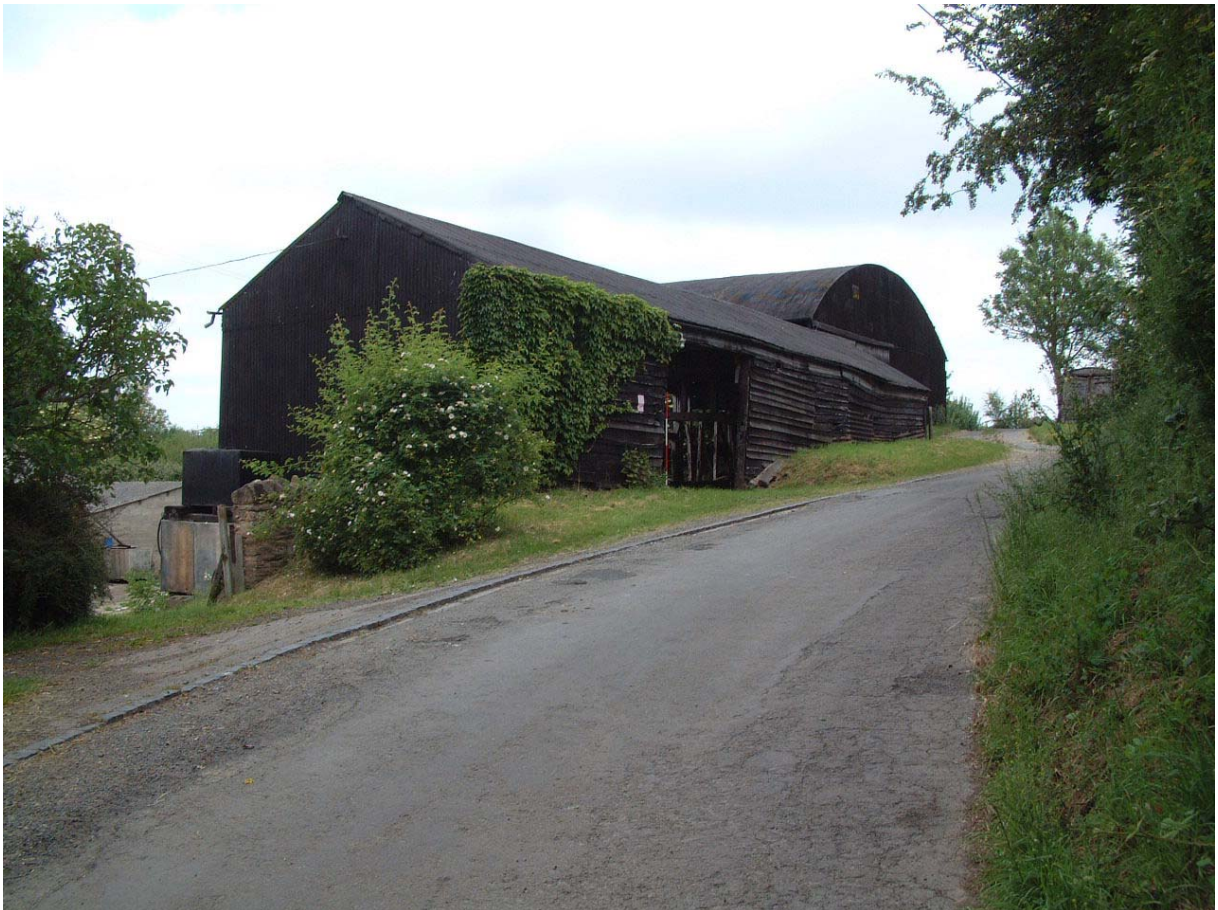
**Plate 1: The barn viewed up the slope to the north**

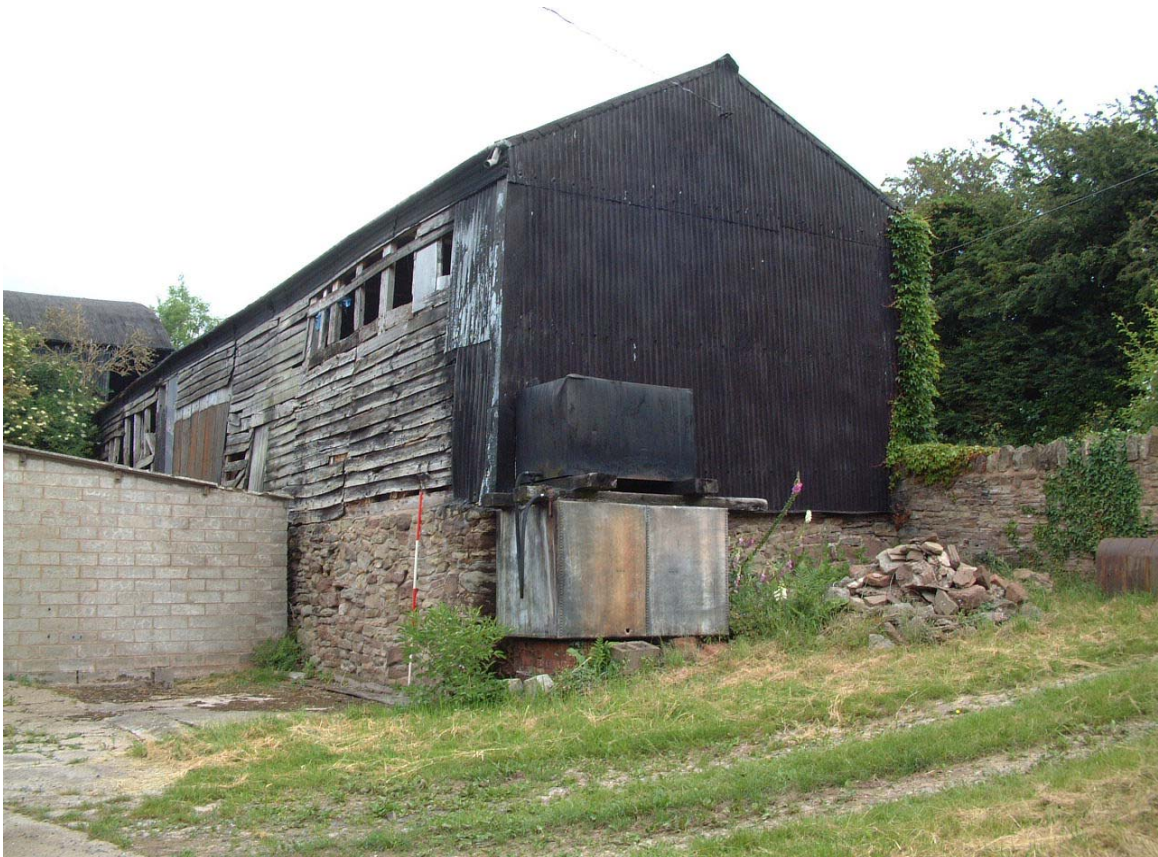
The barn stands adjacent to the western side of the road that follows the natural contours around the ridge on which, Old farm sits. The land slopes steeply away to the west, with shallower slopes to the north and south. The barn structure is knitted into this topographic setting, with the timber sill beam of the western elevation raised up on a mixed stone and brick plinth wall, designed to accommodate the slope (**Plates 1 and 2**). It is noticeable that the barn floor slopes down to the south-west and that the cart bay (bay 2) has been levelled up to provide a level floor (**Plate 3**).

**Plate 2: The barn viewed to the north-east, highlighting the slope of the bank**

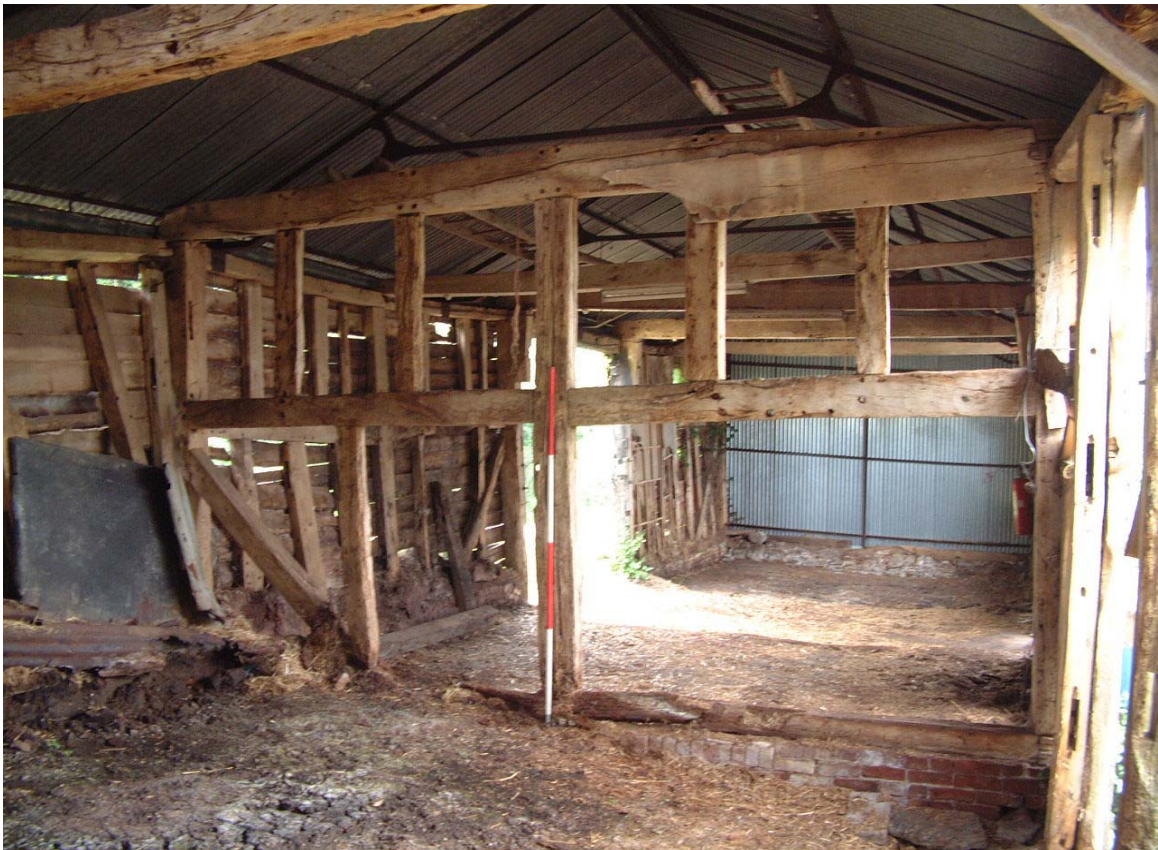
**Plate 3: View to the south inside the barn, showing the levelled up bay 2 (centre of photo) and the floor slope to the south-west**

There is clear evidence that bay 4 was added to the three-bay structure and is of a secondary phase; the timbers used in the bay 4 construction are also re-used, but are noticeably ‘waney edged’, less-well converted and generally ‘rougher’ in appearance than those of the original barn build. Also, truss frame 4 (between bays 3 and 4) was clearly originally an end frame and a remnant fragment of weatherboard is still attached to the outer face of the tie-beam (see **Plate 3**).

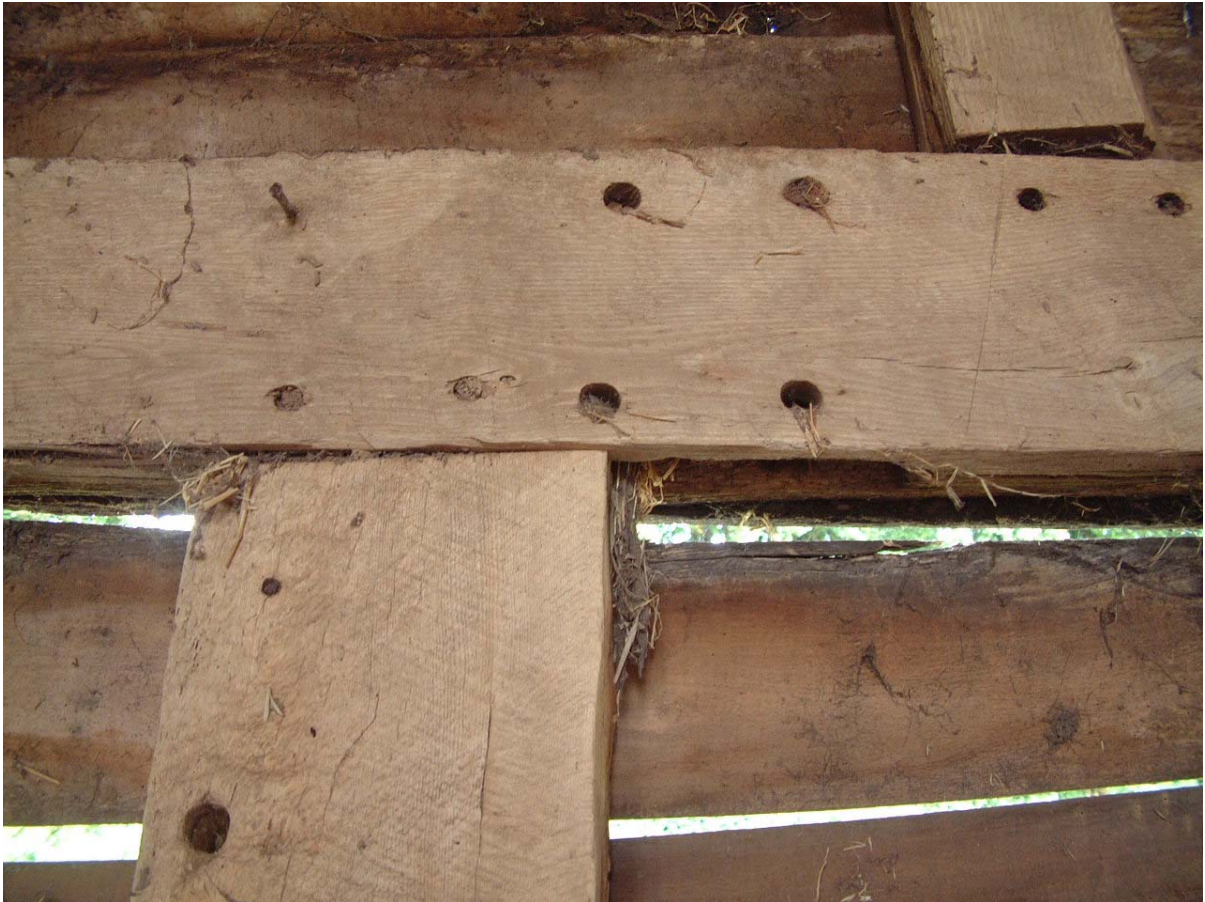
The barn was originally timber-framed with a weatherboard exterior, though it has recently been altered, with the roof-trusses above the collars removed and a lower pitched corrugated steel roof added. The southern gable framing has also been replaced with corrugated steel. The original configuration of the barn was of three bays (bays 1-3), with bay 4 added at a later date. The fabric of the structure appears to be almost entirely of re-used material, which has confused the development of the structure and distracted from its historic value. Agricultural buildings often contain a quantity of re-used material, but usually this can be attributed, at least in part, to later modification / repair / alteration. The earlier usage of the timbers was noticeable as it utilised larger pegs than those used in the present construction (**Plate 4**).

**Plate 4: Smaller pegs of the present structure and the larger empty peg-holes of the original build**

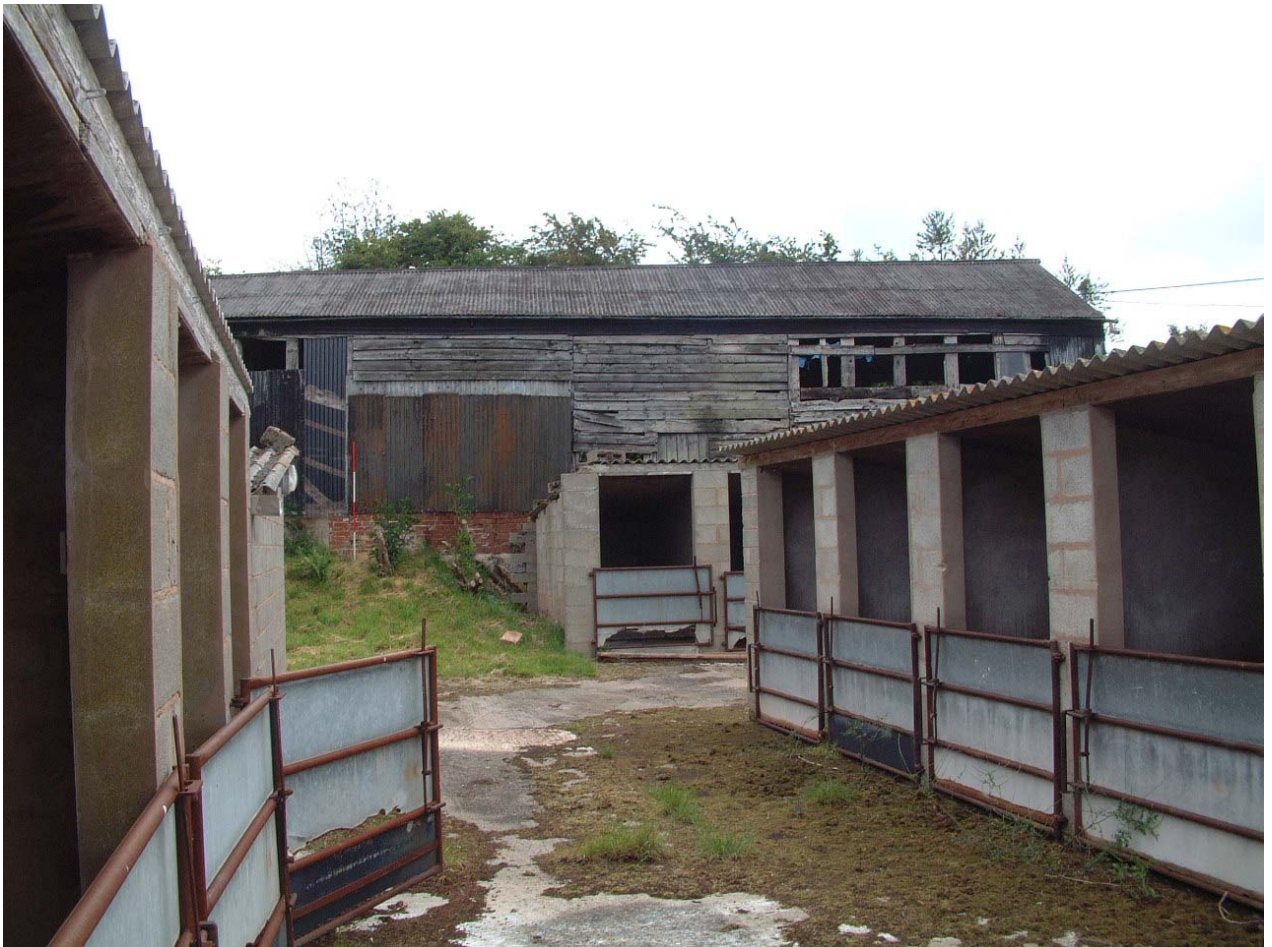
space below. This brings into question the present levels of the slope and the ‘levelled’ area to the west of the barn. A range of ?1960’s breezeblock piggeries sit on a level platform, which abuts the western elevation of the barn (**Plate 6**).

**Plate 6: Former piggeries on the level platform to the west of the barn**

This may suggest that there has been a certain amount of levelling to the west of the barn, resulting in the requirement for under-building on this side, though equally, any levelling may have taken place much earlier. This possibility is supported by the profile of the natural slope against the adjacent wall of the farmhouse (**Plate 7 below**), which is fairly shallow.

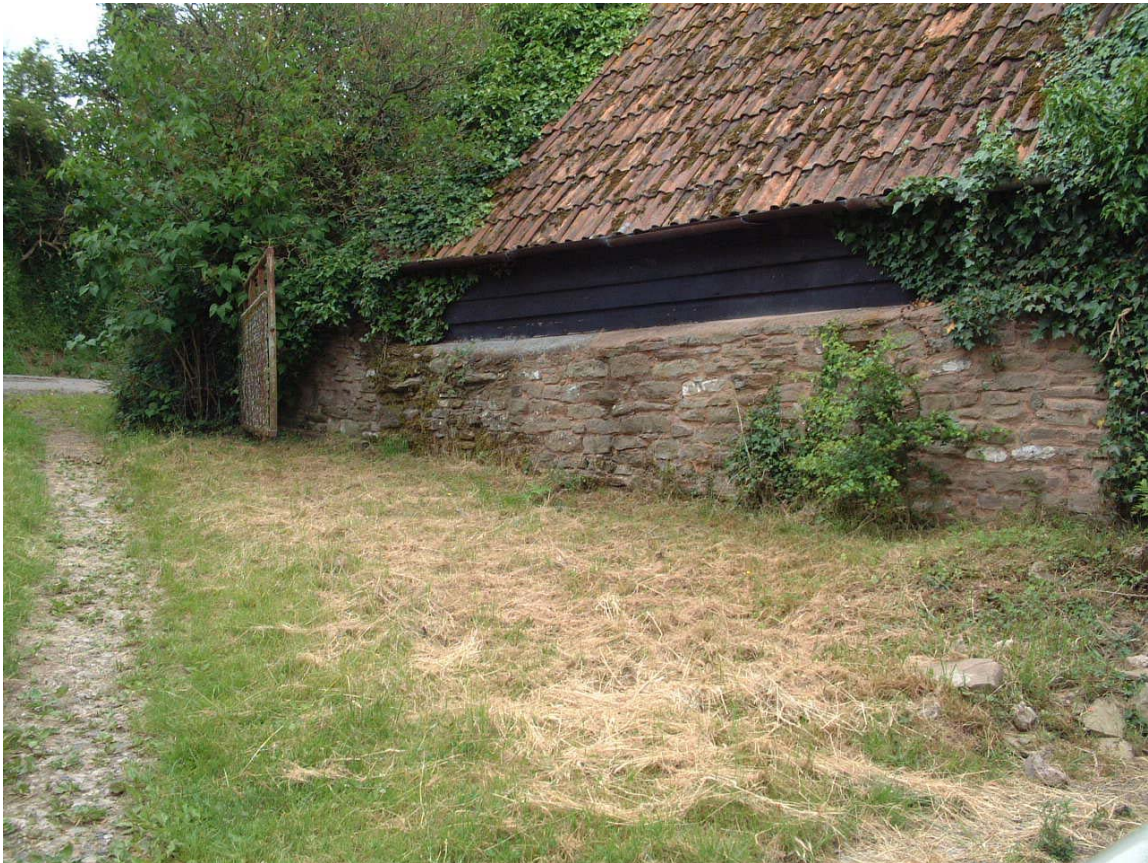
**Plate 7: Natural slope of the land against the adjacent farmhouse garden wall, viewed to the east**
