***Historic Building Appraisal of
The Old Coach House, Pleasant
Harbour, Wribbenhall,
Worcestershire***

A report for Mrs A.E.Hunt

November 2008

Project: PJ 228

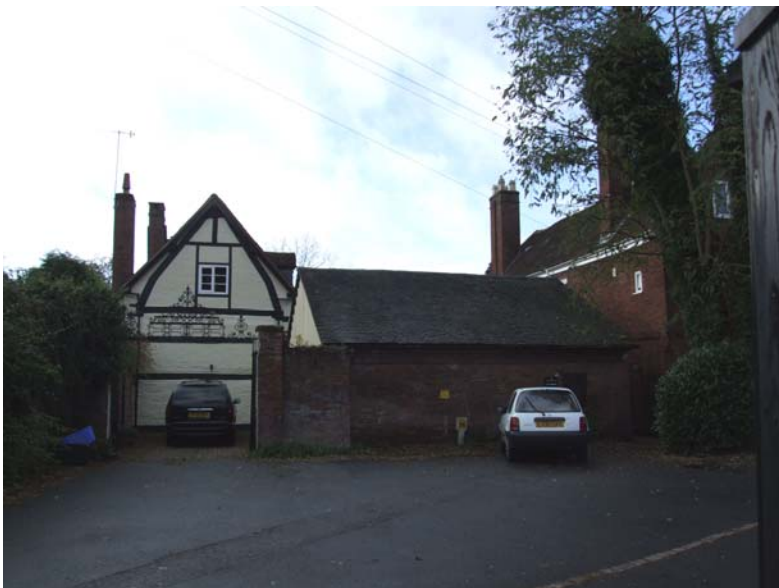
Plate 1: The Malthouse, with the upper cruck clearly visible

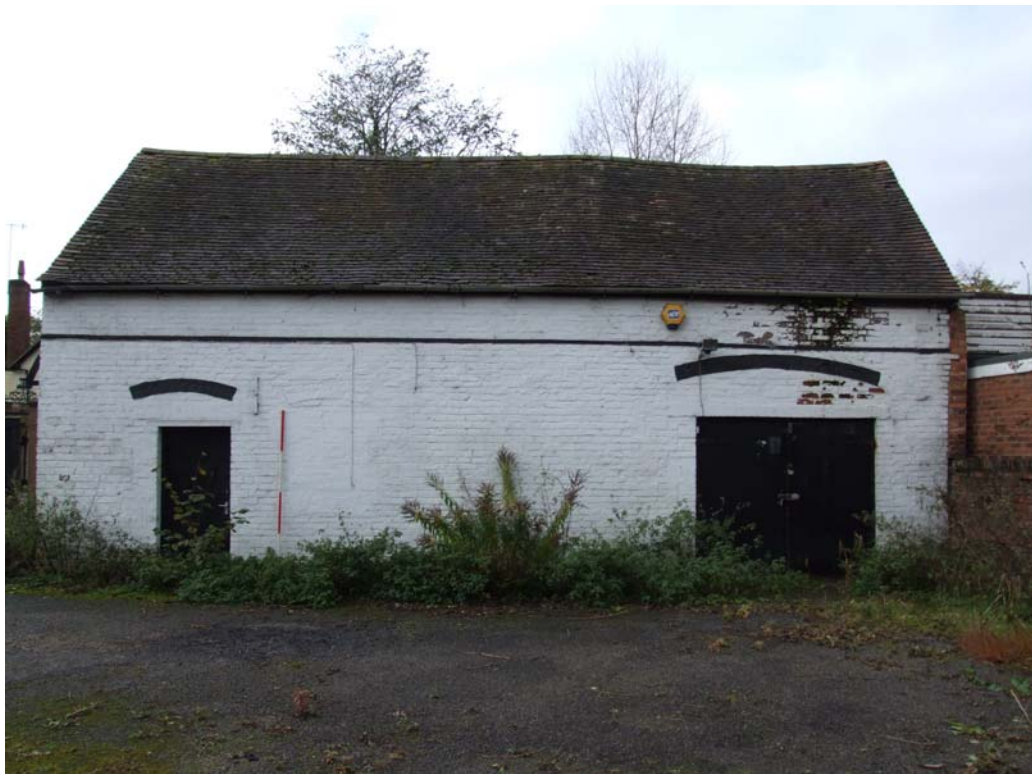
The original construction is of timber-frame, which has been replaced on the north-eastern and south-eastern elevations by solid 9” brick walls constructed in 3”x 9” brick in a Flemish raking stretcher bond, with a Flemish row (alternate headers and stretchers) between each three rows of raking stretchers. There is a blocked window opening to the north-east elevation, below a rough segmental brick arched head, with a similar head above a former doorway, which has been narrowed and a modern door fitted and a further double doorway below a similar arched head, again modified to accept a modern smaller double door arrangement (Plate 2).

Plate 2: North-eastern elevation (scale 2-metres)

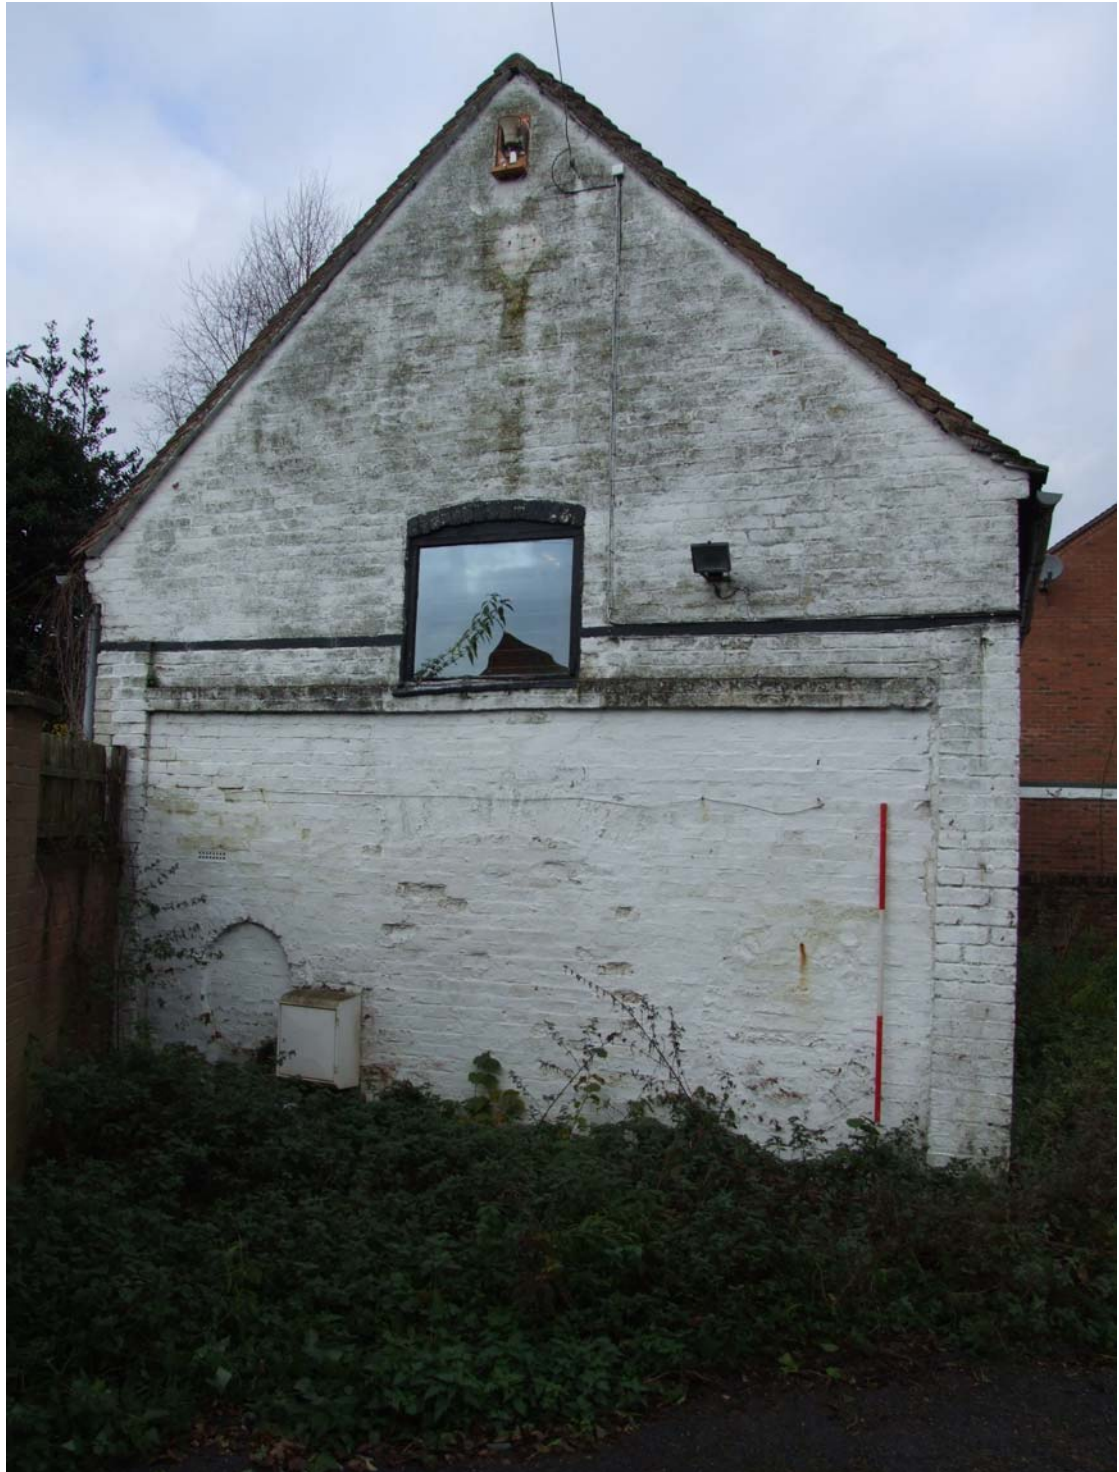
The brick south-eastern gable is curious as it also contains a segmental arched head, below which, presumably there was a doorway, though the brickwork below shows no evidence of straight butt joints that would be indicative of a blocked aperture. To either side of this, there is a pair of oval recesses, within brick header surrounds. The purpose of these is unclear and it is possible that they were simply for decoration, though this does not sit comfortably with the lack of elaboration elsewhere on the building. The corner brickwork of the gable steps out slightly as if to buttress the wall and this suggests that there may have been some rebuilding at this end. There is a modern window at the upper level, set below a brick segmental arch; this may be a direct replacement for a pitching eye door (Plate 3).

Plate 3: South-eastern gable end (scale 2-metres)

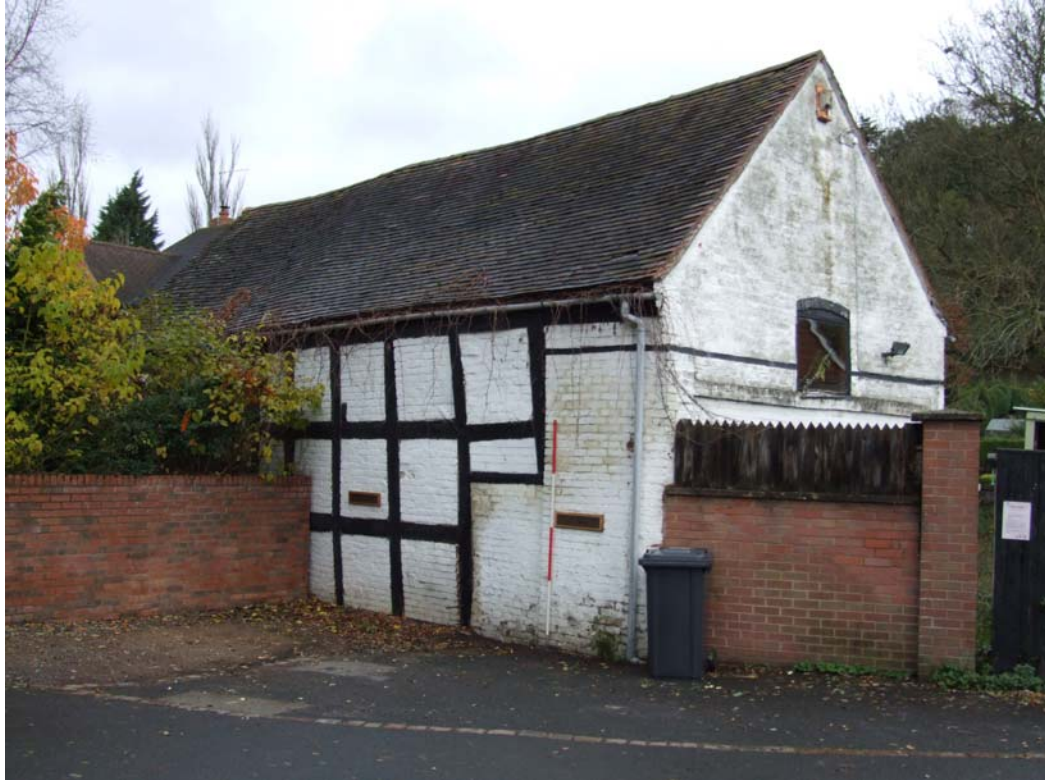
The remaining timber frame to the south-western elevation indicates that the frame was originally of three tiers of square panels between the sole plate, which can just be seen at the south-eastern end, and the wall plate (Plate 4). There is a single (visible) remaining angle brace from the post of T2 to the wall plate.

Plate 4: Timber-framing to the south-western elevation (scale 2-metres)

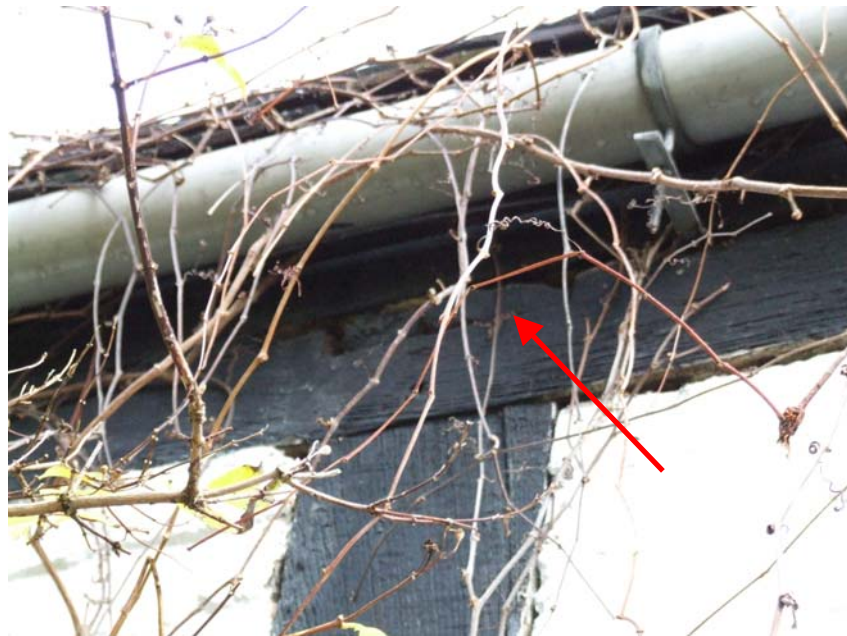
A rebate in the wall plate indicates the possible position of a further truss, which has been removed (Plate 5).

Plate 5: Rebate in wall plate for lap joint to a truss, which has now gone

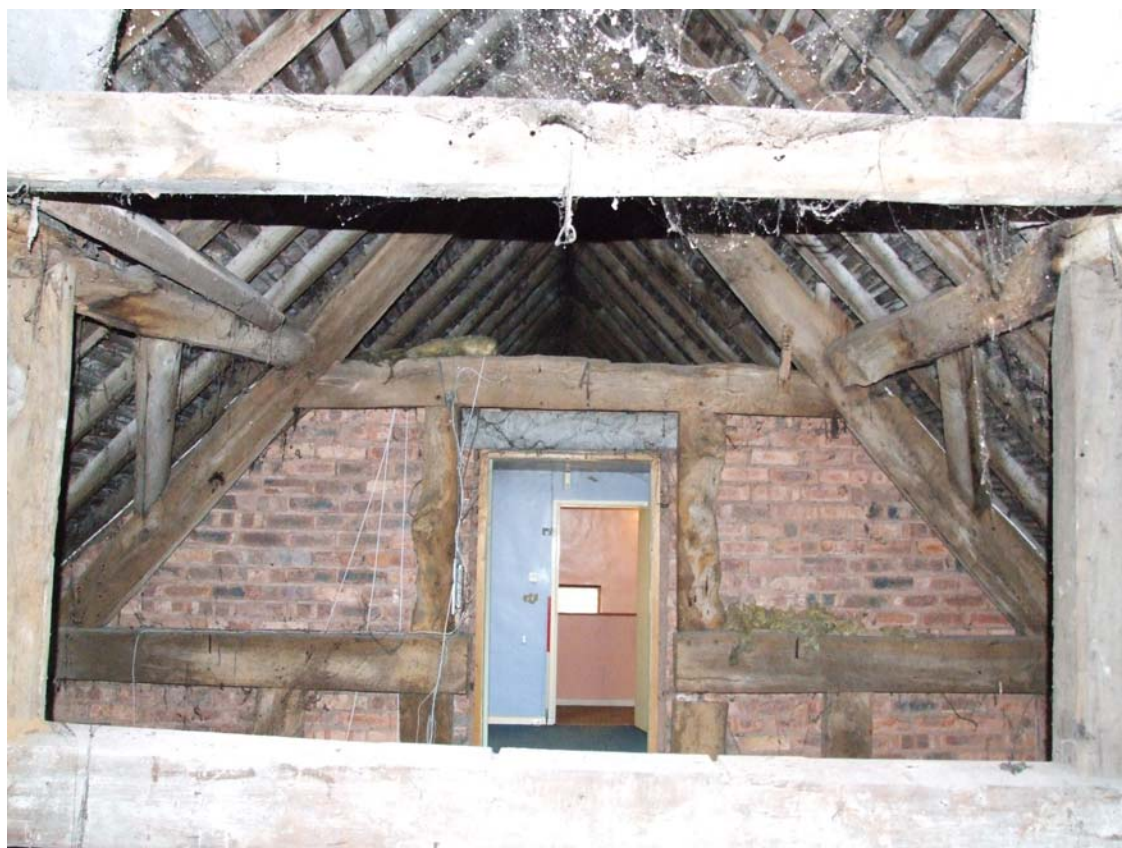
Internally, there are two floors, both extensively modernised, with little visible of the original build. Fortunately, one bay of the upper floor remained without modern cladding and one truss (T2), part of another truss (T1) and remaining roof purlins were visible. Truss T1 could just be seen at the apex of the north-western gable, the remainder is hidden behind an internal brick skin; it is not known if this gable end timber-frame can be seen externally as it faces onto the garden of the adjacent property. Truss T2 comprises a pair of principal rafters single pegged at the apex, with one notched to take a ridge plate (missing); the ends of the principals and tiebeam are hidden within the brick skins of the side walls of the building; a pair of queen-struts rise from the tiebeam to a collar above. The tiebeam has been cut through for the incorporation of a modern doorway (Plate 6).

Plate 6: Truss T2 looking north-west. The doorframe cuts through the tiebeam

The purlins are trenched into the principals close to the collar and a pair of straight wind braces rise from principal to purlin at each side. There are two original studs pegged below the tiebeam and further inserted timbers, which would have been added when the tiebeam was cut. The upper face of the girding beam can just be seen at floor level; this has been notched to give the inserted doorway extra height. The upper face of the tiebeam has a groove cut in it to take the feet of staves, which would be inserted into rebated notches cut into the underside of the collar above, with woven horizontal slivers of cleft oak then interlaced between, which may then have been daubed; the holes for the heads of the staves were only apparent to either side of the inserted modern doorway, which suggests that prior to infilling with brick either side of the doorway, the panels were wattled, and possibly daubed; this also indicates that this was done *after* the doorway was cut through.

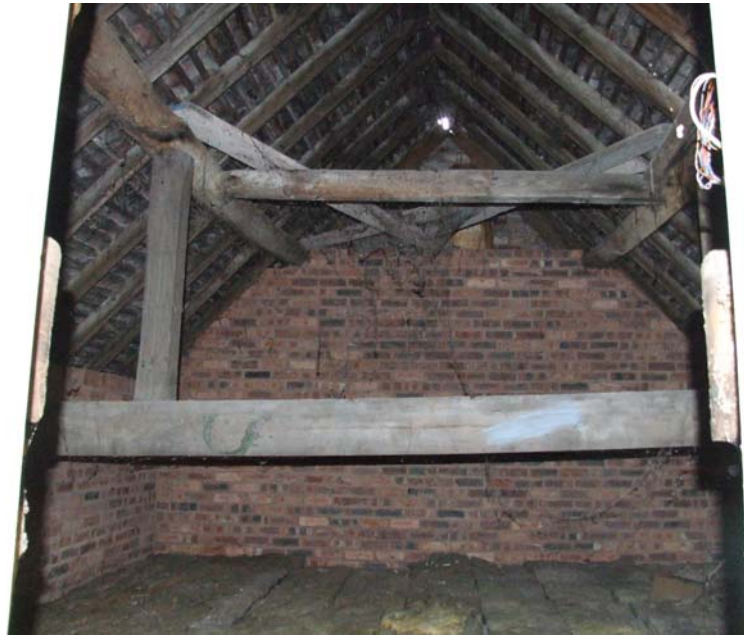
The purlins to bay 1 are supported by an inserted frame resting on a bridging beam that was inserted through the south-western elevation wall (Plate 7). The purlins to the remainder of the building are boxed in and could not be seen.

Plate 7: Inserted frame to bay 1 to support purlins. Also note the apex of truss T1 in the gable end
