# A Historic Building Recording at Larford Farm, Larford, Astley, Worcestershire

*A report for WeatherArk Ltd*

February 2004

**Project: PJ 114**

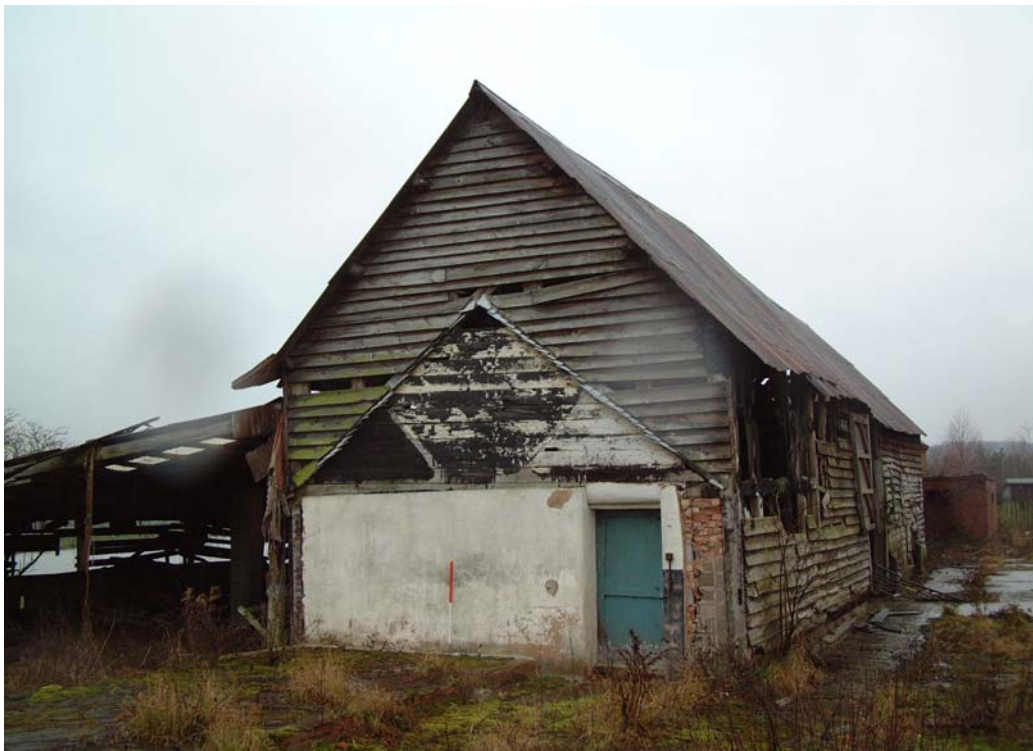
## Plate 2

may have been of thatch, shingles or clay tiles. The building, which is in fair condition, is now redundant and awaits development (Plates 2 and 3).

*The barn showing location of a former building to the north-east (scale 1 metre)*

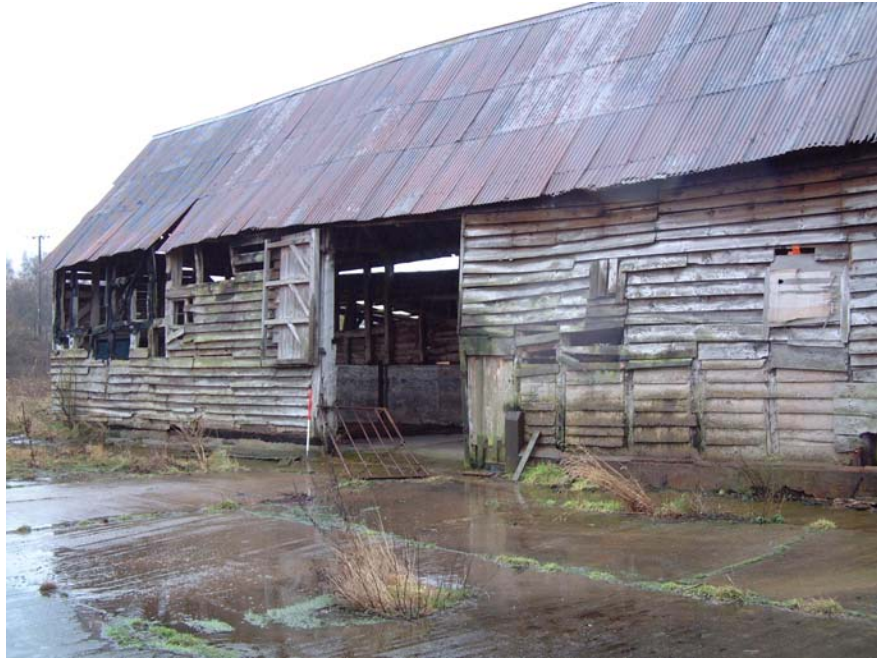
## Plate 3

*The barn viewed to the west (scale 1 metre)*

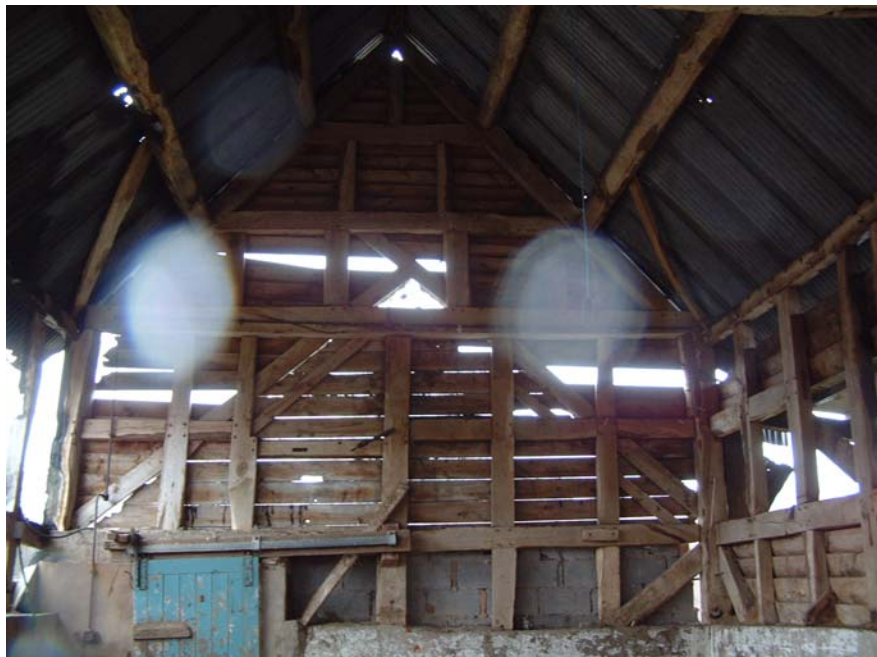
## Plate 4

*Truss T1 at the south-western end of the barn (scale 1 metre)*

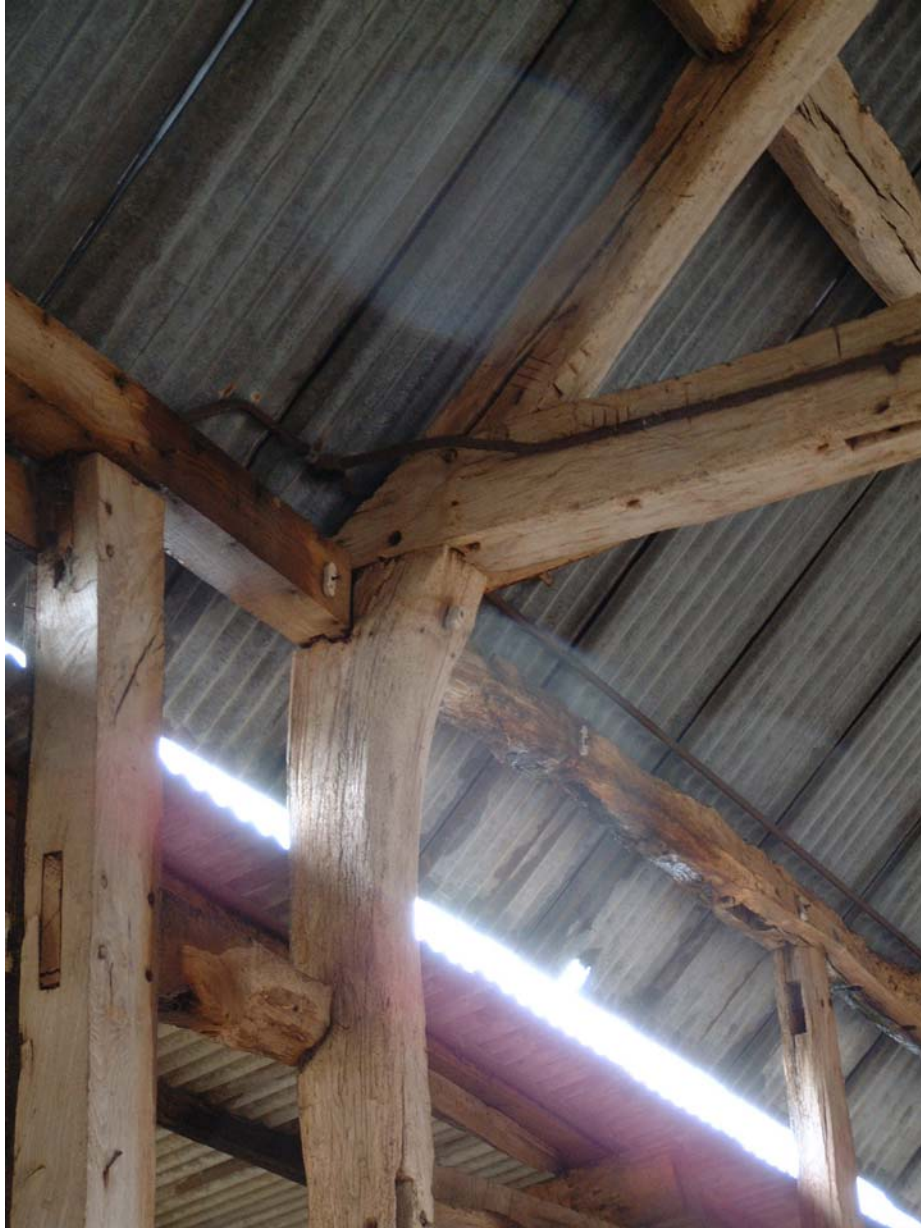
## Plate 5

Truss T2 is comprised of twin vertical queen struts with tie beam and collar supported on jowl headed posts. This was once an end frame, this is indicated by the following: empty mortises and peg holes on the underside of the tie-beam; empty mortises on the inside of the posts that match the pattern of overall framing (Plate 5); the carpenters marks (III) on the tie-beams and principals are facing *away* from the threshing bay (it was usual, although not comprehensive, that the marks within a barn faced towards the threshing bay, thus suggesting this was once an outside face). This indicates that this was originally truss number 4 and the barn was originally a 3-bay barn with a central threshing bay.

The timber-frame is generally in good condition, although there is evidence of a localised fire, which has damaged timbers to the north-west elevation of Bay 1. Structural damage was noticed at Truss 2, where the tie beam has broke away from the north-western post, resulting in the truss being held up by the opposite post only.

*Jowelled post of Frame /Truss T: note the carpenters' marks (III) on the tie beam and principal; the empty mortises on the underside of the tie beam and inner post, indicating removed framing. Note also, the 'newer' framing of bay 1 to the left of the post.*

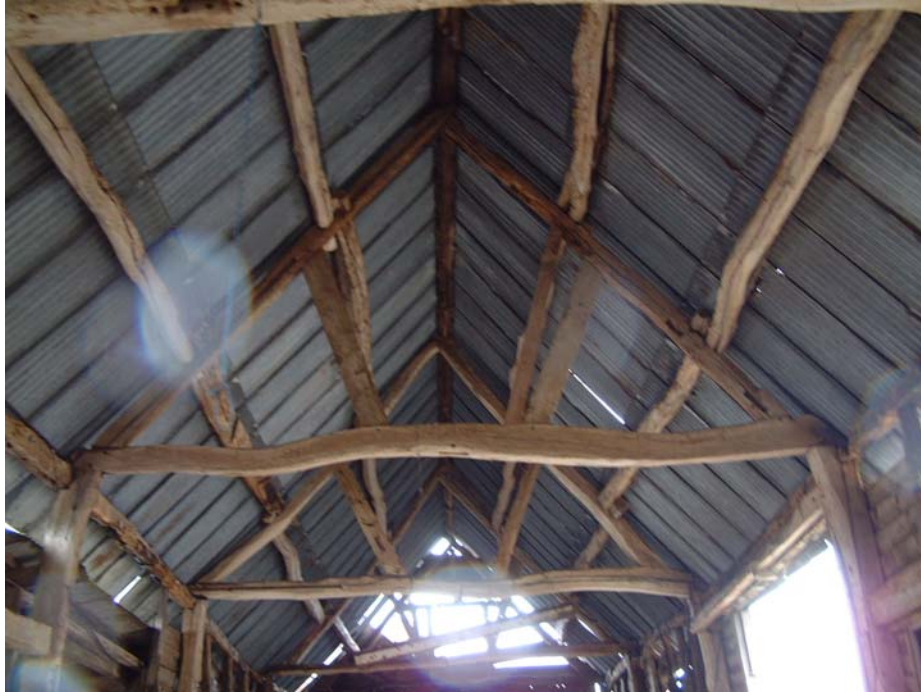
## Plate 6

Trusses T3, T4 and T5 are carpented from waney timbers and are of lower quality than the other trusses (Plate 6). The trusses are of principal and tie beam with long raking struts and no collars. There is also evidence to suggest that Truss T5 was an end truss. There are empty mortises suggesting that the truss was originally a cross-frame. One rail has been sawn off, the stub is still in-situ (Plate 7).

*Trusses T3, 4 & 5, note the waney timbers and compare with truss T1 and T2 (plates 4& 5)*

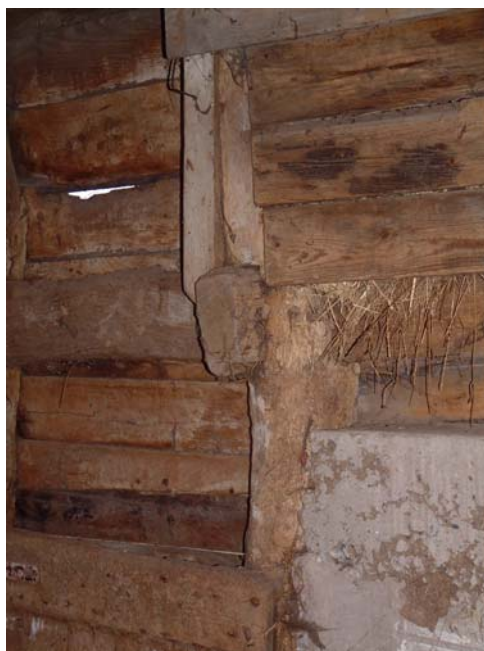
## Plate 7

*Sawn off rail on the corner post of T5, indicating this was once an external frame*

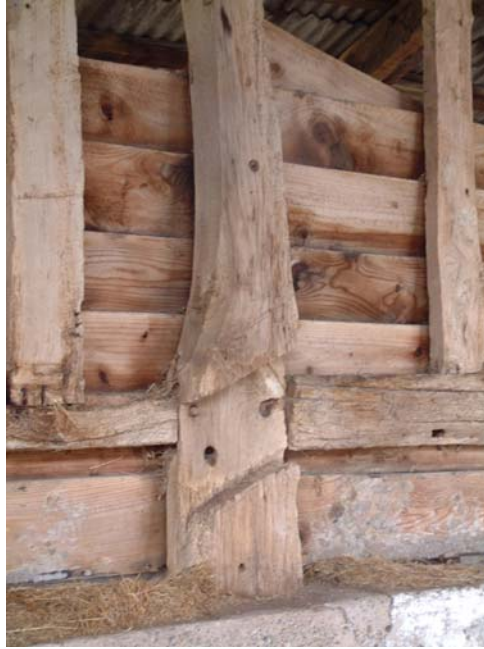
## Plate 8

sequence. Interestingly there were several reused timbers that appeared to be from an earlier cruck-framed building (Plates 8 and 9). Three sections of possible cruck tie beam ends were observed. The half lap joints where the tie beam sat on the cruck blades are clearly visible, as are the large peg holes.

*Re-used tie-beam section from a cruck-framed building within the fabric of the barn*

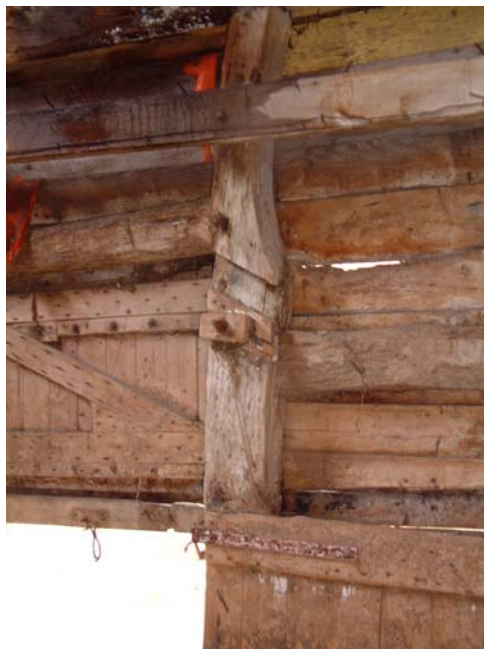
## Plate 9

*Another re-used section of cruck framing in the barn*

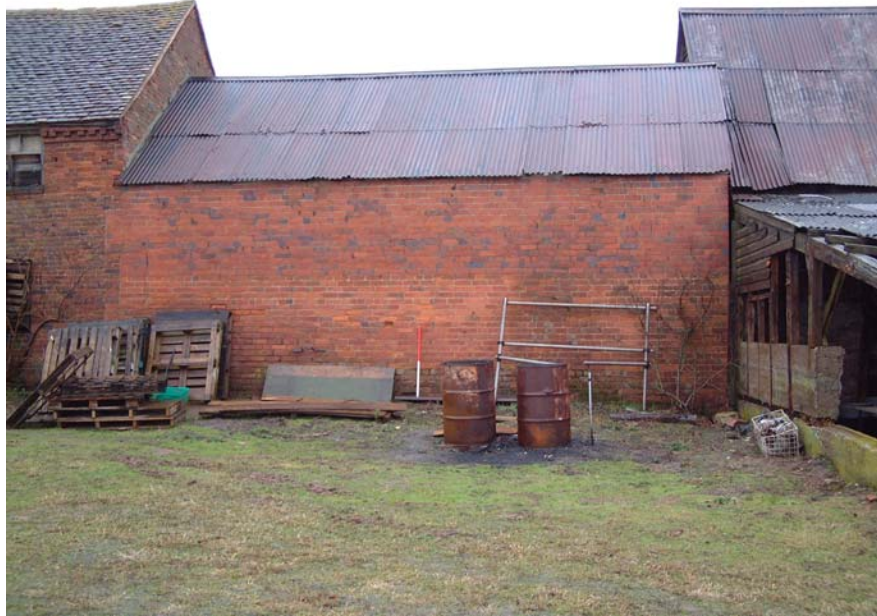
## Plate 10

The brick built structure adjoining the southernmost gable of the barn is a former fodder processing, or mixing shop (Plates 10 and 11). The two-storied structure now has a corrugated-iron roof covering, but originally would have had a handmade clay tile roof. The lower floor brickwork is of random coursing to the south-east elevation and coursed in a type of Flemish garden Wall Bond on the lower north-west elevation. The upper level is later and it is likely that the building was originally single storey. The building has a window and door below segmental brick arches to the north-west elevation with a pitching eye to the upper floor. Fodder and root crop would have been loaded through this opening to be stored on the upper floor before processing.

*The fodder processing shop south-east elevation (scale 1 metre)*

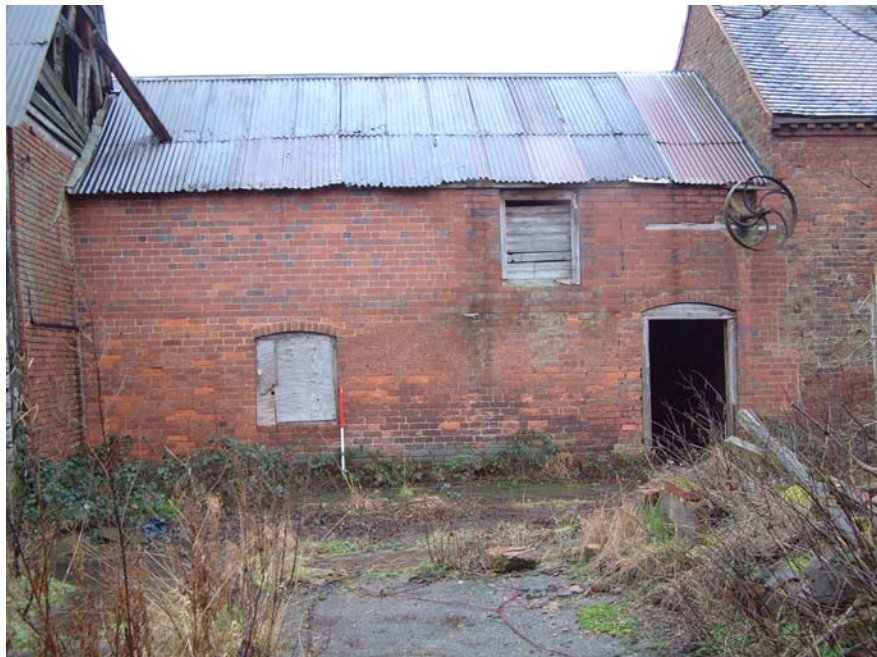
## Plate 11

*The fodder processing shop north-west elevation (scale 1 metre)*

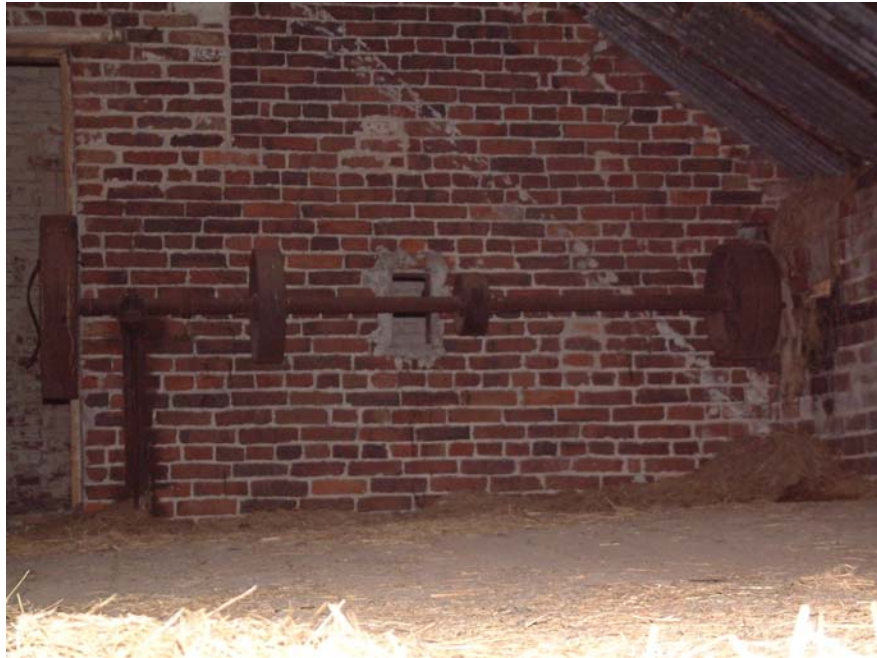
Plate 12

Some of the processing machinery still remains within the building. On the upper floor a series of belt wheels run off a shaft that enters through the front wall (Plate 12). The belts would have been powered by a portable steam engine that was hooked up to the external flywheel. The machinery would have been used for processing raw materials to produce animal feed, such as a chaff cutter for slicing straw or a pulveriser for making cow cake from root crops. Hoppers from the top floor to the bottom would be used for channelling the produce into sacks or storage facilities (Plate 13).

*Belt wheels and shaft inside the fodder processing shop, note the former eaves height of the building as a mark on the wall*

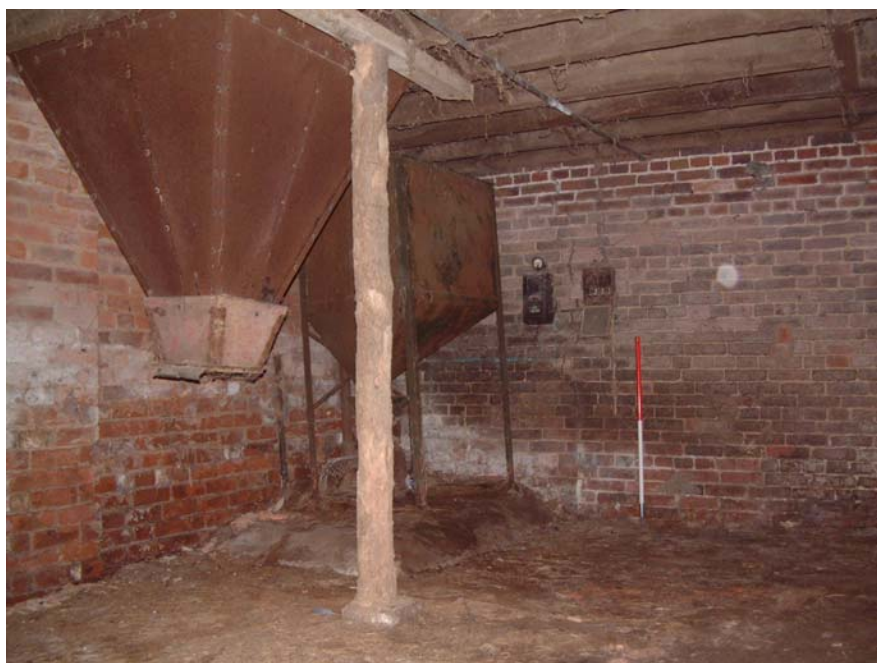
Plate 13

*Hoppers on the ground floor of the fodder processing shop (scale 1 metre)*

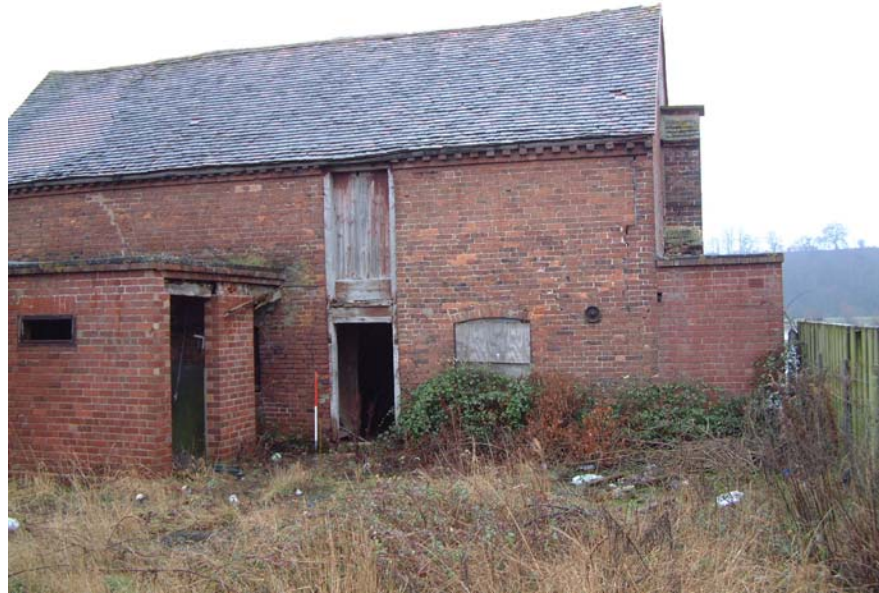
## Plate 14

Adjoining the southern gable end of the mixing shop there is a two-storey brick and tile workers cottage with a hearth and chimney at the southern end (Plates 14 and 15). There are windows below brick segmental arches to the lower level of both side elevations and the upper level of the south-east elevation. There is an upper door to the opposite north-eastern elevation. This would not have provided access, as there are internal steps, but would have been used for offloading produce from the upper storage area of the building onto a cart below.

*The workers cottage north-west elevation (scale 1 metre)*

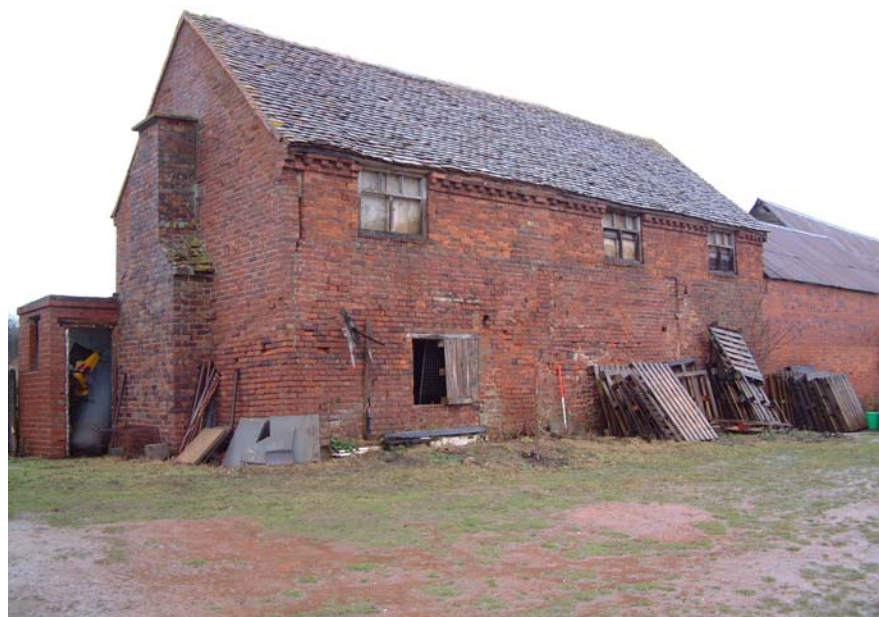
## Plate 15

*The workers cottage south-east elevation (scale 1 metre)*

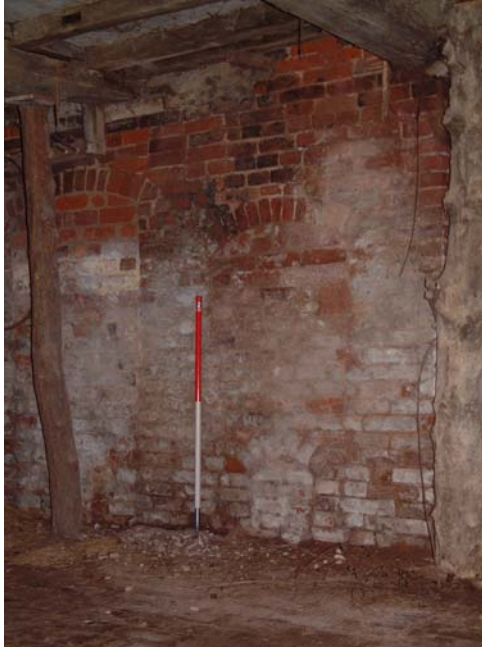
## Plates 16

The building has been extensively altered over a long period. Mid-20<sup>th</sup> century lean-to extensions have been added to the south-west gable and north-west elevation; the height of the gable has been extended to allow first floor use and the rear elevation has had much alteration. There was once a lean-to extension on the south-eastern side. There were two rooms (at least), each entered via a door through the wall to the cottage (Plate 16). A dog door was added to the building in one of the bricked up door apertures into the demolished extension, this was also later bricked up (Plate 16). Dogs were often given the run of the farm as a security measure and to help keep down the problematic rat population.

*Bricked up doors and 'dog door' in the workers cottage (scale 1 metre)*

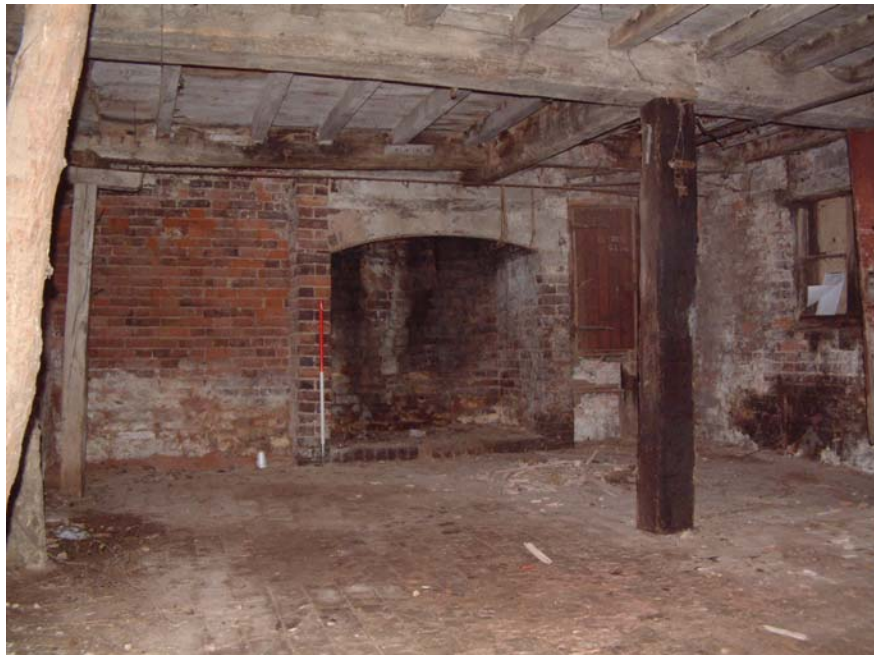
## Plate 17

Internally, the bridging beams show evidence of re-use, with empty mortises alongside the existing upper floor joists. The beams are all wedged up with posts above the well-laid brick floor (Plate 17).

*Inside the workers cottage (scale 1 metre)*

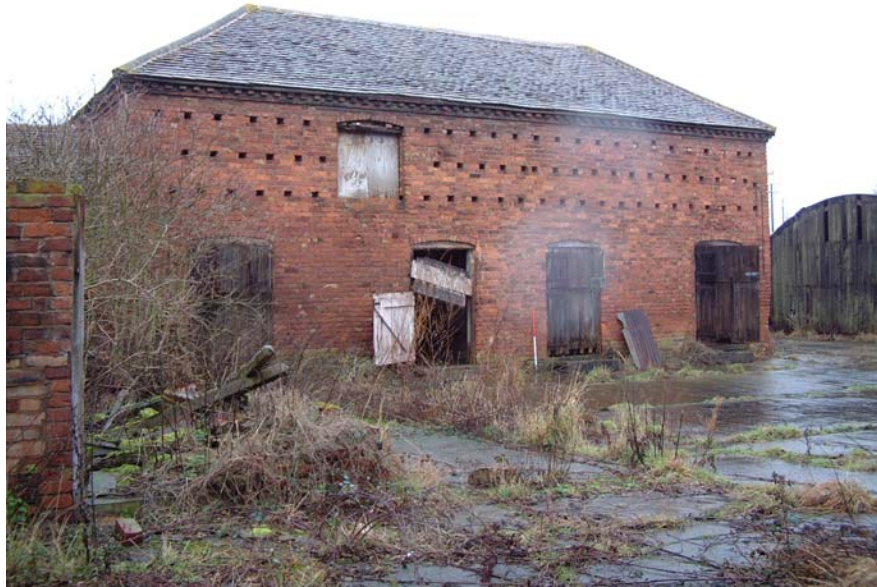
## Plate 18

*The stables with hayloft above (scale 1 metre)*

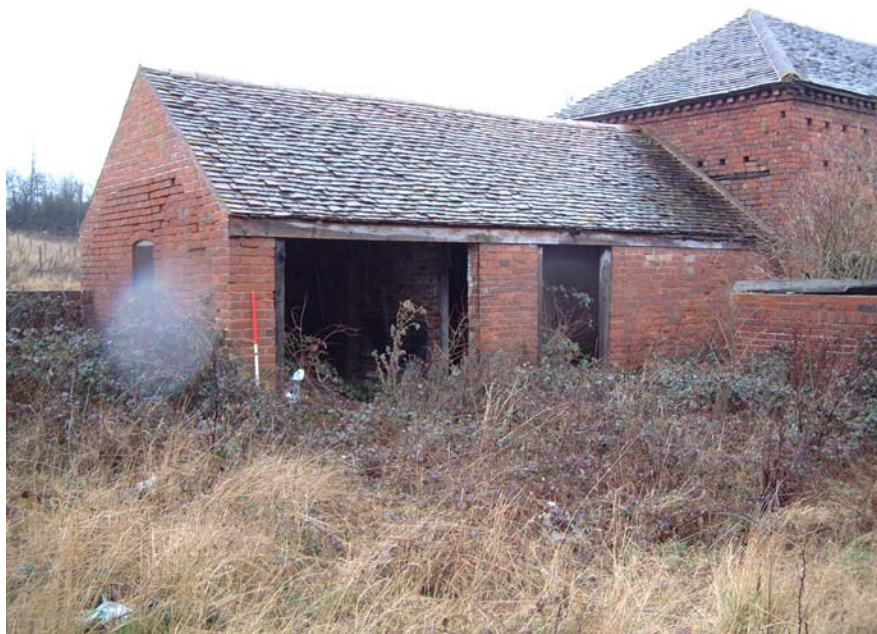
## Plate 19

*The single storey stable and loosebox (scale 1 metre)*
