*Historic Building Recording at New House Farm,
Bransford, Worcestershire*

A report for Mr W. Tooby

March 2005

Project: PJ 132

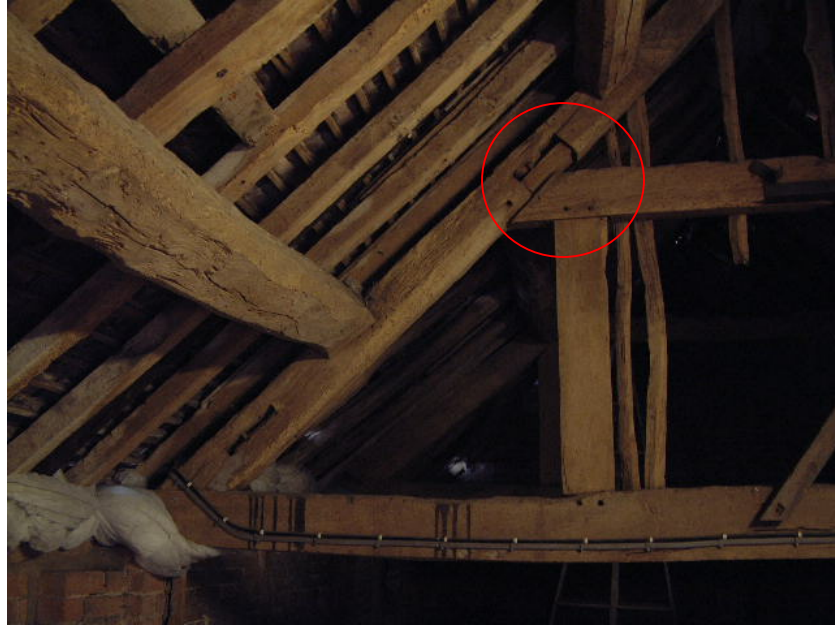
Plate 3

each side of the ridge (Plate 3), and empty mortises in the lower ends of the principals indicate that they were supported by wind-braces (Plate 4). The principals were not diminished above the purlins and empty mortises at the apex suggest that the trusses were further strengthened with a block, which is unusual in a post and truss construction and usually reserved for cruck frames (Plate 5). The rafters are mainly re-used and it is difficult to say that any date from the time of construction.

In truss T2 the principals are pegged to the tiebeam by a pair of raking queen struts that originally were tied below the rebate for the clasped purlins (Plate 3); there is no collar to the truss. Removal of the original purlins has clearly weakened the structure and the principals have cracked and are now supported by later wedged and nailed struts (Plate 9). The tiebeam now sits on the breezeblock wall of infrastructure associated with grain drying, which was inserted into the barn, including excavated pits in the concrete floor, over the last 40 years or so. The remaining post on the northern side has a gunstock jowelled head and just below there is a scotch (Plate 10).

Original position of the clasped purlin at the collar, note the crack in the principal above

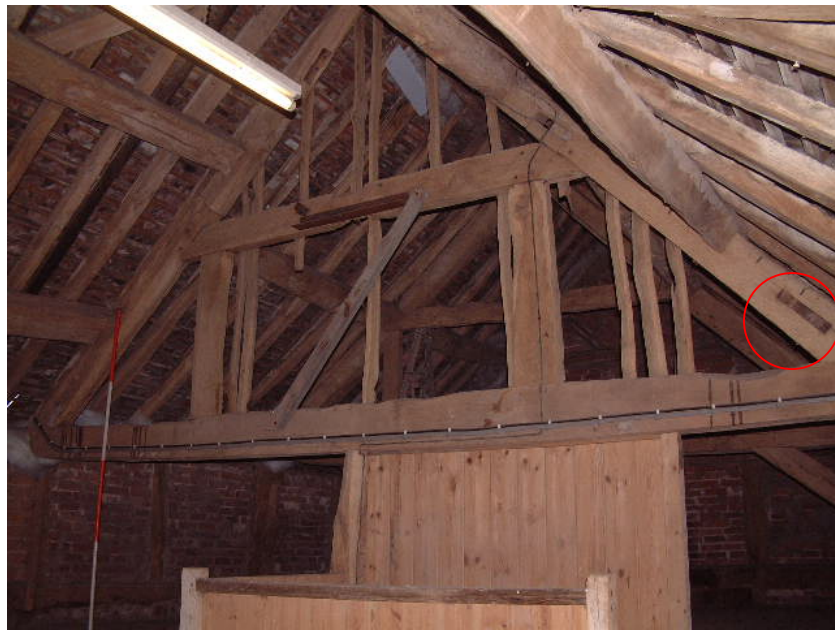
Plate 4

Empty mortise for wind-brace

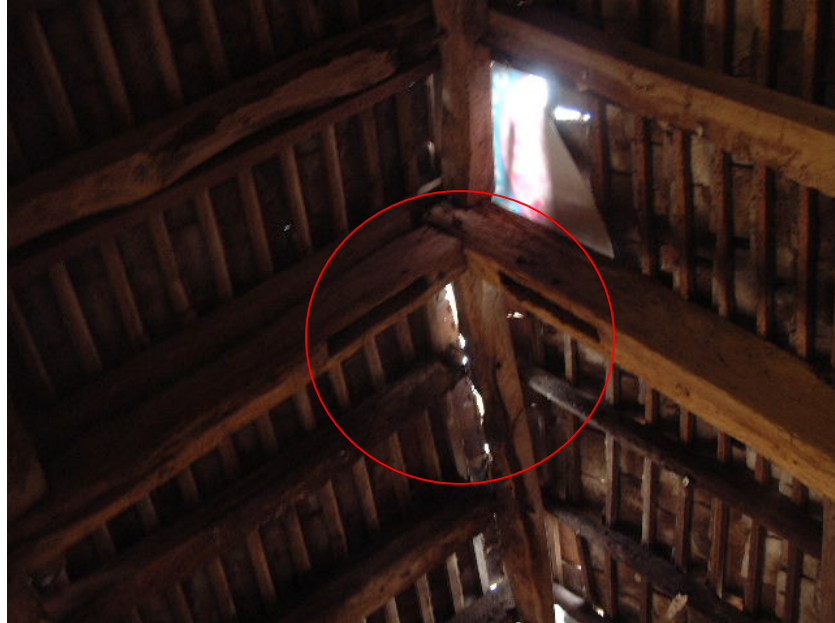
Plate 5

Empty mortises at top of truss showing position of a block, which was probably removed when the new trenched purlins were added

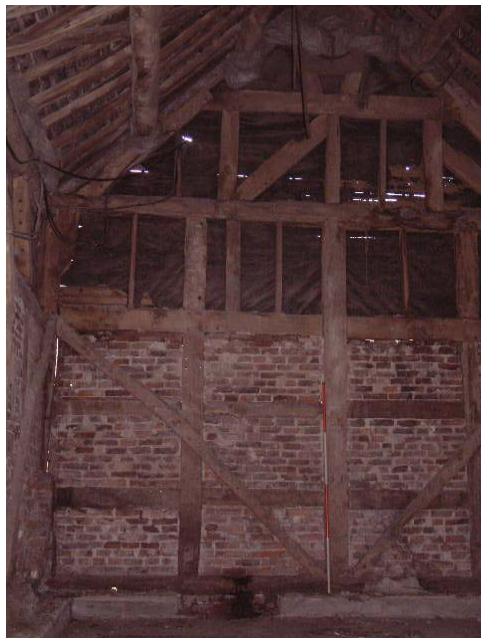
Plate 6

The eastern end truss is of collar supported by a pair of vertical queen struts over a straight tie-beam. There has been additional strengthening at some stage, with inserted studs between the struts (Plate 6). The framing is typical of western-midlands square framing with four rows of panels, the lower three infilled (generally) with 2 ¼ x 9-inch handmade bricks, of the same size as those incorporated in the plinth. The top row is weather boarded at the gable end and a lack of evidence to suggest otherwise probably indicates that the entire upper frame was originally weather boarded. The panel infill type is further discussed below. Only the northern post survives to its full length at this end, the southernmost having been cut off at a later date and the southern wall (of bays B1 and B3) rebuilt entirely in brick. The framing has long slender tension braces, which tie the posts to the sole plate (Plate 6). These are nailed to the frame rather than lap jointed and pegged as would be the case if they were original. The sole plate has a mortise on the external face with a cut off tenon still in place (Plate 7). This has been pegged in from above demonstrating that this was done before the panels were infilled and may represent part of a building at this end as depicted on the tithe map; although there is no further evidence for this. Many of the timbers in truss T1 show evidence of re-use (Plate 8), as is typical of the rest of the timbers within the barn.

Truss T1 and tension braces (scale 2 metres)

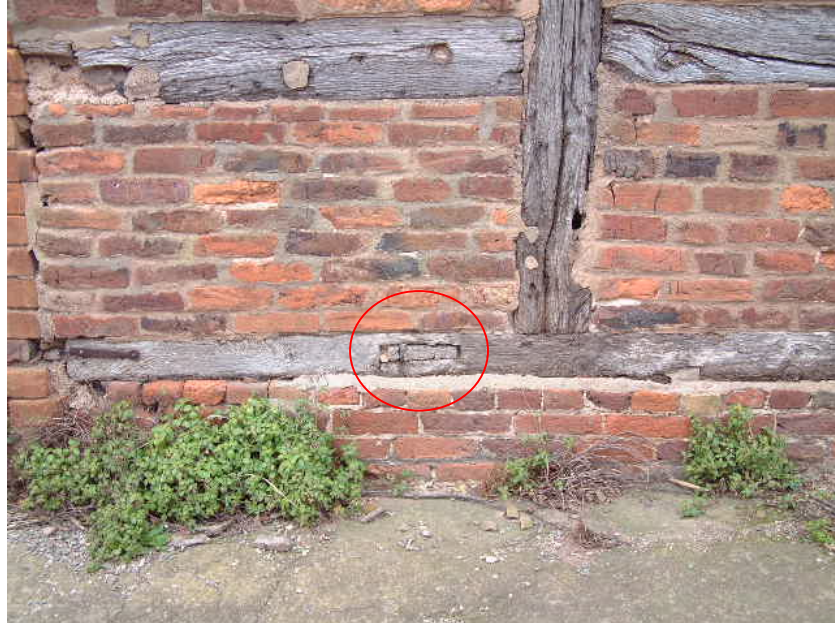
Plate 7

The sawn off tenon in the mortise in the eastern sole plate

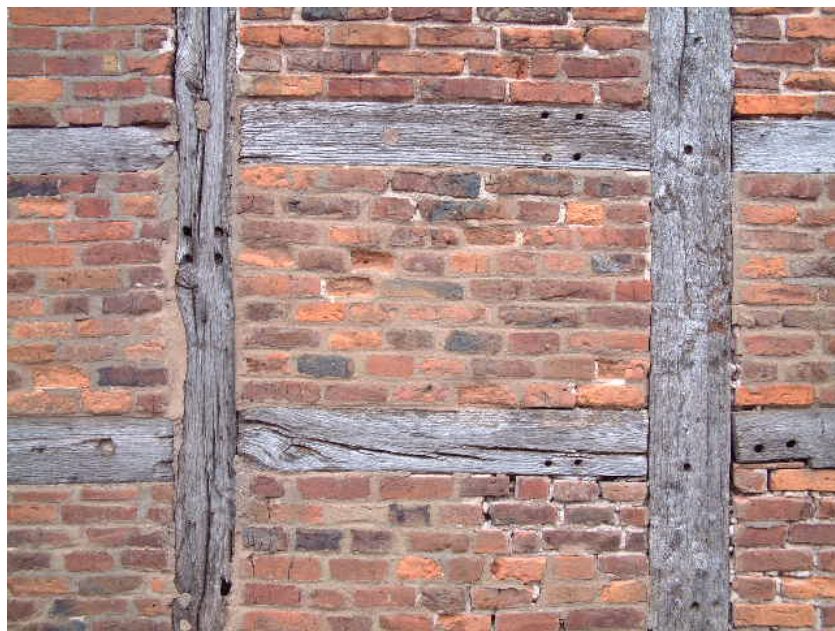
Plate 8

Empty mortises and peg holes in the eastern gable framework

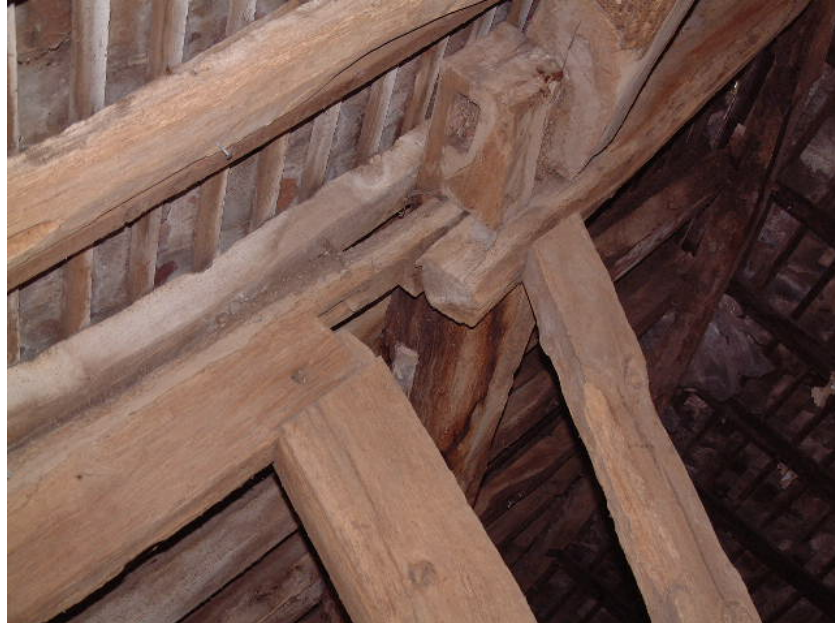
Plate 9

Top end of principal shown wedged up, as removal of the clasped purlin has caused it to crack

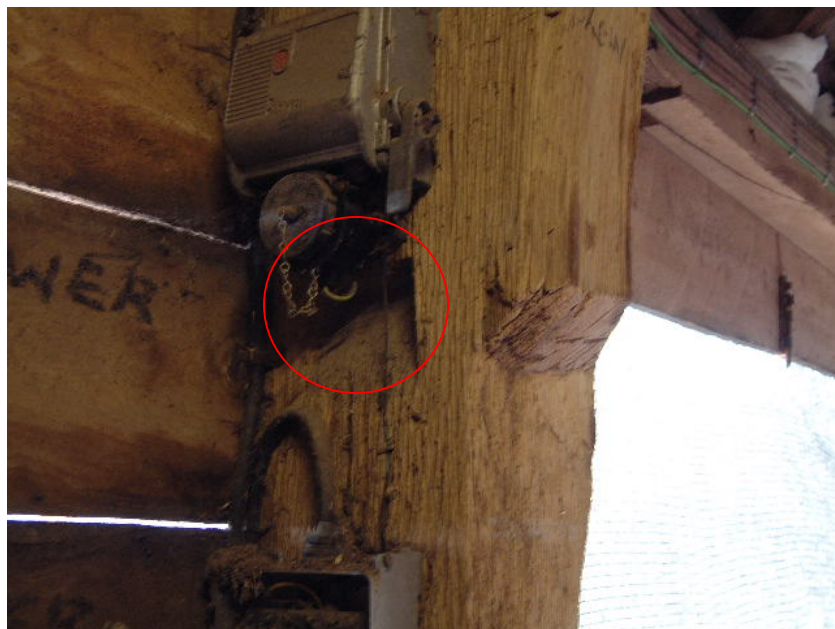
Plate 10

Gunstock jowel on post, with scotch (ringed)

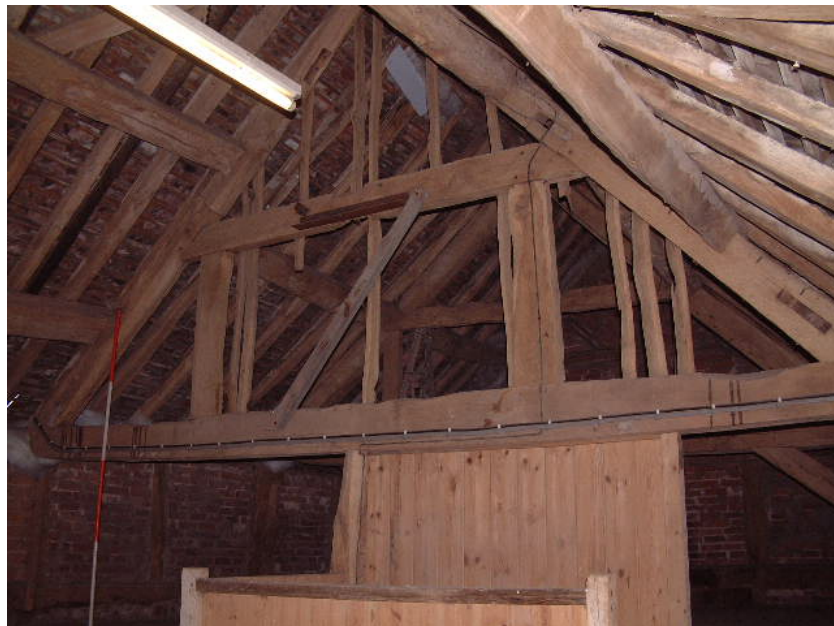
Plate 12

Truss T4 takes the same form as Truss T1, with twin raking queen struts, collar and tiebeam. There are staves nailed onto what would have originally been the outer face (Plate 12). The truss was easily inspected as an upper floor had been inserted over Bay B3, possibly at the same time that the southern wall was rebuilt (? Early 20th century). The remaining post (northern side) has a gunstock jowelled head, but is unusual in that the wall plate has been fixed to the post by a slip tenon (Plate 13), rather than the usual carpented tenon within the top of the post. This design seems to suggest that the original tenon was sawn off and a mortise slot cut in its place. This would allow a new section of wall plate to be slotted in without dismantling the truss and it would also allow a new post to be inserted into the frame if the sole plate could also be cut away; the sole plate is missing in this area. As noted by J.E.C.Peters, this post is chamfered on both sides, suggesting that it was designed to be an internal post rather than in its current location on the corner of the frame. The end frame below the tiebeam has been removed to allow access into the attached timber-framed, indicating that this was added later. At lower level, a modern RSJ and block-supporting wall has been inserted to support the upper floor.

Truss T4 looking into the attached building (scale 2 metres)

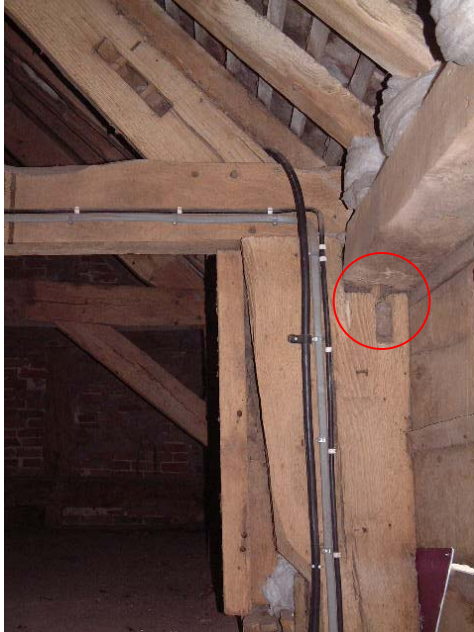
Plate 13

Unusual slip tenon at top of post indicating modification to the original

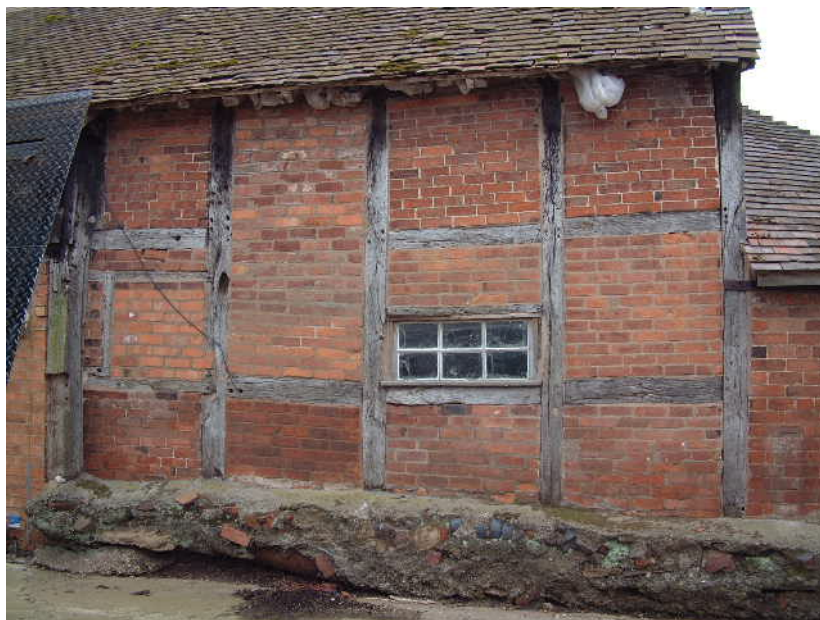
Plate 14

The building attached to the barn on the western side has been identified as a former fodder-processing house or 'chop house' (Peters 1994). It is of square panelled timber frame construction, with three tiers of panels beneath a hand made clay tile roof. It is attached to the remnant framing of the western gable of the barn (Plate **). The panels have brick infills and the doorways in the southern elevation, the western gable, a window to the north and the upper floor are all later (than the external frame) additions. The lack of doorways in the original frame suggests that it was rebuilt / moved from elsewhere and that doorways were added at the time. Unfortunately, much of the evidence for the association between the barn and this building is hidden behind modern alterations. The building is narrower than the barn and is set in on both sides. The studs on the northern elevation have carpenters marks I, II and III (Plate 14), but the north-western corner post is not marked.

Northern elevation frame of the attached (chop house) building. The end post (right) has no visible carpenter's mark, but the next 3 (right to left) are marked I, II and III

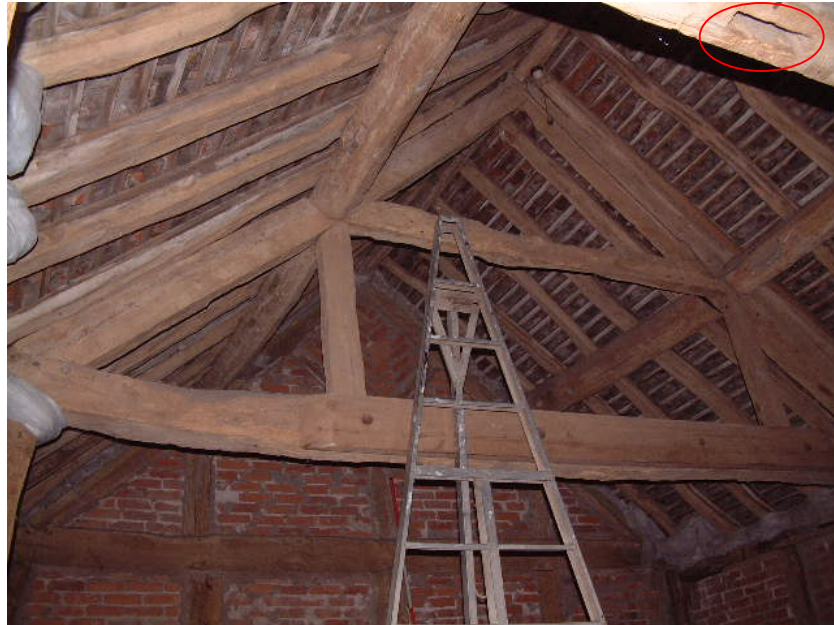
Plate 15

The central truss (T5) is of twin queen posts and collar supporting the purlins, with tie beam between the posts. The tie beam has suffered some damage and has been strengthened by a timber bolted along its length (Plate 15). The western gable end truss is similar with the addition of 'V' struts from collar to principals. The brick infill panels at the apex are laid in a herringbone style (Plate 16). The upper floor has been inserted into the building and is approached via stairs in Bay B3 of the barn

Central truss in chop house. Note the empty mortise on the base of T4 tie-beam, where the end frame has been removed (ringed).

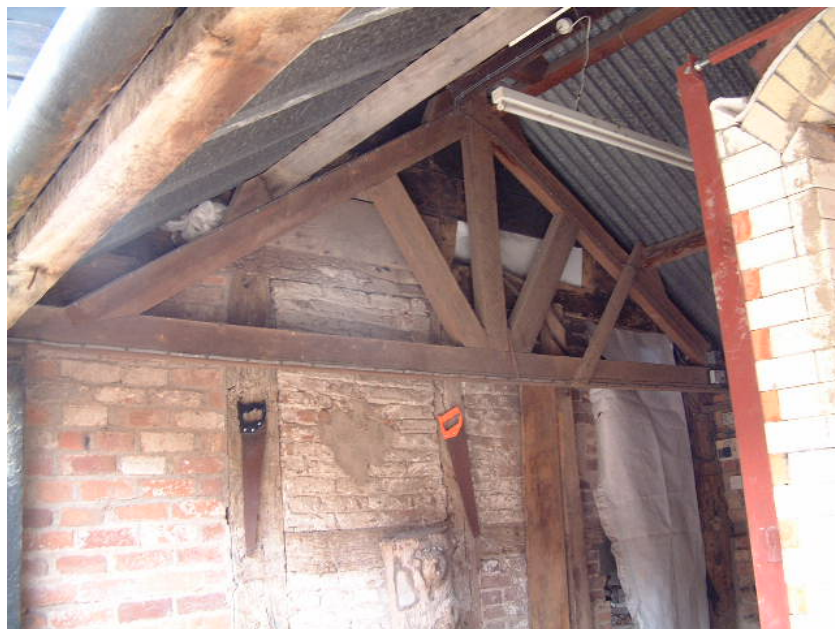
Plate 18

The final building in the recording lies at the eastern end of the barn projecting northwards. It is of brick and mortar construction below a corrugated iron roof covering. The building appears to have once been open fronted to the east, but has been enclosed by corrugated iron and timber doors. The structure has lately been used as a kiln house for one of the attached craft centres. The kiln is still in situ in the open section of the building (Plate 17). The building is a modern structure, although the roof-trusses are 19th century, made from machine-sawn timber with a central kingpost and utilising a combination of small pegs and unpegged joints (Plate 18).

Re-used 19th century roof truss in the store building

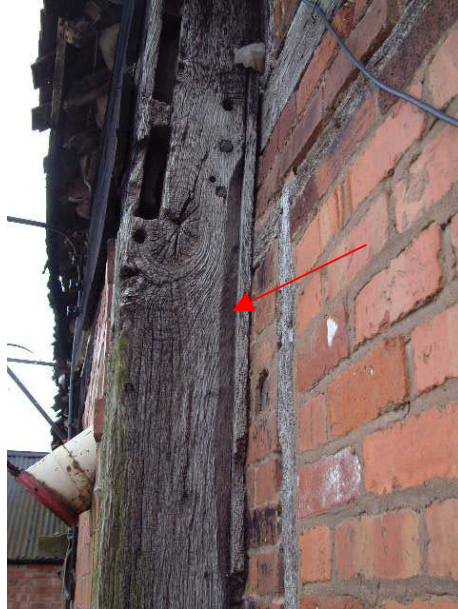
Plate 19

The remaining visible carpenters marks do not give any clues as to the construction of the barn. There is evidence, as stressed above, for much re-use of timbers, even within the original construction. Noticeably and already commented upon by J.E.C.Peters (Peters 1994), the north-western corner post appears not to be original. The evidence, referred to above, is the double chamfer on the post indicating an original position with a bay to either side, empty mortises and peg-holes that do not correspond with the construction (Plate 19) and the use of a slip tenon between the wall plate and tie-beam. This suggests that the post may have been inserted into the frame, rather than the frame having been totally rebuilt.

NW corner post of the barn (truss T4) showing the chamfer on the outside (arrowed)
