HISTORIC BUILDING ASSESSMENT AND  
RECORDING AT  
MUTTON HALL FARM  
FECKENHAM LANE, ASTWOOD BANK,  
WORCESTERSHIRE

WSM 49620

# Historic Building Assessment and recording at Mutton Hall Farm Feckenham Lane, Astwood Bank, Worcestershire

25<sup>th</sup> June 2013

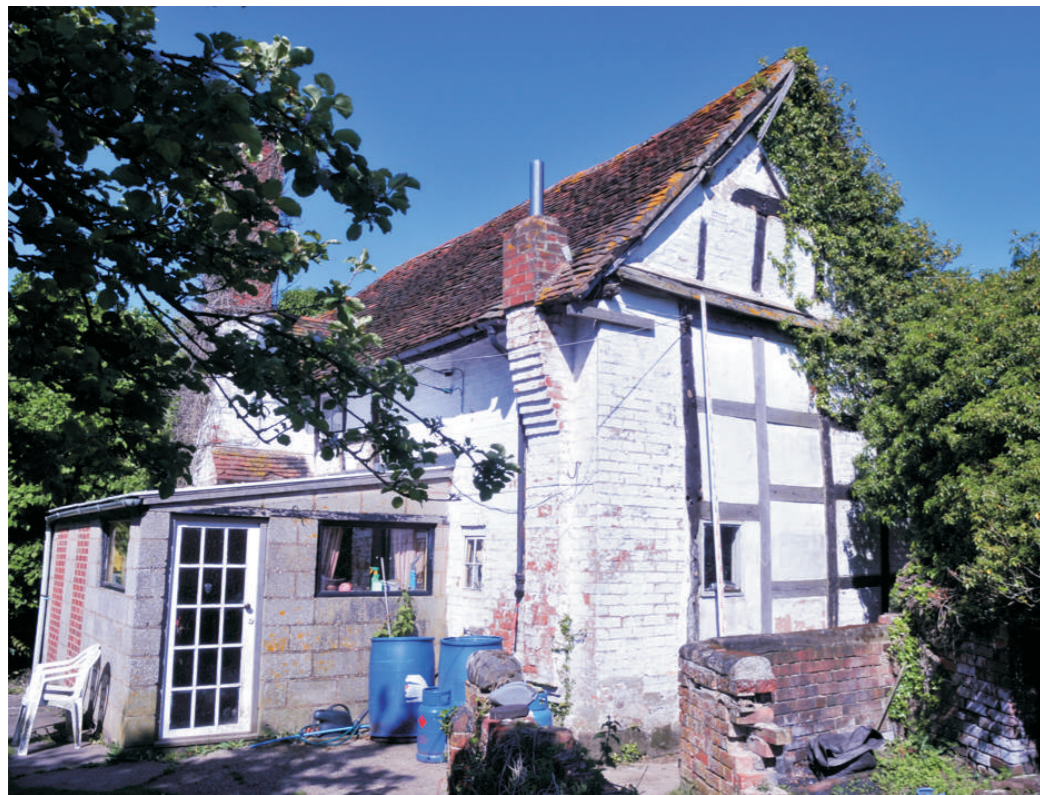
View from south east, note partially restored framing, and unsightly lean-to

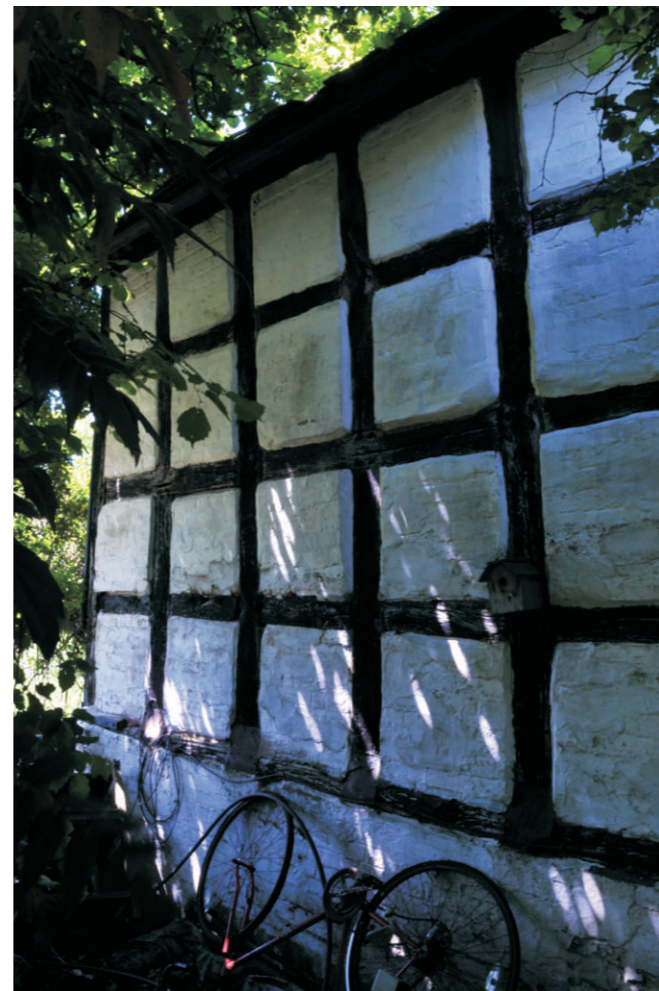
external access is on the southern elevation. It is currently blocked with corrugated iron sheeting, and this has contributed significantly to damp problems in this area and decay of the suspended wooden floor over the cellar. The cellar walls are of well bonded 18<sup>th</sup> C hand made clamp fired brick. There is a course of stone around the external wall at a level broadly corresponding with external ground level – this may have been intended as a damp-proof course. The eastern wall has several large blocks of ashlar at high level, but these are not coursed. The cellar is not ceiled, but the soffit of the floor above is whitewashed, the ground floor appears to be of elm planking, possibly on elm joists and bridging beam.

Western end of southern elevation; cellar access concealed beneath bicycle

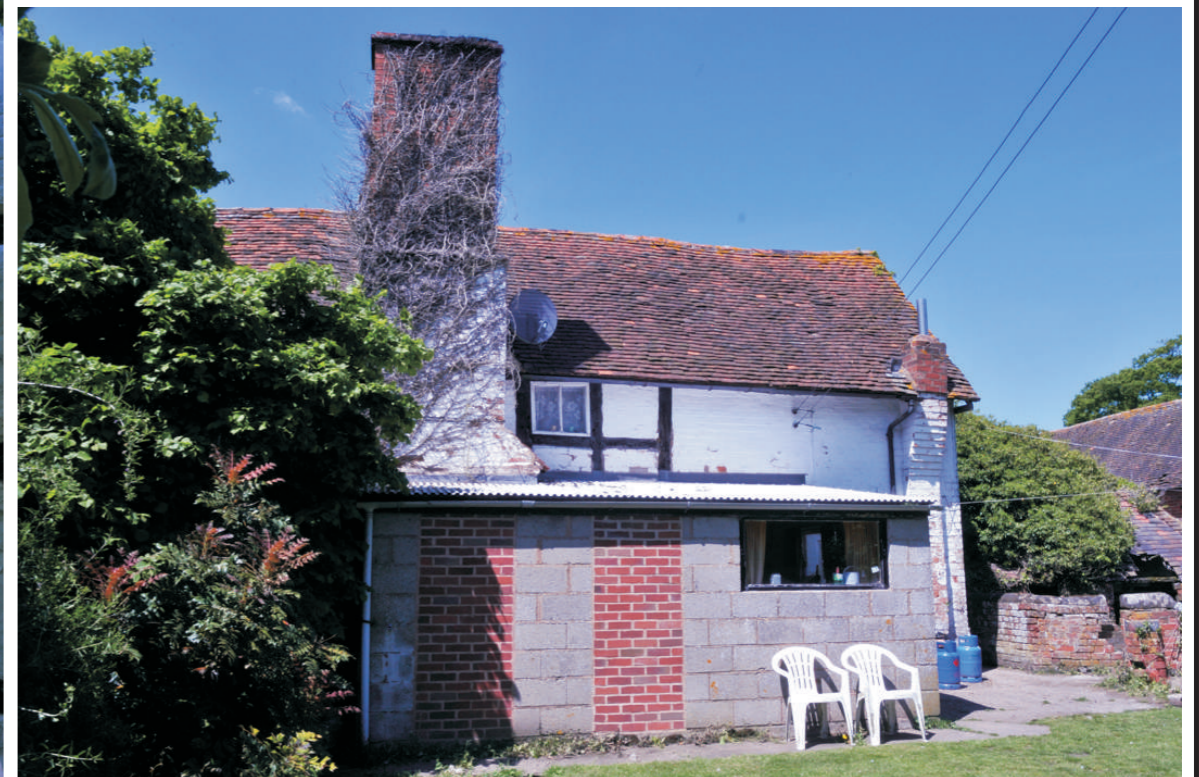
Southern elevation and modern lean-to

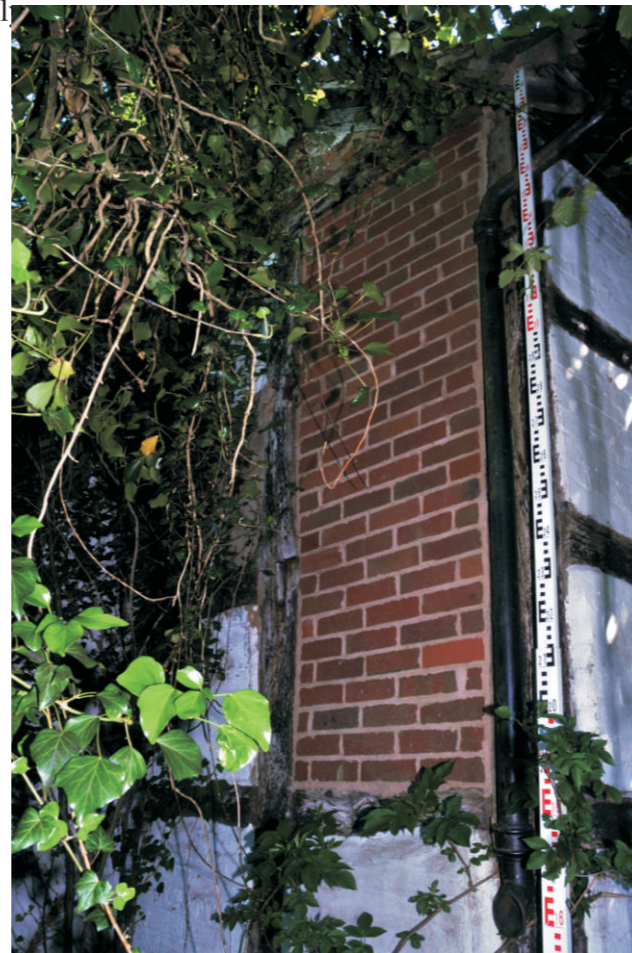
- 9.5 The western gable end is heavily obscured by vegetation. The gable end is of framed construction, over a deep brick plinth. The panel infill is of 18<sup>th</sup> C brick. A small brick chimney has been abutted against the outer face of the gable end, but is not bonded into the gable. This chimney has moved significantly away from the wall, apparently due to inadequate foundation. The brickwork of the chimney is rendered, but appears to be early-mid 19<sup>th</sup> C. There is extensive and very recent brick repair to the southern half of the gable end, with some loss of the horizontal framing members.

Detail of recent inappropriate repair to western gable

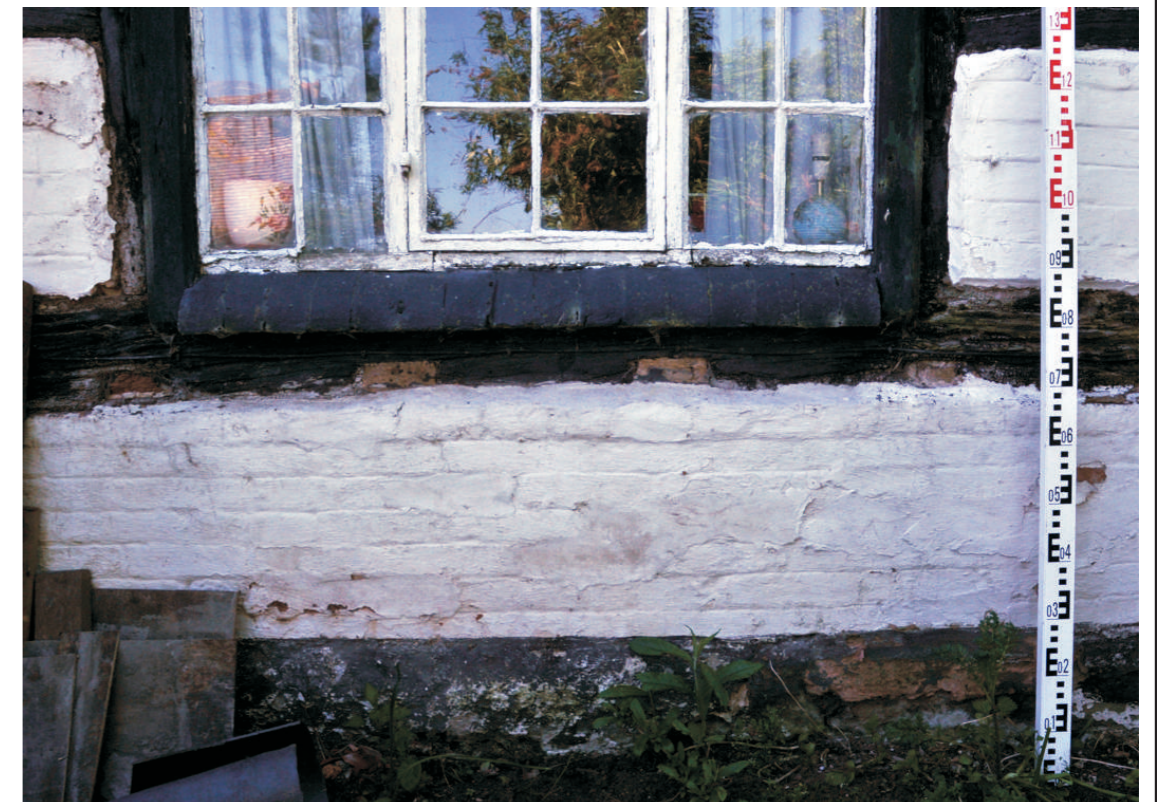
Detail of plinth wall - note that ground cill of framing is re-used timber

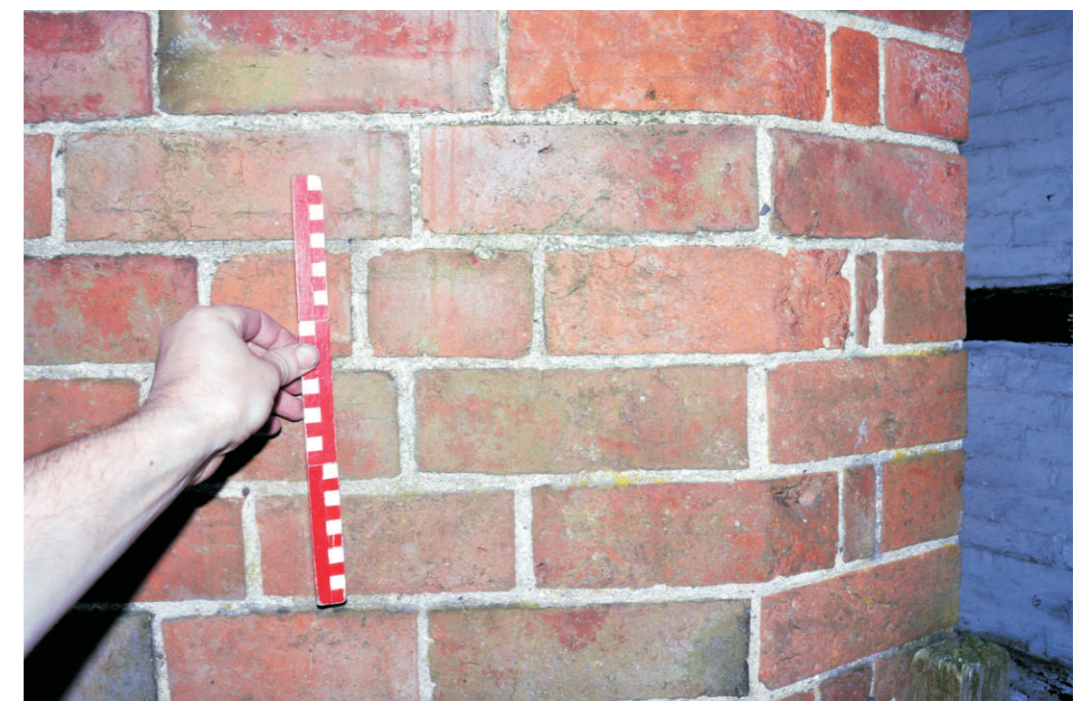
Brickwork detail, north wall of pigsty

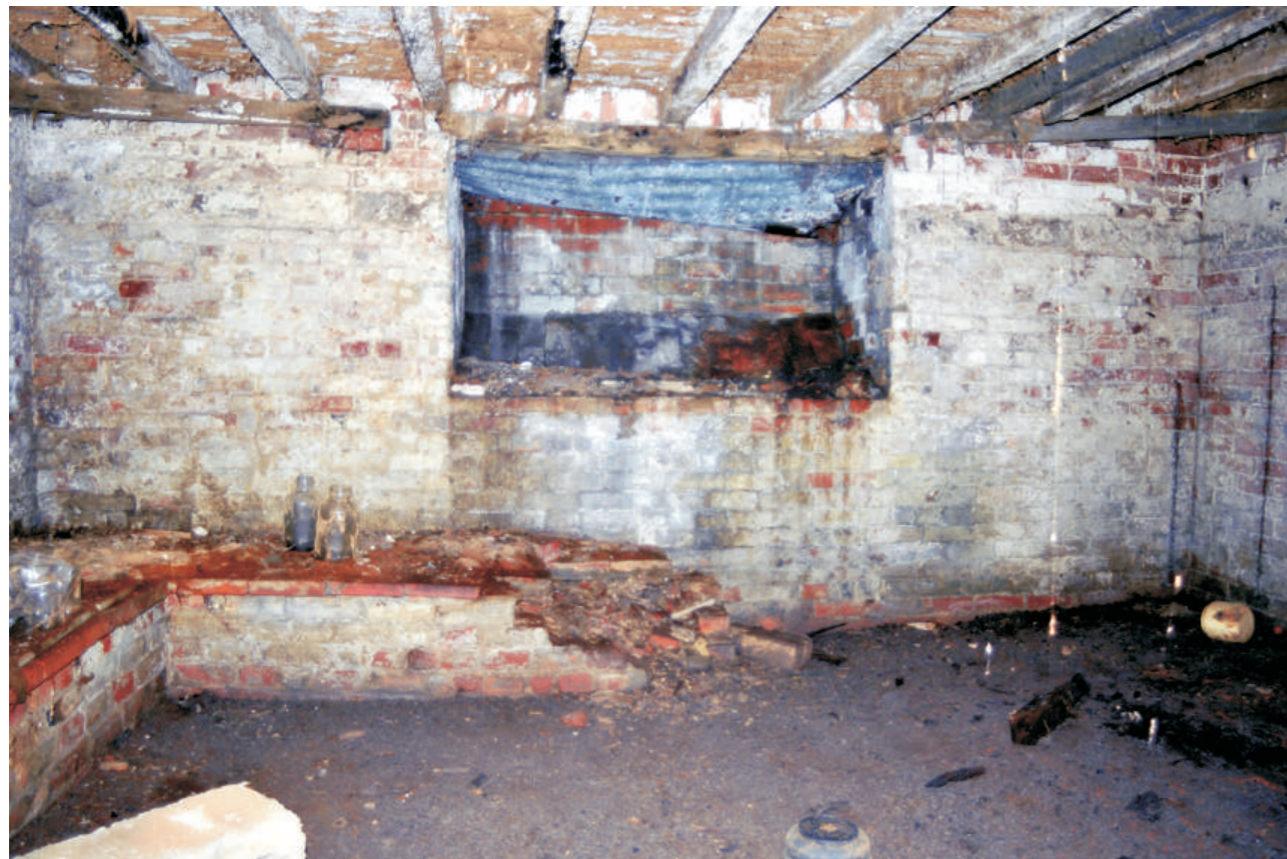
Southern wall of cellar, note brick built stillage and blocked access

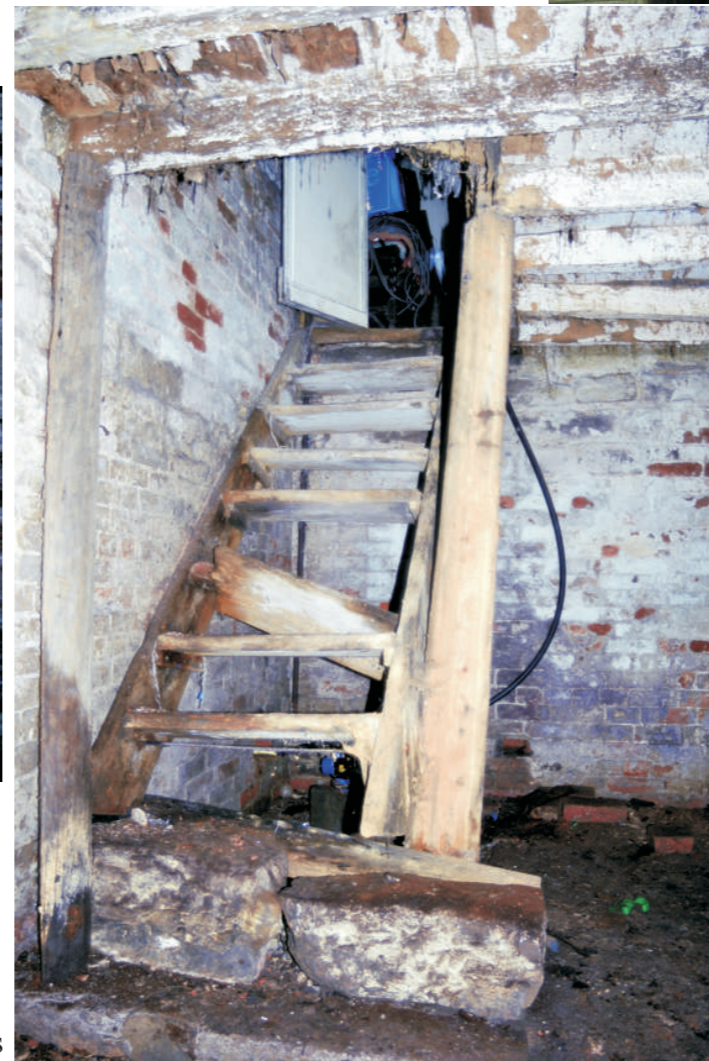
- 9.5 *Cellar*
- 9.5.1 The cellar is accessed from the middle bay by a steep wooden stair in poor condition (Fig 10). The lower two steps are stone . The stair enclosure is of lath and plaster on rough stud construction and of 18<sup>th</sup> or early 19<sup>th</sup> C character. The cellar is spacious with more than adequate headroom. The floor is brick, and there is a raised brick stillage along the southern wall. The original large cellar

Cellar steps

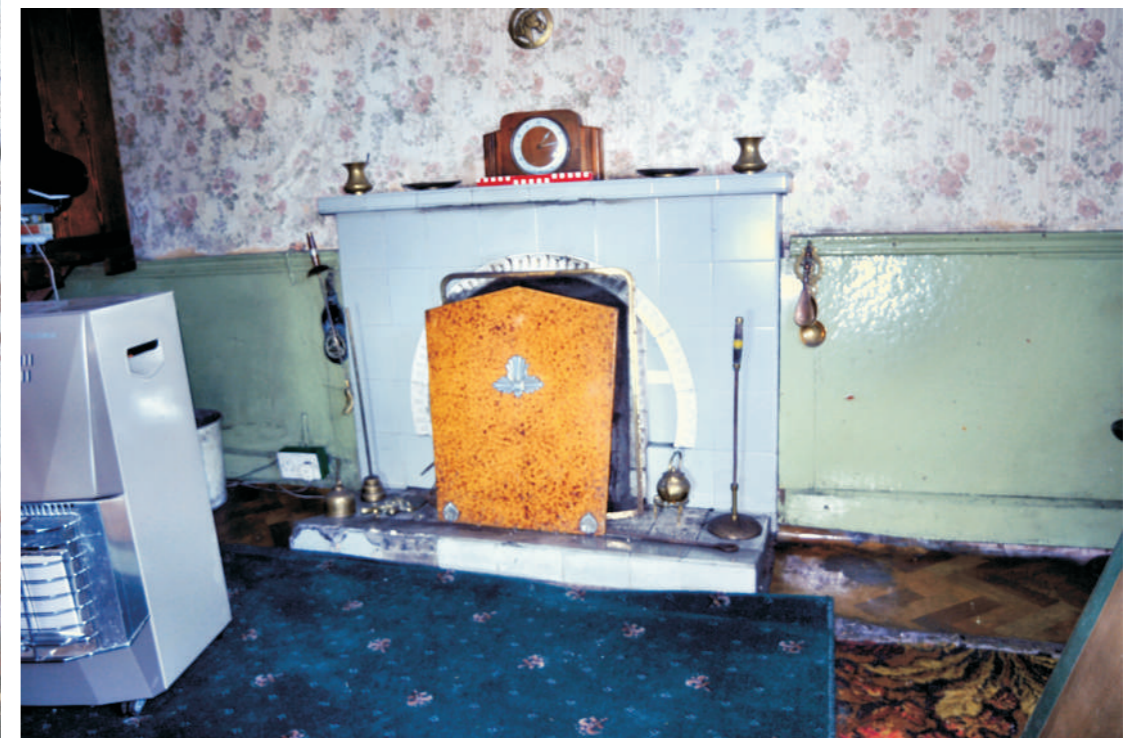
Inserted fireplace (1950s) on western gable end wall, note also modern ?fibreboard panelling to dado level

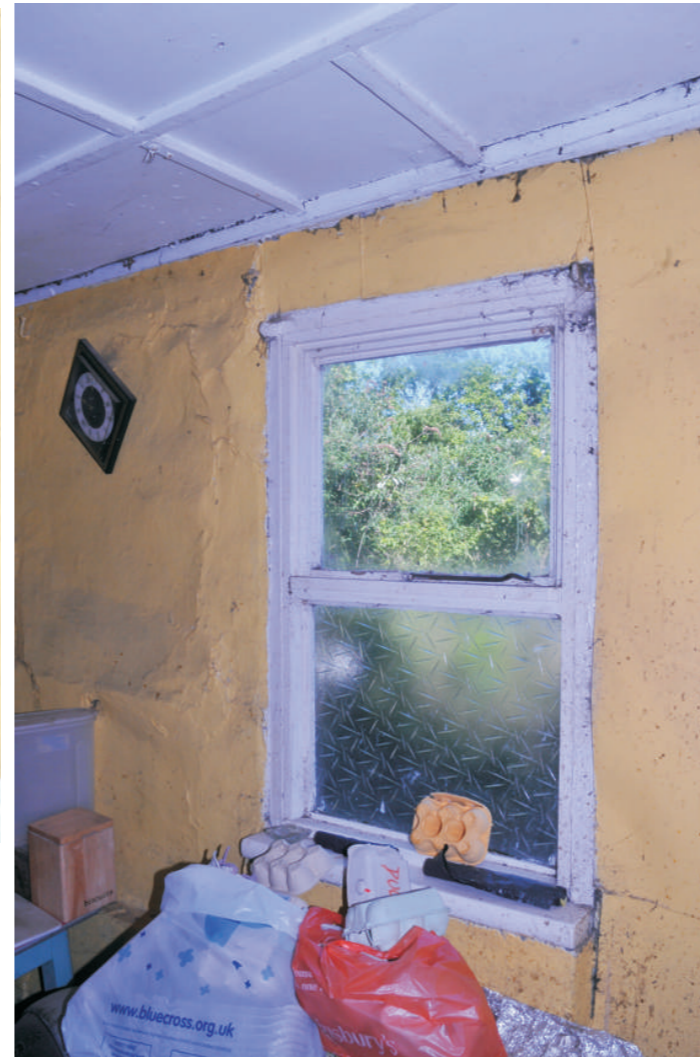
Modern replacement window

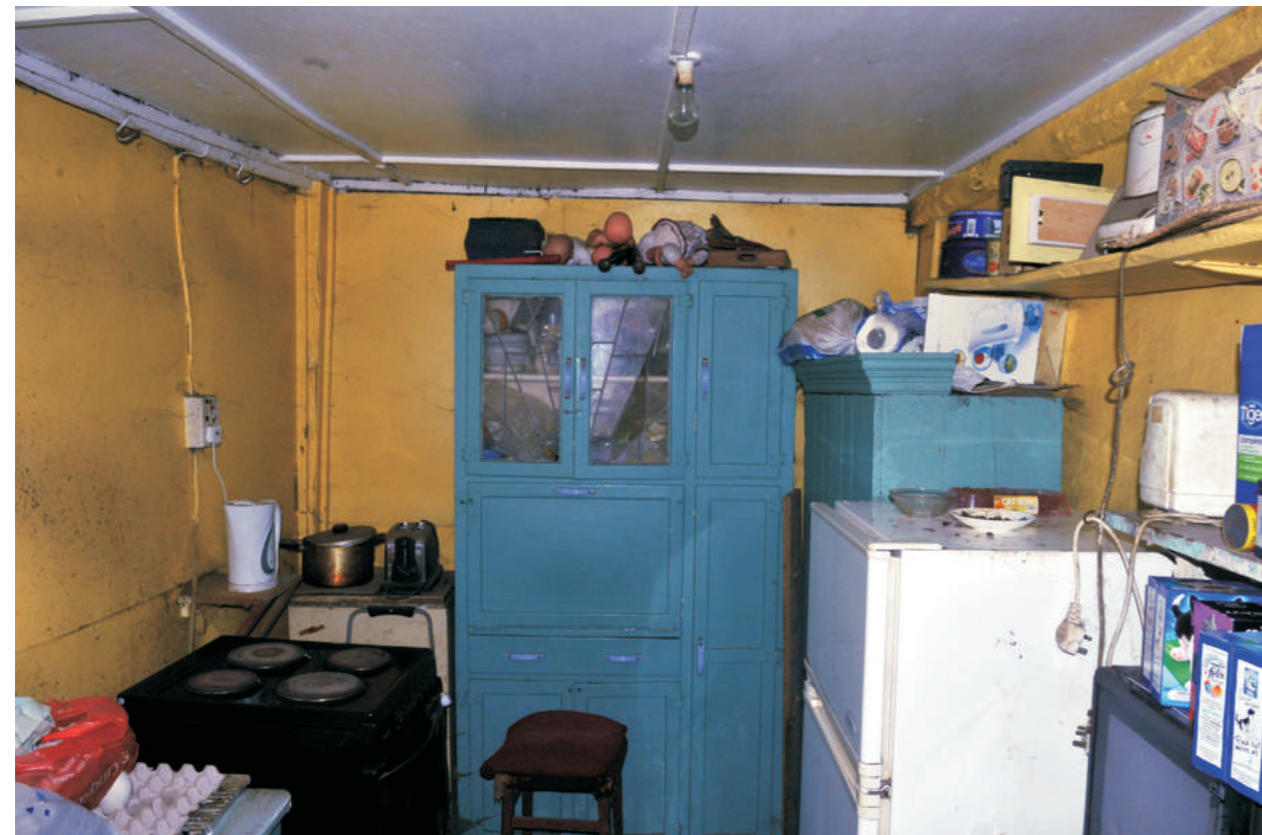
View facing east, note hardboard lining over framing and concealing ceiling
