ARCHAEOLOGICAL BUILDING
RECORDING
OF A TIMBER-FRAMED
OUTBUILDING AT THE COVENTRY
ARMS, UPTON SNODSBURY
WORCESTERSHIRE

WSM 33524

Archaeological building recording of a timber framed outbuilding at the Coventry Arms, Upton Snodsbury, Worcester (WSM 33524) January- February 2004

Mike Napthan 7th March, 2004

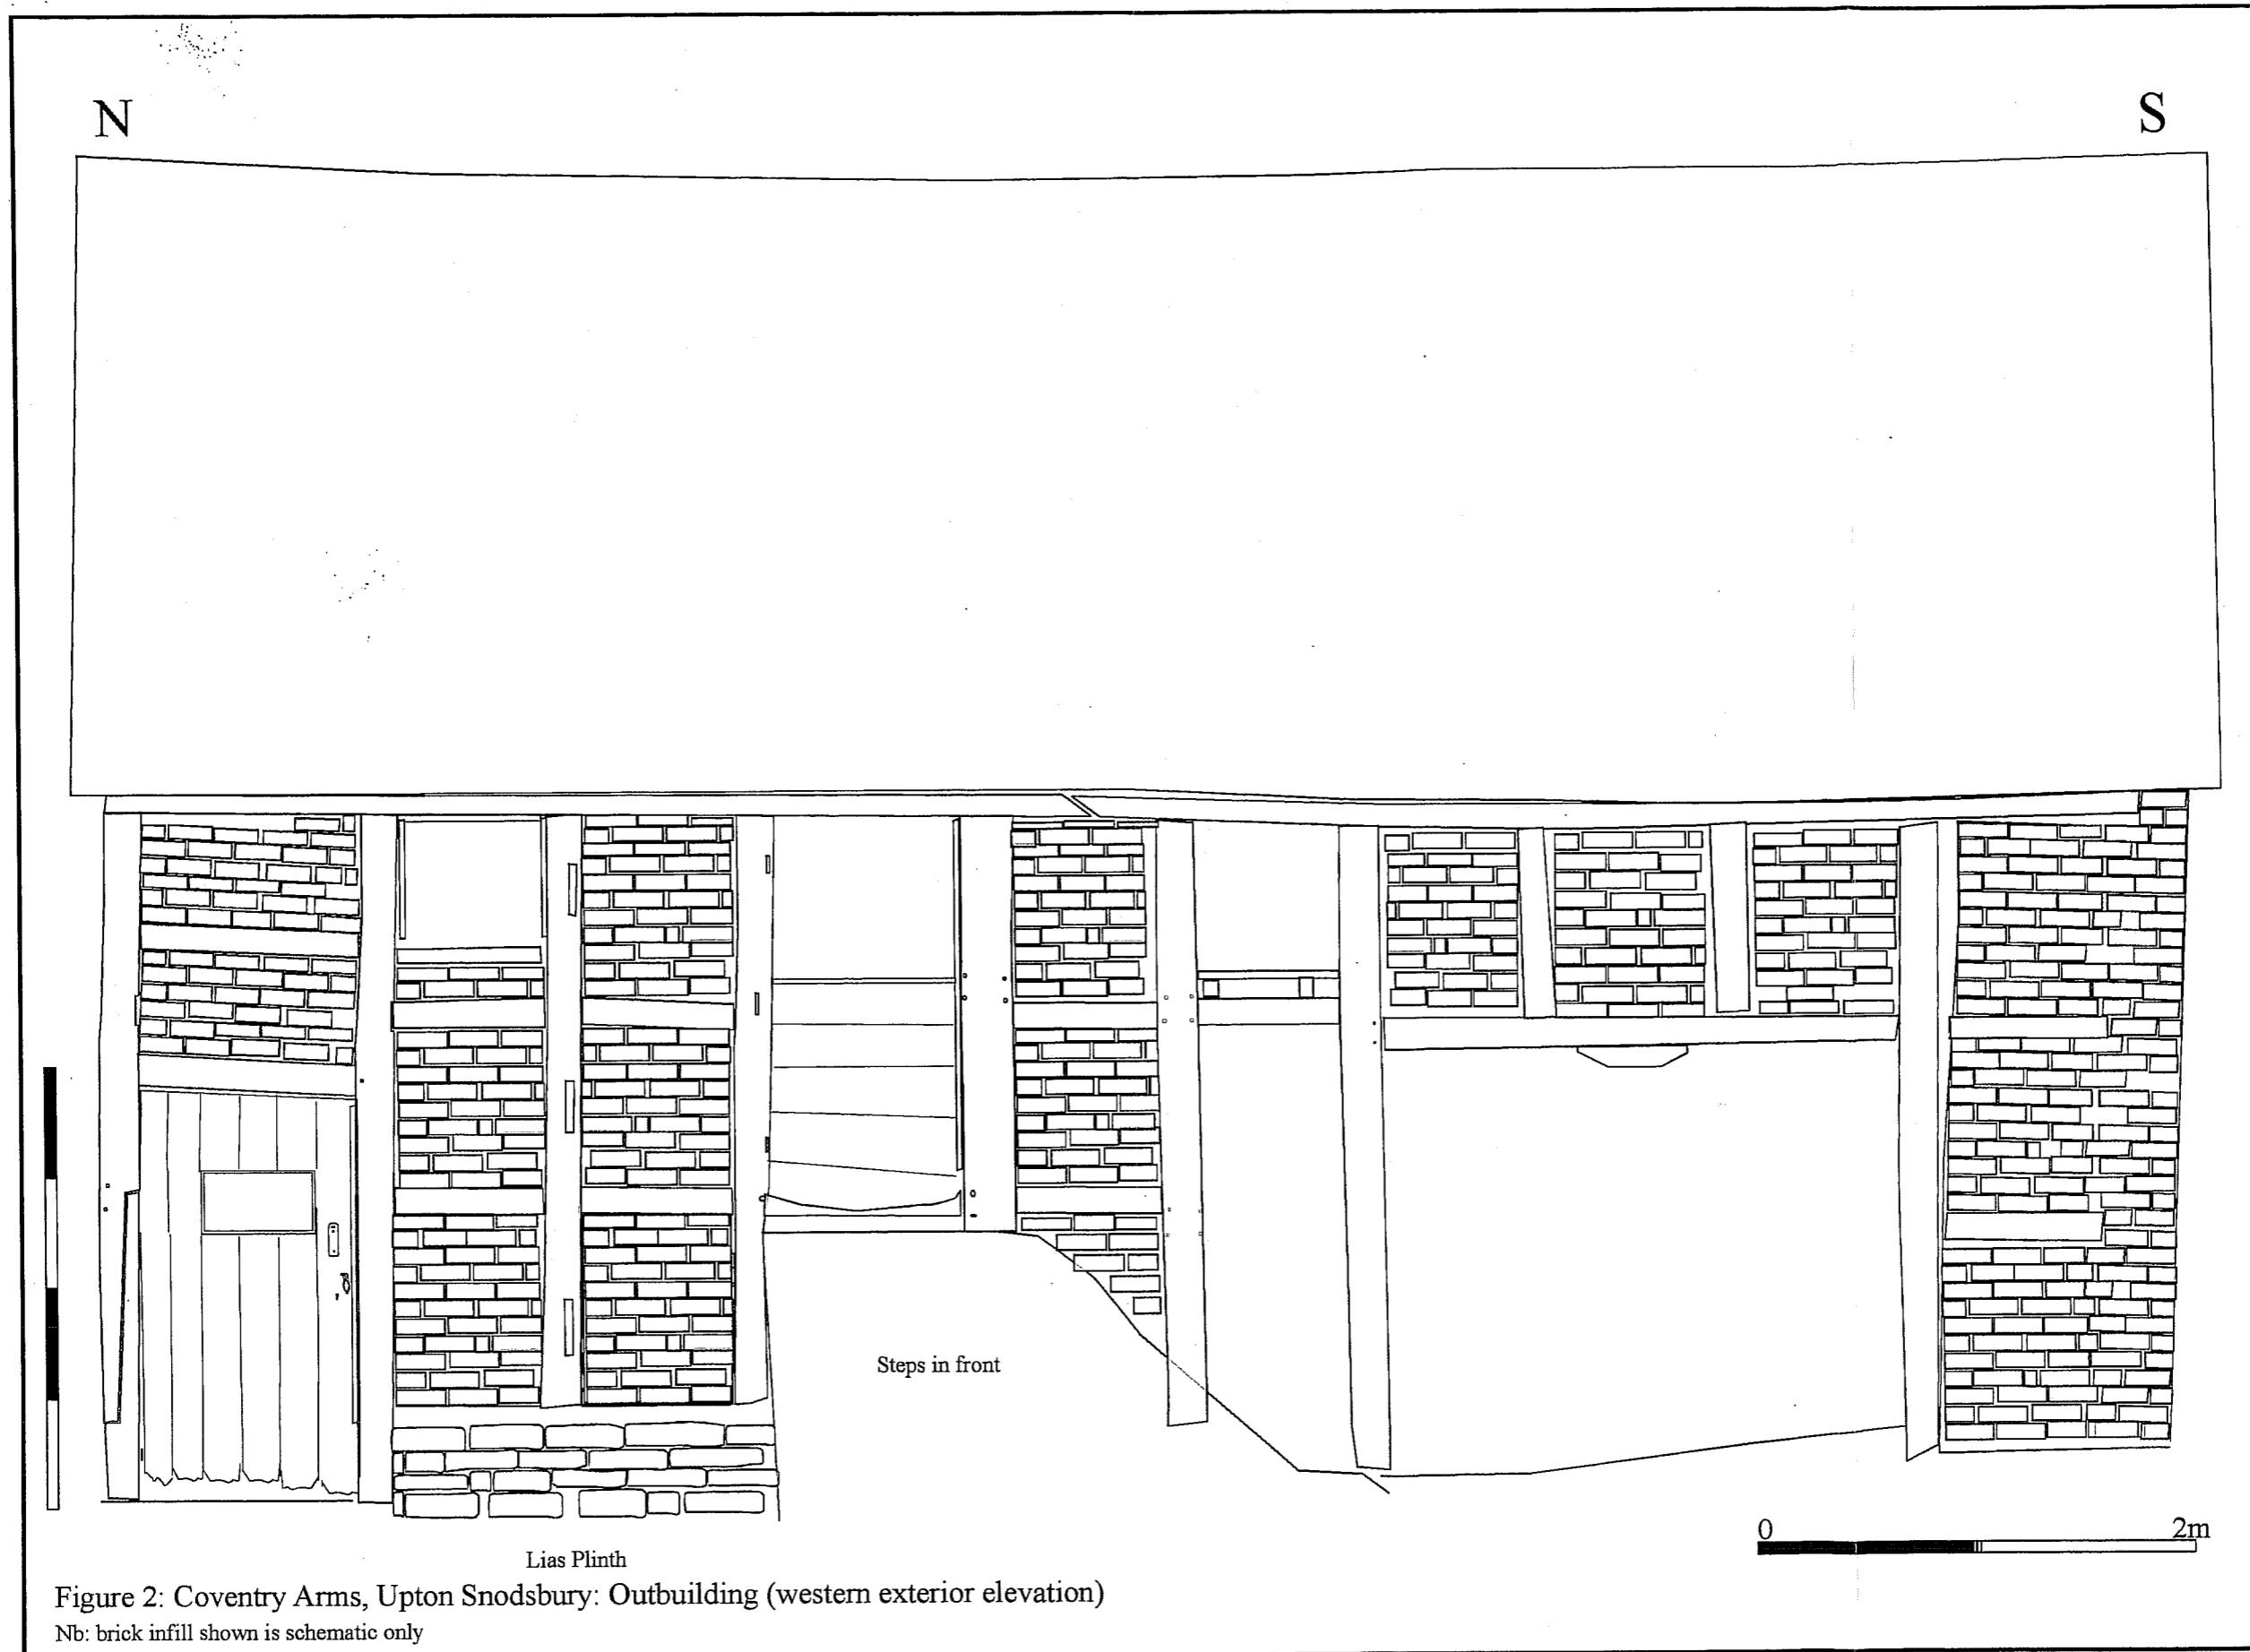
Figure 2: Coventry Arms, Upton Snodsbury: Outbuilding (western exterior elevation)

6.4.2 The western elevation was largely open at ground floor level, and appeared to have been previously secured by double doors, part of which survived on the southern side of the opening (obscured by vegetation in the photographs – Fig 6). A door stop was present in the centre of the door head rail soffit. The panel to the north of the doorway was entirely open, having lost any infill and only mortices for the missing rails showed that it was not formerly an opening. At 1st floor level a further open panel may have been used for light or to load goods, but does not appear to have been originally intended for that purpose, and was grooved to accommodate wattle infilling.

Nb: brick infill shown is schematic only

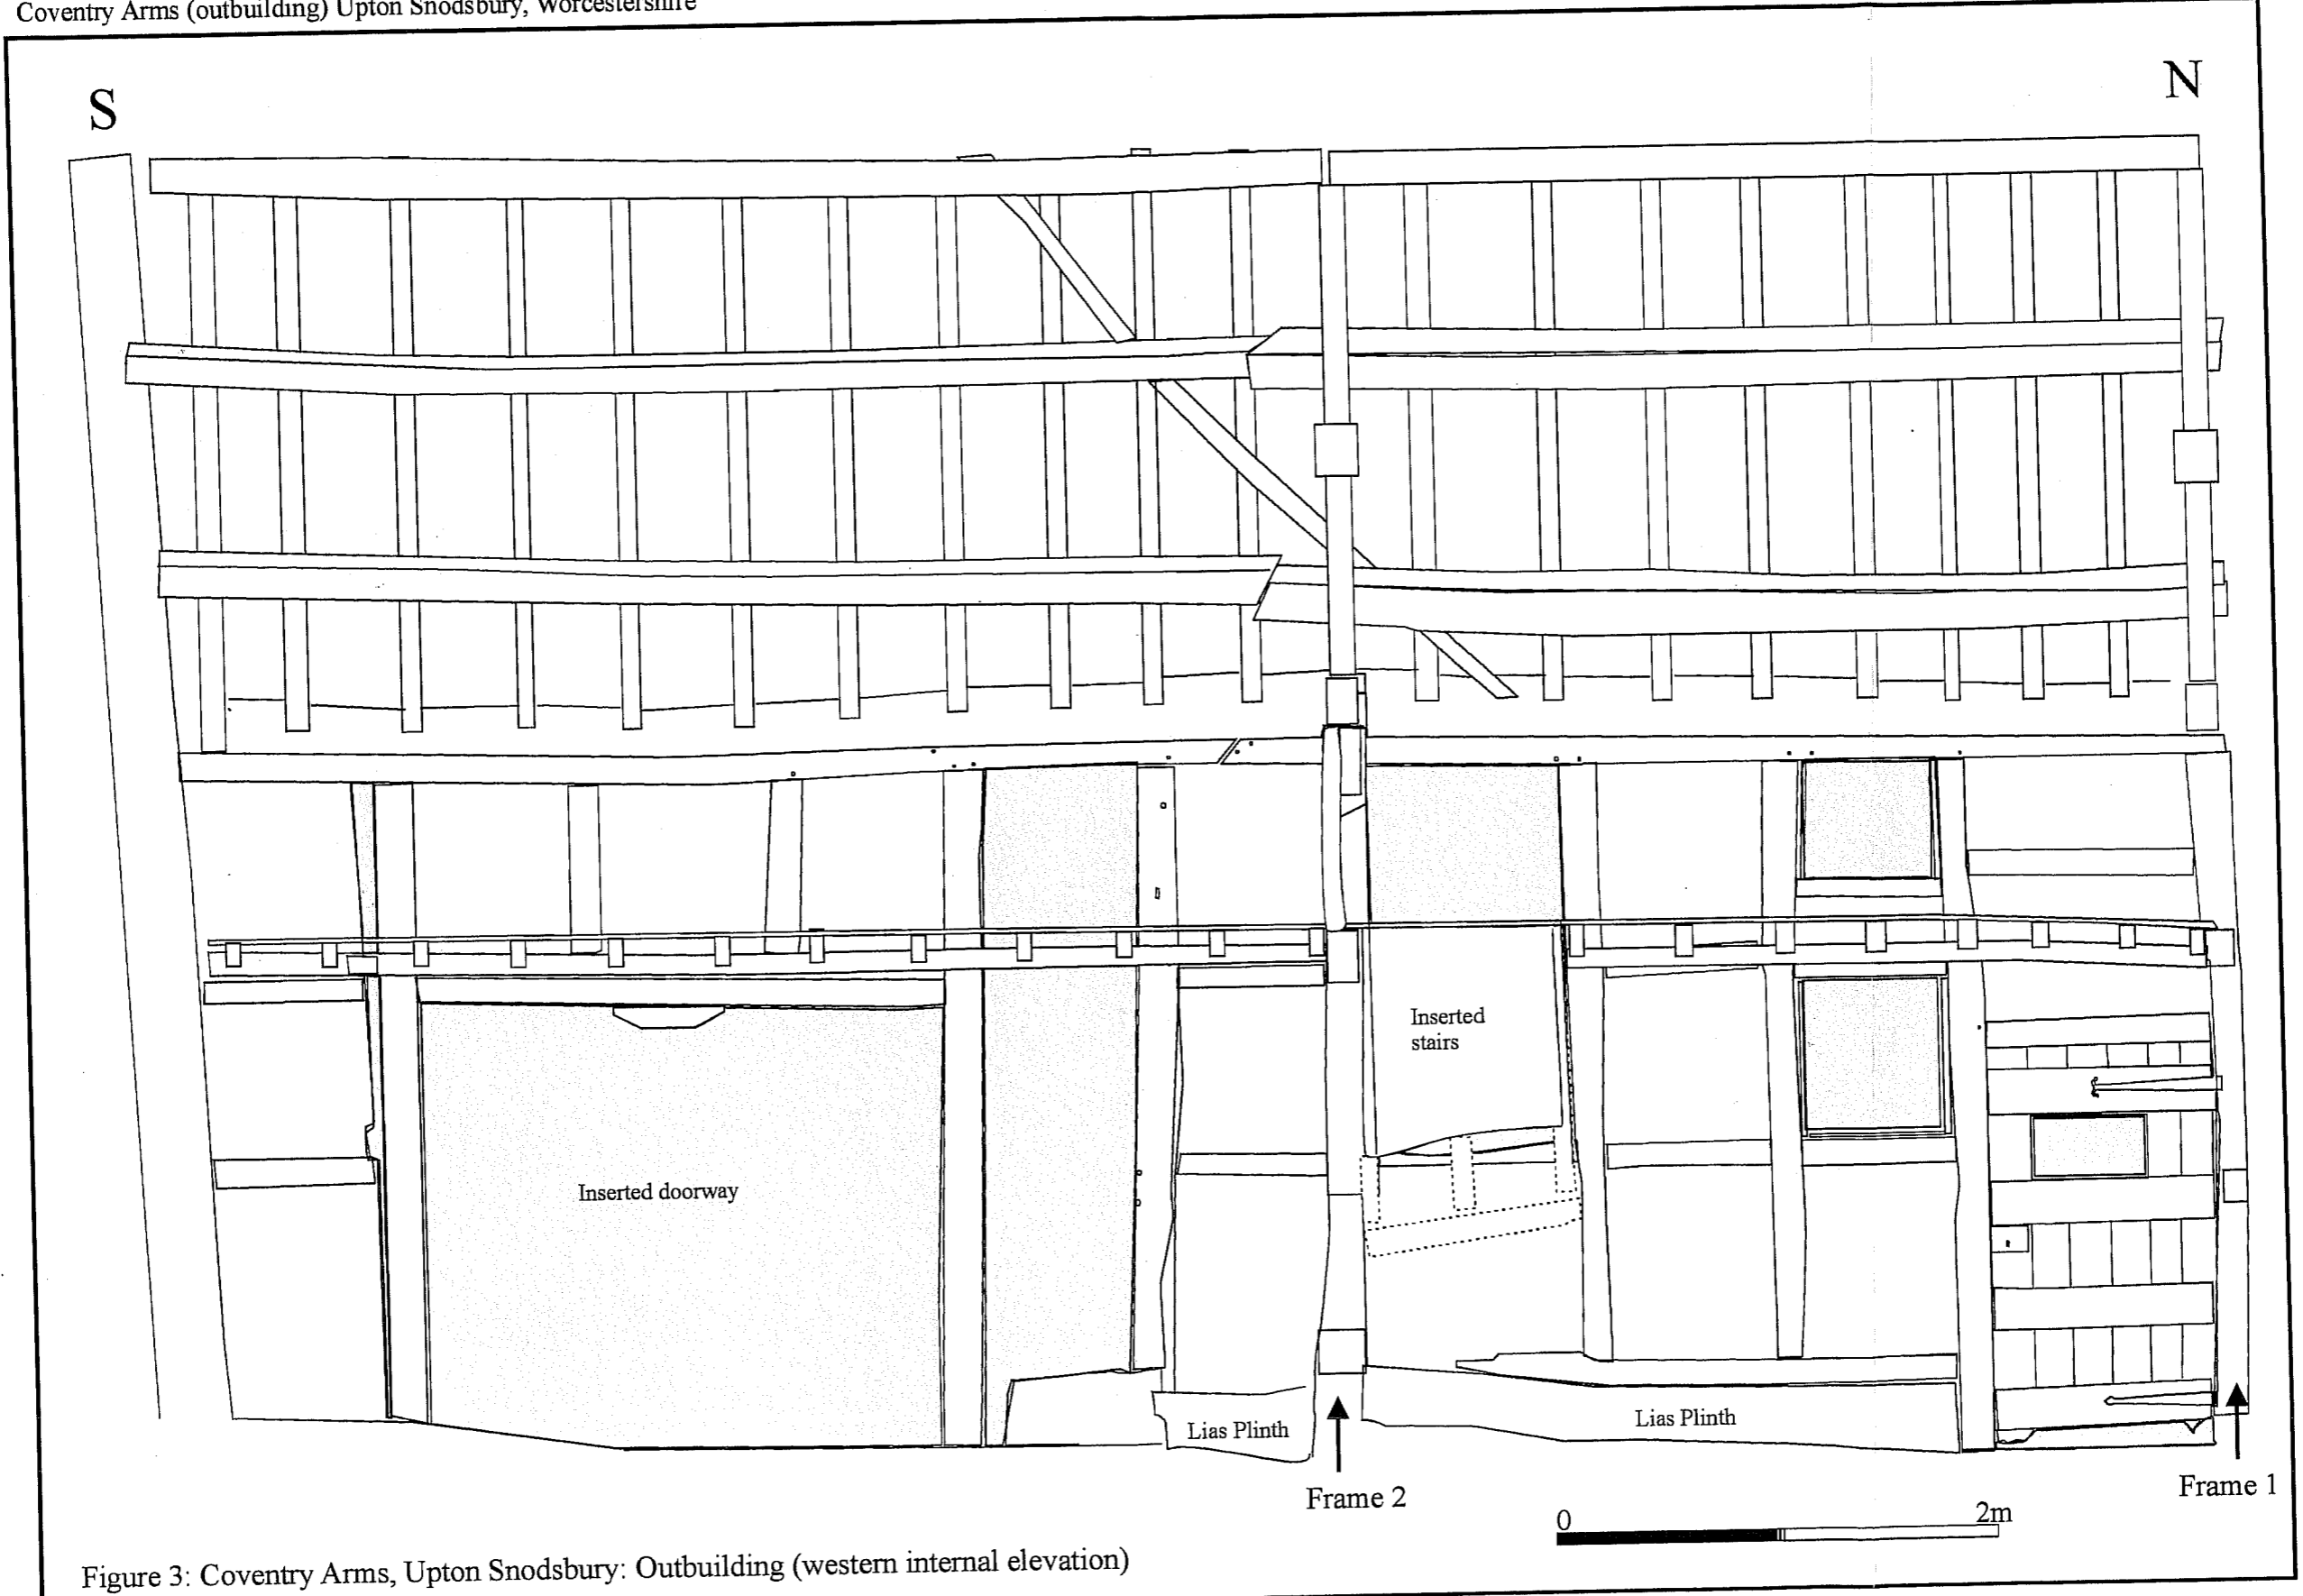
Figure 3: Coventry Arms, Upton Snodsbury: Outbuilding (western internal elevation)

6.6 The Roof (Fig 3)

The existing roof of the building appears to be of largely 18th C date, but was presumably at least partly stripped of its covering to permit 19th C rebuilding of the southern gable end. The flat ribbed and pegged tiles are of post-medieval character in the main with occasional machine made replacements.

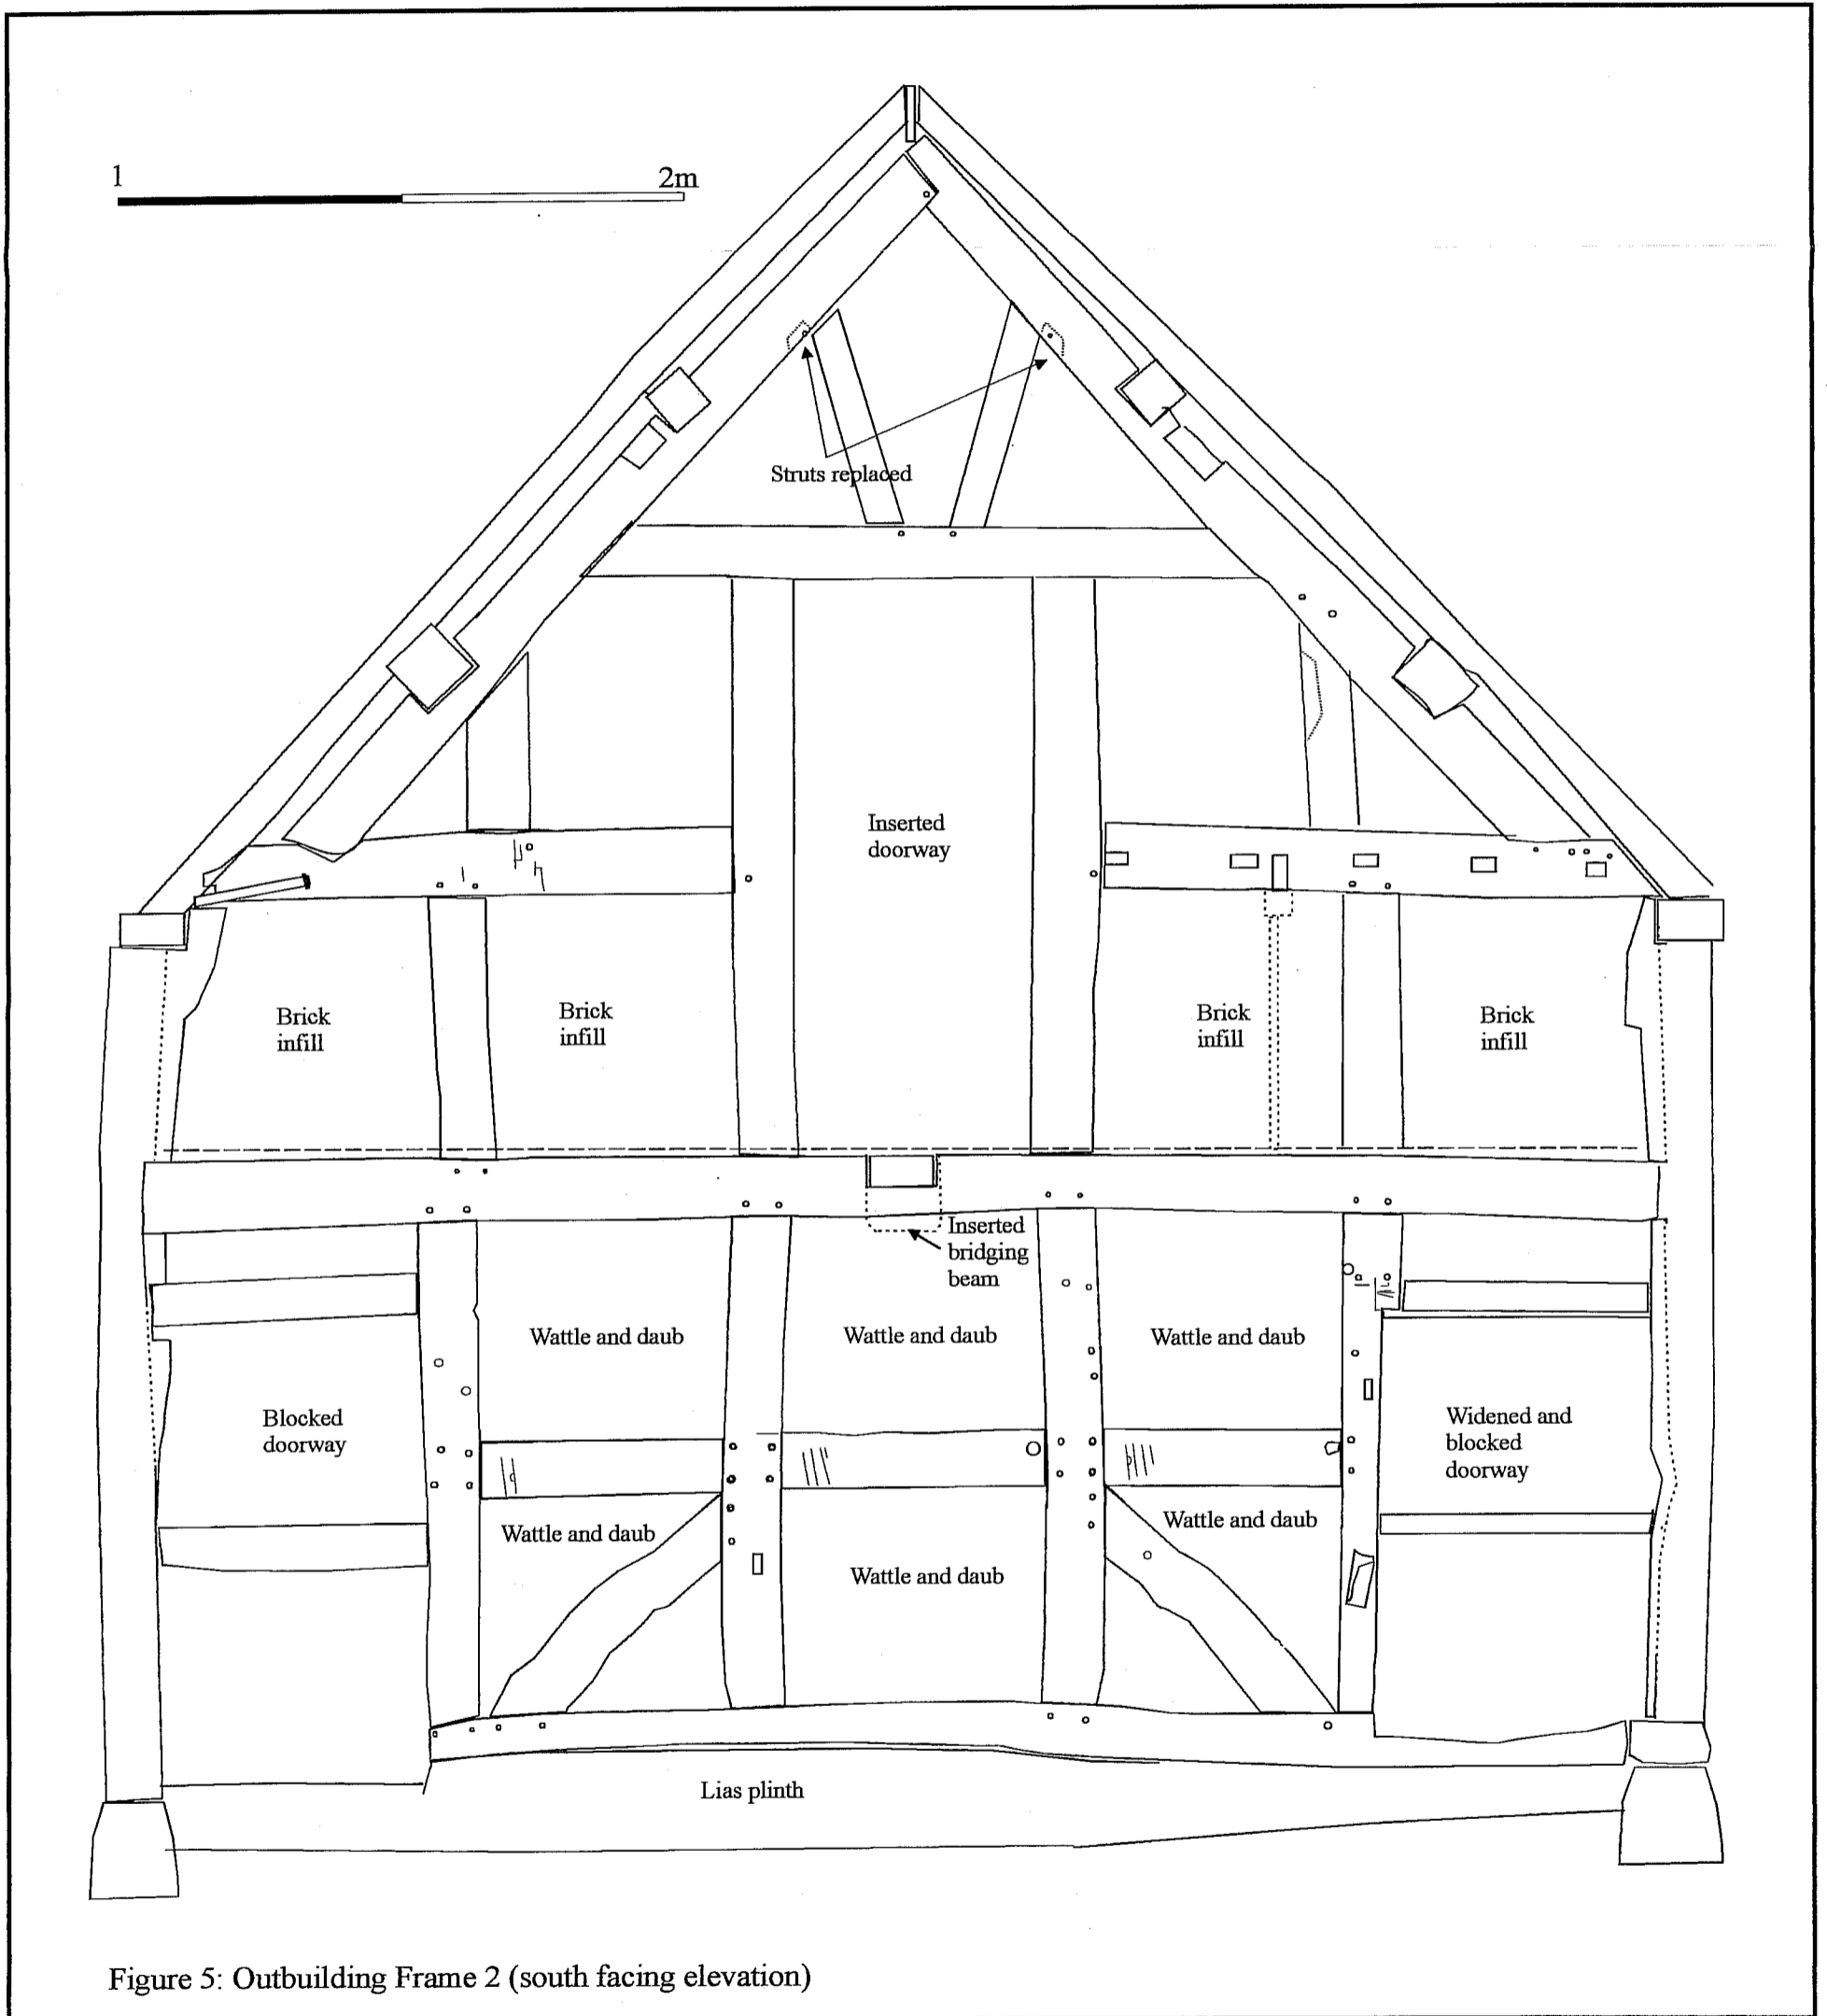
Figure 5: Outbuilding Frame 2 (south facing elevation)

- 6.3.1 This frame lies between Bays 1 and 2, and sits on a shallow Lias dwarf wall, which appears to have been inserted. The frame is of good workmanship (using larger scantling timber than is evident elsewhere in the building) and appears to have been adze or plane finished. There are no certain saw marks on the original elements. Carpenters' assembly marks are visible from Bay 2, and those on the bottom rail include crescents relating to the curved braces between the two blocked doorways. The sill beam is irregular but shows considerable wear at either end from use of the doorways. A possible (and certainly secondary) timber latch rest was noted on the jamb of the eastern doorway, but the method of hingeing was not visible, which may be indicative of "harr" hinges (where projections of the door were shaped as dowels and engaged in sockets drilled into the door head and sill). The eastern door had been widened, possibly to permit stock access, though there was little sign of wear. A mortice in the eastern jamb of the western doorway indicates that the doorway was not original, and that there was formerly a rail across this panel. The majority of panels retained wattle and daub infill, smoothly finished in plaster and whitewashed. The doorway blockings included sawn timbers and split laths together with traditional wattle and daub. The blocked doorways were less smoothly plastered and more typical of agricultural work.

- 6.3.2 The upper part of Frame 2 had been considerably altered to permit insertion of the bridging beam and the first floor doorway. Above the inserted floors some panels had been infilled with brick, and the remainder above the tie-beam planked. The inserted upper door jambs have frequent small rectangular mortices, and these appear to be relics of a previous use of the timber as a bridging beam (the mortices housing floor joists). The two jambs were clearly sawn laterally from a single beam. There also appears to have been some substantial re-arrangement of the studs above tie beam level, and as the beam soffits were not visible it is not possible to determine the original form of the upper part of the frame. The tie-beam itself may not be original as it is rather narrow in relation to the lodgement of the western storey-post jowl. The principal rafters appear to be original, as do the lower purlins to Bay 1. Empty purlin mortices beneath the upper purlins may reflect the previous use of stopped purlins in Bay 2.

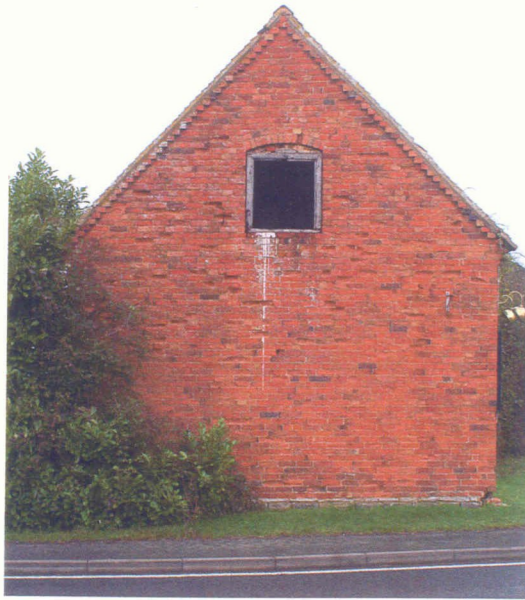
Southern elevation

6.4.4 The southernmost rails of the eastern and western elevations are built into the brickwork at the point where they presumably met the removed third frame. The brickwork of the southern gable end is of probably early 19th C date (bricks 220x115x63mm). The gable end had moved considerably out of true, and very little bearing remained for the roof and bridging beam. There was no clear indication of a window or shutter for the square window aperture at 1st floor level. The only surviving internal fittings in the building were two large timber bins on the eastern side at first floor level. These could conceivably have served as an apple-store or similar, but are probably related to the more recent use of the building as a log-barn.

- 7.8 The southern elevation was entirely brick-built, of early 19th C brick. It appears to have been constructed on the original location of Frame 3, but subsequent movement has increased the bay length slightly. Unfortunately the absence of Frame 3 prevents any firm conclusions being drawn about the possible former presence of an additional bay towards the roadside. The Tithe map evidence suggests that any additional building to the south was gone before 1838.

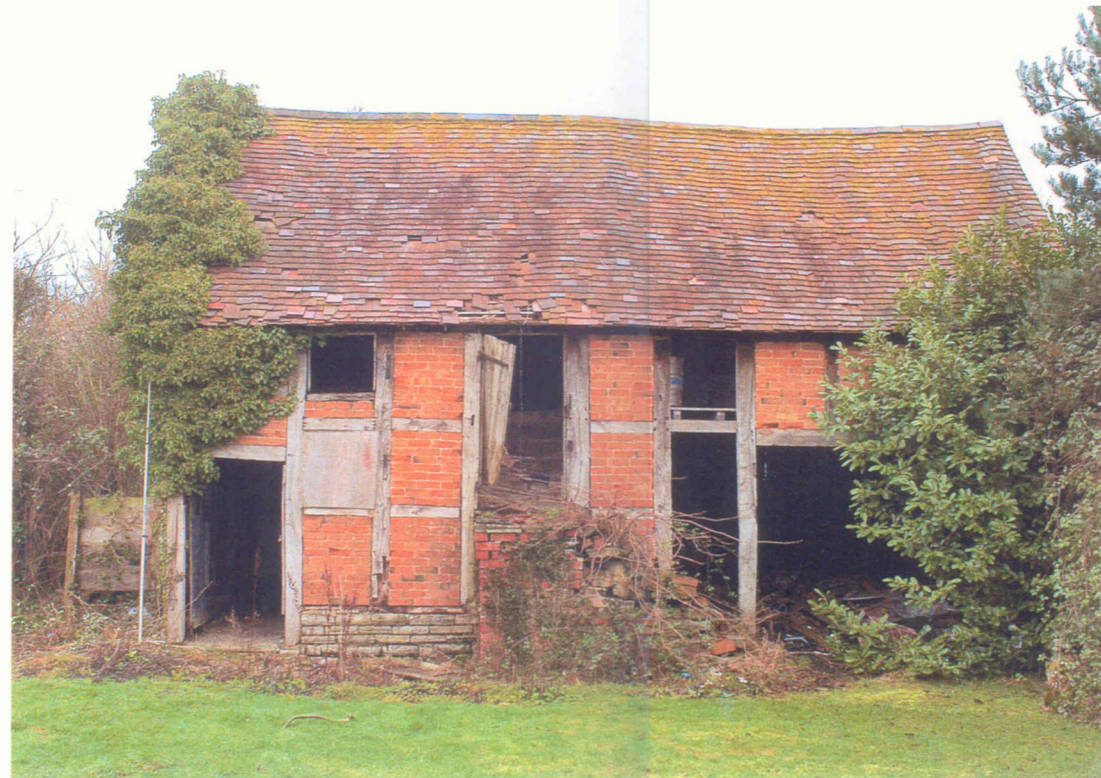
Western elevation

The stone and brick steps were in very poor condition, and it was not possible to determine with any accuracy the number or size of the treads as all of the Lias stone slabs were frost shattered and had been moved by root action. The brick vaulted dog-shelter beneath was however in good condition, and appeared to be of mid 19th C date (bricks 220x110x80mm). The steps were clearly secondary and only abutted the face of the building, which had allowed considerable water penetration and consequent decay of the adjacent timber frame elements

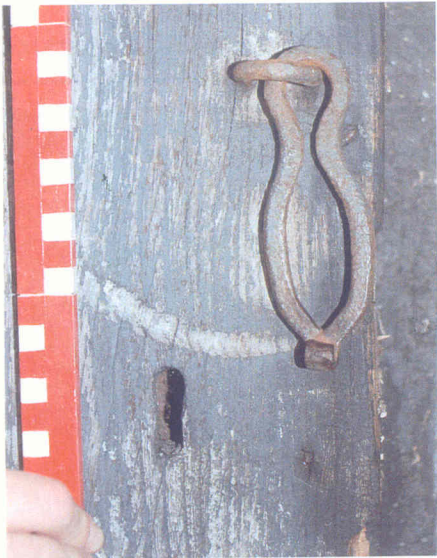
17th Century door pull, ground floor

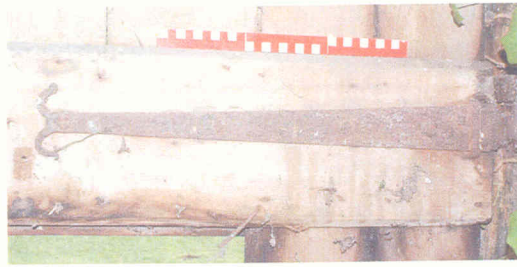
Ground floor door hinges - 17th C (above)-18th Century below right

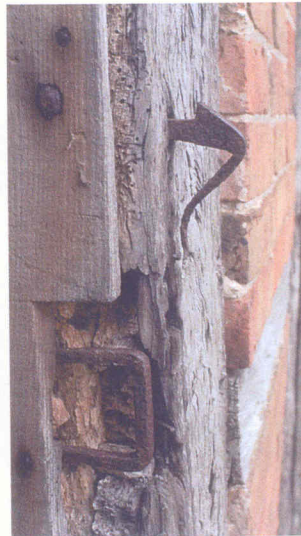
Latch and latch rest 1st floor (L17th - early 18th C)

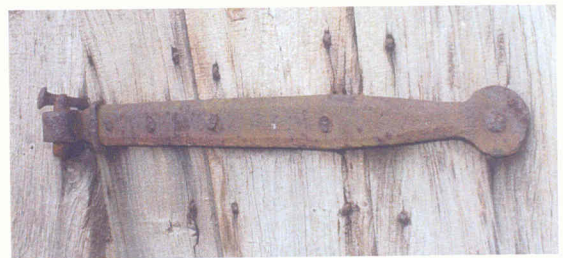
L 17th- 18th C hinges 1st floor doorway, note "anti-lift" nails above pintles

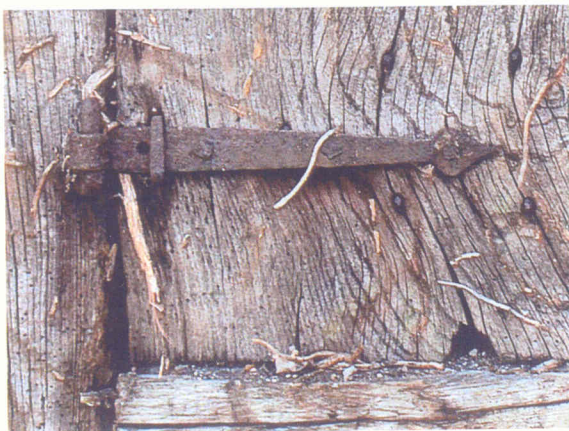
17th - early 18th C shutter hinge, ground floor

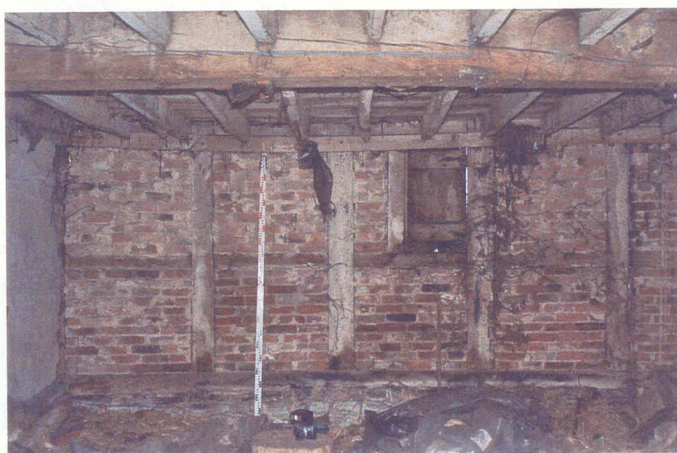
Eastern internal elevation of Bay 2

6.4.3 The eastern elevation survived almost intact, but showed evidence of alteration or repair in the northern corner of the bay, where there were peg-holes suggesting an empty mortice in the top of the sill beam. As noted above (para 6.2) this is a short (less than 2m long) length of sill-beam which was apparently retained beneath Frame 2 whilst the remainder was replaced. The shuttered window (Figs 6 and 8) appears to be an insertion as the northern window jamb has been cut into the head and foot rails and is not pegged but nailed to the rails.

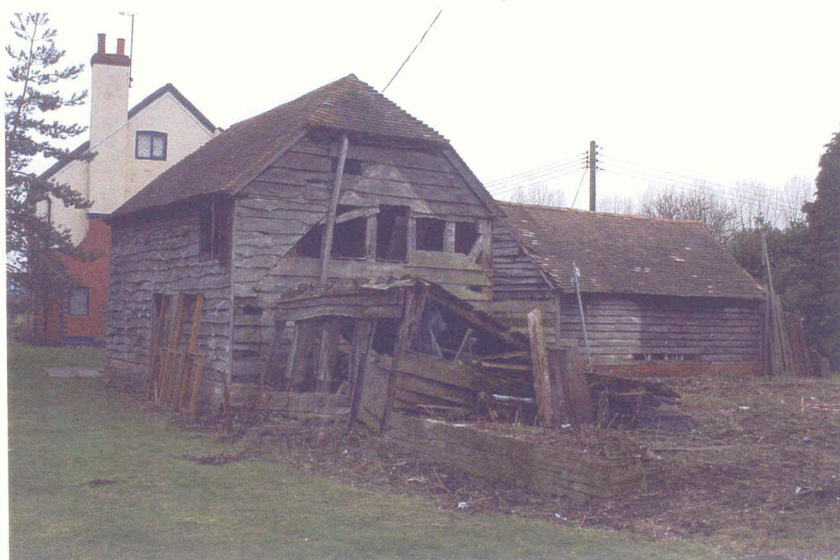
Cider mill-house and other timber framed buildings adjacent to Coventry Arms PH, showing stone plinth of former ?barn (nb: plinth and partially collapsed building in foreground has subsequently been removed to create new drive access)
