Brooklands Mill, Kirkpatrick Durham, Dumfries and Galloway

Historic building record

Report by John Pickin, February 2015

DGC planning reference 14/P/2/0306

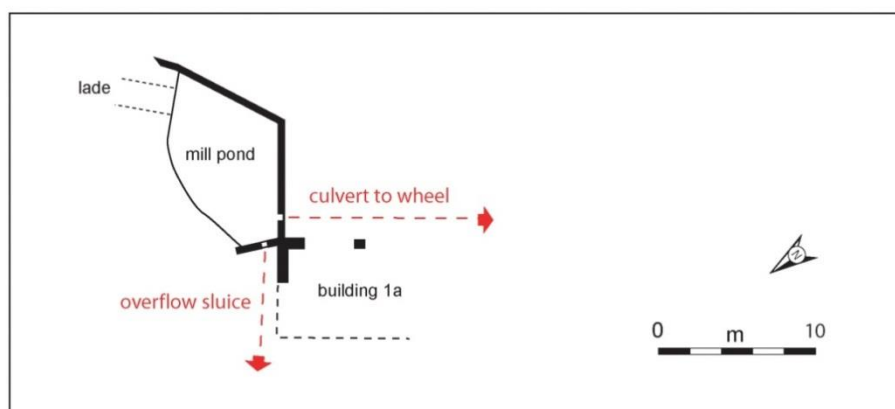
Fig 4. The mill or holding pond

4.3.2 The holding pond is at the W corner of the farmstead. It measures 6.40m x 7.90m and the base is some 0.40m below the level of the adjacent courtyard. The S and SW walls are stone-built and partially covered with a cement render and the SW wall is capped with concrete and occasional stone slabs. The N side of the pond is a curving earth bank which has been faced on the inside with a mortared stone retaining wall; this section appears to post-date the rest of the pond and is probably a later re-build (perhaps after the flooding episode described in 3.4 above). The overflow channel is in the NW corner of the pond and comprises a narrow, vertical break in the pond wall lined with brick and containing the steel side supports for a sluice gate; the use of brick and galvanised steel suggests a comparatively modern rebuild. The outflow channel from the pond is at the base of a recess in the W wall of the pond and is culverted under the courtyard in a salt-glazed ceramic pipe; a removable steel drain head above the pipe indicates a modern rebuild, probably contemporary with the alterations to the overflow sluice.

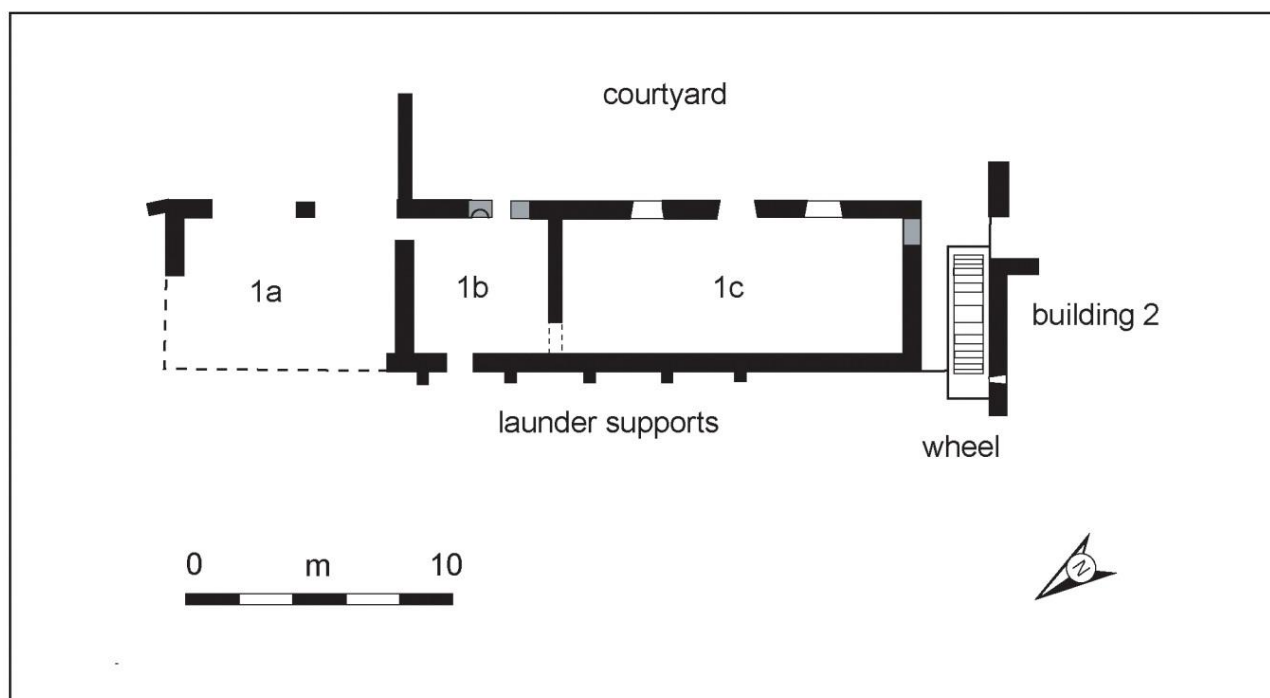
Fig 5. Building 1.

4.4.1 Building 1 is a rectangular, three celled structure, 6.20m x 28.25m, of rubble whinstone construction. The NE section is now ruinous but once comprised a cobble-floored unit (Building 1a; 6.20m x 9.25m) with a double arched entrance on the SE or courtyard-facing side. All that survives of this section is the E corner and the central entrance pillar with angled springer stones for the now collapsed arches. The rest of Building 1 stands to the height of the wall head but the gables have been demolished and the W corner is partially collapsed. Joist holes at a height of

approximately 3m indicate the presence of a first floor but there is no surviving evidence for a stairway. A single shallow-arched entrance, 2.80m x 2.50m high, with a stone linteled window above leads from the courtyard to Building 1b. A doorway in the E corner of this unit connects with Building 1a, there is a partially destroyed window in the NW wall and there is also a blocked first floor window in the NE wall. Space 1b is separated from 1c by a partially collapsed internal wall with a possible doorway at the NW end. The entrance to Building 1b has been partially blocked by the insertion of two unmortared dwarf walls about 1.25m high. The wall on the NW side has an internal curved recess that might have been a small raised hearth or fireplace. These blocking walls are insubstantial and probably postdate the abandonment of the working farm.

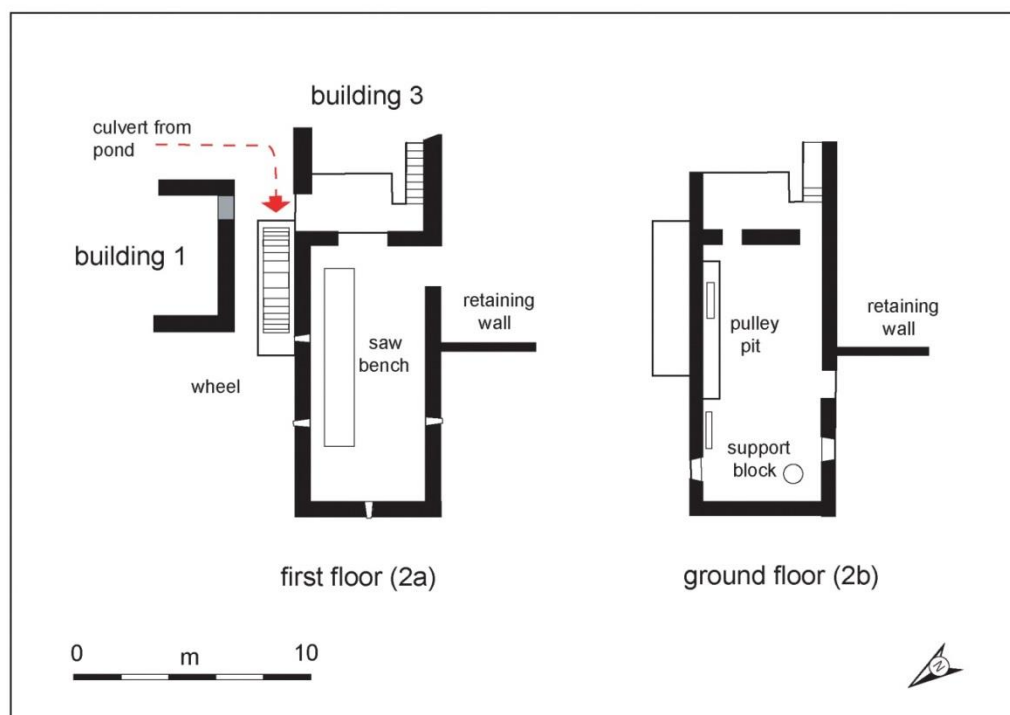
Fig 6. Building 2

4.5.1 Building 2 is a two storey mill building and joins with Building 3 to form the NW end of a long range on the SW side of the farmstead. The mill is built against the natural slope of the hill so that the first floor corresponds to the level of the farmstead courtyard and the ground floor is close to the burn. The mill, in common with most of the other buildings at Brooklands, is random rubble

construction. Built against the NE wall of the mill is a rectangular wheel pit with a 10m long stone arched, cut-and-cover culvert or outflow at the NW end leading to the burn. The pit contains a complete six-spoke iron wheel, 14' (4.2m) in diameter and 3'7" (1.10m) wide. The sides of the wheel are cast iron and the spokes and bucket plates appear to be steel. No manufacturer's mark was observed on the wheel but the materials and construction suggest a date in the first half of the 20th century. There is no gearing on the wheel but an iron axle bearing set in a wall recess above the wheel indicates the presence of geared machinery associated with an earlier wheel.

4.5.7 The NW section of the roof has collapsed but the rest remains in place. It is a timber tie-beam, rafter and purlin A-frame construction with graduated grey tiles attached to timber sarking. There is a metal-framed window light in the roof directly above the first floor window on the SE side. The gable is complete and some stone skewers are still in place.

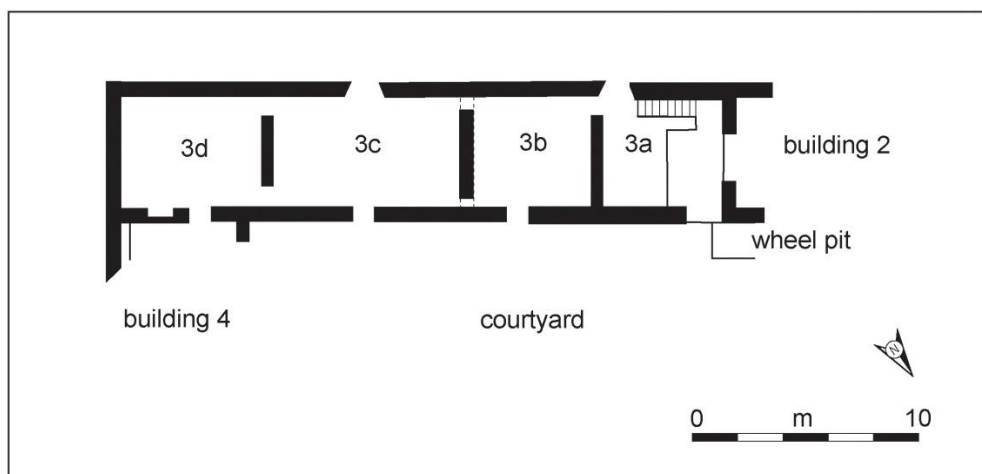
Fig. 7. Building 3.

4.6.1 Building 3 is a roofless five cell block, 6.10m x 27m, forming the SE range of the farmstead. The NW space, building 3a, forms a continuation of Building 2. There is a large opening from the courtyard in the N corner, a doorway in the S corner and a set of stone steps constructed against the SE internal wall leads down to a cellar space and the ground floor of Building 2. The cellar is now an open void but would once have had a timber floor connecting 3a with the first floor of Building 2.

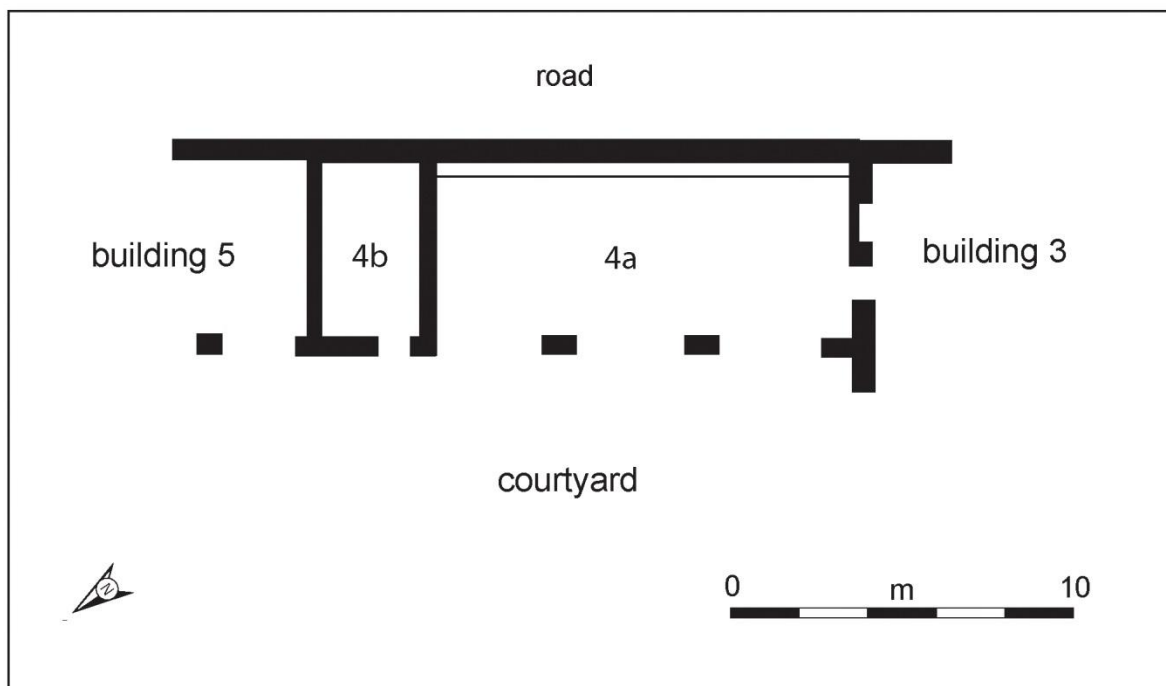
Fig 8. Building 4.

4.7.1 Building 4 is a roofless two cell unit forming the SE side of the farmstead. It is terraced into the hill side and its SE wall also acts as a retaining wall. The main section, building 4a, is 12.20m long internally and has three large, shallow-arched entrances facing the courtyard on the NW side. The arch pillars are constructed from dressed whinstone with pinnings. The SW internal end wall shows the same architectural details recorded inside Building 3d and includes a dressed stone lintel supported by end voussoirs. The other side of the recess observed in 3d appears as a rectangular

4.7.2 Running along the interior of the SE wall of 4a is a stone bench, 0.40m high and 0.50m wide, which holds a series of salt-glazed ceramic sinks or troughs. Cut into the SE section of the wall separating 4a and 4b is a roof line which is 1.90m high in the corner above the troughs and slopes down to a height of 0.95m; the SW extent of this feature was not evident but there appears to be a slight change in the rubble construction of the SE wall at a height of approximately 1.90m. The roof cut probably relates to a lean-to type structure associated with and covering the troughs.

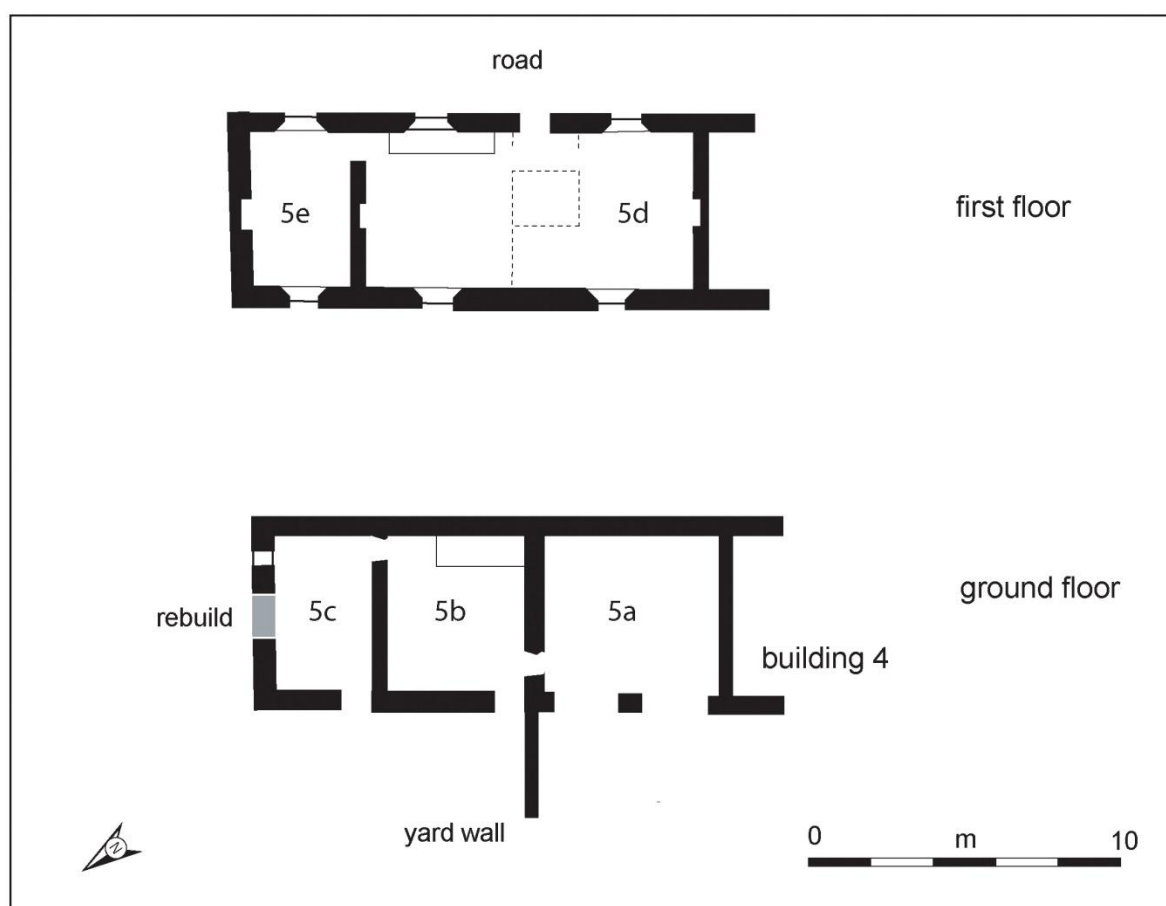
Fig 9. Building 5

4.8.1 Building 5 forms the NE section of the farmstead and, like Building 4, is constructed against the hill slope. The ground floor section, 5a, b and c, opens onto the courtyards and the first floor, 5 e and d, opens onto the roadside.

4.8.6 With the exception of the arches in 5a, the external walls of Building 5 are rough coursed random rubble covered with a grey cement render. The roof is graduated grey slate and the NE end of the roof is hipped. Sandstone ridge tiles survive at the hipped end of the roof but have been removed along the principal ridge line. There are three chimneys, corresponding to the three first floor fire places. The chimney head on the SW gable is brick-built with a concrete (?) cope and a single plain can, the middle chimney head is rendered and has a concrete cope but no can and the NE chimney head, which rises from eaves level, has a cement render, concrete cope, two plain cans and lead flashing at the base.

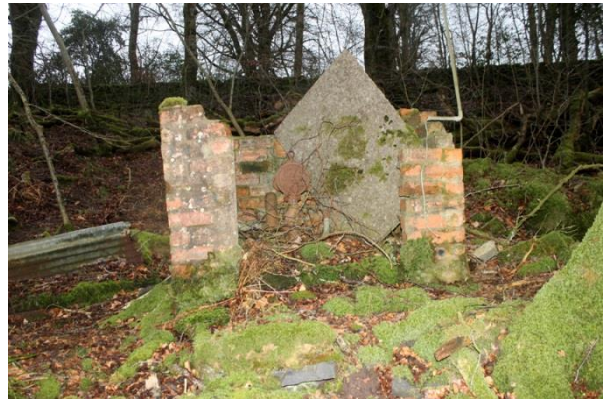
the S side of the lade is a ruinous brick-built and concrete-roofed structure containing the remains of a hydraulic ram pump (NX 8096 7320). The ram, which is probably mid-20th century in date, is no longer working. There is no evidence of there ever having been a piped water supply to Brooklands Mill so the ram may have been installed to provide water for Brooklands House.

Fig 11. Ram pump by lade.

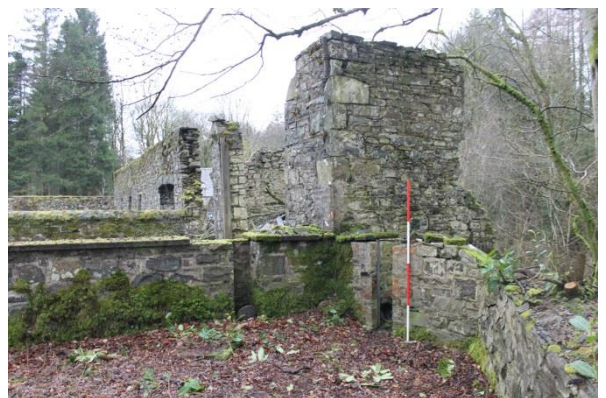
Fig 13. Overflow (right) and culvert recess (centre).

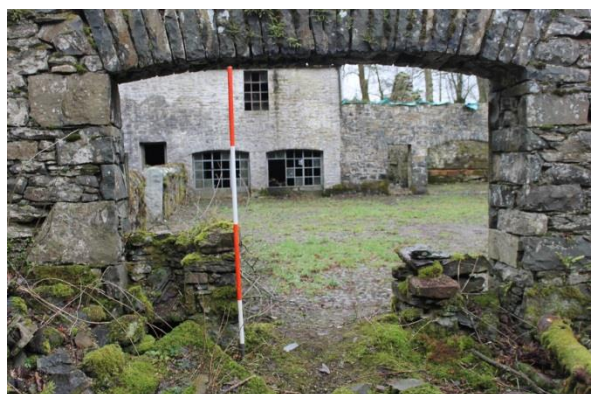
Fig 15. Building 1b entrance with blocking walls.

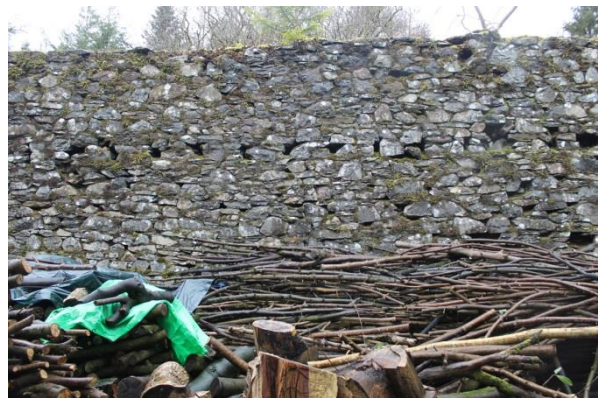
Fig 17. Building 1 b joist holes.

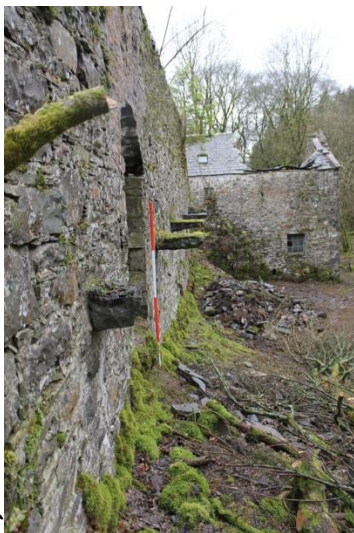
4.4.5 Running along the outer NW wall are a series of horizontally set stone slabs. Five slabs survive of and each one has a vertically mounted iron bolt in the centre. The slabs correspond in height with the level of the outflow channel from the holding pond and it is likely that they were supports for a wooden trough or launder carrying water to the wheel on Building 2.

Fig 18. Launder supports.

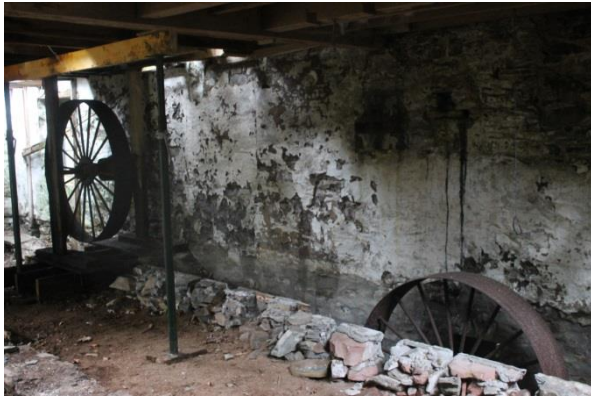
4.5.3 Against the NE wall of 2b is a narrow internal wheel pit which contains a steel pulley wheel connected to the end of the axle of the external water wheel. At the NW end of this pit is a second spoked pulley wheel set in a timber frame. The pulley wheels powered a belt-drive system (now removed) which operated a rotary saw on the floor above. The timber flooring in 2b has been removed to reveal a central stone support spine and set below floor level in the NW corner is a circular concrete block, 0.10m thick and 0.73m diameter with a central iron screw shank; this object was probably a support block for an item of machinery. There are opposing sub- and floor level openings in the side walls at the N end of the building which may once have held timber cross joists, probably support or spring beams for heavy machinery.

Fig 22. Building 2b pulley drives.

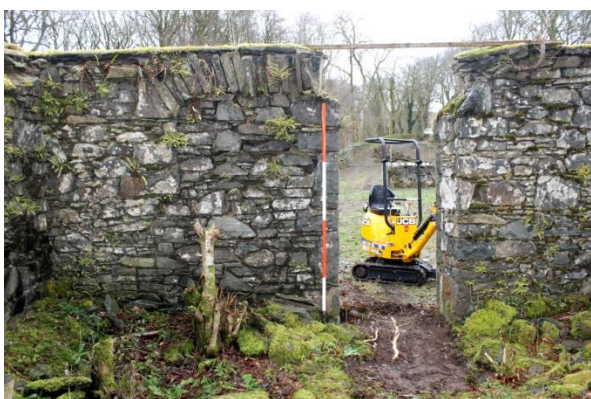
4.6.2 Building 3b is a rectangular space with an entrance in the NE wall leading to the courtyard. The top of the entrance is absent but angled stones set on both sides will have held a stone lintel. Below the inner wall head and immediately NW of the entrance is a line of vertically set stones similar to voussoir arch stones above a window or door; it is possible that there may have been an opening here predating the current entrance but the evidence is not wholly convincing and these stones may be no more than a structural adaptation in response to a weakness in the wall. There is another opening in the W corner which connects with 3a. Parts of the interior walls, especially in the SE section, retain traces of lime wash.

Fig 26. Building 3b door and arch (?) stones.

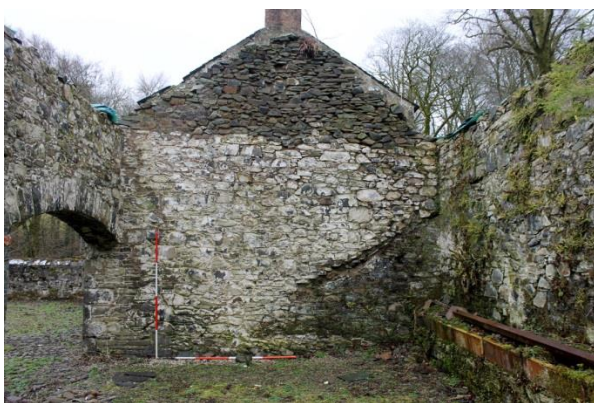
Fig 32. Building 4a, lean-to roof line + troughs.

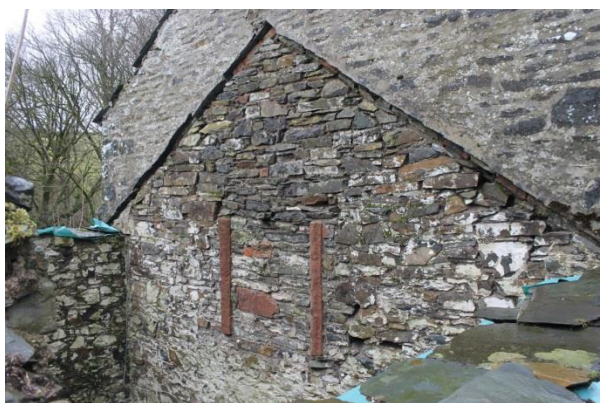
4.7.4 Building 4b is a comparatively narrow rectangular space with a single, timber lintelled door leading onto the courtyard. On the NE interior wall is the gabled outline of the Building 4 roof and below this is a group of cut red sandstone slabs associated with the back of the internal fireplace in the attached cottage (Building 5a). The only internal features in 4b are timber battens attached to the NE and SE walls at a height of around 1.30m. The battens are slotted to hold cross timbers, presumably connected to a wooden surface or bench. At the time of the visit the floor of 4b was covered with rubble.

Fig 33. Building 4b with roof line and back of fireplace.

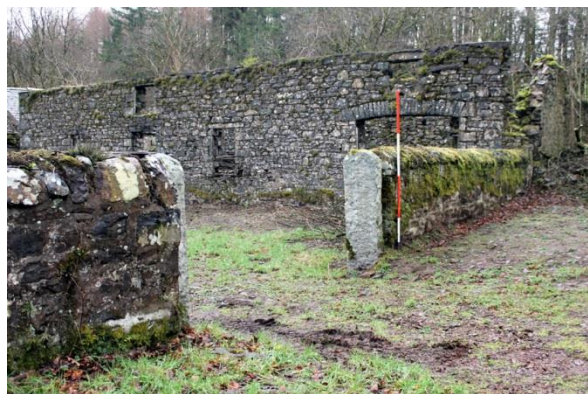
4.9.1 The farmstead buildings have been constructed around two courtyards separated by a stone dividing wall with stone slab gateposts either side of a central entrance. The main courtyard, 18.50m x 19m, is cobbled and has linear, cobbled drains on the same axes as the main buildings. The second courtyard fronts Buildings 1a and 5 and lies at the end of the entrance track from the road. It is also cobbled and is slightly higher than the main courtyard.

Fig 40. Dividing wall of courtyards and Building 1
