# Corseyard Farm 'Coo Palace' Borgue, Dumfries and Galloway

Historic Building Record      February 2018

DGC planning reference: 17/0533/LBC

Listed Building: LB 3381

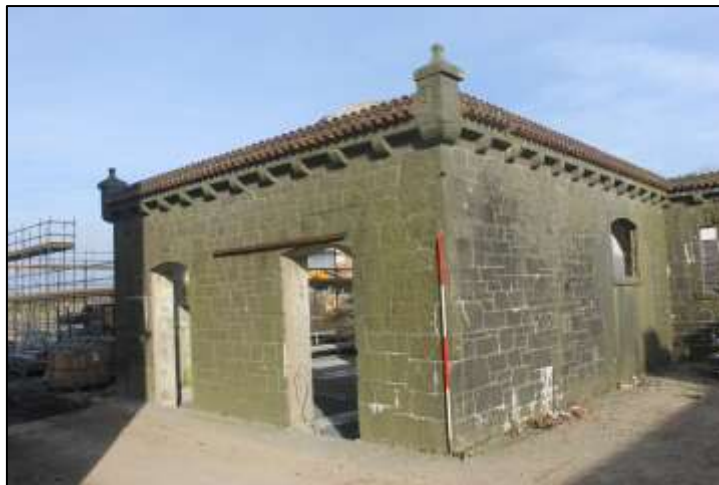
- 5.2.3 The south face has two symmetrically placed arched doorways (06, 07). An iron strip above entrance 07 plus a horizontal line of drilled holes suggest that one or both entrances once had an external sliding door.

**Plate 2. North Range cart shed from south-east..**

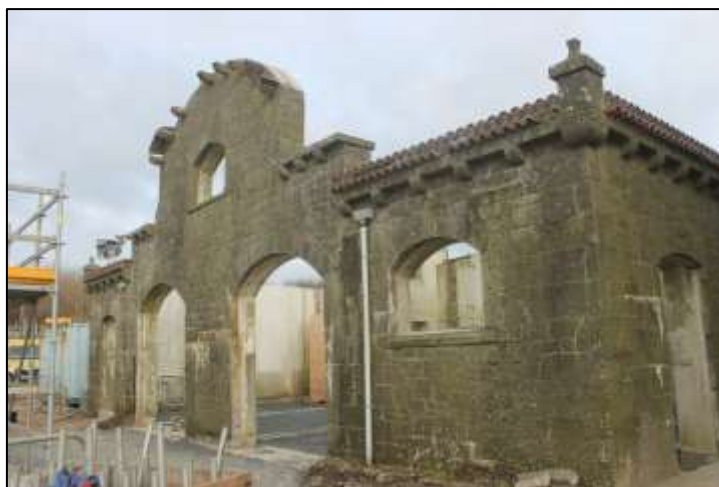
- 5.2.2 The cart shed forms the west wing of the North Range. The principal face is on the west side and comprises two centrally placed vehicle entrances (01, 02) with segmental arches flanked by an arched window to the right (03) and an arched doorway (04) to the left (both the window and doorway have depressed arches and this arch style is repeated throughout the North and South ranges). Positioned above the central entrances is a vertical extension and curved gable with extended timber purlins and a central loft-space window (05). Either side are short cut-stone cornices on square corbels which step down to corbelled stone eaves surmounted by double rows of decorative salt-glazed pantiles set in a mortar bedding (this combination of corbelled eaves with decorative tiles and corner finials is repeated on the other faces of the North Range). At the corners are cut-stone finials without their balls.

**Plate 3. North Range cart shed, west face.**

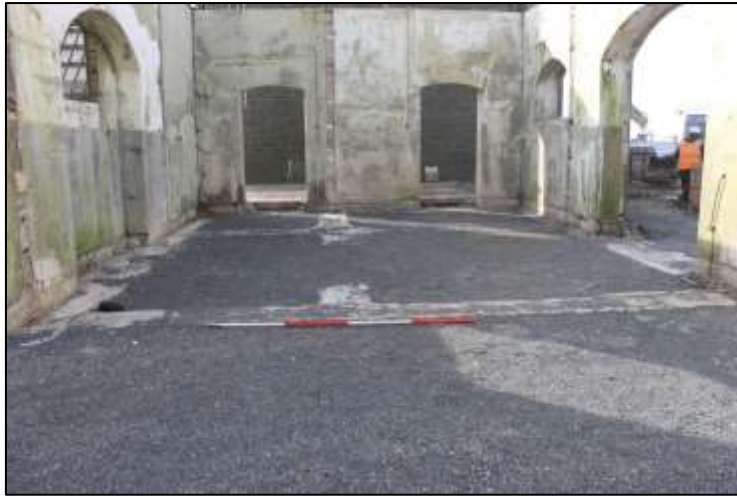
surface survives. All internal walls have been demolished but concrete sub-floor foundations indicate that the cart shed was divided into five spaces (corresponding to and accessed via entrances 01, 02, 04, 06 and 07). The eastern division was effectively the internal wall between the cart shed and barn.

**Plate 4. North Range cart shed interior, view south.**

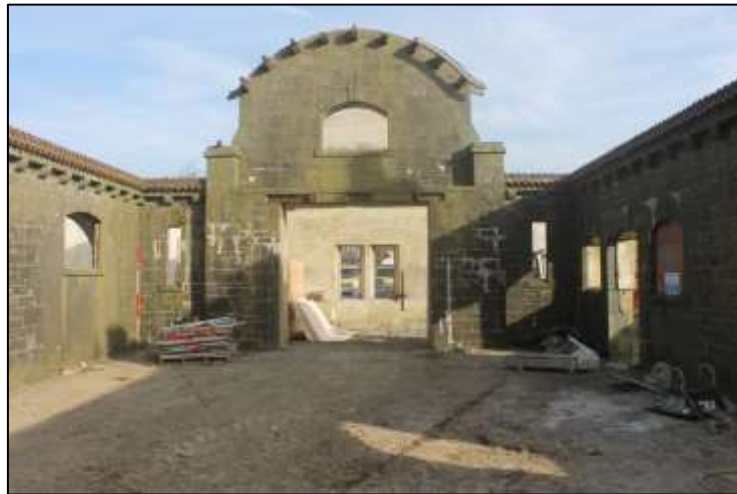
5.2.7 The north face of the North Range incorporates the principal face of the barn and, as described above, the north face of the cart shed. The dominant feature is a centrally placed domed gable with a single loft window (10) which complements the domed gable in the west face of the cart shed. The wall either side of the gable is defined by plain, corniced pilasters and there are two centrally placed vertical slit windows (11, 12). At the east end is a large, square vehicle entrance (13) with an iron lintel that has been disguised by covering the surface with cement render painted to replicate stone courses. The external sides of the entrance are defined by tooled hollow moulding.

**Plate 5. North Range barn, view north from courtyard**

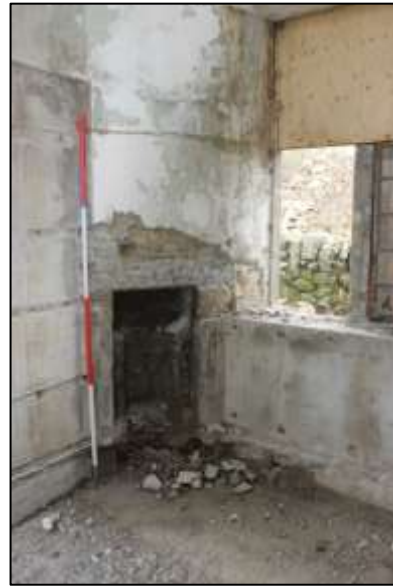
- 5.2.15 The central area, probably the harness room, is defined to the west by doorway 31 and window 32 in the west wall and the square tower to the east. The tower projects internally at the ground floor and comprises a rectangular room with the remains of a brick built fireplace with a stone lintel in the north-east corner and the imprint of panelling on the lower section of the cement rendered walls. A 15-light iron window frame survives within window 24. The room has a concrete ceiling with a loft space above.
- 5.2.16 The southern part of the stables, probably used as a loose box, is a rectangular space accessed by vehicle entrance 30 and lit by slit windows 25-29. The internal walls are cement render on cement leaf.

**Plate 8. North Range stables, harness room fireplace.**

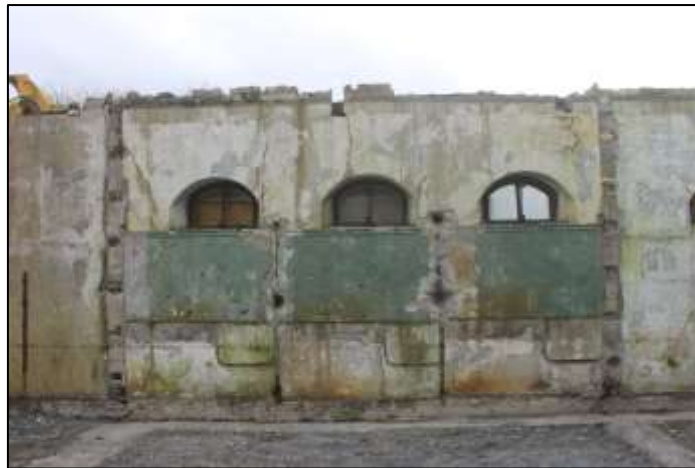
- 5.2.14 Wall lines and sub-floor foundations show that the interior of the stables block was divided into three separate areas. The principal surviving internal feature in the northern part of the stables is a panel of green glazed tiling on the east wall. The panel comprises three conjoining sections, each 1.05m high x 1.80m long, constructed of hexagonal tiles within a ceramic glazed border. The panels mark the position of three horse stalls and on the exposed cement face below are the negative outlines of the trochs and hay hecks. The position of the trevices or stall divisions is marked by the vertical removal lines between and at the end of the panels. Above the tile panels are windows 19-21. These still retain their original single mullioned cast iron window frames which are hinged at the base and open out; the manufacturer's name, very corroded, survives on the outside of window 19 and appears to read – S CRAW—PATENT BELFAST & LONDON. The opposite wall in this area contains

**Plate 9. North Range stables, stalls and decorative tiles.**

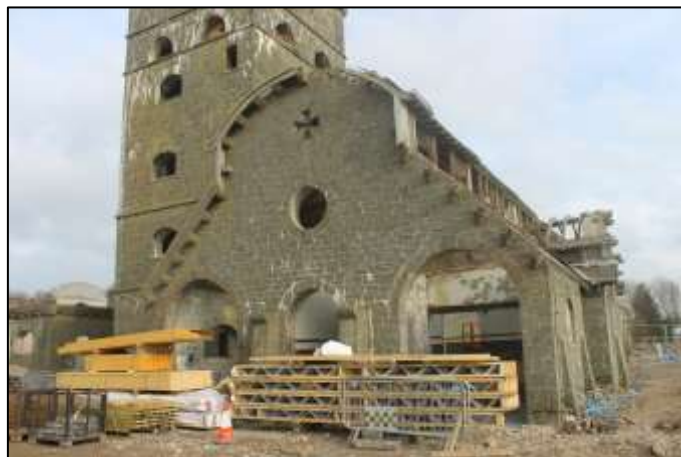
- 5.3.2 The west face of the range has a raised, curved central gable above a pitched roof. At ground level is a centrally placed tall, round arched entrance (36) flanked by taller round arched vehicle entrances (37, 38). Angled buttresses with corbelled tops positioned either side of the central entrance supported a now-demolished hood moulding. Above is a circular window (39) with prominent keystones and set in the gable is a tooled opening (40) in the form of a Maltese cross. The roof purlins extend beyond the wall face to form an overhanging eave faced with partly decorated barge boards.

**Plate 10. South Range, west face.**

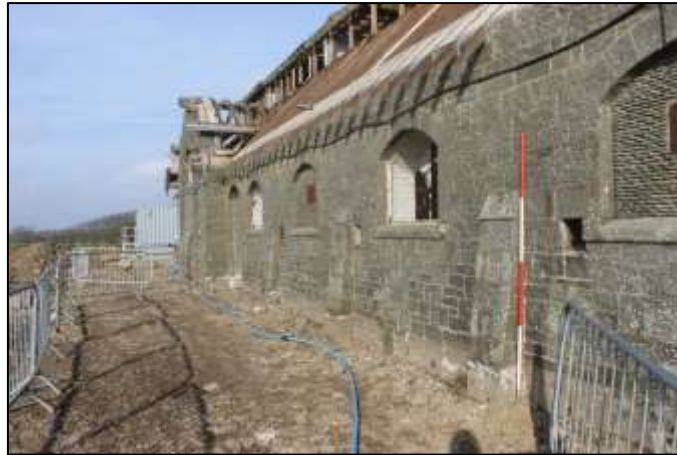
- 5.3.3 The six-bay south face is the longest continuous face in the Coo Palace complex. At the west end is a single arched window (41) set between two half-height buttresses and immediately east is a shallow transept with a low, curved gable containing a high level arched window (42) with a round opening above (42). At ground level is a centrally placed half-height buttress. The south face of the transept reflects the form of the building's larger east and west faces as well as the gables in the North Block. On the east side of the transept is a round headed doorway (44) beyond which is a run of four, symmetrically set arched windows (45-48) with half-height buttresses in between. Windows 46 and 48 are infilled with decorative panels of pebbles set in concrete and which incorporate central iron ventilation grilles. Pebble-impregnated concrete has also been used to form a decorative ground level border at the south-east corner of the building and forms the surround to a number of the down pipe drain heads. Along the whole of the south face at window cill height are 11 ventilation openings of which three still retain part of their original iron grilles.

**Plate 11. South Range, south face from south-east.**

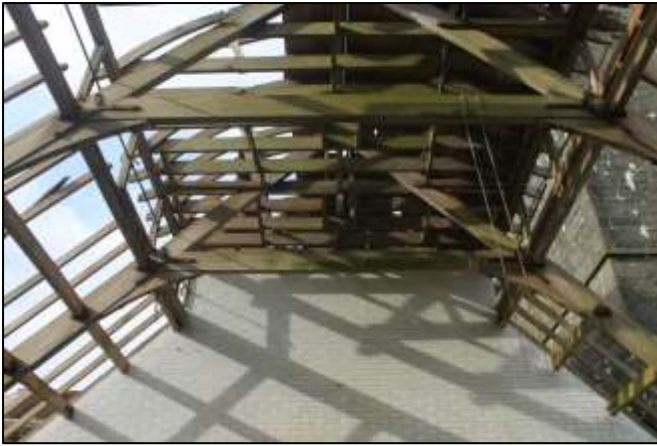
- 5.4.6 The basic structure of the roof has survived and comprises a standard rafter and purlin construction with a cross rafter. The rafters are set in concrete above the masonry wall head and supported by timber braces on internal stone corbels. The roof structure is also supported on the gables of the building's three internal cross walls. Above the cross rafter is a timber clearstorey with a curved roof; the complete clearstorey structure survives in the north-west section of the roof and includes lead-paned windows in timber frames with hung slates and a decorative barge board at the corner. There are indications of a secondary structure beneath the ridge at the west end, possibly part of the dairy's ventilation system.

**Plate 14. South Range roof.**

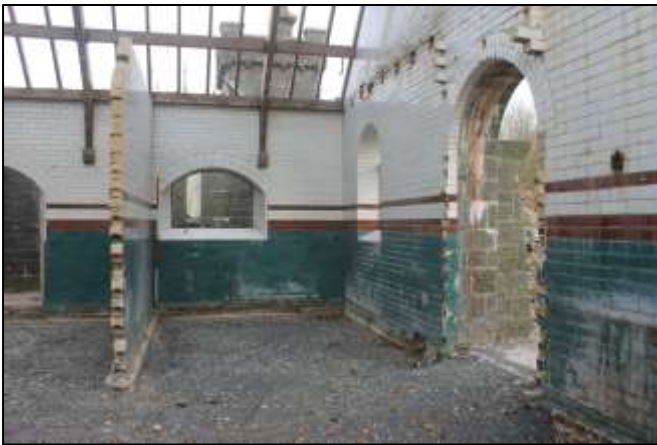
- 5.4.8 At the east end is a rectangular area (area 1) defined by entrance 51 and windows 47, 48 and 54 with a door opening (55) in the north-west corner. There is part of a single skin brick partition wall between window 54 and opening 55 and to the west is a substantial cross wall with a tall, central round-headed opening (60). The partition wall is thicker on the north side of the arch and may have carried a flue connected with a square stone chimney (part of the ventilation system?) above. Eaves level joist holes survive on the east face of the cross wall and on the inner face of the east wall, indicating that this area had a loft space. All the interior walls are covered with glazed, polychrome refractory bricks. These form a green/blue (faience) panel below the level of the window cills, horizontal bands of brown white and brown against the lower sections of the windows and white above. The same pattern of glazed bricks is used throughout the South Range (with the exception of spaces 4 and 5) and in the ground floor of the tower. Some of the loose bricks are marked PLACE DARWEN (Joseph Place and Sons was a brick and sanitary products in Darwen, Lancashire and was operating during the time the Coe Palace was constructed).<sup>1</sup>

**Plate 15. South Range (area 1), view from south-west.**

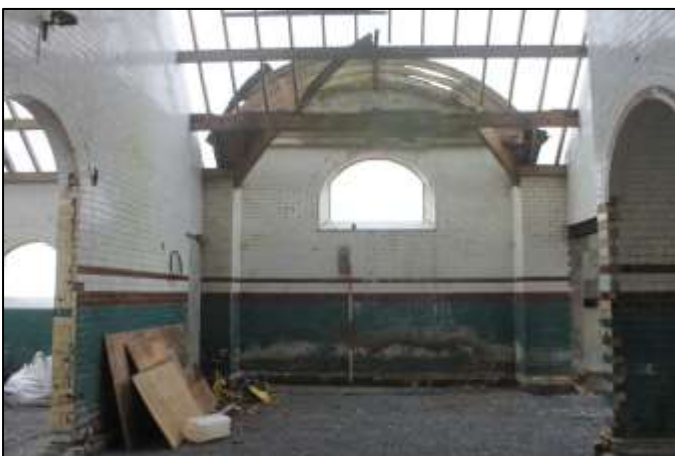
- 5.4.9 The second area (area 2) is east of the transept and tower and accessed from entrances 44 and 58. With the exception of a cast iron fitting (a stall divider support?) against the north-east corner and two iron brackets on the wall above, this space is devoid of features. To the west is a cross wall with a central round headed opening (61), a narrow square headed doorway in the north-west corner (62) and a matching blocked doorway (63) in the south-west corner.

**Plate 16. South Range (area 2), view of transept from north.**

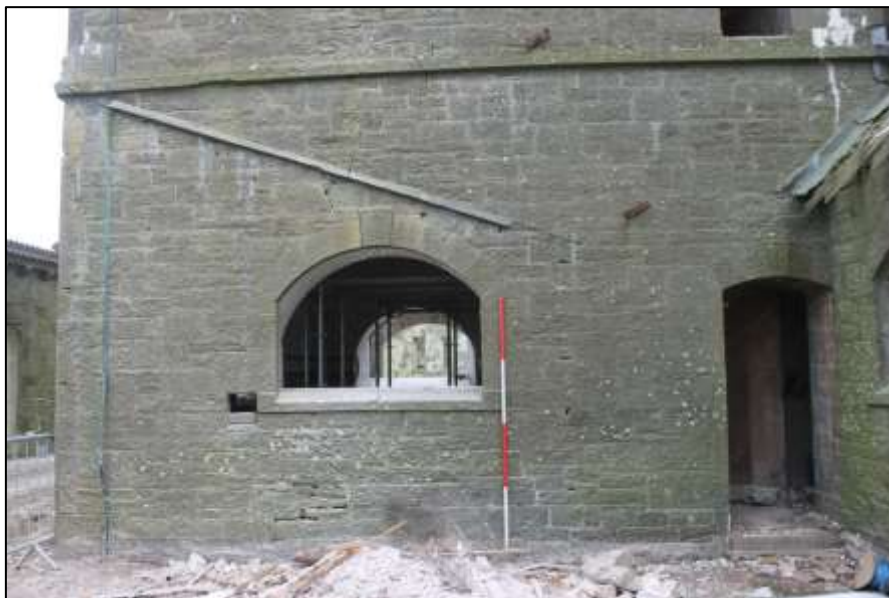
5.5.2 The entrance to the tower is on the south side of the west face. A ground level arched doorway leads to a spiral stair lit by arched windows on the first, second and third floors. Externally the west face has off-centre arched windows on the first, second and third floors (the third floor window is slightly larger), the fourth floor has a matching pair of round-arched lunette windows (the south window is infilled with brick) with a blind arched window above on the level of the water tank. A plain string course marks the first, second and fourth floors and there is a final string course at the level of the blind lunette windows. The sixth stage, the open yard at the top of the tower, has a crenellated face above a corbelled eave and string course and the central curved merlon on the wall head echoes the curved gables in the North and South Ranges. Above the ground floor window is a remnant pitched roof line indicating the presence of a former structure constructed against the tower's exterior.

- 6.3 The tower appears to have seen more alterations and reuse than other parts of the Coo Palace. The pitched roof structure built against the west face of the tower may be a late feature as it encloses the ground floor window and affects the building's architectural integrity; it is not known when this structure was removed but one of the record photographs taken in 1988 and now in the NRHE collection (SC 708919) shows a heap of concrete and masonry close to the tower's north-west corner, perhaps from recent (?) demolition. The modern-looking wall plaster in the first and second floor rooms of the tower and in the lower section of the stair well indicate reuse of this part of the tower at a comparatively recent date. Interestingly, the HES Listed Building account describes the concrete stairs as 'timber encased' which suggests that the plaster surface in the stair well and the lower rooms post-dates the 1980s Listing visit. The Listed Building description also says that the tower was disused soon after erection and so the blocking-up of the third floor sack hoist opening may have been contemporary with the abandonment of the tower.

**Plate 18. Tower, ground floor west face showing entrance to stairs and roofline of former building.**

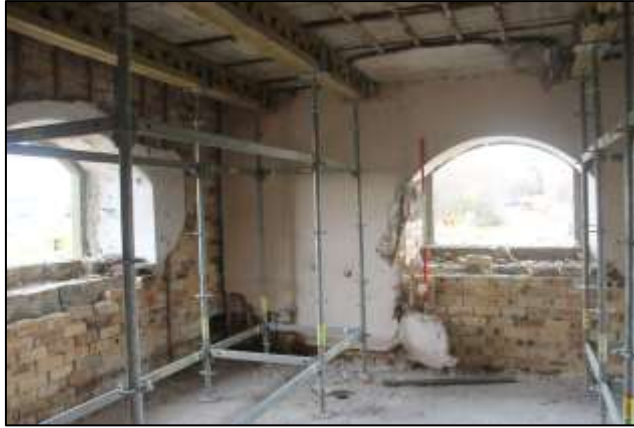
- 5.5.9 The second floor has the same (recent?) plaster wall covering as the first floor room and there appears to have been some repair work to the west window using roughly coursed bricks in a thick cement matrix; the bricks are stamped DICO (Dalmellington Iron Company). In the north-west corner is a blocked, brick-built fireplace and the entrance to the stair well is in the south-west corner. The floor covering appears to be wooden parquet laid in a herringbone pattern. The fireplace suggests this floor had a domestic use.

**Plate 19. Tower second floor, view from south-west.**

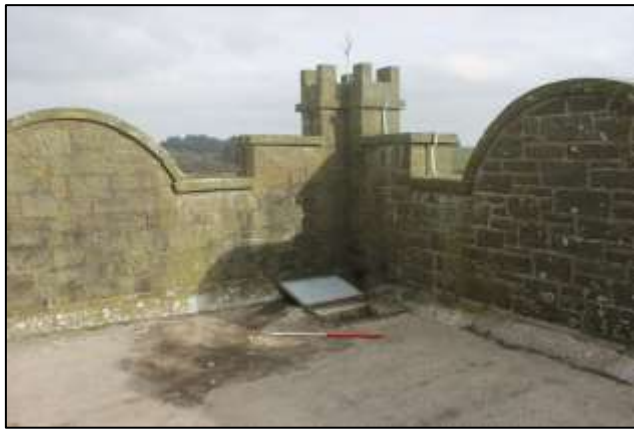
- 5.5.12 The top of the tower is an open yard with a concrete floor. The embrasures at the angles each carry a splayed copper lightning conductor and in the north-east corner of the yard a hinged metal plate covers the inspection pit for the water tank. In the south-west corner, above the stair well, is a circular turret with a crenellated top supported on stepped, double corbels. There is a cruciform opening on the south face of the turret and two copper alloy (?) ventilator grilles (one marked ROBINSONS PATENT RAIN PROOF VENTILATOR. It might be expected that the embrasure at the north-west corner incorporates the flue from the second floor fireplace but this could not be confirmed during the survey.

**Plate 20. Tower yard showing crenellation and access to water tank.**
