DIVING INVESTIGATIONS

FIELD REPORT 84350

Zone 9 - 11 Data Sheet 2 Ref: 7021

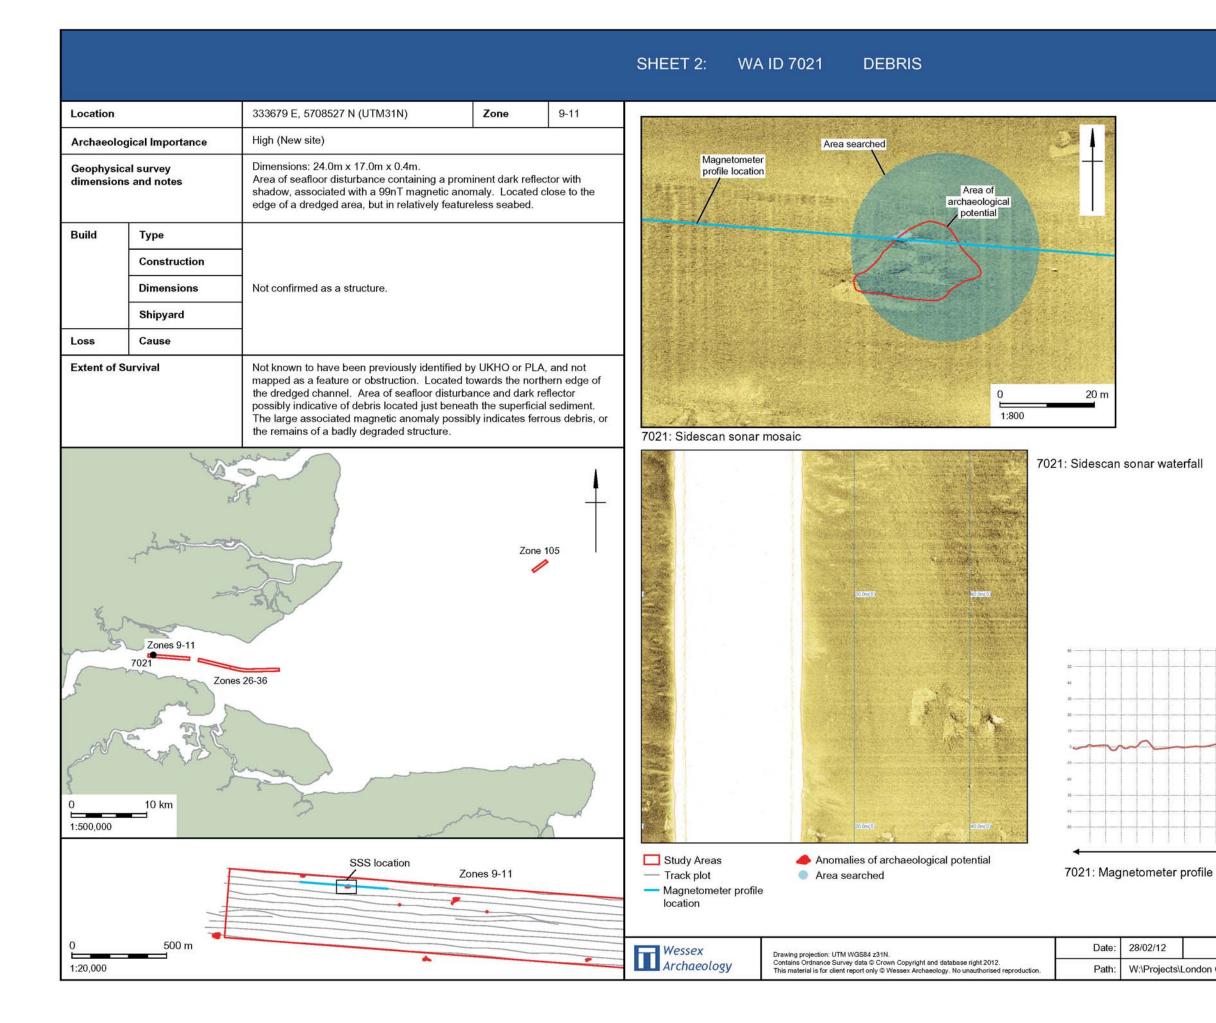
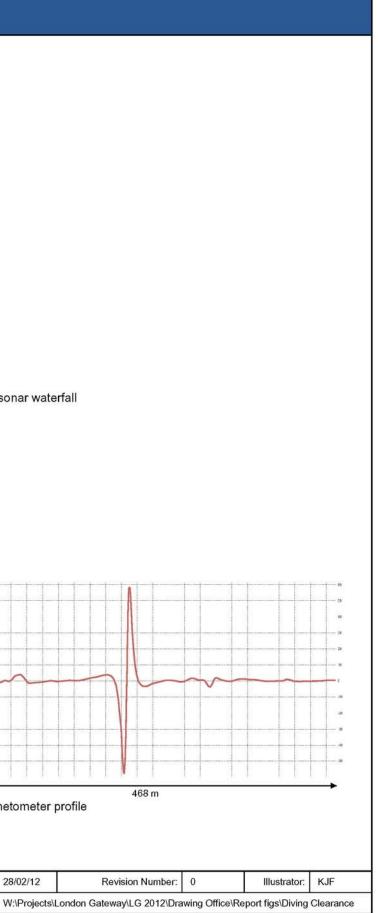
The diver made bottom 4m to the north-east of feature **7021** and proceeded to carry out circular searches from the base of the shot out to 20m. The diver located a hard layer of flint approximately 5-7m south of the shot. The layer of flint was nodular forming a hard surface no more than 1m in length. The diver located a larger feature approximately 2-5m further south. This feature consisted of a section of rebar (iron

reinforcing bars) protruding diagonally up from the seabed. The length of exposed rebar was approximately 1m and rising above bed level by no more than 0.5m. At the base of the rebar was a hard layer approximately 1-1.5m across lying flush with the seabed. The rebar was securely embedded into this layer and not moveable. The surface of the rebar was smooth and free from concretion or marine growth. There were no other features located. The seabed was generally flat and featureless consisting of sand and gravel.

The feature identified by the diver was in the location of the geophysical anomaly. The evidence gathered by the diver would suggest this is a piece of modern debris most probably a section rebar attached to concrete which is predominantly buried beneath the seabed. There was no other evidence of any further debris located in the area.

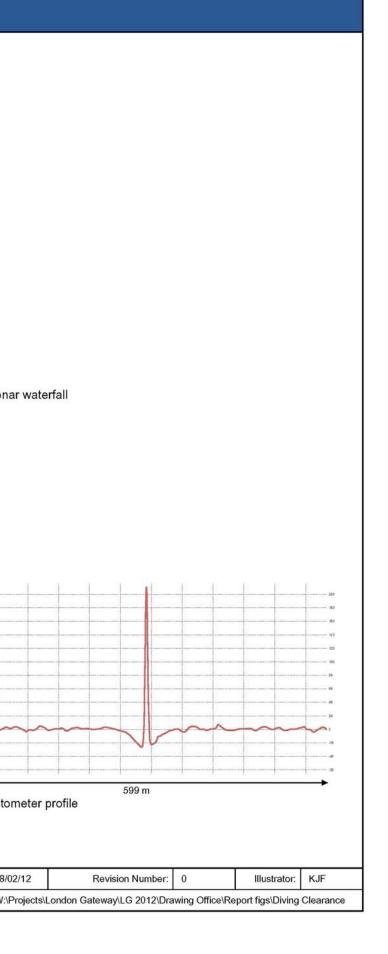
The diver made bottom just to the north of feature **7034** and proceeded to carry out circular searches from the base of the shot. The diver located a scour with a large ferrous object 3-5m south of the shot. The position of the object corresponded with the position of feature **7034** identified in the geophysics. The object described by the diver fitted the description of a large stockless anchor. The surface of the object was smooth and consisted of two exposed sections sloping up 0.5m above bed level

(flukes) with a central linear section (shank) running horizontally across the seabed. The horizontal section was approximately 2m in length and the two sections sloping up from the seabed were *c*. 1m in length. The overall width of the object was 1.5m. There was a scour pit all round the object *c*. 0.5m wide. Therefore, the dimensions of the object including the scour pit around it approximately match the dimensions of the feature described in the geophysics.

The object located on the seabed fits the description of a fairly large stockless anchor typically used on large vessels from the late 19th century and up to the present day. The smooth surface and lack of concretion or marine growth on the anchor would suggest this is fairly modern rather than late 19th century. The anchor is mostly likely to be an accidental loss or a redundant mooring that was not recovered.

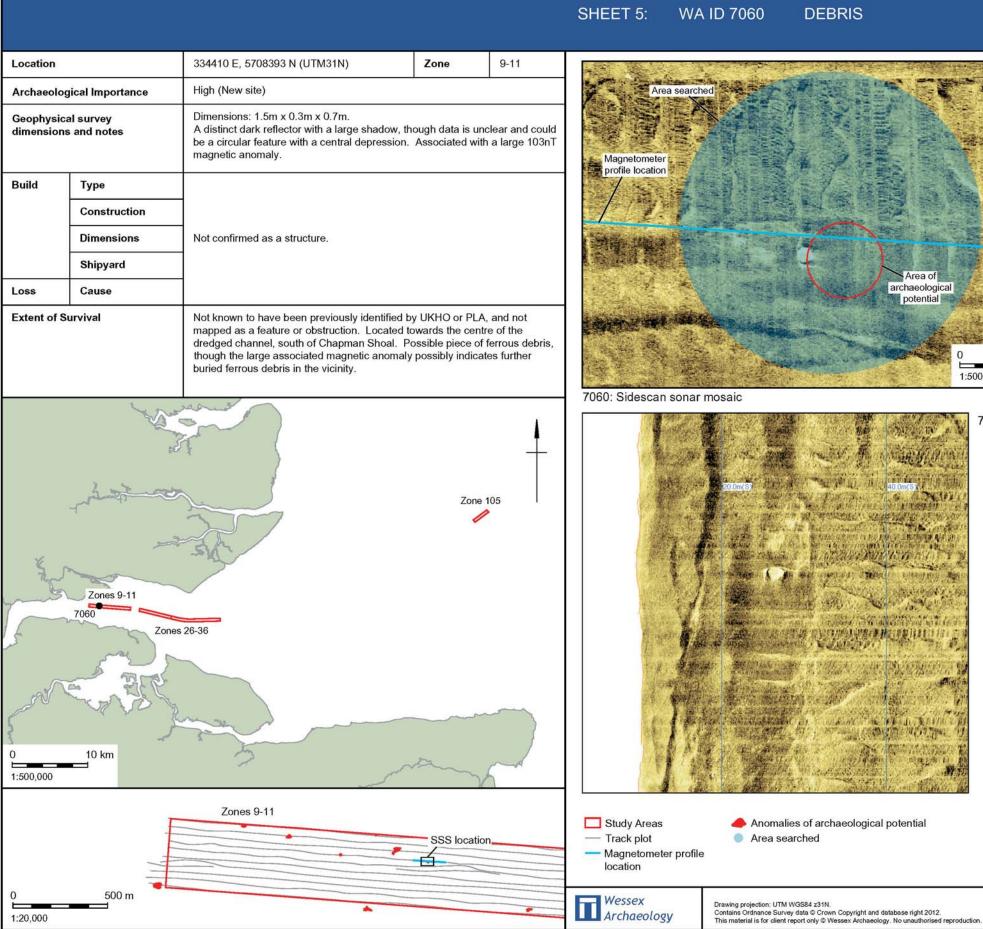
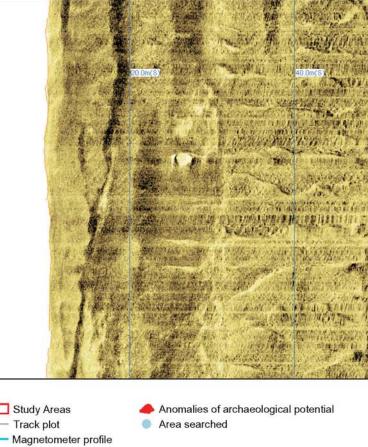
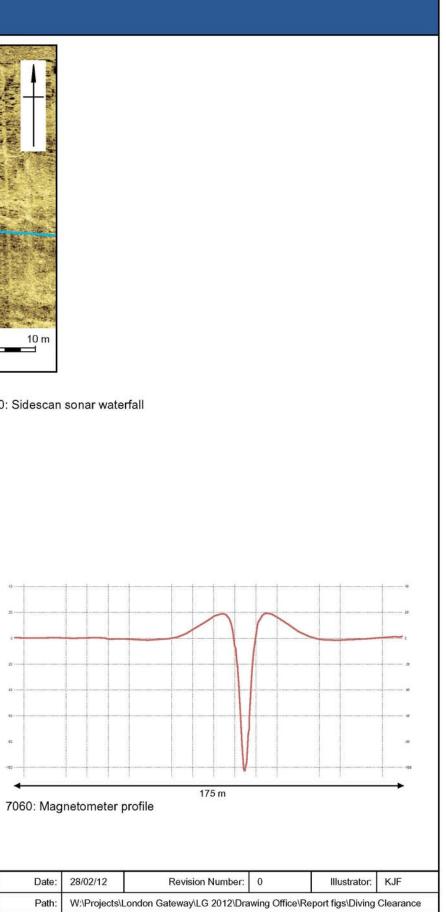
7060: Sidescan sonar waterfall

The diver made bottom 5m north of the position of feature **7060** and proceeded to carry out circular searches from the base of the shot out to *c*. 20m. The diver located a feature approximately 10-15m west of the shot. The feature located on the seabed was a large circular slab-like feature. The feature had a diameter of *c*. 1.5m and a depth of 0.3m with vertical sides. The upper surface was flat and lying at an angle of *c*. 20 degrees from the horizontal. It was lying on a gravel and sand seabed and was partially buried, although the entire upper surface was exposed.

The side of the feature facing the shot was partly scoured revealing a flat or very slightly convex surface underneath. All surfaces had a slightly rough feel which suggests that it was probably concrete rather than ferrous. At the centre of the upper face was what felt like a semi-flush circular metal base plate for a fixing. The diver was unable to move this feature by hand and the feature was not attached to anything. However, the feature was not scoured enough to determine whether it was attached to anything underneath. The area around the feature was thoroughly searched and nothing was found. The object located by the diver corresponds with the image and description of feature **7060** identified in the geophysics.

The object located by the diver is a probable concrete sinker. The metal feature in the centre of the upper surface is likely to be the lower end of a bolt or similar fixing. This would suggest that the sinker is upside down and that there is likely to be a metal eye attached to the lower face. The object also matches the description and location of the geophysical anomaly. As no other objects were found within the search area, there is a very high probability that feature **7060** was located and is a modern sinker, possibly of a type used for buoyage. As such it is considered to be of no archaeological interest.

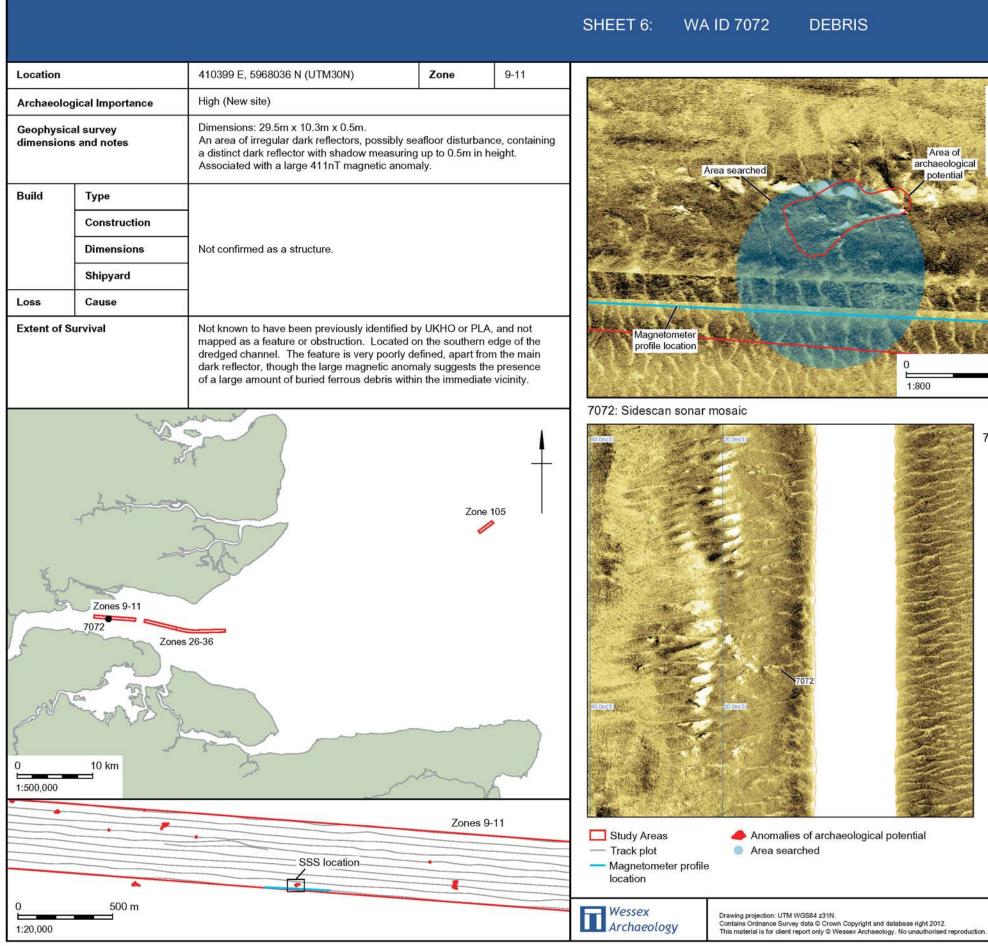
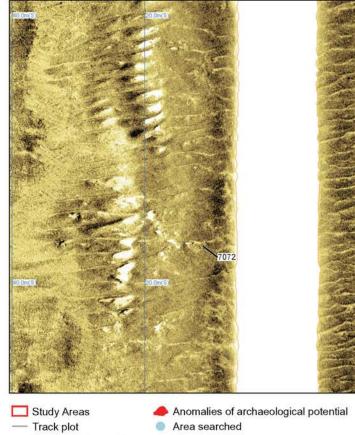
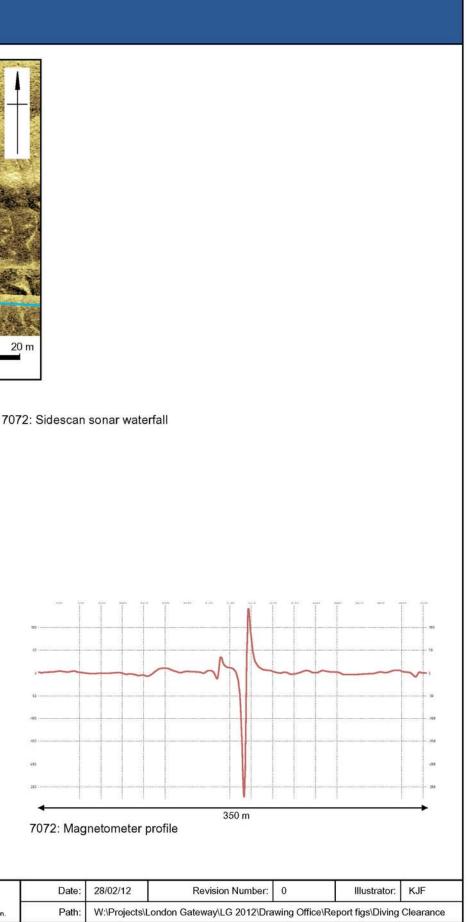
Zone 9 - 11 Data Sheet 6 Ref: 7072

The diver made bottom within the location of feature **7072** and proceeded to carryout a circular search from the base of the shot to *c*. 20m. The diver located an area of disturbed gravel seabed with numerous depressions up to 1.5m deep. This is consistent with the north-south alignment of the sand-waves as seen on the sidescan data. Some sandy patches and edges of exposed compacted gravel were also noted by the diver up to 8m in length. The diver also located two concretions which were

irregular with no obvious shape. There was no evidence of the large magnetic anomaly and no wreck or material of archaeological interest was found by the diver.

All of the features observed by the diver can be explained as natural features with some evidence of disturbance, most probably from dredging related activities.

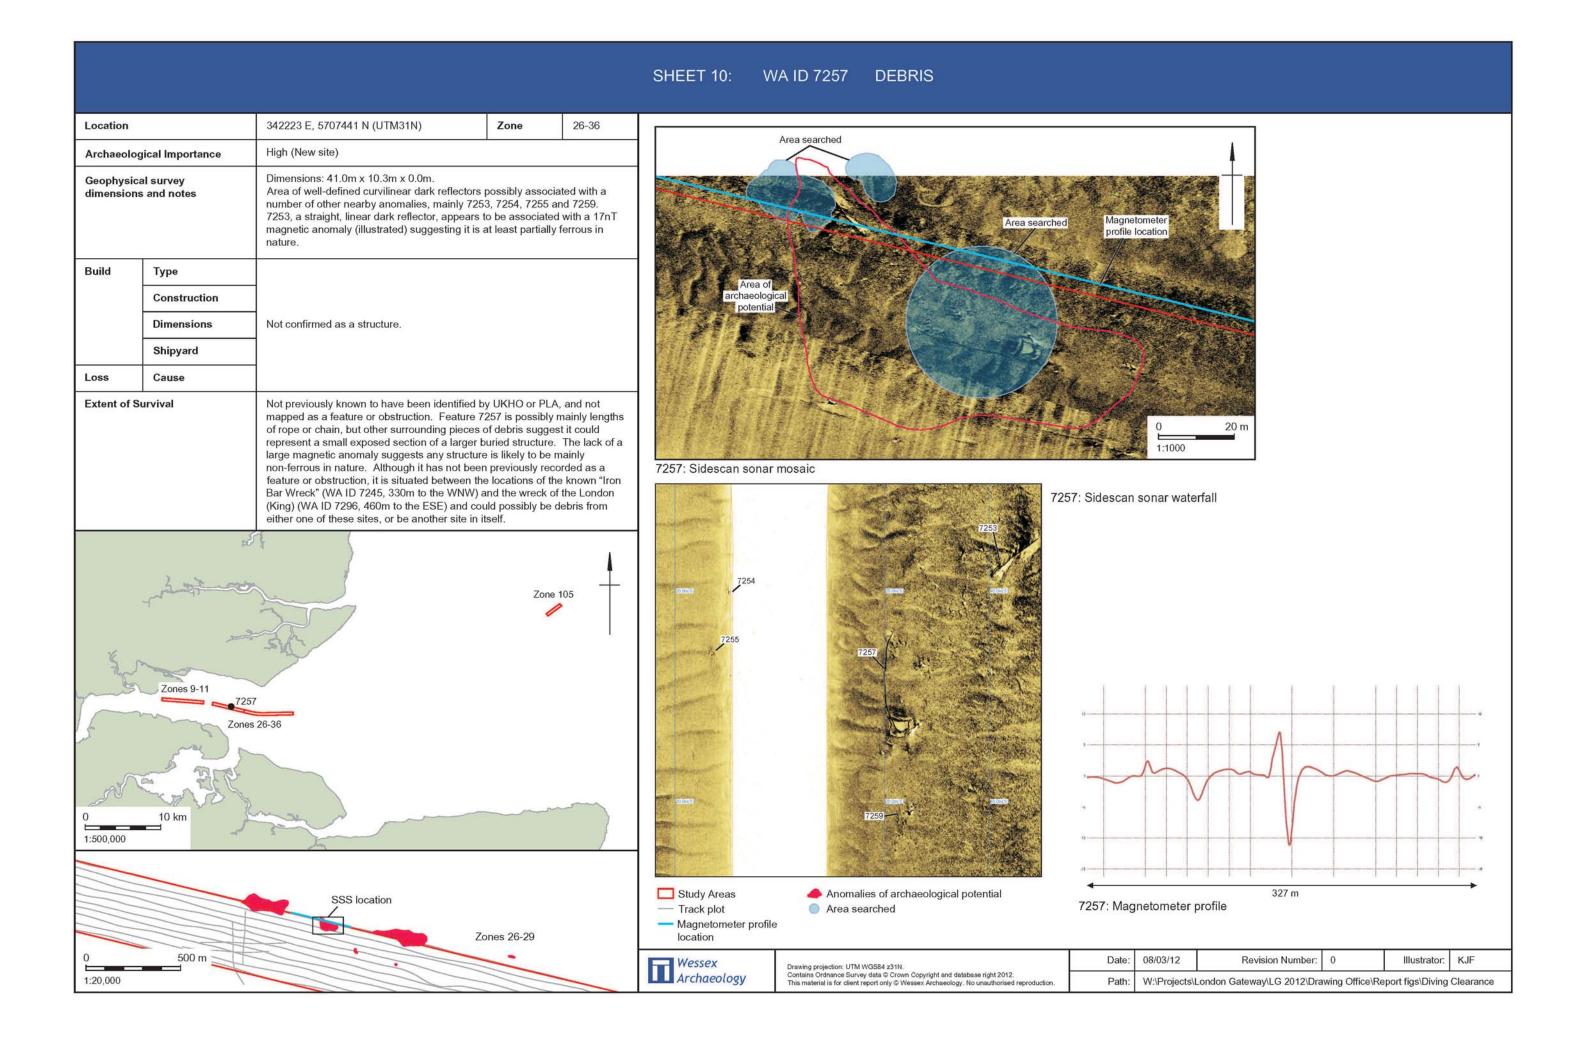
Zone 26-36 Data Sheet 10 Ref: 7257

The diver made bottom close to feature **7257** and proceeded to carry out circular searches from the base of the shot. No features were encountered by the diver during the 5m search. The seabed was flat consisting of fine sand with gravel inclusions. Along the 10m search the diver observed a slight linear depression extending c.10m and between 0.5-1m wide. One side of the depression consisted of fine sand and the other gravel, a scattering of flint nodules were located within the centre of the depression. During the 15m search the diver located a section of chain. The chain was of a medium gauge with links c. 150mm long and 100mm wide. The chain ran east-west along the seabed and had a distinct scour along one side. The length of chain on the seabed was c. 20m. The west end of the chain was found with nothing attached. At the eastern end the chain ended in a bundle c. 1-1.5m across. The chain was situated on a sand and gravel seabed along its entirety. There was no other debris within a 2m area either side of the chain and searches extended past either end of the chain found no other debris.

The diver made bottom 4m west of feature **7253** and proceeded to carry out circular searches from the base of the shot with assistance from diver tracking. A large section of chain was located *c*. 10m west of the shot. The chain was similar to the chain found in the location of **7257**. The individual links were *c*. 150-200mm long. There was a distinct scour on one side of the chain *c*. 200mm-300m deep. The diver located the end of the chain towards the east. The diver tracked back westwards *c*. 10m until directed away from the chain to investigate surrounding area. The length of chain observed by the diver was *c*. 10-15m but is believed to extend further west. Between 2-5m south of the chain an area of loose debris *c*. $2m^2$ was located consisting of rubble and fragments of wire hawser. The seabed around the chain and the area of rubble was flat consisting of fine sand and silt. No other features were located during the dive.

During the diver investigations of features **7253** and **7257**, in both instances a large section of modern chain was located. The chain was sizeable enough to cause a distinct scour on one side which is consistent with the straight, linear dark reflectors seen on the sidescan data. The only other feature recorded by the diver was a small area of scattered rubble and loose debris close to feature **7253**. The site consists of two areas of modern chain that could be connected, probably an accidental loss or associated with an abandoned buoy. As such it is considered of no archaeological interest.

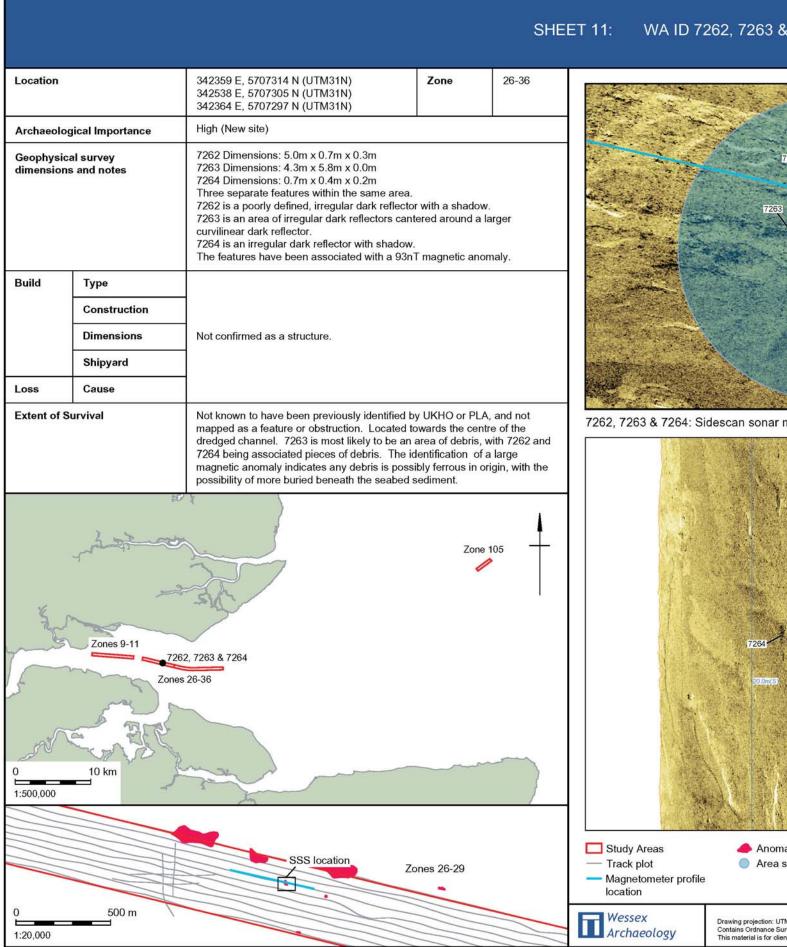
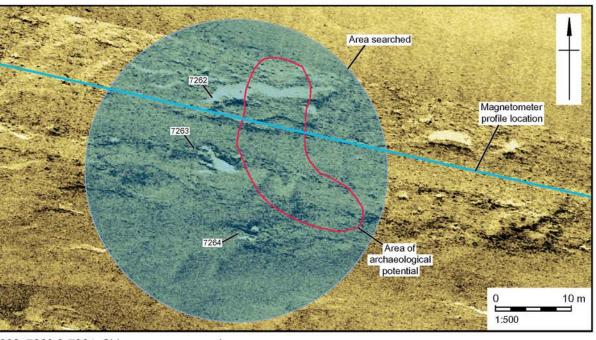
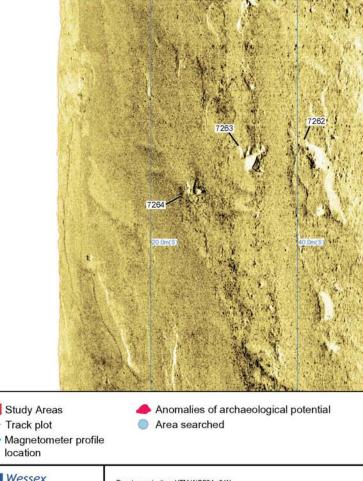
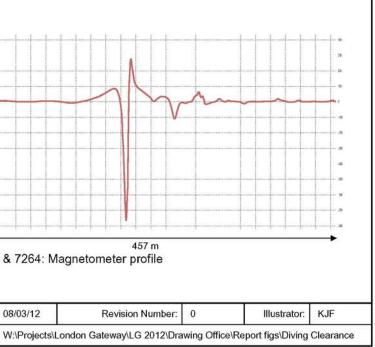
SHEET 11: WA ID 7262, 7263 & 7264 DEBRIS

The diver made bottom 5-10m to the north of feature **7263** and proceeded to carry out circular searches from the base of the shot out to 20m. The diver located a large

ferrous object on one side of a low sand/silt mound 10-15m SSW of the anchor position. This was in the correct area for the location of feature **7263**. The object was aligned *c*. north-east to south-west and was approximately 3m long and 1.2m wide. The north-east end was buried. The object consisted of a small diameter tube *c*. 200-300mm attached to a fragment of a much larger diameter curved plate. The object had a flanged-like lip at the south-west end and another flange in the centre. It had the appearance of a fragment of a larger cylinder that is open at least at one end with a smaller pipe attached to its outer surface. It appears to be a fragment of modern machinery, possibly part of a pressure vessel, such as a boiler. A metal frame-like object with rounded ends *c*. 100mm wide and 2m long was found lying next to it.

Searches to the north in the area of feature **7262** located a low, fine sand or silt mound but no archaeological features. Nothing was located to the SE in the locality of feature **7264** suggesting that this feature maybe buried.

The diver searches covered the areas of all the geophysical features. Nothing of archaeological interest was found at either **7262** or **7264**. Feature **7263** appears to be a section of piping with flanges associated with modern machinery and therefore of no real archaeological interest.

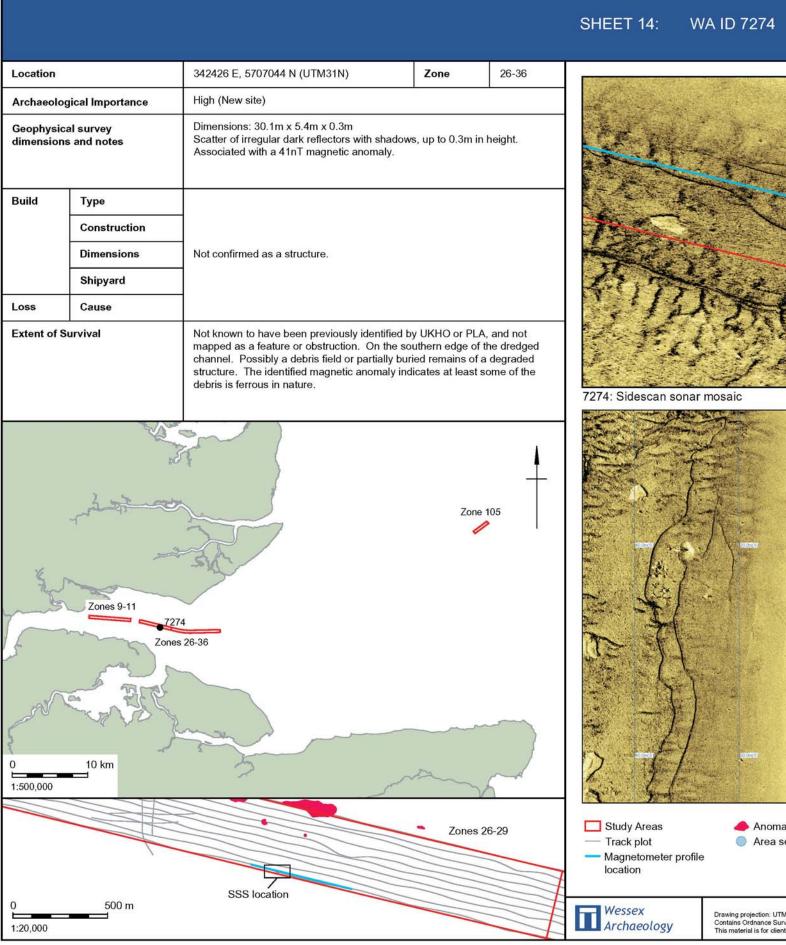
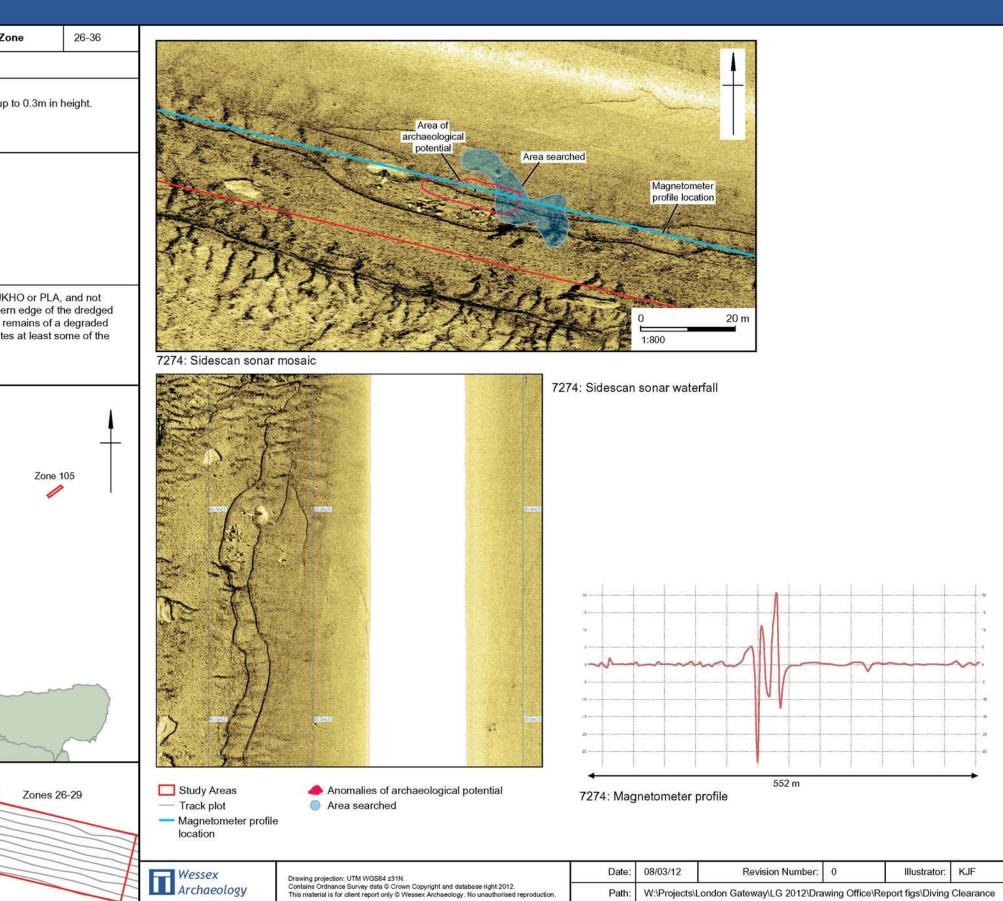
SHEET 14: WA ID 7274 DEBRIS

The diver made bottom 10m south-east of feature **7274** and proceeded to carry out searches from the base of the shot out to 15m. The diver located a scattering of loose debris and large pieces of coal within 15m of the anchor position. The largest area of debris was found between 5-15m west of the anchor. In this area numerous small unidentifiable irregular fragments were found; numerous pipes of 200-300mm diameter and up to 1.5m long, some with flanges and T-section joints; a small section of a girder, *c*. 1m long and 200mm wide; a flat ferrous bar *c*. 1m long and thin ferrous

plates, heavily buckled. Within close proximity to the anchor a number of slab-like objects up to 400mm across appear to be large fragments of coal.

There was no evidence of wreck located by the diver. Feature **7274** and the immediate area around it, appears to consist of a dump of modern debris and therefore, is of no archaeological interest.

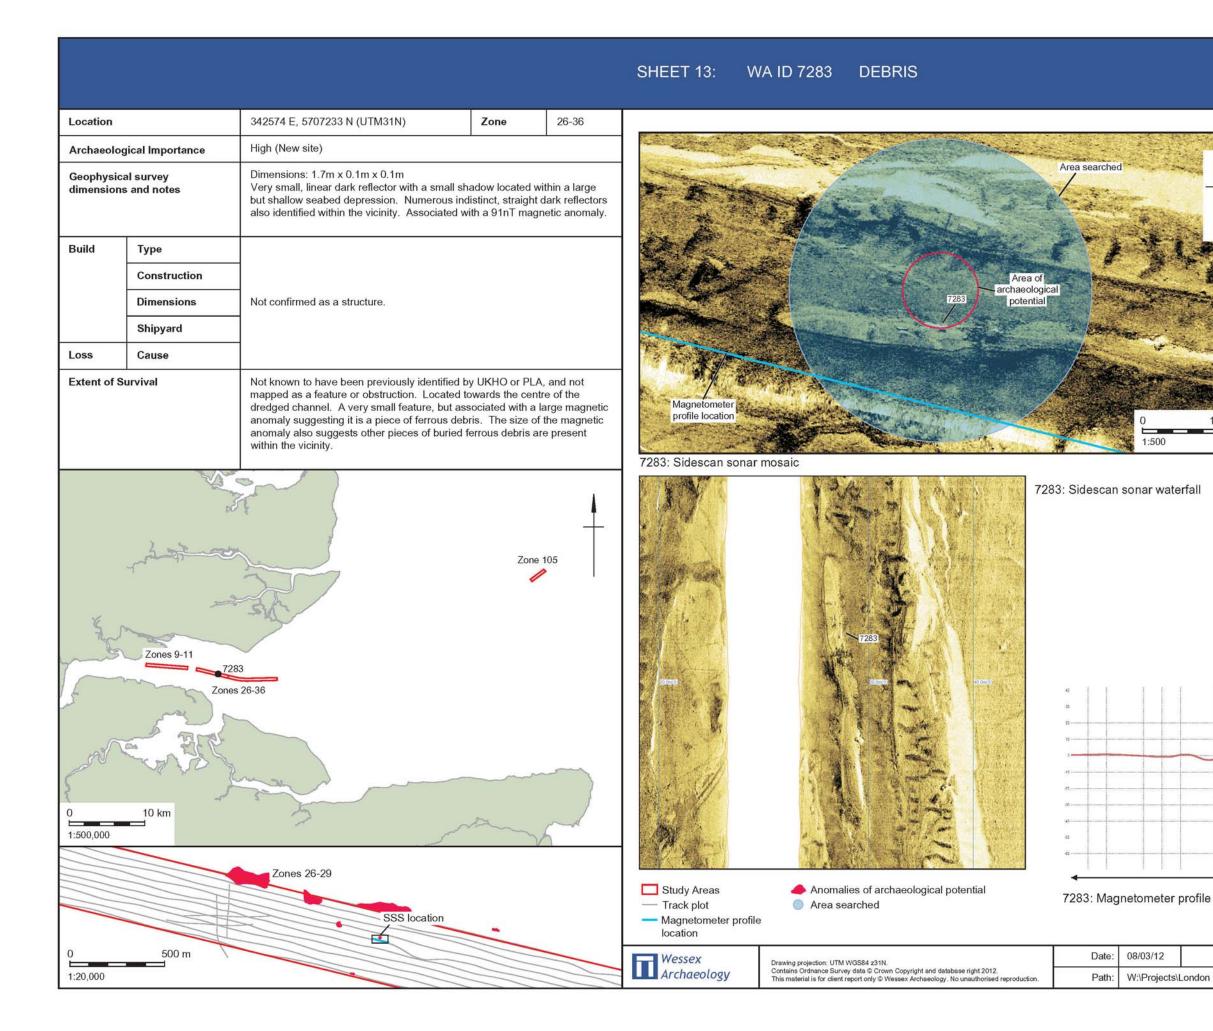
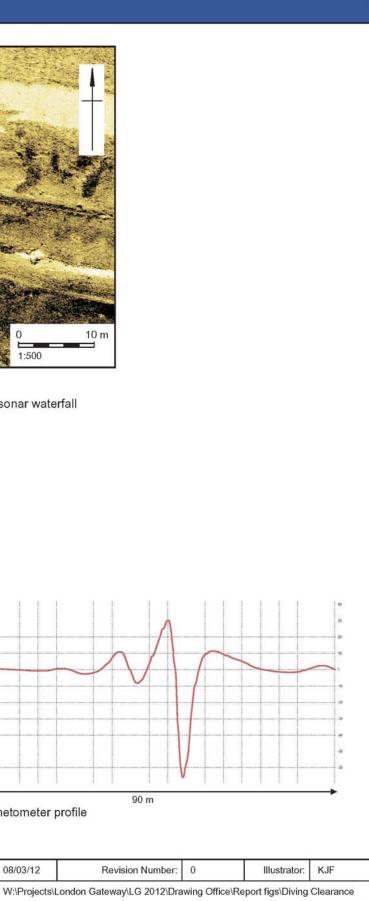
Zone 26-36 Data Sheet 13 Ref: 7283

The diver made bottom close to feature **7283** and proceeded to carry out circular searches from the base of the shot out to 20m. The diver located a scatter of small, irregular and largely unidentifiable concretions on the surface of a shallow depression close to the position of the shot. This scattering of debris covered an area *c*. 5m by 3m. Within this area a partly buried and heavily concreted 1.5m long fragment of wire hawser up to 25mm thick was found. Other objects found and recovered by the diver were a small bracket-like concretion (Find **005**), this could be a fitting, and a small glazed earthenware pottery sherd (Find **006**), probably modern. The seabed

The diver searches covered the area of the anomaly **7283** and the location of the prominent anomaly just to the east of the site position. Only a scattering of small modern debris was located and shallow ridges and depressions with vertical sides, mostly likely caused by the dredge head. It is possible that there has been some infilling of the shallow depressions observed during the geophysical survey and the anomalies recorded (max height 0.1m) have become buried. The site does not appear to represent the remains of a shipwreck or aircraft. It would appear the site is a scattering of loose debris associated with a possible dump of material and therefore of no archaeological interest.

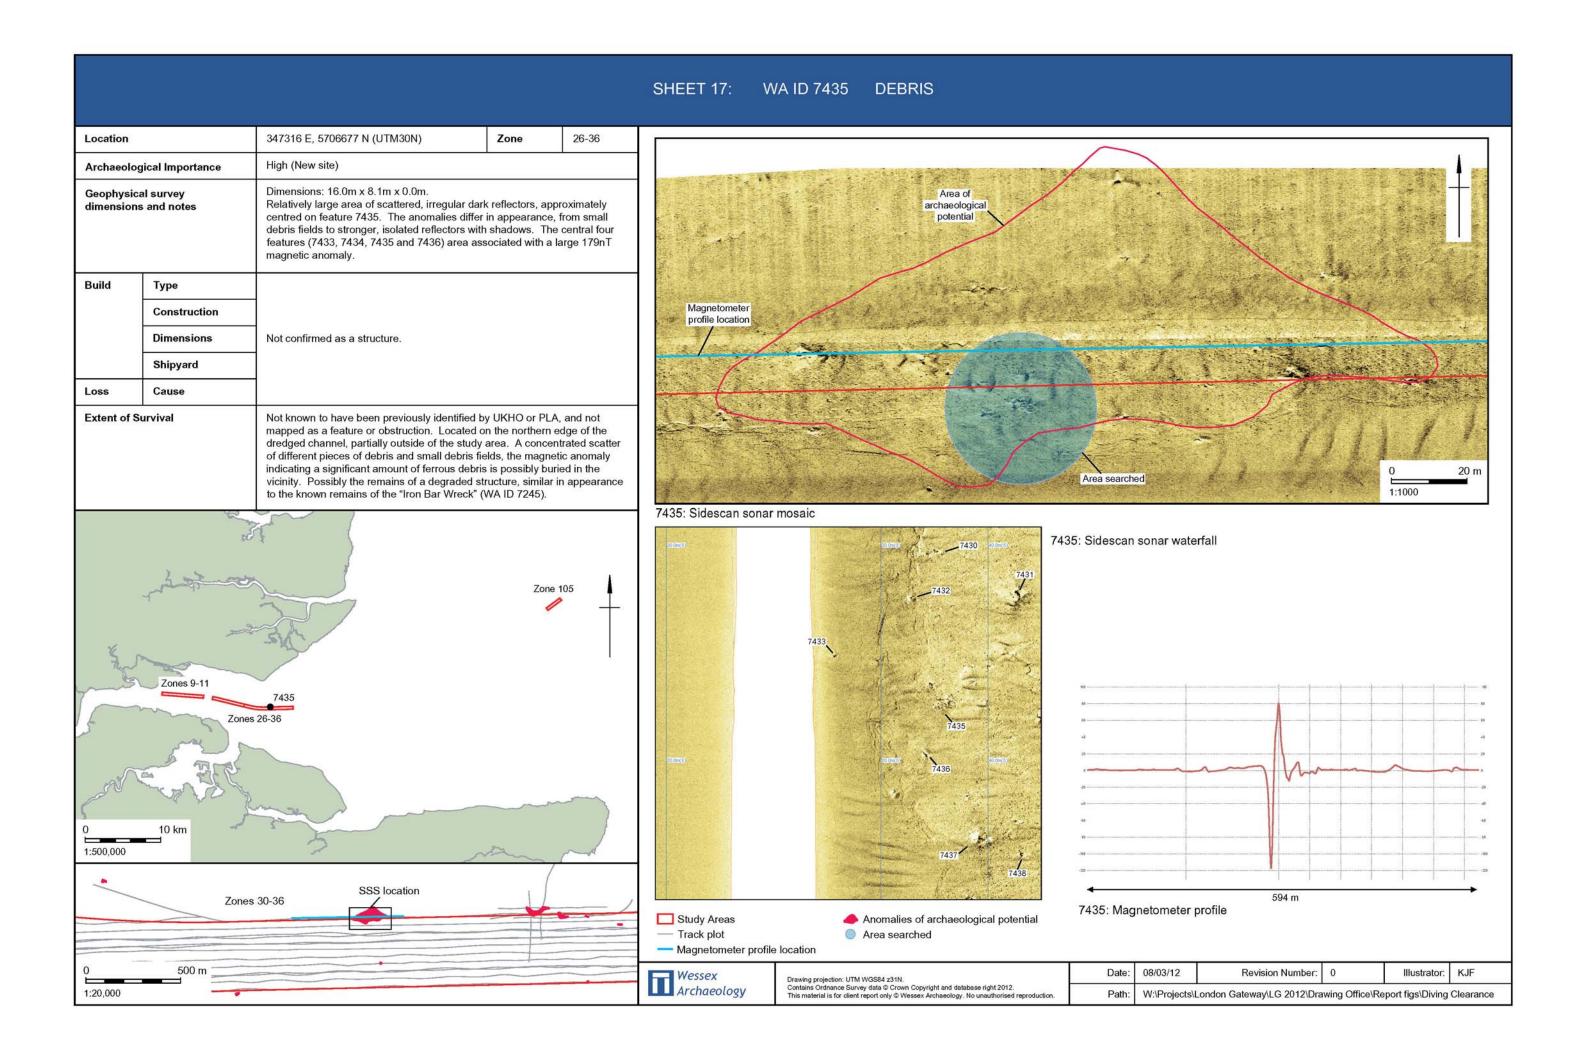
Zone 26-36 Data Sheet 17 Ref: 7435

The diver made bottom 10m to the south of feature **7435** and proceeded to carry out circular searches from the base of the shot out to 20m. The dive located a bundle of wire hawser cable spread over an area of at least 3m ESE of the shot in the location of feature **7435**. Some of the cable was upstanding 0.5m from the seabed. There was a distinct build up of silt and fine sand around it forming a low mound. The cable had an approximate diameter of 20-25mm. It was not possible to find an end of the

cable, therefore more material may be buried beneath the seabed. A second bundle of wire cable was found close to the anchor. It was of a similar size and could possibly be connected to the bundle located at the position of **7435**. No other features were found on the seabed. The seabed was predominantly flat consisting of fine sand and silt.

Although only a relative small proportion of the total area of archaeological potential was investigated, the diver searches covered the area around **7435**, which consisted of at least two bundles of modern steel cable. From the limited dive substantiation, there was no evidence to suggest the cable was attached to anything but they could be connected to one another. The cable has most probably been dumped or abandoned and is of no archaeological interest.

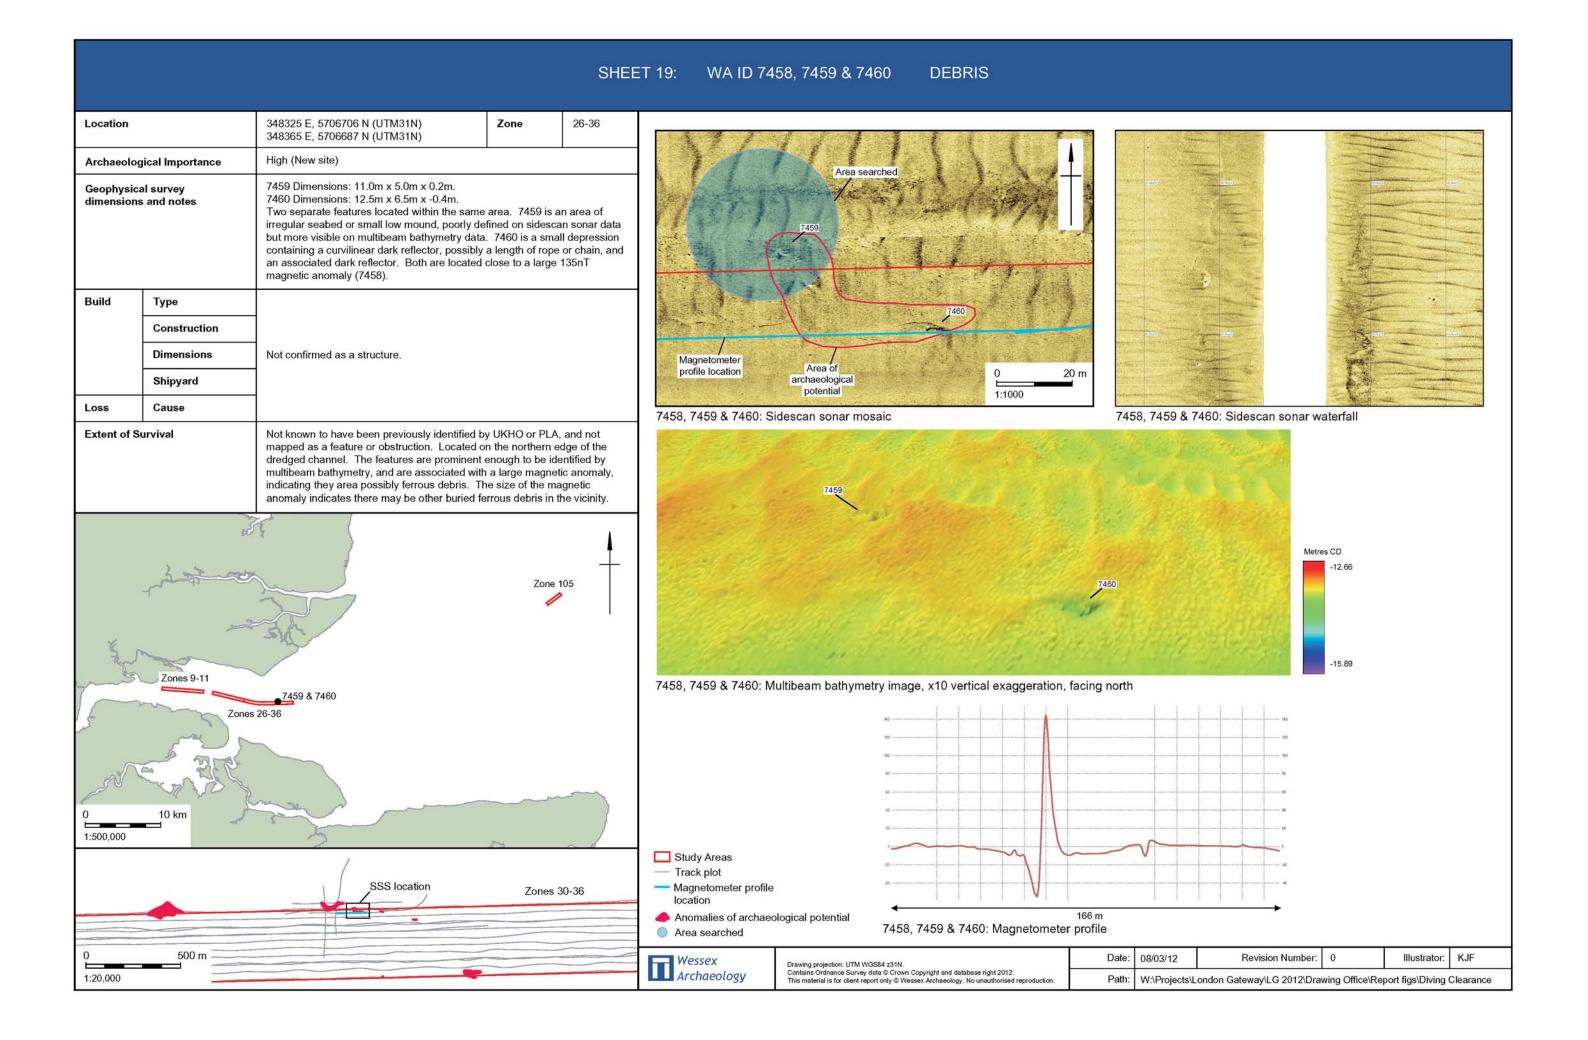
Zone 26-36 Data Sheet 19 Ref: 7458, 7459 and 7460

The anomaly found by the diver was in the location of feature **7459** as identified in the geophysical data. Feature **7459** is a large modern tyre with a build up of sediment around it forming a low mound no more than 0.5m above the general seabed level. As such this feature is of no archaeological interest.

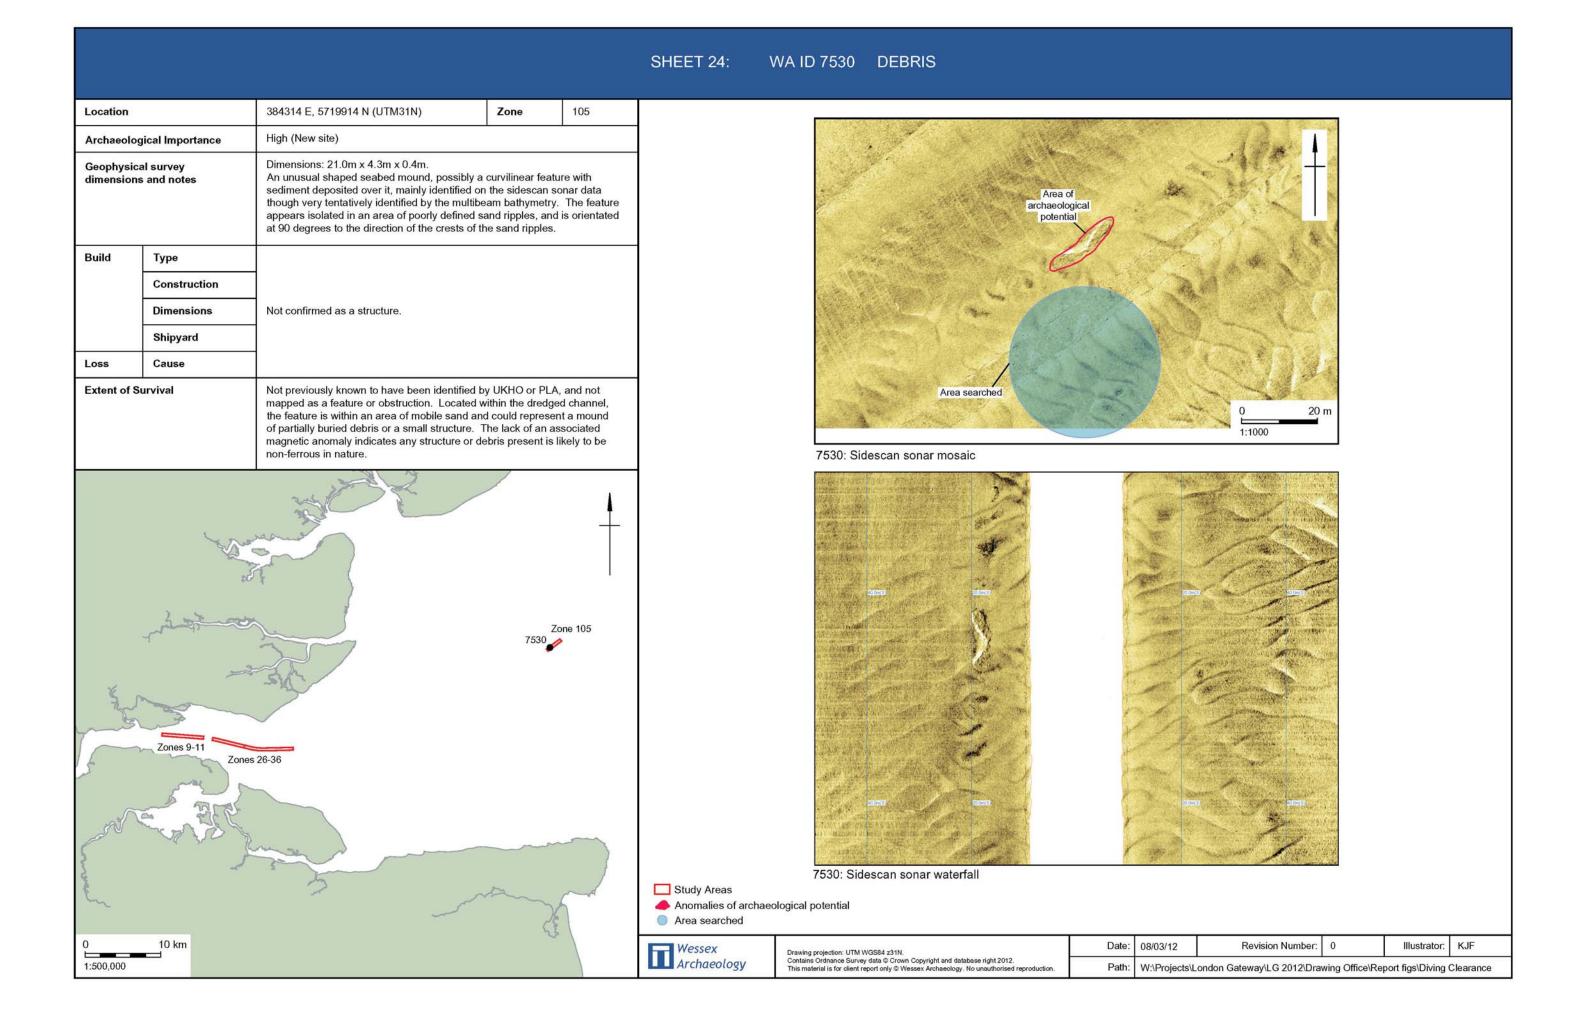
Zone 105 Data Sheet 24 Ref: 7530

The diver made bottom 5m north of the geophysical position of feature **7530** and proceeded to carry out circular searches from the base of the shot out to 20m with assistance from diver tracking. The diver found a small fragment of worked wood loose on the seabed c. 5m south-east of the shot (Find **004**). No other debris or

features were located during the dive. The seabed in the search was made up of small sand waves consisting of fine sand. This is consistent with the general seabed as seen in the sidescan data. Find **004** was a small fragment of worked wood 300mm long with evidence of a small iron nail. The wood was water worn but there was no evidence of gribble deterioration. It was loose on the surface of the seabed and therefore probably a stray piece of timber.

A 20m radius was searched around the geophysical position of feature **7530** and no substantial features were observed through out the dive other than a small fragment of wood. This would suggest the feature is no longer present on the seabed or has been buried. However, since the diving fieldwork was undertaken it has been found that there was an error made in the positioning of the geophysical feature **7530**. The result has been that the position dived was not the position of the feature identified in the sidescan, and was in fact some 30m to the south of the anomaly identified in the geophysics. Thus, the correct position of the feature has not been investigated.

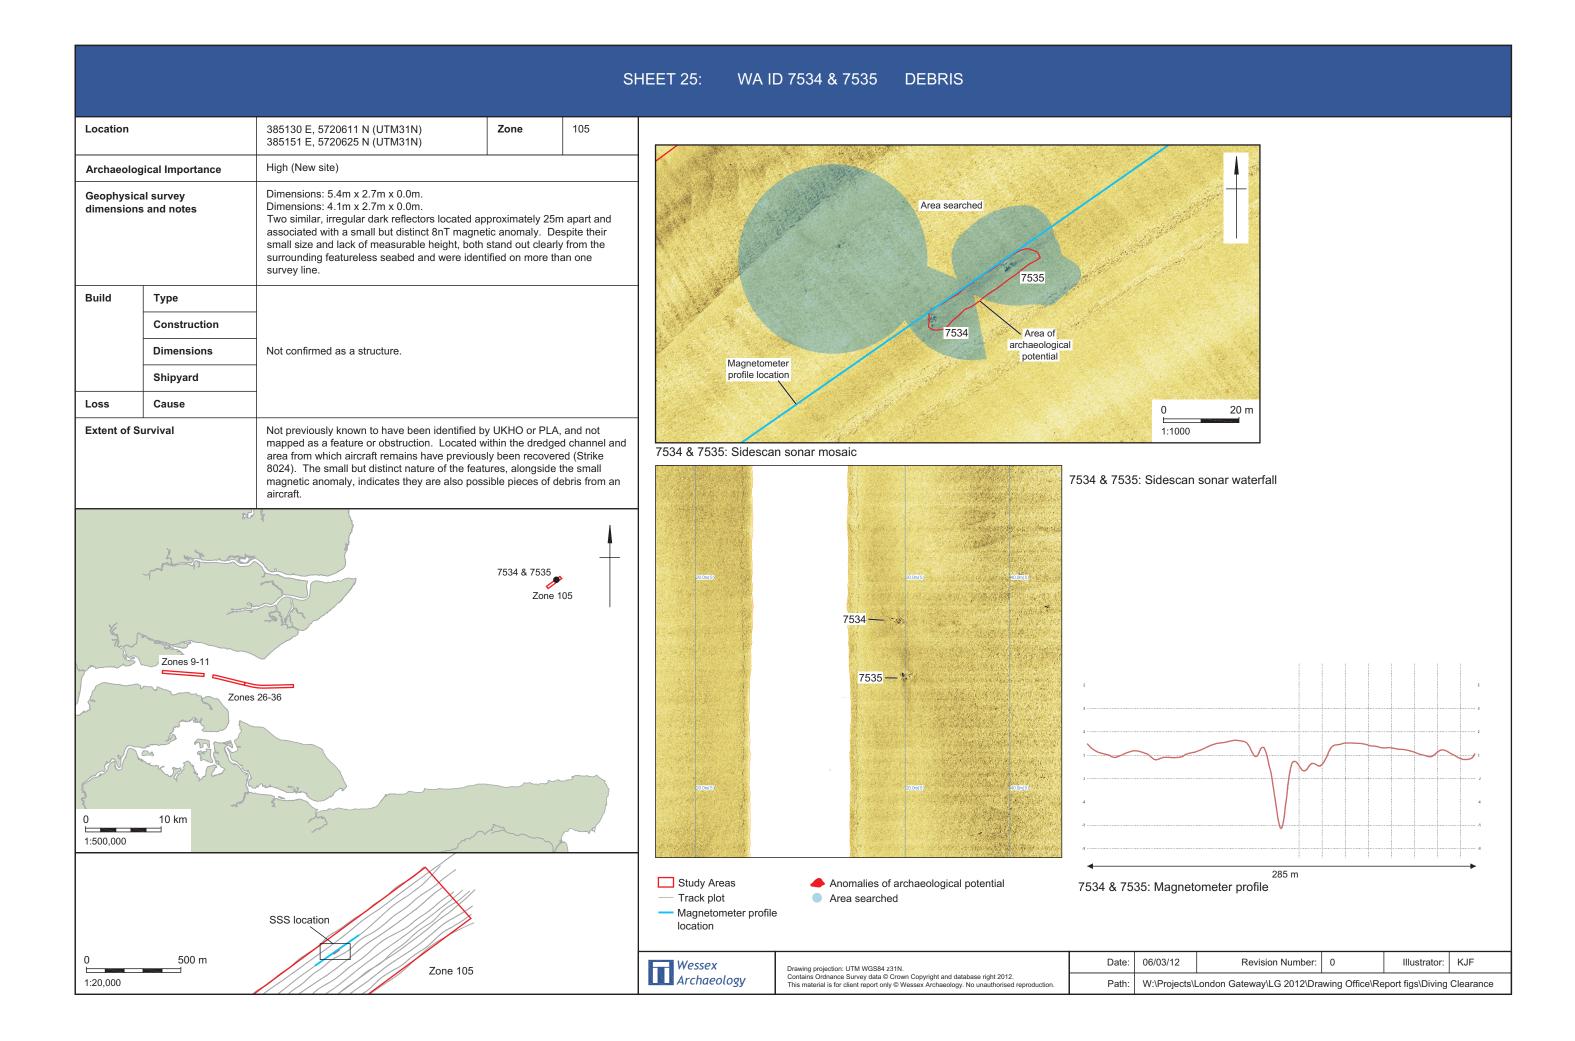
Within 3-5m west-north-west more debris was located consisting of a large upstanding section of partly articulated metal structure. Within close proximity were other partly buried thin metal frame-like objects protruding up to 1m from the seabed at various angles. These too had evidence of riveting. More rubber tubing and other unidentifiable objects were found around this area of debris. The exposed structure

Amongst the main body of wreckage were various component parts that could be associated with the interior of an aircraft. This included numerous fragments of plywood, rubber strips and electrical cable and wiring. The rubber strips and wiring appeared to be firmly attached to structure beneath the seabed but much of the wood was loose and fragile. Also, amongst the wreckage was an area of canvas or similar type material. This was either snagged or mainly buried as it was firmly attached to the wreckage.

The evidence analysed from the geophysical data and three inspection dives on the site confirm there are two distinct areas of exposed wreckage. The description of the wreckage and analysis of the recovered artefacts confirm that this is the site of a crashed aircraft. The recovered finds are also similar in construction and reveal the same shades of dark green-grey paint as that found on the material recovered from strike **8024** by the dredger. Therefore it is highly likely that the site is the remains of a WWII German Junkers Ju 88 reconnaissance aircraft. The distance between the two features suggests they are separate pieces of wreckage. However, the similar components found on both features confirm they are most probably associated with the same aircraft. It has not been possible to determine if the two features became separated when the aircraft crashed or due to the movement of the dredge head through the site.

Both features **7534** and **7535** are areas of partially exposed broken-up aircraft wreckage. In both areas, wreckage which was protruding from the seabed appeared to be firmly attached to structure beneath the sand. This would suggest that more wreckage lies beneath the seabed than exposed. All the material recorded by the diver and material recovered by the dredger had clean surfaces. This suggests recent exposure. Prior to the recent disturbance of the seabed the remains of this aircraft had probably remained buried for a sustained period of time, possibly soon after it crashed.
