London Gateway Port

Assessment of Anchors and Other Maritime Material
at London Gateway Port

Ref: 88633.01
April 2017

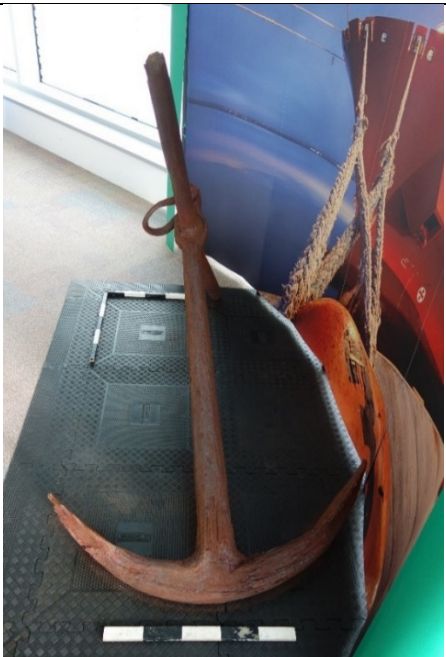
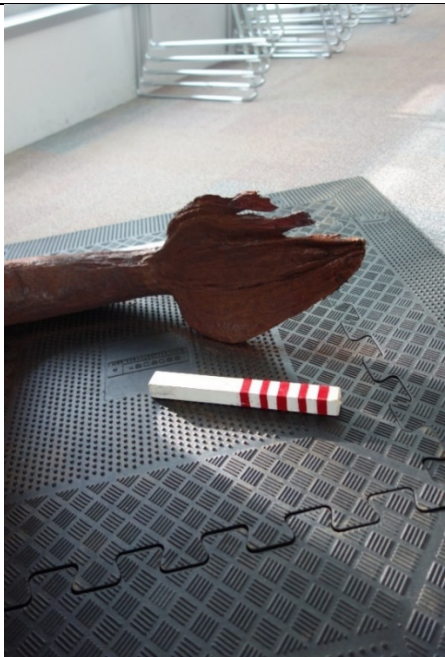
ID	WA9001		
Current Location	Ground floor of LG main office (no.1) - dry storage/ indoor		
Site/Lordi	none	WA no.	1007
		Report no.	113
		ROW droit no.	076/1
Description			
<p>This is a small iron stocked anchor which was initially identified as an Admiralty pattern/fisherman's type. The presence of an iron stock and shackle suggest a date from the 1830s. Measurements are: bill to bill 970 mm, shank length 1330 mm, stock length and thickness at the base 1440 mm and 80 mm, fluke length and width 250 by 170 mm. The crown is curved and 100 mm thick at the throat. The shackle thickness is 30 mm. The flukes are significantly damaged but retain their triangular shape and rounded angles. They do not have an accentuated bill. The original surface of the body of the anchor has been lost due to corrosion. The anchor shows similarities to the Lenox anchor trialled in 1852 by the Admiralty. However, the absence of a well-defined bill could suggest that this is a Dutch anchor. It could have possibly been used as a main anchor of a large boat or small vessel ship or wish fishing gear.</p>

Recommendation			
Label and/or add a sign. Display indoor within LG main office.			
Assessment of the conditions of the items as found		The anchor is heavily corroded and has lost most of the original surface. Some areas such as the flukes were particularly affected and are now relatively fragile. Presence of rust powder suggests the presence of active corrosion.	
Image of object

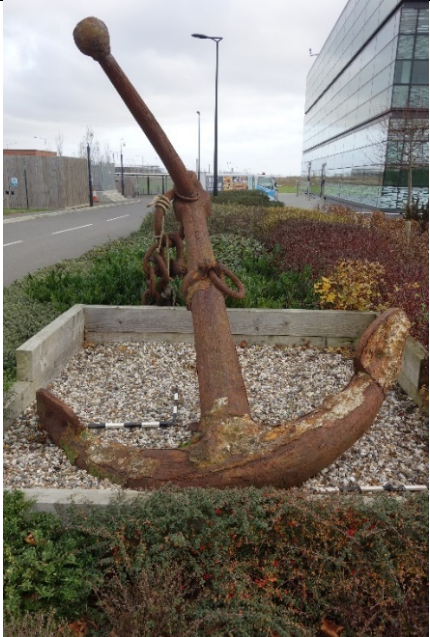
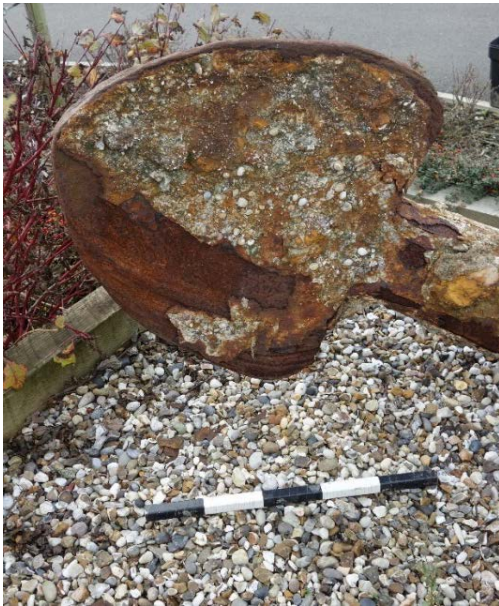
ID	WA9002		
Current Location	On display on a gravel bed outside the LG main office – outdoor		
Site/Lordi	none	WA no.	WA1006
		Report no.	112
		ROW droit no.	076/1
Description			
<p>This is a large stocked iron anchor. A straight iron stock with balls and shackle with studded chain attached suggest a date post-1830s. Catting rings and a balancing band are bolted onto the shank. Measurements: bill to bill 2150 mm, stock length 3100 mm. The shank length is 2870 mm and thickness at the base measures 300 mm. The diameter of the catting ring is 190 mm. The shank has a rounded section. Fluke length and width are 530 by 560 mm, spade-like shaped and at narrower angle than the crown. Crown is curved and 290 mm thick. The shackle thickness is 750 mm. This anchor could have been lost from a merchantman as by the 1840s the British Navy standard anchor was the Admiralty pattern type and the catting rings and lack of alteration suggest that this anchor would not have been used as a fixed mooring in an anchorage. The absence of a defined fluke and shape of the palm could indicate that this is a continental anchor possibly Dutch.</p>

Recommendation			
Label and/or add a sign, to be kept in the gravel bed as historical feature.			
Assessment of the conditions of the items as found		Some sections of the anchors have not been completely cleaned from the compact marine sediments and concretions. These should not be removed as the constitute a partial protection. Some areas of active corrosion for examples in the surface of the flukes that flakes off are noted. Part of the chain and the stock is onto the flowerbed hence they are more exposed to moisture and biological alterations.	
Image of object

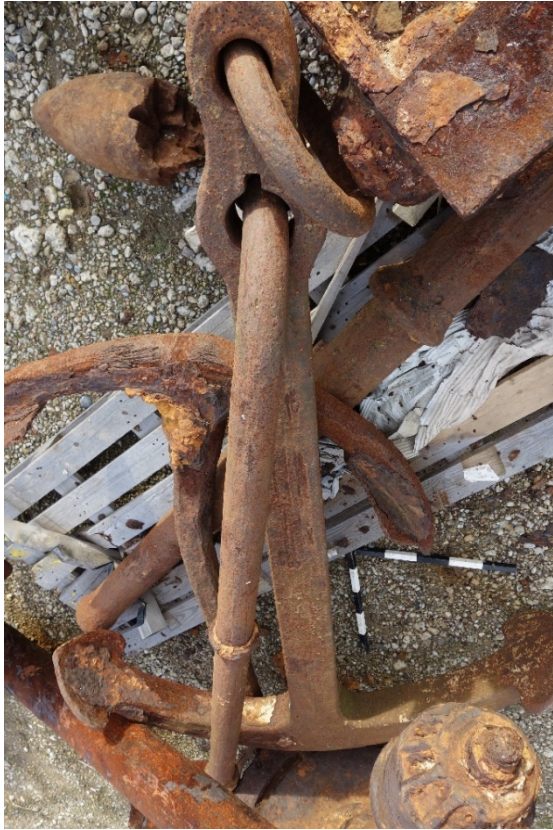
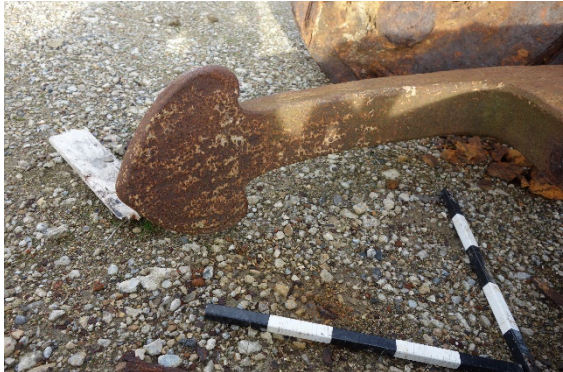
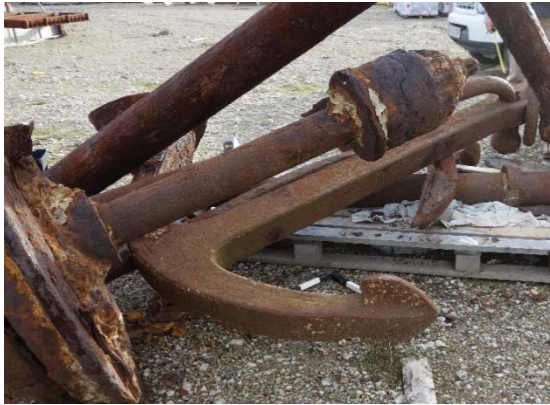
ID	WA9007		
Current Location	Gate 45, LG compound - outdoor		
Site/Lordi	None	WA no.	None
		Report no.	None
		ROW droit no.	Applied for by LGP
Description			
<p>This anchor was difficult to access as it was under other material at the time of the survey.</p> <p>This is probably a Rodger's small palm anchor, patented in 1832. The fact that the iron stock is not fixed could suggest that it may have been lost whilst stowed on deck. Measurements: bill to bill 1570 mm, shank length 2050 mm and thickness 140 mm, shank with rectangular section. Fluke length and width 230 by 300 mm, heart shaped. A ring is attached to the head. The stock could be a Cotsell or Admiralty iron stock. It is likely that this anchor dates to the mid-19th century.</p>			
Recommendation			
Label and/or add a sign, remain with LG to be relocated as historical feature.			
Assessment of the conditions of the items as found		The find does not show any evident ongoing process of corrosion.

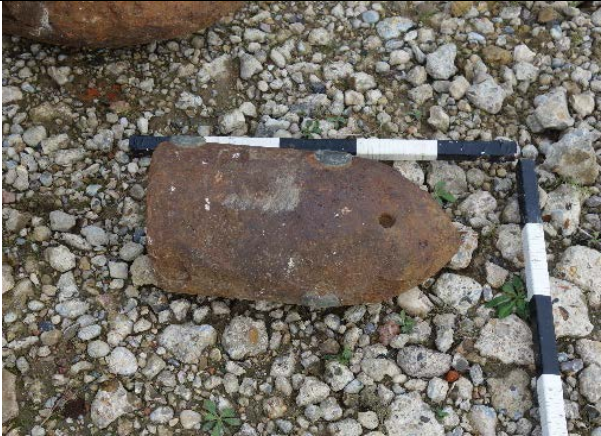
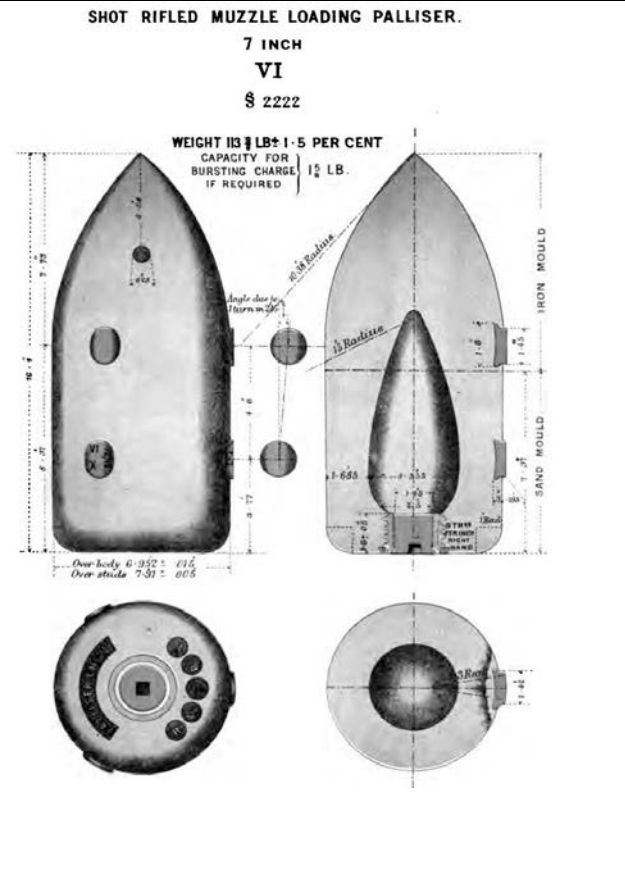
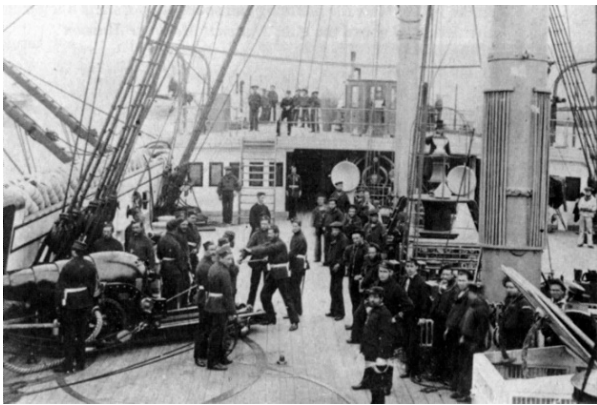
ID	WA9010		
Current Location	Gate 45, LG compound - outdoor		
Site/Lordi	None	WA no.	None
		Report no.	None
		ROW droit no.	Applied for by LGP
Description			
Solid iron projectile with lead or zinc studs. The diameter is 7in/165 mm and length 360 mm. This calibre was adopted for rifled muzzle-loading (RML) guns which commonly armed medium-sized British Warships and land batteries from the 1860s. The studs imparted spin and improved accuracy. The Palliser shot or shell was designed to defeat increases in battleship armour.			
Recommendation			
Label and offer to Coal House Fort. Free From Explosives (FFE) certificate may be required.			
Assessment of the conditions of the items as found		The find does not show evidence of particularly active corrosion other than the presence of rust powder on the surface	
Image of object

<p>SHOT RIFLED MUZZLE LOADING PALLISER. 7 INCH VI § 2222 WEIGHT 113 LB ± 1.5 PER CENT CAPACITY FOR BURSTING CHARGE IF REQUIRED 15 LB.</p> <p>Over body 6.952 = 416 Over studs 7.91 = 405</p>

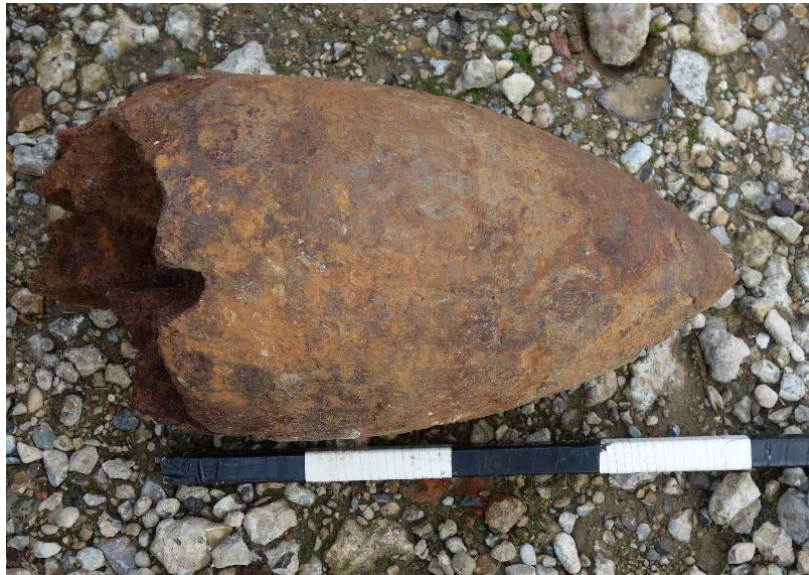
ID	WA9011		
Current Location	Gate 45, LG compound - outdoor		
Site/Lordi	none	WA no.	none
		Report no.	none
		ROW droit no.	Applied for by LGP
Description			
Broken, elongated projectile made of iron. The shot diameter is 230mm which corresponds to a 9in calibre. The length of what remains is 480 mm. Elongated projectiles date from the 1860s.			
Recommendation			
Label and offer to Coal House Fort. Free From Explosives (FFE) certificate may be required. Otherwise discard.			
Assessment of the conditions of the items as found			The surface shows possible pitting corrosion but the find seems to be mostly stable.
Image of object

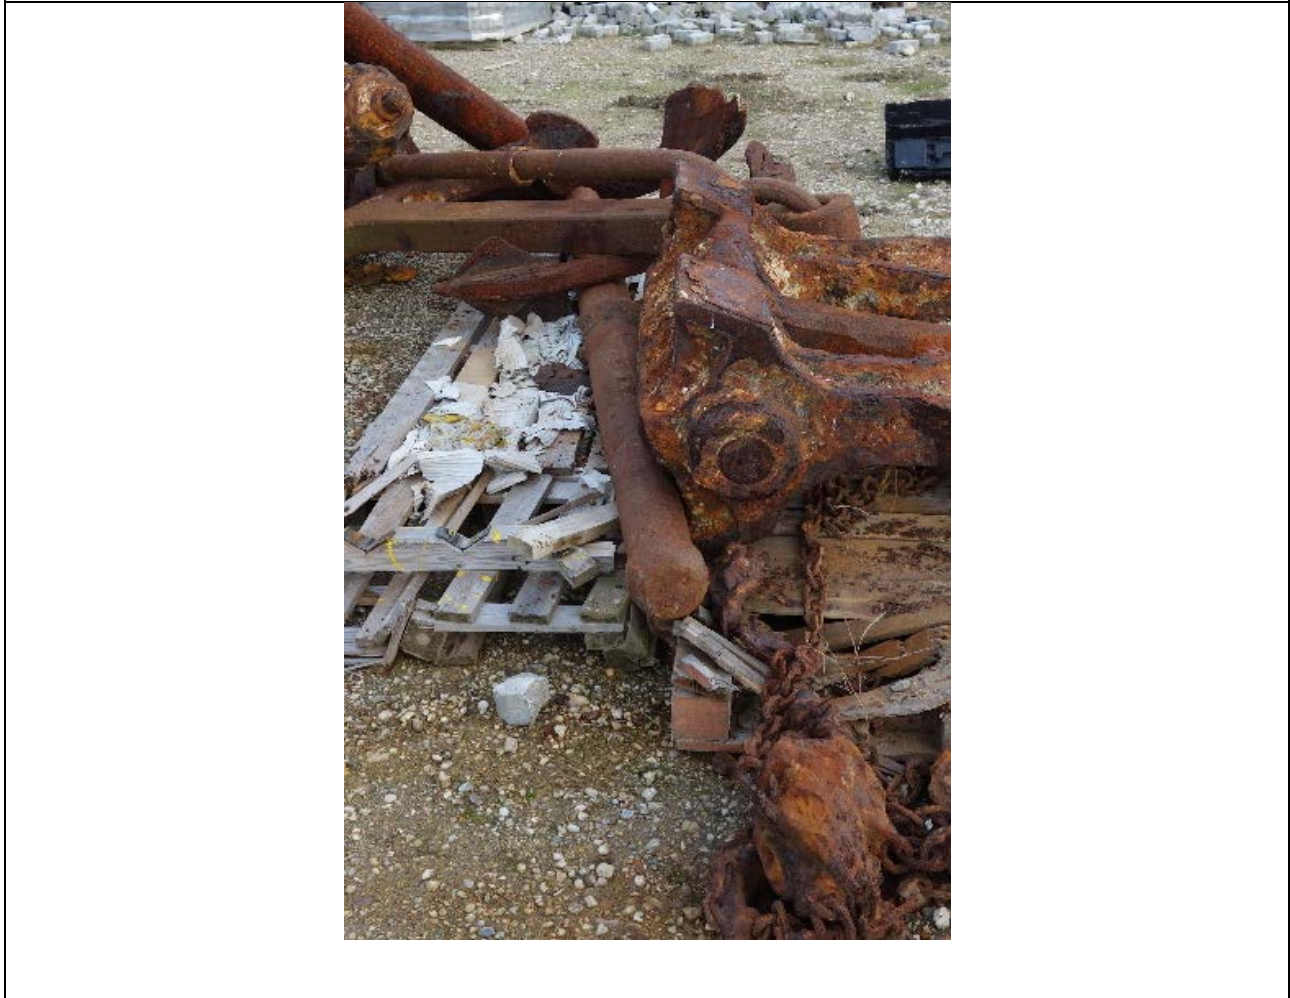
ID	WA9013		
Current Location	Gate 45, LG compound - outdoor		
Site/Lordi	None	WA no.	None
		Report no.	None
		ROW droit no.	Applied for by LGP
Description			
<p>This iron anchor stock was difficult to access as it was under other material at the time of the survey.</p> <p>This is a straight iron anchor stock. Iron stocks were used in the Royal Navy from 1807 however the adoption of iron stocks in anchors of sizeable dimensions (30+ cwt) dates from the 1830s.</p>			
Recommendation			
Disposal/discard

Assessment of the conditions of the items as found	Mostly stable with few areas of active corrosion.
---	---

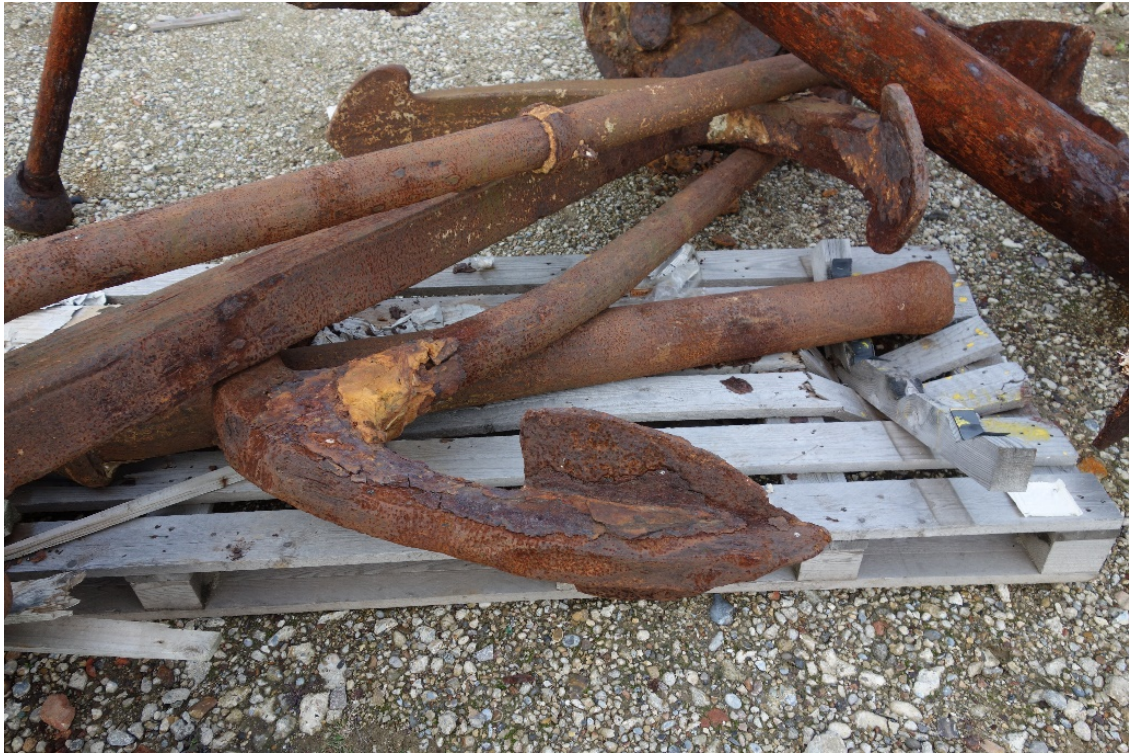
ID	WA9014		
Current Location	Gate 45, LG compound - outdoor		
Site/Lordi	None	WA no.	1008
		Report no.	114
		ROW droit no.	076/1
Description			
This is a small stocked anchor of the Admiralty pattern or fisherman's type, although the stock is missing. The rounded arms and metal stock along with the use of a ring instead of a shackle suggests a date 1800-1850 at the latest.			
Recommendation			
Label/add a sign, remain with LG to be relocated as historical feature.

Assessment of the conditions of the items as found	The surface of the anchor easily flakes off is a sign of an active corrosion.
---	---

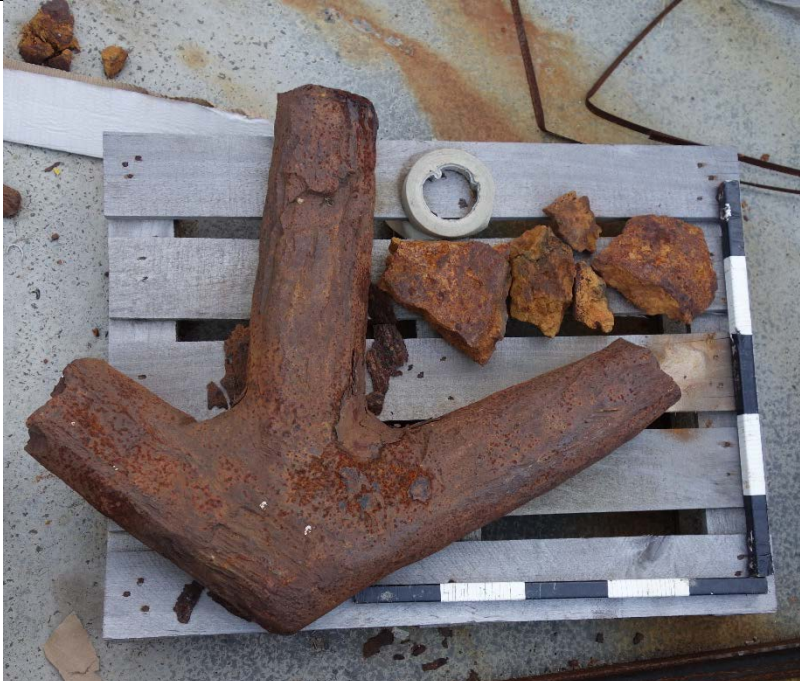
ID	WA9015		
Current Location	Outside the terminal building - outdoor		
Site/Lordi	none	WA no.	1008
		Report no.	114
		ROW droit no.	076/1
Description			
<p>Long shank type anchor with straight arms. This anchor has lost both flukes and parts of the arms. The shank has a circular section. The length of remaining shank is 610 mm. The pointed crown and the angle of the arms of 60 degrees could indicate a late production date (18th or early 19th century) rather than an early one.</p>			
Recommendation

<p>Label/add a sign, remain with LG to be relocated as historical feature, possibly indoor. Otherwise discard.</p>	
<p>Assessment of the conditions of the items as found</p>	<p>The presence of flakes and loose rust on the surface suggests the presence of active corrosion.</p>
<p>Image of object</p>
