Thames Gateway

Report on the investigative conservation of waterlogged finds

Date: 25/01/16

York Archaeological Trust Conservation Report Number 2015/43

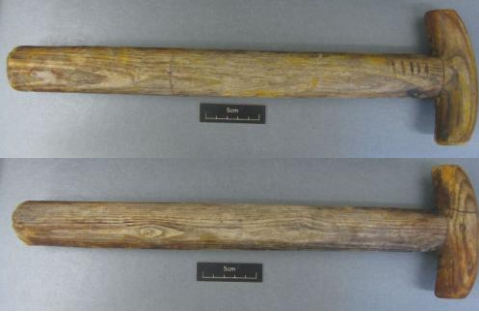
<p>66896/5051/0046 Wood shovel handle</p> <p>Wood shovel handle. The object arrived wet packed and in quite good condition, although quite soft in places. The handle was in two joining fragments. Wood species identified as ash (<i>Fraxinus Excelsior</i> L.)</p> <p>Treatment: The condition assessment suggested the handle should be put through a PEG treatment regime of 10% PEG400 v/v and 25% PEG 4000 w/v in water. The PEG additions were carried out in 5% increments beginning with the PEG 400 until the desired concentration was achieved. Further additions of PEG 4000, in 5% increments were then made until a total concentration of 35% wax was reached. The solution was periodically dosed with 0.2% v/v of Linkcide KMC biocide to control microbial activity.</p> <p>Once impregnation was complete, the wood was frozen and then freeze-dried in the small 7.5litre Birchover drier, with the run lasting 4 weeks. After drying excess PEG wax was removed from the surfaces using a hot air blower and absorbent towelling. The surfaces were then coated with 25% w/v aqueous solution of PEG 6000. After freeze-drying the two pieces of the object were adhered together using HMG Cellulose nitrate adhesive.</p>

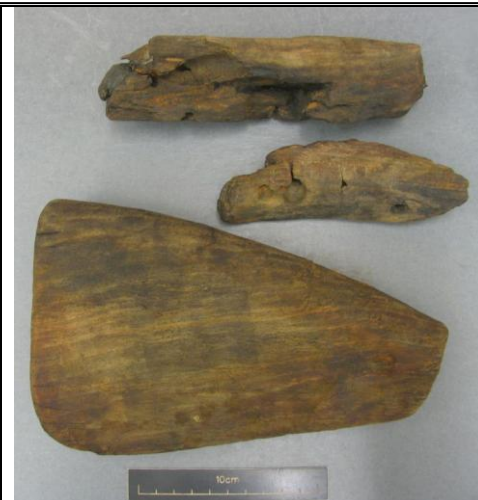
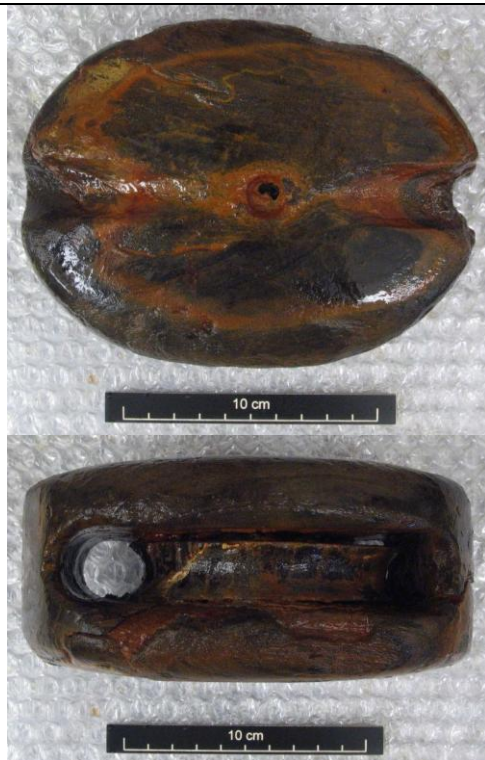
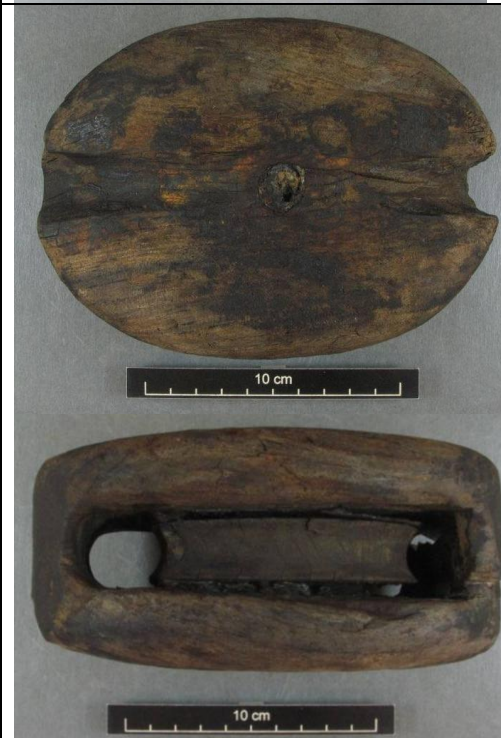
<p>5019/001 Wood gun stock fragments</p> <p>Fragments of gun-stock of <i>Fagus Silvatica</i> L. (beech). The three fragments fit together but the joins are not good due to erosion of the edges and some shipworm damage. The wood itself is in good condition, a little soft and with some marks to the surface, but otherwise stable.</p> <p>Treatment:</p> <p>As much iron staining as possible was removed by immersing the object in a 3% Ammonium citrate solution w/v in tap water for roughly 7 hours. After rinsing, the object was put through a PEG treatment regime of 10% PEG400 v/v and 25% PEG 4000 w/v in water with the addition of 0.2% v/v of Linkcide KMC biocide.</p> <p>At this point the object was freeze-dried in the 2m Birchover unit, the run lasting one month.</p> <p>After freeze-drying, the surfaces were cleaned of excess PEG using small amounts of hot water, dried off with paper towelling and further dried with a hot air blower. The surface was then coated with 25% PEG 6000.</p>

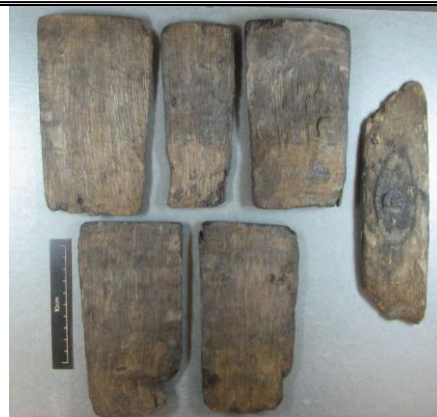
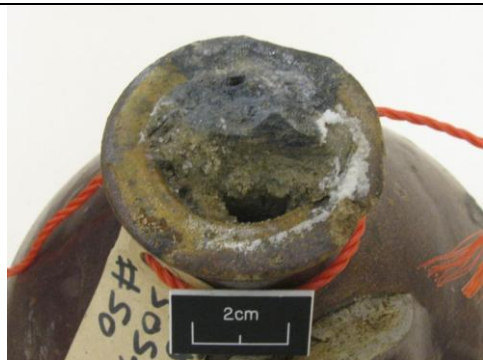
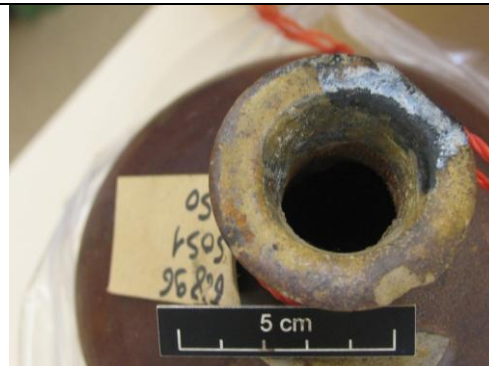
<p>5051/66896/0051 Wood bucket elements</p> <p>Bucket, waterlogged and in a fair condition, with both soft and hard zones present, indicating heterogeneous decay. Wood species identified as oak, <i>Quercus spp.</i></p> <p>Treatment</p> <p>The condition assessment suggested the bucket staves should be put through a PEG treatment regime of 10% PEG400 v/v and 25% PEG 4000 w/v in water. The PEG additions were carried out in 5% increments beginning with the PEG 400 until the desired concentration was achieved. Further additions of PEG 4000, in 5% increments were then made until a total concentration of 35% wax was reached. The solution was periodically dosed with 0.2% v/v of Linkcide KMC biocide to control microbial activity.</p> <p>The bucket was frozen and then freeze-dried in the 7.5 litre Birchover unit (run number 7), the run lasting one month.</p> <p>After freeze-drying, the surfaces were cleaned of excess PEG wax using small amounts of hot water, dried off with paper towelling and further dried with a hot air blower. The surfaces were then coated with 25% w/v aqueous solution of PEG 6000.</p>

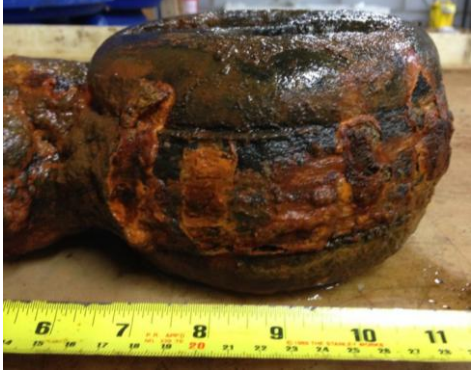
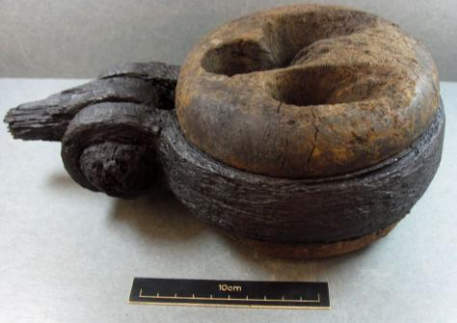
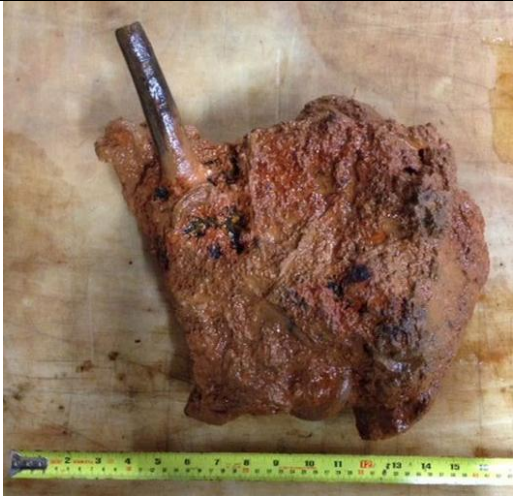
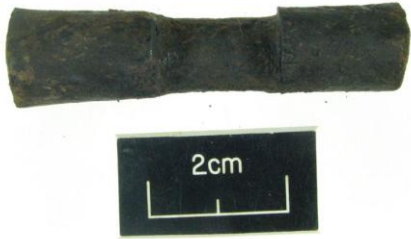
5019-008 Wood and iron dead-eye

Complete dead-eye, consisting of a round wood central core with three perforations surrounded by an iron band and with a section of iron at the top encased in concretion. The top of the concretion has modern rope attached.

The object is in fair condition, the wood is solid and heavily mineralised due to the contact with the iron and the surface of the iron is somewhat corroded.

Treatment: Concretion was removed from the iron using a hammer and chisel and an electric engraving tool at which point the object was desalinated. Once the chloride levels were measured stable below

<p>50ppm the pre-treatment of the wood could commence. The object was put through a PEG treatment regime of 10% PEG400 v/v and 30% PEG 4000 w/v in water with the addition of 0.2% v/v of Linkcide KMC biocide and 0.2% Hostakor IT™ corrosion inhibitor. At this point the object was freeze-dried in the 7.5 litre Birchover unit (run number 18), the run lasting one month. After freeze-drying, the surfaces of the wood were cleaned of excess PEG using small amounts of hot water, dried off with paper towelling and further dried with a hot air blower. The surface was then coated with 25% PEG 6000. The iron surface was treated by removing any active corrosion with a stiff brush and treating with 10% tannic acid w/v in 50:50 Industrial Methylated Spirits and water applied with a brush, followed by a layer of microcrystalline wax.</p>

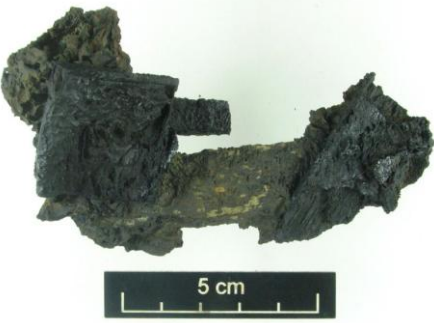
<p>Concretion with wood handle protruding</p> <p>This concretion appeared to be a conglomeration of a large collection of iron and wood objects. The most noticeable item is a wooden handle protruding from one side. The concretion was X-rayed and was also found to contain a lead object.</p> <p>Treatment:</p> <p>The concretion was investigated by removing corrosion and concreted material initially from the surface and around the protruding wooding handle. This revealed a plethora of other objects of wood and iron including rings, rods, bars, a shackle, a complete padlock and several other handles. Each object was gradually removed from the conglomeration by continuing to remove the concretion from around each object. The iron objects revealed were found to be completely mineralised and were very fragile and with surfaces that often retained impressions of the concreted material. Each object was labelled with a letter for ease of reference.</p> <p>Once all the objects had been separated out from the concretion they were placed in water baths to check the chloride levels. All the objects were found to be within acceptable limits for chlorides.</p>
