Well House Cottage Wellhouse Lane Headbourne Worthy Winchester

Level 2/3 Historic Building Recording

CA Project: AN0194

August 2020

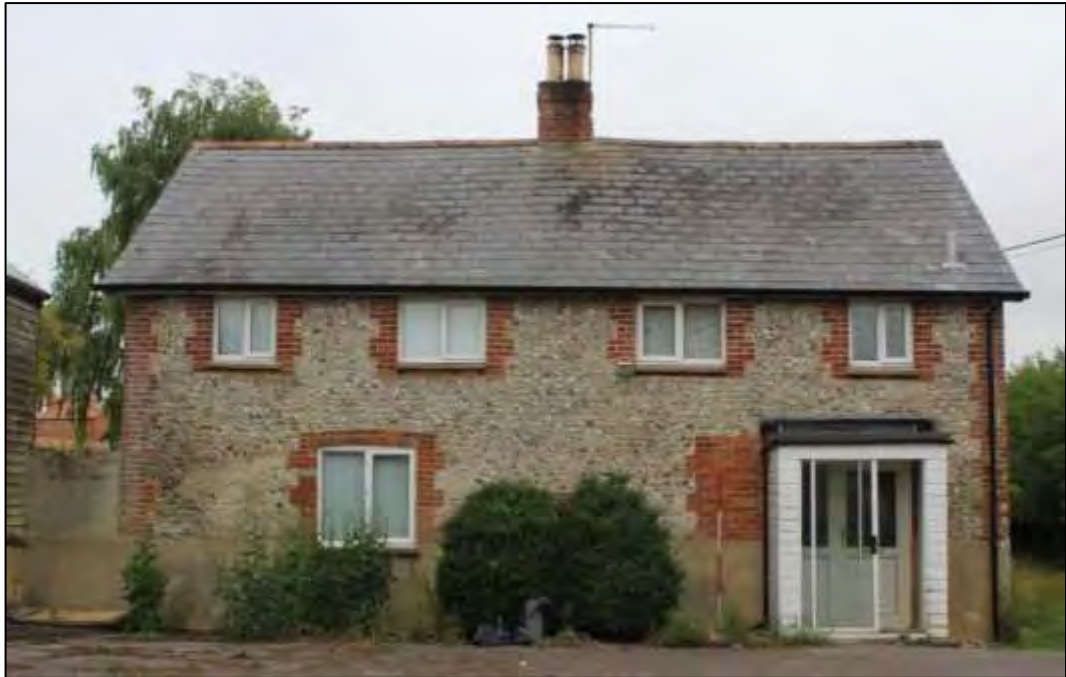
- 4.17. The elevation has been unsympathetically repointed in the past, resulting in patches where the mortar has been slurried over the facing flintwork and in places over the brickwork, especially apparent to the south and around the ground floor window. Sitting centrally on the elevation, planting hides a low-level flint and brick lean-to with a tiled roof; its purpose currently unknown.

Photo 2 Principal (east) elevation

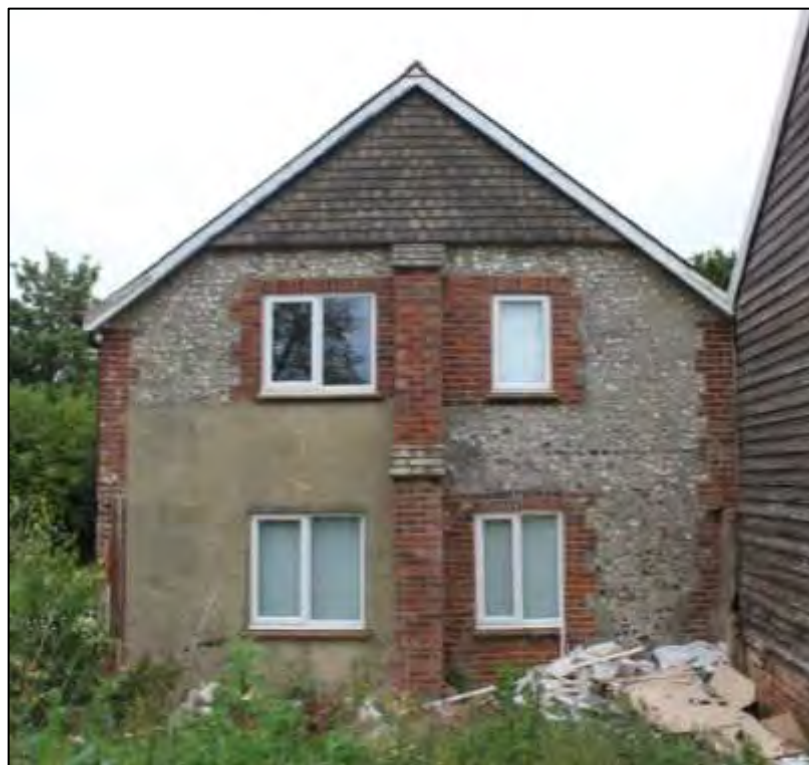
- 4.21. A large amount of building debris was piled at the base of this elevation, which prevented close inspection of the wall. However, brick infill beneath the window suggests a door opening has been reduced. This door corresponds with the location of the door in the north elevation, and is also believed to be the 'back door' to the southern cottage. The window now in this opening has narrower and taller proportions akin to a former door opening and also sits under a cambered arch.

Photo 5 South elevation

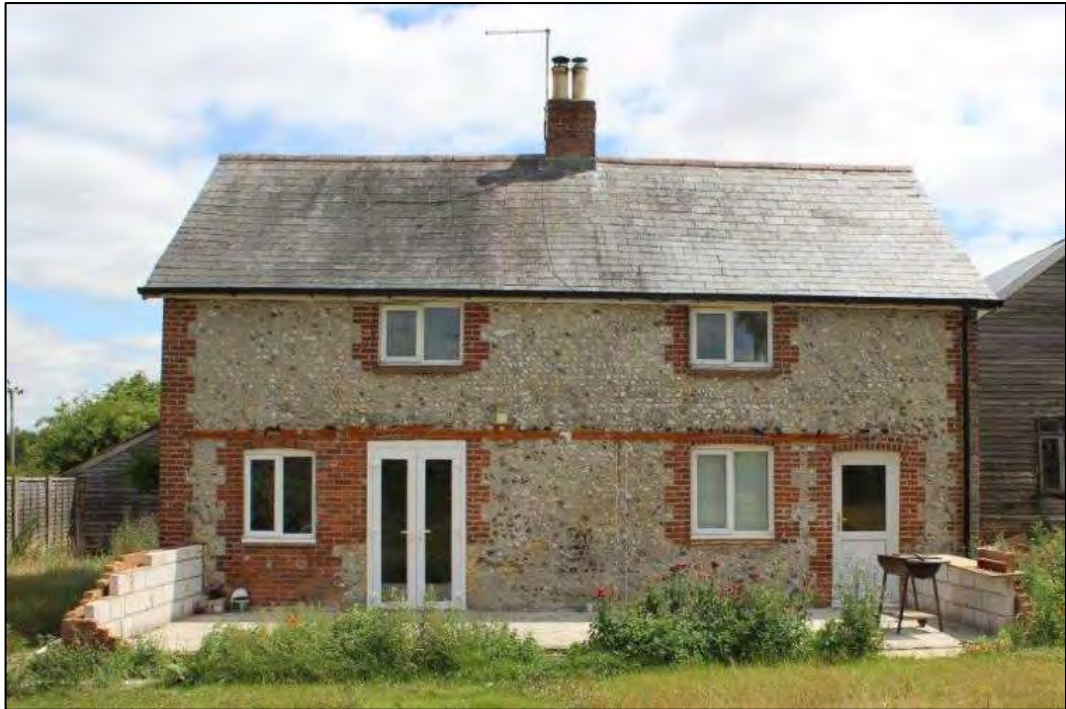
- 4.22. To the rear, scarring on the elevation, together with the concrete pad and remnants of low-level cavity walls, suggests a structure has been removed. Otherwise, the elevation is composed similarly with the front elevation, its symmetry disrupted by later alterations to the ground floor fenestration to the north. The remains of historic brick quoining and brick infill suggest a door where there is now a window, with a former window opening altered to provide a double-door (Photo 6). In its original form, the fenestration of this elevation would have appeared more formal by virtue of the alignment of the windows on the ground and first floors, which also suggests it may have been the 'front' elevation. As elsewhere, the doors and windows are uPVC replacements with storm profiles.

Photo 6 West elevation

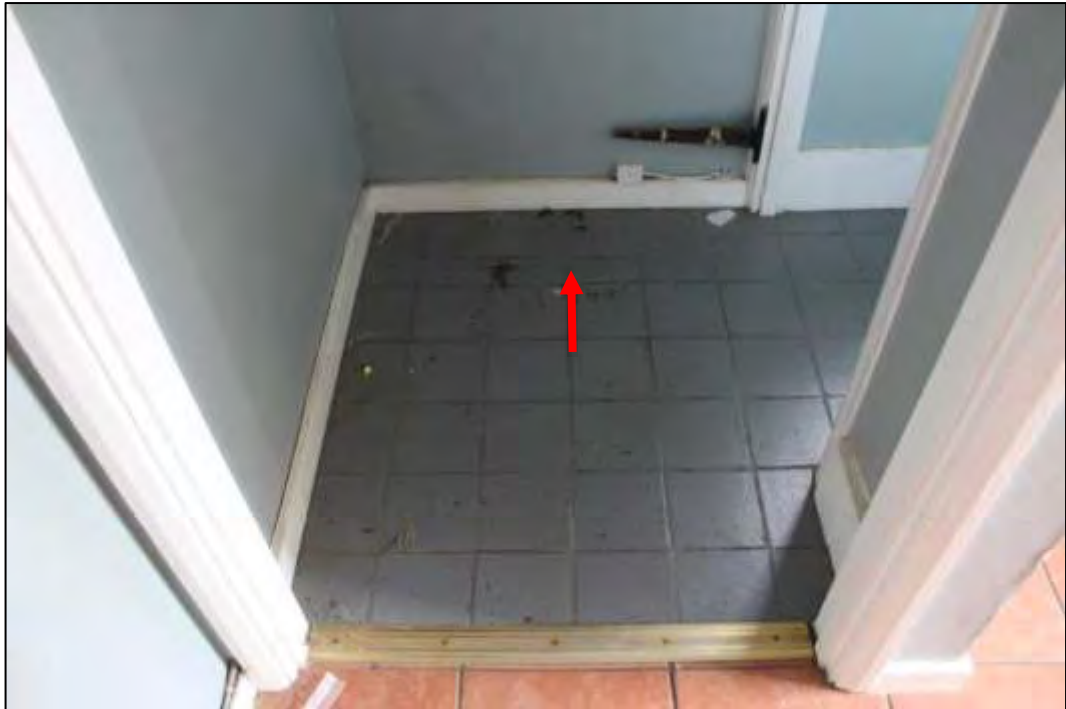
- 4.27. Immediately inside of the entrance, a small WC has been inserted along the north wall, comprising two small spaces. The WC (Fig. 3; **C04**) is reached via a small 'lobby' (**C03**) corresponding with the location of the external door, now blocked. The narrow window adjacent serves the bathroom, and may have been inserted at a later date, though this is not immediately apparent in the external brickwork (see Photo 3, above). The introduction of plumbing may also account for the area of later brickwork below the window (giving the appearance of some rebuilding). The floor is painted tile, with a small inset stone threshold in the lobby, corresponding with the location of the door (Photo 10). This has an early 20th century appearance of a hearth, perhaps in a small rear kitchen, though there is little evidence for a chimney against the external wall. Given the position of the stone, if this were a 'hearth' the chimney would have been built against the external wall.

Photo 10 Lobby to WC, with stone threshold indicated by red arrow

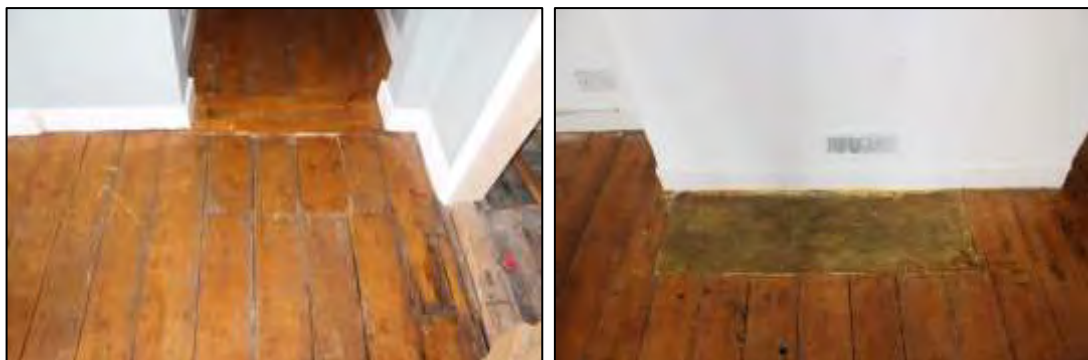
4.34. In contrast to the ground floor, all of the doors are extant at first floor. These comprise timber braced and ledged doors which have been stripped of paint (Photos 17 & 18). The doors have an ad-hoc collection of, presumably reused, hinges and latches which adds to the overall historic character which is more apparent at first floor. With the exception of a small area in the airing cupboard off the hall (Fig. 3; **C13**), the pine floor boards have been stained and have an unfortunate yellowish-orange tint (Photo 19). This treatment has also been applied over the stone hearth surviving in the south bedroom (**C10**; Photo 20).

Photos 19 & 20 Stained floorboards contrasting with the unstained boards in the airing cupboard (left) with stain carried over the hearth (right)

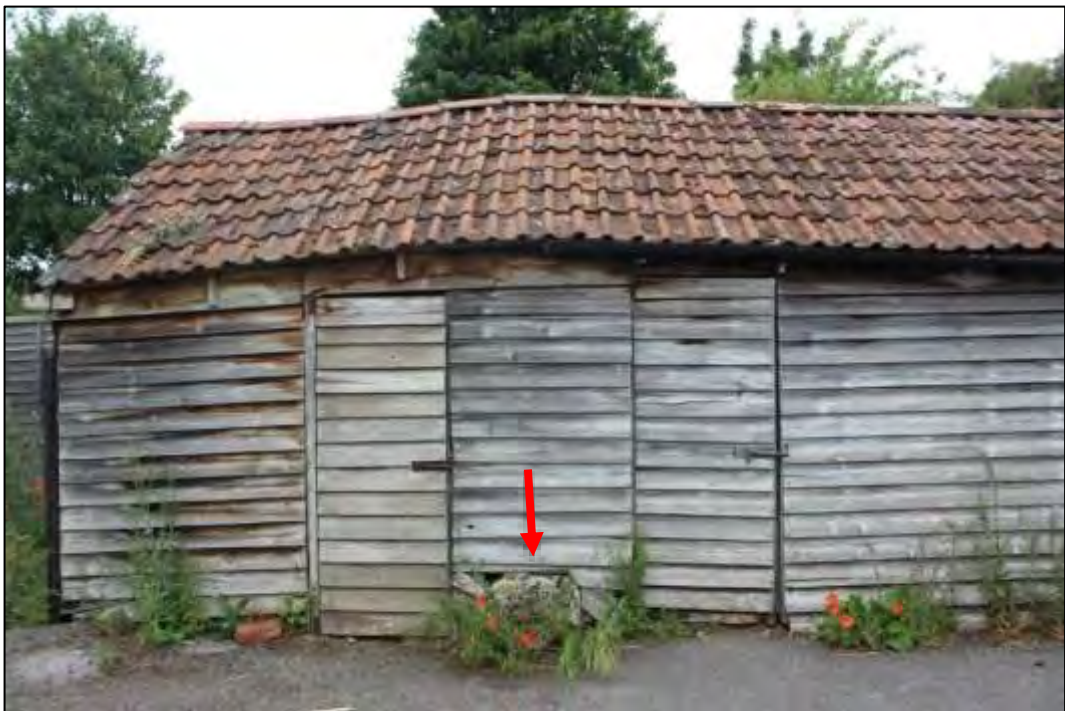
Photo 28 South elevation, with the padstone identified by the red arrow

4.41. Whilst the cladding has been applied over the frontage, the rhythm of the bays can be discerned from the surviving 4no. padstones at the base of the posts, which protrude forward of the cladding (Photo 28). These survive on Frames B, C, E and F as shown in Fig. 4, though B and C represent more complete examples with extant bracing (Photos 29 & 30). Otherwise, the posts appear to sit directly on the concrete floor.

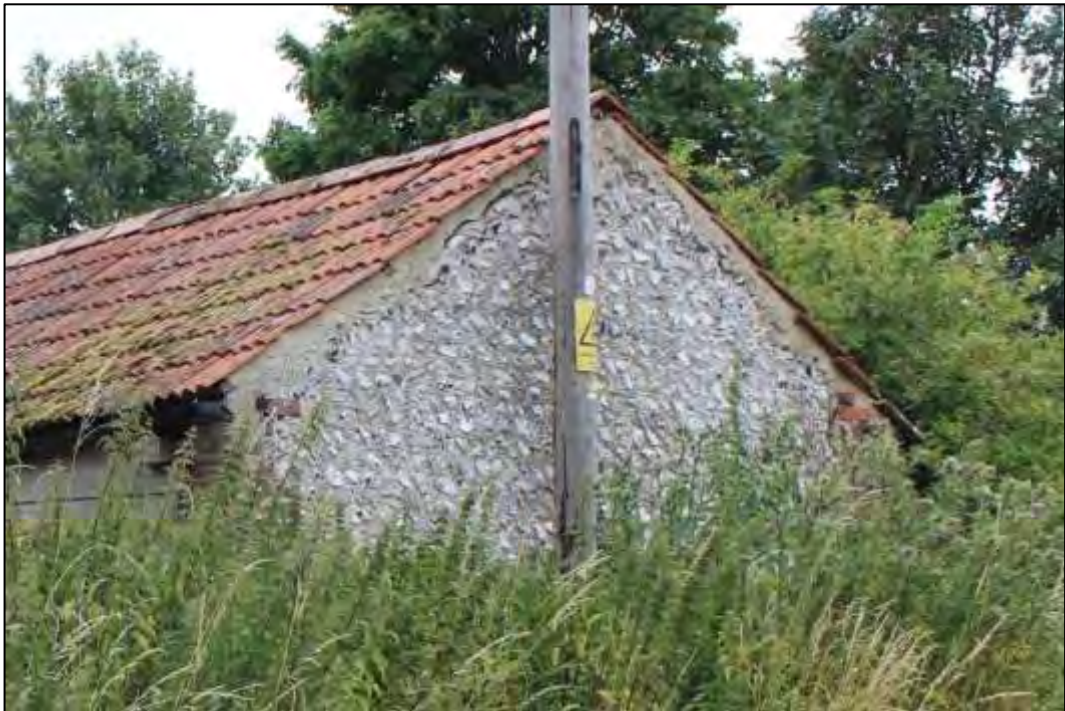
4.42. The verges adjoining the masonry walls are overgrown, preventing close inspection of the rear (north) and east walls of the shed. It is proposed to retain the wall which fronts onto Wellhouse Lane as part of the redevelopment of the site. A substantial crack in the north-east corner, visible both internally and externally, suggests some structural issue, though the corner is reinforced with brick quoins. Mortar has been applied over the verge on the underside of the tile, following the pitch of the gable, with a rather untidy appearance (Photo 31).

Photo 31 East elevation of the shelter shed

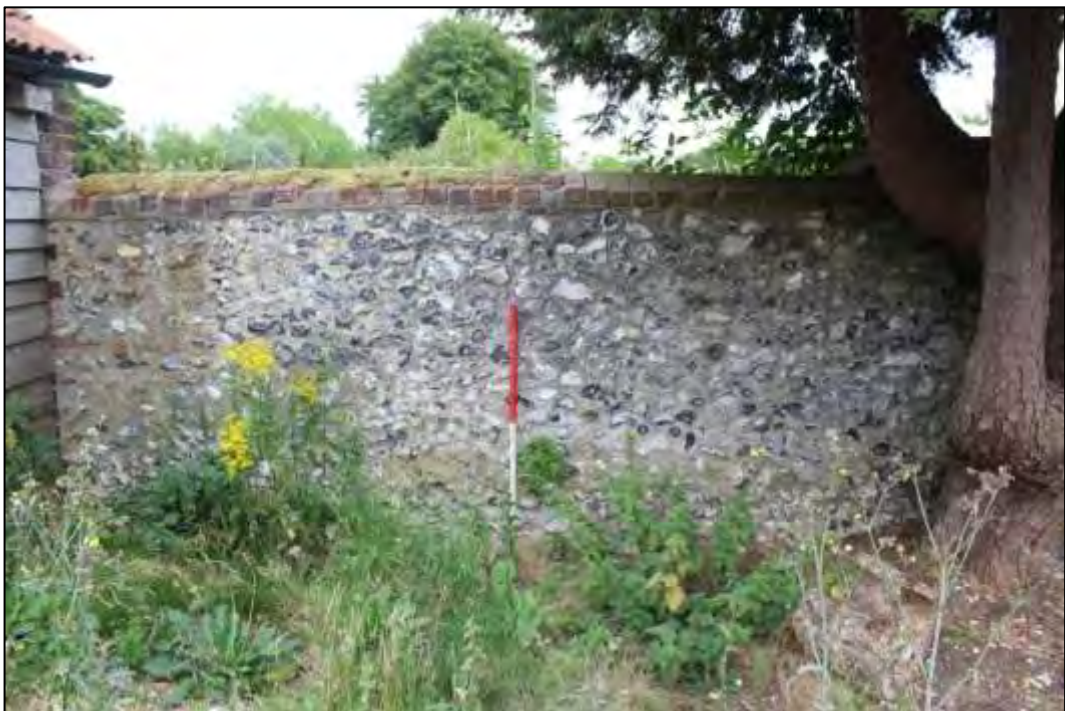
4.43. The shelter shed adjoins a small section of wall with a triangular brick coping (Photo 32). Whereas the flints on the building's elevations are field flints, many of the flints on the inner face of the wall are snapped (i.e. the crust broken off to reveal their 'glassy' interiors). Unfortunately, there has been some poor-quality repointing with mortar smeared over the wall. The outer face of the wall was overgrown but also

appeared to feature some snapped flints, and may have been built at a different stage to the shed walls.

Photo 32 East face of the courtyard wall, adjoining the shelter shed

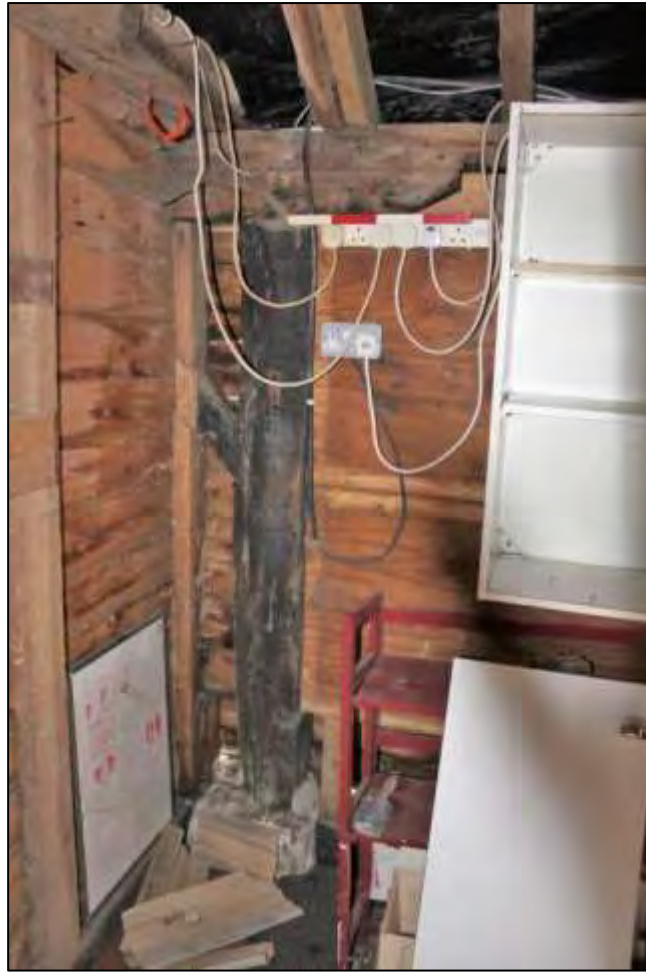
- 4.48. At its southern end the tie does not sit directly over the top of the post, but is slightly offset to the east (Photo 38). In contrast with the post on Frame B, the posts on Frames C – F have been tarred or painted in the past, indicating their exposed nature. A redundant mortice in its north face of Frame C suggests the presence of a N-S brace which would have supported the south end of the tie, but it is unclear whether this is related to this particular frame (as found to the east) or if the timber is reused.

Photo 38 Detail of the south end of Frame C

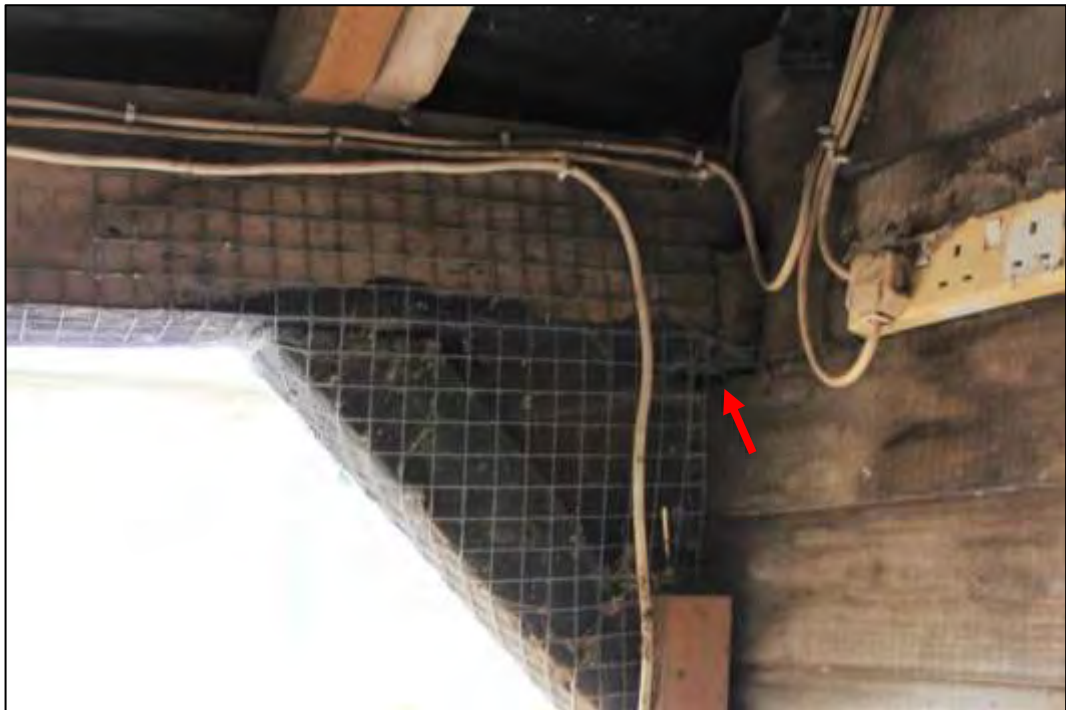
- 4.49. The post on Frame C supports a further junction in the plate, to the east of which there is a more substantial plate with a deeper section than the plate to the west (Photo 39). This is perhaps the explanation for the bolsters, which are more characteristically used to provide additional support to upper stories or where more extreme loads are expected. The remaining posts to the east all directly support the plate, without the use of a bolster, but with extra support to an additional joint in the plate on Frame E (Photo 41, below). To the east, a straight brace (in the E-W plane) supports the underside of the deeper sectioned plate, while the bolster makes up the depth below the shallower plate to the west. The western side of the post has been obscured by a piece of plywood internally and the cladding externally, so it was not possible to tell whether there was a corresponding brace, but this would seem unlikely.

Photo 39 Detail of the post on the south end of Frame C, with junction identified by red arrow

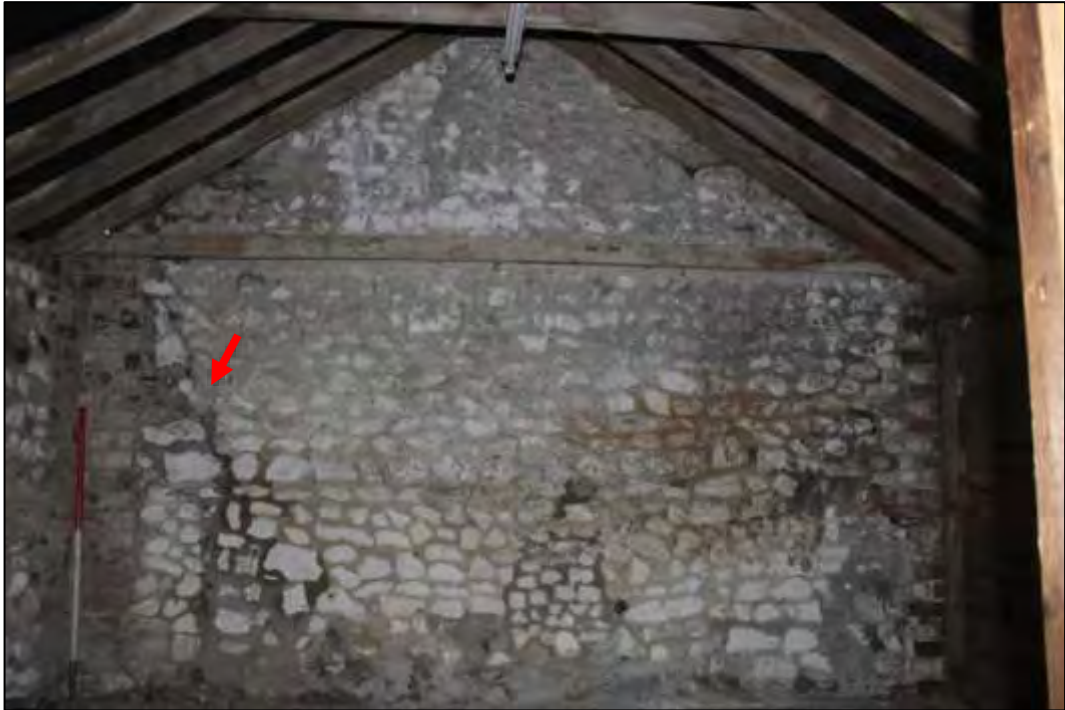
4.53. Bays 5 and 6 are accessed internally from Bay 4. The masonry gable is a prominent feature within Bay 6 (Photo 44) but is showing signs of structural distress in the north-east corner where there is a sizeable crack. Infilling of the south elevation is also readily apparent there, with a simple frame of uprights supporting the external weatherboarding (Photo 45).

Photo 44 Internal view of East masonry wall, with crack location identified by red arrow

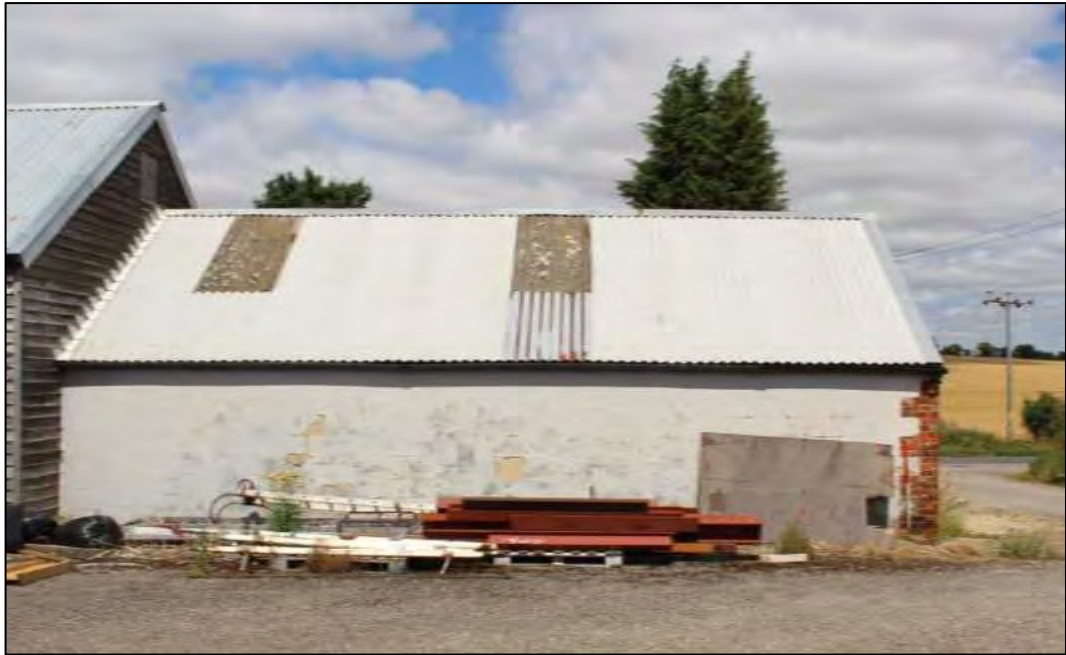
- 4.57. Similar to the north, the south elevation of the smaller element is blind. The colour-washed render is cracking, revealing the pattern of concrete blocks which make up the substrate. The corrugated metal roof has two agricultural style 'rooflights' made up of clear plastic panels, and there are black uPVC gutters.

Photo 48 South elevation of the Warehouse's smaller element

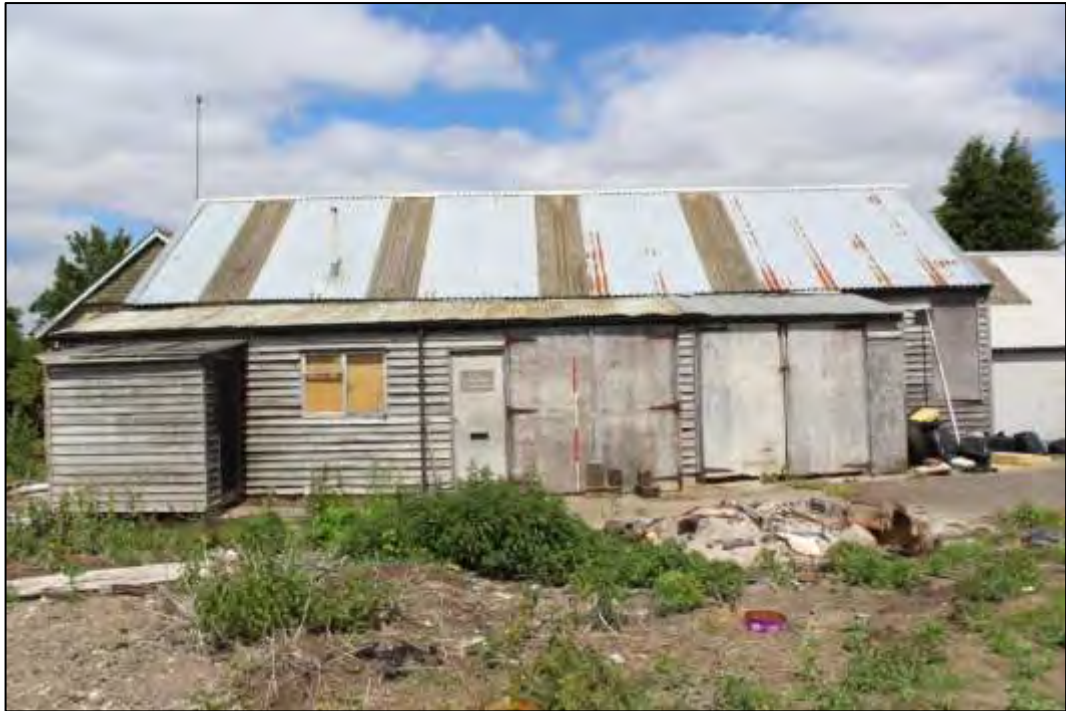
- 4.58. The larger element of the Warehouse features an aisle across much of its south elevation, and a further lean-to raised up on cement blocks towards the west end (Photo 49). The aisle has been constructed in two phases, with the eastern end added onto the end of an earlier aisle. The concrete foundation of the earlier element is visible between the two sets of large doors, and there is an obvious change in the corrugated roof material. This has been constructed over the external cladding of the main element of the Warehouse. As elsewhere, the roof is corrugated metal, with four full-size plastic 'rooflights' evenly spaced at the west end.

- 4.60. The lean-to outshot has a mono-pitched felted roof and is entered from the east. This is a later addition, without the benefit of foundations or a concrete pad, and appears to have been an ad-hoc addition. At the time of the visit, a garden hose was inserted through a small hole in the south elevation, and the surrounding ground was wet and slippery.

Photo 49 South elevation of the Warehouse's larger element

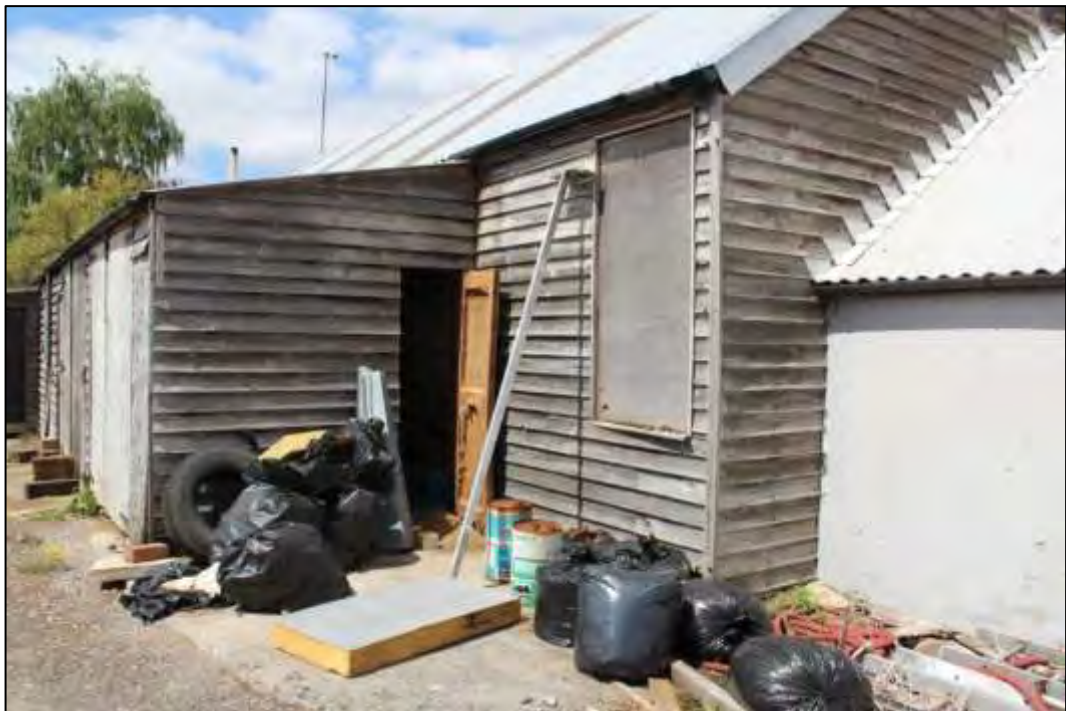
- 4.59. The pairs of doors are ad-hoc, made up of plywood sheets with rusting metal strap hinges. Otherwise the elevations are in the same horizontal, sawn timber cladding as found throughout. A piece of plywood is framed at the eastern end, suggesting a previous opening (Photo 50).

Photo 50 South-east corner of the Warehouse's larger element

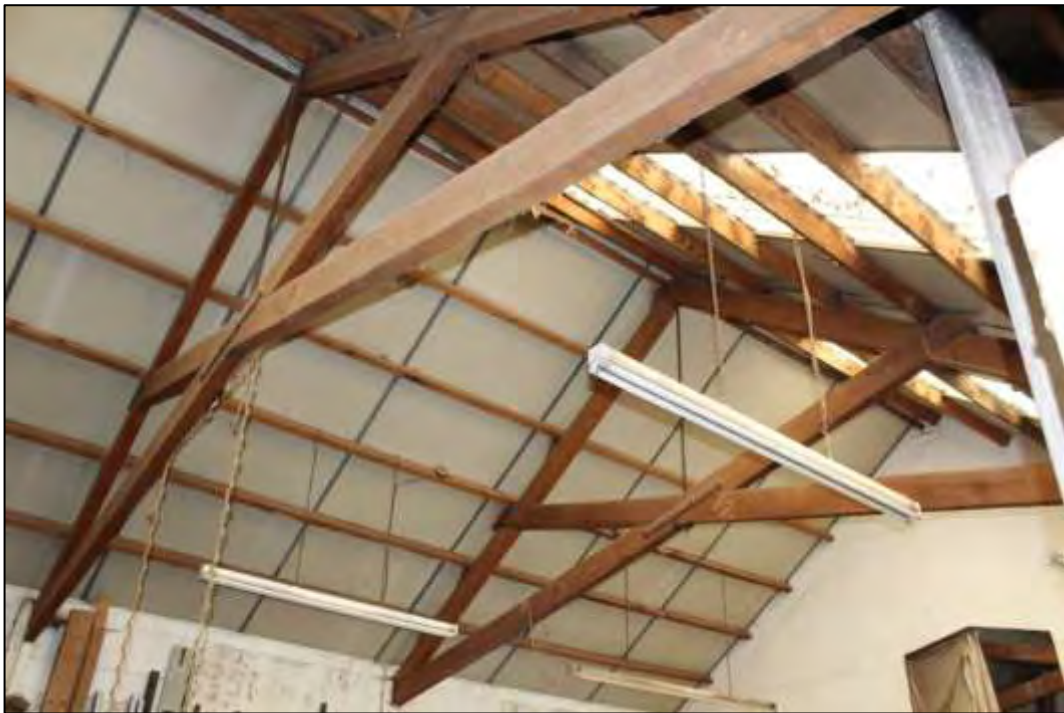
- 4.62. Whilst no planning records could be found to confirm, it is understood that the Warehouse was partially destroyed by a fire in the 1990's, and subsequently re-roofed. The fabric seems to support this, particularly on the interior, but also with the use of concrete block where brick or flint might normally be found.

Photo 53 Scissor trusses in the larger Warehouse element
