THE RUISLIP CHURCH HOUSE (ALMSHOUSES), MIDDLESEX: RESULTS FROM A WATCHING-BRIEF

Colin Bowlt

SUMMARY

This paper gives the results of a survey of a timber-framed building latterly known as 'The Almshouses', Eastcote Road, Ruislip, during its conversion in 1979/80, and its known owners and inhabitants during its 400 years existence. It was originally built as a dwelling house c.1570, converted into ten cottages for the poor in 1616–17, altered in 1939 when accommodation was provided for the sexton, and again in 1956, when modern amenities were installed to avert a demolition order. After years of dereliction the building was restored in 1979/80 and has since been inhabited as four flats and a maisonette. The form of the original structure and the effect of the 1616–17 conversion are discussed.

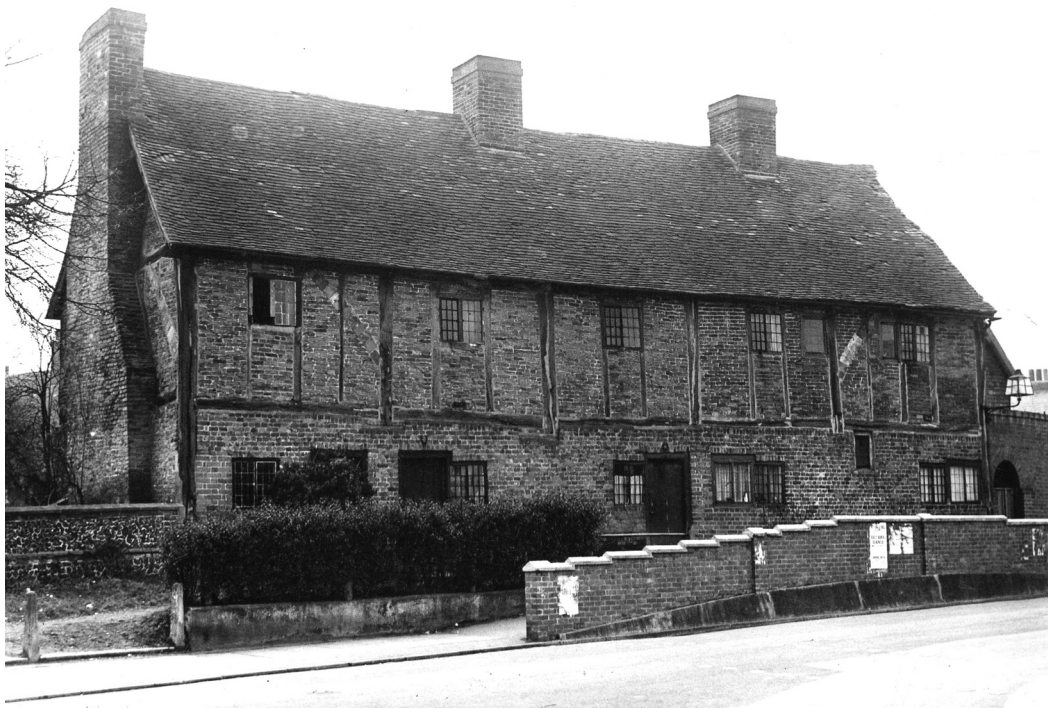
Fig 2. The Church House before the 1979/80 conversion: north elevation facing Eastcote Road

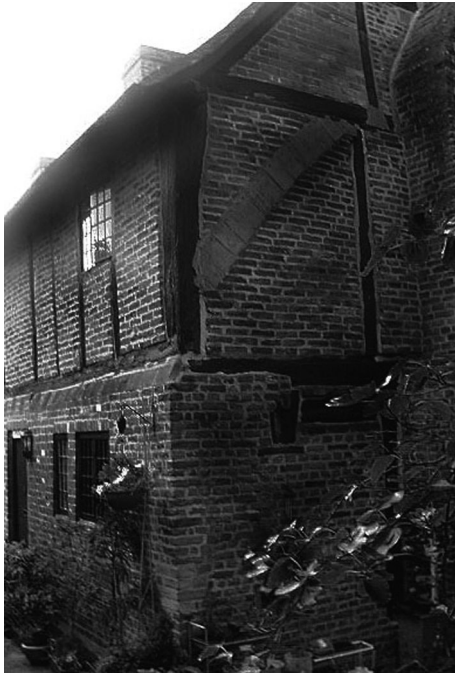
Fig 4. South-east corner showing jowl

The six cross-frames, forming the five bays, are still extant, but the lower parts of the 28cm square main posts have mostly decayed and have been replaced by brickwork (see Fig 2). The external facings of remaining timbers are much weathered and many peg holes have been obliterated. The tops of the main posts have long jowls (Fig 4). The external walls had arch-bracing on the upper storey. It is still in place, from main post to wall plate at two positions on the north side and one position on the south side (see Figs 2 and 5). At the east gable end there are arch-braces between the corner main posts and the tie-beam. The west gable end is similarly braced except that the southern one arises from a stud rather than from the main post. All the bracing is now covered externally with tiles. No evidence remains of bracing to the external walls of the ground floor, except that during recent renogging (1979–80) at the west end a mortice was revealed on the girding beam for a missing brace to the lower part of the north-west main post.

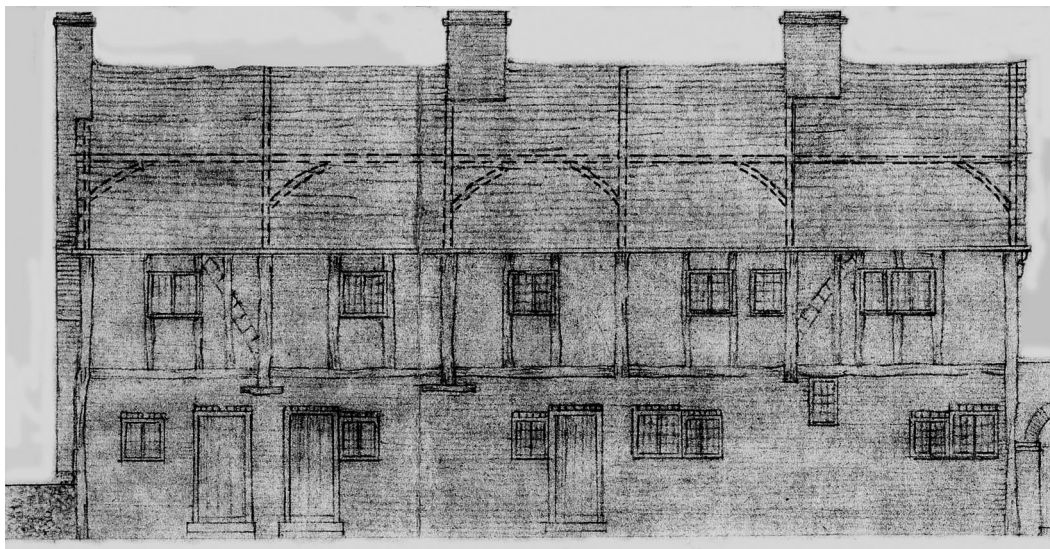
Fig 5. Architects drawing (1949) showing the north elevation with wind-bracing under the tiles added (shown dotted)

In the roof curved wind braces between principal rafters and purlins are positioned symmetrically about the central bay (Fig 5), which would have been visible in the original build since the upper chambers were open to the roof. The wind braces in sections A and H are now hidden behind the later pitched ceilings.

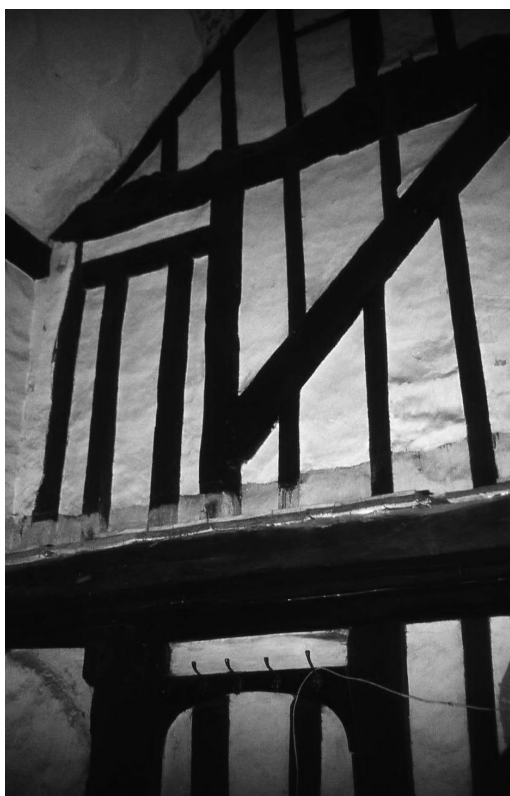
Fig 7. View, looking south-west, of internal wall between hall and service room with floor removed, showing original doorways; these were blocked and the upper room pitched to the purlin during the 1616/17 conversion

and upper floor respectively (see Fig 7). Arch-bracing is present in the internal wall between AB/CD in the upper floor matching that between GH/JK.

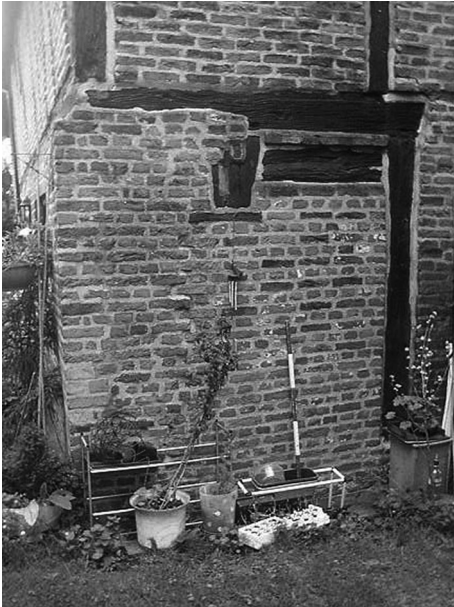
Fig 8. Remains of external doorway of the original building, in the east gable end (20cm scale divisions)

of the remaining long door jamb, still visible inside the building, it seems likely that the original door was in two parts like a stable door (heck door). The rather unusual position in the gable end of a low status door strongly suggests that it functioned as an outlet from the service end of the original building.

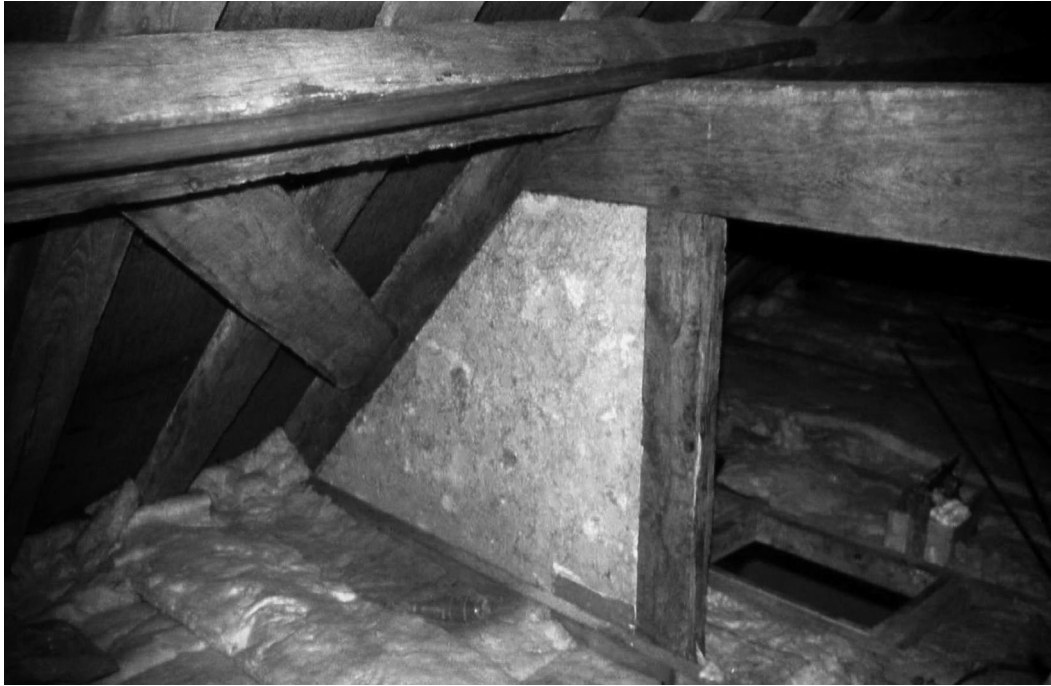
The roof is of clasped purlin with queen struts type and rather simple scarf joints (Fig 9), as is general in most of the local timber-framed buildings. There was no smoke blackening of any of the rafters (they were in remarkably pristine condition and probably original), showing that it had always had a brick chimney, and not a smoke bay originally.

Fig 9. Clasped purlin with queen strut in roof truss (second from east end, looking north-east)

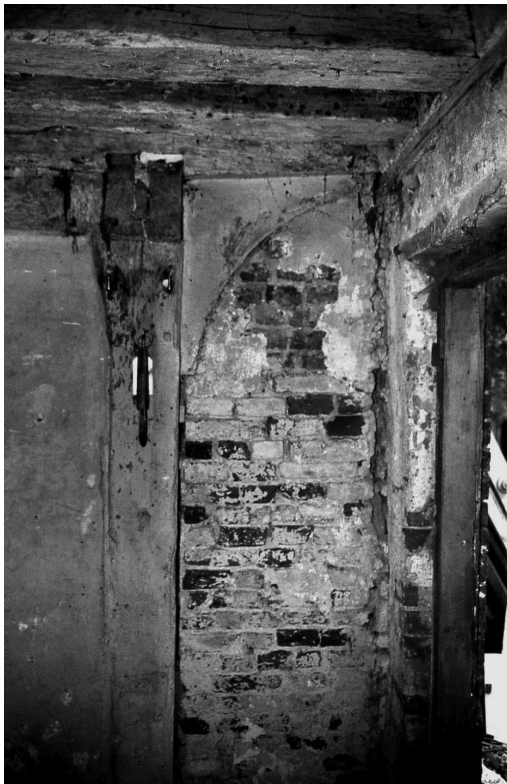
adjoining county of Hertfordshire, at least, had fallen completely out of favour by the end of the 16th century (Smith 1992, 111). The 74cm overhang at Church House was filled in with brick walling at some later period, perhaps during the early 17th-century alterations. During conversion work in 1979–80 the positions of the main posts supporting the originally protruding joists were very obvious and can still be seen externally in the east gable end. One of the original jetty brackets was still *in situ* incorporated into an internal wall (Fig 10).

Fig 10. Infill between H/K looking east, showing jetty bracket, jetty post with slight jowling, and cut end of jetty plate. 17th-century cottage door is on the right

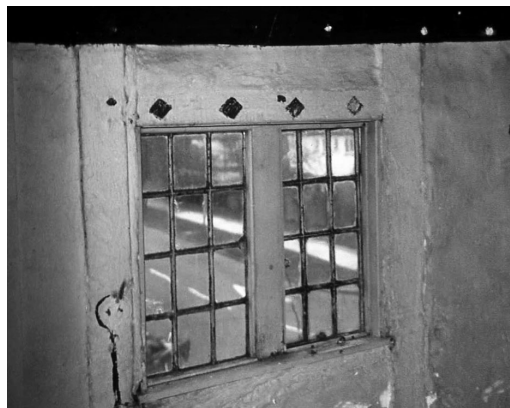
Fig 11. Original window lintel turned through 90 degrees and showing mullion sockets, in upper room of G looking north
