Report 2709

**Historic Building Recording at  
East Week Farm, South Tawton, Devon.**

June 2011

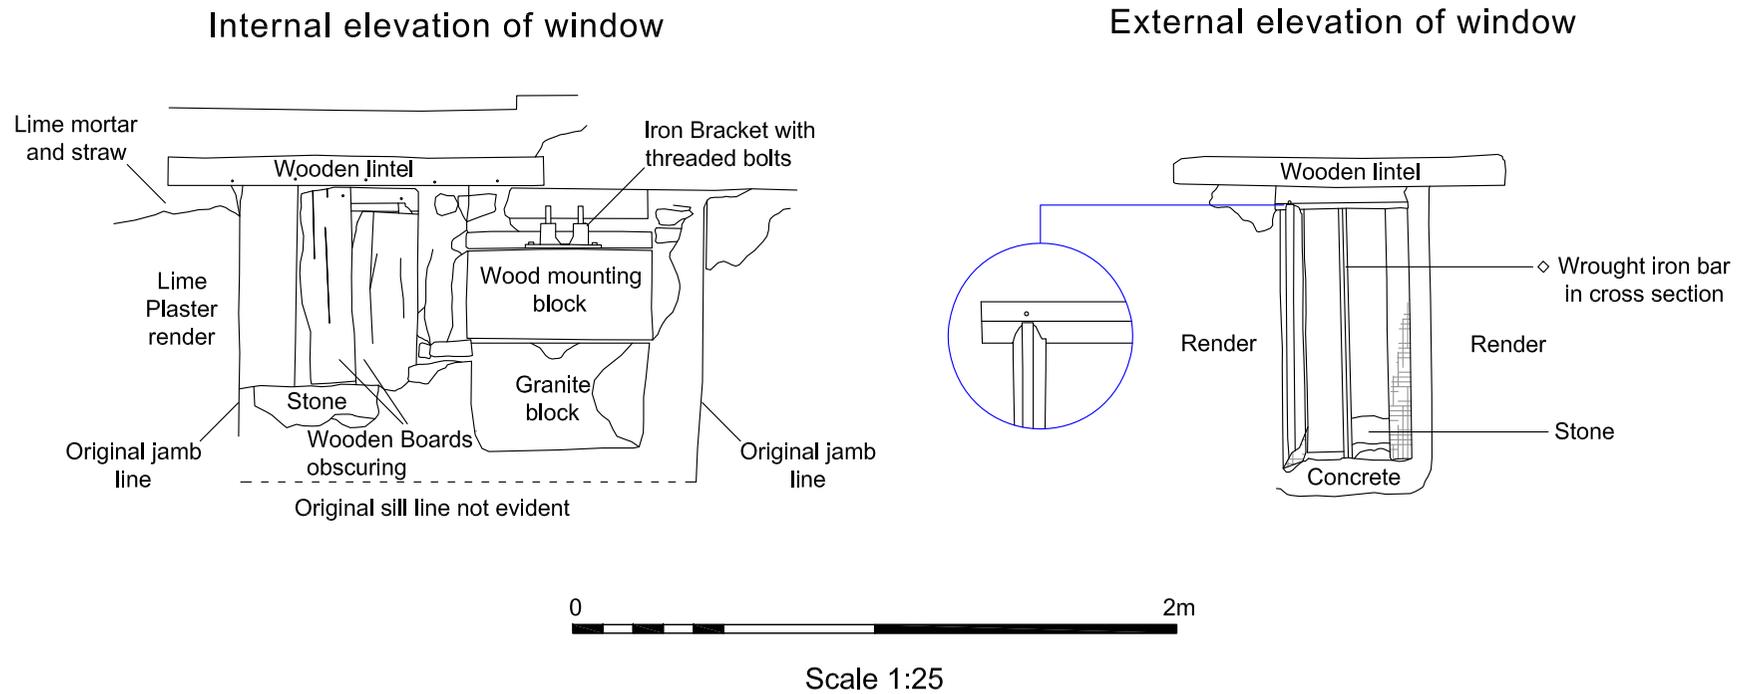
**Figure 3.** Internal and external elevations of window

The window was originally c.1.5m wide x c.1m high, but has since been reduced in width to c.0.4m by stone blocking of the southern section. The existing opening has a timber frame and central wrought iron mullion and it has been boarded up. The original southern jamb is visible as a line in the internal plaster. The northern edge of the window appears to be original and has a flared plastered reveal and it is interesting to note that the later southern reveal has also been flared to match the original north side. The timber lintel does not extend across the full width of the original window and appears to have been put in when the window was reduced in size.

The stone blocking has been externally rendered and internally lime washed. A large projecting granite block with a rounded end appears to have been incorporated into the blocking at some time and this supports a squared timber block with a large iron fitting, which appears to have been lined up with a hole and timber in the opposite wall. The timber block is secured in place by a concrete block. It is unclear if the granite block was put in to deliberately support the timber block or whether it was an existing feature. The original purpose of the timber block and iron fitting is uncertain, although it would have provided an incredibly secure anchor point.

The granite block has a notch carved in the top surface that does not seem to relate to its use as the support for the timber block and its size (c.0.35m thick) and projecting form do not seem consistent with its use as a sill in the original window. Therefore, it is most likely that it has been reused from elsewhere. It is possible that further details on the block may be revealed if it is removed during the renovation works.

In general the window is in relatively poor condition, with the timber frame being fairly rotten and the external and internal wall finishes needing attention. The presence of a nest of bees is also a consideration as it is likely to be in, or have created, a cavity in the wall, which may be of some size. Relocation of the colony rather than eradication may be recommended.

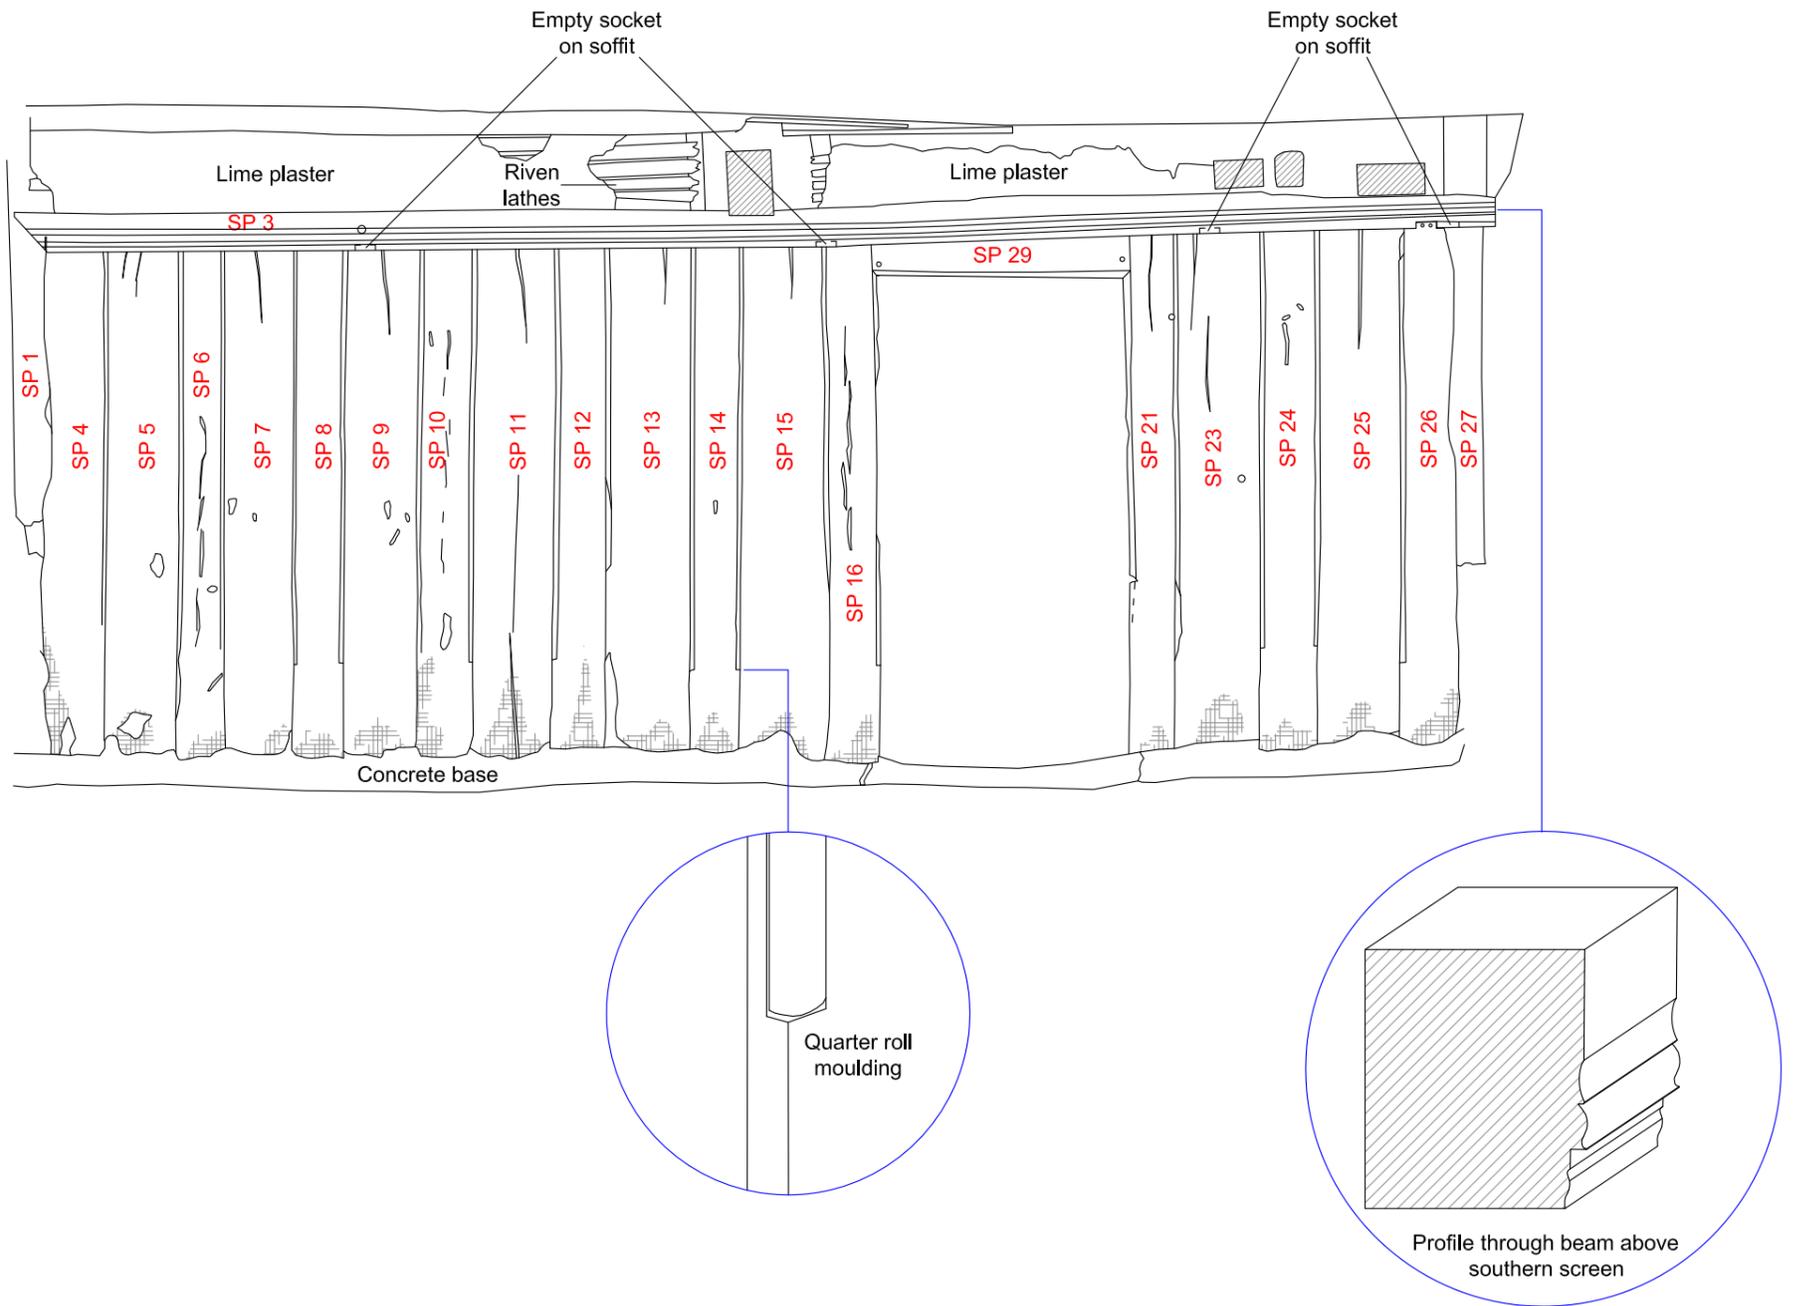
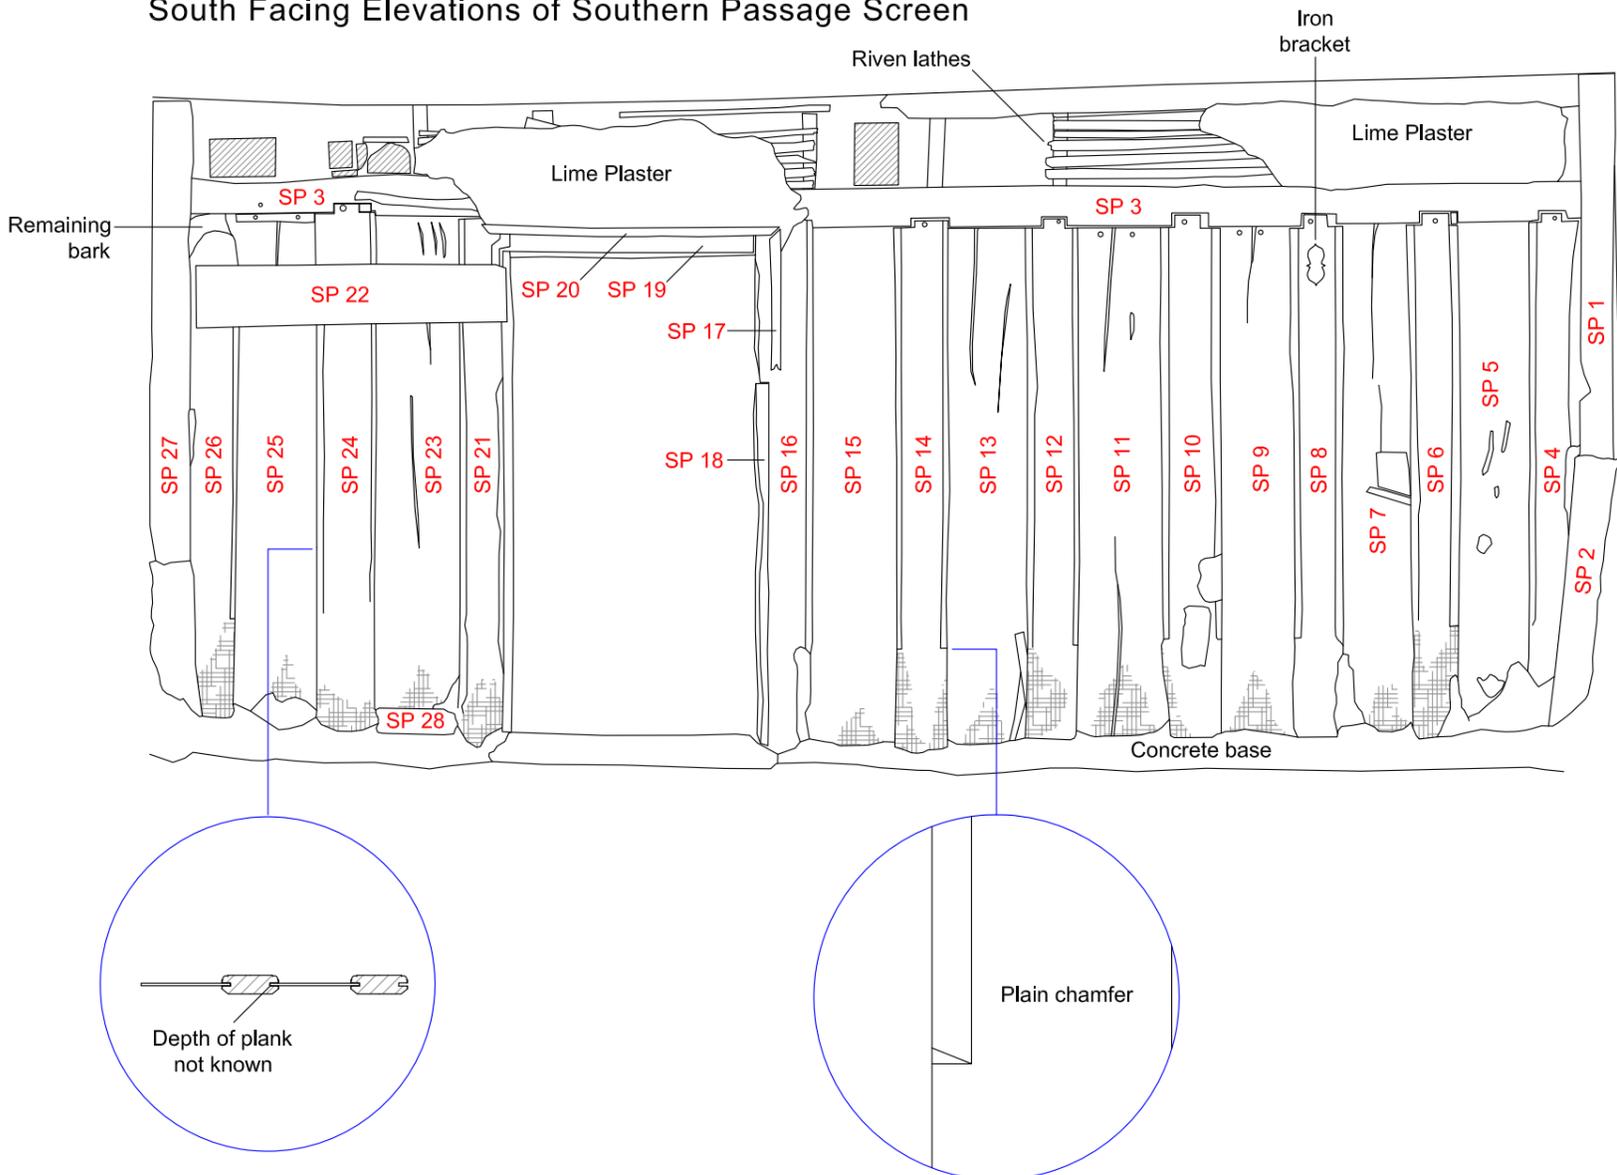
**Figure 4**  
North Facing Elevations of Southern Passage Screen

Overall the screens are in fairly poor condition, with large areas cracked and rotten, particularly along the bottom as the bases have been encased in concrete. There has inevitably been some movement in the screens as the timbers have degraded and the floor above has settled. None of the timbers can be reused in their current state and their removal for repair should take into account the different type of fixings used in the screens: the earlier northern screen has pegged mortise and tenon joints where it meets the head beam (NP4) and the later southern screen has been fixed using iron nails.

It is doubtful that any of the timbers will be completely reusable and many will need to be partially or completely replaced, so, given the significance of the screens, it may be desirable to identify the replaced areas somehow (by colour or material?) in order to highlight the important surviving sections.

It is recommended that as the screens are dismantled, details of their construction should be recorded and added to the existing survey drawings.

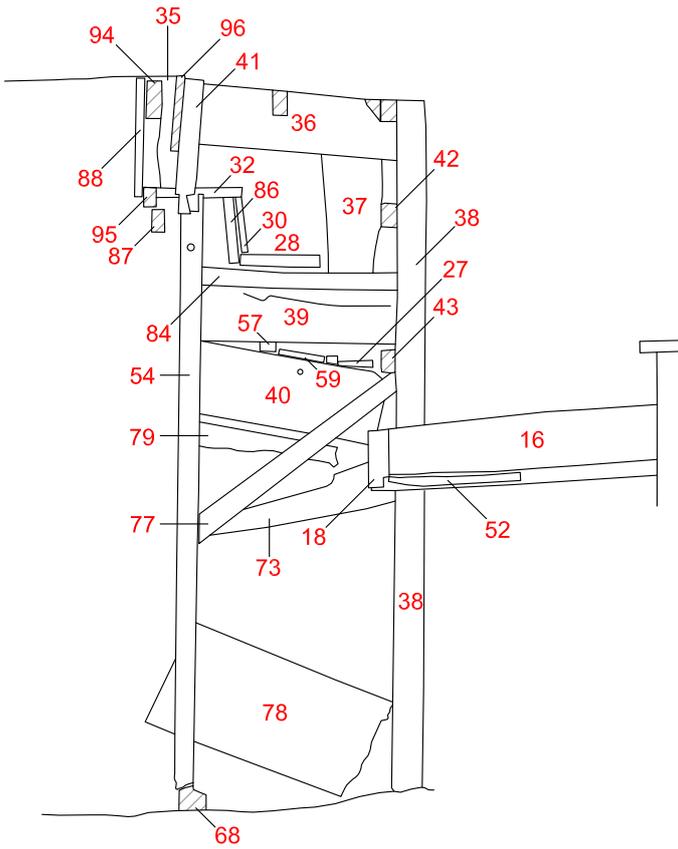
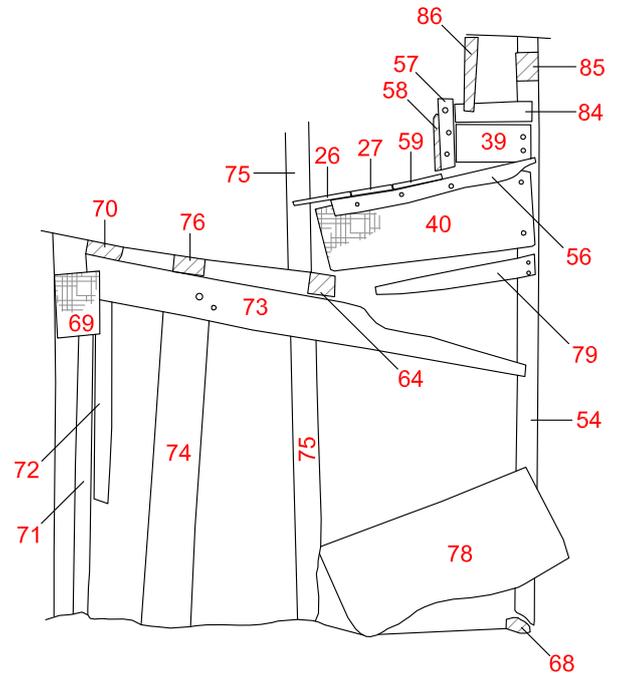
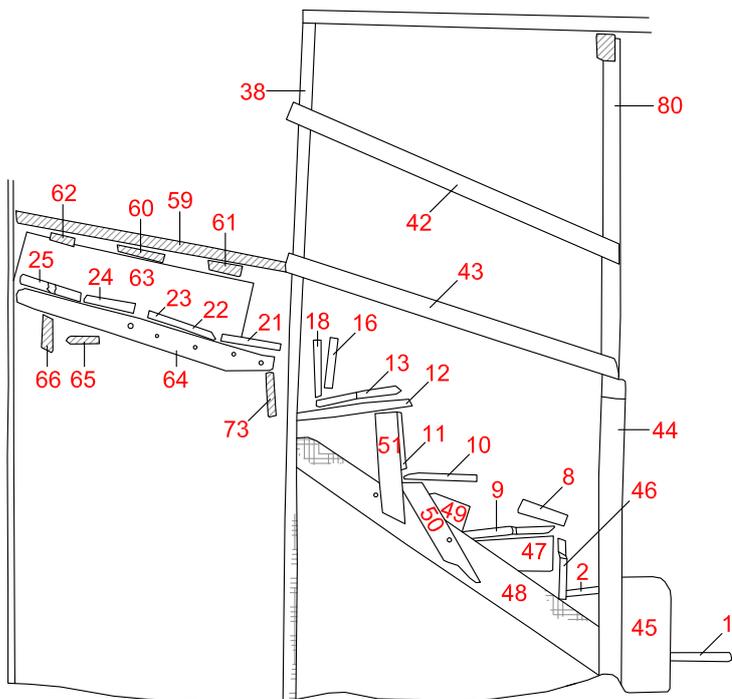
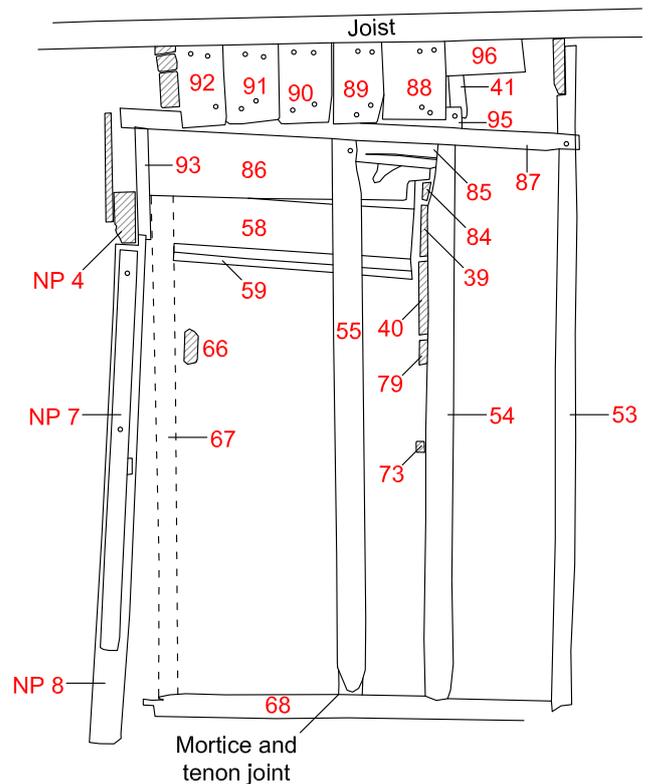
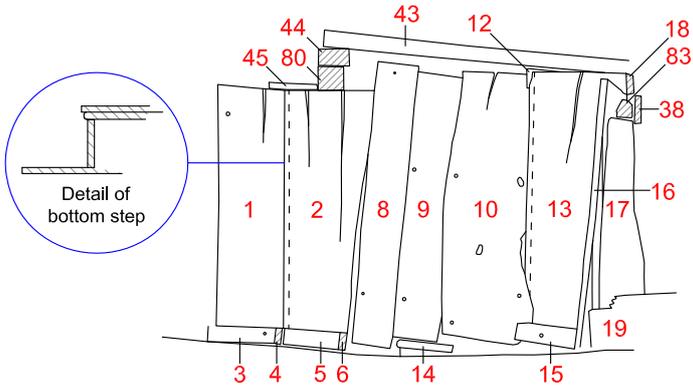
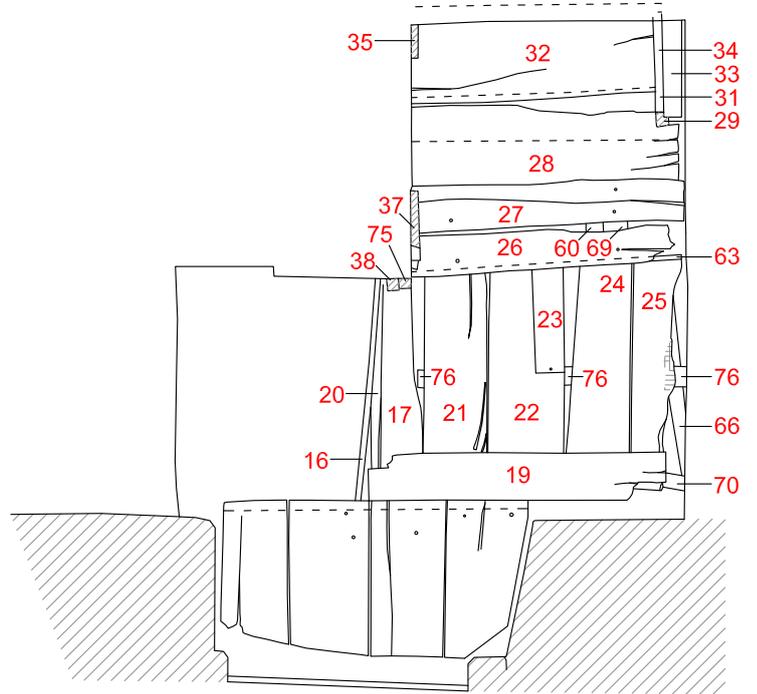
There are no significant features on the surviving staircase and most of the timbers are rotten and will need replacing or substantial repair. Given the doubt over the dating of the stairs there does not seem any reason to rebuild the stairs like-for-like, but the location of the stairs is significant and should be maintained if at all possible within any redesign. If a like-for-like staircase is required the individual timbers in the structure have been numbered to allow their removal repair and reconstruction.

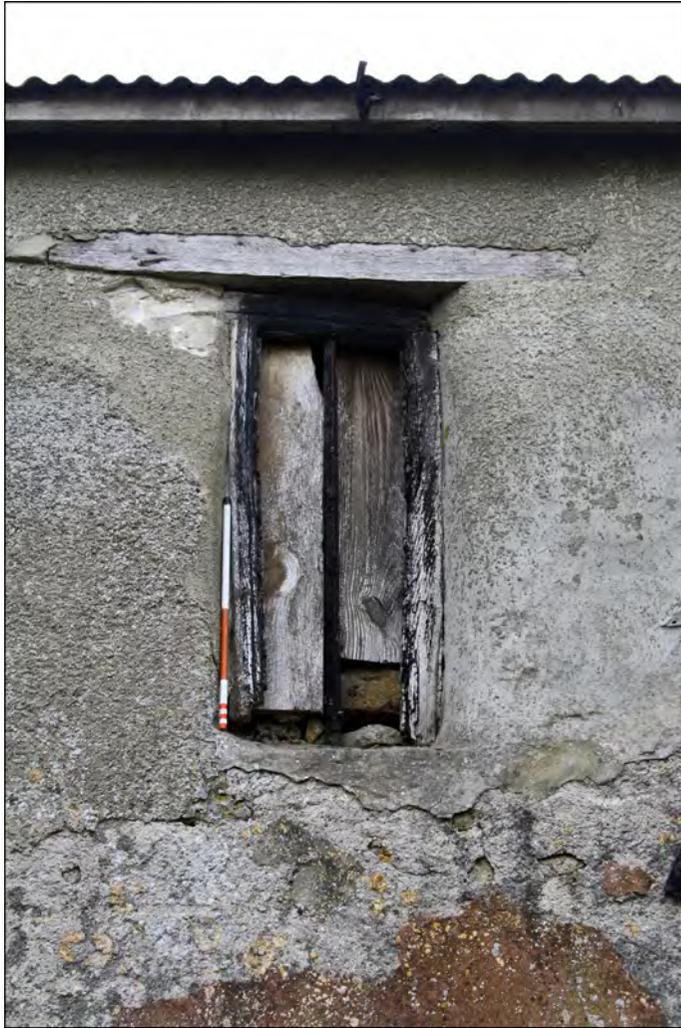
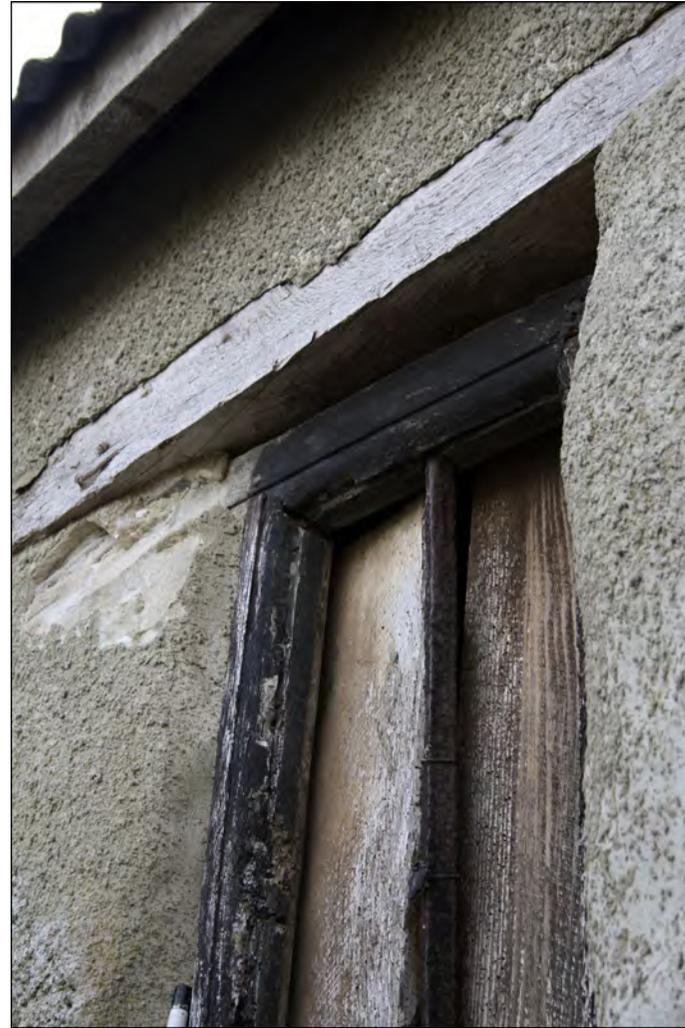
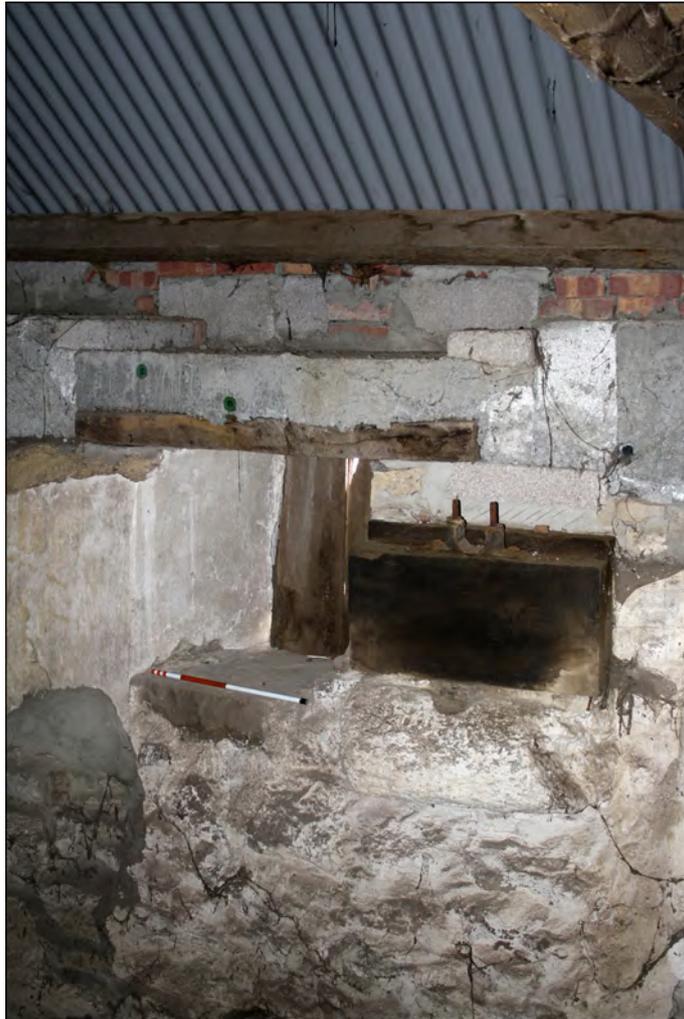
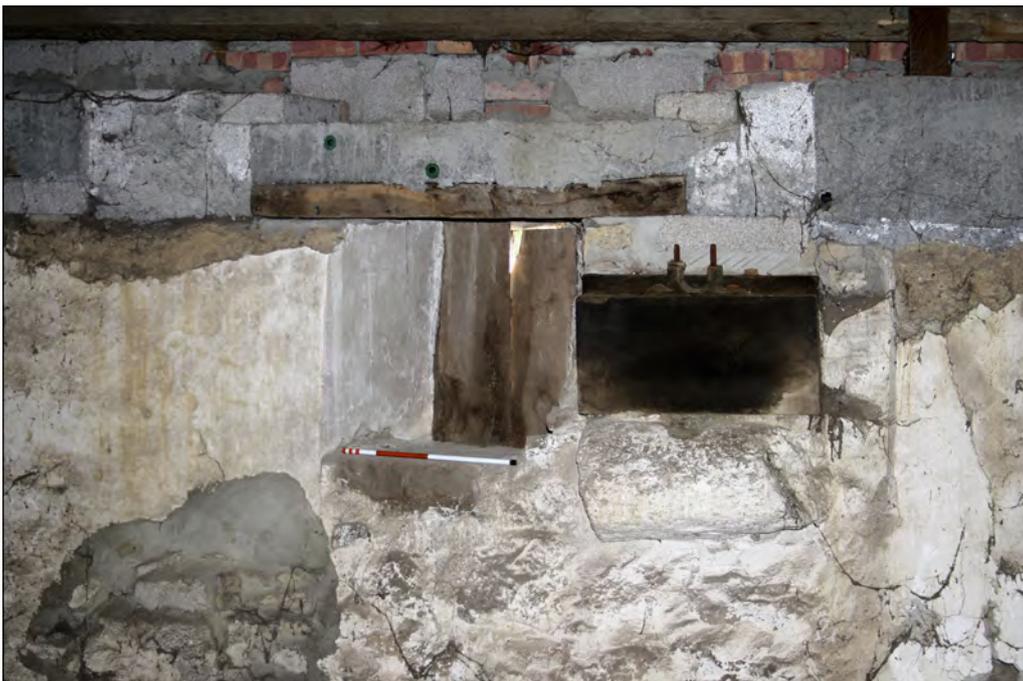
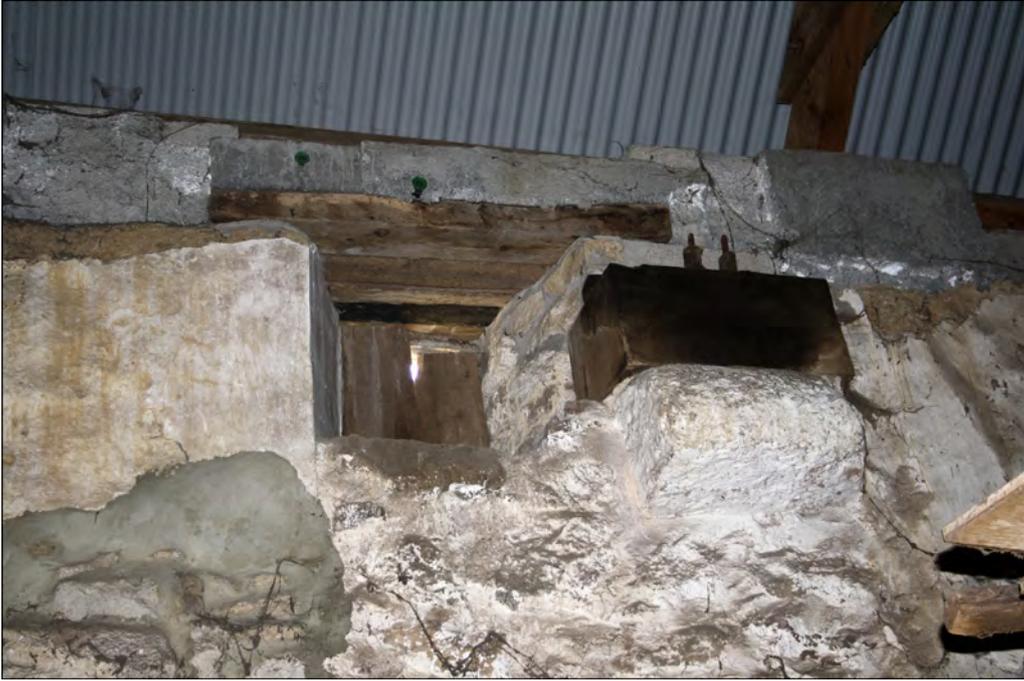
Plate 1. External view of window, 0.5m scale

Plate 2. External view of window, detail

Plate 3. Internal view of window, facing east, 0.5m scale

Plate 4. Internal view of window, facing east, 0.5m scale

Plate 5. Internal view of window from below

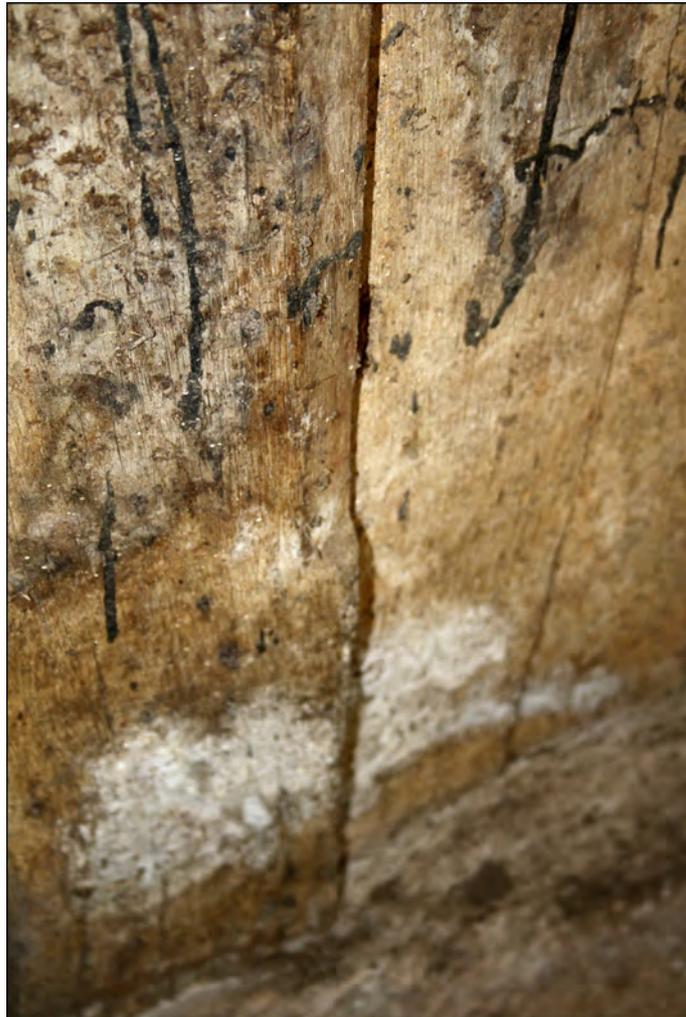
Plate 10. Worn chamfer on south screen, south elevation

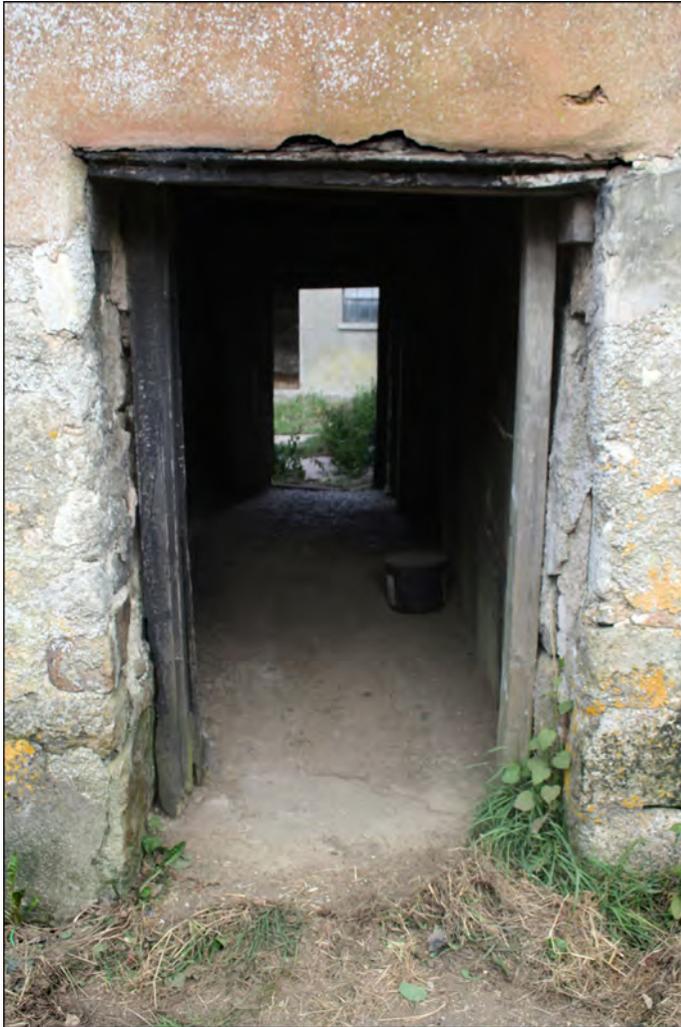
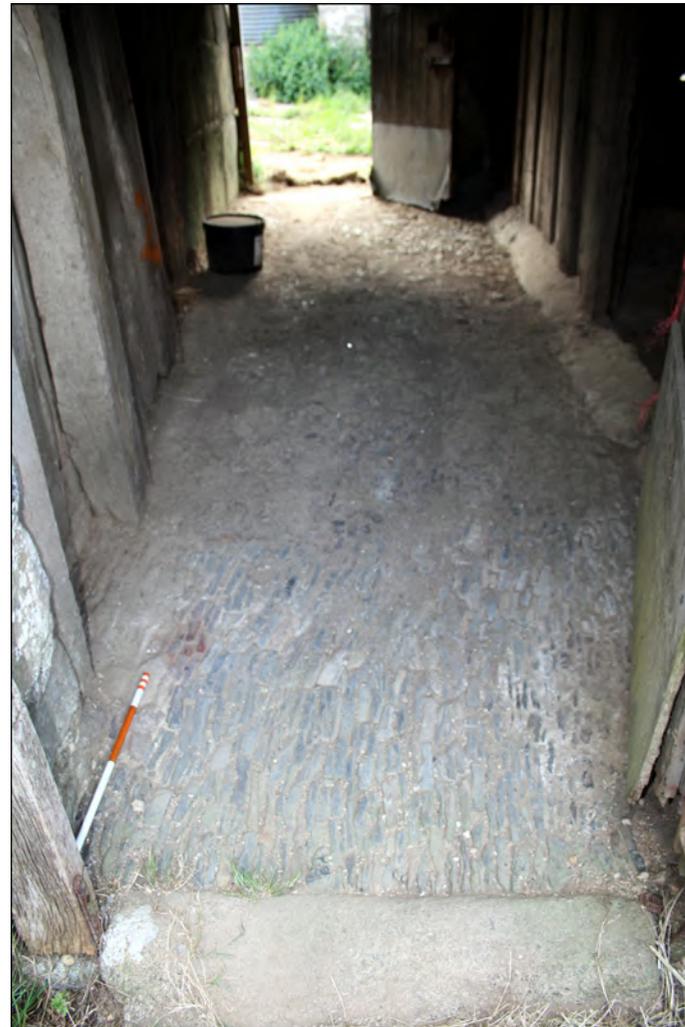
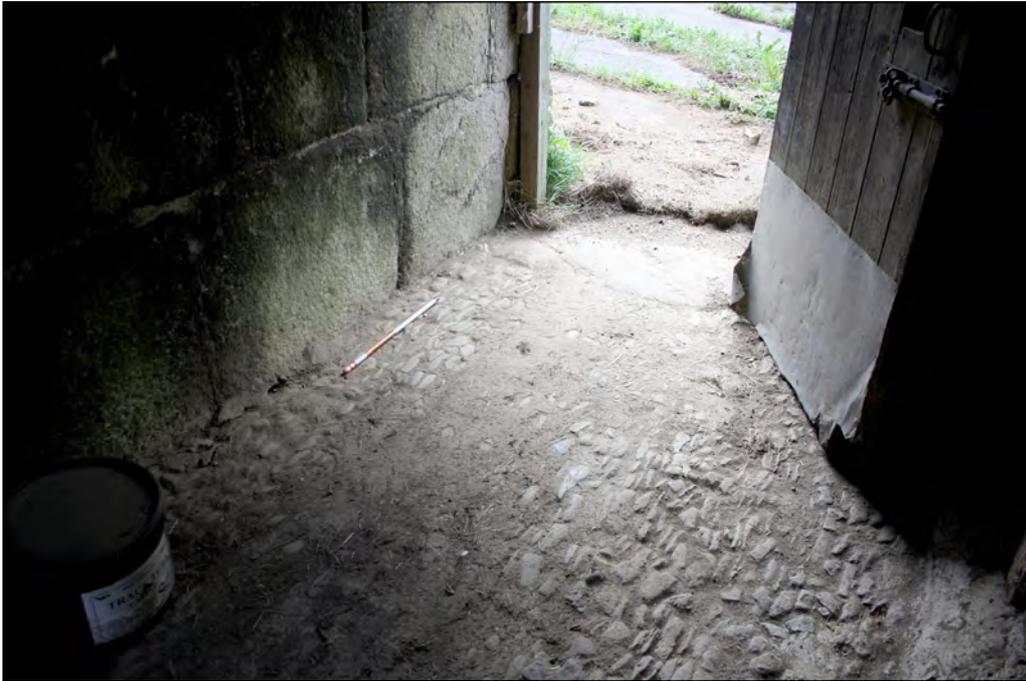
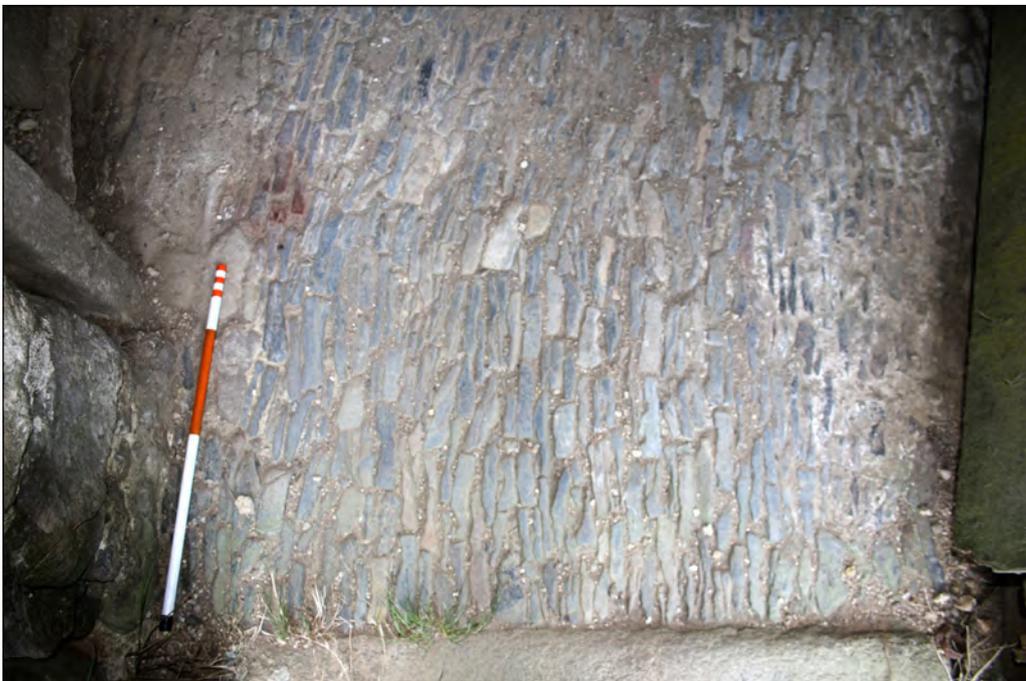
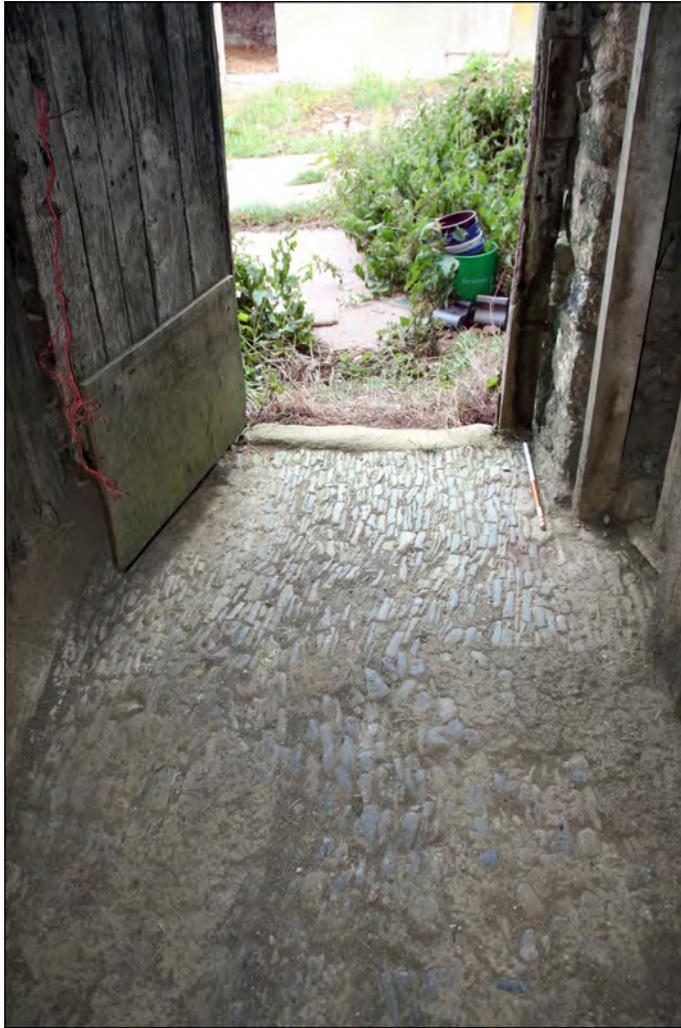
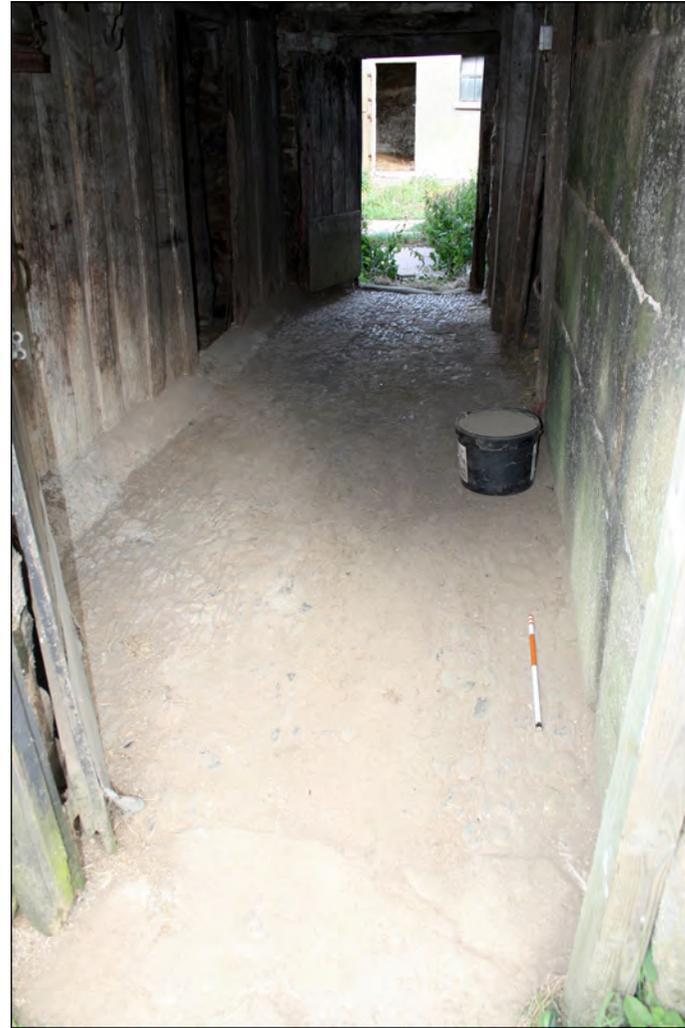
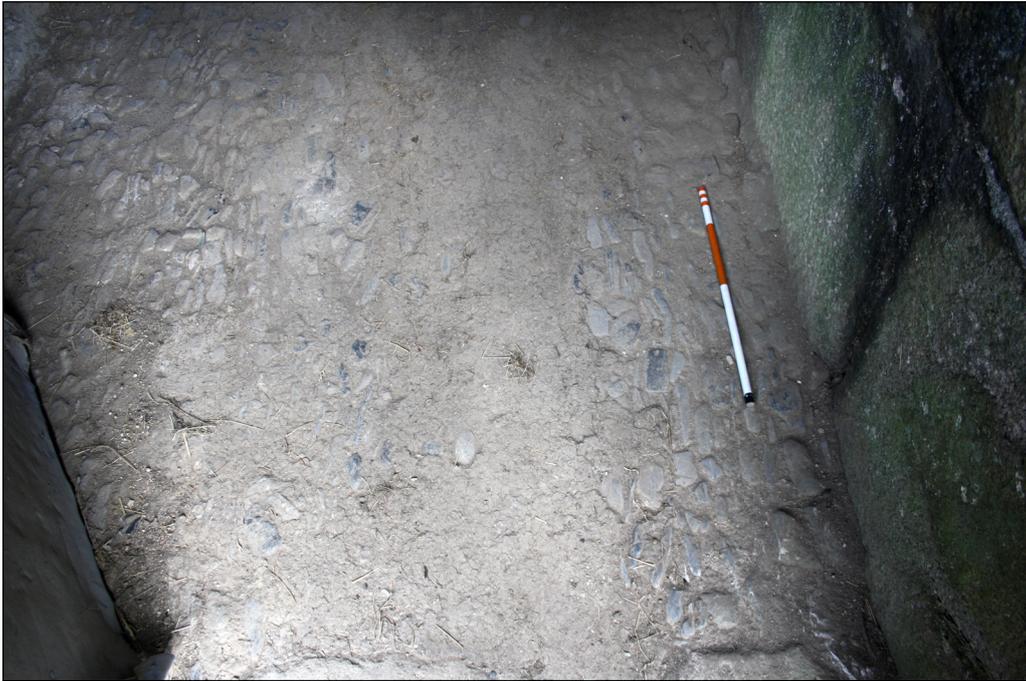
The cross passage floor dates from the 17th-century, possibly part of the late 17th-century remodelling, and consist of tightly packed pitched stones, with possible later repairs of loose-packed cobbles towards the east end. The floor is in fairly good condition and is to be retained in any refurbishment. It is currently covered by a layer of accumulated soil, dust and debris, which has probably protected it from recent damage.

There may be some areas of the floor that will require attention during the refurbishment, but it is felt that this will be minimal and largely superficial, so the character of the floor will be retained and it should be possible to emphasise the phases of construction.

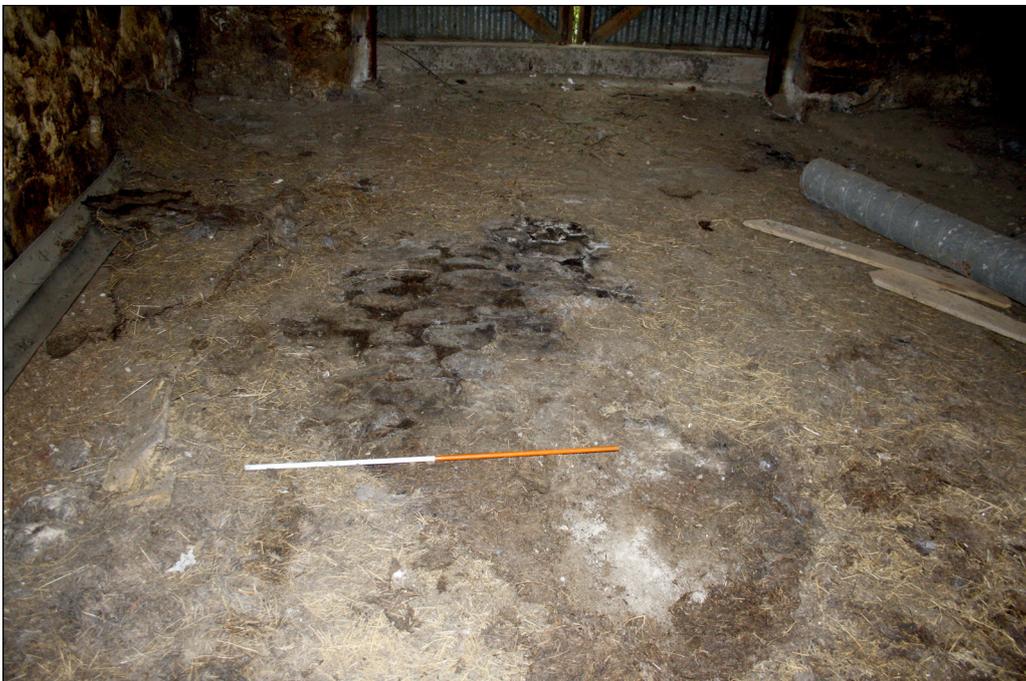
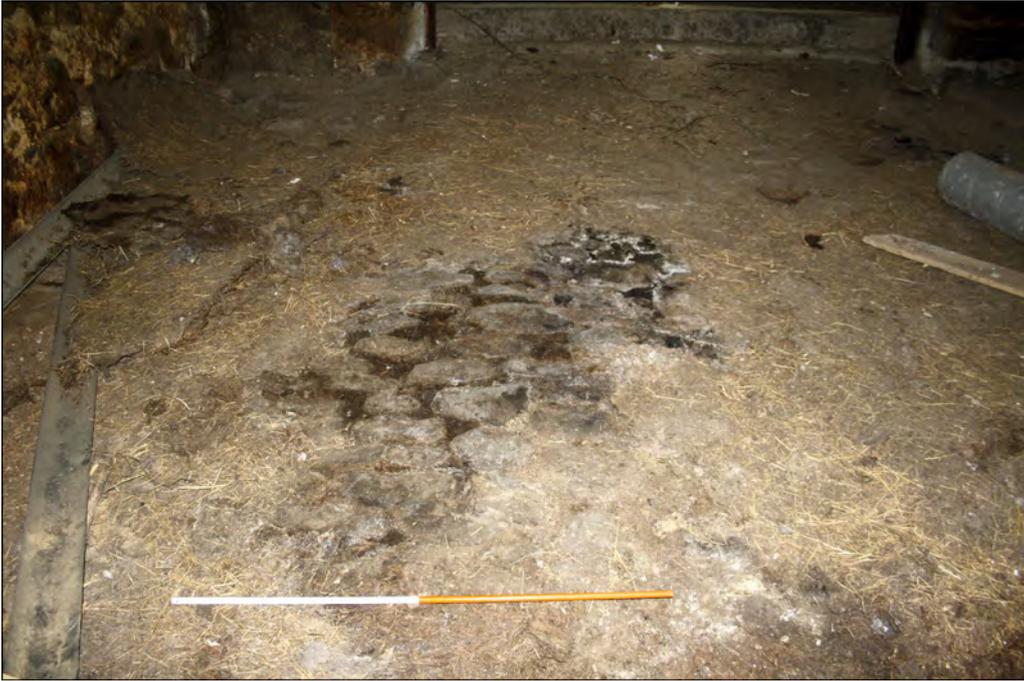
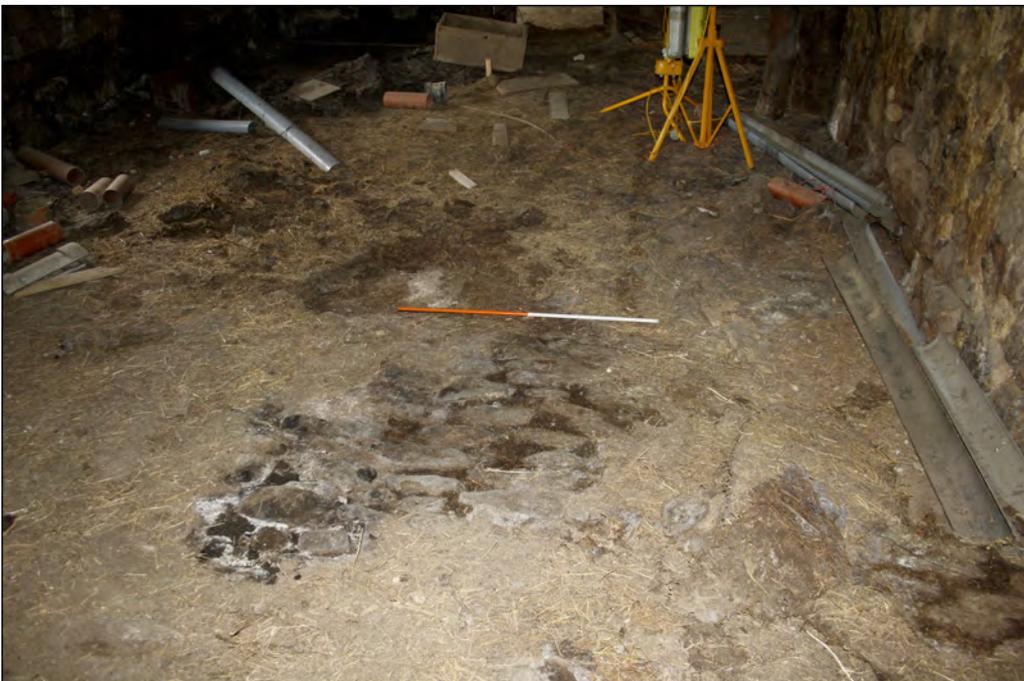
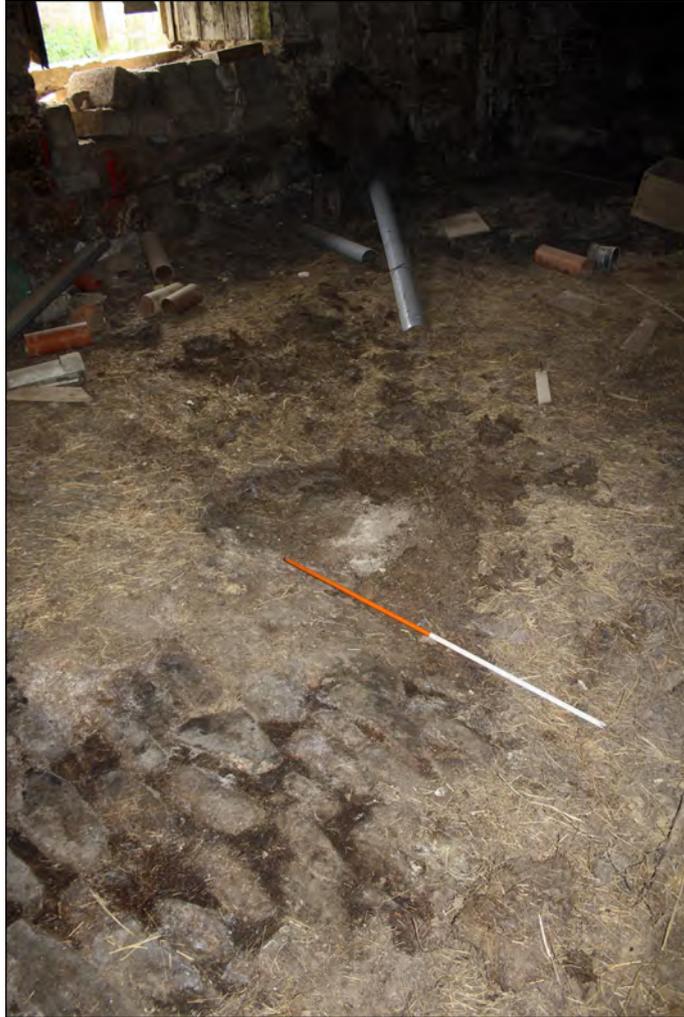
The floor is an important part of the structure, but unlike the passage screens, for example, it was built for convenience and not as a 'feature'. Therefore, even though it is to be lifted and re-laid it is not considered necessary to produce a detailed stone-by-stone record of the floor as using the same stones will retain the character of that part of the building. A photographic record of the floor after clearing and cleaning the floor and lifting the concrete that is present (if feasible) should provide an appropriate record of the floor.
