#### Report 2774

# Archaeological Watching Brief at the Church of St Mary the Virgin, Church Road, Yelverton, Norfolk

ENF128742

June 2012

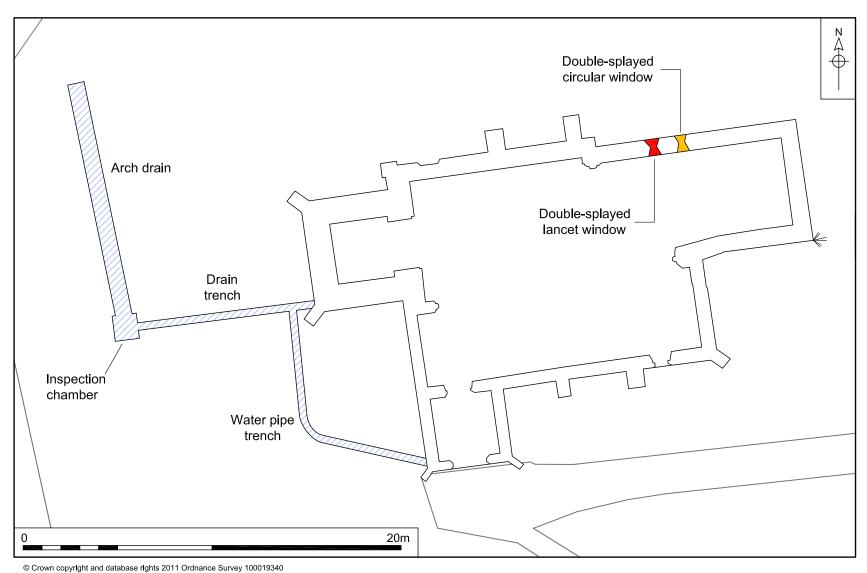
Figure 2. Plan showing location of external works and double-splayed windows. Scale 1:200

Three trenches were excavated; for a water pipe, drain and arch drain (Fig. 2).

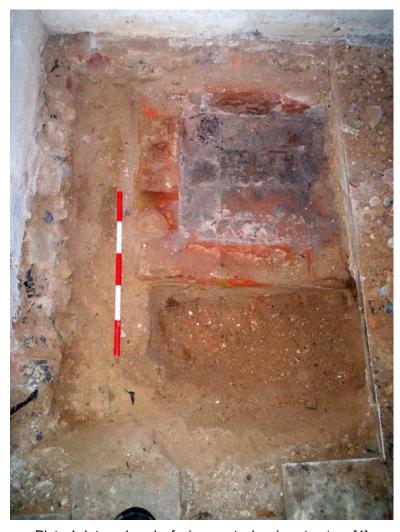
Once the present 9" pamment floor [1] was removed, a layer ([2]) of mid brown sand with frequent brick, tile and mortar rubble was encountered. This was sealing layer [3], a compacted mid brown sand with moderate brick and mortar fragments and structure [4] (Plate 1).

Structure [4] was constructed of what appeared to be reused floor bricks bonded with a white chalky mortar. The structure appeared to be a trough, possibly to contain fuel or fire debris from a stove. Its fill ([6]) was a dark brown ashy sand with frequent rubble fragments. Also revealed were the stepped footings ([5]) for the tower. These stepped out up to 0.08m and were constructed of flints held in a white chalky mortar. The footings for the west wall contained brick as well as flints.

Plate 1. Internal works facing west, showing structure [4]

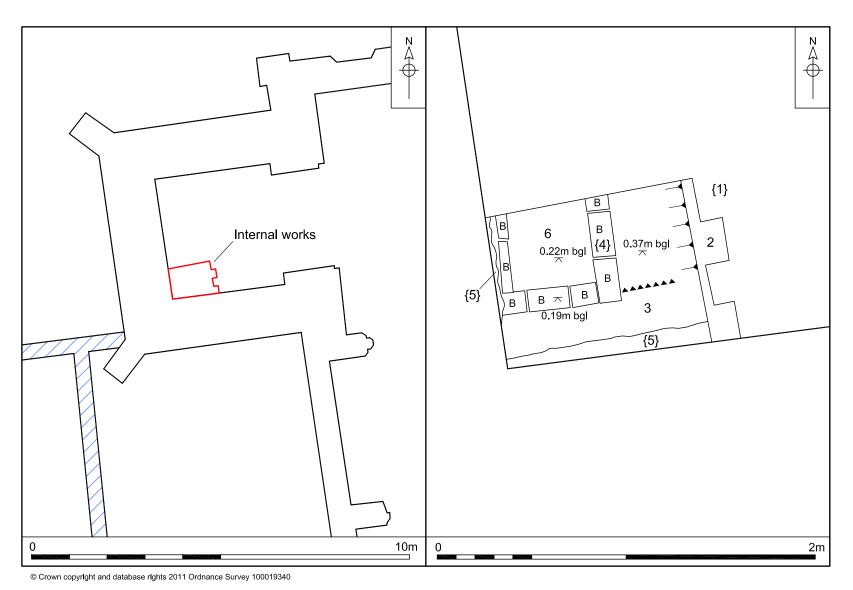
The internal works consisted of a shallow hole dug in the south-west internal corner of the tower, to facilitate drain runs out through the tower wall. The hole was 1.2m long, 0.8m wide and 0.37m deep (Fig. 3).

Figure 3. Plan showing location of internal works (left) and detail (right). Scale 1:100 and 1:20

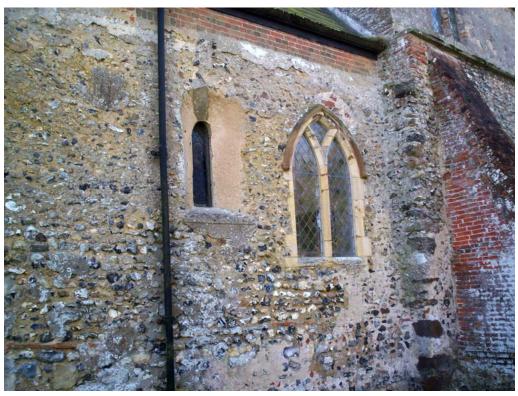
Unconnected directly with the monitoring of the excavations, the northern wall of the chancel was looked at, as there is an interesting double-splayed lancet window visible. It was noted that to the east of that window was a blocked circular window, possibly also double-splayed. Both window styles are typically Late Saxon in style and positioned to cast light onto the altar. Below these windows was a course of reused Roman tile, another typically Saxon feature (in imitation of Roman building methods and rarely used in later buildings). This feature, which does not continue further east than a change in masonry, suggests a later extension of the chancel. In addition, the north-eastern corner of the nave uses irregular blocks of conglomerate, rather than the imported limestone commonly used on Norman or later buildings. The combination of these architectural elements suggests a Late Saxon date for this building, rather than the early Norman date recorded in the NHER. The Saxo-Norman period saw a great number of what would become parish churches built (Morris 1990), but it is often difficult to differentiate whether such buildings originated pre- or post-1066, as Late Saxon styles continued in use for some time.

Plate 2. The north wall of the chancel showing the double splayed lancet window, the blocked circular window to the left, the course of Roman brick below and the north-east corner of the nave
