**Archaeological Historic Building Recording at  
Church Farm Barn, Shelfanger, Norfolk  
(Level 1 Photographic Survey)**

ENF129340

September 2012

*In May 2012 NPS Archaeology undertook a Level 1 photographic survey of a barn at Church Farm, Shelfanger in Norfolk.*

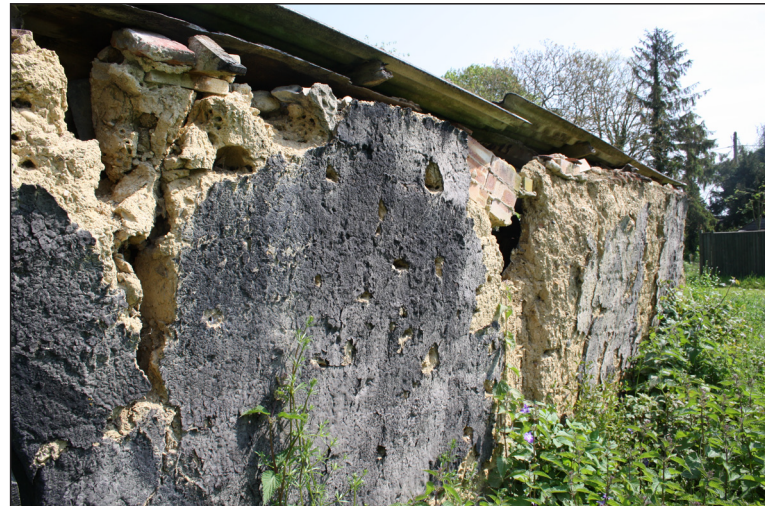
Plate 8. Close up of degraded small clay lump barn located just north of the barn.

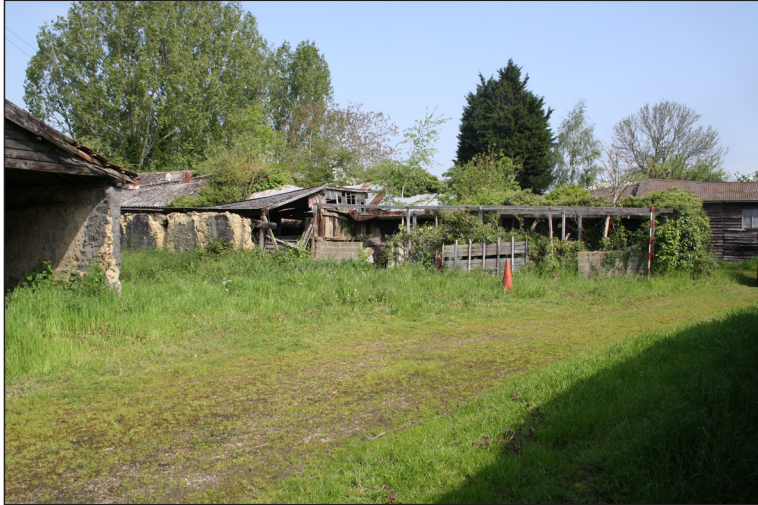
Plate 9. Degraded outbuilding. Facing north-west.

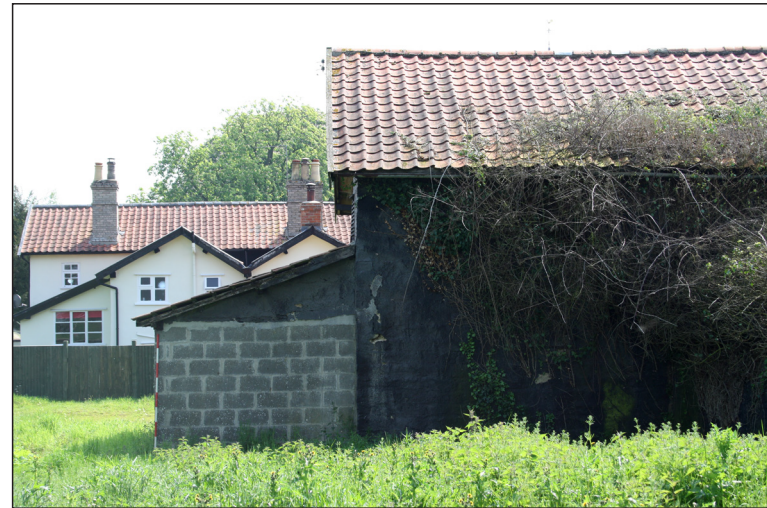
- Plate 16 West elevation. Back of two storey part of the barn. It also shows the straight joint between the breezeblocks and the barn at the back of the lean-to

Plate 16. West elevation.

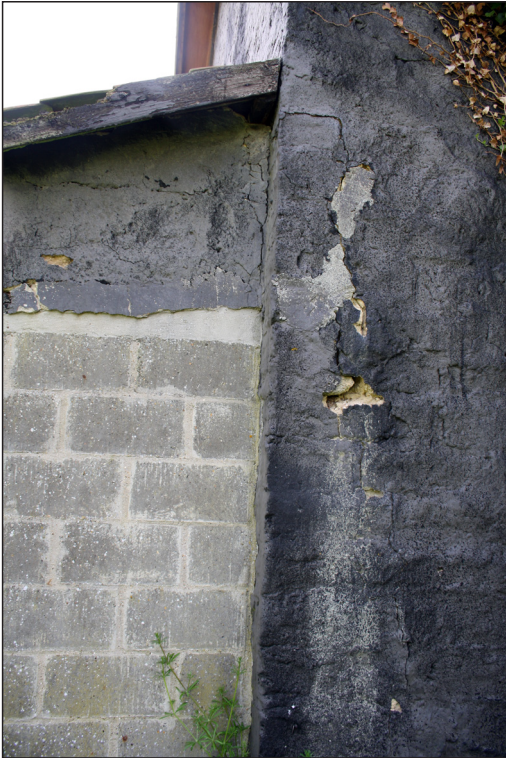
- Plate 17 Close up of straight joint
- Plate 18 North elevation (back) of cow shed. Difficult to see what is happening to the building under a large amount of plant growth

Plate 17. Close up of straight joint.

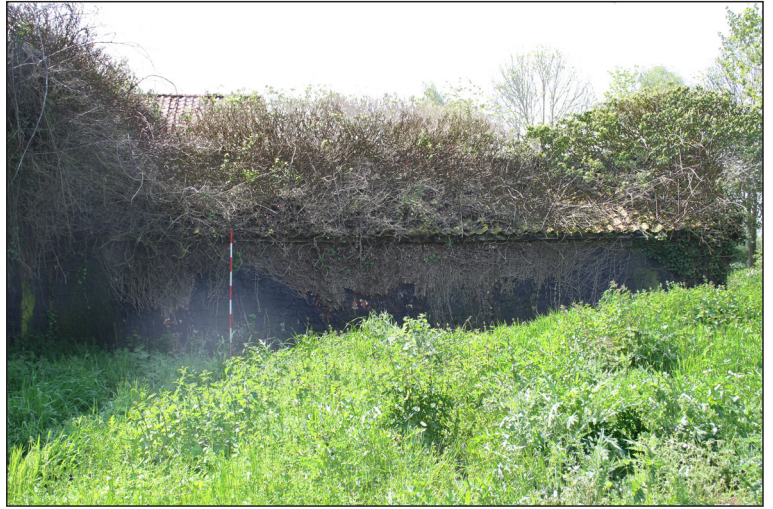
Plate 18. North elevation (rear) of cow shed.

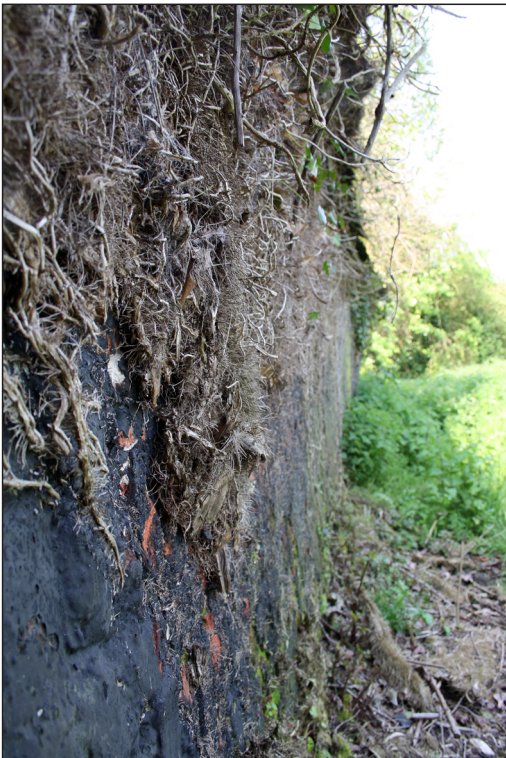
- Plate 19 Shot looking along the north wall of the cow shed. This shot was taken to identify how the wall undulates.
- Plate 20 A close up of the joint between the cow shed and two storey part is obscured by plant overgrowth. The materials for construction may hint at the cow shed being later than the two storey element but both these construction methods can be used simultaneously

Plate 19. Looking along the north wall of the cow shed.

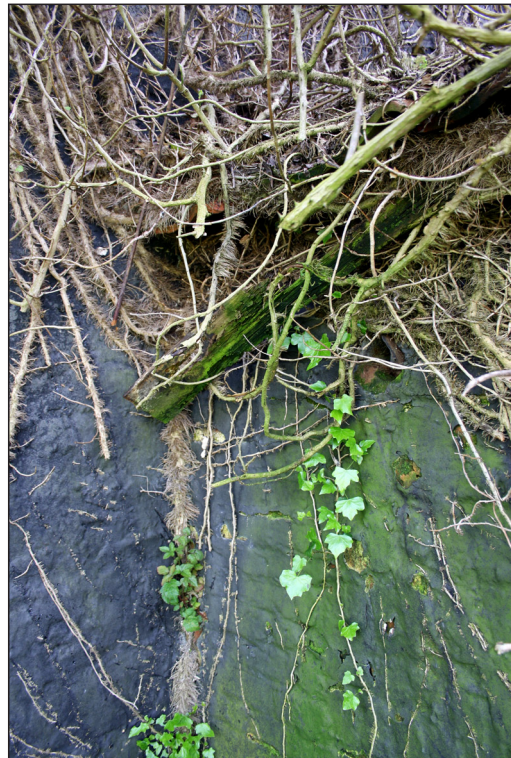
Plate 20. The joint between the cow shed and two storey part of barn is obscured by plant overgrowth.

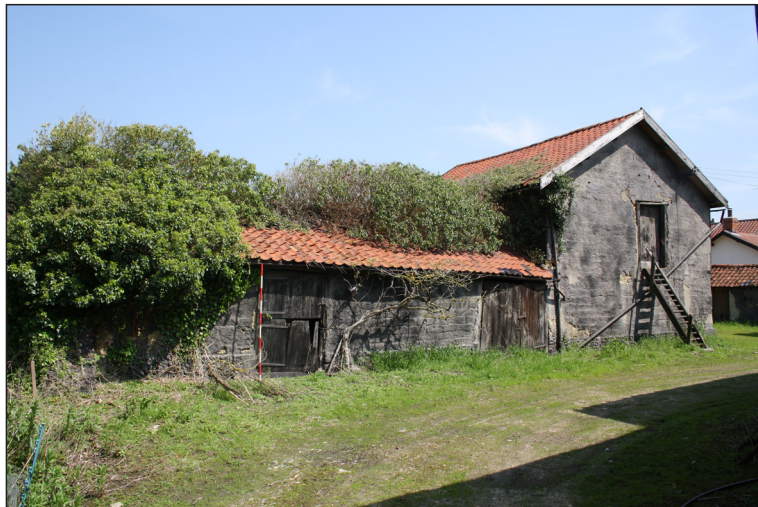
- Plate 22 Southern elevation of cow shed
- Plate 23 Whole southern elevation of the barn. It shows that the Clay lump walls sat on top of a Clay lump base. There is a straight join between the two storey and single storey parts of the barn suggesting that they

where possibly built in two separate phases. The fixtures and fittings identified here will be discussed later

Plate 23. Whole southern elevation of the barn.

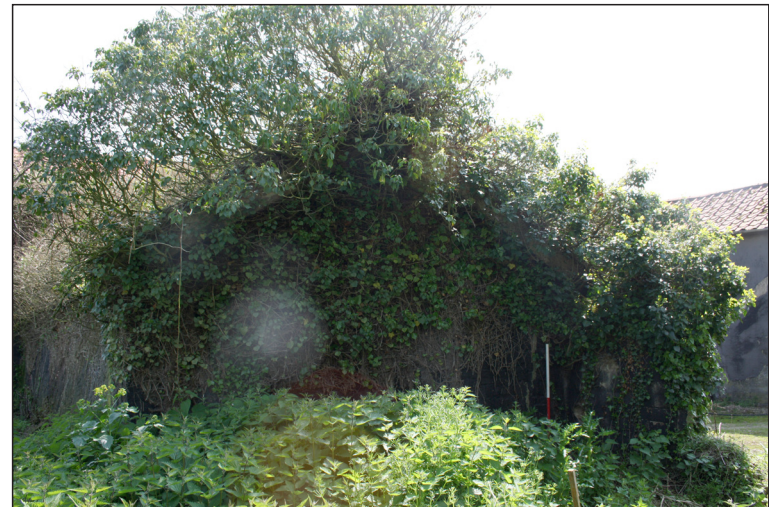
- Plate 24 West elevation of cow shed, difficult to see under the ivy. It is noted that the west and north walls of the cow shed are constructed from herringbone bricks which can be seen more clearly on the inside
- Plate 25 Close up of clay lump and low flint wall. These low walls are evident under all of the surviving clay lump walls, the two storey barn and the southern wall of the cow shed and act as damp courses. This photograph shows part of the cow shed next to the western most door

Plate 24. West elevation of cow shed.

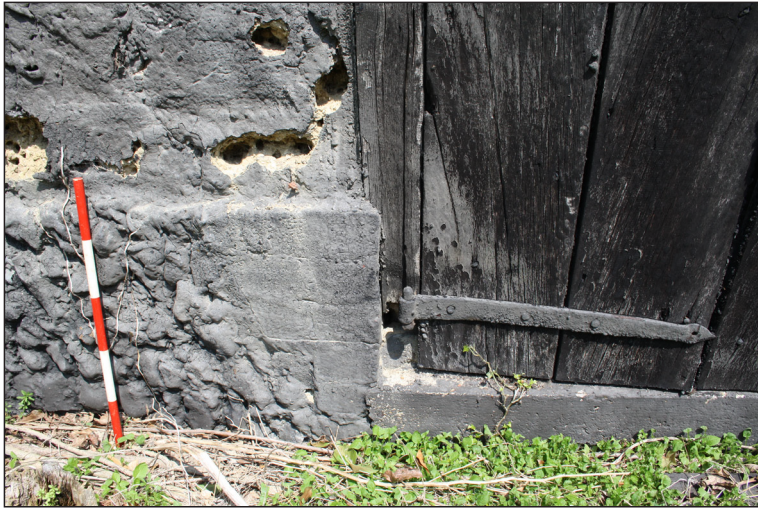
Plate 25. Close up of clay lump and low flint wall.

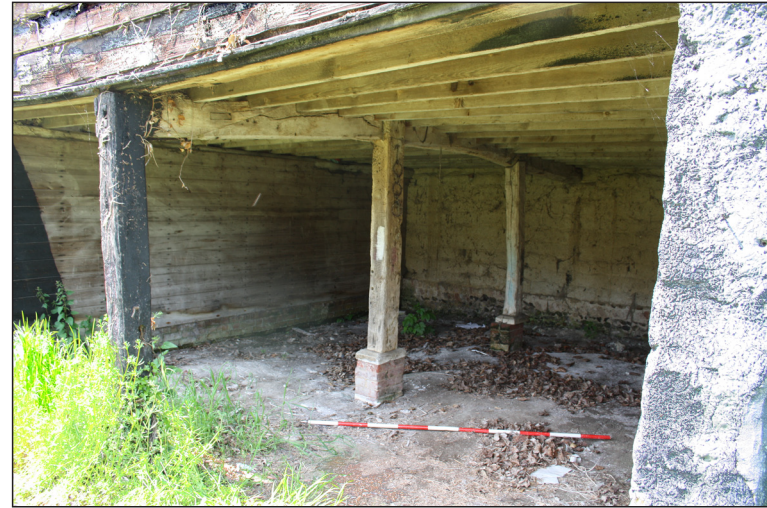
- Plate 26 The cart shed. The three posts and principal beam are thought to be amongst the oldest timbers within the building. All have evidence of re-use with the remnants of mortise and dowel holes. The largest mortise joint can be seen on the central of the three posts which also has remnants of tree bark on it (Plate 28). Compacted earth and chalk floor.

Plate 26. The cart shed.

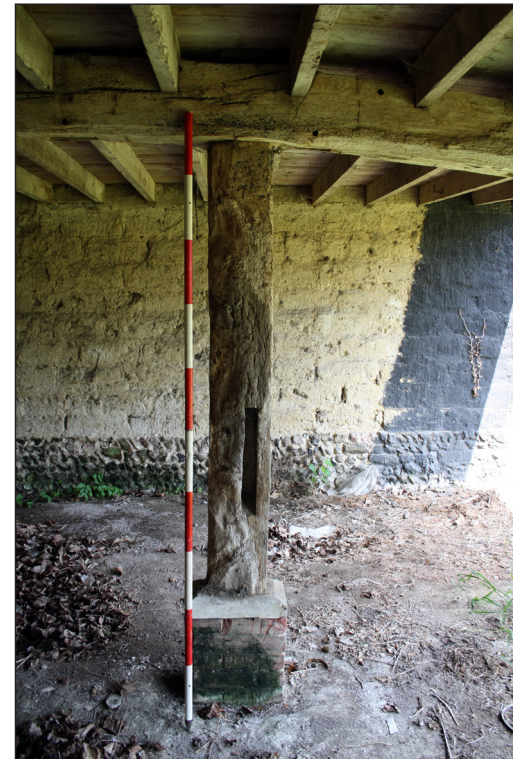
- Plate 27 Interior of cart shed
- Plate 28 Reused post. One of two posts and the central beam all showing signs of reuse
- Plate 29 Evidence of axe and adze marks on the principal beam and posts

Plate 28. Reused post.

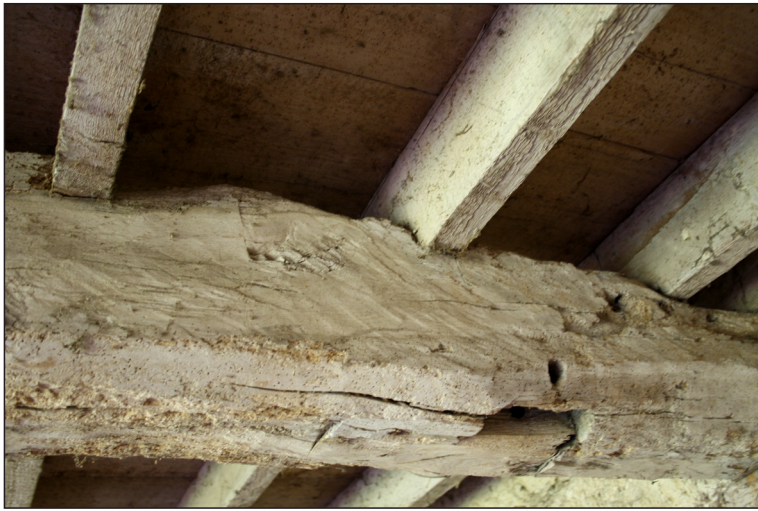
Plate 29. Evidence of axe and adze marks on the principal beam and posts.

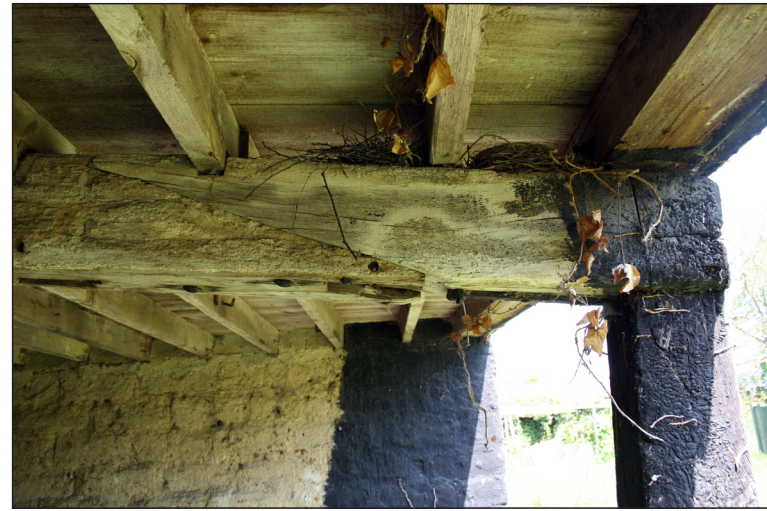
- Plate 30 The principal beam shows evidence of failing at some of these old tenon joints, and there is evidence of previous repair with a large scarf joint above the front post

Plate 30 a. The principal beam shows evidence of failing at some of these old tenon joints.

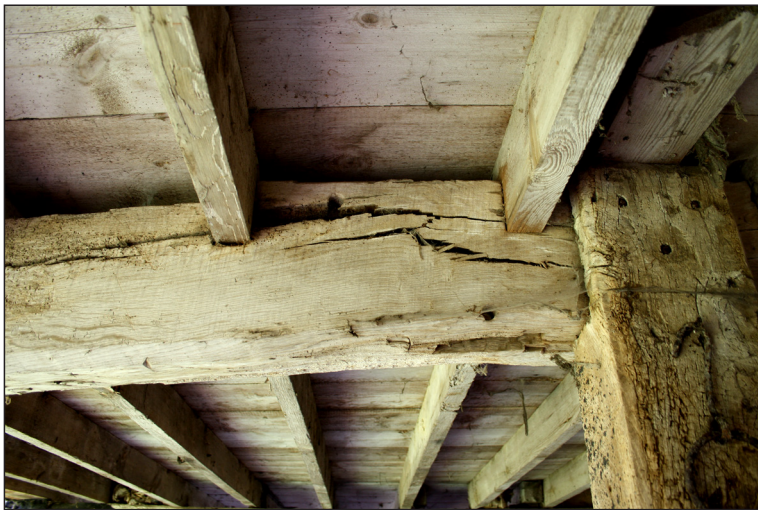
Plate 30 b. There is evidence of previous repair with a large scarf joint above the front post.

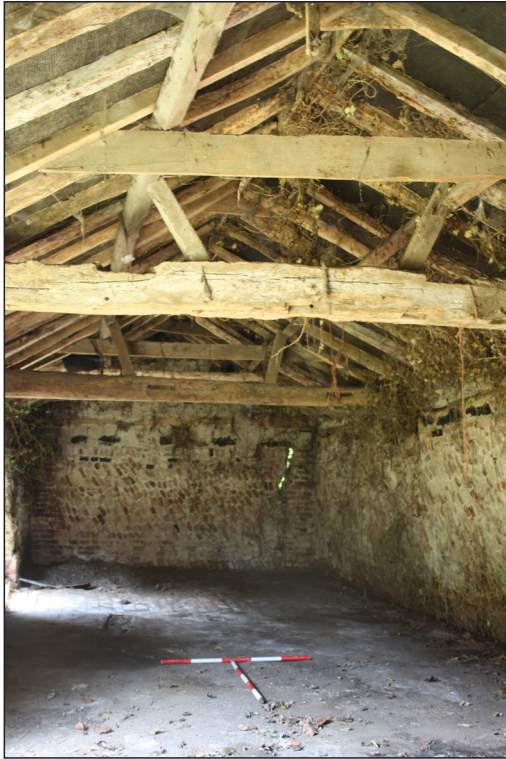
- Plate 31 Interior of lean-to wagon store
- Plate 32 West-facing shot of the interior of the cow shed. Herring bone walls. The clay lump wall may have been added slightly later to enclose an open cow shed. The roof structure may all be contemporary but with some older timbers being re-used. There is evidence that some roof timbers look machine cut when the others are hand cut

Plate 32. Interior of the cow shed. West facing.

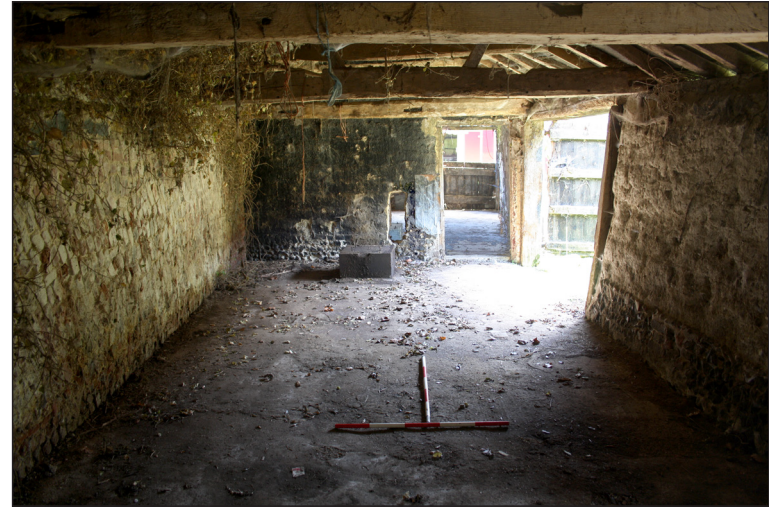
Plate 33. Interior of the cow shed. East facing.

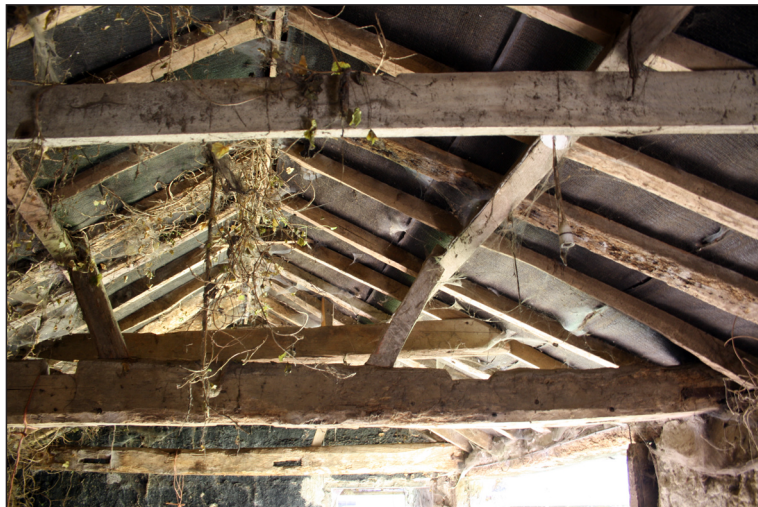
- Plate 33 East-facing shot of the interior of the cow shed. Shows clay lump wall, brick herring bone wall and the compacted chalk dirt floor
- Plate 34 Cow shed roof structure. Shows that it has had modern underlay added at some point

Plate 34. Cow shed roof structure.

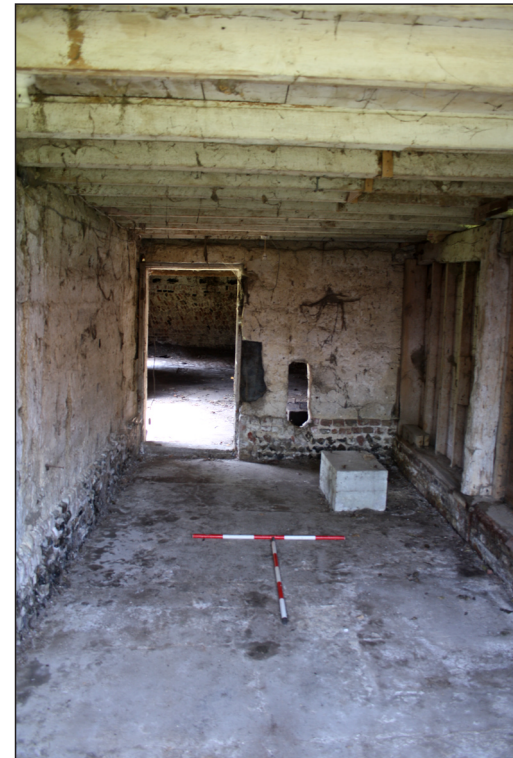
- Plate 35 West-facing photograph of the work room/stable under hayloft next to the cart shed. There is evidence of some removed farm machinery by the plinth and the hole cut through the wall into the cow shed

Plate 35. The work room/stable under hayloft next to the cart shed. West facing.

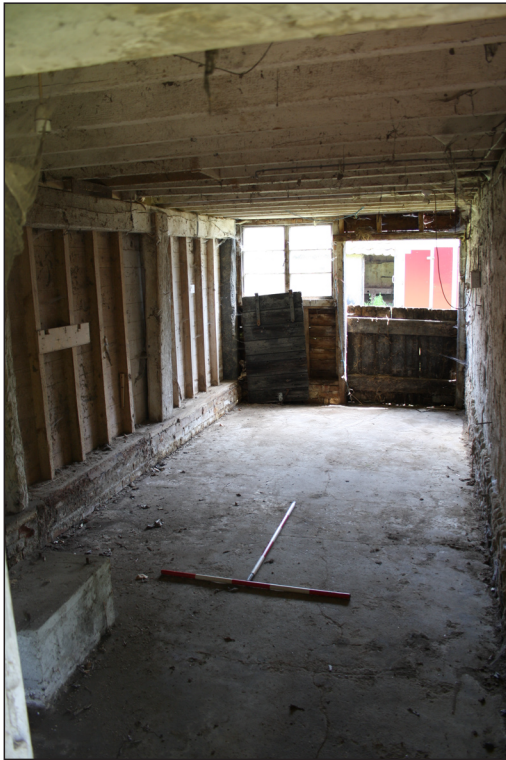
- Plate 36 East-facing photograph of the work room/stable under hayloft next to the cart shed. The dividing wall between this room and the cart store look as though it has been restored and revamped at some point. Electricity has been introduced into this room too

Plate 36. The work room/stable under hayloft next to the cart shed. East facing.

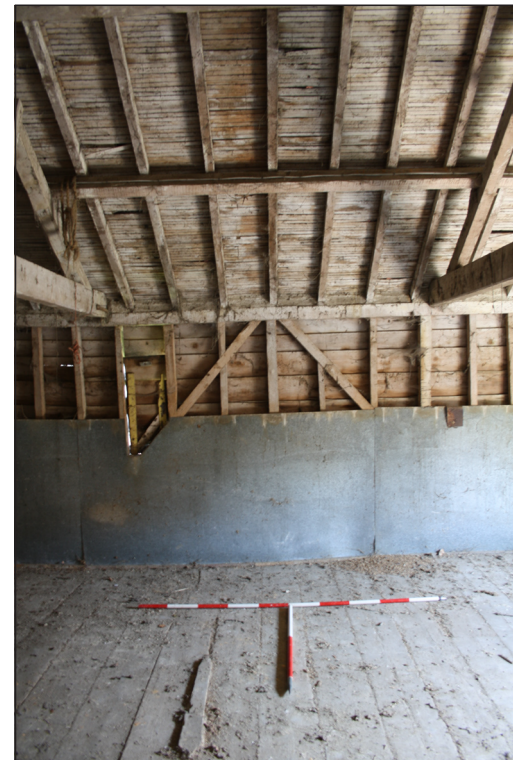
Plate 39 East wall interior of the hayloft showing a small door, possibly to insert a chute. It also depicts the back of the weather-boarding and that the underside of the tiled roof is lathed. This may indicate the building was once thatched or that there was a straw insulation layer between that and the tiles

Plate 39. East wall, interior of the hayloft.
