NORFOLK ARCHAEOLOGICAL UNIT

Report No. 1089

A Photographic Survey and Observations at the former Corn Windmill, Cooper's Mill, Walpole Highway, Walpole St Peter, Norfolk

Simon Underdown
August 2005

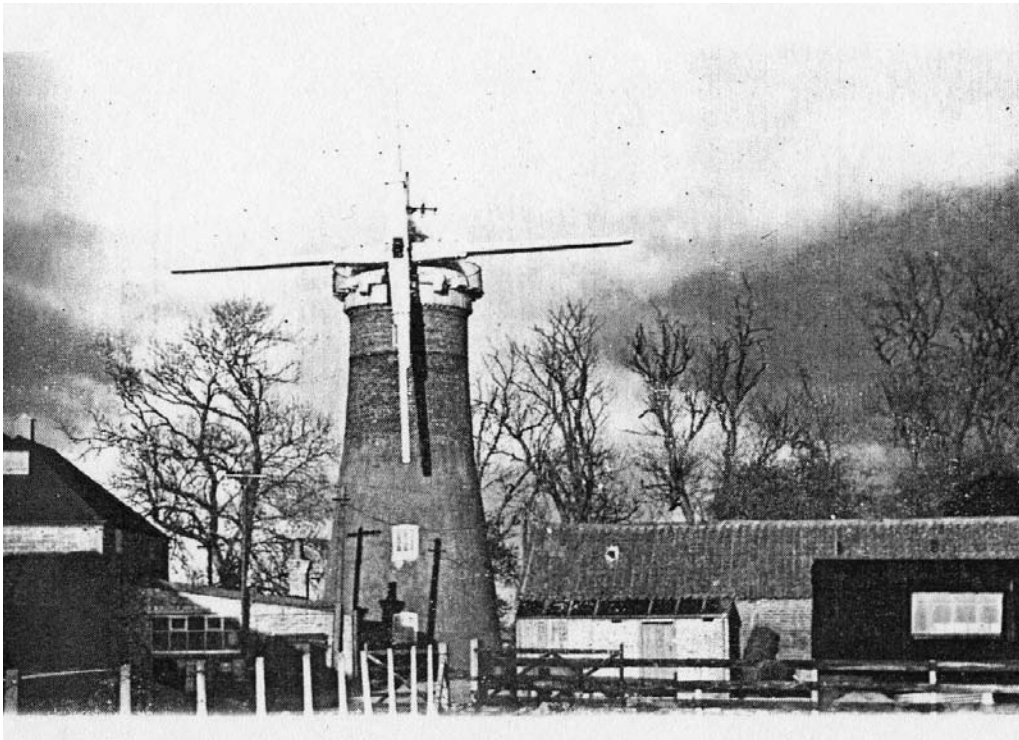
In 1957 the September edition of the *East Anglian Magazine* contained a photograph of the mill by J. W. Whitelaw (Plate 1) showing it with cap and sail stocks still in place but the sail frames and shutters removed. This photograph was probably taken shortly before publication in 1957. The photograph is looking east, showing the west side of the mill with two windows one on the ground and one on the first floor. The photograph is also interesting as it shows a north-south brick range (with pantile roof on the right), south-west of the mill. This was demolished by the present owner who constructed a brick bungalow dwelling on the site (pers. comm. Barry Lord). The later granary complex is visible to the left of the mill.

Plate 1. Cooper's Mill from the West in 1957 with cap and stocks in place, outbuildings to right since demolished. (Photo by J. Whitelaw, *EAM* Sept. 57)

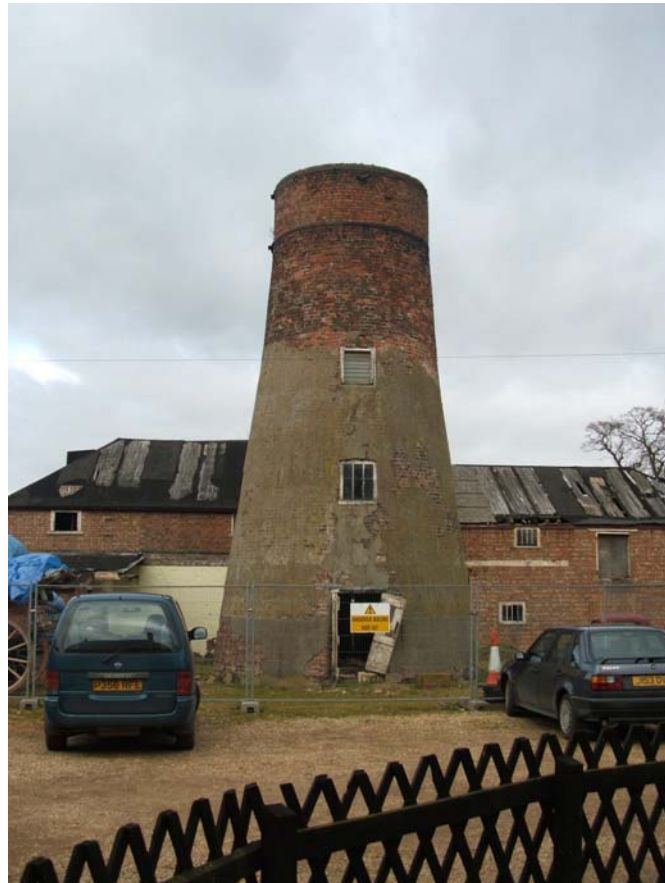
The mill is a brick-built structure, circular in plan, nearly vertically sided at the top with a pronounced batter from the third floor down (Plate 2). The tower is 11m high, 5.8m wide at the base and 4.3m wide at the apex (the batter continues to a

Plate 2. South elevation of the mill with granary behind, looking north from the house.

From 1.4m above ground level to the top of the batter, the mill has an external coating of cement render which has been in place since at least the 1930s. The base has a later application of render which has fallen off in large areas leaving the brick exposed.

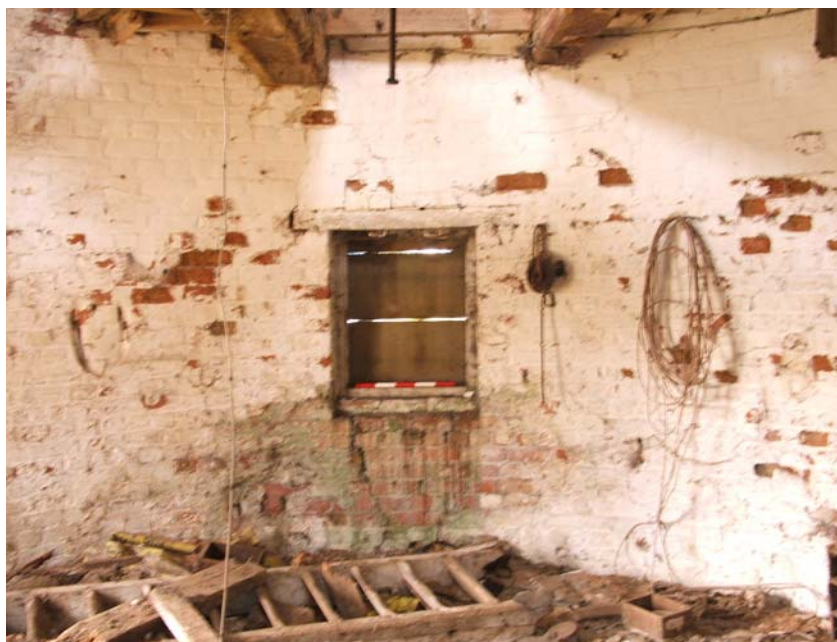
At the time of the visit the floor of the mill was covered in debris mostly consisting of fallen timber from the floors including rotted floorboards and the original steps from the ground to first floor (Plate 3).

Plate 3. Ground floor, looking west, showing boarded window and fallen stair, 0.5m scale.

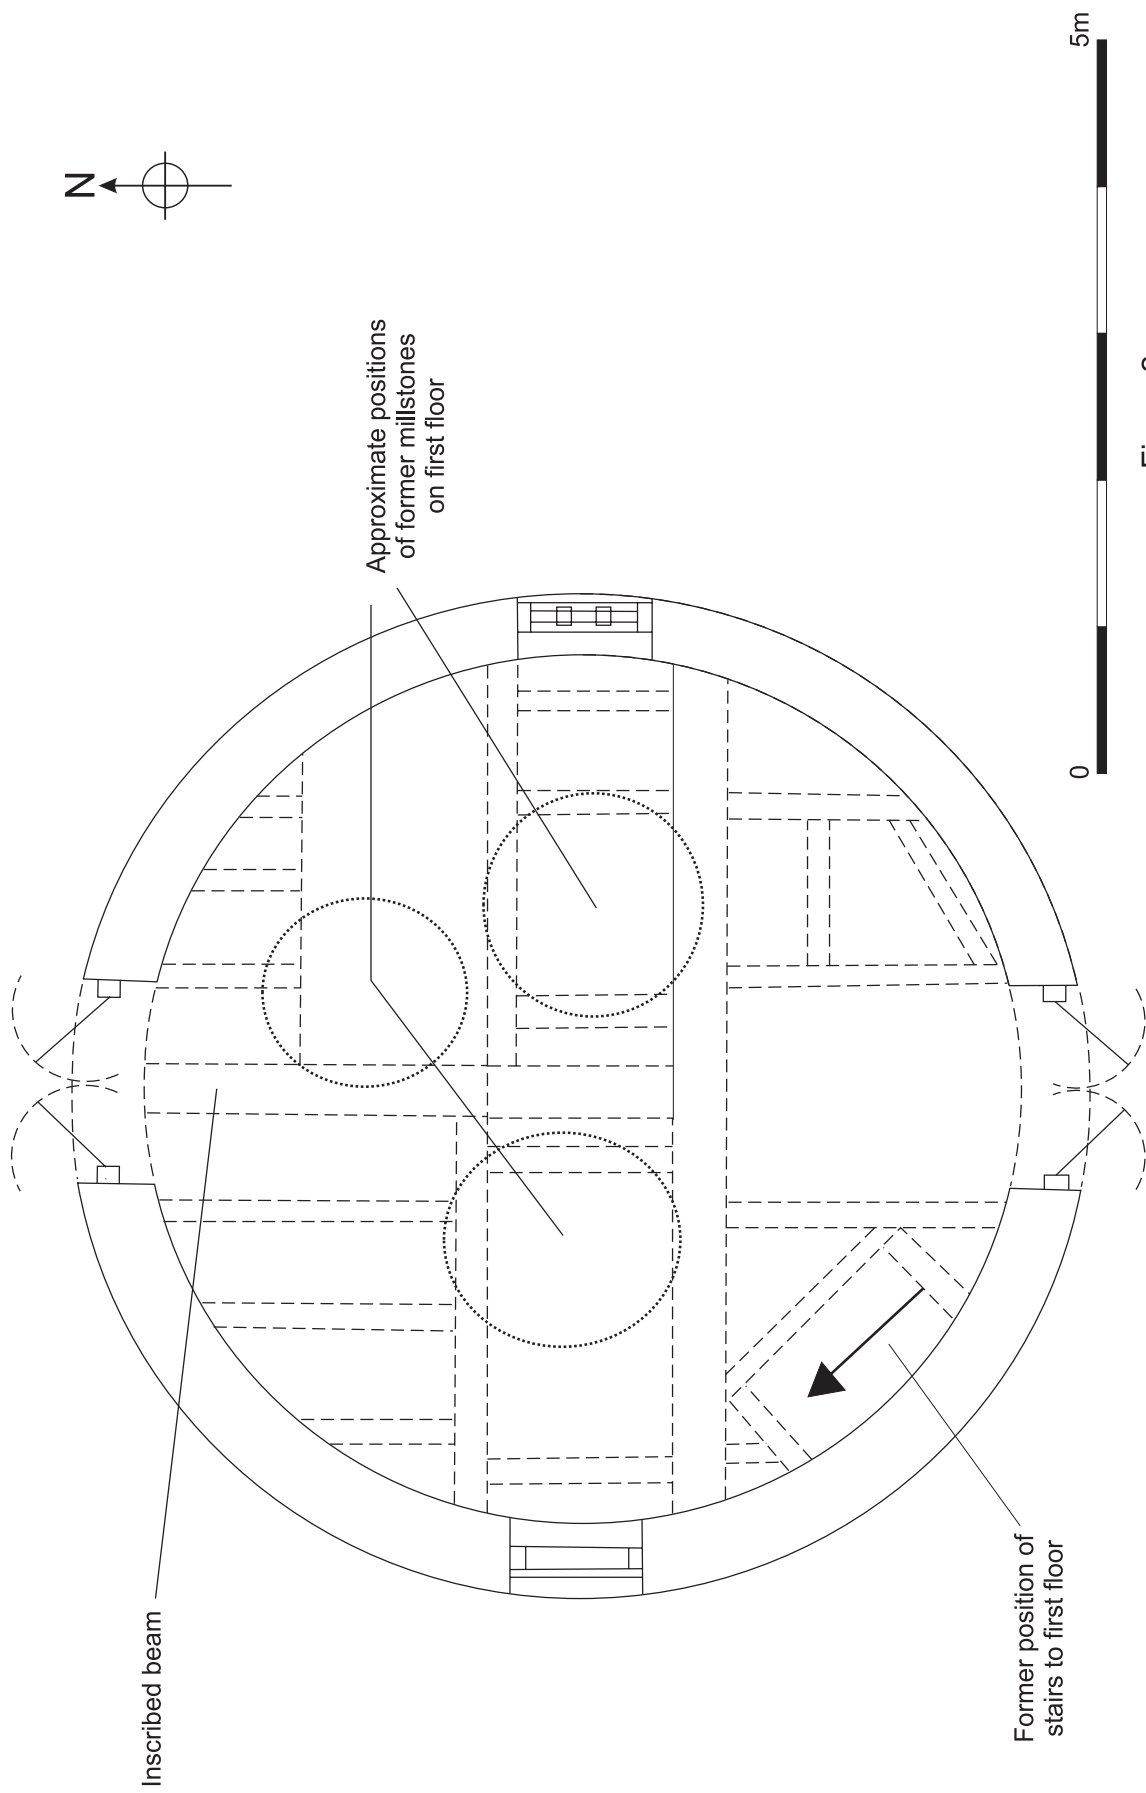
Figure 2.
Plan of ground floor of former windmill, showing first floor timbers.
Scale 1:50

The ground floor ceiling (Plate 4) is comprised of the timbers supporting the first floor (the stone floor); the main beams are in an unusual T arrangement (Fig. 2). There is a main bridging beam spanning the mill east-to-west just south of the centre-line with its ends bedded into the walls. From the centre of the north side of this beam, a second shorter beam runs to the north wall of the mill which supports it. The second beam, just north of where it joins the first, is inscribed on its lower face ‘_H 1743’ (Plate 5), the first letter is unclear, as it is obscured by an iron spike and a hole in the timber. The listing description erroneously gives the inscription as T F1743. Apling records the inscription as T.H. 1743; so although not readable now it may be reasonably safe to assume the first letter was a T. This beam appeared to be of hardwood, possibly oak, whereas the first beam was of a lighter timber, possibly pitch pine. The inscribed beam is almost certainly re-used from an earlier building and has been shortened for use here. The significance of an inscribed date is often uncertain; the post mill at Finchingfield in Essex, for example, has many dates inscribed in it, the earliest being 1753 which may indicate the age of the mill (Gifford 1979, 31). The date here implies the beam is earlier than the mill and from a structure of 1743 or earlier.

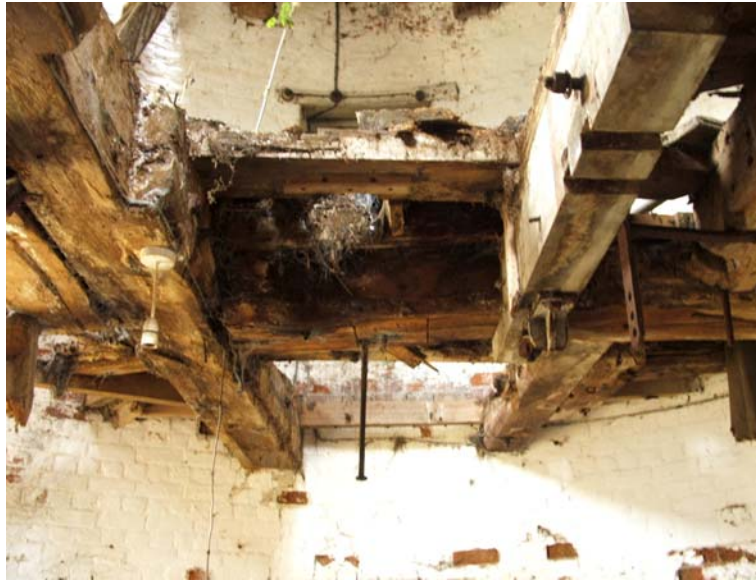
Plate 4. First floor timbers looking west.

From the dated beam two main joists run east and west with their outer ends bedded in the mill walls; that to the east is a relatively modern replacement or insertion. These joists are parallel to the main bridging beam and together with it and smaller north – south joists formed rectangular frames to support the main pairs of stones on the first floor. A second main joist ran east from the dated beam to the wall north of the first joist, probably forming support for a third smaller pair of stones. The frames for the main stones were open allowing a view up to the timbers of the second floor. Smaller north-south joists ran from the bridging beam and the main joists to the north and south walls to support the floorboards of the stone floor. There is a large crack in the brickwork above the north door, probably due to the fact that the door lintel is flat and has shifted under the load from the inscribed main beam which is bedded into the wall above it.

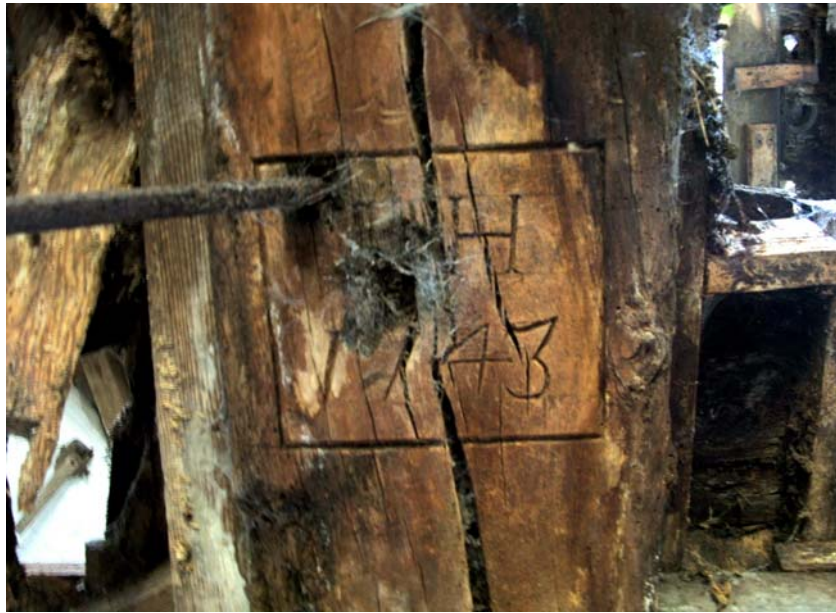
Plate 5. Inscription on beam of first floor. Looking north.

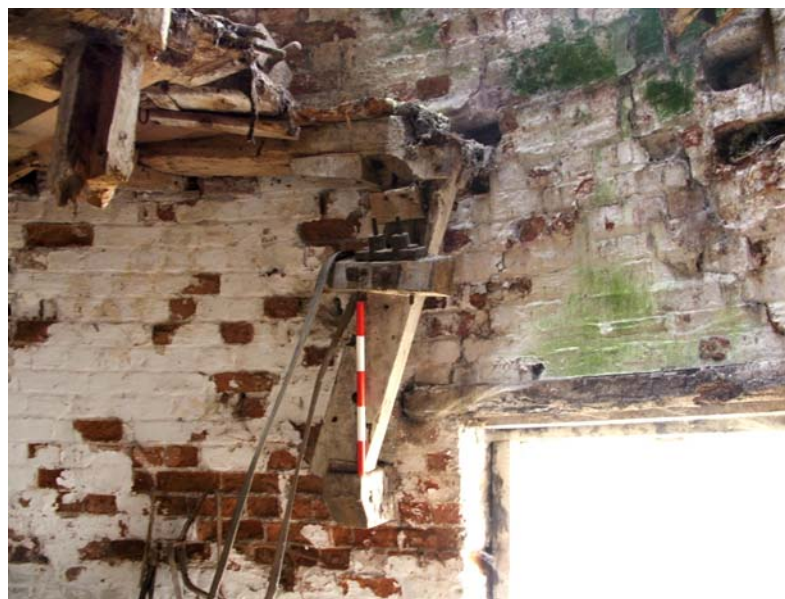
Plate 6. Corbel bracket, strut and machinery attachment, Ground floor, looking south, 0.5m scale.

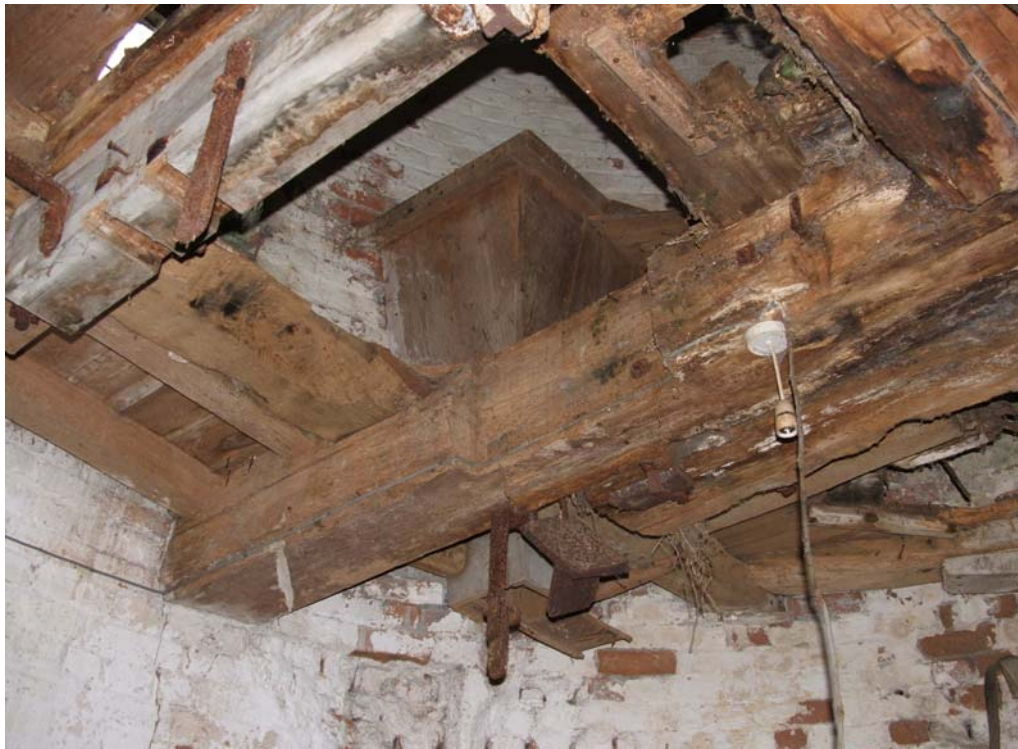
There are three spaces for stones on this floor, which tallies with Apling's description of the mill 'as worked' and is an increase of one pair from the description of 1861. He also states there were four other pairs of stones driven by an oil engine; if these were situated in the tower mill they must have been on a different floor or floors. The stones were positioned on the east, west and north sides of the floor, access from the steps was on the south-west, and a small wooden bin or hopper which survives (*in situ*) is to the south-east (Plate 7).

Plate 7. First floor timbers and wooden bin. Looking up and south-east from ground floor.

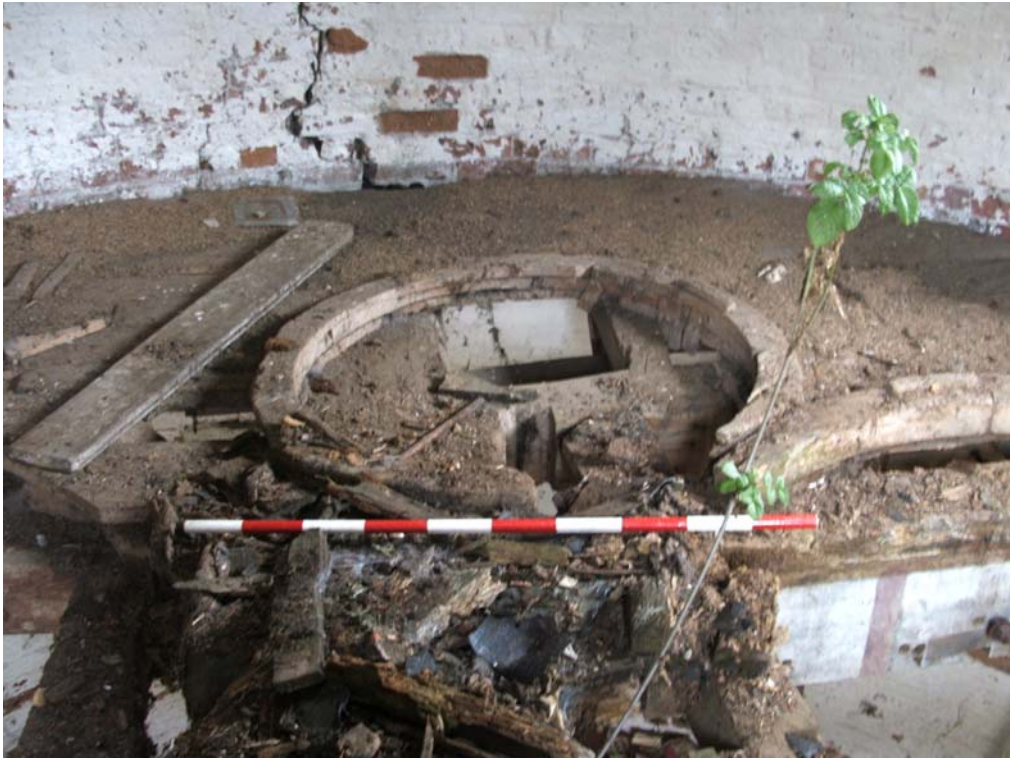
The stone housings on the east and north are in the best condition, with their circular edging strips or kerbs surviving. That on the east is the larger being about 1.20m in diameter (Plate 8). The smaller housing on the north was about 1.00m in diameter, whilst that on the west, which is little more than a hole in the floor now, was probably originally roughly the same size as the eastern example.

Plate 8. First floor, Millstone housing in floor, looking north, 1.0m scale.

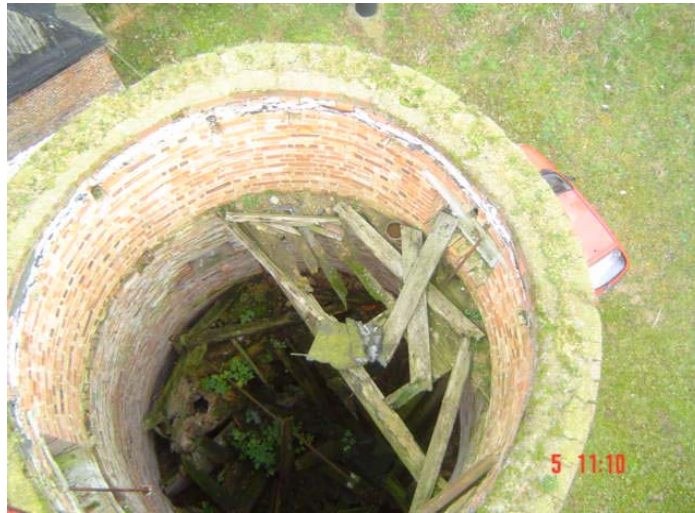
Plate 9. Overhead shot of mill, looking north-east (Photo by Barry Lord).

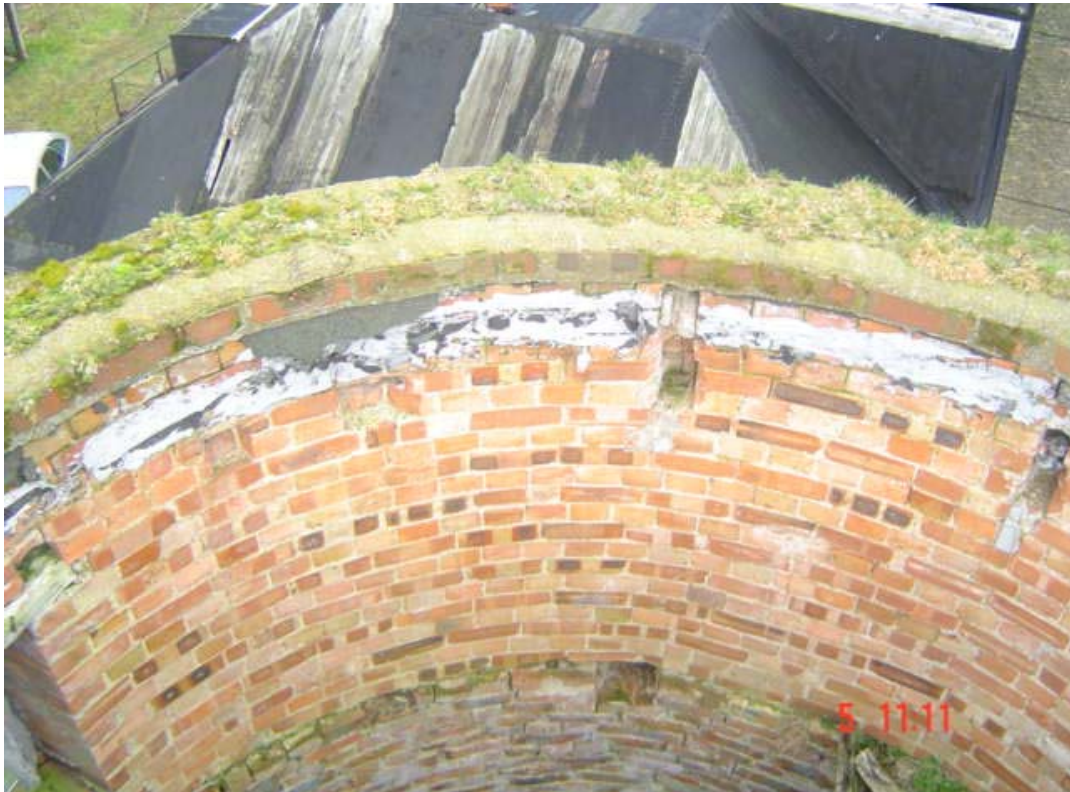
Plate 10. Interior of top of tower, looking north-west (Photo by Barry Lord).

Plate 10 shows detail of the top of the tower. The upper, later build has slots in it at the top which may have supported timbers. It is hard to tell but if these slots were cut later they may have supported a temporary roof after the cap was removed. The very highest course of bricks appears to be a later build and to have remnants of roofing felt beneath them. Just below this are the remnants of a band of cement and more roofing felt. So it appears that there may have been two phases of temporary roof structure since removal of the cap in 1969.
