**NORFOLK ARCHAEOLOGICAL UNIT**

Report No. 822

**Building Survey and Photographic Record of the  
Former Malthouse, Kerrison Road, Norwich**

May 2003

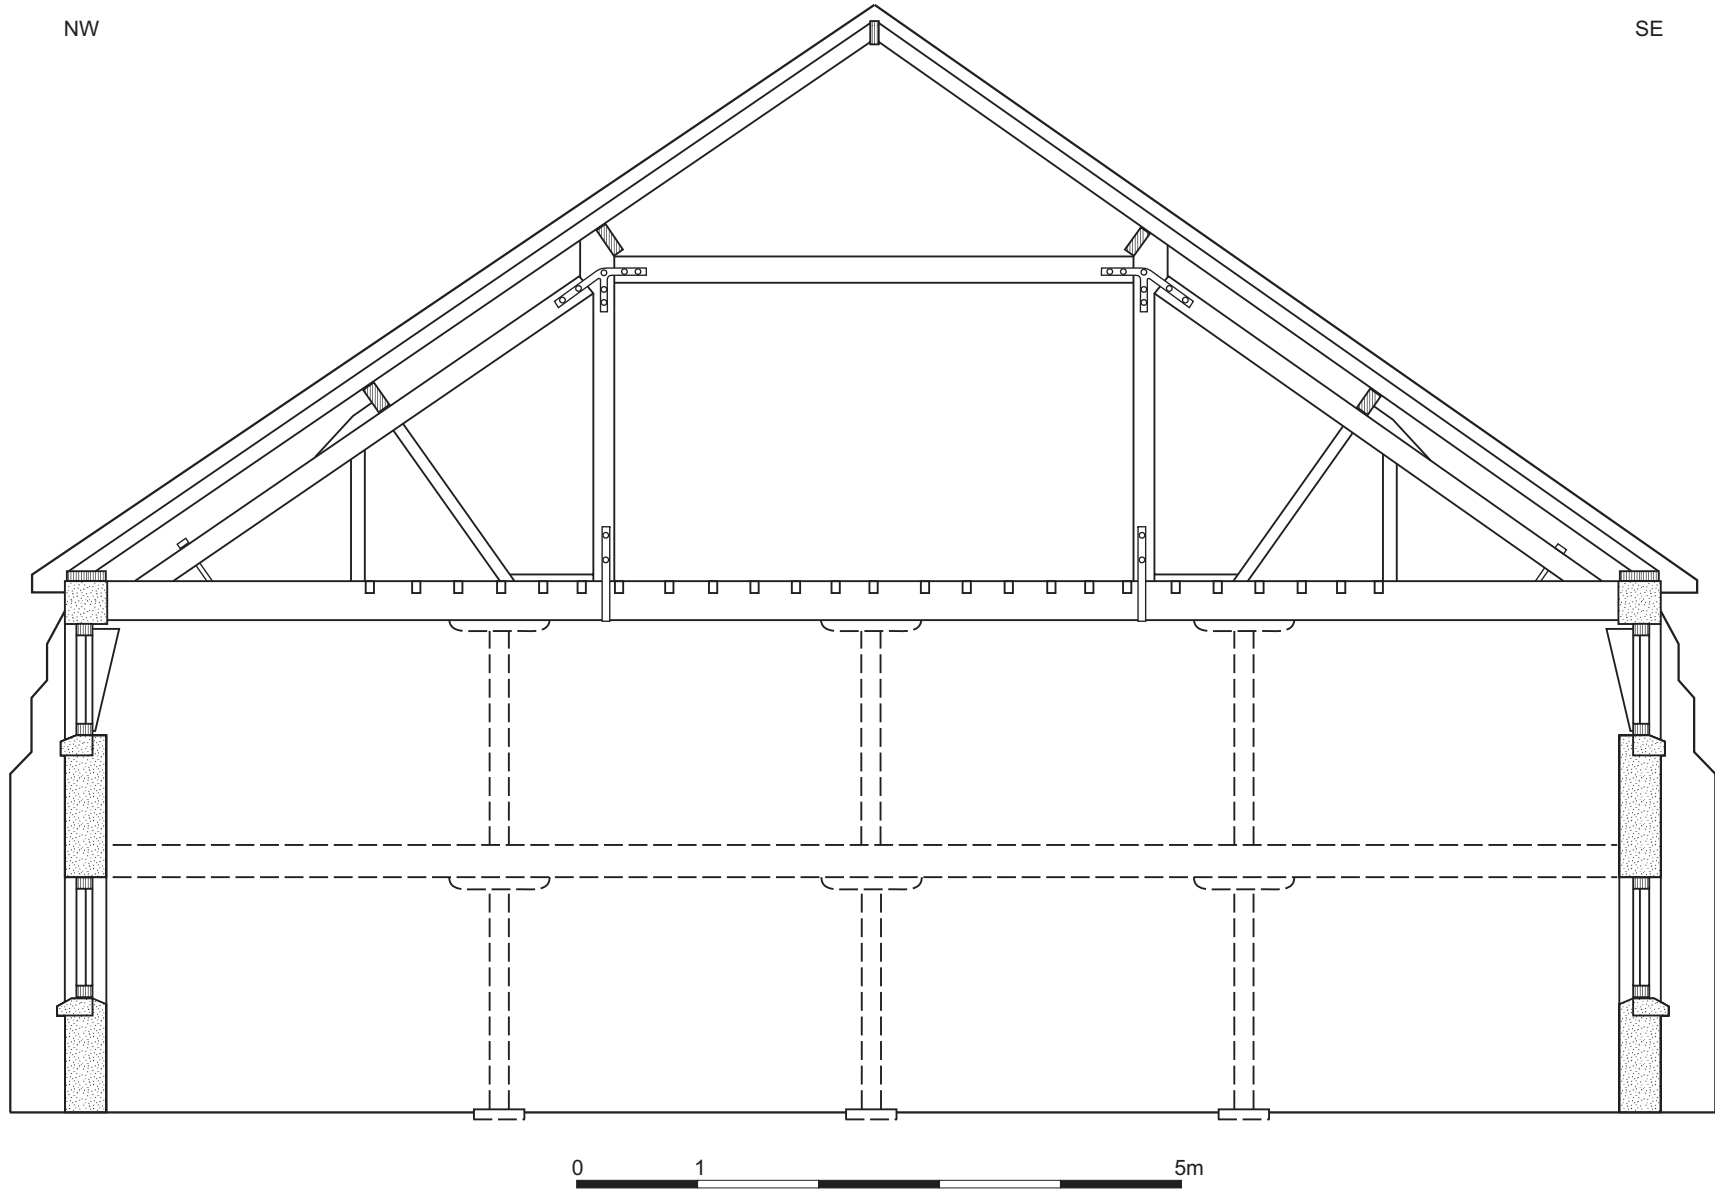
Fig. 3 Cross section of malthouse with positions of removed floor and posts marked. Scale 1:40

This report contains measured sections to illustrate aspects of the building's construction, and layout relating to its function as a maltings. Figure 3 restores removed posts and the putative intermediate floor, allowing the original form of the structure to be visualised. The report also contains descriptions and interpretations of features relating to the original function of the building with discussion of later alterations and use.

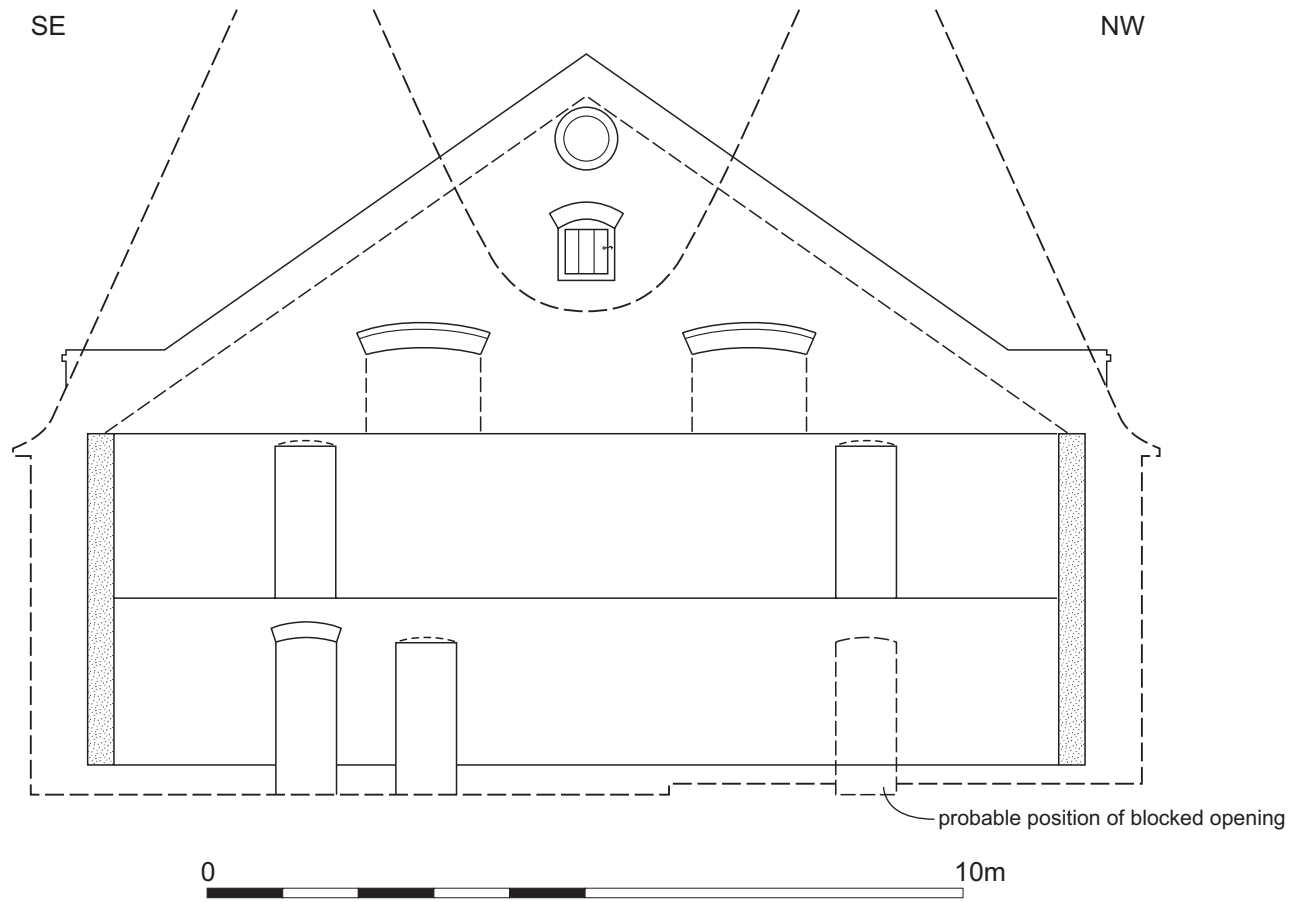
Fig. 4 Elevation of south-west gable showing openings into kiln towers. Scale 1:100

There are two entrances to the south-east kiln at ground level (Fig. 4). The northern entrance is blocked and may be later. It possibly formed an entrance to a former chamber beside the actual furnace. These areas were sometimes used to store malt, and by the malt-floor workers as a rest space (pers. comm. Robert Moody). If this is the case there might be more entrances, as there was usually a space either side of the furnace, though other examples have this space running across the building rather than longitudinally. There is no opening to the north-west kiln at ground floor level, though there may have originally been one which is blocked and not visible. At first-floor level there are symmetrically placed entrances to the drying floors of both kilns.

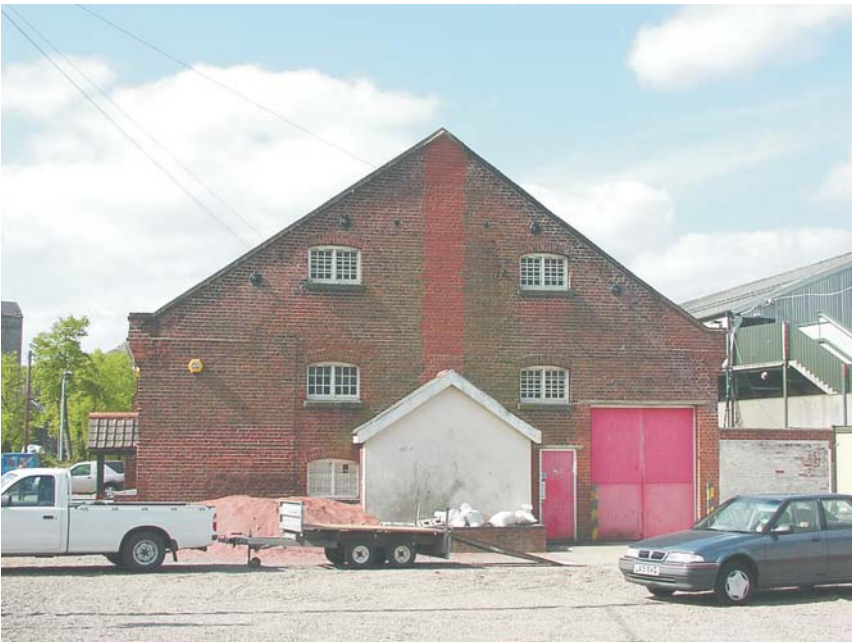
Plate 3 The eastern gable

The building is constructed with red bricks laid in English bond and there are two tiers of windows in the long side walls. The north gable (Plate 3) has three tiers of windows and all of the window openings have a segmental brick arch made up with two orders of headers between stretcher springers. The two-light windows have 3 x 3 panes and some of the top windows, if not all (later alterations make this difficult to assess), were bottom hung and the extent to which the windows opened was determined by triangular 'stops' (Plate 4). There are horizontal metal security bars across the outside face of the windows that are contemporary with the openings.

The gable has kneelers that consist of four orders of ovolo-moulded bricks and from the apex downward the central section of the wall has been rebuilt. At first sight this rebuilding appears to be associated with the removal of an external chimney stack although there is no evidence inside the building for an associated fireplace. The problem over quite what this rebuilding / repair relates to is further confused by the existence of a small, low structure with a pitched roof central to the gable that now has no obvious door opening and appears to be a later addition, possibly, because of a change in the character of the bricks, in two phases of construction.

The north-east gable has windows at three levels (Plate 3). Two are located in the first floor and attic storey, with only one on the ground floor which has clearly been inserted as the voussoirs are different from the others, but the same as the inserted doors and window on the south-east side. A modern door opening occupies the potential position of the other ground floor window.

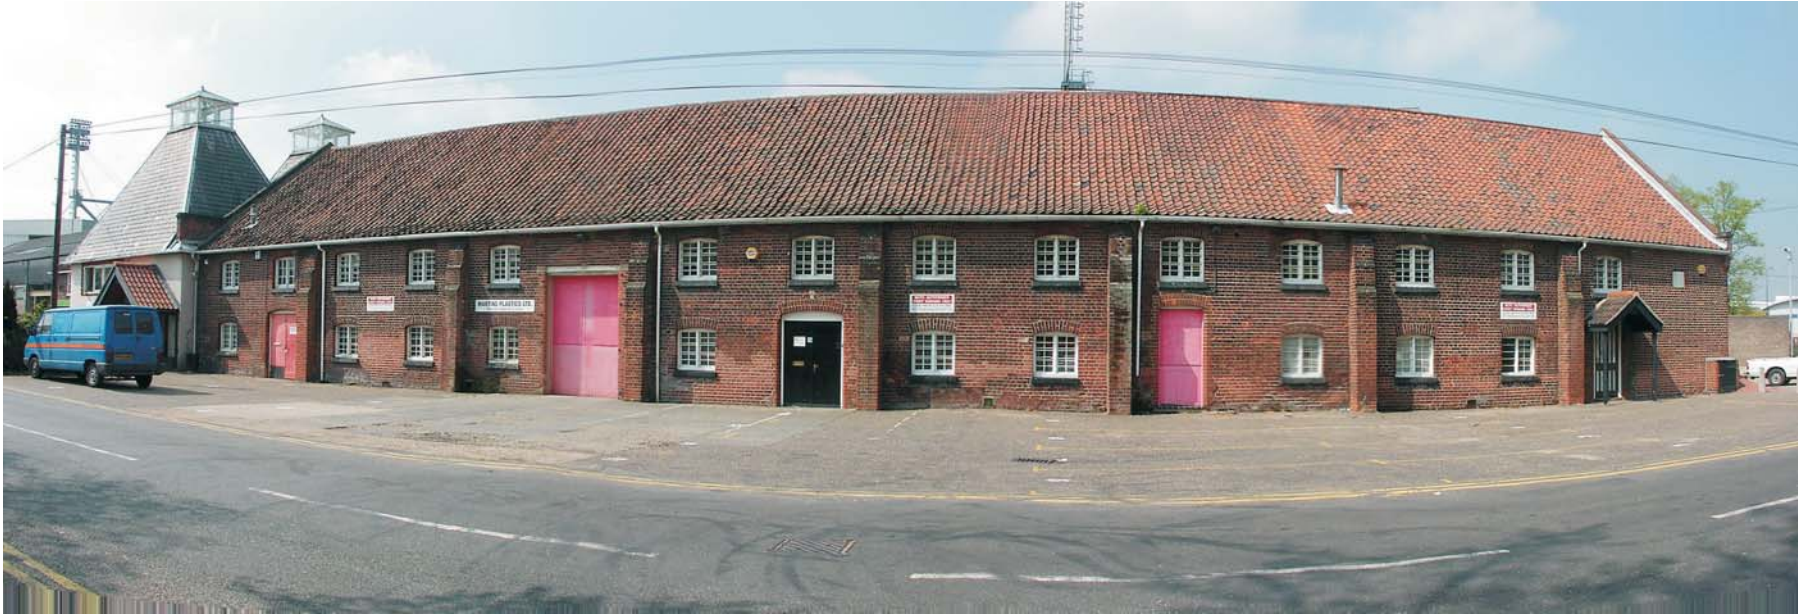
Plate 5 East-facing elevation of malthouse, by Robert Smith

The long sides of the building are in eight bays demarcated by brick buttresses that have three offsets (Plate 5). The buttresses are not bonded into the main wall. They are however attached by metal ties that are visible on the inside face of the wall and this arrangement could suggest that the buttresses are later additions (Plate 6).

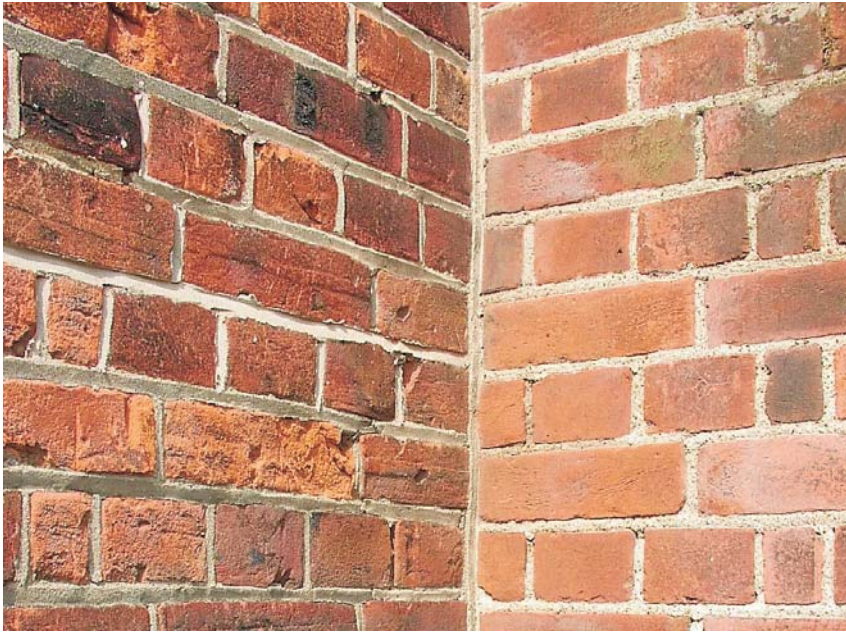
Plate 6 The junction between the outside wall of the building and a buttress. The difference in the characteristics of the bricks and the lack of bonding shows that the two are not contemporary

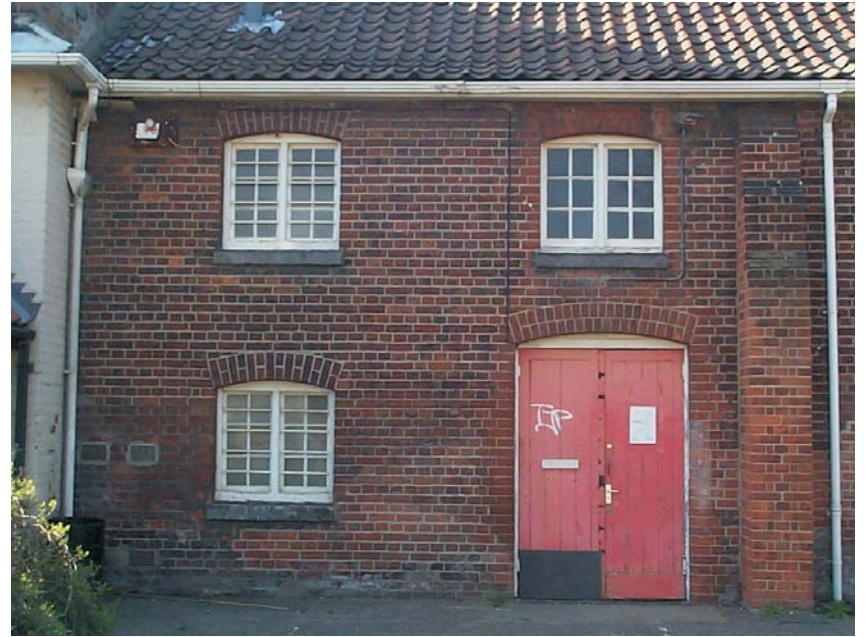
Plate 7 First two bays at south-west end of Malthouse showing renewed door and window and later buttresses

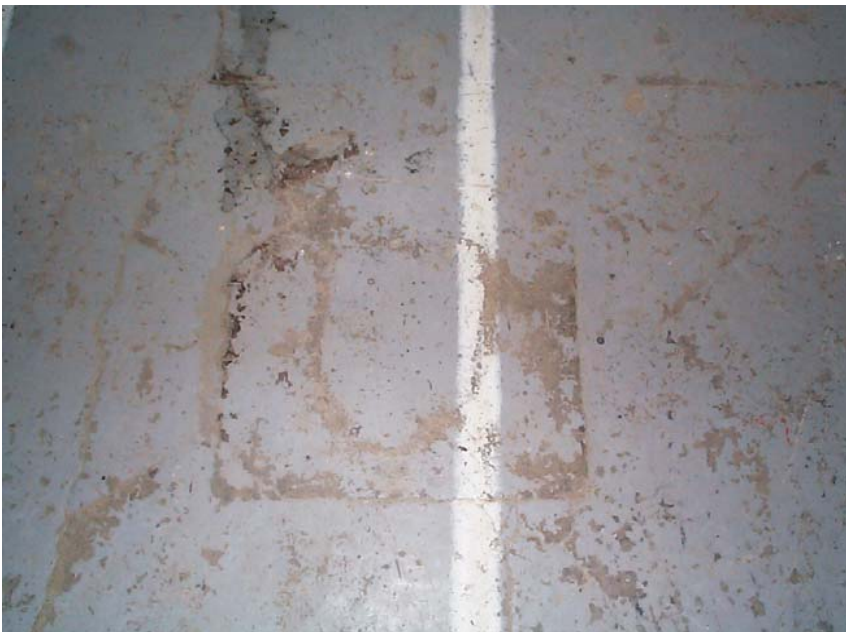
At the northern end nine padstones survive in a later concrete floor (Plate 8), which originally supported Samson posts or columns. These are arranged in three rows beneath the roof trusses. Pillows, which concentrated the load from the roof trusses on to the upper posts (Plates 9 and 10), are seen attached to the tie beams at both ends of the building. The posts probably supported the first floor before rising up in the same line to support the roof trusses bearing the weight of stored grain and/or malt. The round scar on one of the pillows (Plate 10) suggests that iron columns may have been used, an increasingly common trait in industrial buildings from the late 18th century onwards. This is paralleled at Beaven's Maltings in Diss, where three rows of iron columns support the first floor in one of the malthouses.

Plate 8 Stone base for Samson post preserved in later floor

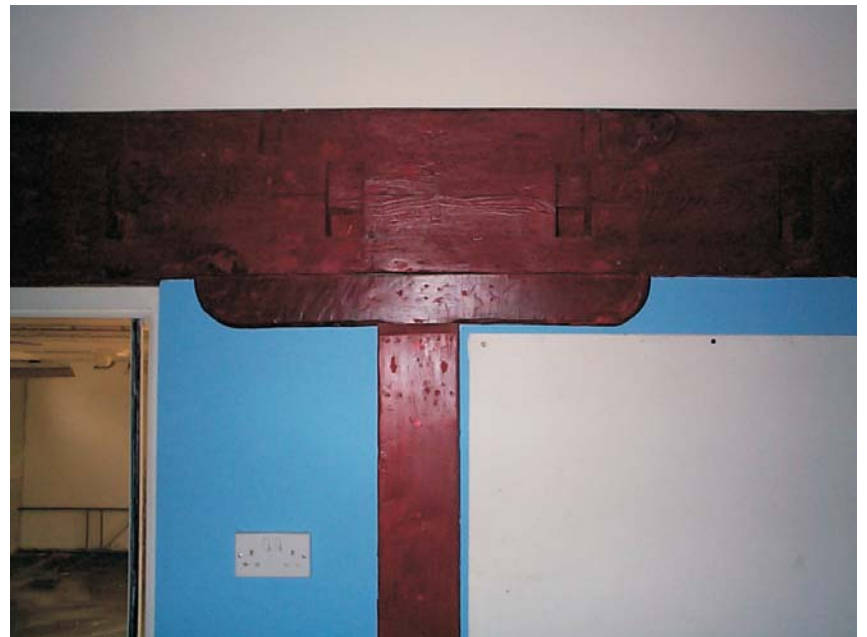
The south-western face of the tie beam of the end truss and a pillow block are visible in the partition wall (Plate 9). This tie beam has joist mortices which are set lower than those in the other tie beams, with a row of smaller mortices above

different to those seen elsewhere. These were designed for diminished haunch tenons, although the reason for this is unclear.

Plate 9 Tie-beam of south-west end truss showing joist mortises, pillow block and post
