**Report № 1899**

**Former Service Station, Salhouse, Norfolk:  
An Historic Building Record**

NHER 51770

September 2008

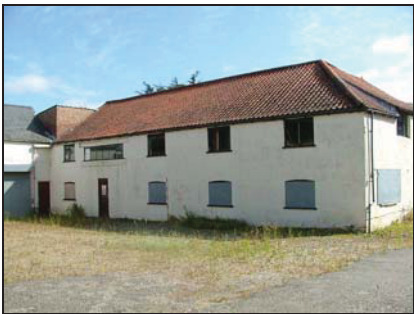
Along its western elevation there are four windows at ground level with arched heads, and a single doorway (Plate 3). At first-floor level along this elevation there are four windows located just below the eaves and directly above those on the ground floor, although these have straight heads (Plate 6), and above the doorway is a long narrow window with six fixed panes, and horizontal timbers acting as lintel and cill.

Plate 3. West elevation of buildings to the rear of modern service station

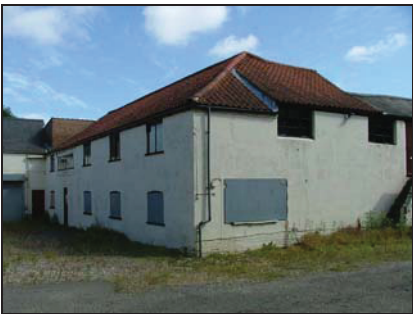
Building A is a two-storey brick-built structure laid in Flemish Bond, which consists of alternate headers and stretchers used in each course. The roof is laid in red pantiles with semi-circular-section ridge tiles. It is gabled at its northern end, although this does not appear to be original. There is a partly hipped roof to the southern end and this seems to respect the western end of Building B (Plate 4).

Plate 4. South elevation of Building A

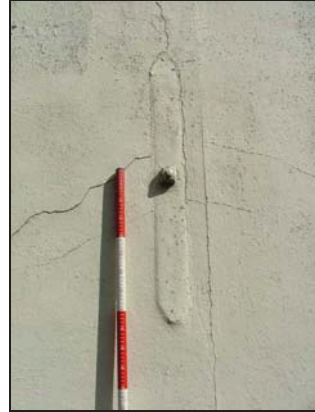
In the south facing elevation of Buildings A there is window at ground level, now boarded over like those on the west elevation, and at first floor level are two windows below the eaves (Plate 5). It is interesting to note the change in roof pitch to accommodate these windows, this may be due to the windows being a later addition, however the roof was clearly raised like this on the pre-1930s photograph. At ground floor level in this elevation are two decorative metal grilles for ventilation (Plate 7). To the right of these is a vertical iron wall tie (Plate 8).

Plate 8. Metal wall tie, south wall of Building A

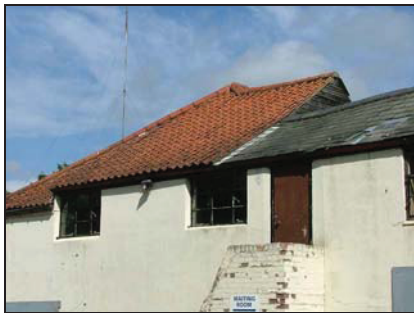
The change in roofline between Buildings A and B as seen from the south is an interesting feature (Plate 9). It was not possible to note externally or internally any vertical construction break between these two buildings due to external render and internal wall coverings, yet the change in roof line does suggest two separate construction phases. Although it was not possible to note during the site survey, modern satellite photography via Google Earth does show that Building A incorporates part of Building B within its fabric in the south-east corner (suggesting that Building B was in existence prior to Building A).

Plate 9. Change in roof lines and materials between Buildings A and B

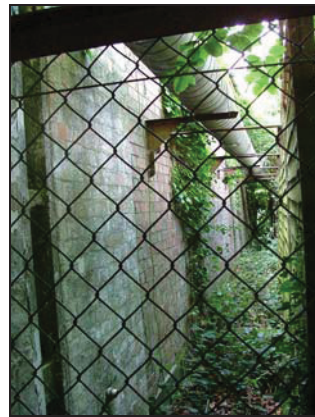
The north elevation of Building A was not possible to observe due to foliage and restricted access. It was consequently not possible to note if there was a vertical construction break between Buildings A and C on the north elevation (Plate 10).

Plate 10. View looking west along the north elevation of Building A

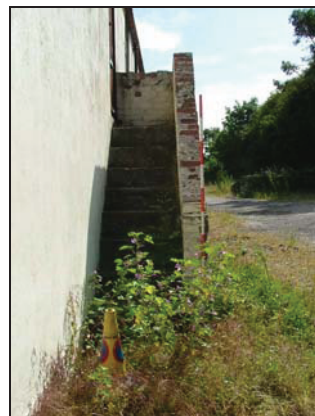
Along the south-facing elevation of Building B are concrete steps which provide access to the first floor, which may not be an original feature (Plate 12). At ground level there is a doorway and large window, both have been covered over with metal sheets to restrict access, and at first-floor level there are two windows of different sizes just below the eaves (Plate 11). In the east-facing elevation is a boarded-over window at first-floor level. At ground level it was not possible to note any original windows or doors due to the presence of the modern flat-roofed extension constructed from block work (Plate 13).

Plate 12. Concrete steps set in a brick surround, south elevation of Building B

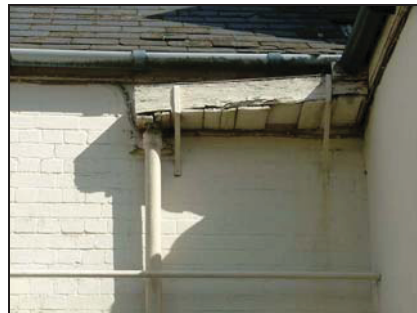
use of the site as a garage (Plate 15). Above the smaller doorway is what may be an original rainwater hopper constructed from timber (Plate 16).

Plate 16. Rainwater hopper, south elevation of Building C

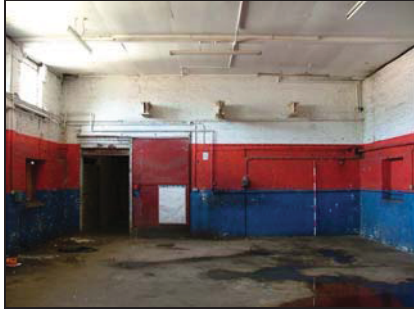
The interior of Building A could be accessed via the door on the west elevation (Plate 3). The floor of the interior of the building is of concrete and the walls have been painted in bold horizontal strips of blue and red with white above (Plate 25). The interior of Building A has two internal cross-walls, one to the north is of brick laid in Flemish Bond (Plate 25), and the southern cross-wall is of modern concrete blocks with iron columns supporting a concrete lintel (Plate 26). Within the northern cross-wall (Plate 25) there is a modern doorway with sliding door, and at its eastern side, a blocked doorway (Plate 27). Three steel girders project from this wall; these appear to be the ends of the girders which support the first floor of the room to the north. Along the east internal wall of Building A were formerly two large doorways to allow vehicular access, although one has subsequently been blocked-up, and has a blocked window above (Plate 28). To the north of this blocked doorway is a blocked window, above which is a further blocked window at first-floor level. The presence of the windows at first-floor level indicates that there was originally a first floor, however this has obviously been removed, although it was difficult to observe any blocked up holes for the joists.

Plate 25. Interior of Building A, view looking north

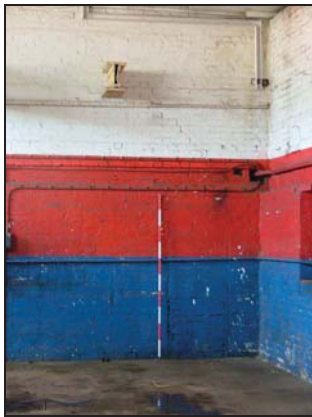
Plate 27. Blocked doorway in northern cross-wall, interior of Building A

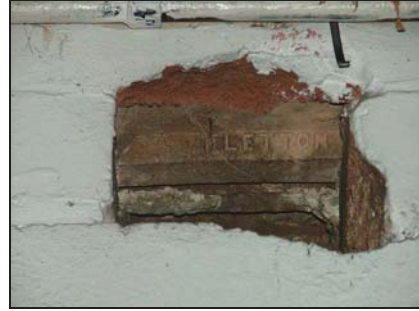
In the west wall of this room is a large blocked doorway, which would have provided access into Building C (Plate 29). On the other side of the brick cross-wall shown on Plate 25, there remains a door *in situ*, although this door is blocked behind (Plate 31); this is the blocked doorway shown on Plate 27. Where a brick has been removed on the north side of the internal brick cross-wall in Building A, it was possible to note that it was constructed of 'Fletton' bricks; these were a type of common brick made from the Oxford clays of the Peterborough area.<sup>4</sup> Flettons were a blotchy pink self-firing brick which were pressed in a mould. They were manufactured from around 1900, and were often used for internal walls (Plate 32).

Plate 32. 'Fletton' brick visible in northern interior cross-wall in Building A

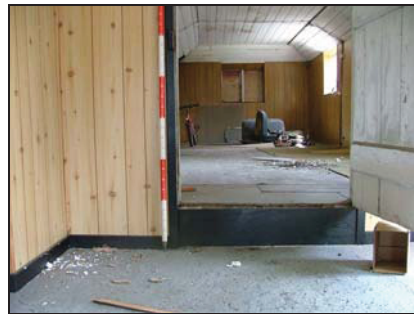
The first floor of Building B was accessed via the external stairs on the south elevation. It was observed that at the point where Buildings A and B meet, the difference in floor level was 20cm higher to Building B (Plate 42). This change in floor level may be indicative of these two buildings being of separate construction phases.

Plate 42. Difference in floor level between Buildings A and B

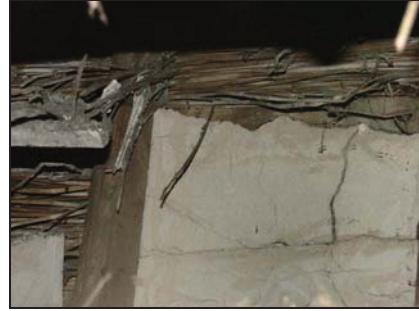
Plate 44. Roof space of Building B showing reeds/straw covered in plaster

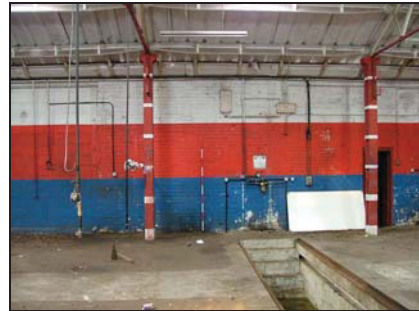
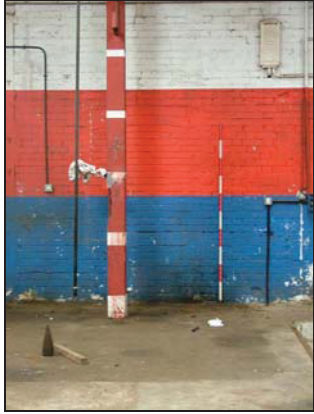
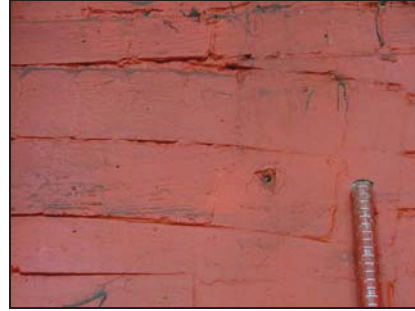
Along the western wall of this building (the original external east wall of Building A), it was noted that there was blocked doorway with arched head, and a blocked window with arched head to the north of that (Plates 48–50). A single square tie-plate was noted in the wall between these two blocked apertures (Plate 51).

Plate 48. West wall of Building D showing blocked door

Plate 49. Blocked door in west wall of Building D

Plate 50. Detail of arched head to blocked door

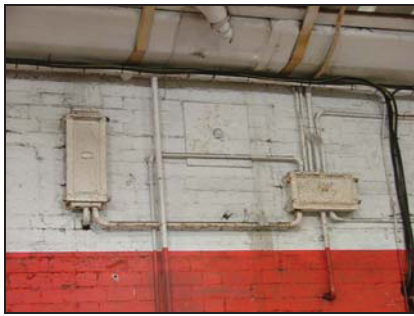
Plate 51. Square tie-plate, original east external wall of Building A

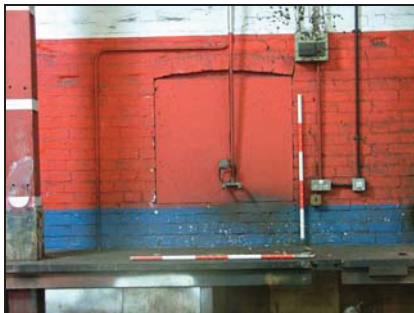
Plate 53. Window with arched head in original north wall of Building B

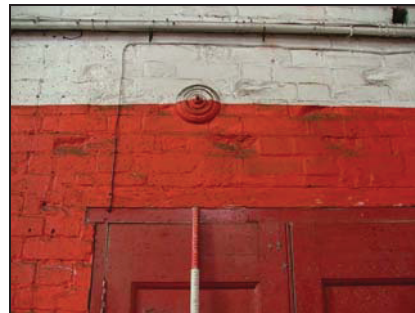
Plate 54. Circular tie-plate, original north wall of Building B
