Report № 1984

**Sunnyside Farm, Colby, Norfolk:
An Historic Building Survey and Photographic Record**

NHER 52555

December 2008

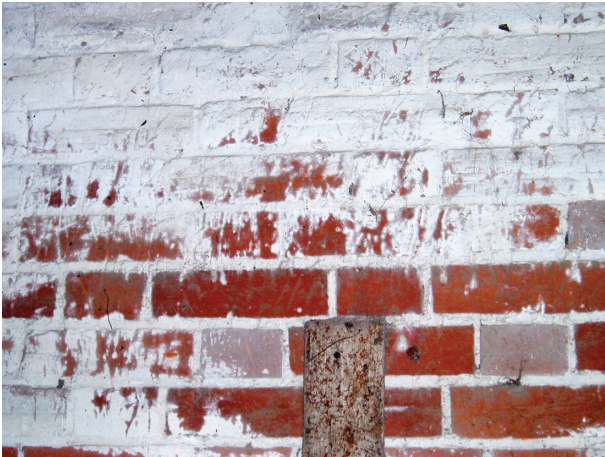
On the northern portion of the western wall (now the interior of Building C) evidence for deep vertical scratching into the soft brickwork was noted between approximately 1m and 2m from the ground (Plate 1). To the south of Building A stands an earlier farmhouse with which it shares its southern wall (Plate 2; Fig. 2).

Plate 1. Vertical scratches on exterior west wall of Building A

After the construction of Building C, the portion of this wall enclosed within in it was whitewashed in a similar fashion to Building A, covering over the deep vertical scratching mentioned above. The northern and western walls were also whitewashed. An area of the interior surface of the western gable wall was notably smoother than the surrounding brick work and slightly concave (Plate 8).

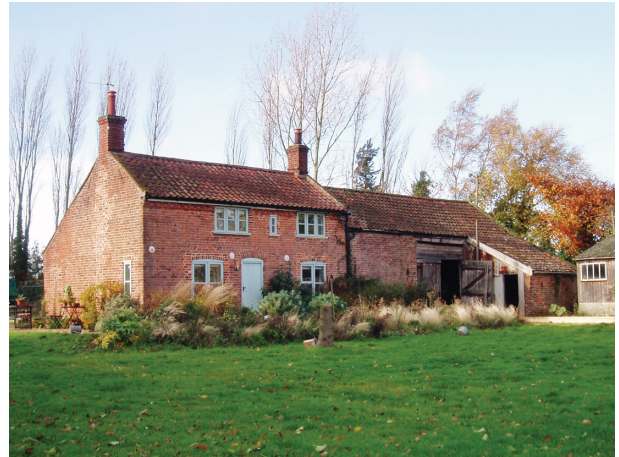
Plate 2. Building A and Farmhouse, looking north-west

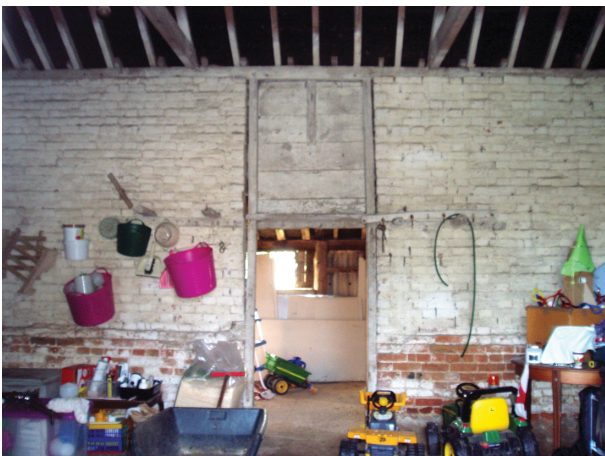
Plate 3. Western doorway of Building A, from interior

Either side of the western door two wooden beams had been incorporated into the fabric of the building at lintel height. These appear to be part of the original build and were no doubt designed to accommodate nails and hooks, off of which equipment could be hung (Plate 3). A further beam, likely for the same purpose was identified on the eastern wall towards the southern corner, and this may indicate that the modern doorway located nearby is in fact an original entrance.

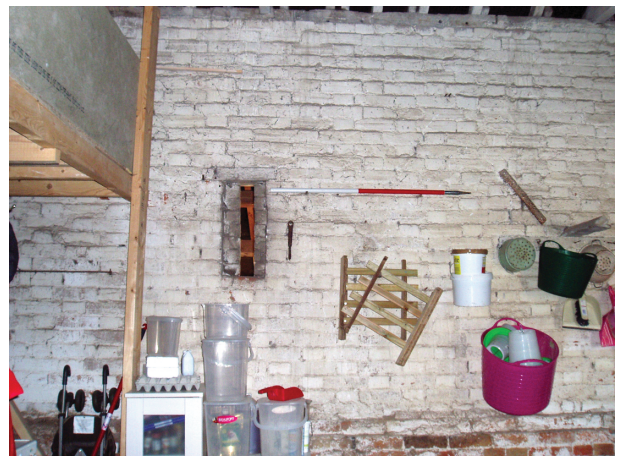
A single window or ventilation slot was recorded at the southern end of the western wall. The opening was 0.09m wide with and 0.63m high. Internally the window was recessed by the thickness of a single course of bricks and was positioned approximately 1.7m above the ground. It had a wooden lintel above, with the jambs and sill being of brick (Plate 4). No other evidence was found to indicate the presence of further original openings.

Plate 4. Ventilation slot on west wall of Building A, interior. Scale 1m

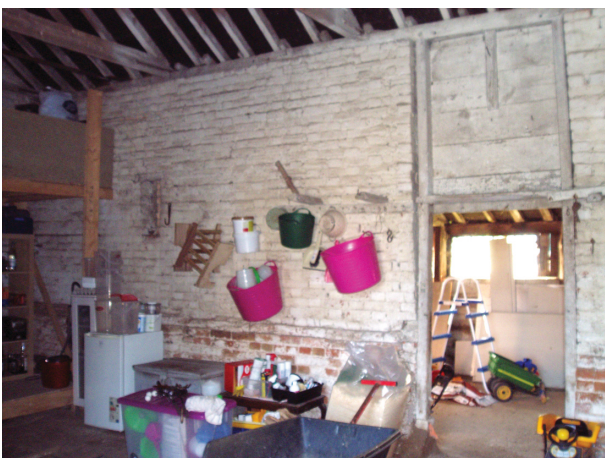
Plate 5. Interior of west wall showing plinth in Building A, looking south-west

Internally the building was divided into five bays, all of which were of roughly equal width with the exception of the central bay, which was slightly larger, and the northernmost bay, which was slightly narrower. In effect the internal floor space was of three units with a central brick-paved threshing floor dividing the storage spaces either side, as is usual design for barns of this type. All four walls had been whitewashed to their full height and a plinth approximately 80mm wide ran along the eastern and western walls from which much of the whitewash had been worn away (Plate 5).

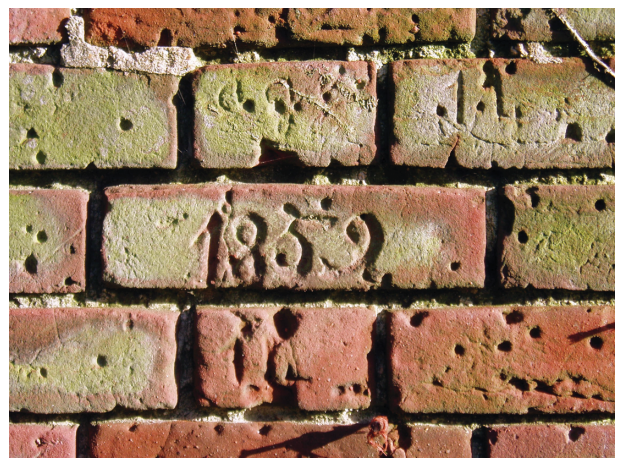
Plate 6. Inscription on gable wall of Building C

Building C constituted an east–west structure appended to the northern half of the western wall of Building A. Essentially it contained two walls, both of brick and mortar of the types already described. Its northern wall measured 7.4m long and the western gable gave the building a width of 3.6m. Several inscriptions had been carved into this wall, but only one remained legible, giving a date of 1859 (Plate 6).

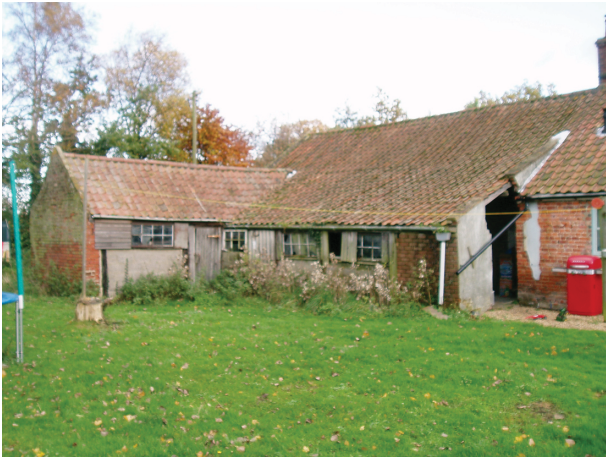
Plate 7. Buildings C and D, facing north-east

The southern wall must have originally been open fronted, with three large posts located across it at intervals, the easternmost of which currently functions as the door jamb. The space between the other two posts had been in filled with concrete blocks and windows inserted above this to the height of the wall plates (Plate 7).

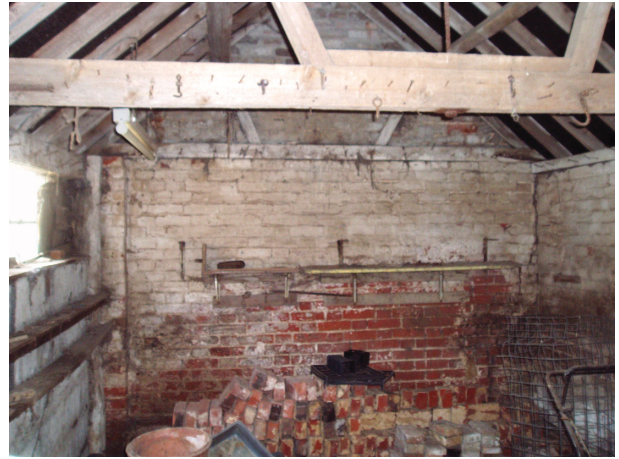
Plate 8. Area worn smooth and concave on gable wall of Building C, facing west

The open frontage of Building C suggests that it was utilised as a cattle shelter, and although there was no evidence of stall divisions the area rubbed smooth on the western wall is the approximate height at which cattle would have stood.

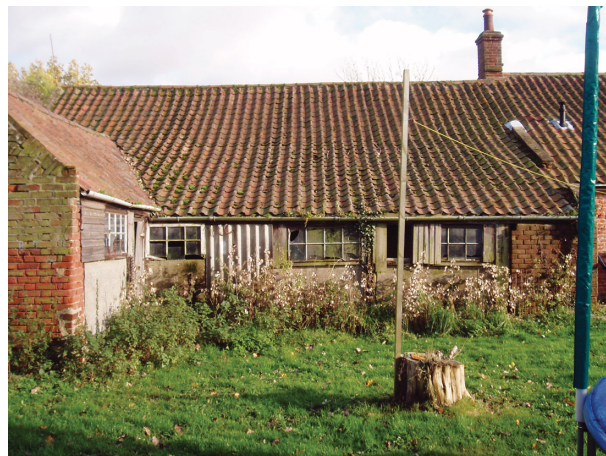
Plate 9. Building D, facing east

Building D takes the form of a lean-to running parallel to the main barn. It measures 7.4m long and 4m wide. As with Building C, it appears that initially this structure was also open fronted, its western elevation consisting of a series of regularly spaced posts with a wall plate on top. Only two, or maybe three, of these

posts remain, the rest having been removed and replaced with a combination of concrete blocks and modern brickwork. The southern part of the building, in particular, has been extensively rebuilt in this way (Plate 9).
