NORFOLK ARCHAEOLOGICAL UNIT

Report No. 990

Building Survey and Photographic Record of Sandpit Farmhouse, Deopham, Norfolk

September 2004

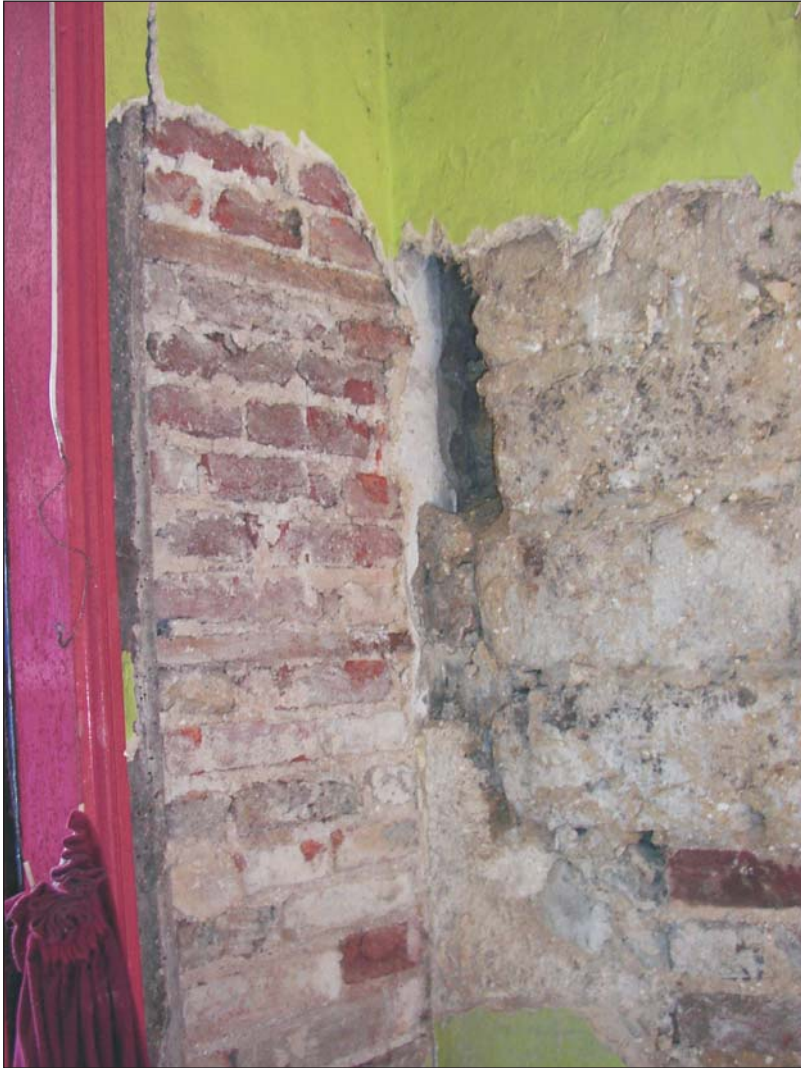
There are two anomalies in the fabric of the building which raise questions about its original layout. The first is the fact that the plaster on the wall dividing the south service room from the central room is plastered beyond the face of the external wall (Plate 11) and the second concerns the position of the lateral beam that spans across the service rooms. This beam 'should' be above the wall between the service rooms and the central room, unless that wall is a later insertion, and the plaster 'should' end on the line of the face of the external wall unless the external wall has been rebuilt.

Plate 11. Junction of the brick wall of the south service room and the south wall showing the apparent anomaly of the plastered surface extending beyond the face of the outside wall

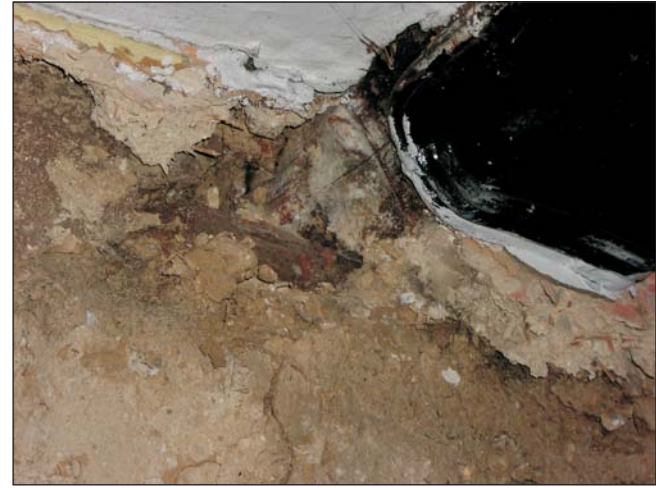
The same reasoning for reuse applies to the beam at ground floor level in the central room where some of the 19th-century casing has been removed at the south end of the beam to reveal that the stops are within the wall face (Plate 12). This beam is large, measuring 0.31m across, and has a larger version of the same straight-cut chamfer and simple concave and stepped stop as seen on the axial beam in the west room.

Plate 12. Chamfer stop partly within wall

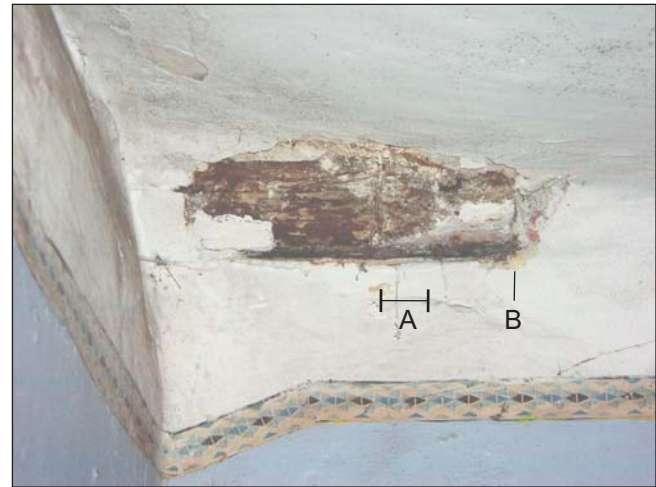
The lobby is formed with clay lump walls in a reversed 'L'-shape configuration extending away from the gable wall; the reason for this configuration, in addition to creating a lobby, is to provide support for the end of the reused axial beam. The size of the room took precedence over the length of the reused beam as this ends some 0.85m away from the gable wall and is, as said earlier, supported on the return wall of the lobby. Reuse of the beam is suggested by the fact that the chamfer stops do not relate to the wall (Plate 13) and above the fireplace the face of the stack mostly hides the stops.

Plate 13. Chamfer stop on re-used beam.
A = extent of stop
B = end on beam

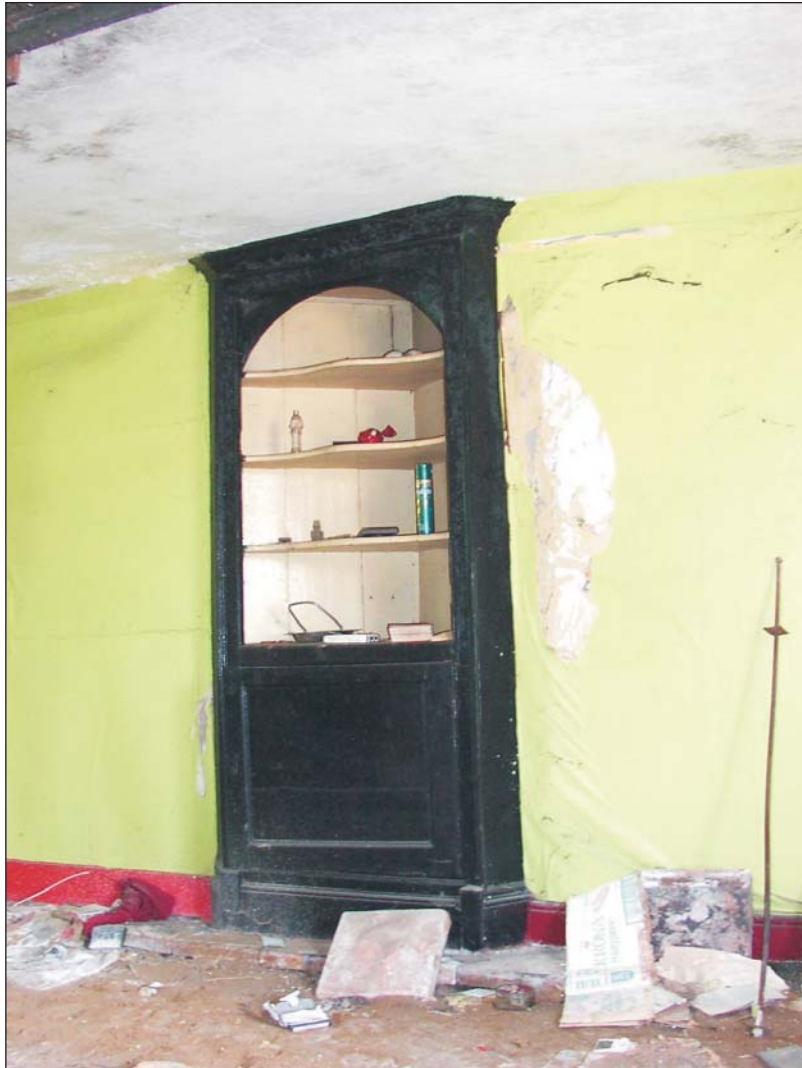
As stated earlier the internal doorway to the north service room has been blocked and the room last functioned as a store with external access only. A late 18th-century corner cupboard has been inserted quite incongruously into the lateral wall to the side of the blocked door (Plate 9) and in the south service room against the dividing partition there are two shelves that (Plate 5) could conceivably, due to the size of the shelves and the design of the central and end supports, be contemporary with the construction of the building. The shelves have been removed on the other side of the room although the end supports survive.

Plate 9. Eighteenth-century corner cupboard

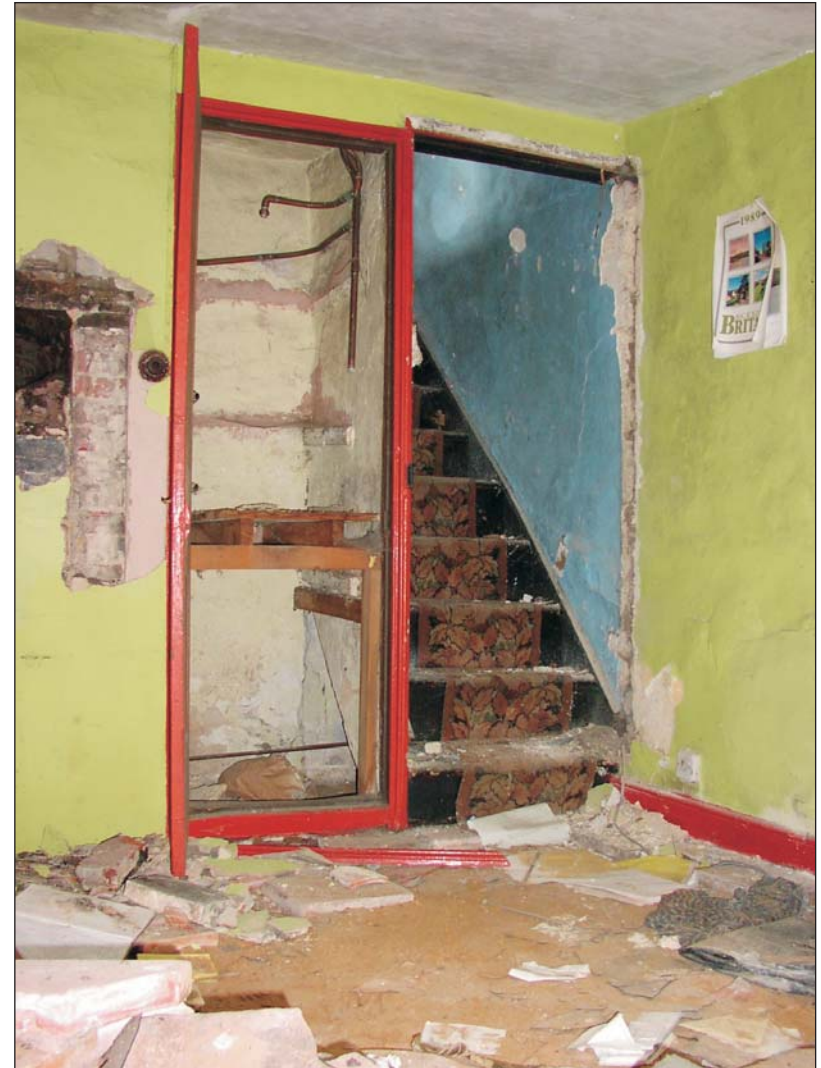
Plate 10. Stairs up to first floor level

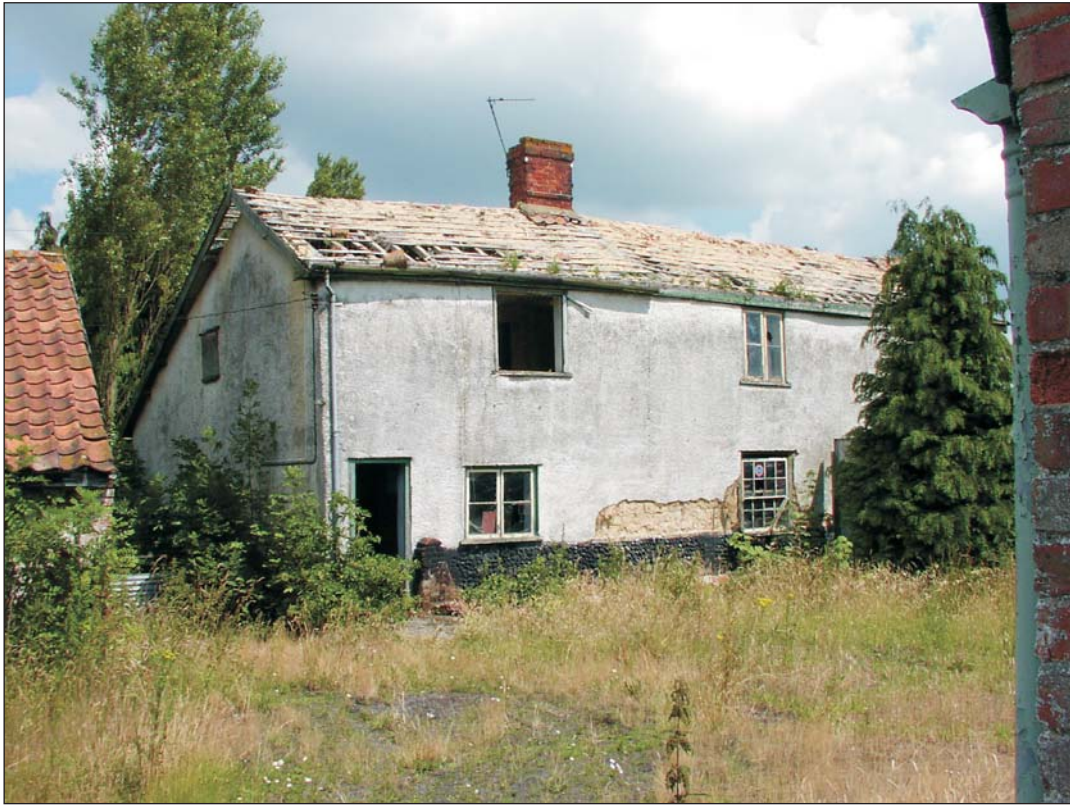
There is a second external doorway in the south wall adjacent to the west gable (Plate 1) and this gives access to a lobby that is now partly closed off by a 20th-century timber partition (see Fig. 2) and was probably associated with the use of the building as an office for the coal depot.

Plates 1. South elevation looking north-east

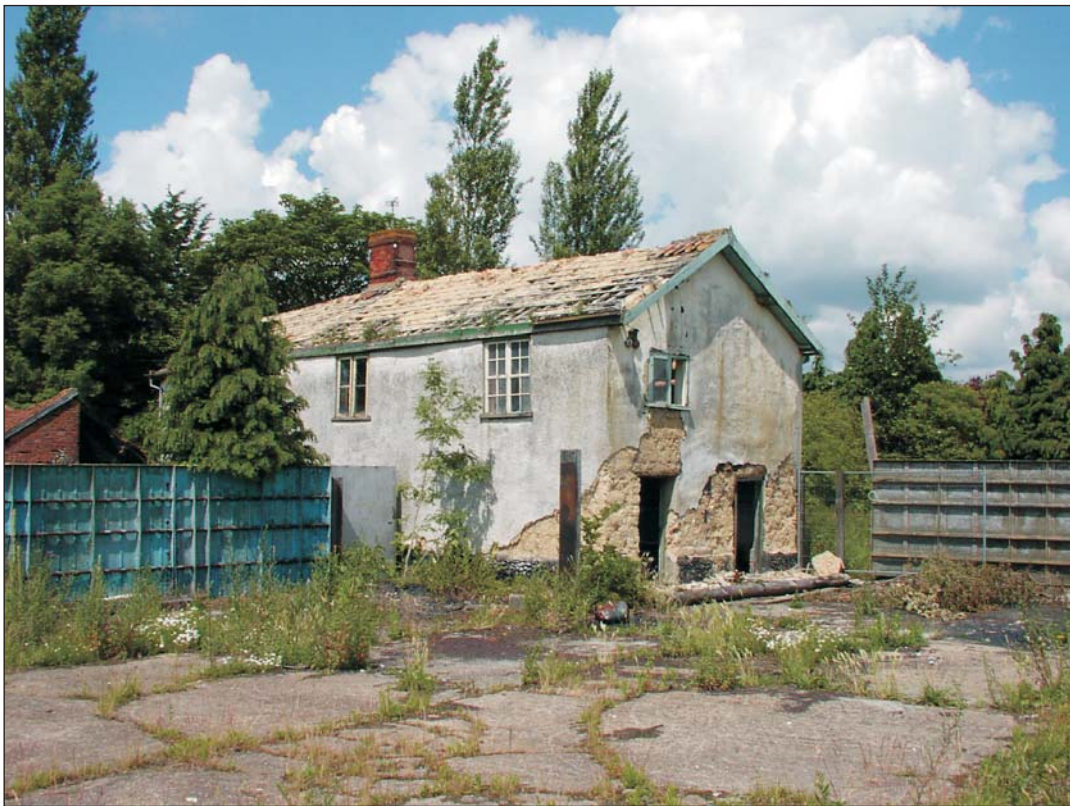
When the building was constructed both of the end service rooms were accessible from inside the building, although now the doorway to the room on the north side is blocked. Both rooms have slightly later (to judge by the one remaining complete frame) external doorways (Plate 2).

Plates 2. South elevation looking north-west

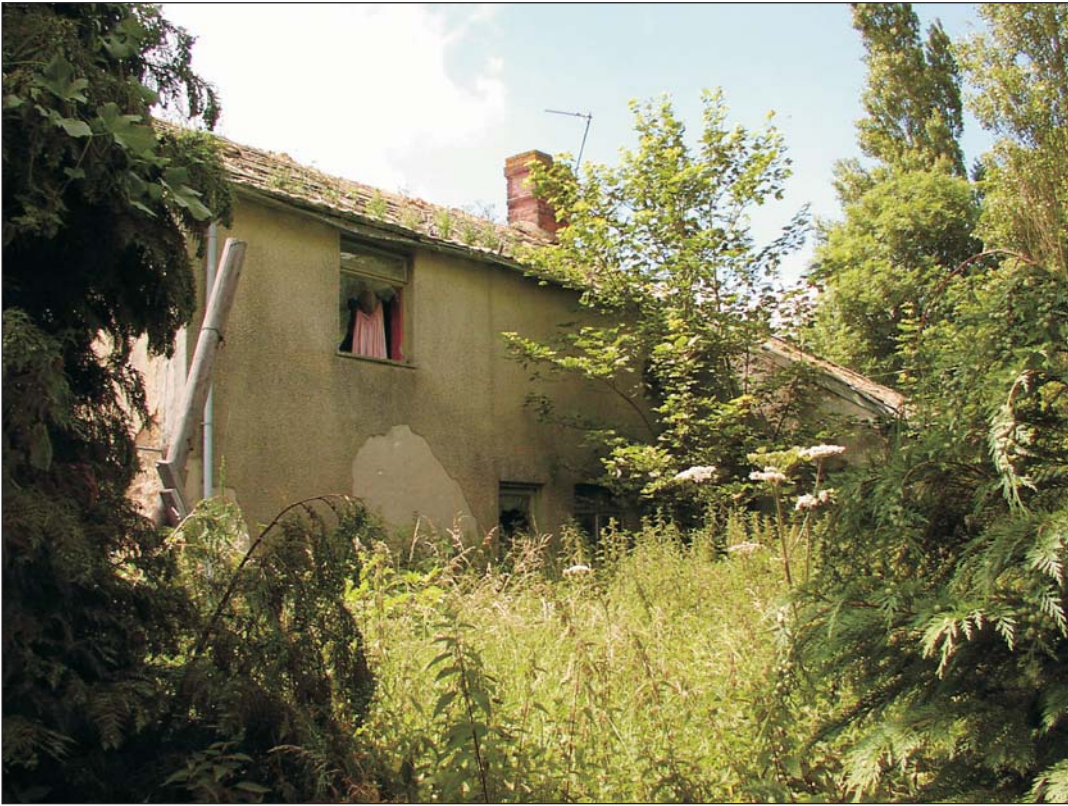
Plate 3. The east end of the north elevation

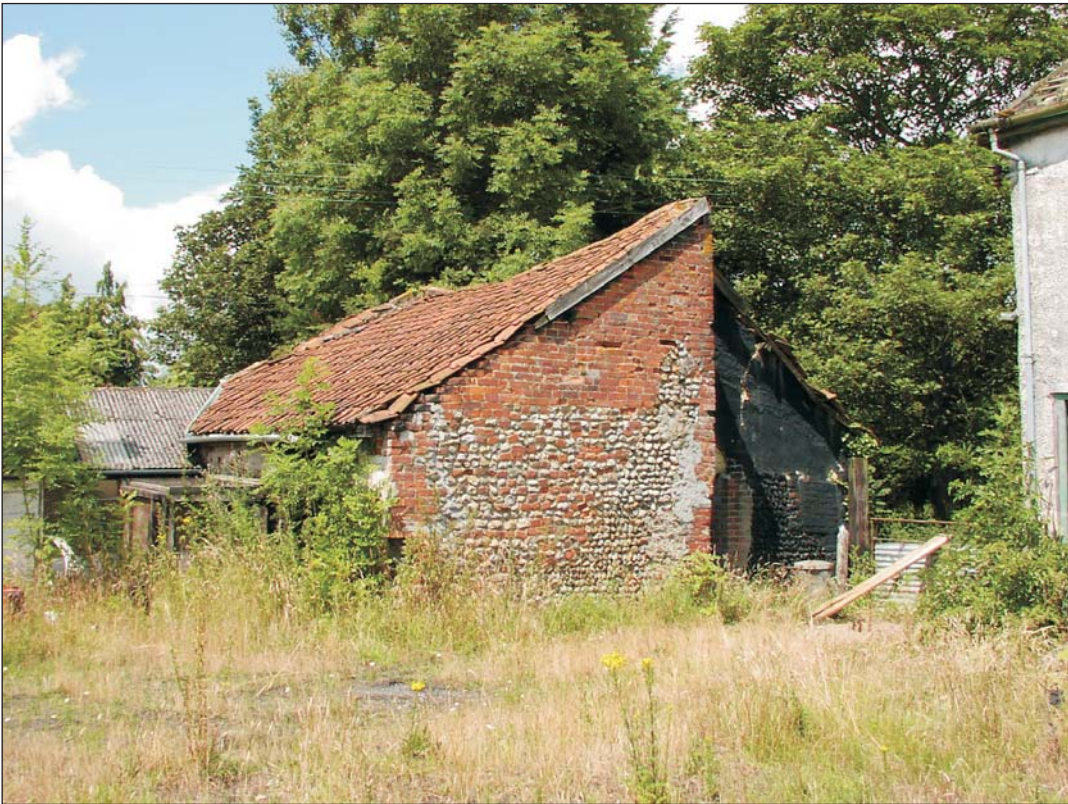
Plate 4. The outbuilding to the west of the main block

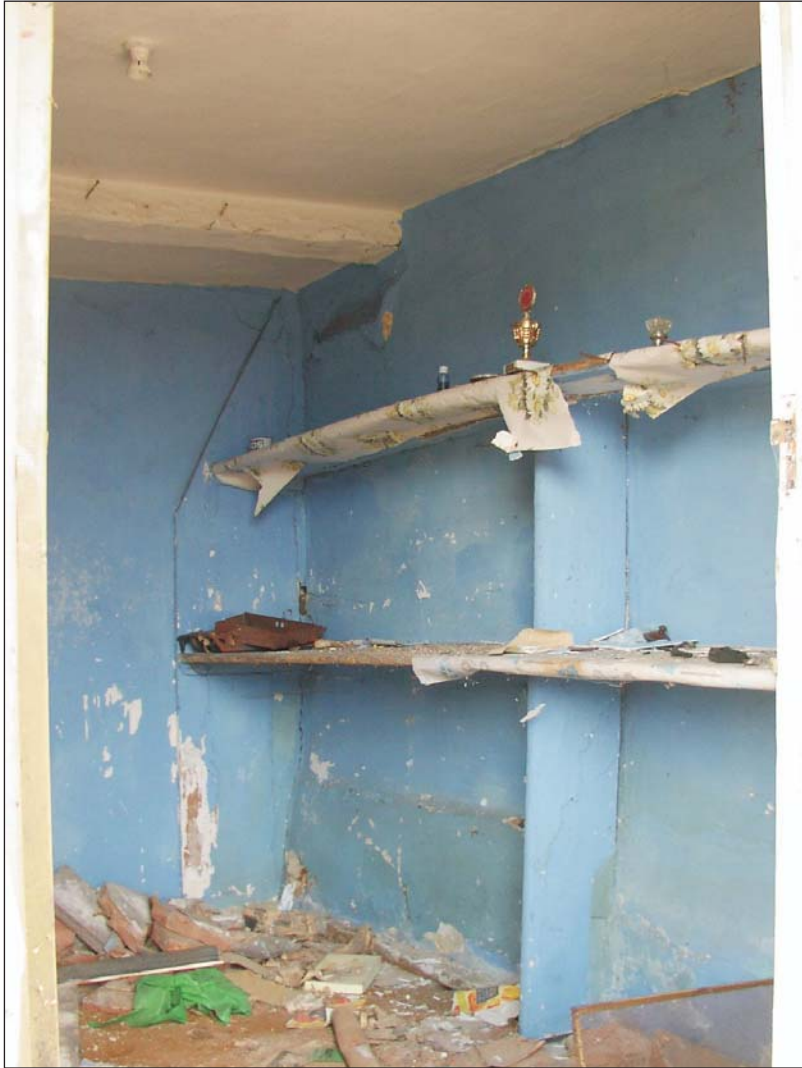
Plate 5. Shelving in the south service room

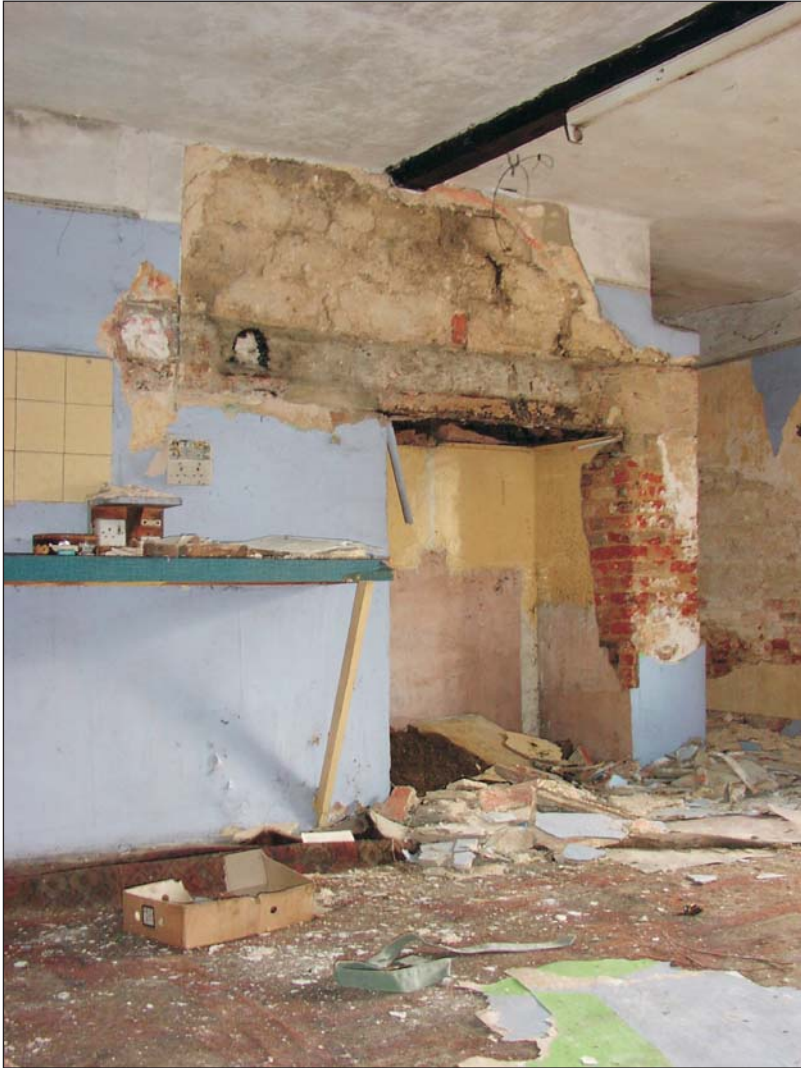
Plate 6. Fireplace in the west room

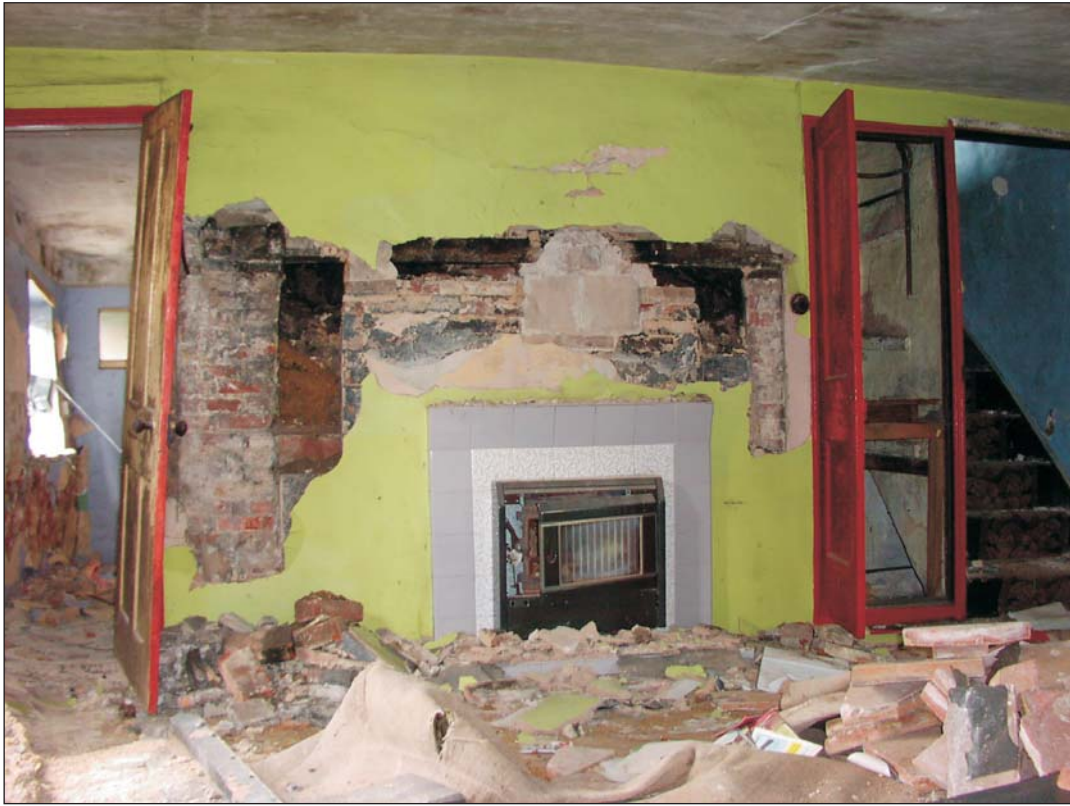
In the principal range within the house there are two heated rooms that are served by relatively large back-to-back fireplaces and the third room is divided into two by an axial partition. At ground floor level the fireplaces have undecorated timber lintels (Plate 7) and are constructed with brick, replaced by clay lump at first floor level, where it appears there were never any fireplaces, and above the level of the ridge the stack was rebuilt in the 19th century using red brick.

Plate 7. Fireplace in the central room

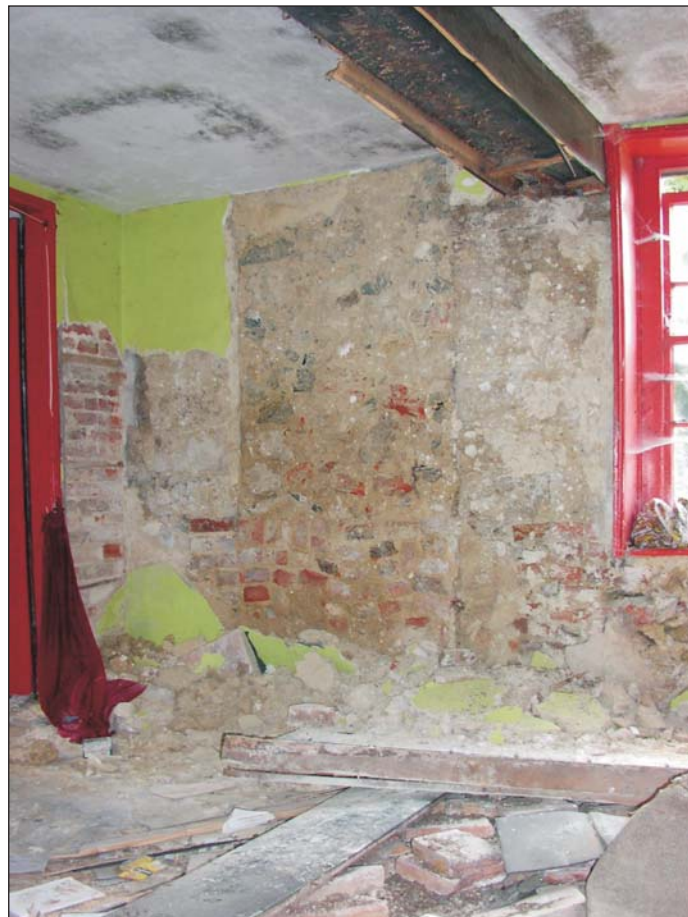
There are two doorways opposite each other in the north and south walls at the east end of the central room, although the opening on the south side has been blocked with a mixture of brick and flint (Plate 8).

Plate 8. Blocked doorway in the south wall of the central room

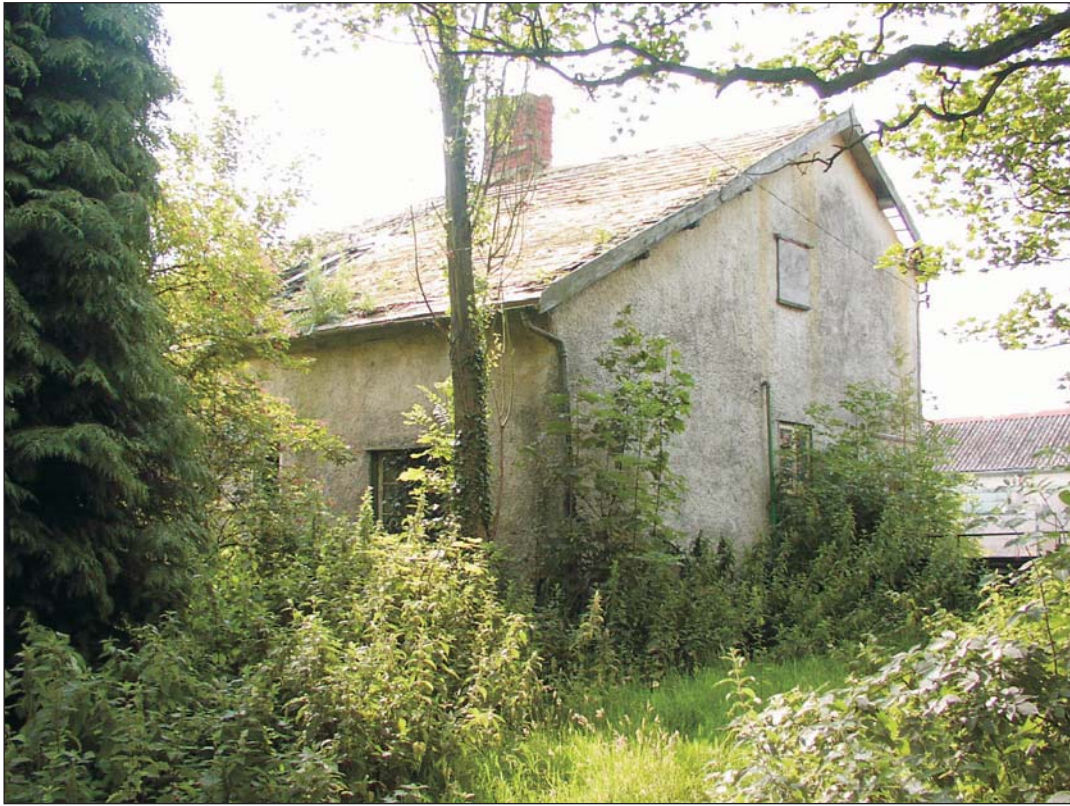
The three-cell building is aligned east-to-west (Fig. 2), it is two storeys high and constructed with rendered clay lump external walls above a brick and flint plinth. There is also a one-and-a-half storeys high, two-roomed extension on the north side of the western room (Plate 14) and a flint and brick outbuilding to the west of the main block (Plate 4).

Plate 14. The west end and part of the north elevation

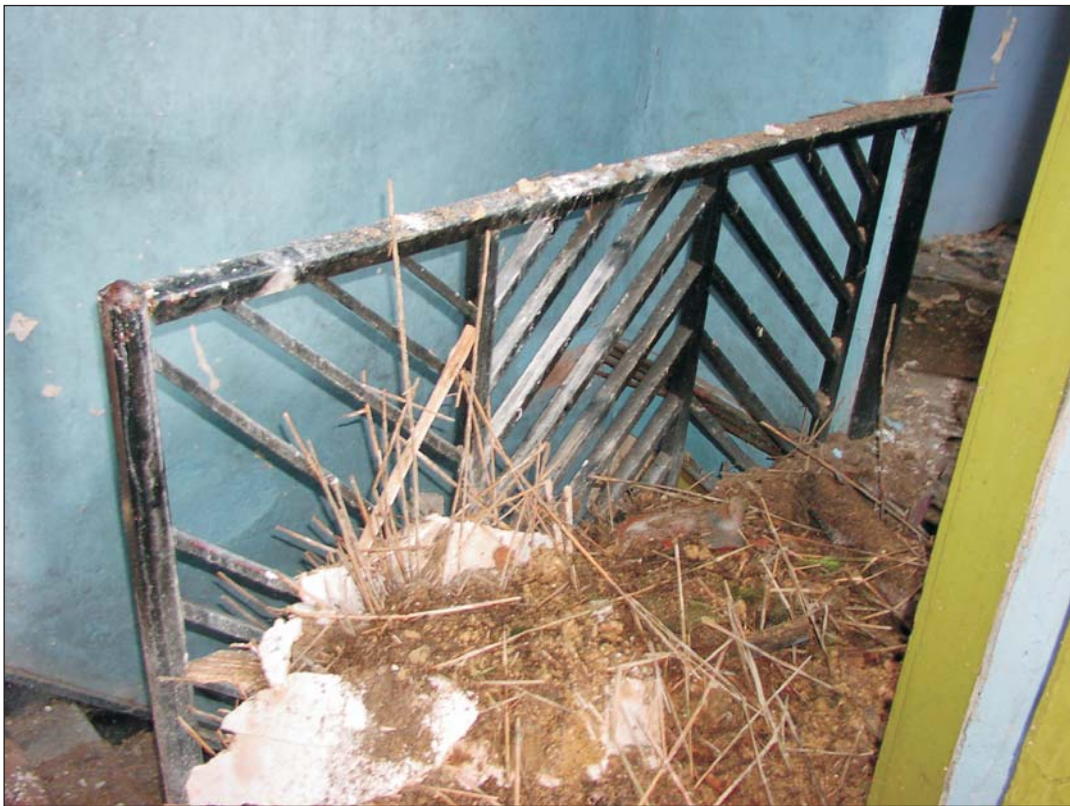
The stairs to the first floor level are on the north side of the chimney stack (Plate 7) and consist of a straight flight with an open fret baluster (Plate 15) at first floor level that suggests a 19th-century date for the stairs, unless of course the baluster is a later replacement. That the stairs were always in this position is suggested by the fact that the chimney stack is off-centre to the south although in all probability the present flight replaced a winder type of stair, although this is purely conjectural and is based on common comparative examples.

Plate 15. The baluster associated with the ?replacement stair
