NORFOLK ARCHAEOLOGICAL UNIT

Report No. 1006

Building Survey and Photographic Record of Elm Farm, Wymondham, Norfolk

Kenneth Penn November 2004

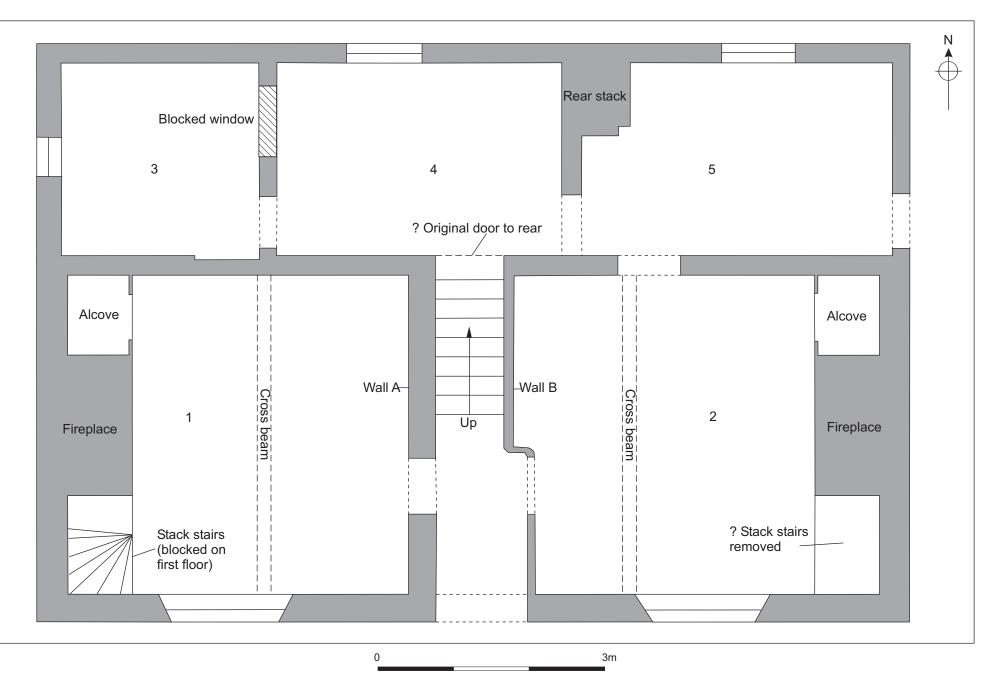
Figure 2. Plan of ground floor. Scale 1:50

The ground floor had stairs rising from the entrance, between Walls A and B, with a door to each side giving access to Rooms 1 and 2. A door in Room 2 gave access to the rear rooms (3, 4 and 5). A door in Room 5 gave access to the outside. There was no evidence of blocked windows in the rear of Rooms 1 and 2.

Both Room 1 and Room 2 had large cross beams supporting the first-floor joists; each was 7" (180mm) wide and 9" (230mm) deep with stop chamfers. The beam in Room 1 had been enhanced by the addition of softwood mouldings to produce a more decorative effect.

The main internal walls on the ground floor were about 0.26m thick; the exception was Wall B which was only about 0.10m thick and found to be a modern insertion of breeze-block. This was presumably done to enable the central stairway to be built which indicates that they were not original and that access to the upper floor was *via* the stack stair(s) in the first instance.

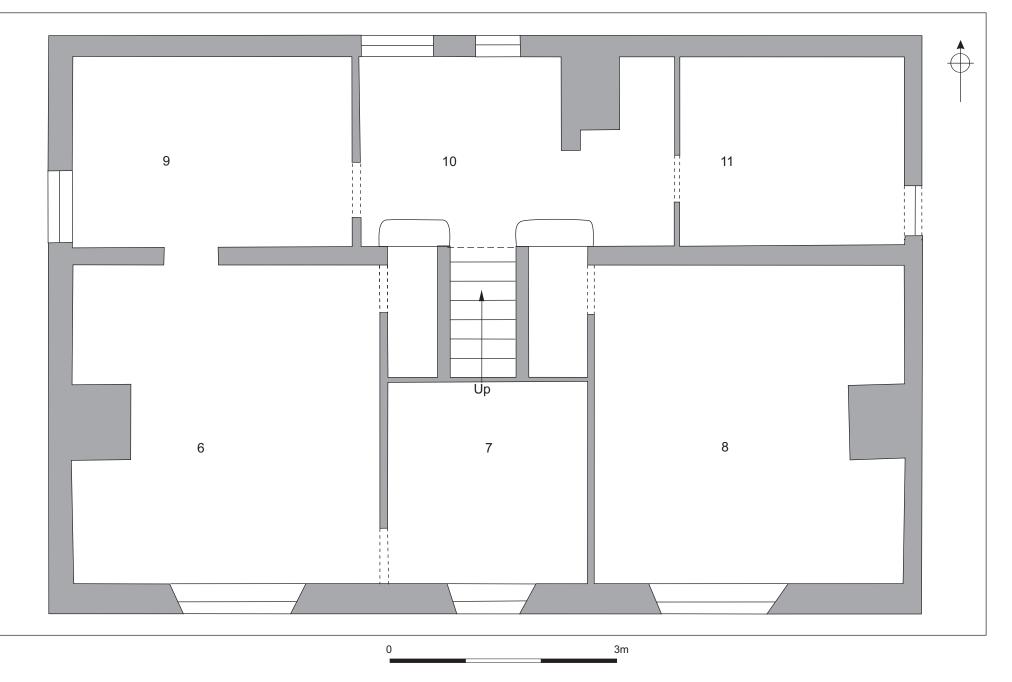
Figure 3. Plan of first floor. Scale 1:50

The upper floor was divided into six rooms (6 to 11) with three rooms to front and three to the rear. The original arrangement of the rooms is uncertain due to the insertion of the central stairway, which may have altered the layout. Except for the wall between front and back, the internal walls consisted only of slight partitions. The rear rooms are lower than the front.

Originally, stairs came into Room 6 by the stack (evidenced by blocking of the floor here) and probably into Room 8 in a like manner. A door in Room 6 (1.62m high) also led into the rear, Room 9 (Plate 5).

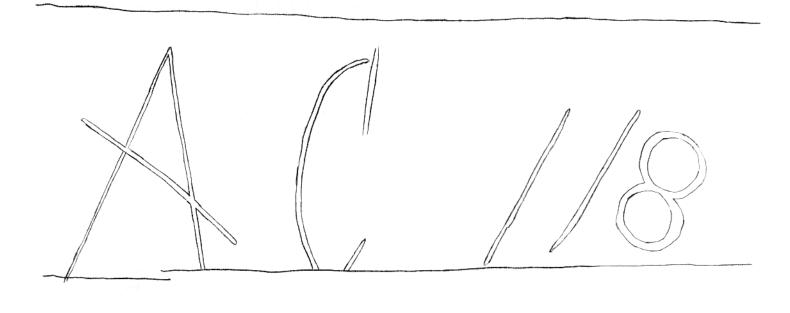
Figure 4. Carpenter's mark. Scale 1:2

Wall plates (of softwood) rest on the front, middle and rear walls; these were inspected after removal and found to have no evidence for tenons or any other jointing. The rear wall plate carried a possible carpenter's mark, perhaps AC 1 1 8 (Fig. 4).

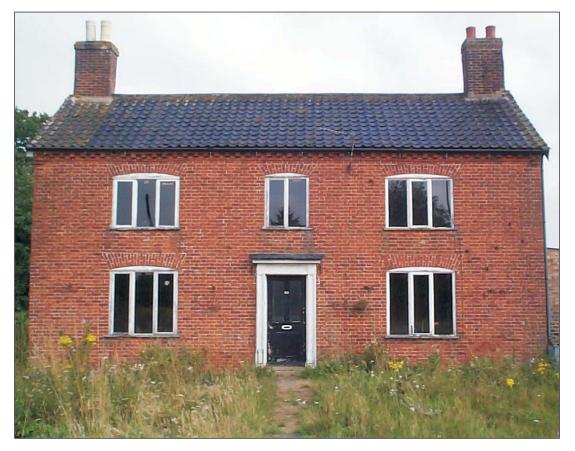
Plate 1. Elm Farm, south (front)

- The date of 1806 seen on the barn (see above).
- The original doorway was round-headed (Plate 1). The curve of this brick arch was cut to accommodate the rectangular frame of the present doorframe.
- The beam in the left-hand room (Room 1) is the same as in Room 2, but with the additions of modern softwood mouldings for decoration.
- On the upper floor, in the catslide roof (between Rooms 6 and 9) the blocked cupboard is in fact a door, blocked only in Room 6 but with the door still in place. (Some step must have been provided for access from Room 6 to 9).
- The brickwork is dentilated to front and rear (only).
- It may also be noted that there were no blocked openings on the external brickwork.

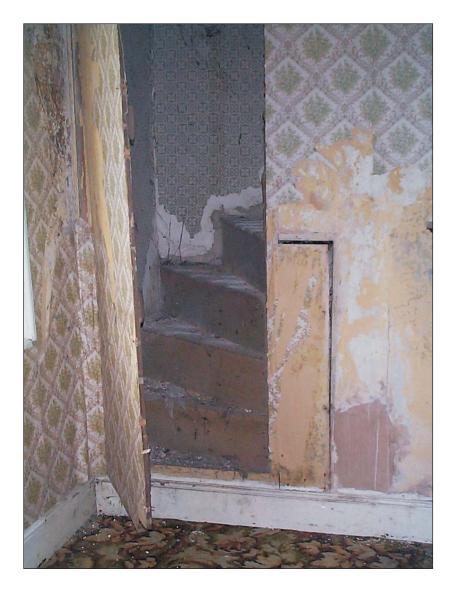
Plate 3. Room 1, stairs by stack

Room 1 was reached from the small hallway, *via* a door in the Wall A. Wall A was 0.26m thick and of brick, with some breeze-block inclusions. The cross beam ran from front to back, supported on the window lintel. The stack contained a fireplace of probable 19th-century date. On one side of the stack was an alcove, on the other behind a board door, was a flight of stairs to Room 6 (Plate 3). These stairs were blocked on the first floor by inserted floorboards.

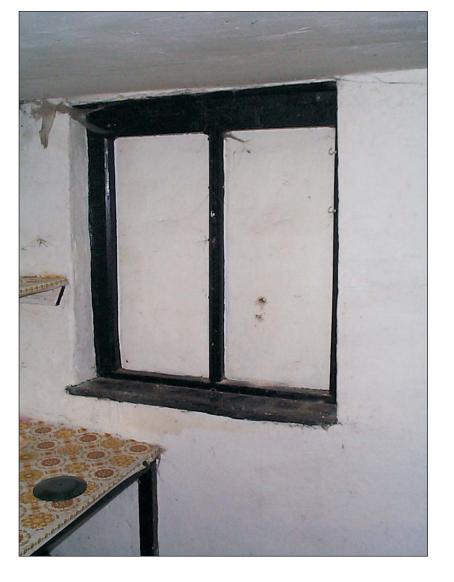
Plate 4. Room 3, former window

The rear of the ground floor was divided into three rooms (3, 4 and 5) set at a lower level than those at the front. Curiously, the internal wall between Rooms 3 and 4 contained a window (Plate 4). Room 5 contained the rear stack. The rear windows are original.

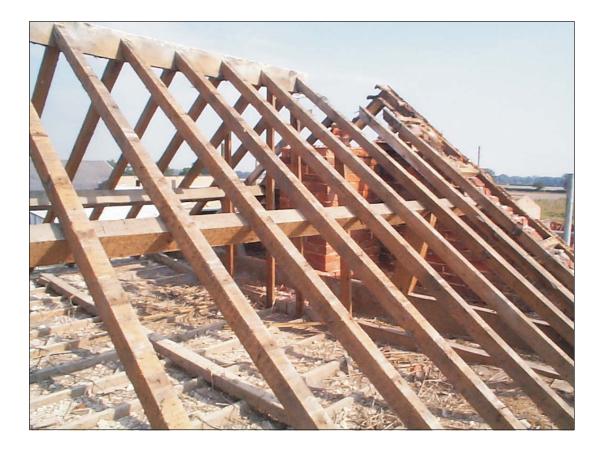
Plate 6. Roof timbers

The main roof consisted of common rafters $(2" (50mm) \times 3" (80mm))$, four pairs of which were (nail) fixed at the foot to the four tie beams. There is a purlin in each pitch, fixed in the gable brickwork and supported by raking struts rising from the four tie beams, nailed in place. A ridge board runs between the two stacks.

The catslide roof is at a lower pitch, and consists of common rafters (2" (50mm) x 3" (80mm)) resting on the lower wall plate and the brickwork of the central wall. The rafters are supported by a purlin (in three overlapping sections).
