NORFOLK ARCHAEOLOGICAL UNIT

Report No. 1011

**Building Survey and Photographic Record of
Barns at Home Farm, Westacre,
Norfolk**

Location: barns at Home Farm, Westacre, Kings Lynn
District: West Norfolk
Grid Ref: TF7929 1847
HER No.: 32149WAC
Date of fieldwork: July to August 2004

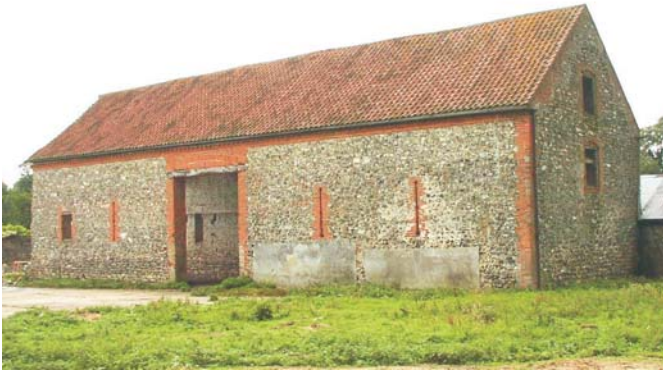
Plate 1
Building A from
north-east

The entire south gable of the barn plus a short return stretch of each side wall has been demolished (Fig. 3). The surviving walls are faced with a combination of knapped and unknapped flint and brick. Both the inside and outside faces of the wall plate are covered with six courses of brick and there is a block cornice (Fig. 4). The top edge of the surviving gable is also formed with brick although not to a regular pattern, as is 'normal' and this could suggest a later rebuild/repair (although due to the similarity between the bricks in the gable and those seen elsewhere in the barn this is far from certain).

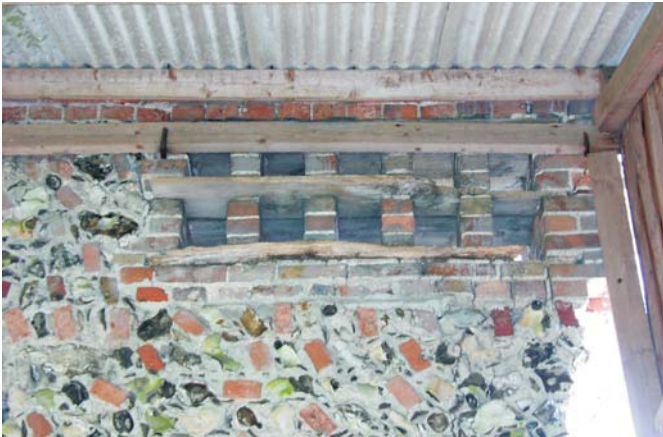
Plate 2
Building A from
west (interior)

Below the six courses of brick in the south end of the west wall there are ten open-sided compartments in two tiers that are each formed with three courses of brick and divided horizontally by a plank. The inside face is covered with vertical planks and the similarity between the bricks and those above suggests that the feature is contemporary with the construction of the barn and it functioned as a nesting box? (Plates 2 and 3).

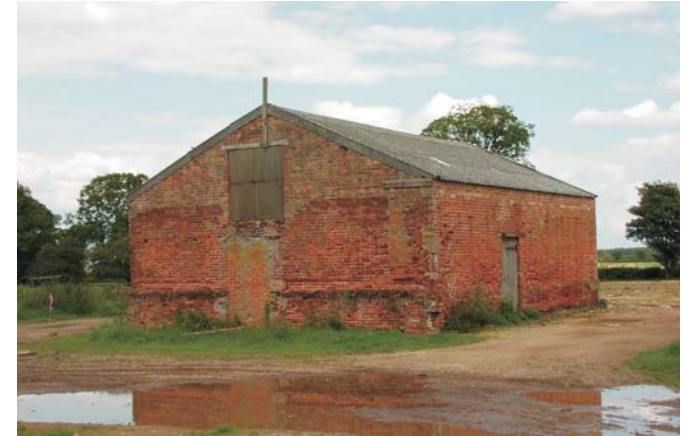
Plate 10
Building D from
south-west

This is a relatively small building (Fig. 7) with a rectangular plan and constructed with red brick walls (Plate 10). There is a pair of sliding doors in the east gable wall, a slightly off-centre blocked door opening with a blocked window above in the west wall, two blocked window openings in the north wall and a door in the south wall. Internally brick pilasters form the sides of the opening with the sliding doors and there are pilasters in the north-east and south-east corners plus two pairs on each side to the east of the door in the south wall. A plinth extends around the wall internally and between the pilasters and there is an external plinth along the length of the west and north walls.

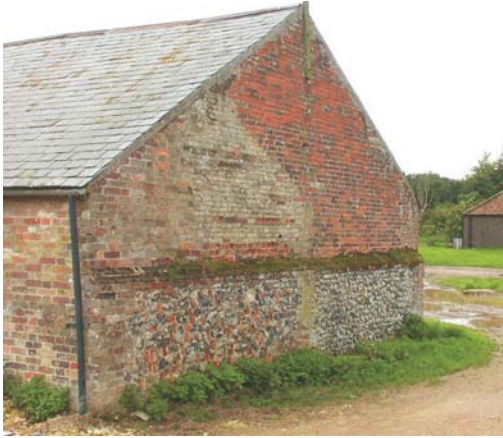
Plate 13
Building F1 from
north-east

The eastern half of the north gable represents the sole remains of an earlier building (Plate 13) and is faced with relatively small bricks laid in Flemish bond above a relatively wide and high plinth that is faced with a random mixture of brick and flint. The line of the right-hand pitch of the roof associated with the earlier building is visible although the left-hand side was rebuilt when the east wall of the building was itself rebuilt.

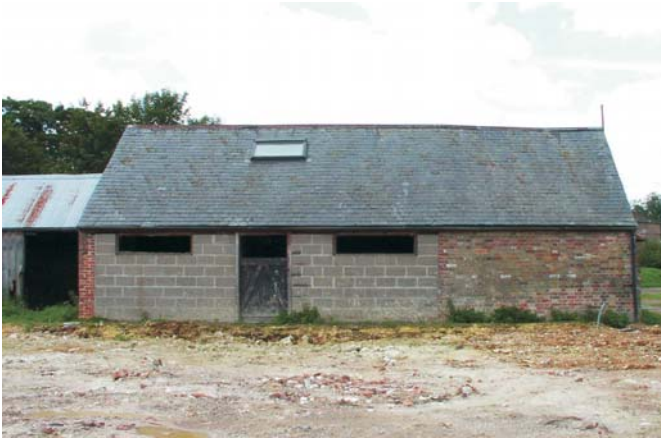
Plate 14
Building F1
from east

The east wall now consists of a stretch of brickwork that wraps around and has replaced part of the earlier north gable wall and the end corresponds with a lateral internal wall. Between this stretch of brickwork and the gable wall with the off-centre door opening the east wall consists of concrete blocks with a high level window on each side of a central doorway (Plate 14).

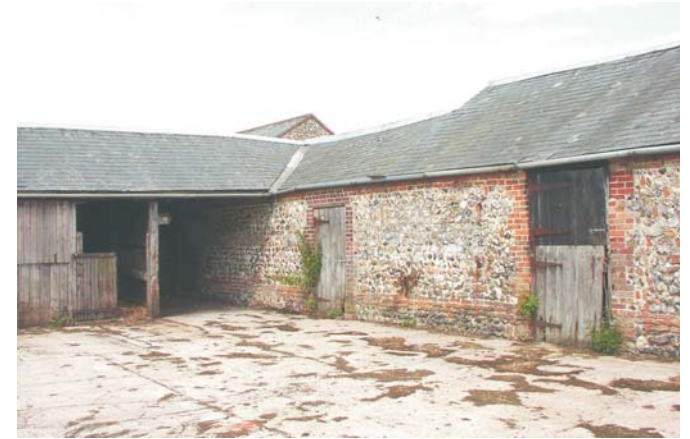
Plate 17
Building F3
from west

The west wall is faced with a random mixture of brick and flint, the door openings are formed with bricks in a block design (Plates 17 and 18) and these are joined above a flint plinth by three courses of brickwork (at the south end).

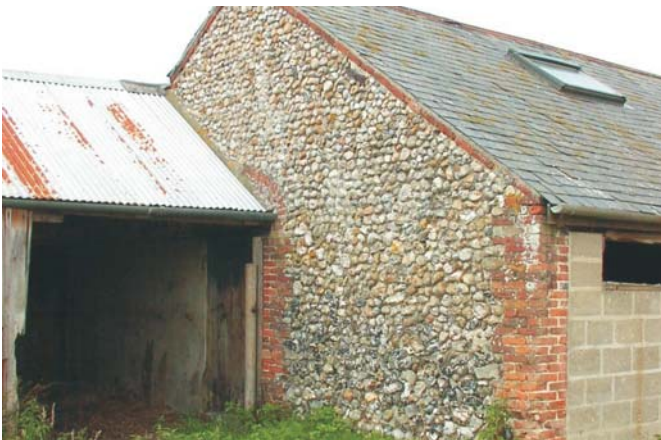
Plate 15
Building F1 from
south-east

The south wall of this block is faced with unknapped flints and the quoins and the jambs of an off-centre door opening are formed in red brick and the wall is contemporary with the westward extension. Above the off-centre door opening there is a semi-elliptical relieving arch that appears to be as much a decorative feature as a structural element (Plate 15).

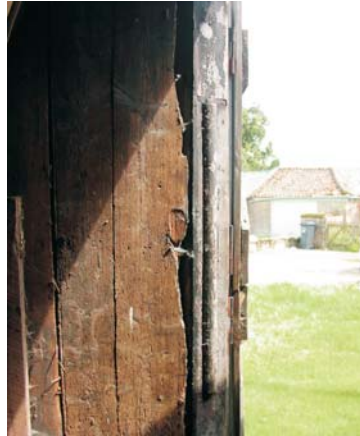
The east wall is faced with relatively large unknapped flints and the door openings have simple brick jambs and all, apart from the north room with the internal partitions, and are infilled with 20th-century concrete blocks. The south wall has a central door opening that is flanked on both sides by a window and there is a further window above the door and the openings are formed with brick and all have a shallow segmental arch. The door opening in the end wall is in keeping with the other three in the east wall – the blocked door immediately adjacent to the south gable is a later insertion – and has a deep internal splay that contains a rare survival. On each side of the opening, approximately half way up from ground level a vertical roller has been set into the jamb to minimise scraping to the sides of the animals and wear on the jambs (Plate 19).

Plate 19
Building F3 looking
south through
doorway in south
wall, showing *in situ*
rollers

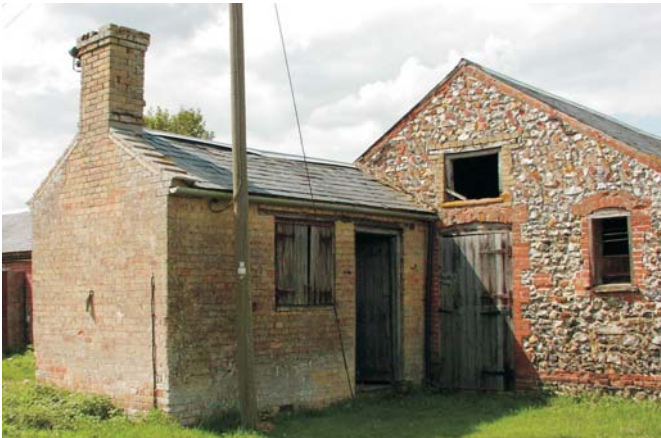
Plate 20
Building F3 Tack Room
from south-east

A small tack room has been constructed against the south end of the block (Plate 20), blocking one of two windows in the south wall mentioned above: the width of the room was determined by the position of the central doorway between the two windows. The room is constructed with gault bricks and is heated by a small fireplace on the south wall and panelled with vertical planks (Plate 21) below a horizontal rail at cornice level that supports the tack pegs.

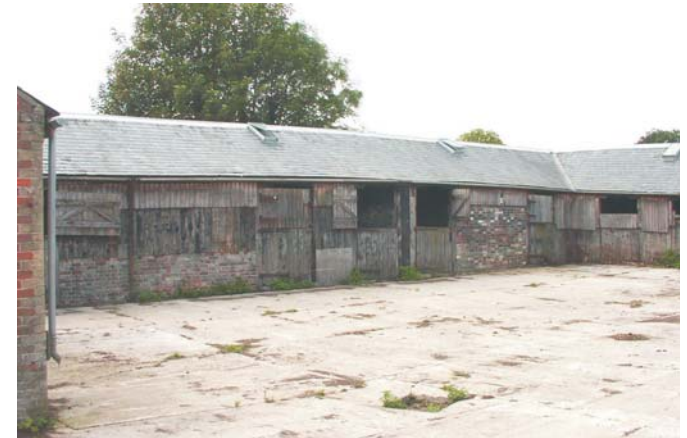
Plate 23
Building G
from east

The walls facing the yard are constructed with upright timber posts that support vertical planking (Plates 23 and 24) and in the north range the three-quarter high doors. In the west range there is a 0.9m brick wall and a short stretch of 2m high brick wall with vertical planking above, that, along with a door opening, defines a separate room.

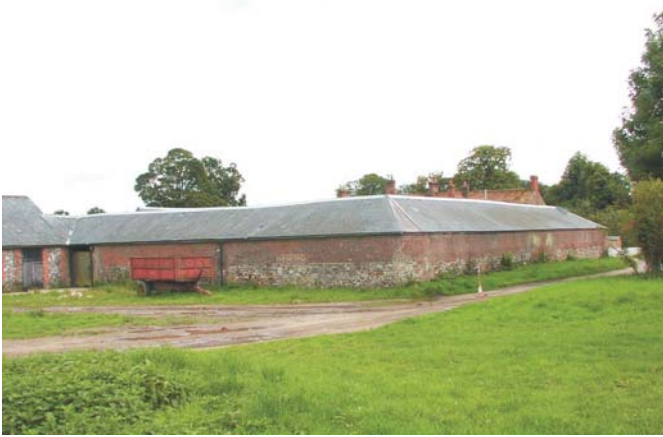
Plate 25
Building G from
north-west

The upper half of the external walls are all constructed in brick laid in English bond (Plate 25) and below this the north and west walls are faced predominantly with unknapped flint with some brick and at the same level the south wall is constructed with headers laid vertically. Above identical headers the east gable wall has been rebuilt in the 20th century with bricks laid in English bond and the top eight courses are taken-up with ventilation bricks that are laid in an alternating horizontal/vertical pattern.

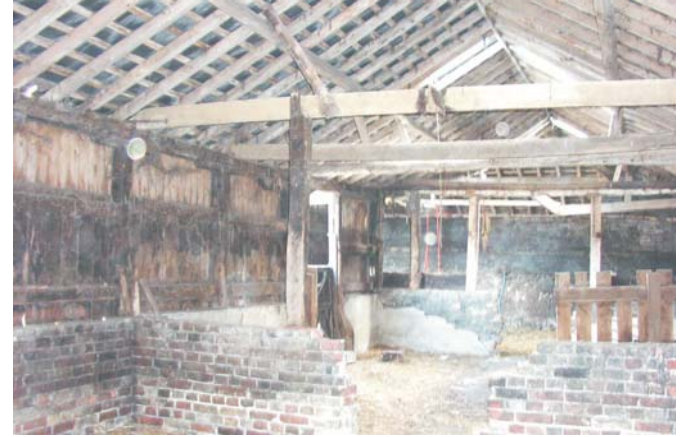
Plate 28
Building G (interior)
from north

South from this there are four compartments that are separated by low brick walls (Plate 28) the central portions of which have been crudely broken through. The doors in the west range are the conventional two leaf stable doors and the roof has a single purlin in each pitch that is supported by inclined up-raking struts.
