**NORFOLK ARCHAEOLOGICAL UNIT**

Report No. 797

**Report on an Archaeological Watching Brief at  
St John's Church, Waxham, Norfolk**

March 2003

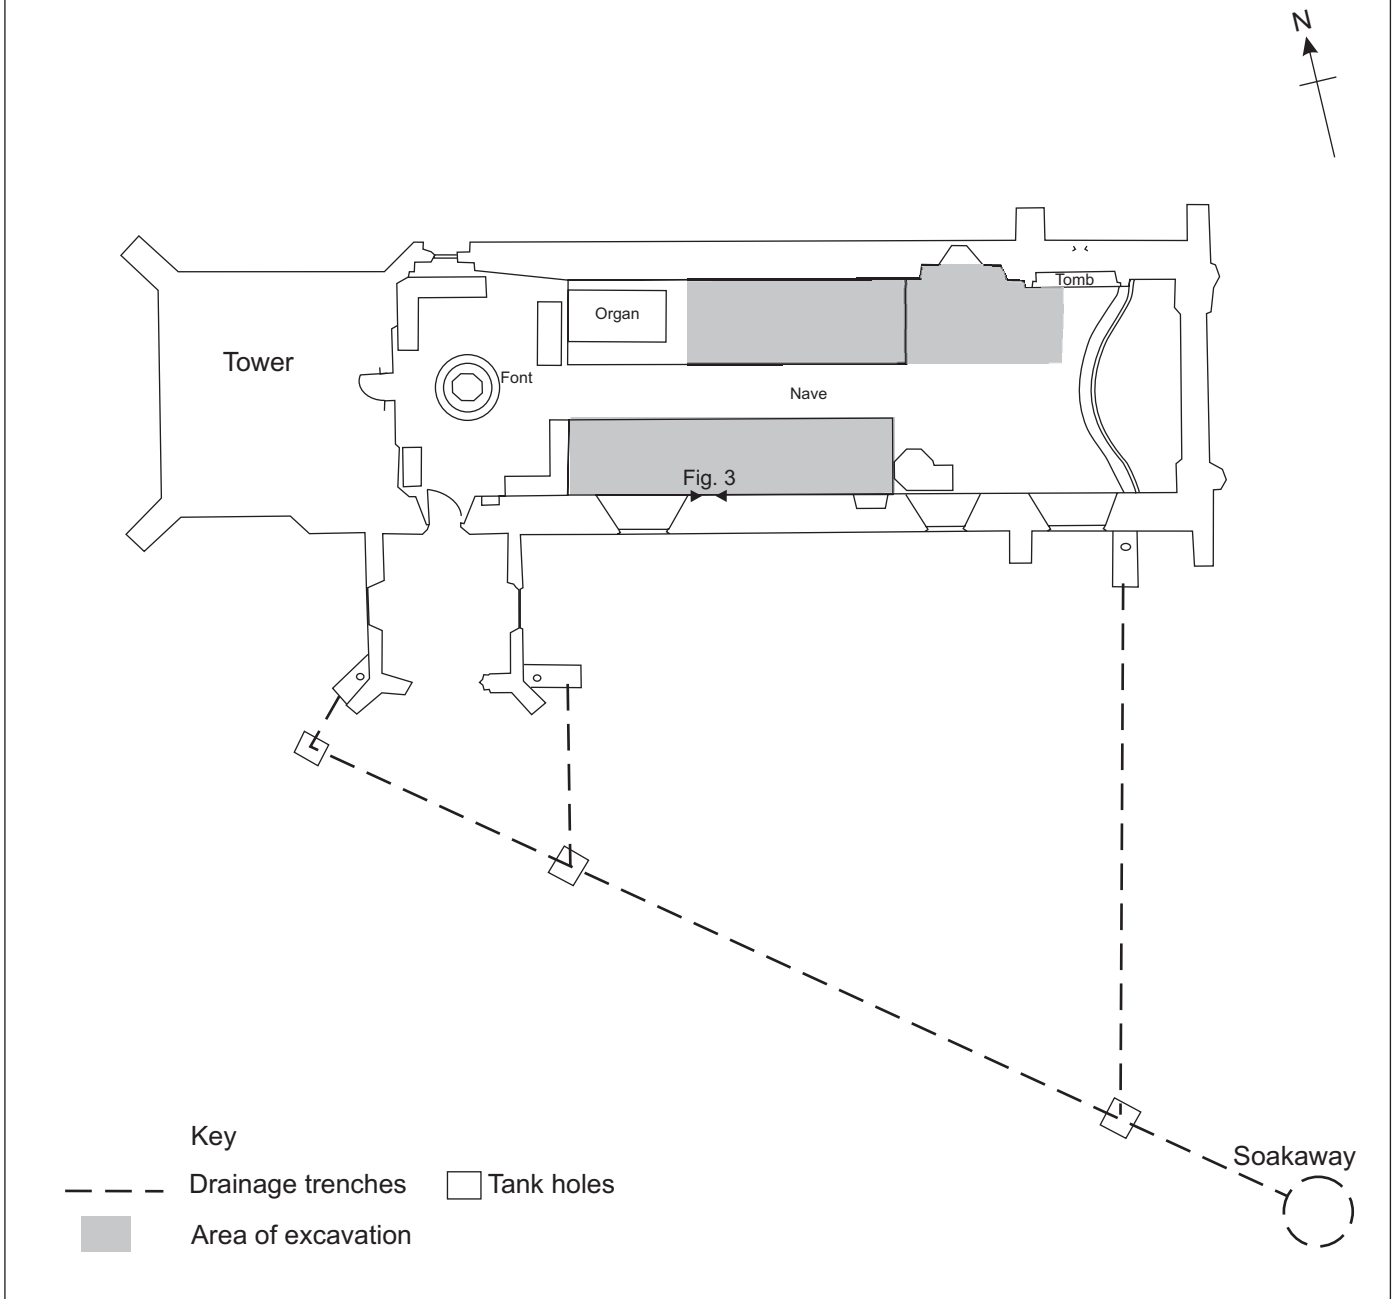
Figure 2. Trench Location. Not to scale

Trenches, inspection tank holes and a soakaway on the south side of the church were monitored during excavation. The trench was 0.5m wide and ranged in depth from 0.5m to 0.9m and the inspection tank holes were between 1.0m and 1.1m deep. The soakaway was excavated to 1.7m depth.

One burial was slightly disturbed during excavation at the base of the central inspection tank hole. The bone remained *in situ* and the rest of the burial remained in tact. Although a small amount of disarticulated human bone was encountered in the drainage trenches, no other articulated burials were observed.

Where the foundation of the south wall of the church was exposed it was seen to consist of flint nodules in a very white lime mortar.

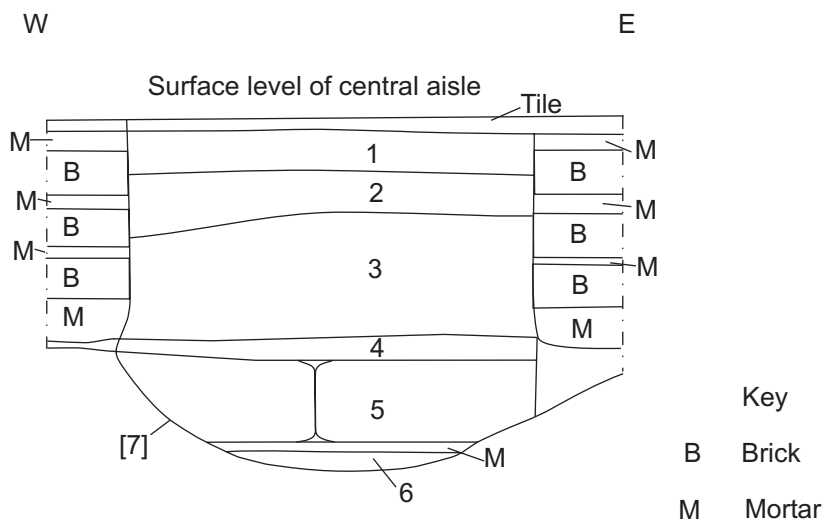
Figure 3. South-facing Section. Scale 1:10

In the second gap and associated depression from the west was observed the south face of a possible circular stone plinth ([5]). The top of this was 0.32m below the surface of the floor of the central aisle. The masonry appeared to be made of two distinct pieces of worked stone with a definite joint in the stonework. Above the plinth was a layer of thin mortar and sand bands as seen in the sides of the depressions

([4]). Above these bands was a 0.15m thick layer of red orange sandy clay ([3]) which lay directly beneath the loose dusty material ([2]) beneath the bricks of the aisle floor ([1]).

No further stonework was observed in the remaining two depressions and from the observations it was speculated that the pits originated from the robbing of stonework beneath the floor, although if this was the case, for some reason the stone plinth was left *in situ*.

The stone plinth observed in one of the depressions in the south nave area was not investigated any further than its initial observation within the sand. It was not ascertained therefore, whether this was part of the fabric of the church left *in situ* or if

it was a fragment of worked stone discarded within a layer of floor makeup. It was noted however, that no other stone was located and that a deposit of reddish brown silty sand was found beneath the stonework in section, similar in colour and consistency to that found across the exposed area of the north nave. This might indicate an isolated fragment, although the unbroken joint in the stonework perhaps implies an intact piece of masonry lying along the centreline of the church. This may represent the remains of an earlier phase in the fabric of the church, perhaps indicating the line of a columned aisle.
