**NORFOLK ARCHAEOLOGICAL UNIT**

Report No. 1035

**Report on Historic Building Recording at  
Holly Farm Barn, Reedham, Norfolk**

Location: Holly Farm, Holly Farm Road, Reedham  
District: Broadland  
Grid Ref: TG 4270 0155  
HER No: 11580 RED  
Date of work: 17th October 2004

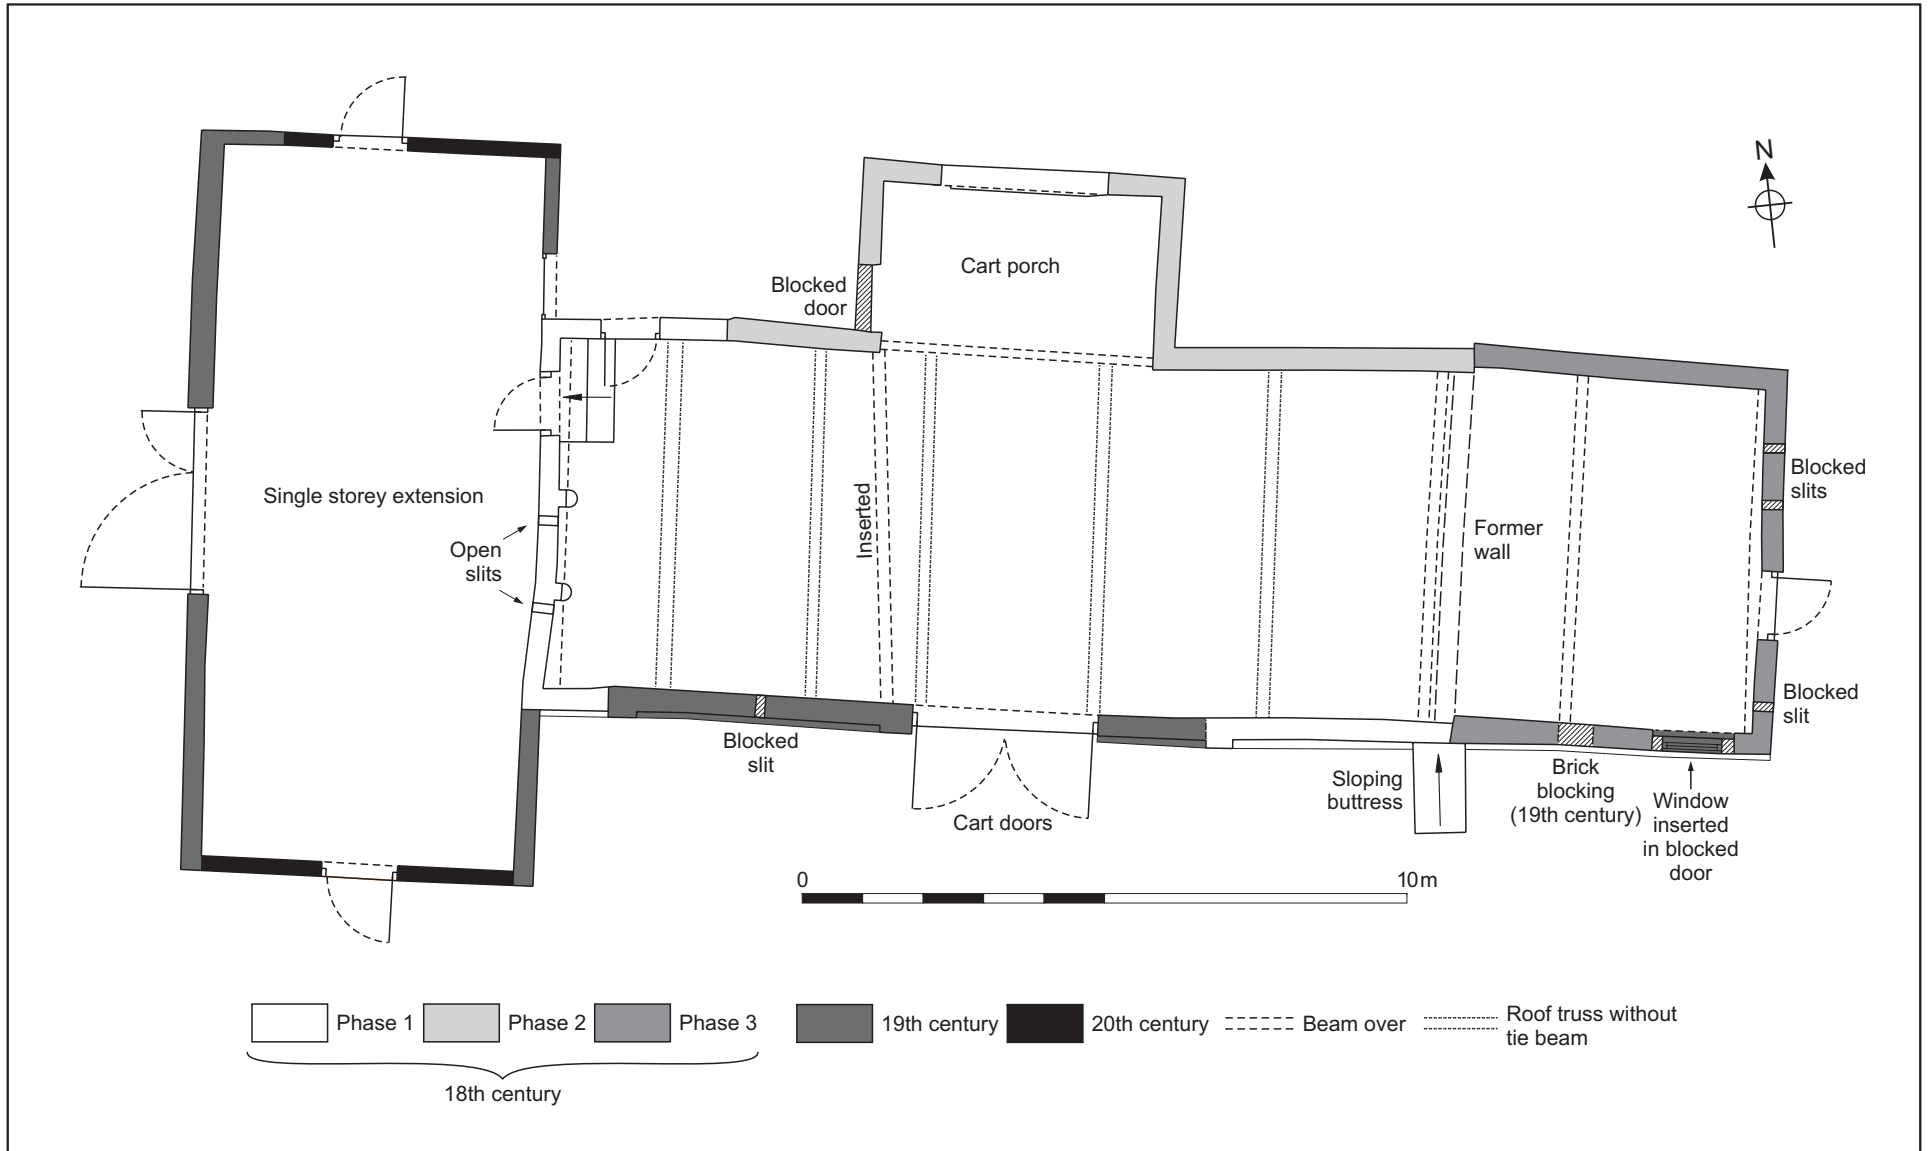
Figure 2. Plan of barn. Scale 1:125

The barn is aligned east-to-west and lies on the northern side of Holly Farm Road, immediately east of the farmhouse. It is a red brick structure measuring 21m x 6.5m in plan (Fig. 2) with a later north-to-south aligned brick extension measuring 12m x 6m at the western end and a projecting cart porch measuring 5.5m x 3m on the northern side. There is a large cart door west of centre in the south wall which is in line with the cart porch at the north. The timber roof is of steep pitch and currently clad in corrugated asbestos sheets. The western gable is of brick with brick coping and the east gable is weatherboarded.

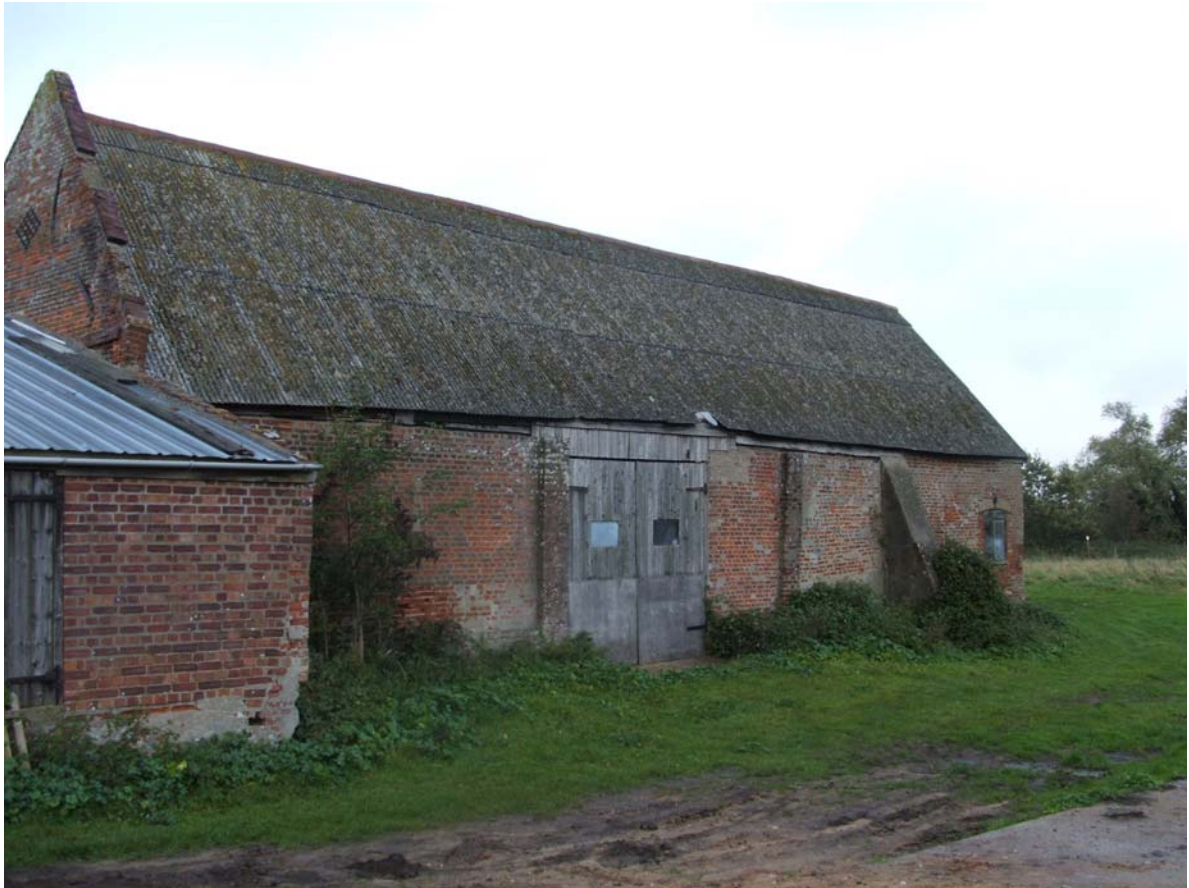
Plate 1. South elevation

A later single-storey extension on a north-to-south alignment is attached to the western end of the barn. This measures 12m x 6m, abuts the original western wall and extends 3m to the north and south. The south wall of the extension has been rebuilt in modern flettons in English bond and contains a single door opening.

The first metre of wall at the west end of the main south elevation is of English bond, the bricks having diagonal skintlings. This piece of wall appears to be continuous with the west wall. Abutting this and extending to the main double cart door is a later build of wall with shallow buttresses at either end, a plinth and a blocked central ventilation slit. This wall is of English bond and the bricks exhibit horizontal skintlings. East of the doors is a 2m long section of wall of Flemish bond composed of bricks with horizontal skintlings, with a plinth and a shallow buttress at the east end. This abuts a 3m long section of wall of an irregular version of English bond with diagonal skintlings. The east end of this wall is abutted by a large sloping brick buttress 1m wide x 1.5m deep, rendered on its upper surface.

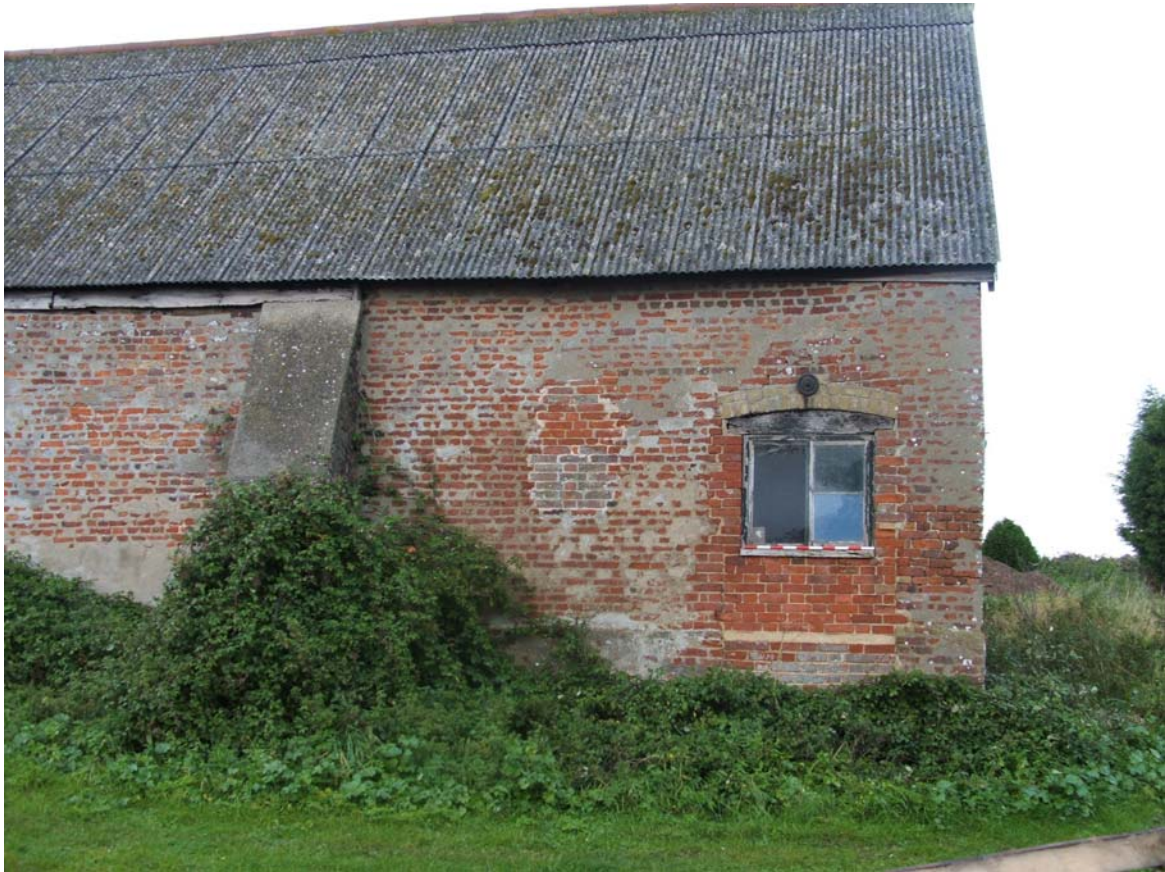
Plate 2. East end of south elevation

East of the buttress is the 5m long wall of the east end extension (Plate 2) which abuts the wall to the west (the evidence for this is internal). This wall is of English bond with diagonal skintlings. There is a patch of brick blocking 0.65m wide by 1m high 2m east of the buttress which probably indicates the position of a small window opening. At the east end is a square window which has been inserted into an original door opening. The lower blocking is of Flemish bond abutting the original door jambs. The window jambs have been bonded into the upper door jambs. Above the window is a wooden lintel beam below a segmental arch of gault brick.

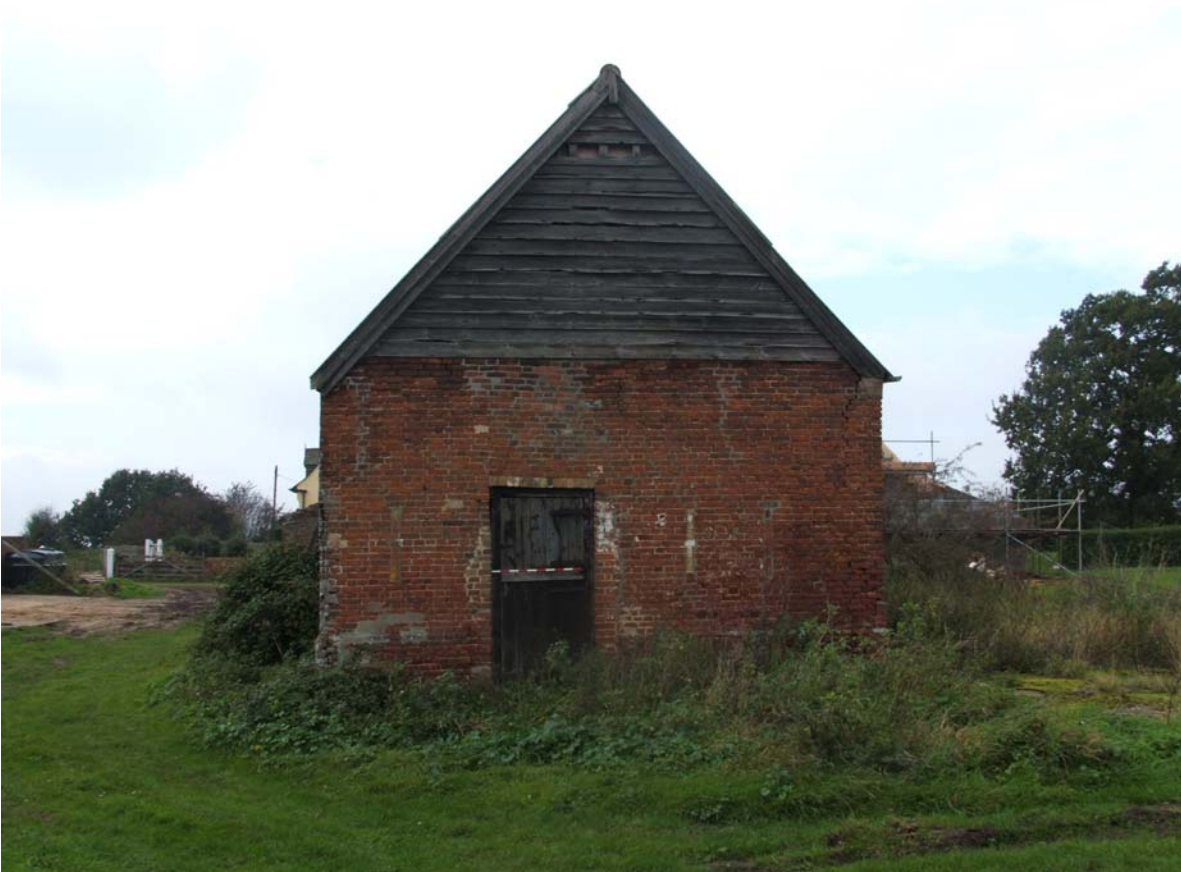
Plate 3. East elevation (1m scale)

The east end wall is 6.5m long and is of the same build as the east end of the south elevation, *i.e.* of Flemish bond with diagonal skintlings. The gable end above the wall is clad in timber weatherboarding. The wall contains a single door opening off centre to the south and three blocked ventilation slits. The door has a flat lintel

of a single course of gault bricks on edge. The major part of the lower jambs of the door have been rebuilt for some reason. However the original sections of upper jamb and the spacing of the door and slits show this is an original opening and not an insertion. Differential weathering of the bricks reveal the ghost of a single storey pitched roof structure abutting this end, the south wall of which was aligned with the south elevation of the barn, the north wall being 1m south of the barn's north wall. This structure was not bonded to the east wall and was probably of light timber construction.

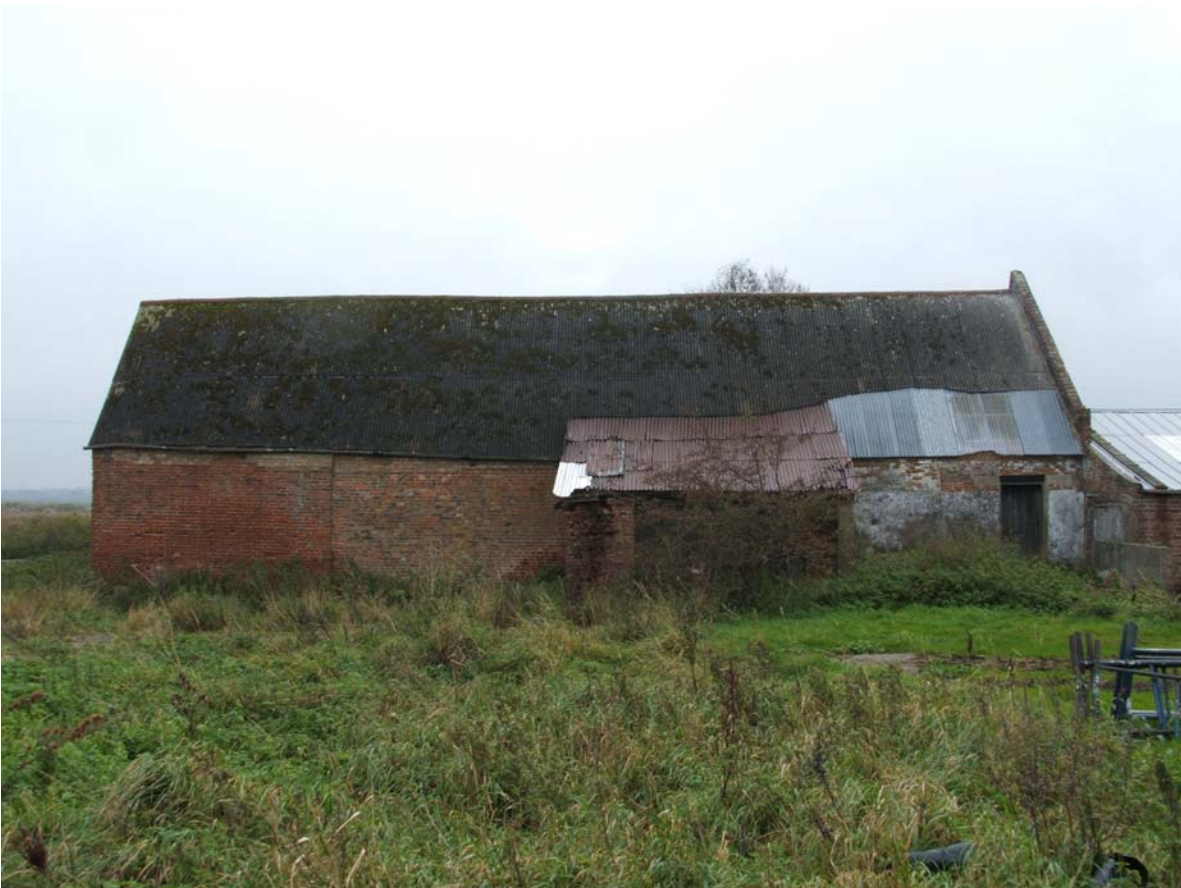
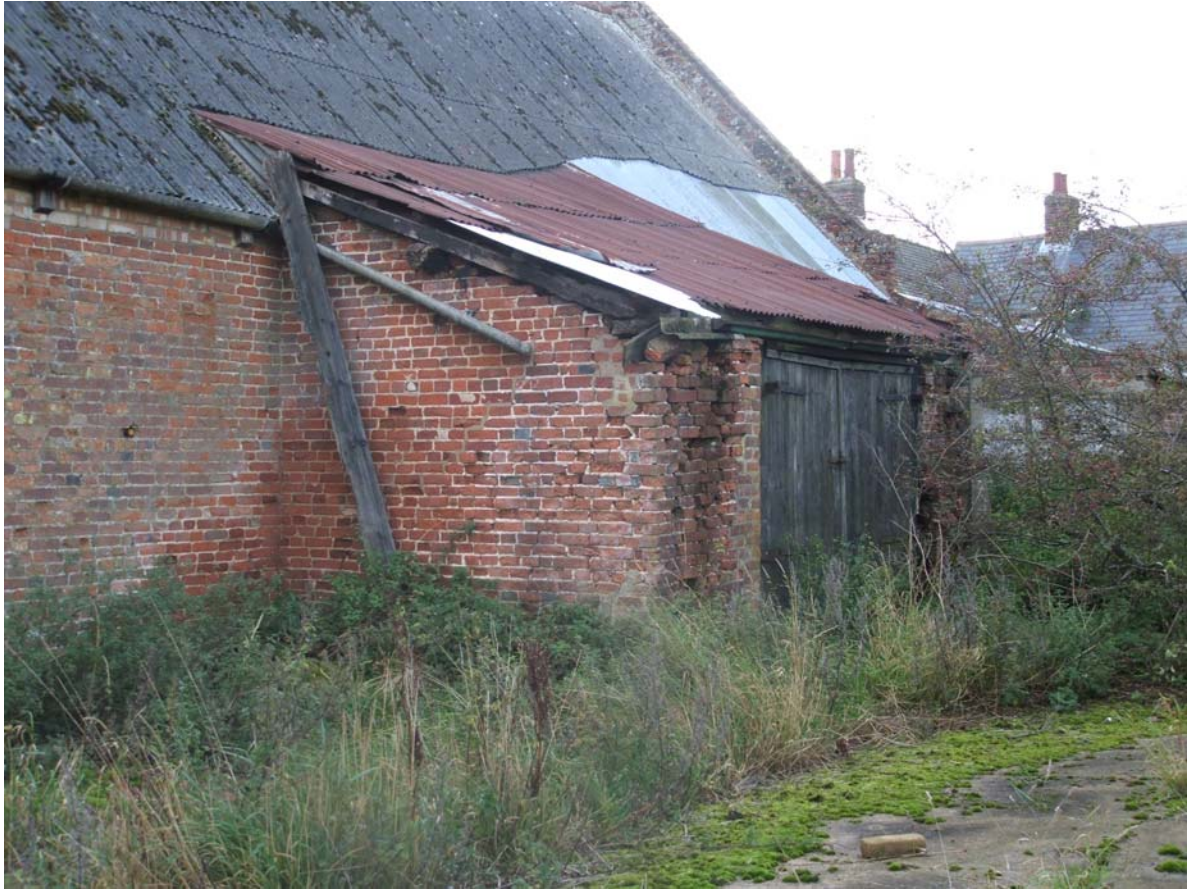
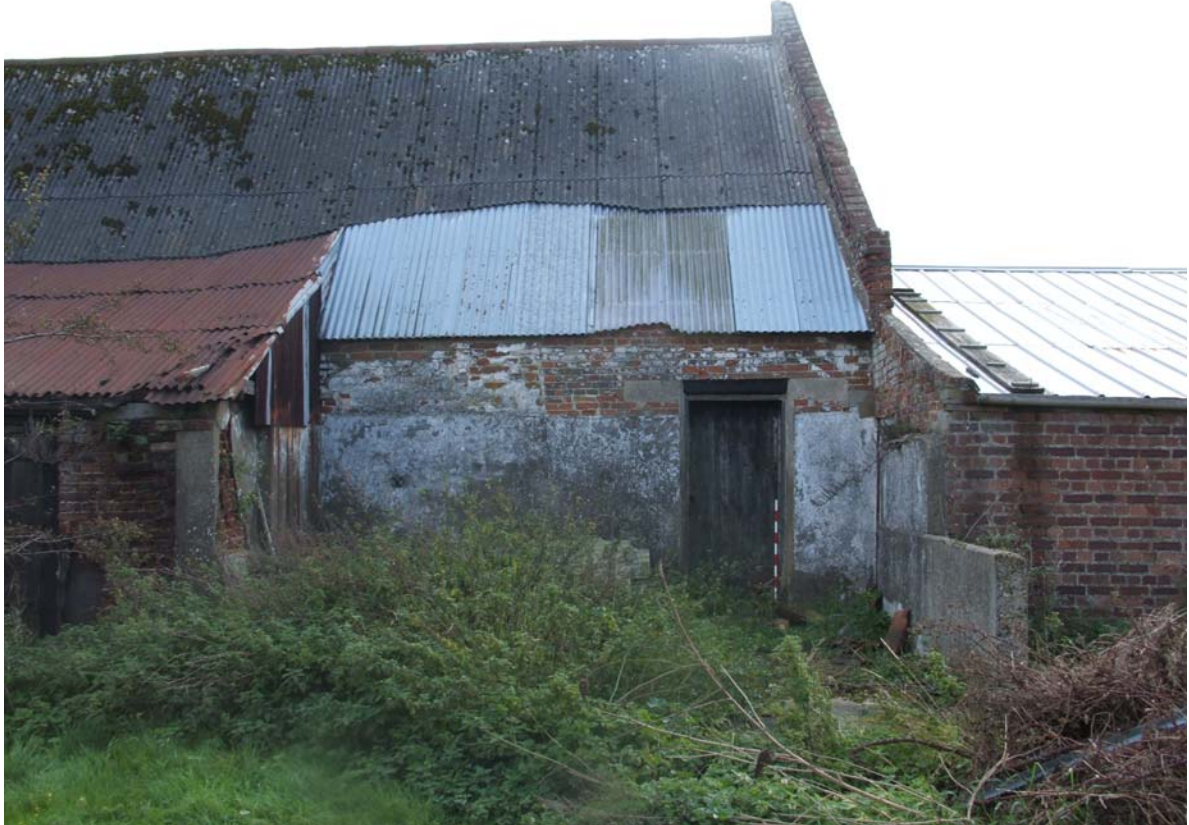
The eastern 5m of the north elevation is of the same build as the remainder of the east end and abuts the section of north wall to the west. It also respects a plinth at the base of this wall, this can be seen both externally and internally. This next section of wall is of random bond and extends for 5m westwards to the corner of the cart porch, which itself extends north for 3m and appears to be of the same build (Plate 5). The cart porch is 5.5m wide with a 2.75m central opening with double doors in the low north wall. The roof slopes down to the north. The west wall of the cart porch is partially rendered and partially clad in corrugated tin sheeting. Internally a blocked doorway is visible at the south end of this wall. The westernmost section of the main north wall (Plate 6) runs for 5m from the cart porch to the corner of the later west extension. The lower 2m of this wall is rendered, and above this the brickwork displays two builds. The first appears to be of random bond and extends 2m west of the cart porch. This abuts or is abutted by a build of English bond which extends for 3m to the end of the main elevation and contains a single door opening. The later west extension extends 3m north from the corner of the main elevation, and its north wall then runs for 6m westwards. The first 4.5m of this stretch is a later rebuild in flettons laid in English bond, and the western 1.10 m is of older red brick also laid in English bond.

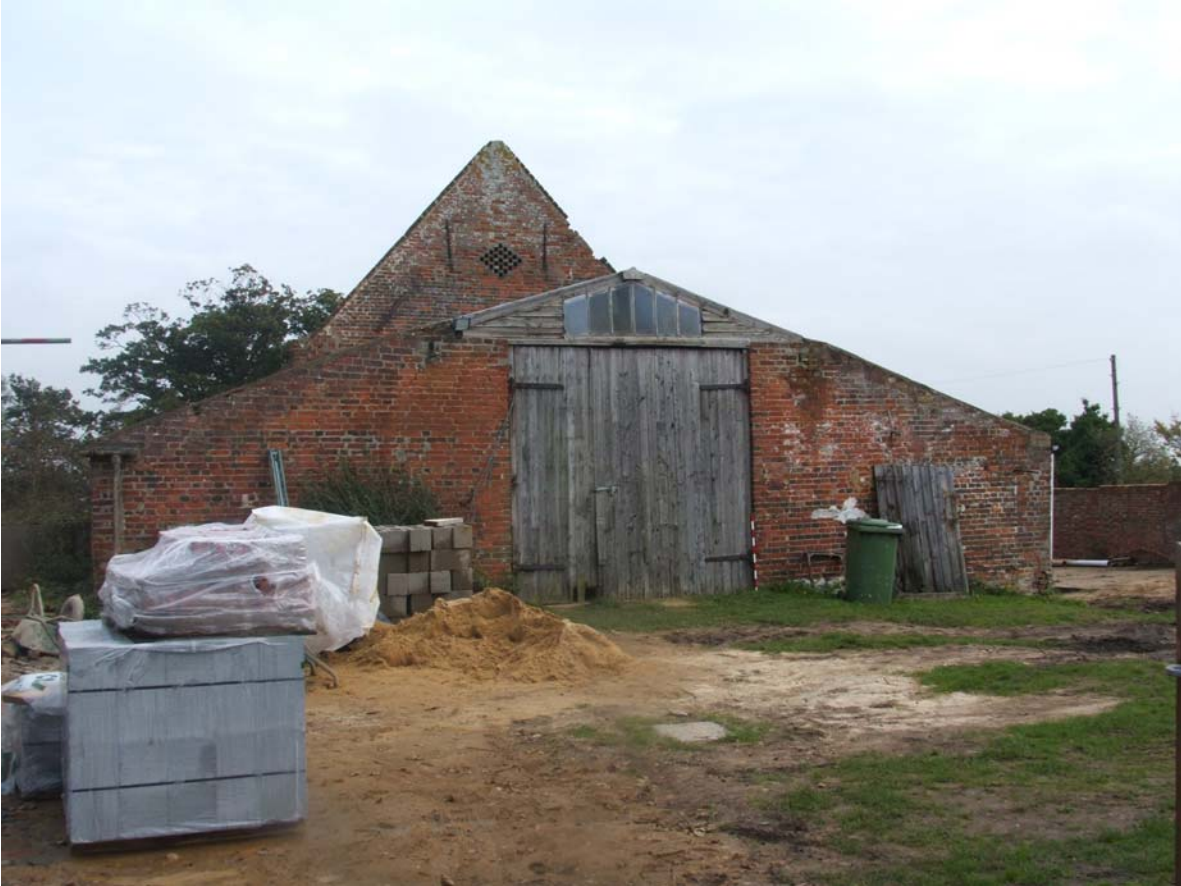
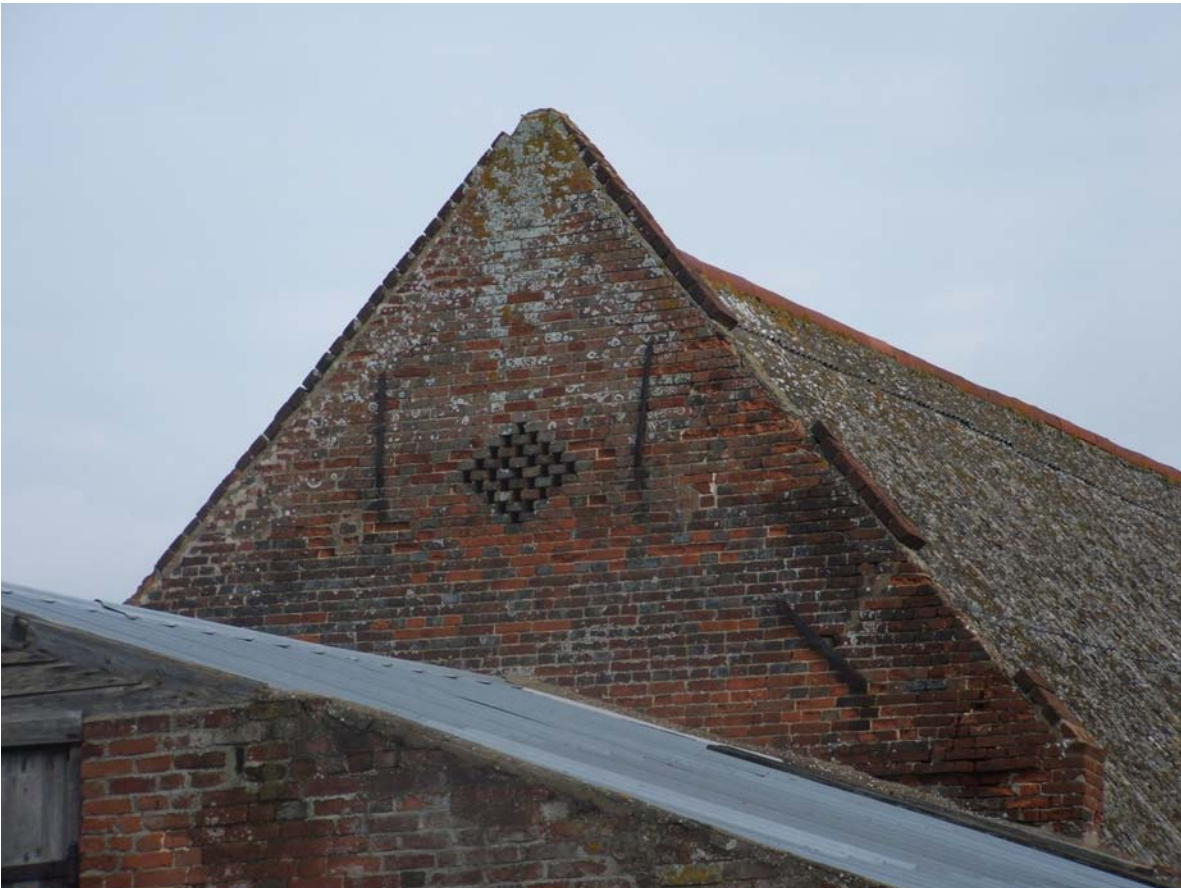
The lower part of the west elevation comprises the later, possibly 19th-century, red brick extension. This is aligned north-to-south but the ridge of the roof is aligned east-to-west as the main barn. There is a large central door opening, and the gable above the door is boarded and glazed. The wall to the north of the door is of random bond, whilst that on the south is of English bond up to eaves level. Above that the gable is more random. Above and behind the extension is the west gable of the barn, which is of red brick laid in English bond. The gable is coped with a single course of headers. There is a central lozenge shaped ventilation constructed of spaced headers. Four iron strengthening straps are bolted through the gable wall to attach to the roof purlins. The gable is leaning in towards the barn at a noticeable angle.

The west gable wall leans noticeably to the east at about the same angle as the roof is racked. It is possible that a failure of the east gable caused this racking and initiated the construction of the east end, or conversely the extension of the barn to the east and deliberate removal of the gable caused the racking and leaning of the west gable.

The west gable leans at a noticeable angle to the east and the roof is similarly racked in that direction. There is a large sloping brick buttress supporting the south wall at the point where the removed wall would have met it at the original south-east corner. The later rebuilt sections of the south wall also incorporate shallow buttresses. This all suggests either that the earlier east wall was demolished which caused the racking and other structural problems or that the east gable failed, causing the west gable and roof to rack. Thereafter the opportunity was taken to

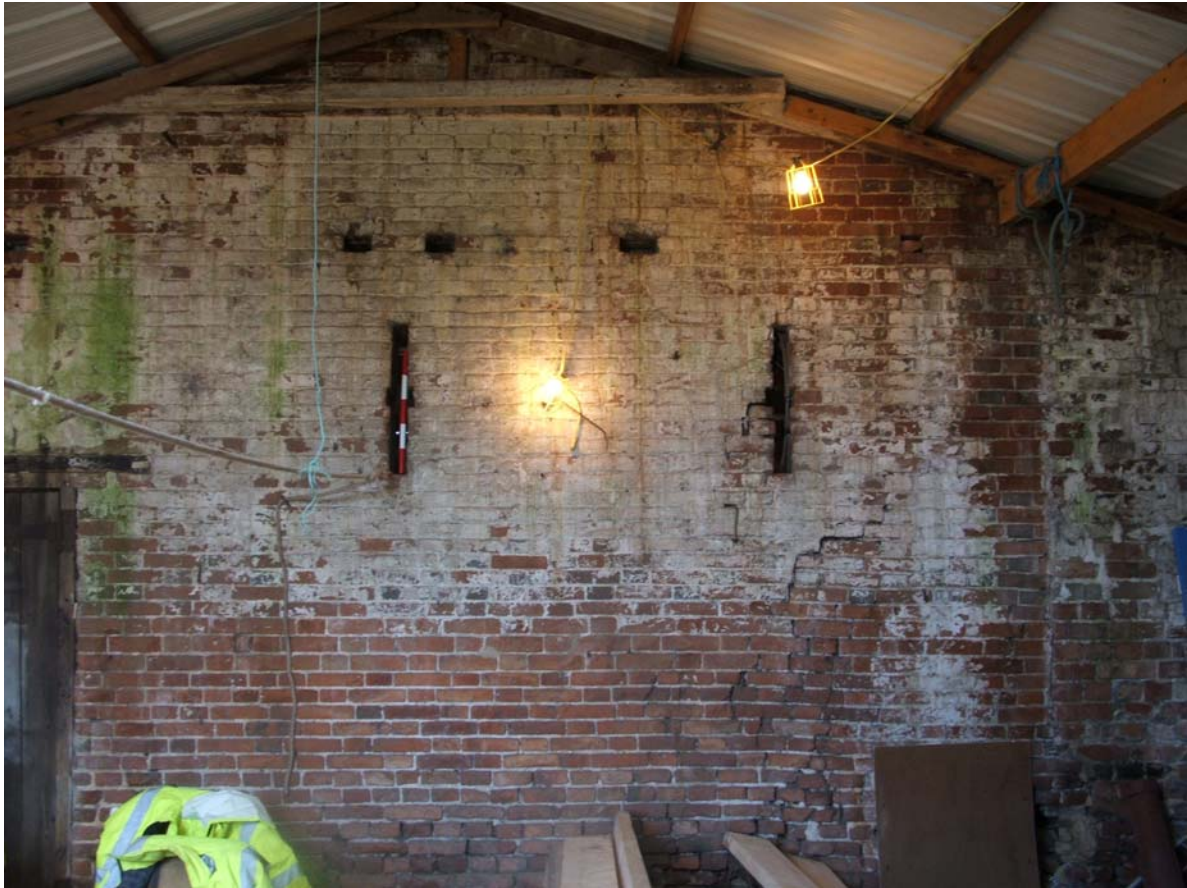
Plate 9. Lower West wall with ventilation slits. (0.5m scale)

On entering the west extension the original exterior lower west wall of the barn is seen, with the extension walls abutting its north and south corners (Plate 9). There

is a door opening in the north end of the wall and two unblocked ventilation slits south of this. These have a short central bar like the slits in the east end but are placed higher in the wall. The plinth is laid in English bond, and from the plinth up to the top of the slits the bricks are laid in Flemish bond. Above this the brickwork reverts to English bond again.

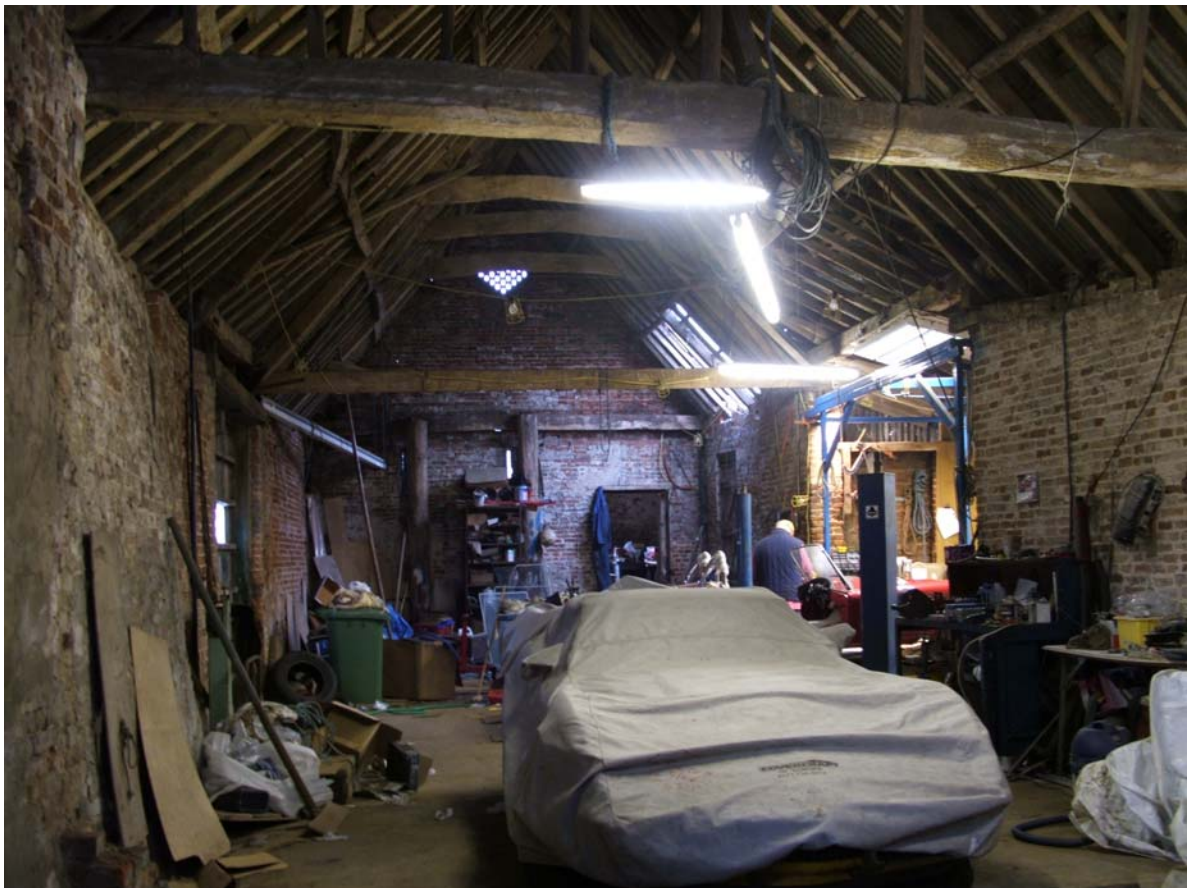
Plate 10. Interior looking west

Inside the main structure the sequence of builds largely reflects what has been described on the outside. The roof is discussed below. The west wall has two halves of a tree trunk placed vertically against it with their apexes against an inserted tie beam (Plate 10). These were probably used for strengthening the wall and were perhaps placed here after the gable leaned in.

The roof is of eight bays, the eastern two of which are above the eastern extension. The main roof has trusses consisting of principal rafters with slightly arched collars and two orders of staggered butt purlins (Plate 10). There is only one tie beam (besides that at the west end) in this part of the roof, this lying to the west of the doors. This is not in line with a truss, nor perpendicular to the walls and is probably therefore a later insertion.

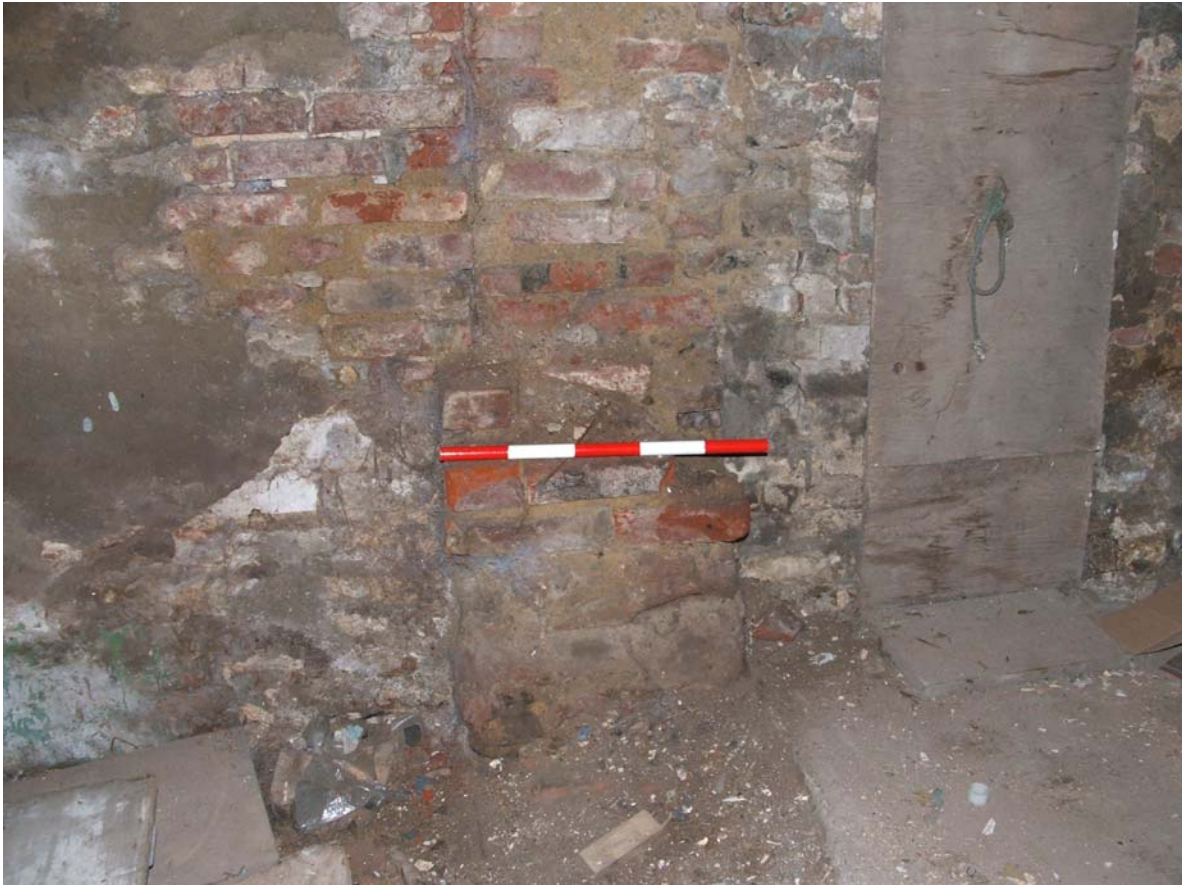
Plate 11. Scar of north-to-south wall with plinth looking south (0.5m scale)

The north and south walls of the east end of the barn abut the north and south walls to their west. Originally there was a north-to-south aligned cross wall at this point. This was an exterior wall as it had a plinth which can be seen fossilized in both the north and south walls (Plate 11). This wall was probably the end wall of the barn at one time. However, the plinth on the north side looks as though it may have been added to an existing wall base and a wider wall then built on top of it.

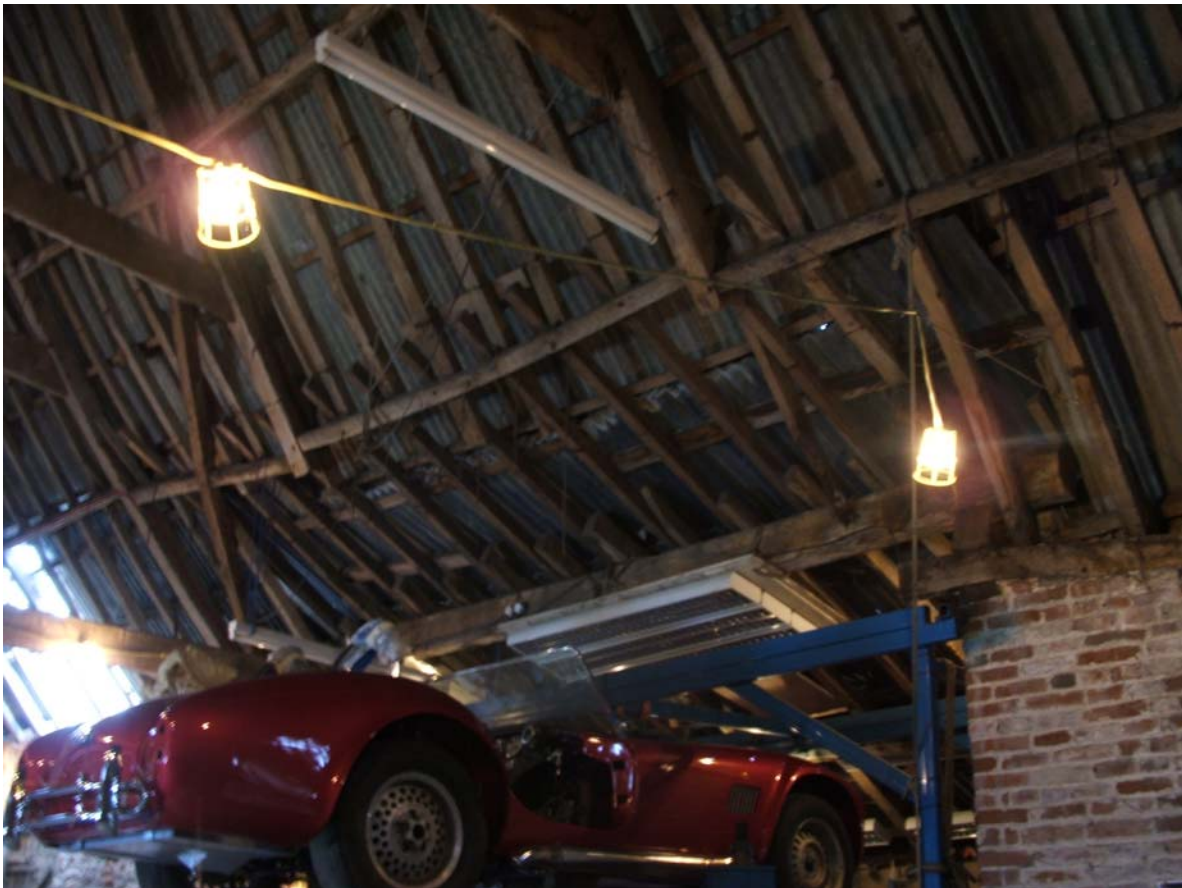
The lower portions of two principal rafters on the north side have been removed for the insertion of the cart porch and a plate inserted to bridge the gap above the opening into the porch which is wider than the original bay (Plate 12). The opening for the cart doors on the south has been similarly widened beyond the original bay

Plate 12. Roof trusses on north side truncated to insert cart porch

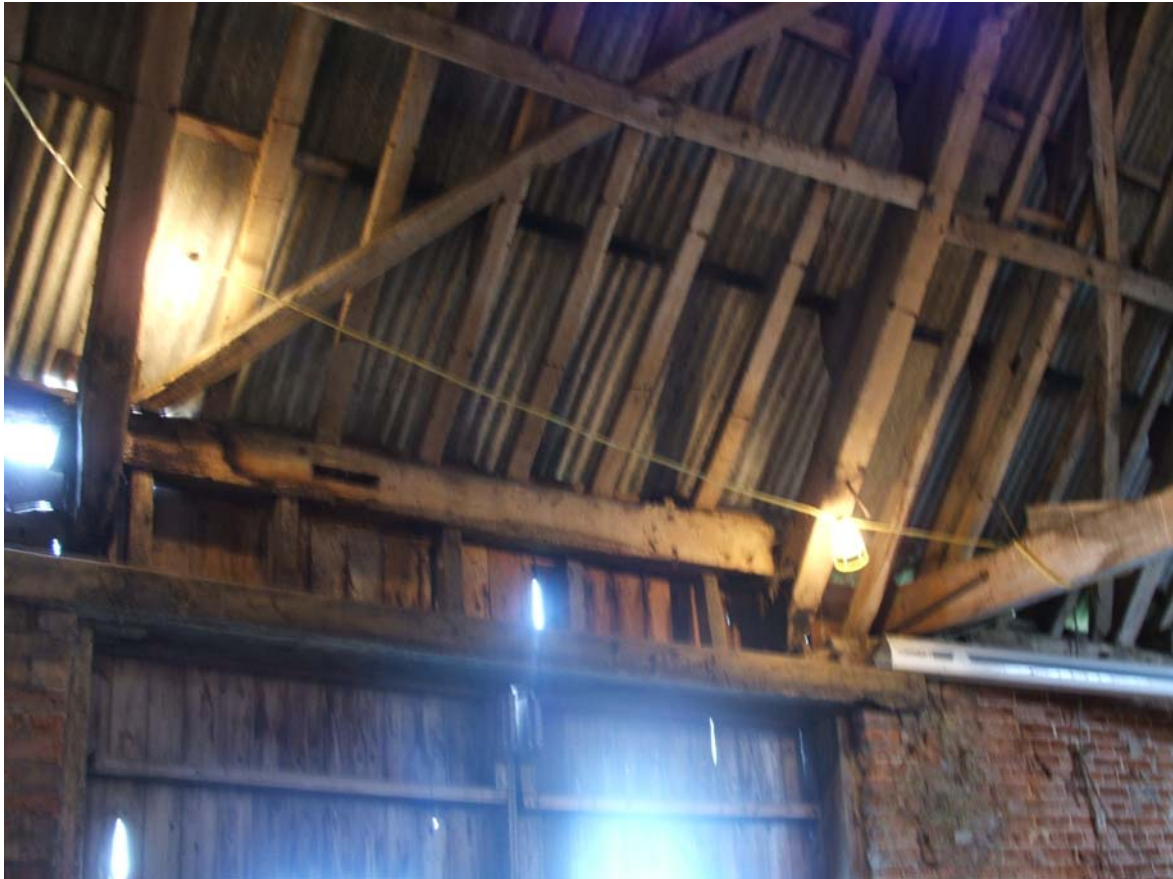
width and a re-used timber beam or post has been laid on the backs of two principal rafters to support the common rafters above the opening (Plate 13).

The remaining parts of the south wall are probably of 19th-century date. The southern double doorway has been rebuilt to make it wider than the original, and it is now slightly wider than the roof bay above. A re-used timber has been inserted to support the common rafters.

Plate 13. South cart door with inserted reused timber

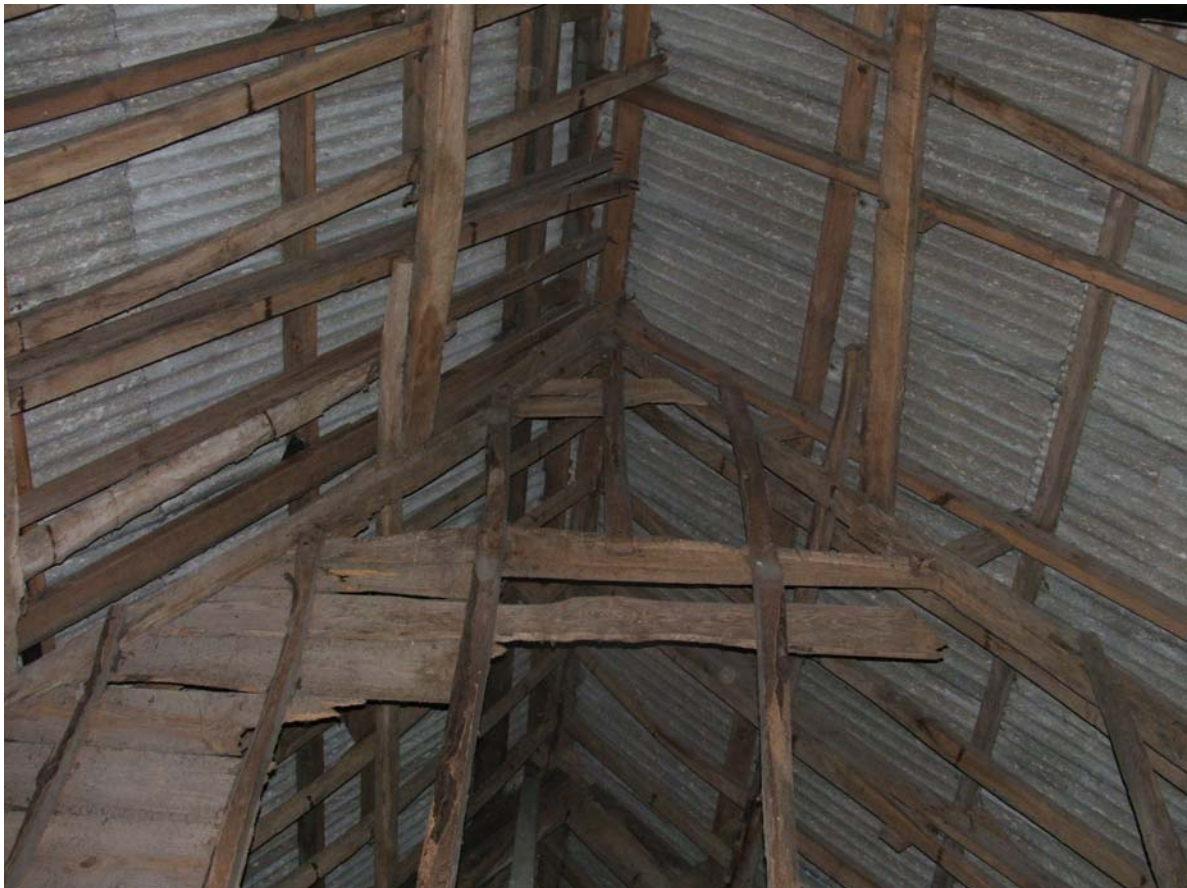
The trusses above the east end have tie beams and straight collars. The truss above the removed east wall has empty mortices in the principal rafters and in the tiebeam. Those in the tiebeam were probably for arched braces, thus suggesting it is re-used from a fully timber-framed structure. The principal rafters are possibly also re-used, as the two empty mortices in the west side of each member are close together and were possibly for purlins and/or windbraces. There are also mortices for a collar just above the present collar. The purlins which are supported by this truss sit on the backs of the principals and are not morticed to them as with all the other trusses. The purlins from the west side project for a distance east of the truss which seems odd if the roof originally stopped at a brick gable here corresponding to the west gable. However these purlins perhaps extended well into the gable wall for support. The roof is also racked to the east, and if this occurred before this truss was inserted it may explain the projecting purlins.

The east gable wall has holes for joists for a loft and the truss above the removed wall has the remains of boarding indicating a loft space separated from the main barn (Plate 14). The truss above the east end wall is externally weatherboarded.

Plate 14. Roof truss at east end above removed wall
