**A Level 2 Historic Building Recording Survey at
Creake Abbey Farm, North Creake, Norfolk.**

July 2010

Location: Creake Abbey Farm, North Creake, Norfolk
District: King's Lynn and West Norfolk
Grid Ref: TF 856 395
OASIS Ref.: 79418
Client: Mr Anthony Scott
Dates of Fieldwork: 24 June 2010

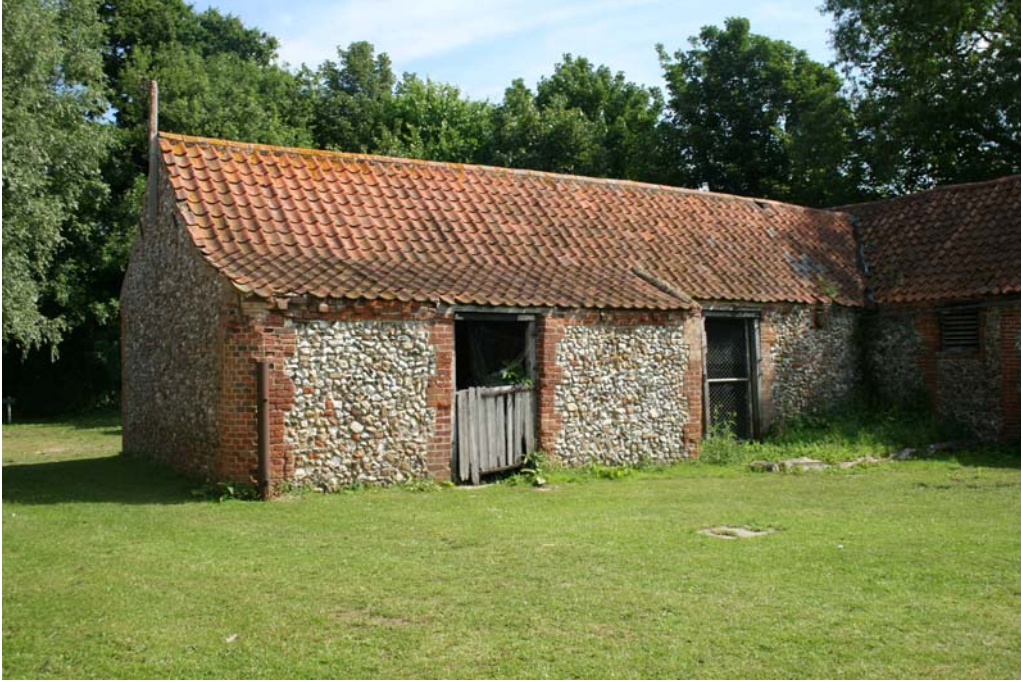
Building B1, a rectangular structure, formed the northern limit of the yard projecting west away from the north-western corner of Building B2 at a right angle on a roughly east - west alignment (Plate 1). It had a length of 12.1m and width of 4.74m and was constructed of un-coursed flints in a lime mortar with soft red brick dressings. Numerous brick headers were also dispersed throughout the walling as well as fragments of shelly, yellowish white limestone some of which obviously had been moulded and presumably came from Creake Abbey to the north. The western elevation was gabled while its rounded south western corner appeared to have been adapted to allow the entry of farm machinery and equipment into the yard without damage to the structure (Plate 2). Internally there were two independent cells separated by a flint and brick cross wall near the centre of the building. The eastern cell was the slightly smaller of the two and was accessed from the southern wall via a door just to the east of the internal cross wall. A second door had clearly been provided in the eastern end of the northern wall but had subsequently been in-filled using modern brick (Plate 3). The eastern wall probably belonged to Building B2 but had in any case been taken down to allow entry to the northern cell of Building B2 to the east with modern brick pillars providing the necessary structural support to the roof (Plate 4). The remaining walls had been whitewashed and a concrete floor installed but little else remained to indicate its function. One slightly unusual feature was a small square opening towards the centre of the southern elevation just beneath the eaves into which a small section of a log had been inserted presumably to block it up. The remnants of a small pen constructed of concrete and wire fencing were visible just outside the eastern cells entrance (Plate 1).

Plate 1. South elevation of Building B1

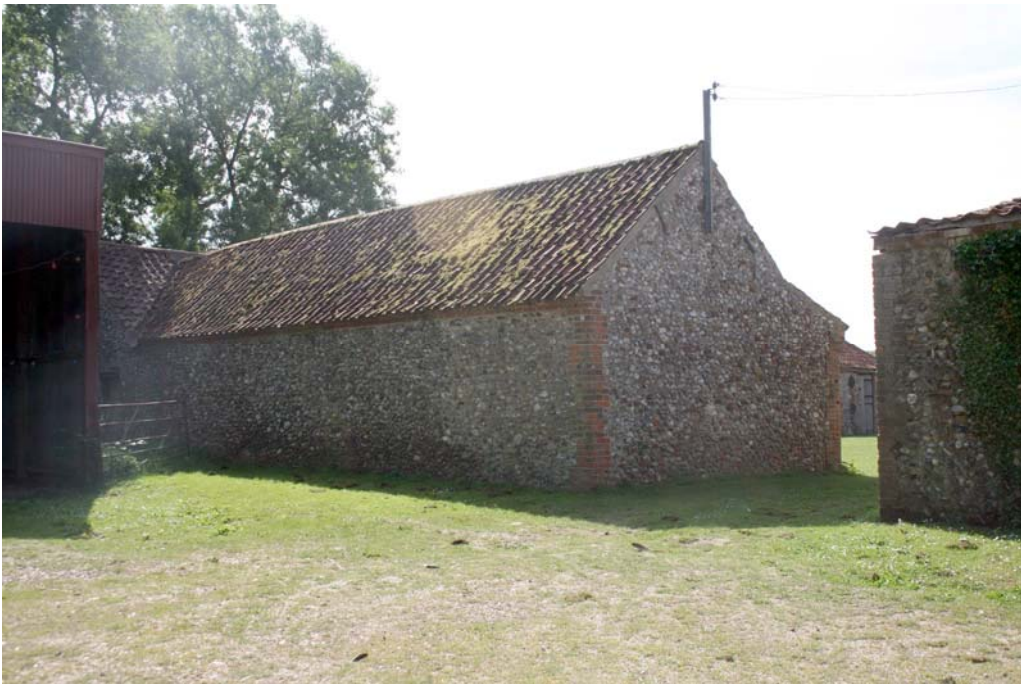
Plate 2. West gable and northern elevation of Building B1

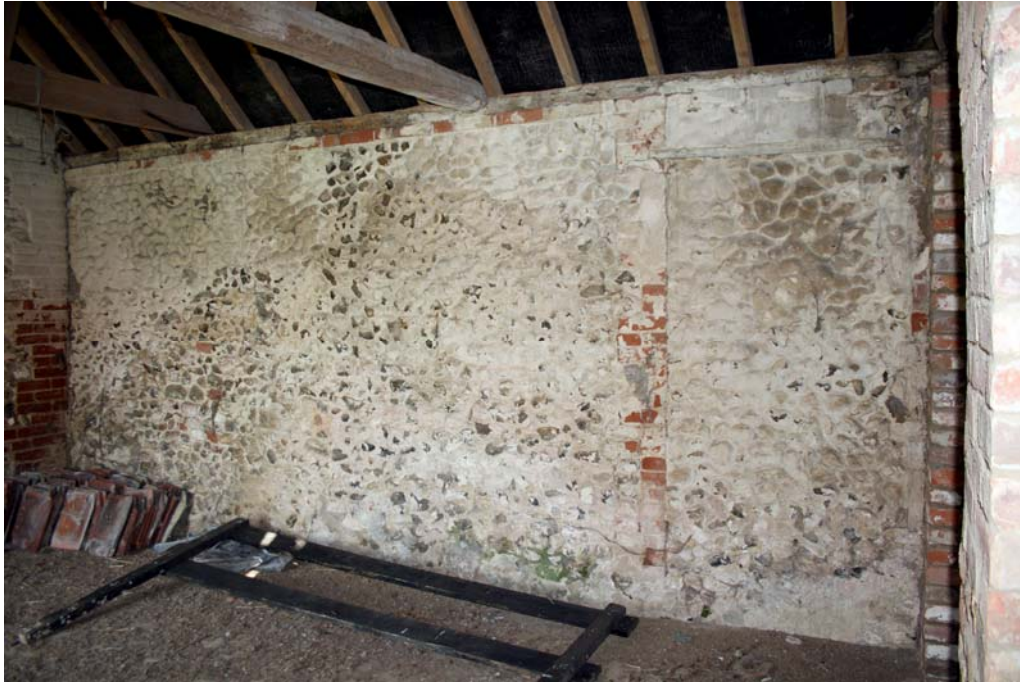
Plate 3. Blocked northern door way in eastern cell of Building B1

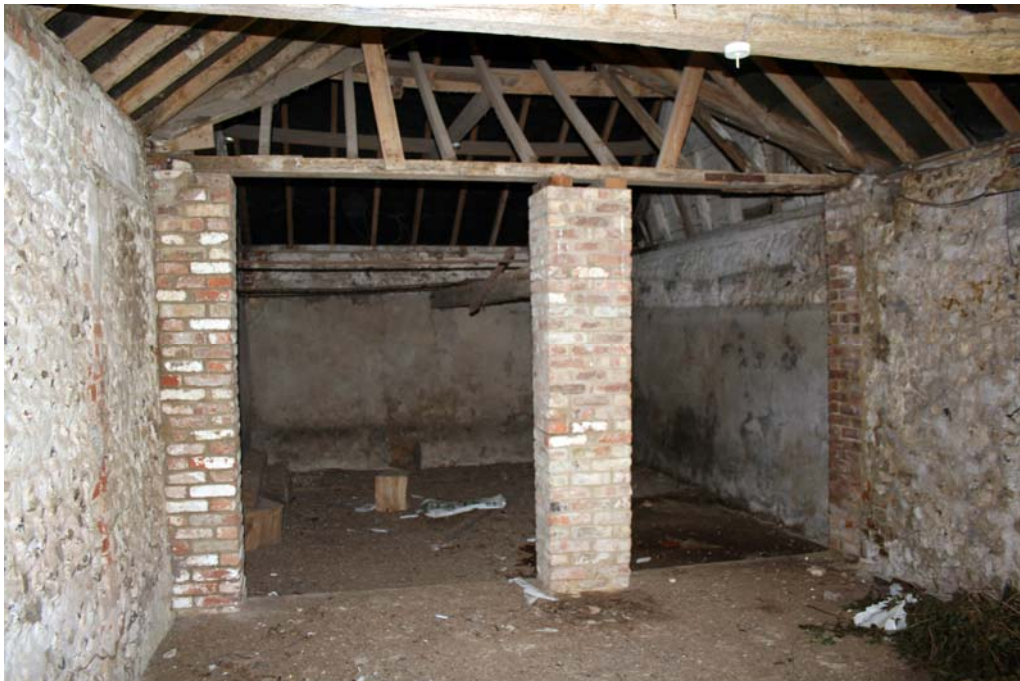
Plate 4. Modern brick piers dividing eastern cell of Building B1 from building B2

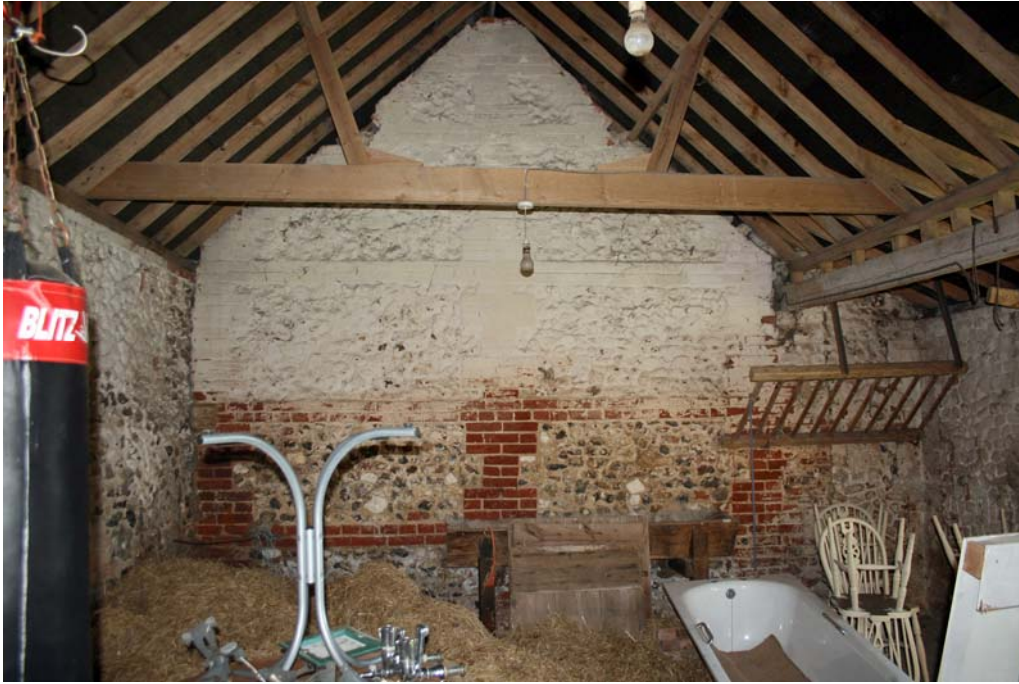
Plate 5. Eastern wall of western cell Building B1 showing hay rack and trough

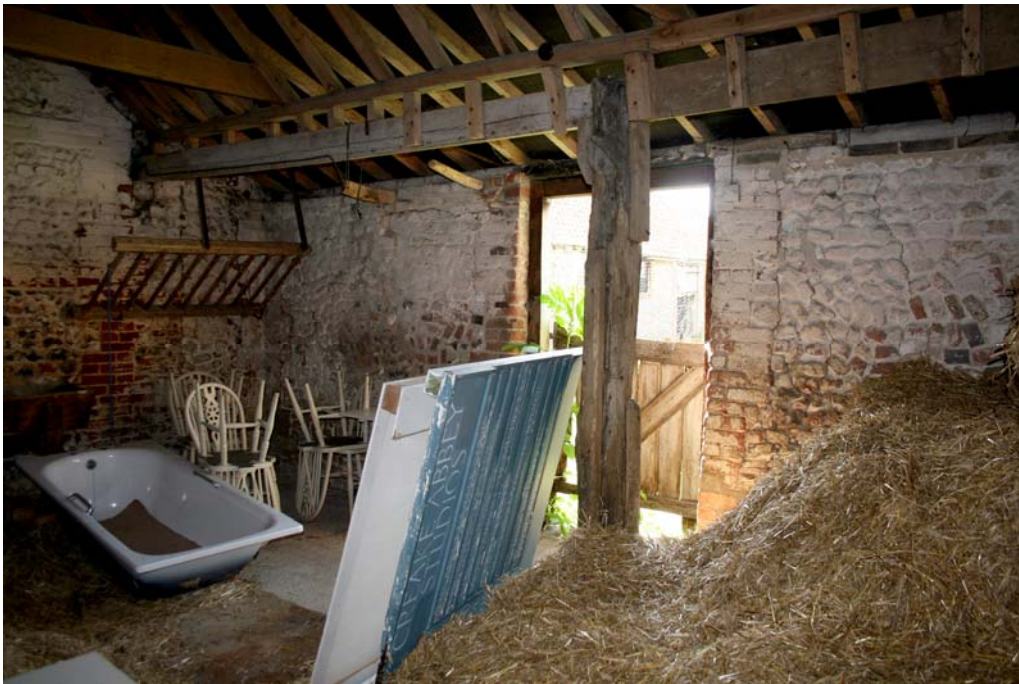
The western cell had been extended to the south by approximately 1m and the roof carried on over this extension as a cat slide above a dentil cornice (Plate 1). At the centre of the southern wall of this extension a wide doorway provided entry to the interior from where a wooden hay rack was observed to be attached to the southern corner of the eastern wall (Plate 5). A little further to the north it was accompanied by a wooden trough that rose upon posts from the concrete floor. Immediately to the east of the entrance two wooden pegs were set into the southern wall upon which equipment might be hung (Plate 6). As with the eastern cell all the walls had been internally whitewashed.

Plate 6. Interior of Building B1 western cell facing south

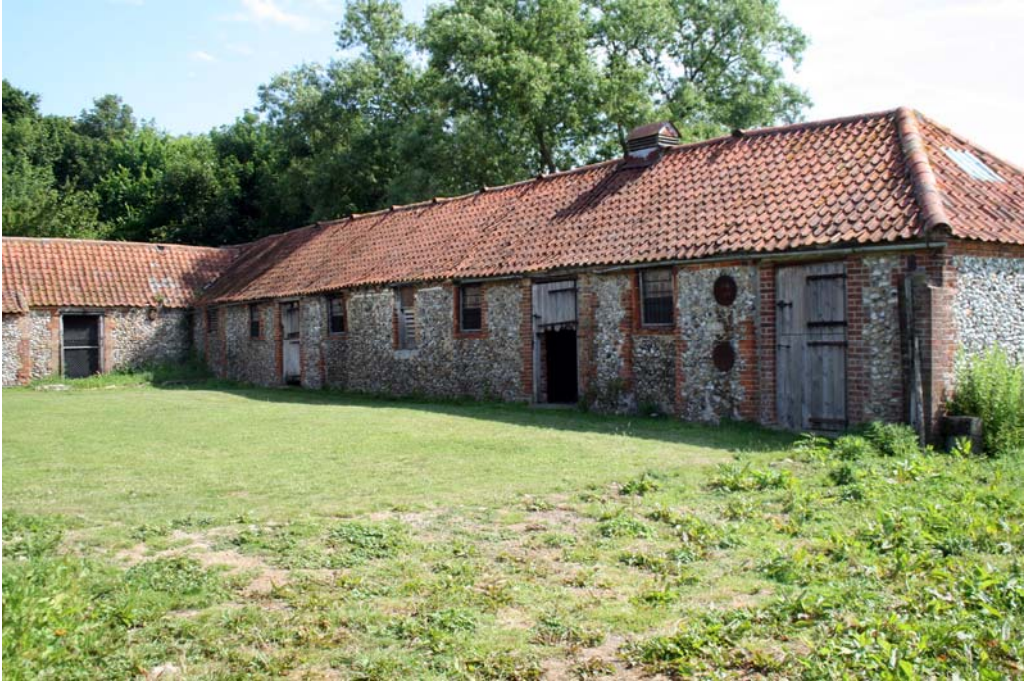
Building B2 was the largest of the structures surveyed and measured some 31m long and 5.3m wide with a north-east alignment that demarcated the eastern extent of the yard (Plate 7). Its construction was similar to that of the previously discussed building but, excluding the dressings, there were very few bricks used in the external walling. Internally the walls were constructed quite differently however with flint and brick headers set in courses on the diagonal in almost equal proportions using a lime mortar which was then finished with a coat of whitewash (Plate 8). The roof, hipped to the south and gabled to the north had a covering of red pan-tiles with a ridge ventilator at the southern end. Numerous repairs and alterations had clearly been made to the building in particular to the southern wall where the quoins had been rebuilt in modern brick (Plate 9). Three doorways were arranged along the western elevation, two within the southern third and the other towards the centre although the evidence suggests this may not always have been the case. Six rectangular windows were located at regular intervals across the same elevation but it is likely that at least three of these began life as a doorway. The eastern elevation contained just two small, high windows, one at the southern end and a second towards the centre however the latter had been blocked up while the former looked at least from the interior as if it was a later addition (Plate 10). Proximity to the river and vegetation prevented closer external examination. The northern elevation was gabled with two doorways in the western half, one on ground floor and a second at first floor height (Plate 11). Both had been bricked up at some point in the 20th century. The portion of walling to the west of the upper doorway was the only external area of Building B2 to contain any significant quantity of brick and was almost certainly rebuilt, perhaps upon the insertion of the first floor doorway which did not fit comfortably into its space.

Plate 7. Western elevation of Building B2

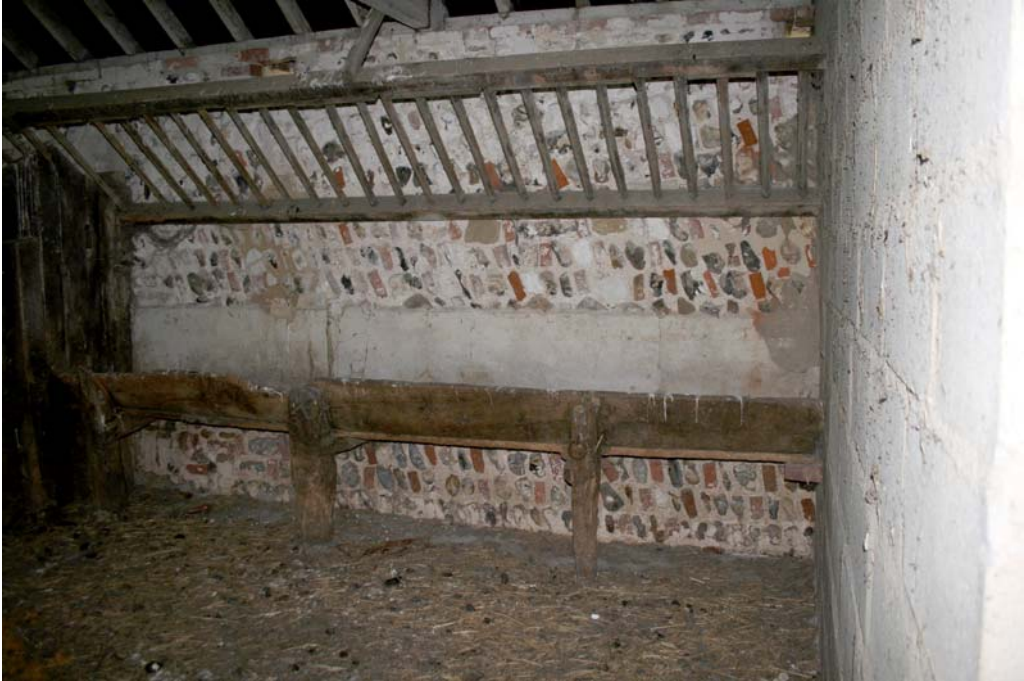
Plate 8. Eastern internal elevation of Building B2

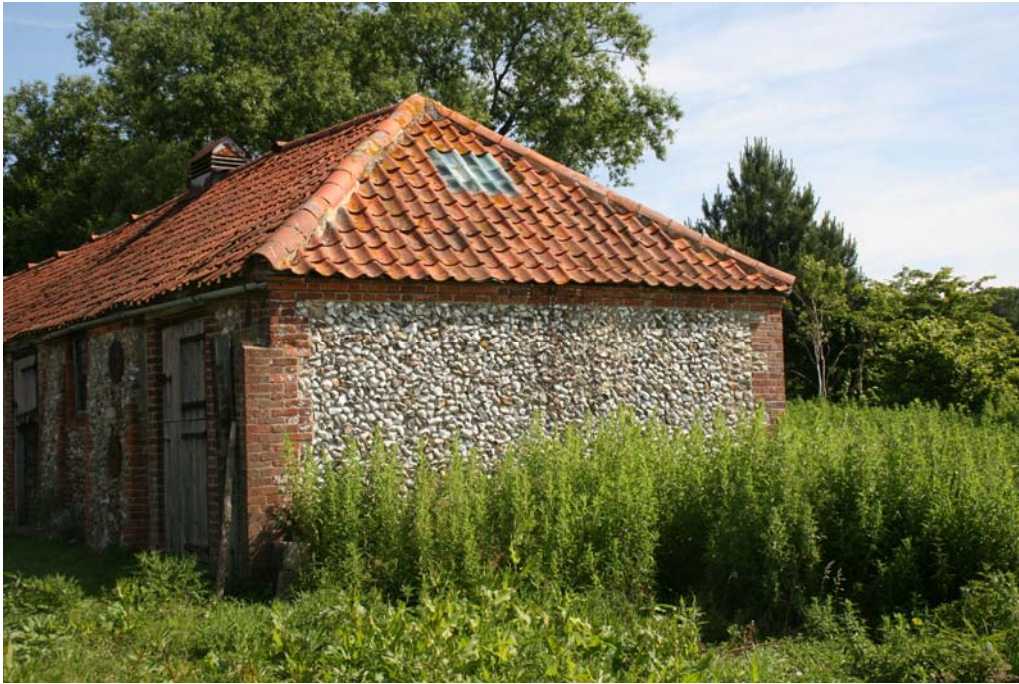
Plate 9. Southern elevation Building B2

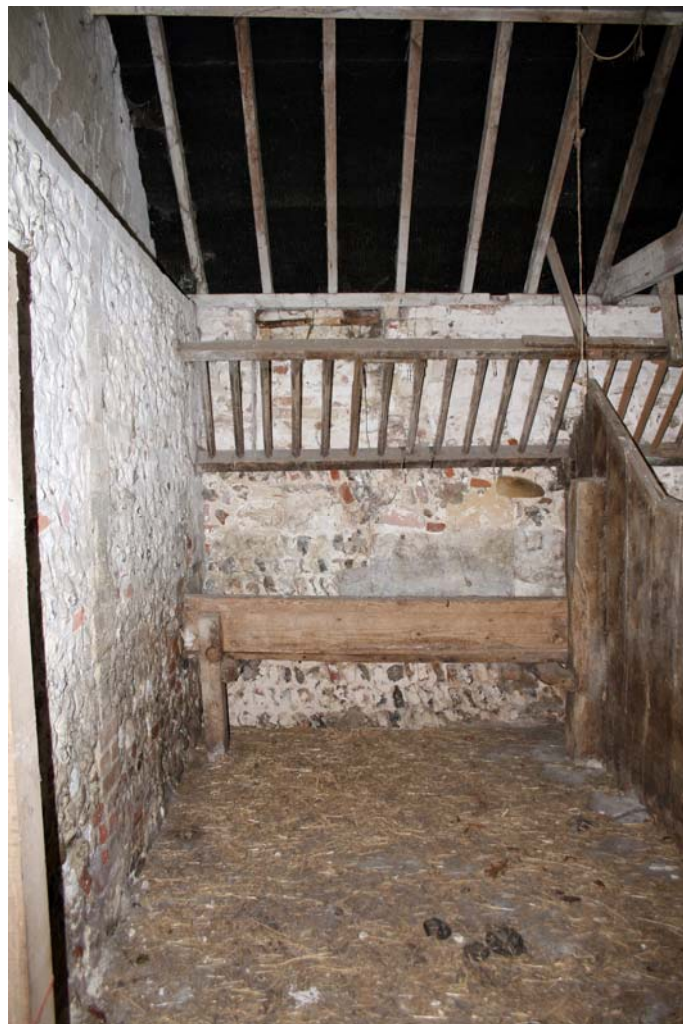
Plate 10. Blocked window behind hay rack on eastern wall of Building B2

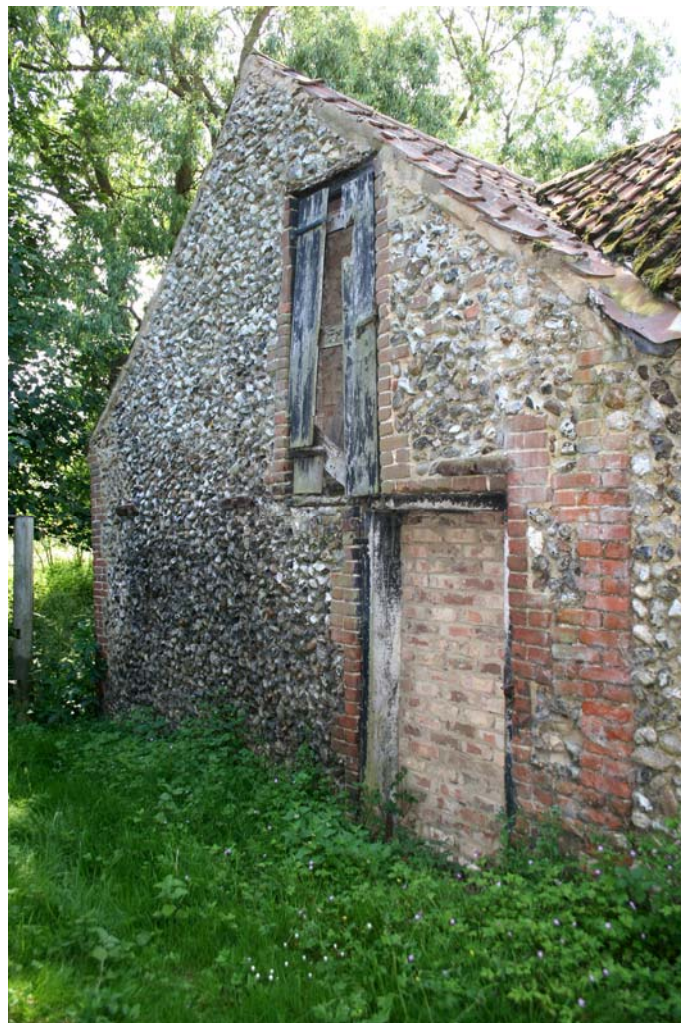
Plate 11. Northern gable of Building B2

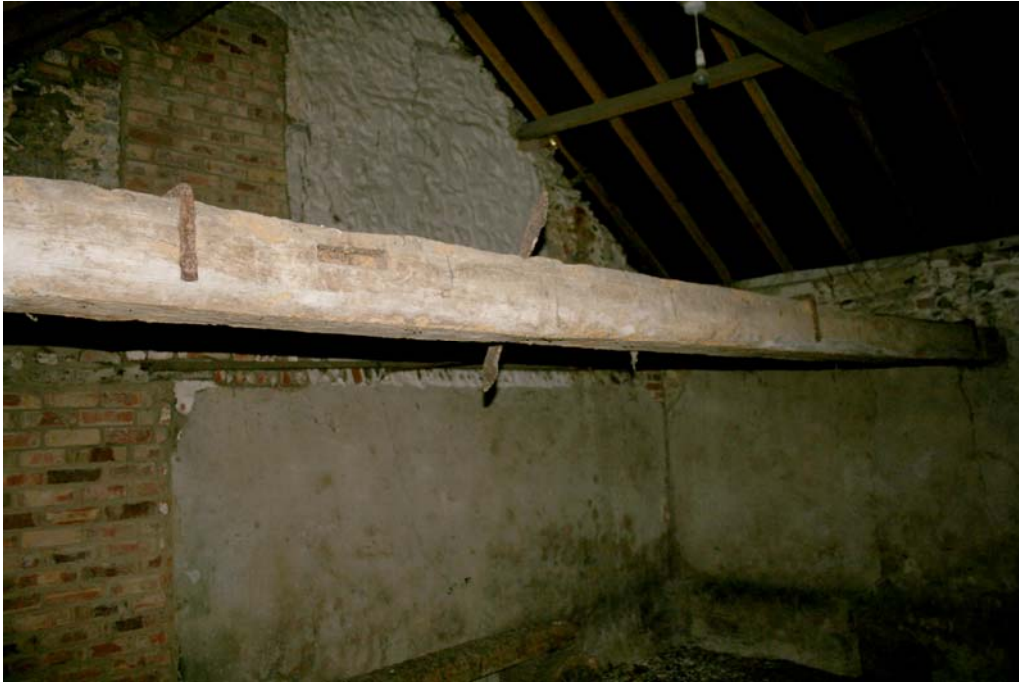
Plate 12. Cross joist for upper floor, northern cell of Building B2

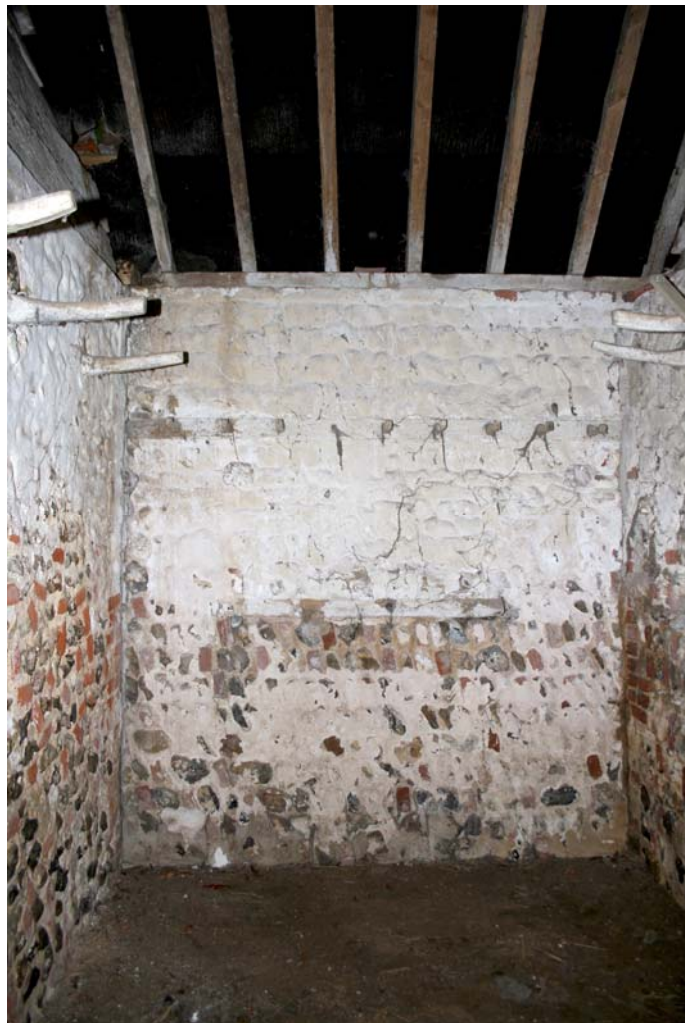
Plate 13. Tack room in Building B2

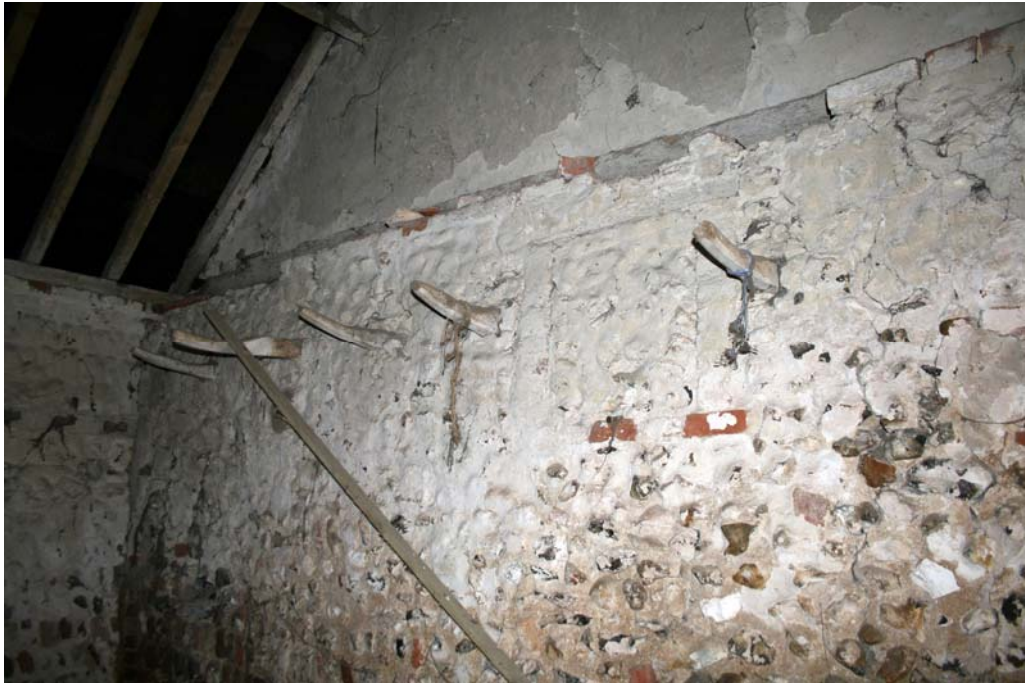
Plate 14. Rectangular niche in tack room

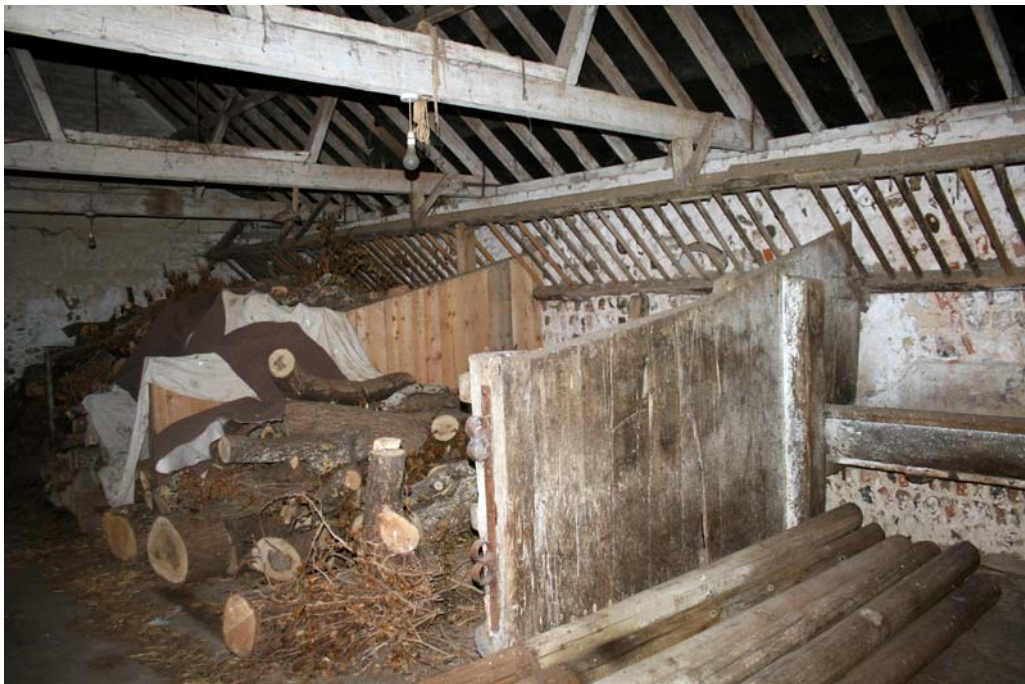
A continuous wooden hay rack ran along the eastern wall and beneath this sat a wooden trough supported by low posts many of which retained their iron tethering ring (Plate 15). To the north of the western external doorway two wooden pegs projected away from the wall with a small window directly to the north. A second window to the south of the door may well have replaced an earlier blocked doorway (Plate 16). The second-most southerly cell was very similar to the last with similar dimensions and the same arrangement of hay rack and trough along the eastern wall separated by low wooden partitions, however here the two southern partitions were over a metre wider than those in the central cell which left only enough room for one smaller stall to the north (Plate 17). The external doorway was positioned a little to the south of centre with two windows to the north and a third to the south. Two wooden hooks projected from the east wall just to the north of the door (Plate 18). The southern cell was a little under 3m wide but the partition wall was constructed entirely of concrete blocks and the external doorway of modern brick. It seems likely therefore that this cell was divided off from the cell to the north in the more recent past. A portion of hay rack with trough below nevertheless seems to have survived the division as did the three wooden pegs arranged in the centre of the southern wall (Plate 19) Again the walls were whitewashed and the floor had been concreted.

Plate 15. Central cell of Building B2 facing north

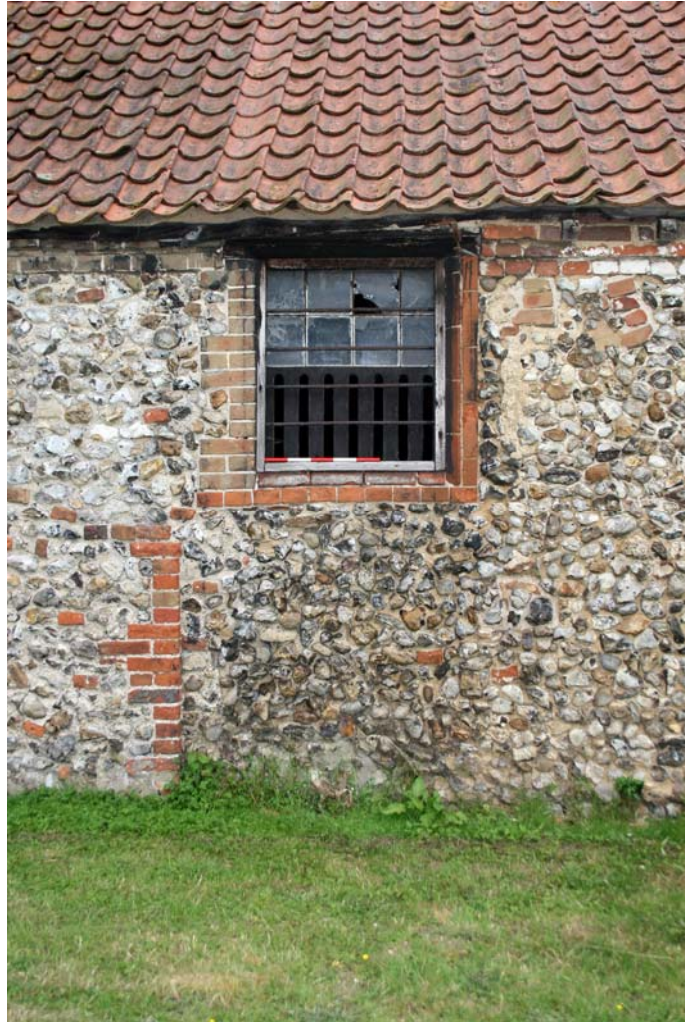
Plate 16. Blocked doorway, central cell Building B2 1 x 0.5m scale

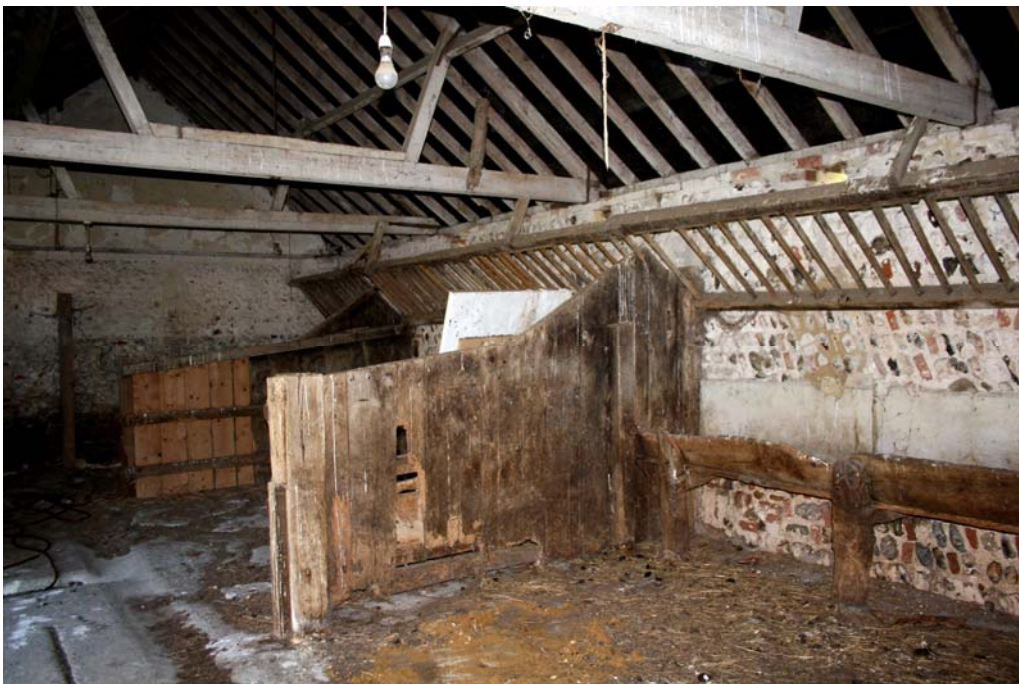
Plate 17. Second-most southerly cell, Building B2 facing north

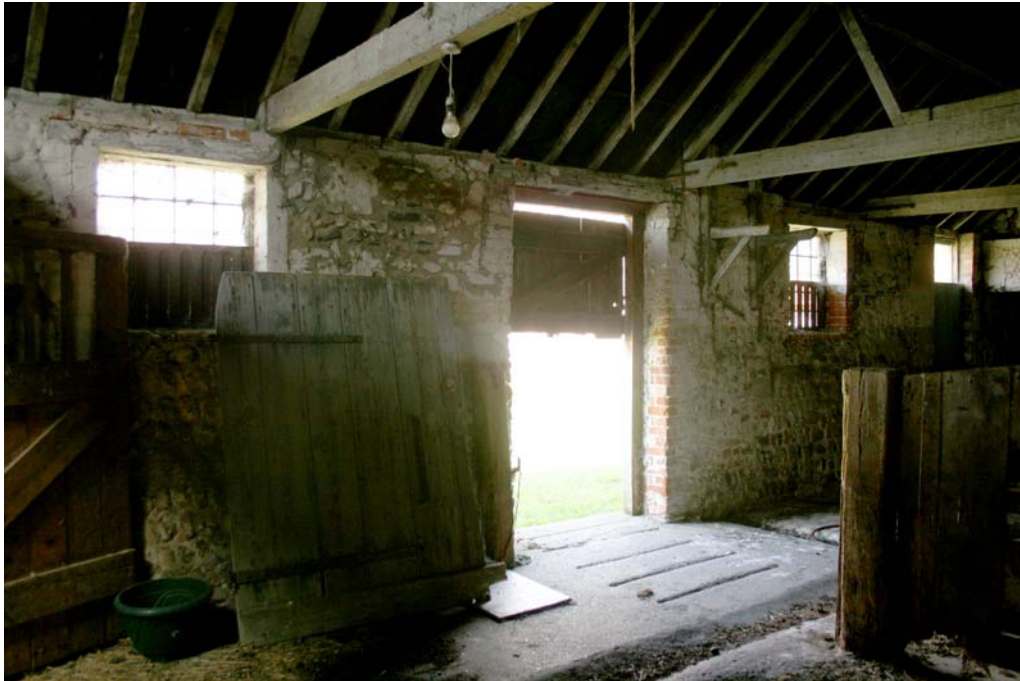
Plate 18. Western internal elevation, second cell from the south, Building B2

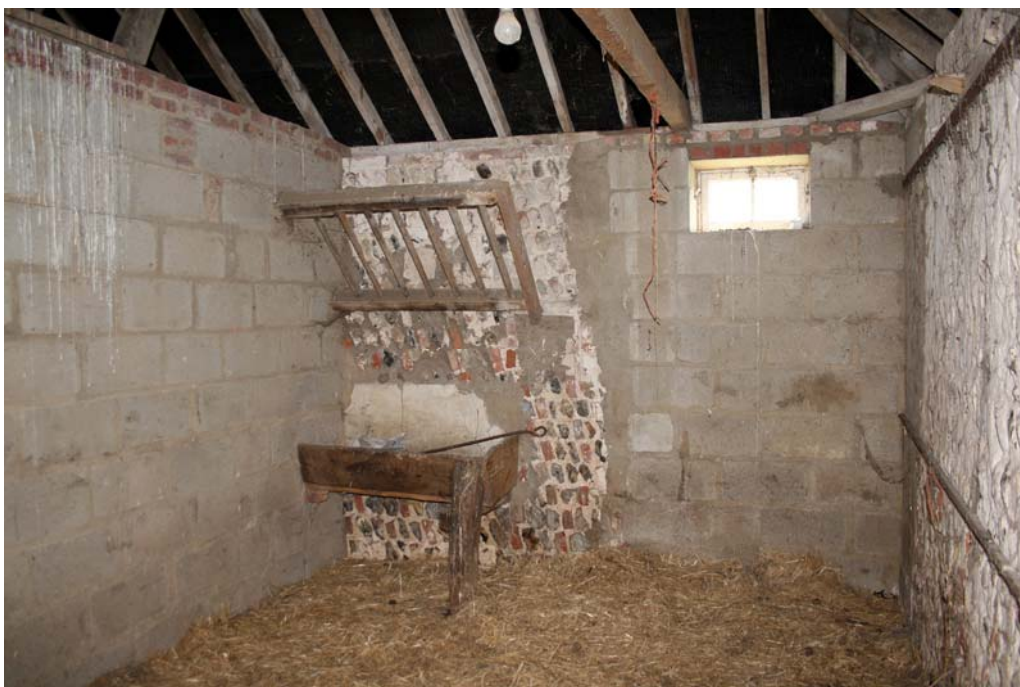
Plate 19. Southern cell Building B2 facing east

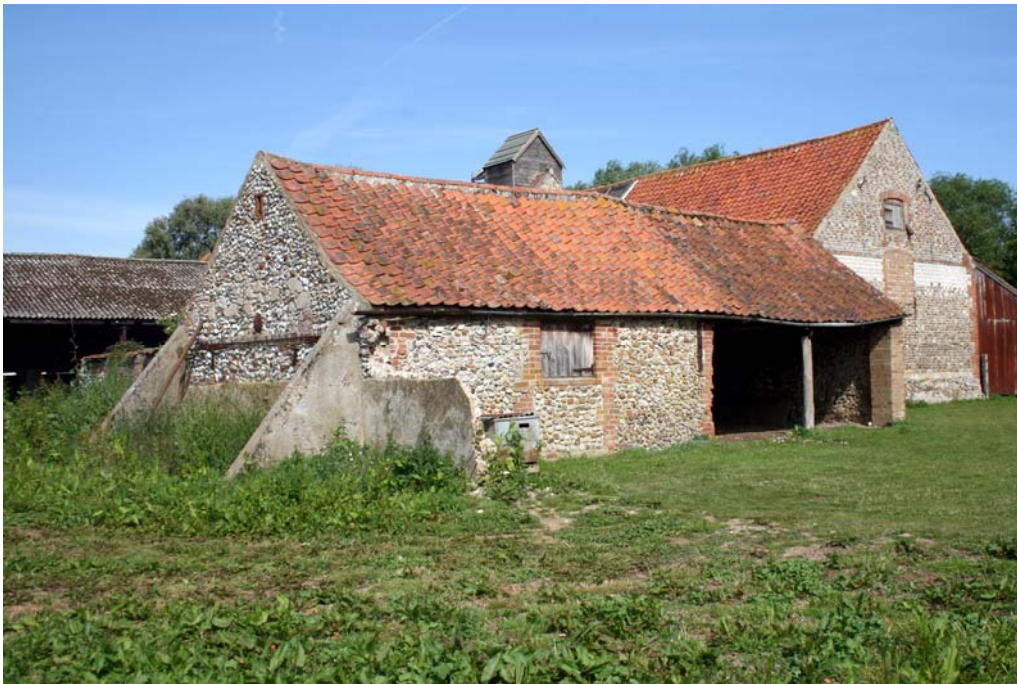
Building B3 was of rectangular design 12.3m long and 4.8m wide on a north - south alignment forming the south-western boundary of the farm's eastern yard (Plate 20). It was constructed of the same materials as Building B1 excepting the upper gable to the north which was of corrugated iron (Plate 21). Two modern triangular concrete buttresses projected from the southern wall no doubt providing additional support where necessary (Plate 20). A central flint cross wall divided the structure into two distinct and roughly equal spaces between which there was no direct access. Entry to the southern cell was provided by a wide doorway located at the southern end of the western elevation with a second doorway in the centre of the eastern elevation having been converted into a shuttered window (Plates 22 and 23). Ventilation slots were visible in both the apexes of the southern gable and the cross wall while a sturdy tethering post stood in the north-western corner (Plates 24 and 25). Concrete blocks had been used internally to reinforce each of the four walls up to the wall plates and a steel water feeder sat in the south eastern corner upon a concrete floor into which drainage channels had been formed. A modern concrete pen approximately 5m square had been constructed externally projecting from the western elevation with a second tethering post positioned in its north eastern corner (Plate 22). The northern cell was open to the east with a single wooden post supporting the wall plate at the centre point. A diagonal low partition had been erected in the south-western corner as a hay feeder while the floor appeared to be of dirt, although a significant quantity of manure lay upon it (Plate 26). As with the other structures the roof was covered in red pan-tiles.

Plate 20. Building B3 facing north-west

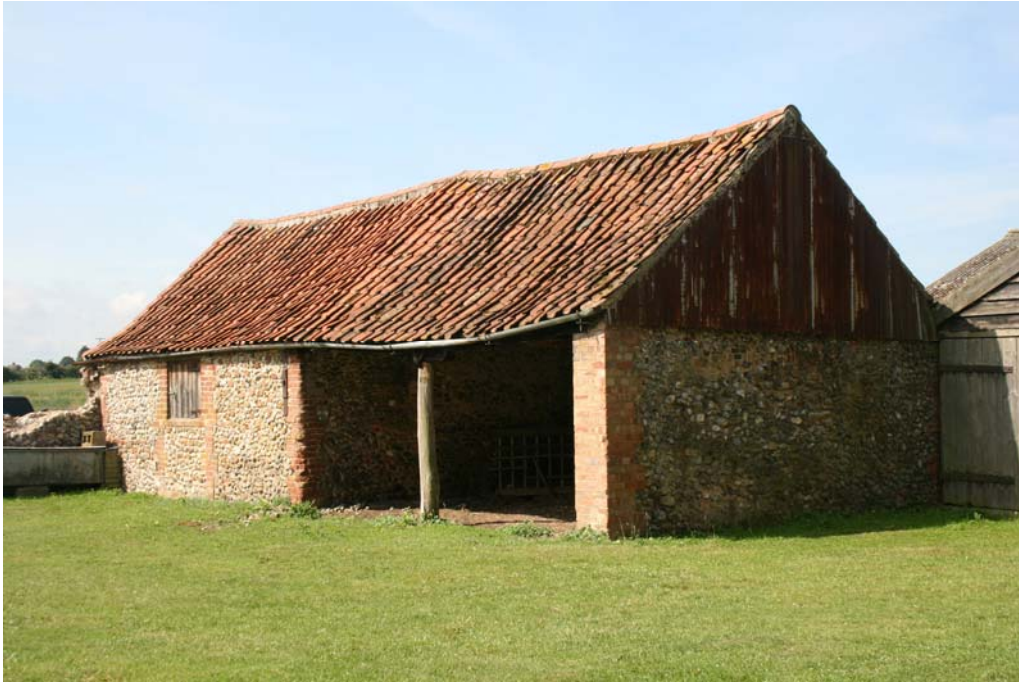
Plate 21. Building B3 facing south west

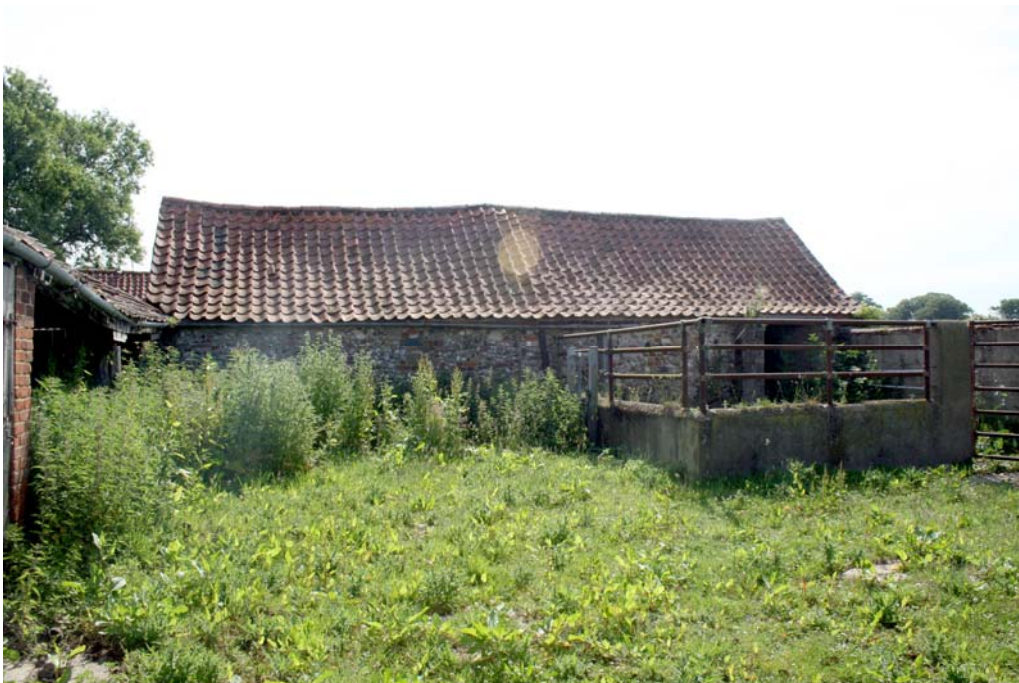
Plate 22. Western elevation of building B3, doorway to right

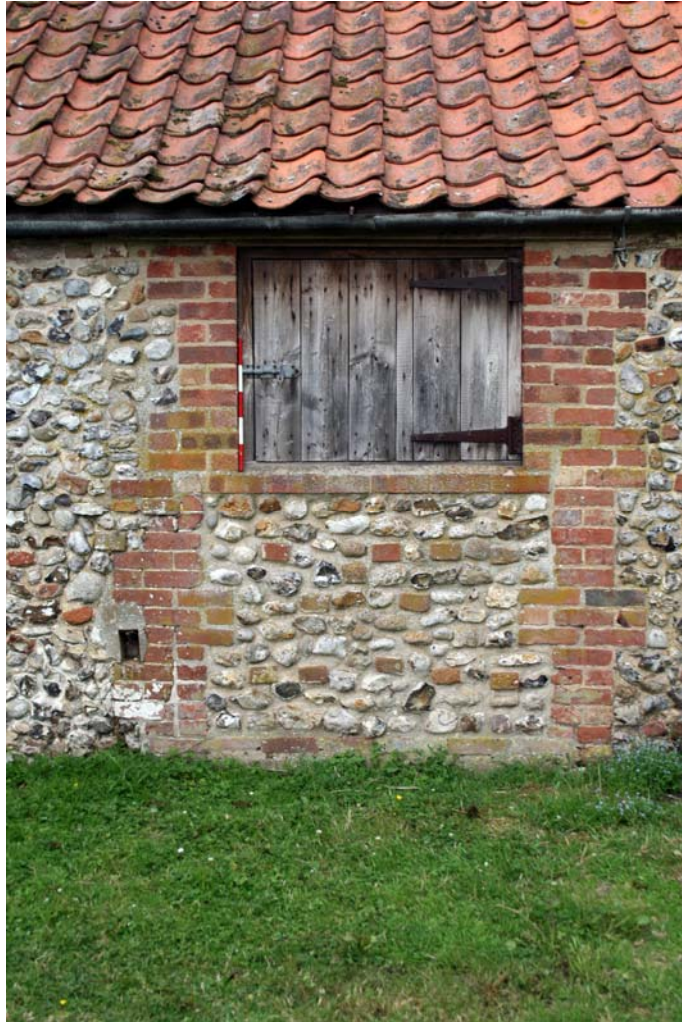
Plate 23. Doorway converted into window on eastern elevation of building B3

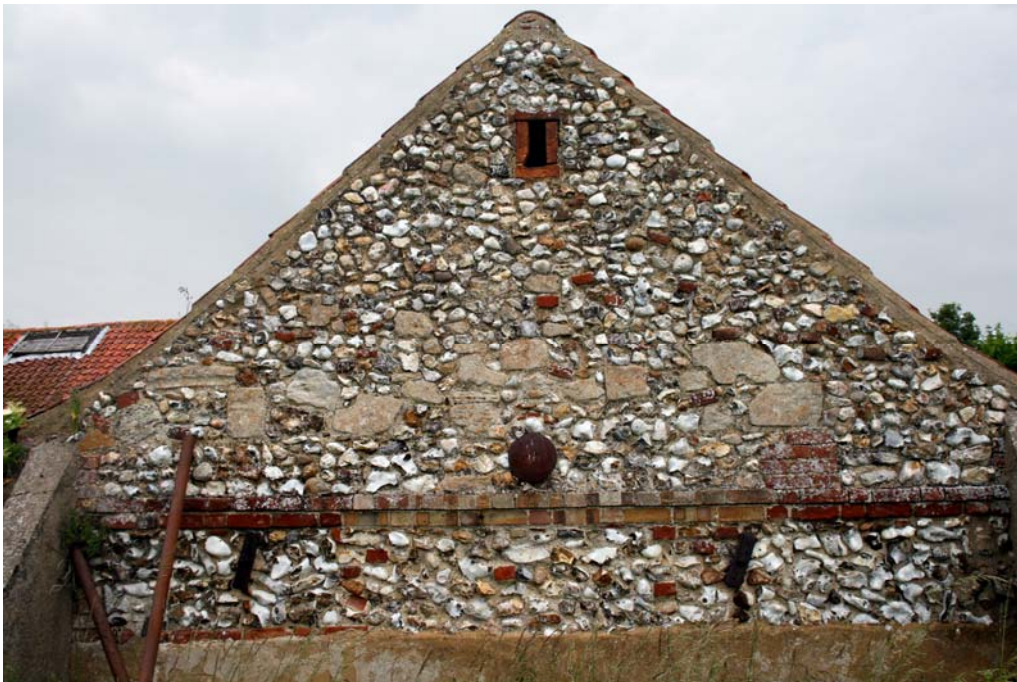
Plate 24. Ventilation hole south elevation building B3

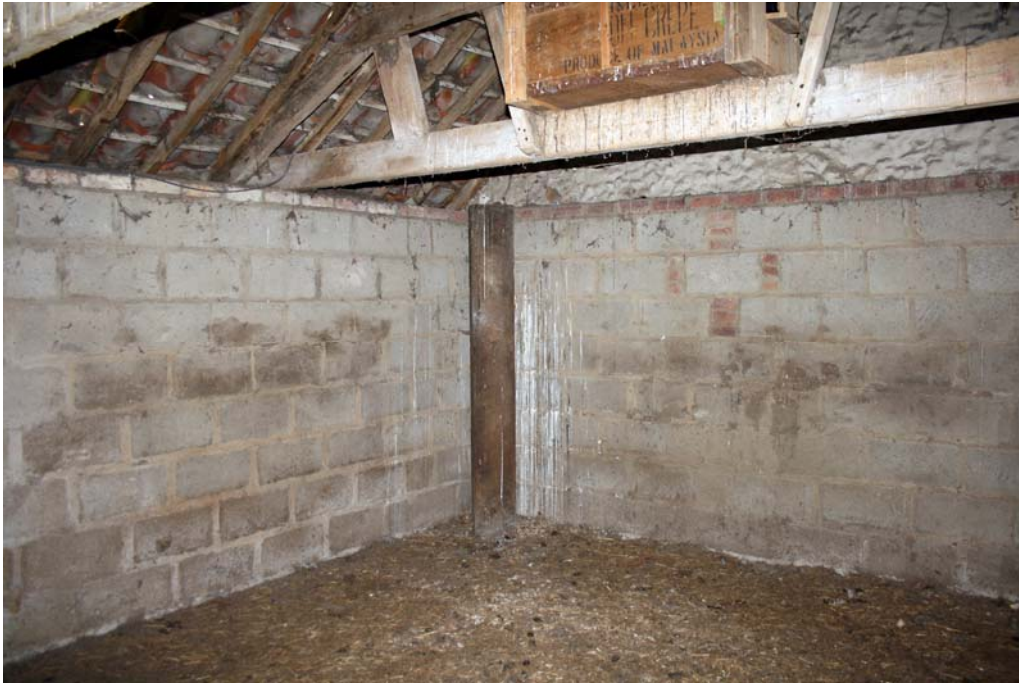
Plate 25. Tethering post in building B3

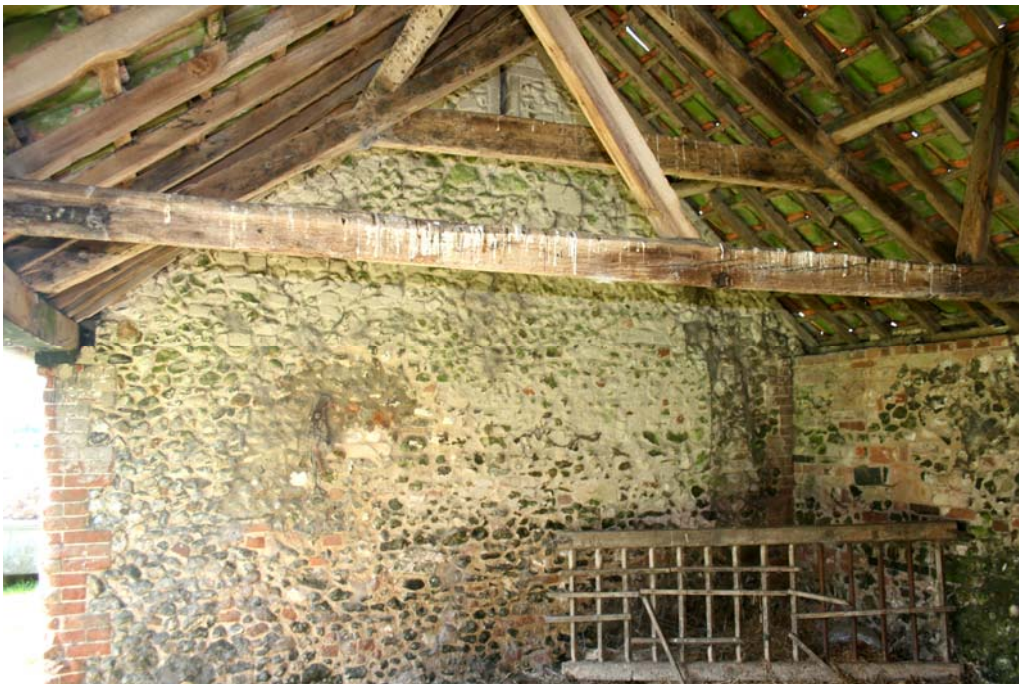
Plate 26. Interior of building B3, northern cell facing south

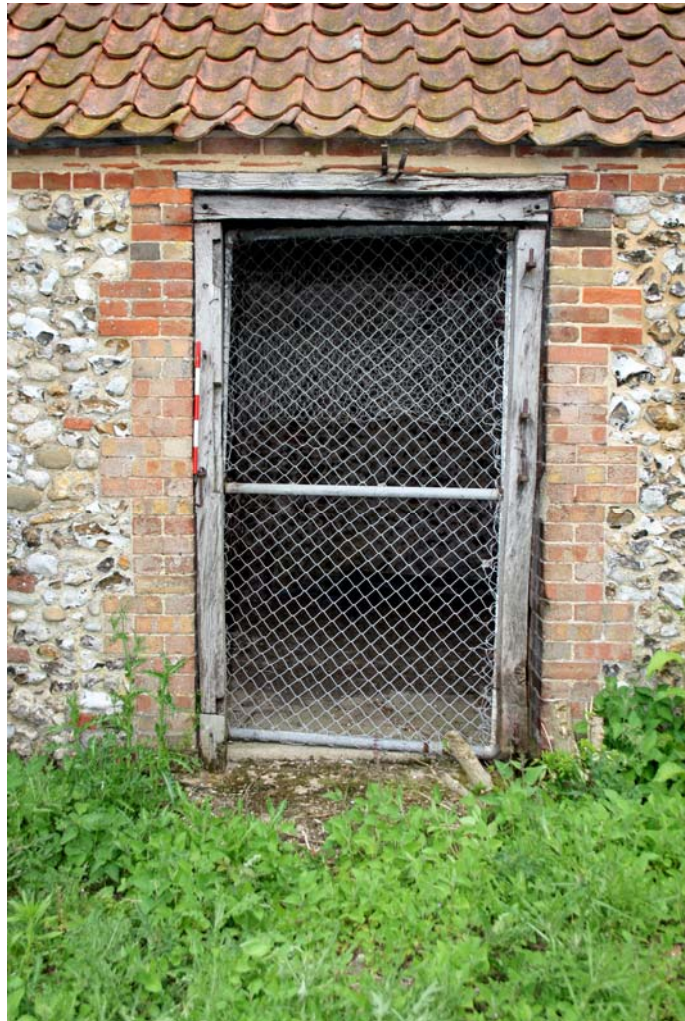
Plate 27. Southern doorway, eastern cell Building B1

The alterations carried out to Building B1 have led to the removal of most of its original fixtures and fittings however certain conclusions can be drawn based upon what does survive. Most significantly its location along one edge of a cattle yard makes it likely that it performed some function relating to either the maintenance or housing of livestock. For reasons discussed below we can be fairly certain that it post-dates the construction of Building B2 and that given the proximity of its northern doorway to the doorway in the northern gable of Building B2 originally there was probably a solid wall between the two structures. The width of the eastern cell's southern door indicates that at some point it was used to house cattle or maybe horses however the lower jambs of this opening in contrast to the earlier upper jambs have been completed in 20th-century brick suggesting it may have begun life as a window (Plate 27). The northern doorway is of narrower width and more suited to human traffic indicating its original purpose was not for cattle or horses. As such it may have been used for some storage function or alternatively for poultry if we interpret the small rectangular hole in the southern elevation as an entrance and the small concrete and wire fenced pen as a run. Of the western cell
