NORFOLK ARCHAEOLOGICAL UNIT

Report No.1066

**Historic Building Survey at Primrose Farm Barn
Shelton Green, Shelton, Norfolk**

May 2005

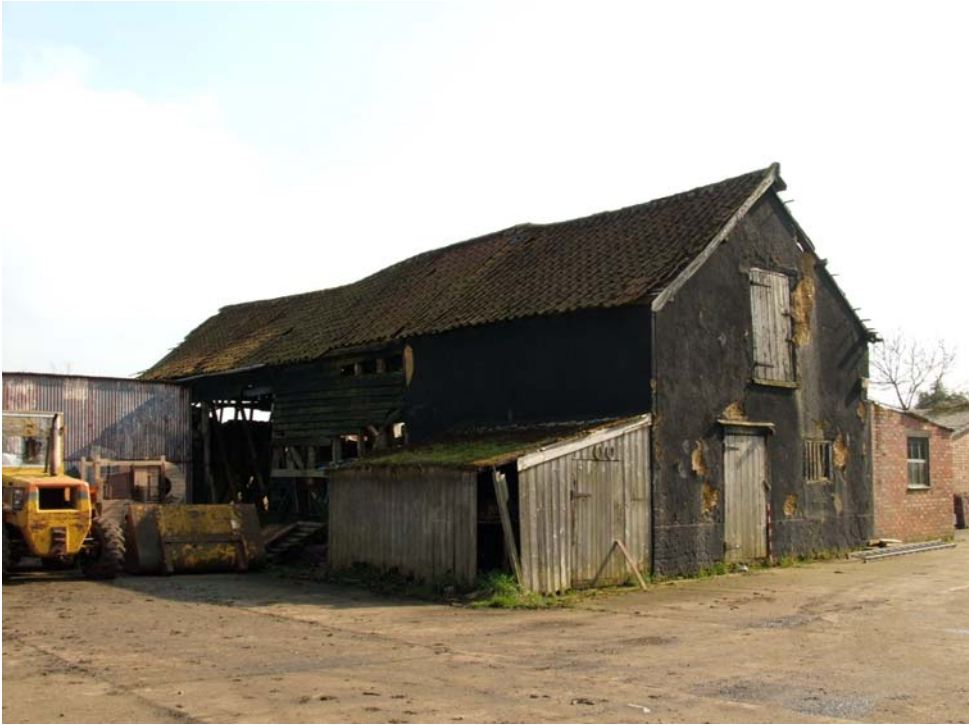
Plate 1. Exterior looking south-east

The barn (Plates 1 and 2) is situated north-east of the farmhouse and is aligned east-to-west. It is of timber-framed construction consisting of three bays (or steads) sitting on a low brick plinth, weatherboarded externally with pantiles cladding the roof.

The western extension (Plate 1) is constructed of clay lump on a low brick plinth; it is of the same height and width as the original barn and essentially extended the barn by an extra bay 5.5m long. It was probably constructed during the 19th

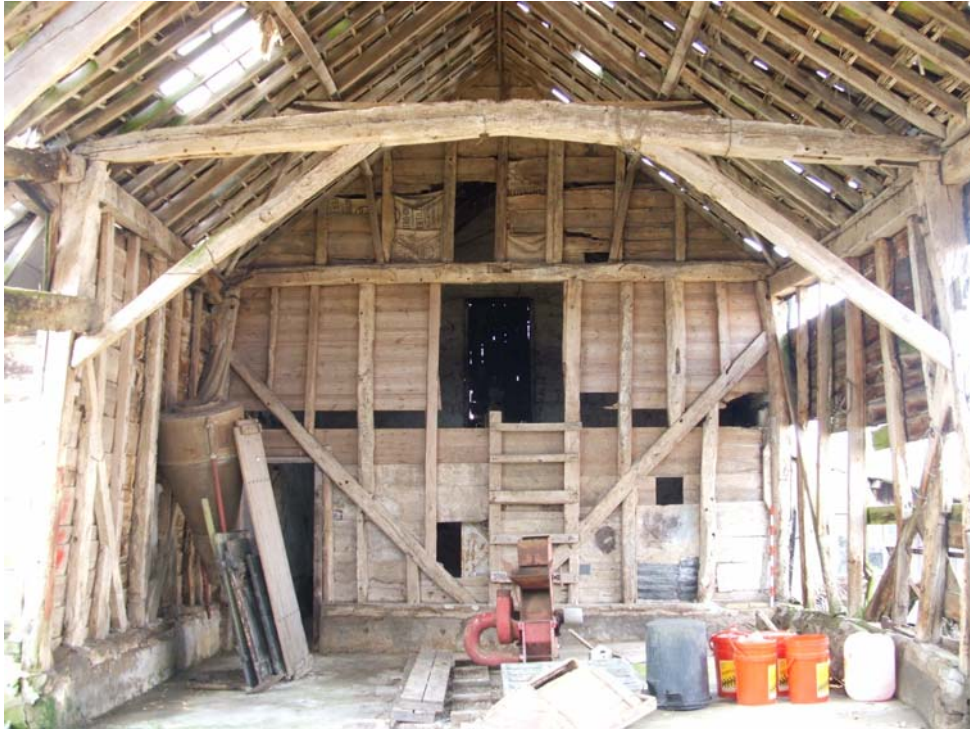
Plate 3. Interior looking west, 1m scale

The frame (Plate 3) consists of jowled posts, at the corners and at the ends of the two central trusses, sillbeams and wallplates with studs between and straight tension braces. In places the studs are offset above and below the tension braces. The trusses have tiebeams and straight braces from beams to posts. Many of the studs have been replaced.

The tiebeam of the west truss is re-used. It is cambered and has mortice holes for braces closer to the ends of the beam than the present straight braces, these were probably for arched braces (Plate 3). Other notable re-used timbers occur in the north wall. A stud in the centre of the north wall of the east stead has a row of mortices on its southern face and is a reused plate (Plate 4). The wall plate above has some empty mortices and may be reused. The post at the north end of the east truss has four diamond mullion sockets and four mortices on its east face and more mortices on the west face and the south face (Plate 5). The east face has been reduced at some time because there are exposed open peg holes in the surface; an additional piece of timber has been added to create the jowl at the top of the post. This post is a plate or rail from a house probably dating to before c. 1600, which is about the latest date for the use of plain diamond mullions in Norfolk (pers. comm. Bill Wilson).

reused. There is an opening in this wall below the tiebeam (see Plate 3) which gave access to the now missing upper storey of the west extension which was used as a hayloft (pers. comm. Laurence Bartrum).

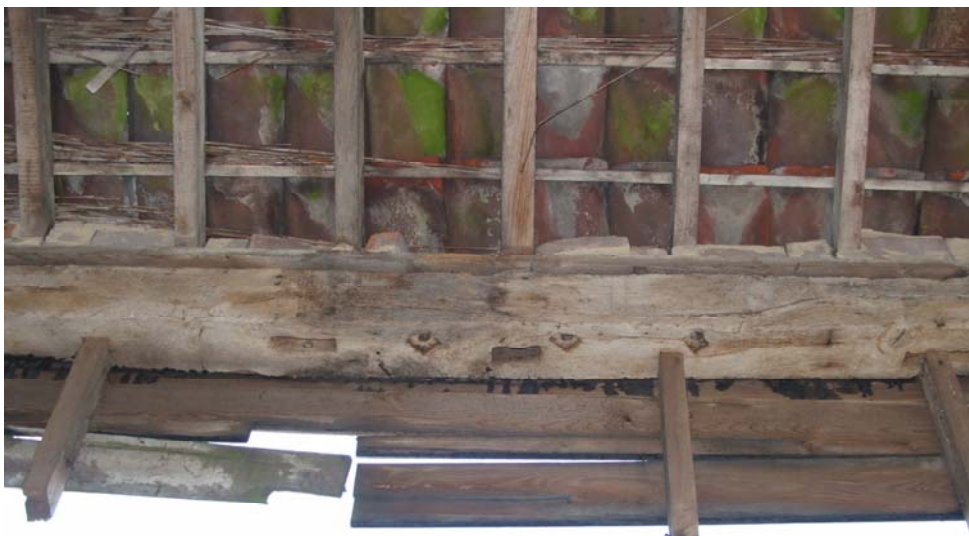
Plate 6. Wallplate with diamond mullion sockets over cart door, looking north-east

The wall plate over the cart doors exhibits three diamond mullion sockets with mortices either side and a later central mortice on its underside (Plate 6). This plate is probably similarly from a 16th-century (or earlier) house. The central mortice with no peg-hole is for a movable post for fastening the cart doors. This post would have slotted into the mortice at the top and a movable board or 'lift' (Peters 1991, 14) at the base. The lift was held in place by battens fixed to the posts either side of the doors (these are still in place at Shelton). The lift kept the doors clear of manure or other material in the yard, and kept animals out of the barn when the doors were open for threshing etc. The doors themselves are missing but the three iron hinge pins driven into the exterior face of either post survive.

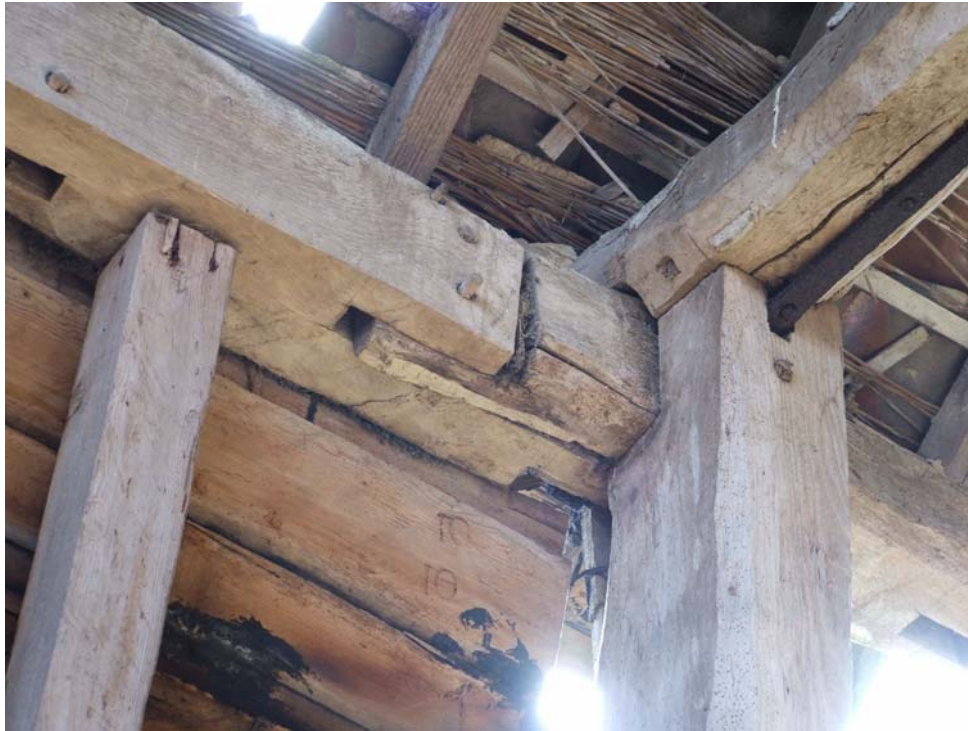
Plate 7. Face-halved and bridled scarf joint in south-east wallplate

There is a face halved and bridled scarf joint at the west end of the wall plate in the south wall of the east stead (Plate 7). This type of joint was first used in the 16th century, and became the dominant form of scarf in the 17th and 18th centuries. The studs in this section of wall have mostly been replaced, the west end of the wallplate and plinth here are missing and the main post and studs have dropped and been displaced slightly to the north.

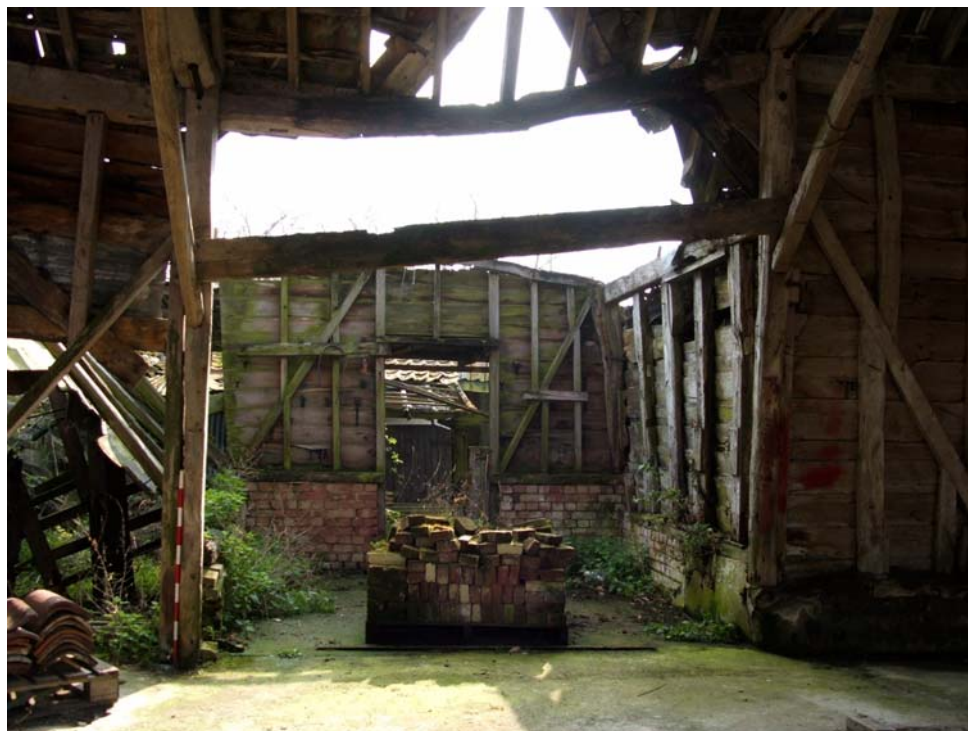
Plate 8. Porch looking south, 1m scale

The porch itself is 3.2m square in plan and extends south from the central bay it is timber framed and weatherboarded in a similar fashion to the barn (Plate 8). The roof is missing and the east wall has collapsed outwards. The porch walls are a metre or so lower than the barn walls. The wallplates of the east and west walls are mortised into the outer faces of the southern main posts of the barn trusses below the barn wallplates and supported by shorter jowled posts at the south corners of the porch. The jowled posts and the wallplates and studs of the east and west walls appear original. The studs are of larger scantling than those of the main barn and there is no bracing. The sillbeams and brick plinth walls, which are now at several levels, have been replaced in the 19th or 20th centuries.

The porch had a pitched roof. The north end of the ridgeplate and the short end rafters are still attached to the barn roof just above wallplate level, and two angled plates indicate the join of the porch and barn roofs (Plate 8).

The porch is to be demolished as part of the proposed development.
