**An Historic Building Recording Survey at  
Ivy Farm, Stanhoe, Norfolk**

ENF125176

Prepared for  
**Strata Architectural Ltd.**

December 2010

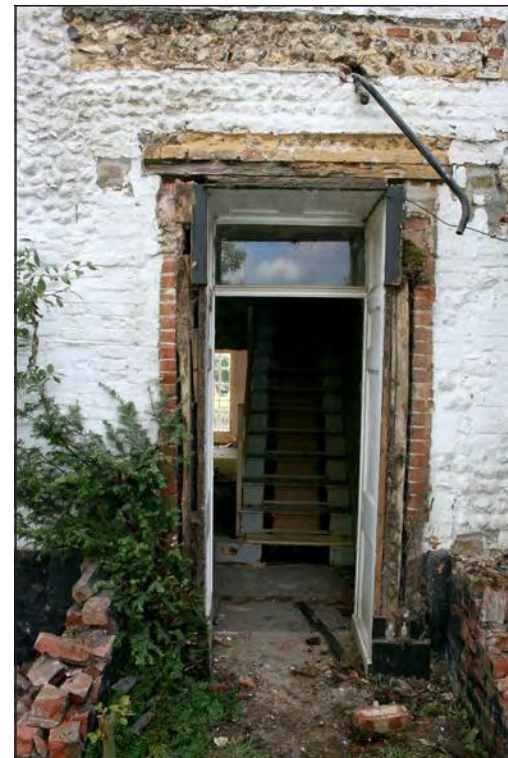
Plate 4. Front door with porch surround removed

The northern elevation constructed of coursed flint and brick constituted the main approach to the house and displayed four large rectangular windows evenly spaced across the façade's first floor giving the appearance of four distinct bays (Plate 3). The first and third windows (east to west) showed preserved sash windows of 10 over 10 lights, while the two remaining had been replaced with casements. Each window had brick jambs however those of the westernmost window differed slightly in character, and the opening was narrower than the other three perhaps suggesting an adaptation. On the ground floor a large canted bay window just to the west of centre must have dominated the elevation, although obscured by bushes at the time of the survey. It had a central sash of 8 over 8 lights with subsidiary sashes each side half this size. The front door stood to its east with traces of a removed porch visible upon the surrounding walls (Plate 4).

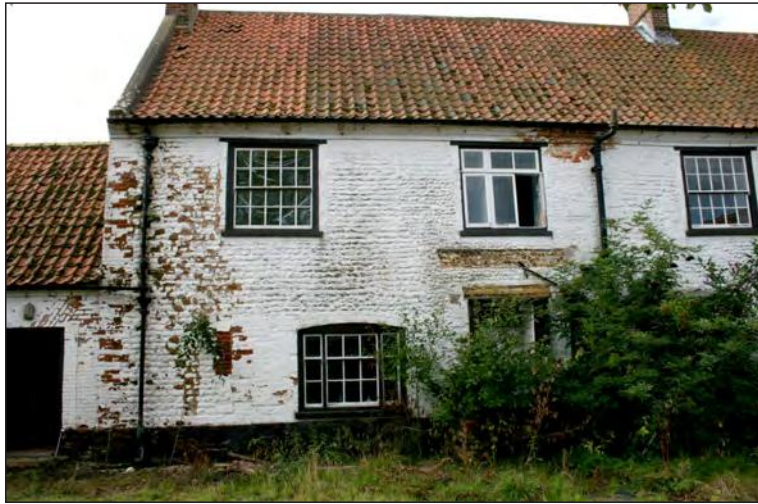
Plate 5. Relocated ground floor window on northern elevation of Building A

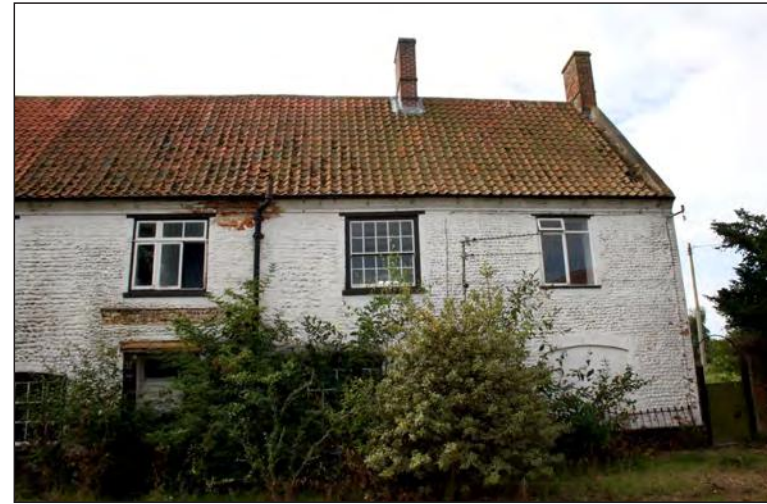
Plate 6. In-filled window on northern elevation of Building A

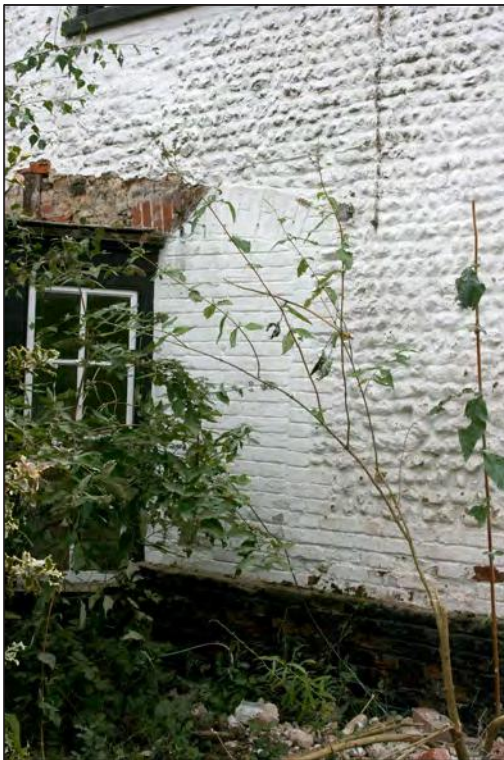
Between the front door and the bay window sat a small casement window, again obscured by foliage, while at the east end a large 3 over 6 sash beneath a shallow cambered arch appeared to have replaced an earlier opening further to the east that may originally have been more in line with that on the floor above (Plate 5). At the west end a second shallow cambered arch framed a similar opening but the use of brick varied from that to the east and the jambs had more in common with the window above. Unlike the cambered arch window to the east this opening had been in-filled and the in-fill rendered over (Plate 6). Inspection of the walling immediately to the west of the bay window suggested this feature had replaced an earlier opening as the remnants of a blocked cambered arch and western jamb similar to those seen to the west had survived the insertion and appeared to line up with the window on the floor above (Plate 7).

Plate 7. Blocked window beside bay window

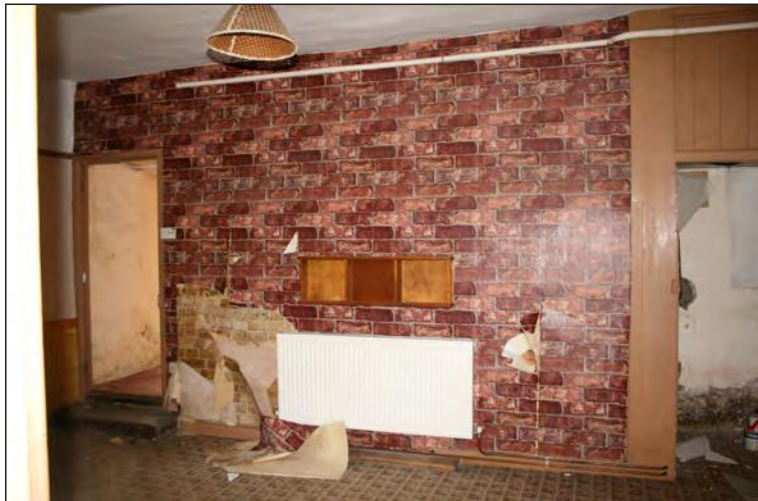
Plate 15. Boarded up fire-place in eastern ground floor room, Building A

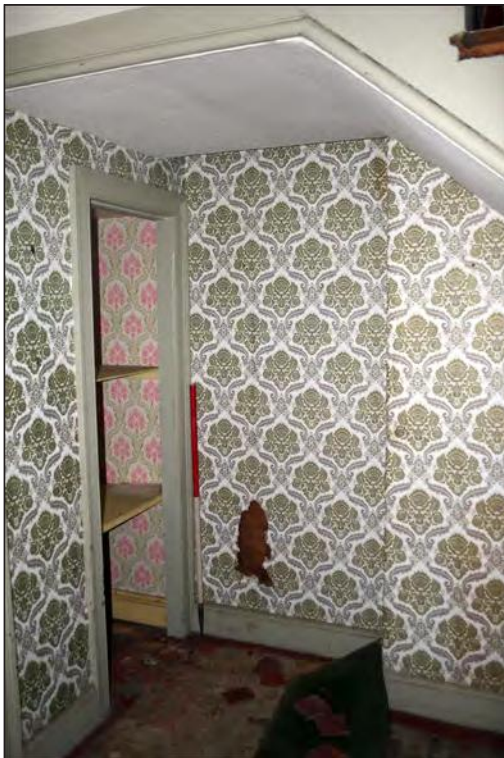
Plate 19. Blocked doorway beneath stairs  
in Building A, 1m scale

It was clear that previously it had been possible, via a door in the west wall below the stairs to gain entry to the remainder of the ground floor of the house from the hall but this had been blocked up when the house was converted into two separate dwellings (Plate 19). Access to the ground floor on the western side of the building was granted by the doorway on the southern side of Building A, to the east of the rectangular bay window in the southern elevation. From here a large living room was located to the west with a fireplace against the centre of the western wall and bay window to the south (Plate 20). Along the northern wall an arched niche had been recessed into the centre of the blocked window visible from the exterior. Directly to the north of the southern doorway a second living space was present with a fireplace again set against the centre of the western wall (Plate 21). This room housed the bay window visible on the main elevation at the centre of the northern wall while a built in cupboard had been erected in the north-eastern corner. From the south-eastern corner of this room a staircase had been inserted (at the time of the division of the house) which led to the upper floor while the space beneath had been converted into a toilet with its entrance immediately to the east as you entered the house from the southern doorway. On the southern wall of Building A against which the staircase had been inserted it was possible to see the upper portions of what may have been originally an internal doorway leading into Building B (Plate 22). This too was likely blocked at the time of the partitioning of the house.

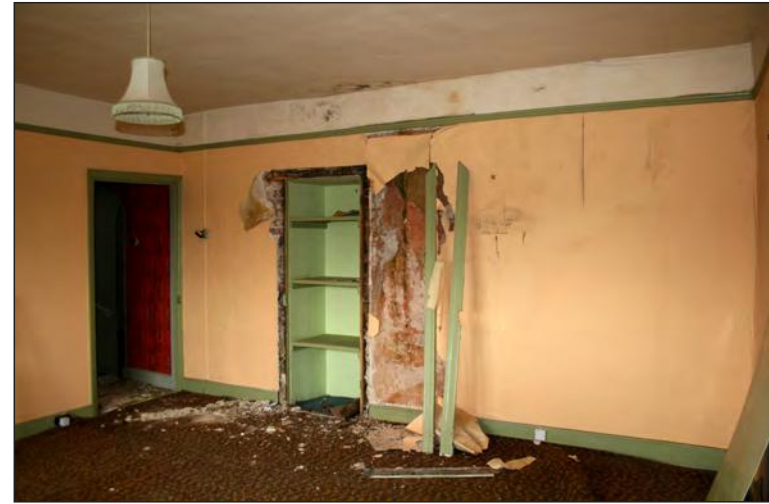
In the eastern half of the building the staircase led up to a small landing from which a further short step up led south into the first floor of Building B (Plate 25). Here two rooms of roughly equal size, one to the east and another to the west, were divided by a north-south partition wall. Each room had its own fireplace at the centre of its respective gable wall while the eastern room displayed a niche along its northern wall that indicated the previous location of a doorway between

Plate 26. Niche indicating previous doorway in Building A

Buildings A and B (Plate 26). From the small landing turning east led up to the main landing corridor that ran north to south across the width of the house. From this corridor two rooms were accessible to the east both of similar dimension. The southernmost of the two served as a bathroom while that to the north appeared to be another bedroom. They were divided down the centre by an east-west cross-wall which intersected the chimney breast at the centre of the eastern wall.

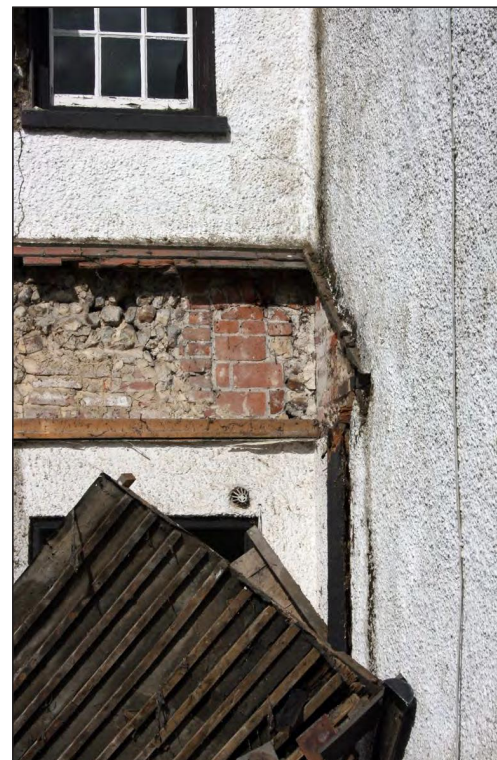
Several details came to light as a result of the demolition of the building that would otherwise not have been visible. Most obviously the construction methods used for the walls were recorded in cross section revealing the walls of Building A to be 0.65m thick at the base tapering gently to the wall plates (Plate 28). In contrast the walls of building B were 0.50m thick on the ground floor narrowing at first floor height by approximately 0.2m (Plate 29). Both buildings used chalk rubble and flint in a lime mortar with occasional bricks throughout and at the openings. Also of note was the identification of a small blocked window at first floor height on the southern elevation of Building A and partially obscured by the construction of Building B (Plate 30).

Plate 30. Blocked opening on southern elevation of Building A

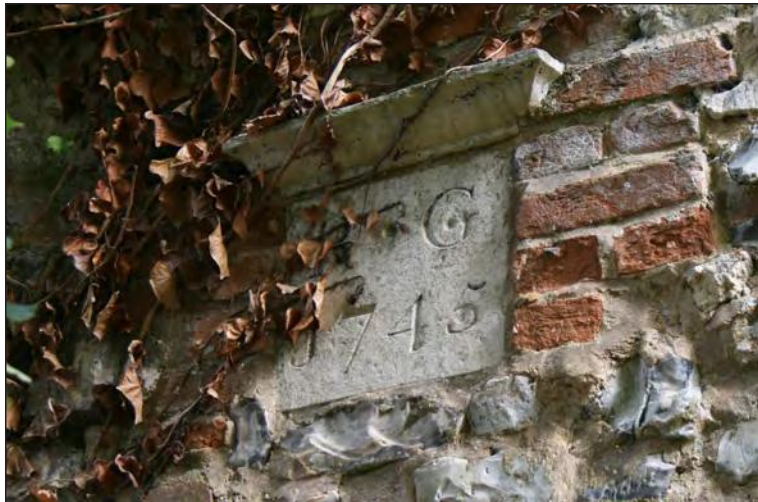
Plate 47. Date stone above blocked door on Building G

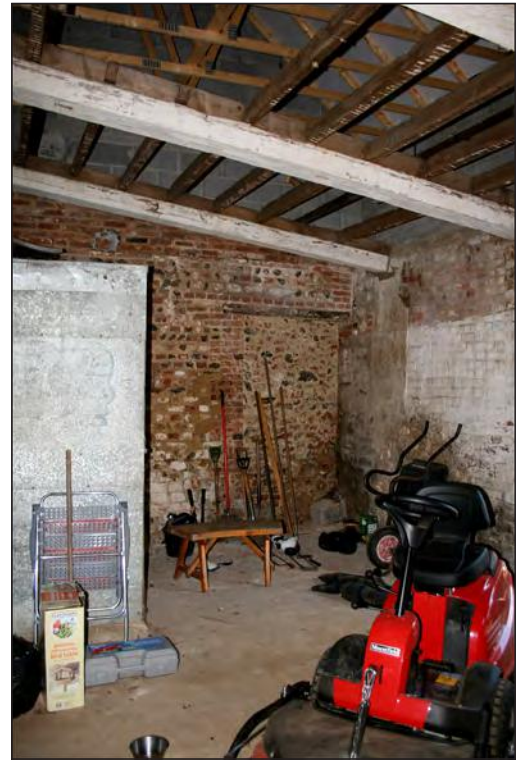
Plate 50. Blocked door in northern wall of northern cell, Building G
