A Historic Building Recording Survey at Grange Farm, Pulham Market, Norfolk

NHER 40398
ENF125621

Andy Phelps BA

April 2011

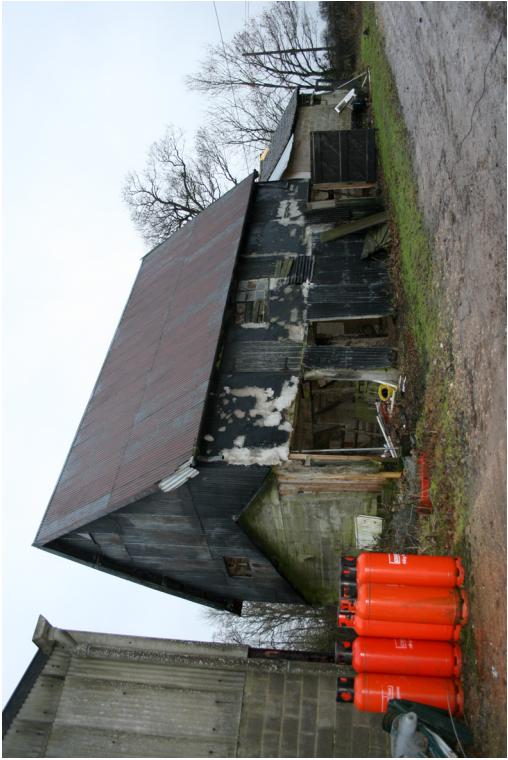
The northern elevation faces the farm house and provides the only (currently) visible access with a large opening to the east, a single doorway immediately to the west and a large third opening at the western end. This latter opening is the only one with doors, which opens externally into the yard. The first floor displays a door to the centre of the eastern end with a four light window at the approximate centre of the elevation flanked directly to the west by a second partially boarded-up doorway. The first floor is rendered in a lime mortar and covered in tar proofing with patched repairs in cement while the ground floor is clad in corrugated iron, painted black to match above (Plate 1).

The eastern gable wall has a single blocked doorway at its northern end with a rectangular window at first floor height to the south. The upper gable is clad in tarred corrugated iron but the lower is of horizontal wooden planks with the roof scar of a demolished shallow gabled building dividing the two (Plate 1).

Plate 1. East gable and north elevation of Building A

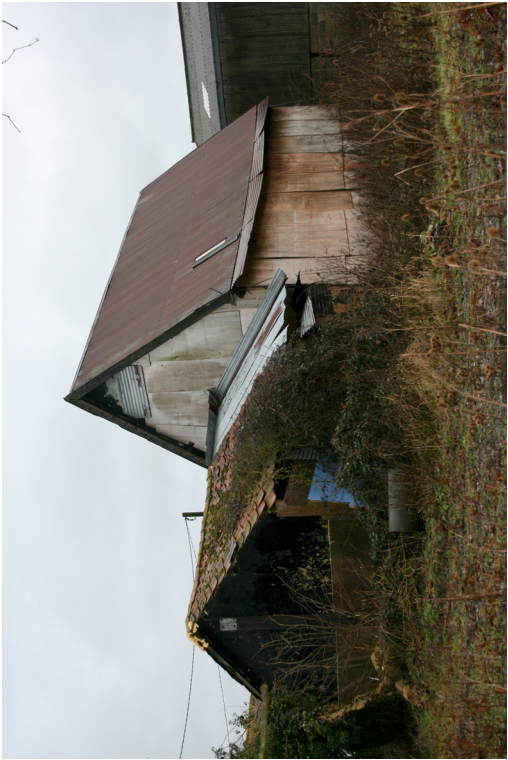
The southern elevation is entirely obscured by a makeshift covering of plywood sheets that hide any openings that may survive (Plate 2).

The upper portions of the western elevation are also clad in plywood sheets with a single sheet of corrugated iron hiding a two light window towards the apex. The lower half the elevation is obscured by Building B which projects westwards from this wall however internal inspection identified horizontal planks in the same manner as those at the eastern end (Plate 2).

Plate 2. Buildings A and B facing north east

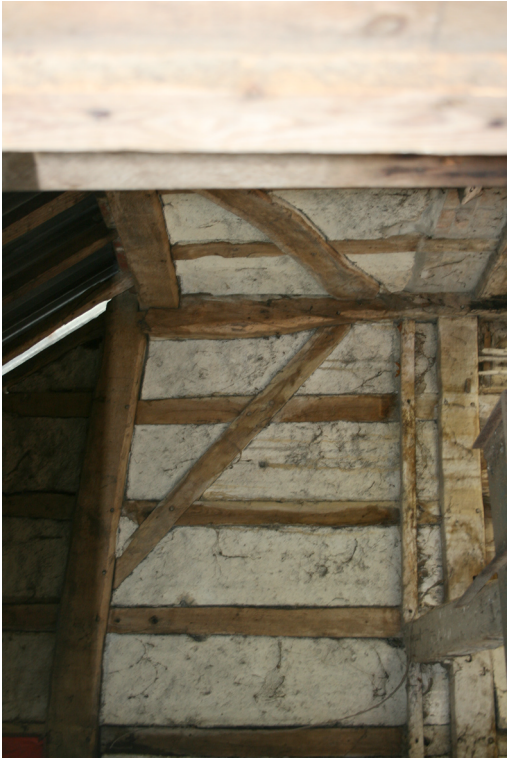
Plate 3. Building A jowled post head in north-western corner

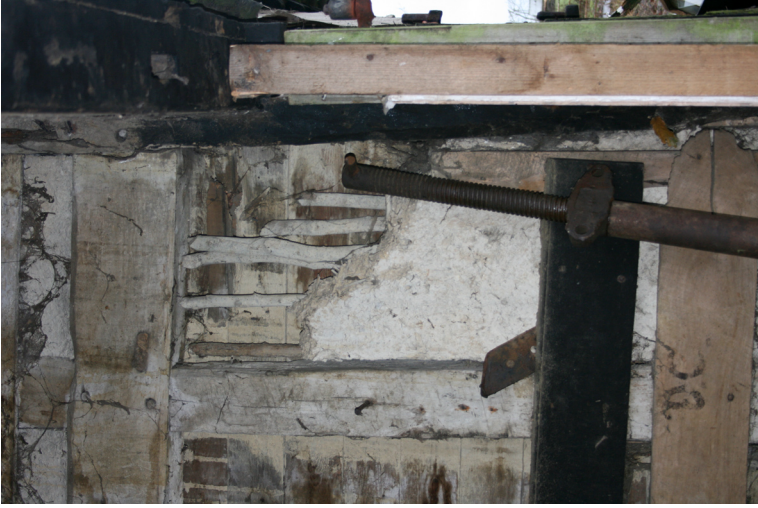
Plate 4. Building A ground floor vertical staves within damaged infill panel

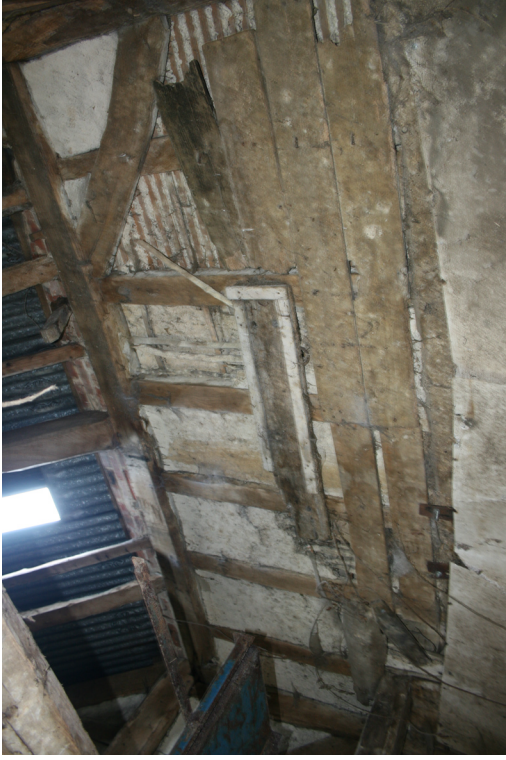
Plate 5. Building A south wall interior west end
showing lathe and plaster

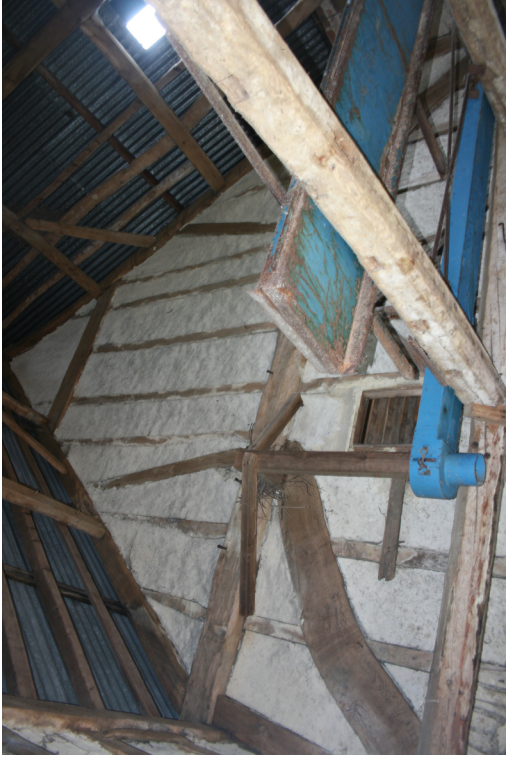
Plate 6. Building A partition wall facing east

The walls themselves are composed of studs; each of which is a full storey in height creating fairly narrow panels in proportion to their height. The infill of these panels varies with what appears to be lath and plaster on the southern wall where it survives and vertical staves and daub used on the western wall (Plates 4 and 5). The eastern wall makes much use of horizontal wooden boards nailed into place over the studs except above the first floor where corrugated iron has been used. Corrugated iron is also used on the ground floor of the northern elevation but the infill panels on the first floor remain intact and beyond the use of lime render between exposed timbers their construction could not be detected. The cross-wall infill also remains in good condition with a full lime render on the eastern face and exposed timbers between panels to the west. A small portion of damaged panelling suggests the use of vertical staves here (Plates 6 and 7).

The building is arranged over three floors with the ground floor divided into four bays (Figs 3 and 4) by partitions between the third and fourth bays and second and third bays from the east while the first and second bays are largely as one. The westernmost bay is open to the roof without any upper floor but there are indications that this has not always been the case with beams for a first floor still in place (Plate 6).

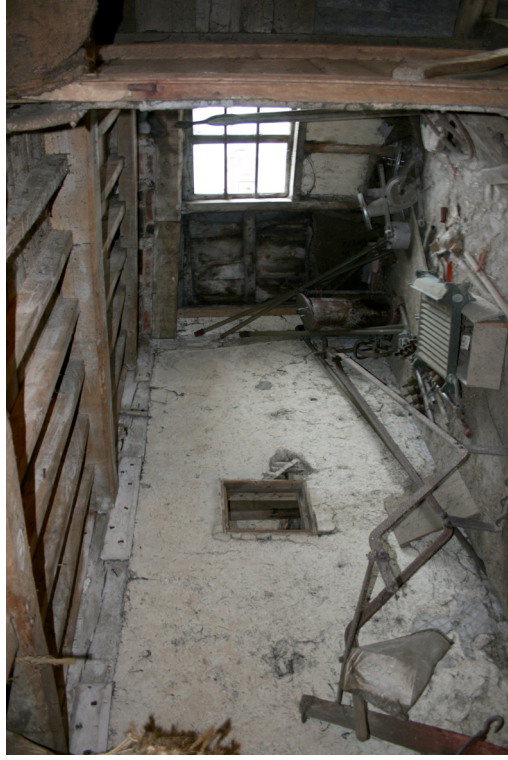
Plate 7. Building A first floor partition wall, staves just
visible to right of window

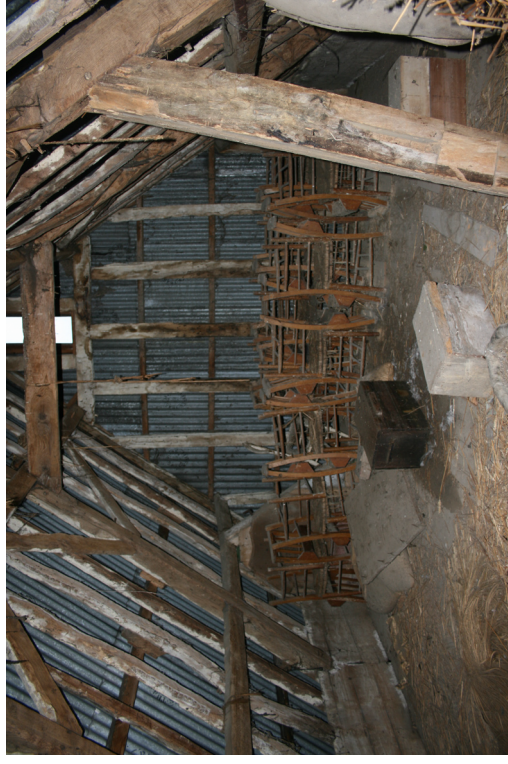
Plate 8. Building A second floor facing east
showing roof structure

The roof is of five bays with principal trusses of clasped purlins with reduced principals and curved wind braces. There is a second pair of butt purlins (Plate 8).

The second floor (Figs 3 and 4) is set within the roof space although the steep pitch of the roof allows for plenty of head room. The roof is discussed in detail above (see Structure) and its access is restricted to what could be seen from the steps as the floor boards are deemed to be unsafe, however it is currently used for storage and there is no indication that it had ever served any other purpose. The only source of light is provided by a rectangular window high up at the apex of the eastern gable (Plate 8).

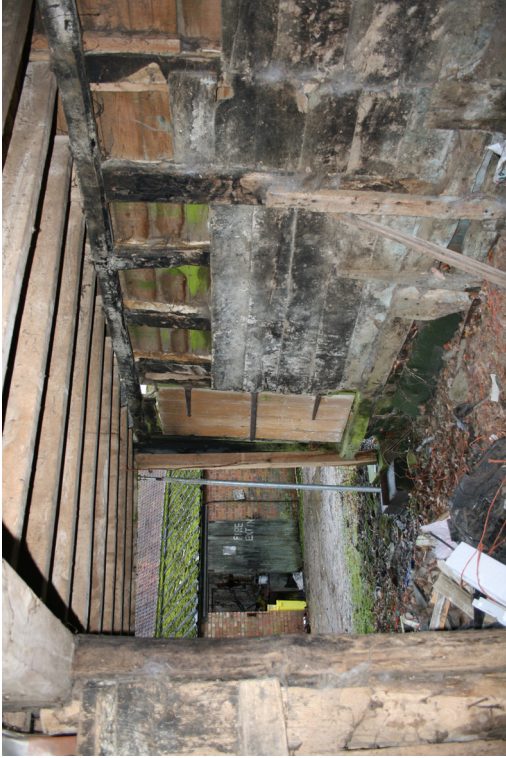
Notably the carpentry at the eastern wall of the ground floor in bay one is of a fairly crude nature in comparison to the remainder of the building with nails used in places rather than jointing (Plate 9). This may have been the result of extensive but localised repair work as the first floor and above appear to be of better quality. The opening in the northern wall of the first bay retains no doors and from the soffit of the mid rail above it several empty sockets denote the previous spacing of studs in place of this doorway (Plate 10). This is also the case at the western entrance where missing studs provide evidence for an original continuous wall at this end.

Plate 9. East wall of Building A facing north-east

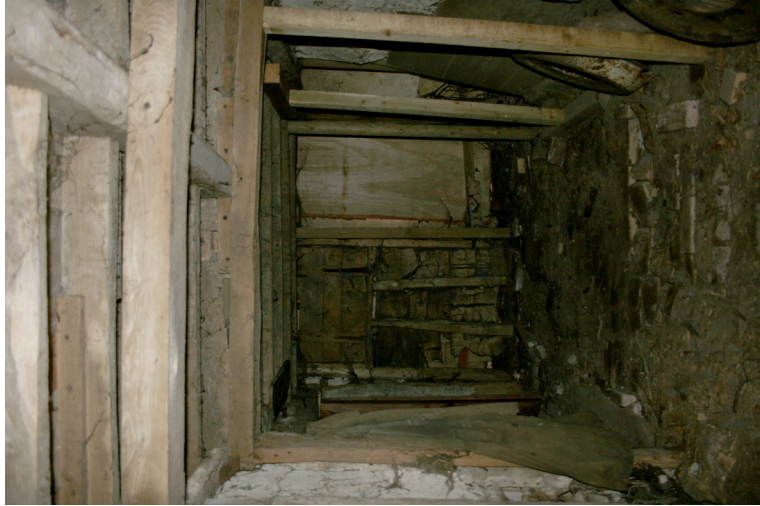
Plate 11. Building A to west of stairs facing south towards shuttered window, brick floor below and blocked door to right

Further investigation indicates that based upon the spacing of stud work the original door is located within the centre of the northern wall within bay three and is only just over a metre wide. It is no longer in use having been covered over with corrugated iron. The majority of the ground level flooring is of dirt although other surfaces may be obscured beneath. The exception is at the rear of the third bay where a small portion of brick flooring survives *in situ*. Two further doorways not visible from the exterior are identified on the southern wall arranged immediately adjacent to each other either side of the partition wall dividing bays three and four. Neither appears to be original as they both coincide with empty stud sockets on the soffit of the rail above and both doorways have been boarded up. A small rectangular window with a wooden shutter hinged at the sill sits just to the east of the eastern most of these doorways (Plate 11).

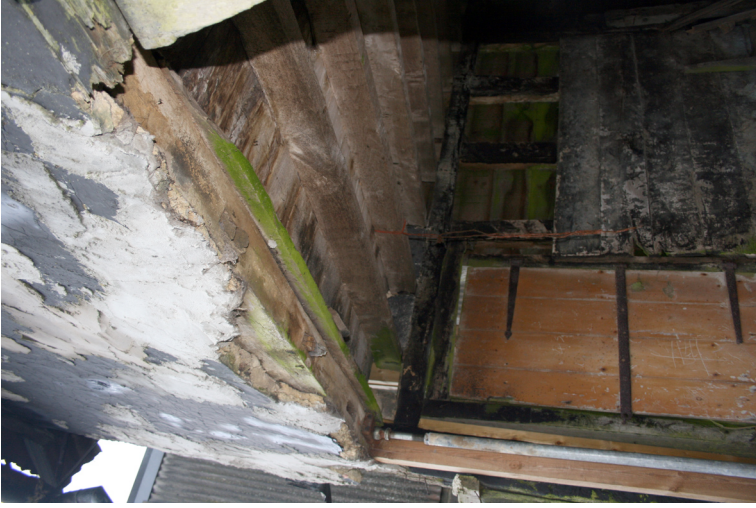
Plate 10. Empty sockets on north wall of Building A

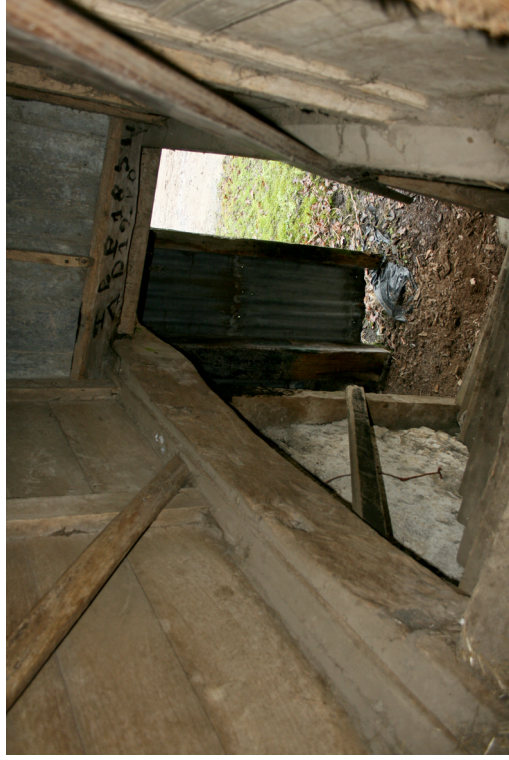
Plate 12. Building A empty floor joist sockets to left of stairs

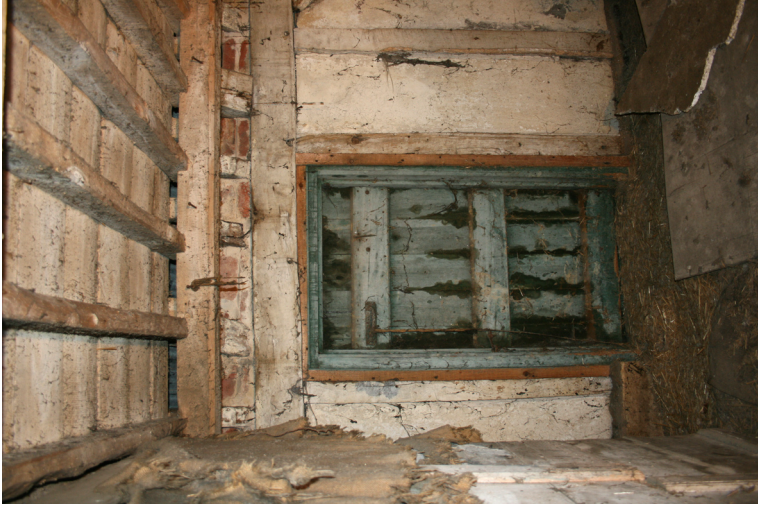
Plate 14. Building A first floor door in north wall showing redundant peg hole above

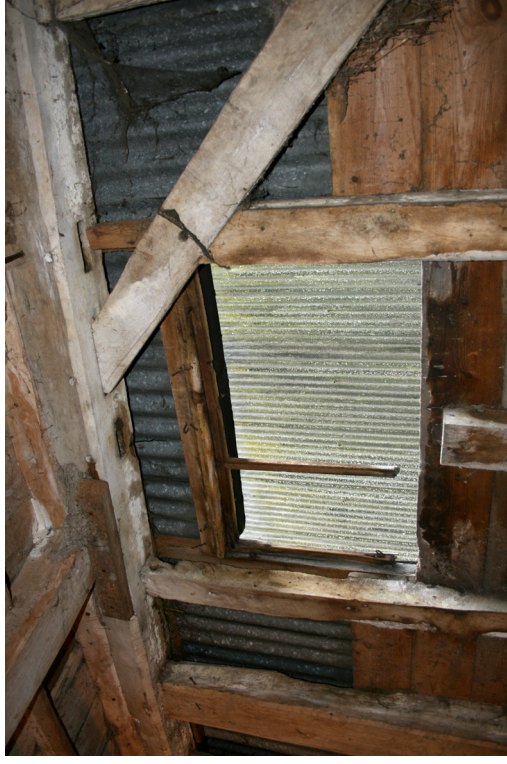
The first floor (Figs 3 and 4) is laid with wooden floor boards and their fragility prevented full inspection of the northern end of the room however certain details could still be recorded. It is possible to see that the both of the first floor doors visible from the exterior are probably not original. A redundant peg hole at the centre of the wall plate above each door indicates the previous location of studs at intervals which fit the spacing pattern of those remaining studs (Plates 14 and 15). The same was also true of the four light window sited between these doors although it is possible these pegs holes relate to previous mullion positions rather than studs. An empty socket above the three light window on the eastern wall also suggests a later insertion or alteration while the small central square window in the cross-wall looking out over the open westerly bay gives no indication as to its provenance, although its soft wood frame is certainly of a later date (Plates 16 and 17).

Plate 16. Building A first floor east window, note empty stud socket in wall plate

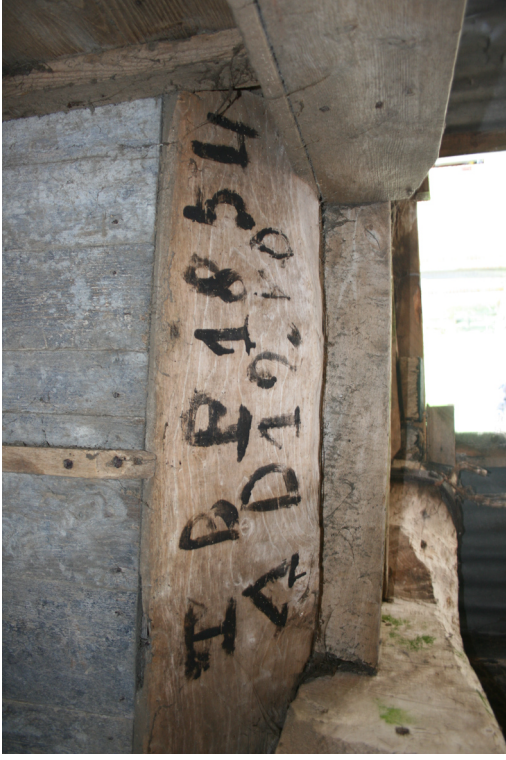
Access to the first floor is provided by a staircase in the western end of the second bay but again empty joist sockets on the adjoining first floor beam indicated this to be a later insertion (Plate 12). Upon a board above the stairs is painted the initials 'IBP' with the dates of '1854' and 'AD 1910' to the right and below (Plate 13).

Plate 13. Building A graffiti above stairs

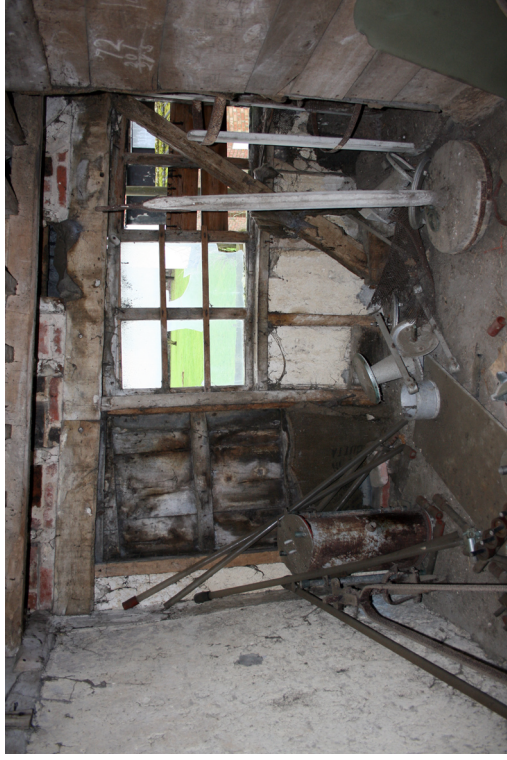
Plate 15. Building A western first floor door and window on north wall, note redundant peg holes in wall plates above

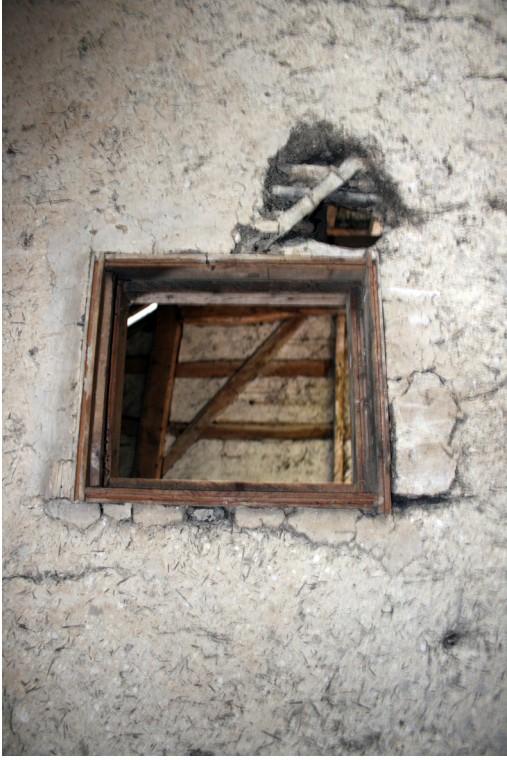
Plate 17. Building A first floor internal window looking west

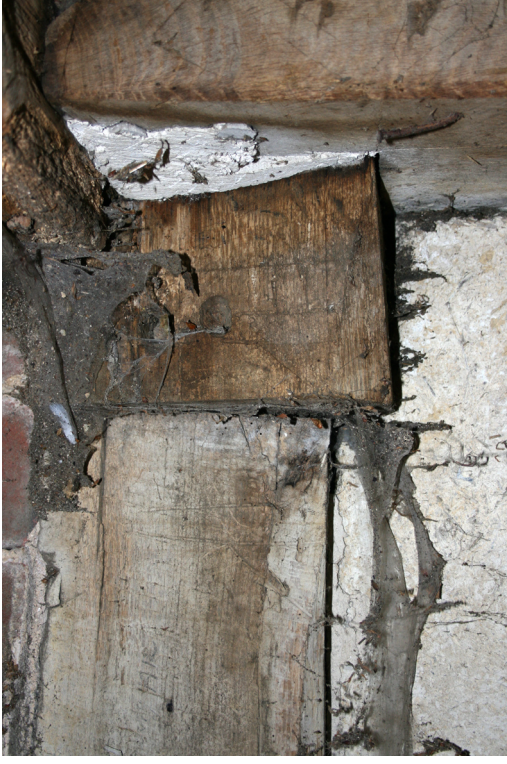
Perhaps of most interest on this floor is the survival of numerous carpenters' marks scribed on the lower portions of the studs on the southern wall and also on the upward brace dividing bays two and three along this wall (Plate 18). Further marks are located at the base of the studs on the eastern wall and again on the western wall at the opposite end of the building and on the northern wall within bay four. It is possible that detailed investigation might reveal many more of these marks although those on the ground floor appear to have been lost through degradation of the lower timbers.

Plate 18. Building A carpenters' marks on beam joint

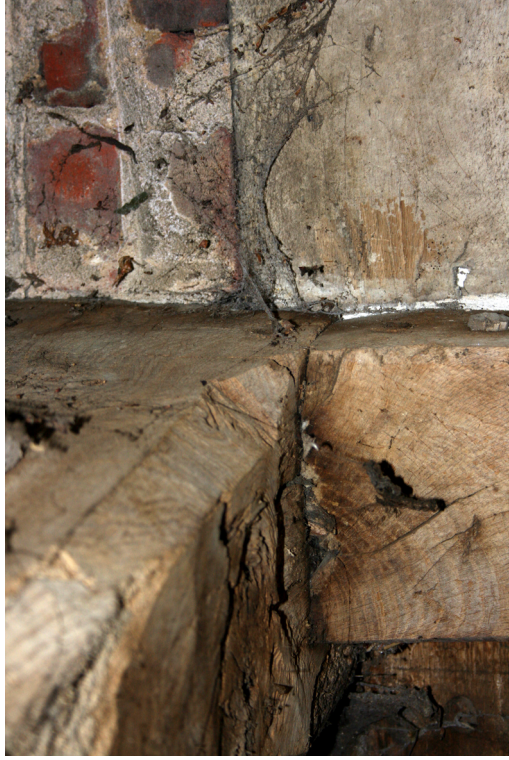
Also worthy of mention is the use of lambs tongue chamfered stops on the ends of several of the main floor beams for the joists above and in fact these are observed on the ground floor ceiling beams too (Plate 19).

Plate 19. Building A chamfered beam stop

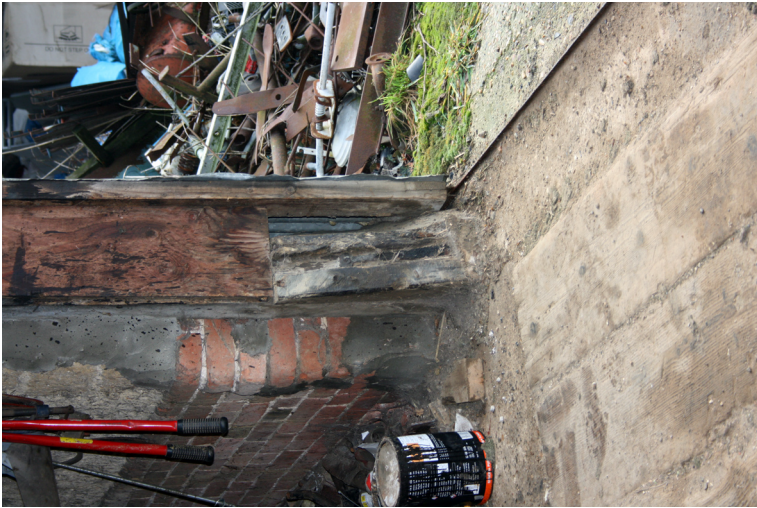
Plate 25. Building C groove at the base of southern door

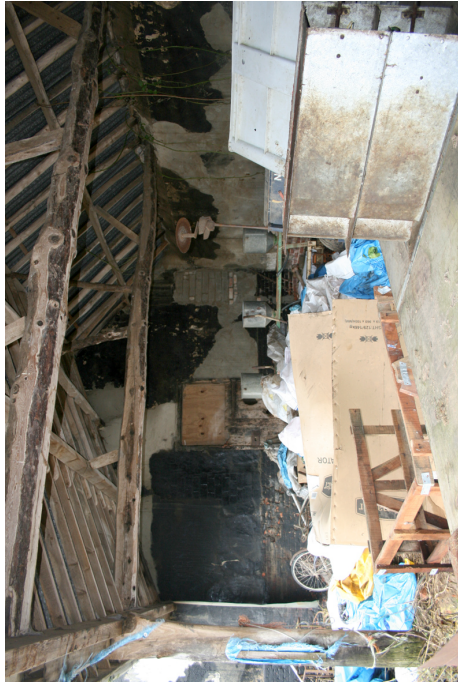
It is divided into four bays with the three to the north open to the west, the arcade plate being supported at the centre of these northern bays by a single post (Plate 32). The roof trusses are of simple design consisting of roughly cut tie beams resting upon each wall plate with diagonal struts rising to clasp through purlins (Plate 32). The remainder of the building is of lime render and tarred clay lump on a brick plinth with the exception of the western wall of the southern cell which was composed of concrete blocks above the plinth. The building is being used for storage and what fixtures and fittings may be in place were either hidden from view or have already been removed, however the southern bay has been divided off at the truss to create a small rectangular cell accessed via an internal doorway at the western end of the partition wall. From its appearance it has probably been used as an animal shelter at some point. The erection of Building D certainly post-dated that of C as at least two of the windows on the southern wall of Building C have been obscured by the roof line and eastern wall of Building D (Plate 33).

Plate 33. Building D interior facing north, note the blocked window to the right
