New Tesco Store, Streatham Hub, London Borough of Lambeth: A Historic Building Record and Conservation Assessment

Planning Application Number: 08/03477/FUL & 08/03457/CON

AOC Project No: 30968

Date: July 2011

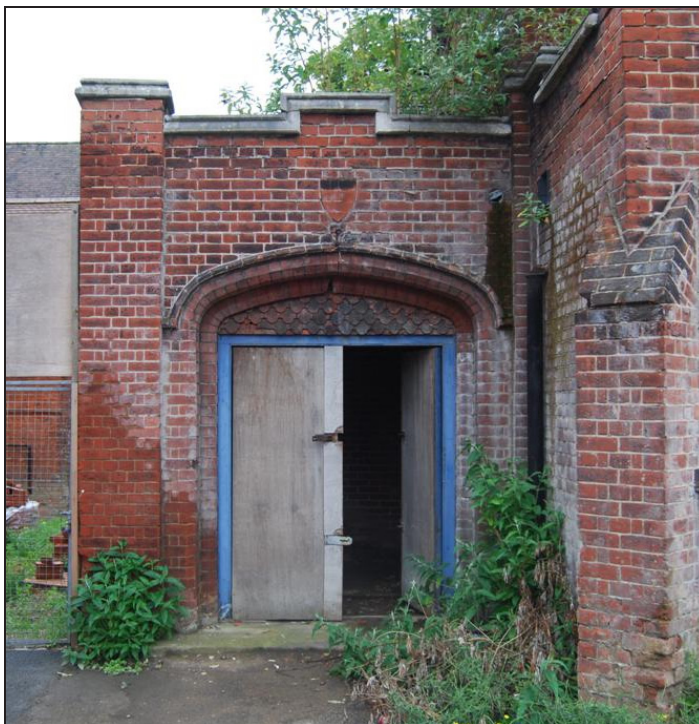
Plate 2: Southern Porch

- 8.2.7 The northern entrance (**Room 3**) is boarded up and has an unsafe roof following rafter failure. The fixtures and fittings are likely to be the same as are seen in the southern entrance (**Room 2**). Twin doors open into the lobby from the east and retain some original fixtures on the inside. The outside of the doors are boarded over for security. These doors were originally half-glazed with boards in the lower panel. The original door handle is an iron ring, mounted on a circular backplate with four protruding screw fixings. Above the door is an original gas light with a gridded globular lantern. Other fittings include a modern ‘Chubb’ lock and a bolt. The floor of the entrance lobby is terrazzo with a surrounding strip of black and white mosaic tiles. A stone window surround has a single stone

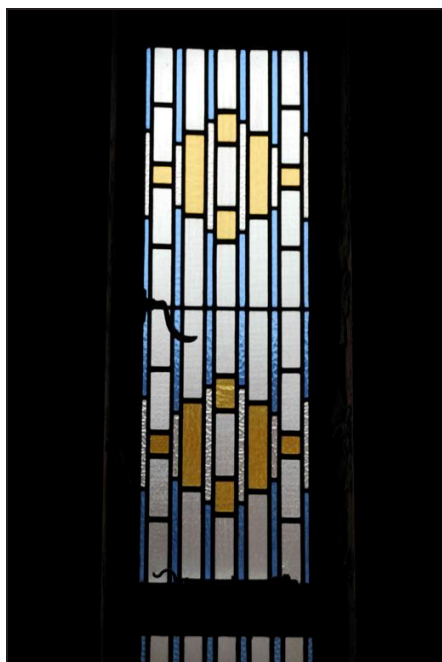
Plate 14: Stained Glass on First Floor

9.1.2 The glass panels inside the Ice Rink are in good condition but there is some corrosion and splitting on the iron window frames into which the glass panels are set. The panels on the outside are in good chemical condition although many of the panes have been smashed.

9.2.4 The glass would be easily removed under supervision of AOC Archaeology Group conservators, the glass and the window panel frames would be kept together to ensure the glass is not damaged.

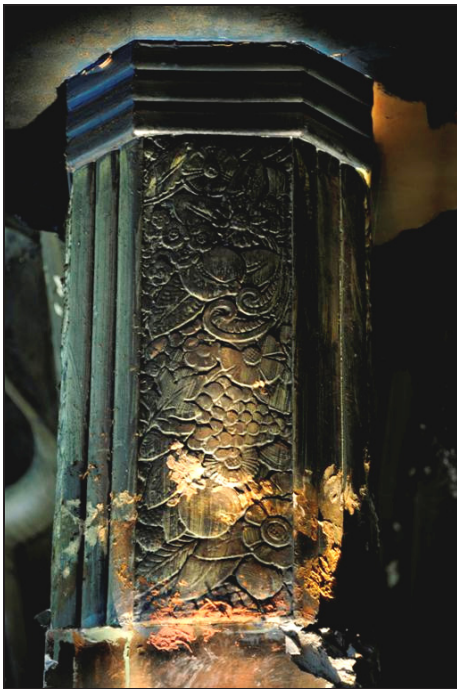
Plate 23: Foliate Capital

8.3.15 The room was in semi-stripped condition at the time of recording with a wooden floor, which had been lifted, revealing a steel and concrete floor. The ceiling is supported by four large I-beams, clad to give a square profile, but with a polygonal capital with floral, foliage and fruit panels and fluting to

the sides. These panels are generally in poor condition. Around the walls are raised strip designs with rounded ends, much of which has fallen away. The steel columns support steel beams that support a flat roof above and these are also decorated with strip designs, formed of plaster over a hessian base. The beams that span the roof form nine compartments; the central row is inset with polygonal panels with ogee curves and straight corners. Two front compartments have panels that are pierced in a regular decorative fashion. These may have held lights, but there were no surviving fittings to prove this. The walls have several decorative elements, including two pairs of pilasters over steel beams hidden within the north and south walls; these pilasters have incised fluting and an incised fluted capital. The condition of the decorative plasterwork is poor and much of it has already fallen from the ceiling. The existence of any original decorative colour scheme for the Function Room is not proven; the walls are currently painted dark green, black and mud brown paint.

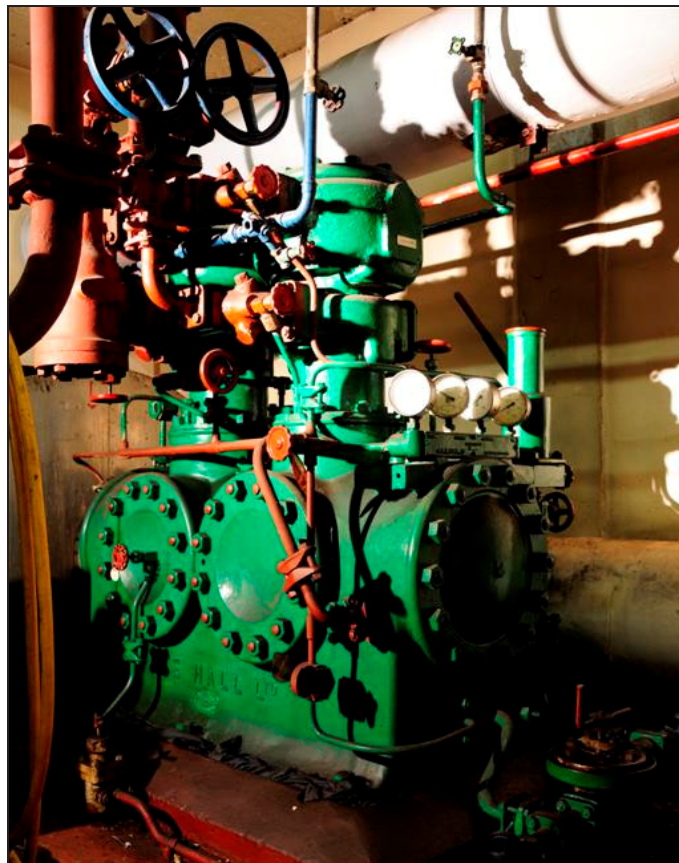
Plate 27: Compressor Manufactured by J & E Hall Ltd

9.1.4 The three 1920s ice compressors remain in working order, although ammonia ice and gas is evidently leaking from at least the northernmost L Sterne machine.

9.2.8 The JOE Hall and two L Sterne ice compressors are all very early examples of their type. It is unlikely that these machines can be recovered to be installed elsewhere in running order, but it is recommended that if practicable they should be recovered and offered as museum exhibits.

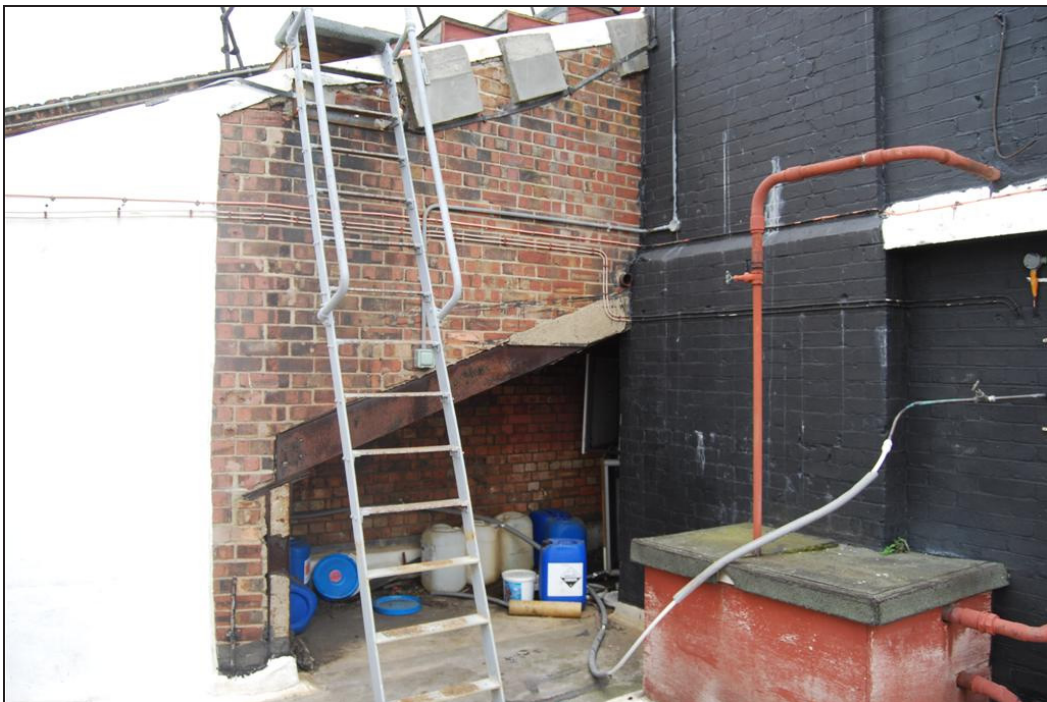
Plate 33: Roof at Rear

- 8.3.31 The roof of this part of the building is flat and is formed of reinforced concrete beams with precast concrete slabs between. There has been some materials failure, as shown by water damage to the floor. Small windows overlook the Ice Rink and there is an external door to an external flat roof, next to the chimney. A low parapet wall surrounds this roof space. There is a low ladder leading to the pitched roof over the Ice Rink. One store room on the flat roof could not be accessed (**Room 64**)

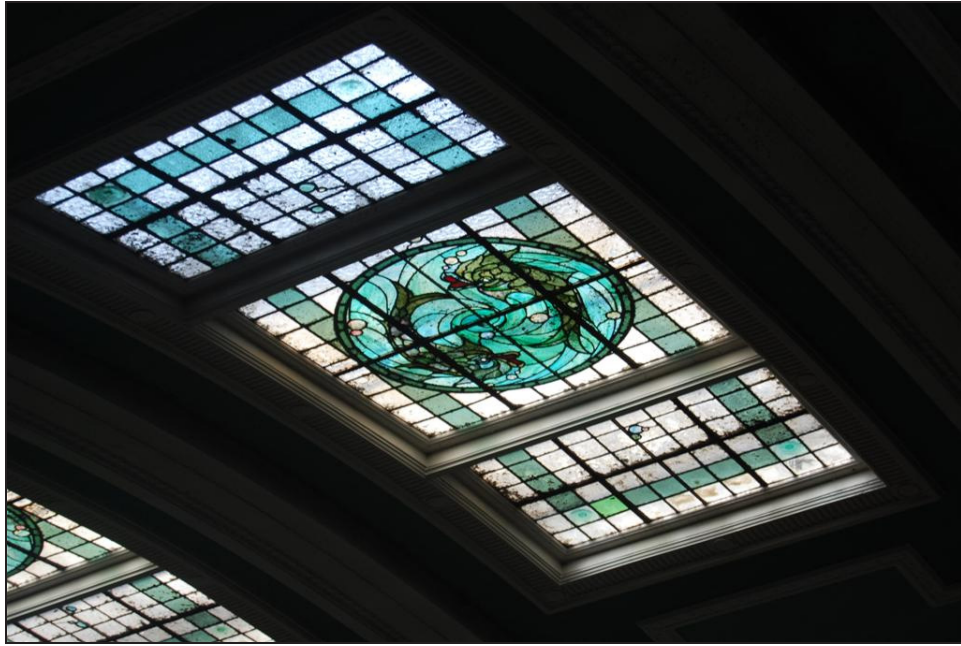
Plate 40: Decorative Glass Panel in Swimming Pool Roof

- 8.4.16 The most decorative element of the Swimming Pool Hall is the roof, which is a curved ceiling, suspended below a glazed hipped girder frame. Each truss of the main frame supports a roof truss: There are nine trusses and 10 compartments in the roof space. The two end compartments are flat beneath the rounded roof at first floor ceiling level: these have tripartite decorative end panels with geometric borders, in the same style as the main roof panels. The remaining eight roof panels are in two groups of four. The central two panels of both groups have identical green, blue and clear stained-glass windows in three sections. These each have a central panel of two head-to-tail fish with a fluvial background. The rest of the panel has rectangular panes in lead cames. There is an outer pale blue border to the windows. Decorative bubbles are present in the rest of the glass. These central units are flanked by panels with relief moulded geometric designs. There a total of four of these coloured glass panels and they are in varying condition. The glass to the west is in the worst condition as the cames are beginning to distort from the outer frame. There is also some damage to the roof above with water staining and general grime apparent on the outside faces of the glass, suggesting leaks in the roof above.

9.1.1 The third panel from the front of the swimming pool is beginning to fail, natural daylight and the ceiling above is visible through a crack which is forming between the glass and the support. Water was noted dripping through the panels, which will damage the lead comes and weaken the structural integrity of the panels.

9.2.2 A scaffold would have to be erected to remove the panels, the best way to achieve this is with the assistance of the appointed demolition company. The panels would need to be wrapped and hoisted down individually. Work would have to be supervised by AOC Archaeology Group conservators to ensure the panels were not damaged during removal.
