Nine Stone Rig, East Lothian Archaeological Re-instatement: Data Structure Report

Nine Stone Rig, East Lothian, Archaeological Evaluation and Re- instatement: Data Structure Report

AOC Project No: **22125**

Date of Report: **13th July 2012**

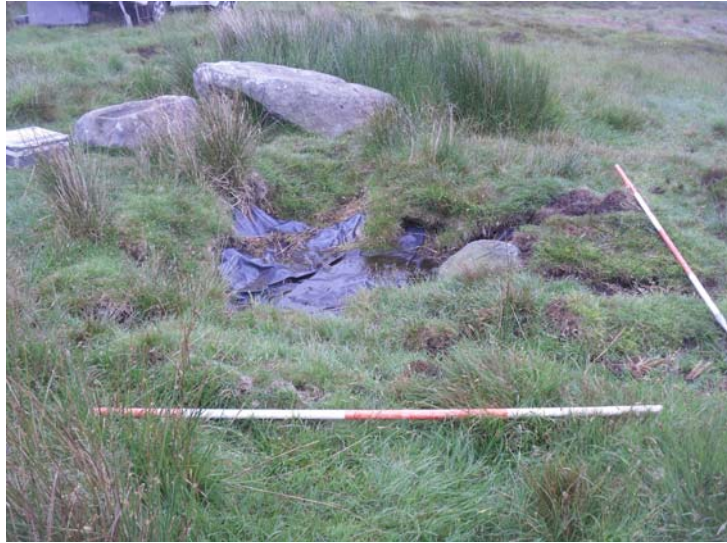
central area of the SM, enclosed by the stone circle, which was damaged by the removal of an area of heather and turf by a JCB (Plate 1) for a bird feeder.

Plate 1: Pre-excavation shot of Scheduled Monument

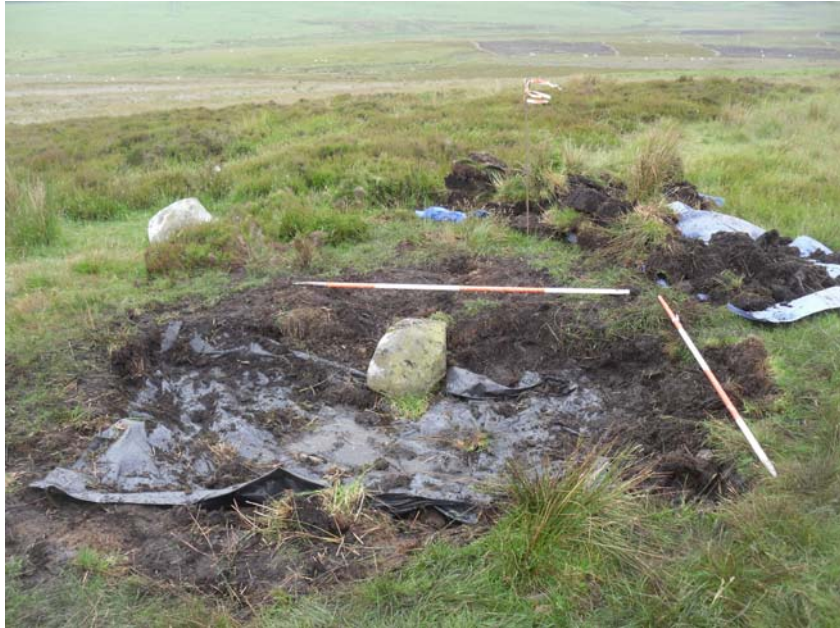
- 4.2.4 On excavation, the main area of disturbance was found to be relatively limited, the works having avoided the majority of the surrounding stone circle. Instead, the damage comprised the machine excavation of an approximately 2.8 m by 2.5 m area. The disturbance consisted of the removal of up to 0.25 m of turf and peat. A plastic sheet was then laid across the area, to catch rain water and act as a bird feeder. The displaced material was placed around the edge of the bird feeder, raising the edge slightly, resulting in a bowl feature.

Plate 2: Post-excavation shot following removal of peat and turf

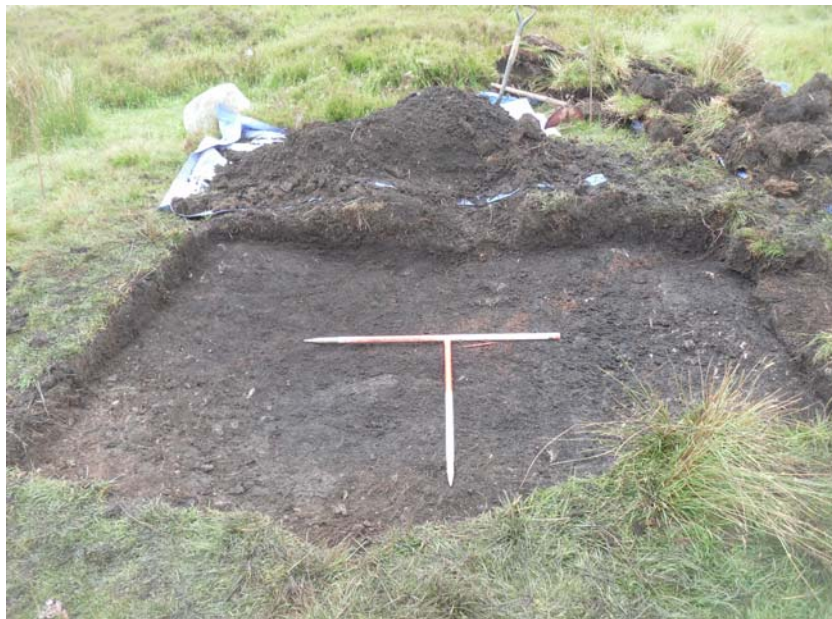
Plate 3: Post-excavation shot following removal of plastic sheeting

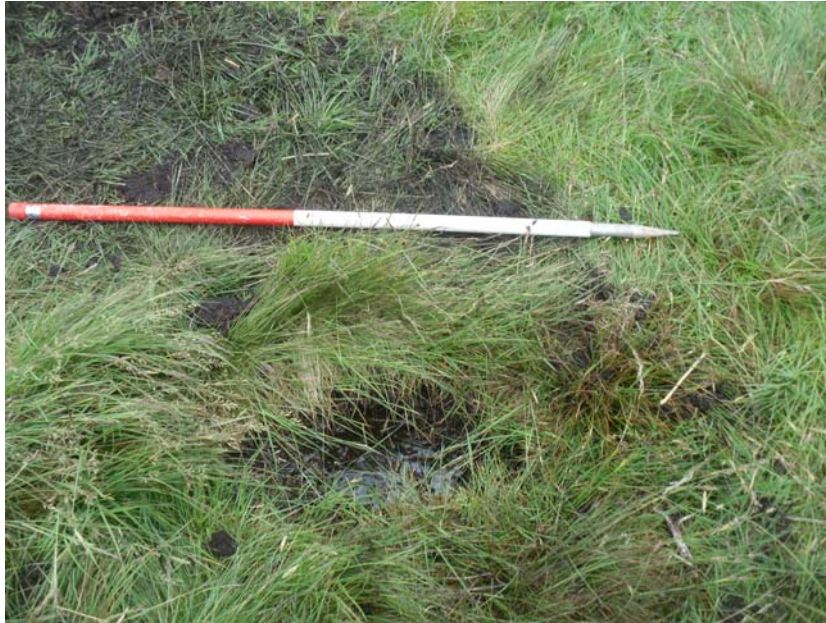
- 4.2.5 A second point of disturbance comprised the displacement of one of the standing stones. The stone was identified within the centre of the SM, partially overlying the waterproof sheet of the bird feeder. The whole area, including the main area of disturbance was inspected in an attempt to identify the location of the stone socket. No socket was identified within the central area, suggesting that the stone had been disturbed from outwith this area and subsequently placed within the bird feeder area to help weigh down the sheeting. A small hole, measuring 0.60 m by 0.40 m in size, was identified to the south-west of the main disturbance, but within the stone circle (Figure 2 and Plate 4). The size and location of the feature suggest it is a likely origin for the stone. The probable socket hole was recorded and planned and the stone placed within it (Plate 5).

Plate 4: Detail of probable socket hole identified to the south-west of main disturbance

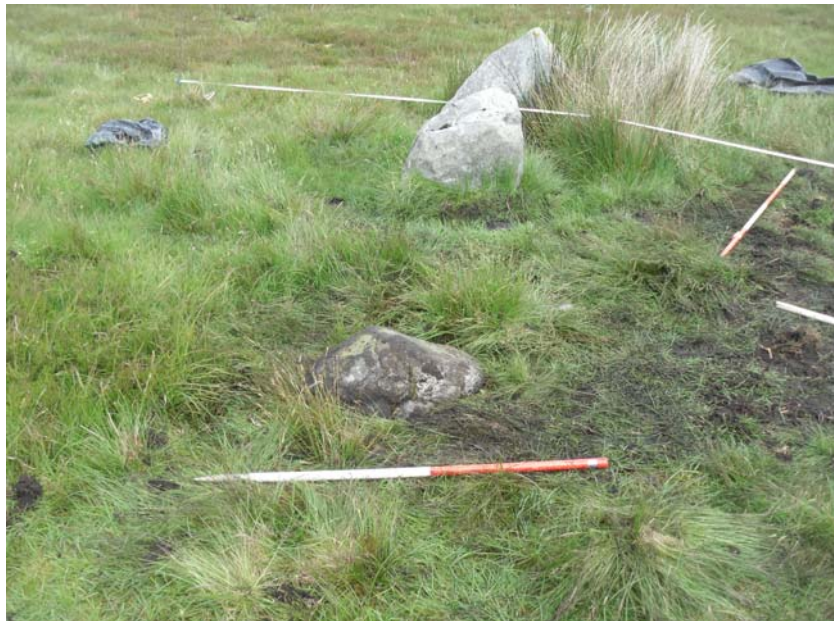
Plate 5: Detail of displaced stone re-instated in former position

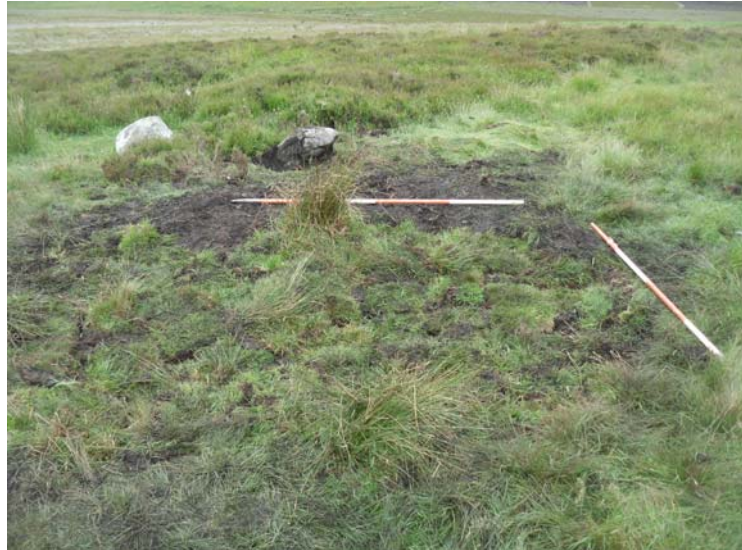
Plate 6: Detail of SM following backfilling

- 4.2.6 Following excavation and recording the area was lined with geotextile sheeting and the hand excavated material replaced. Additional loose material that had been disturbed during the unauthorised groundworks was gathered and used to help reinstate the site to its former height (Plate 6).

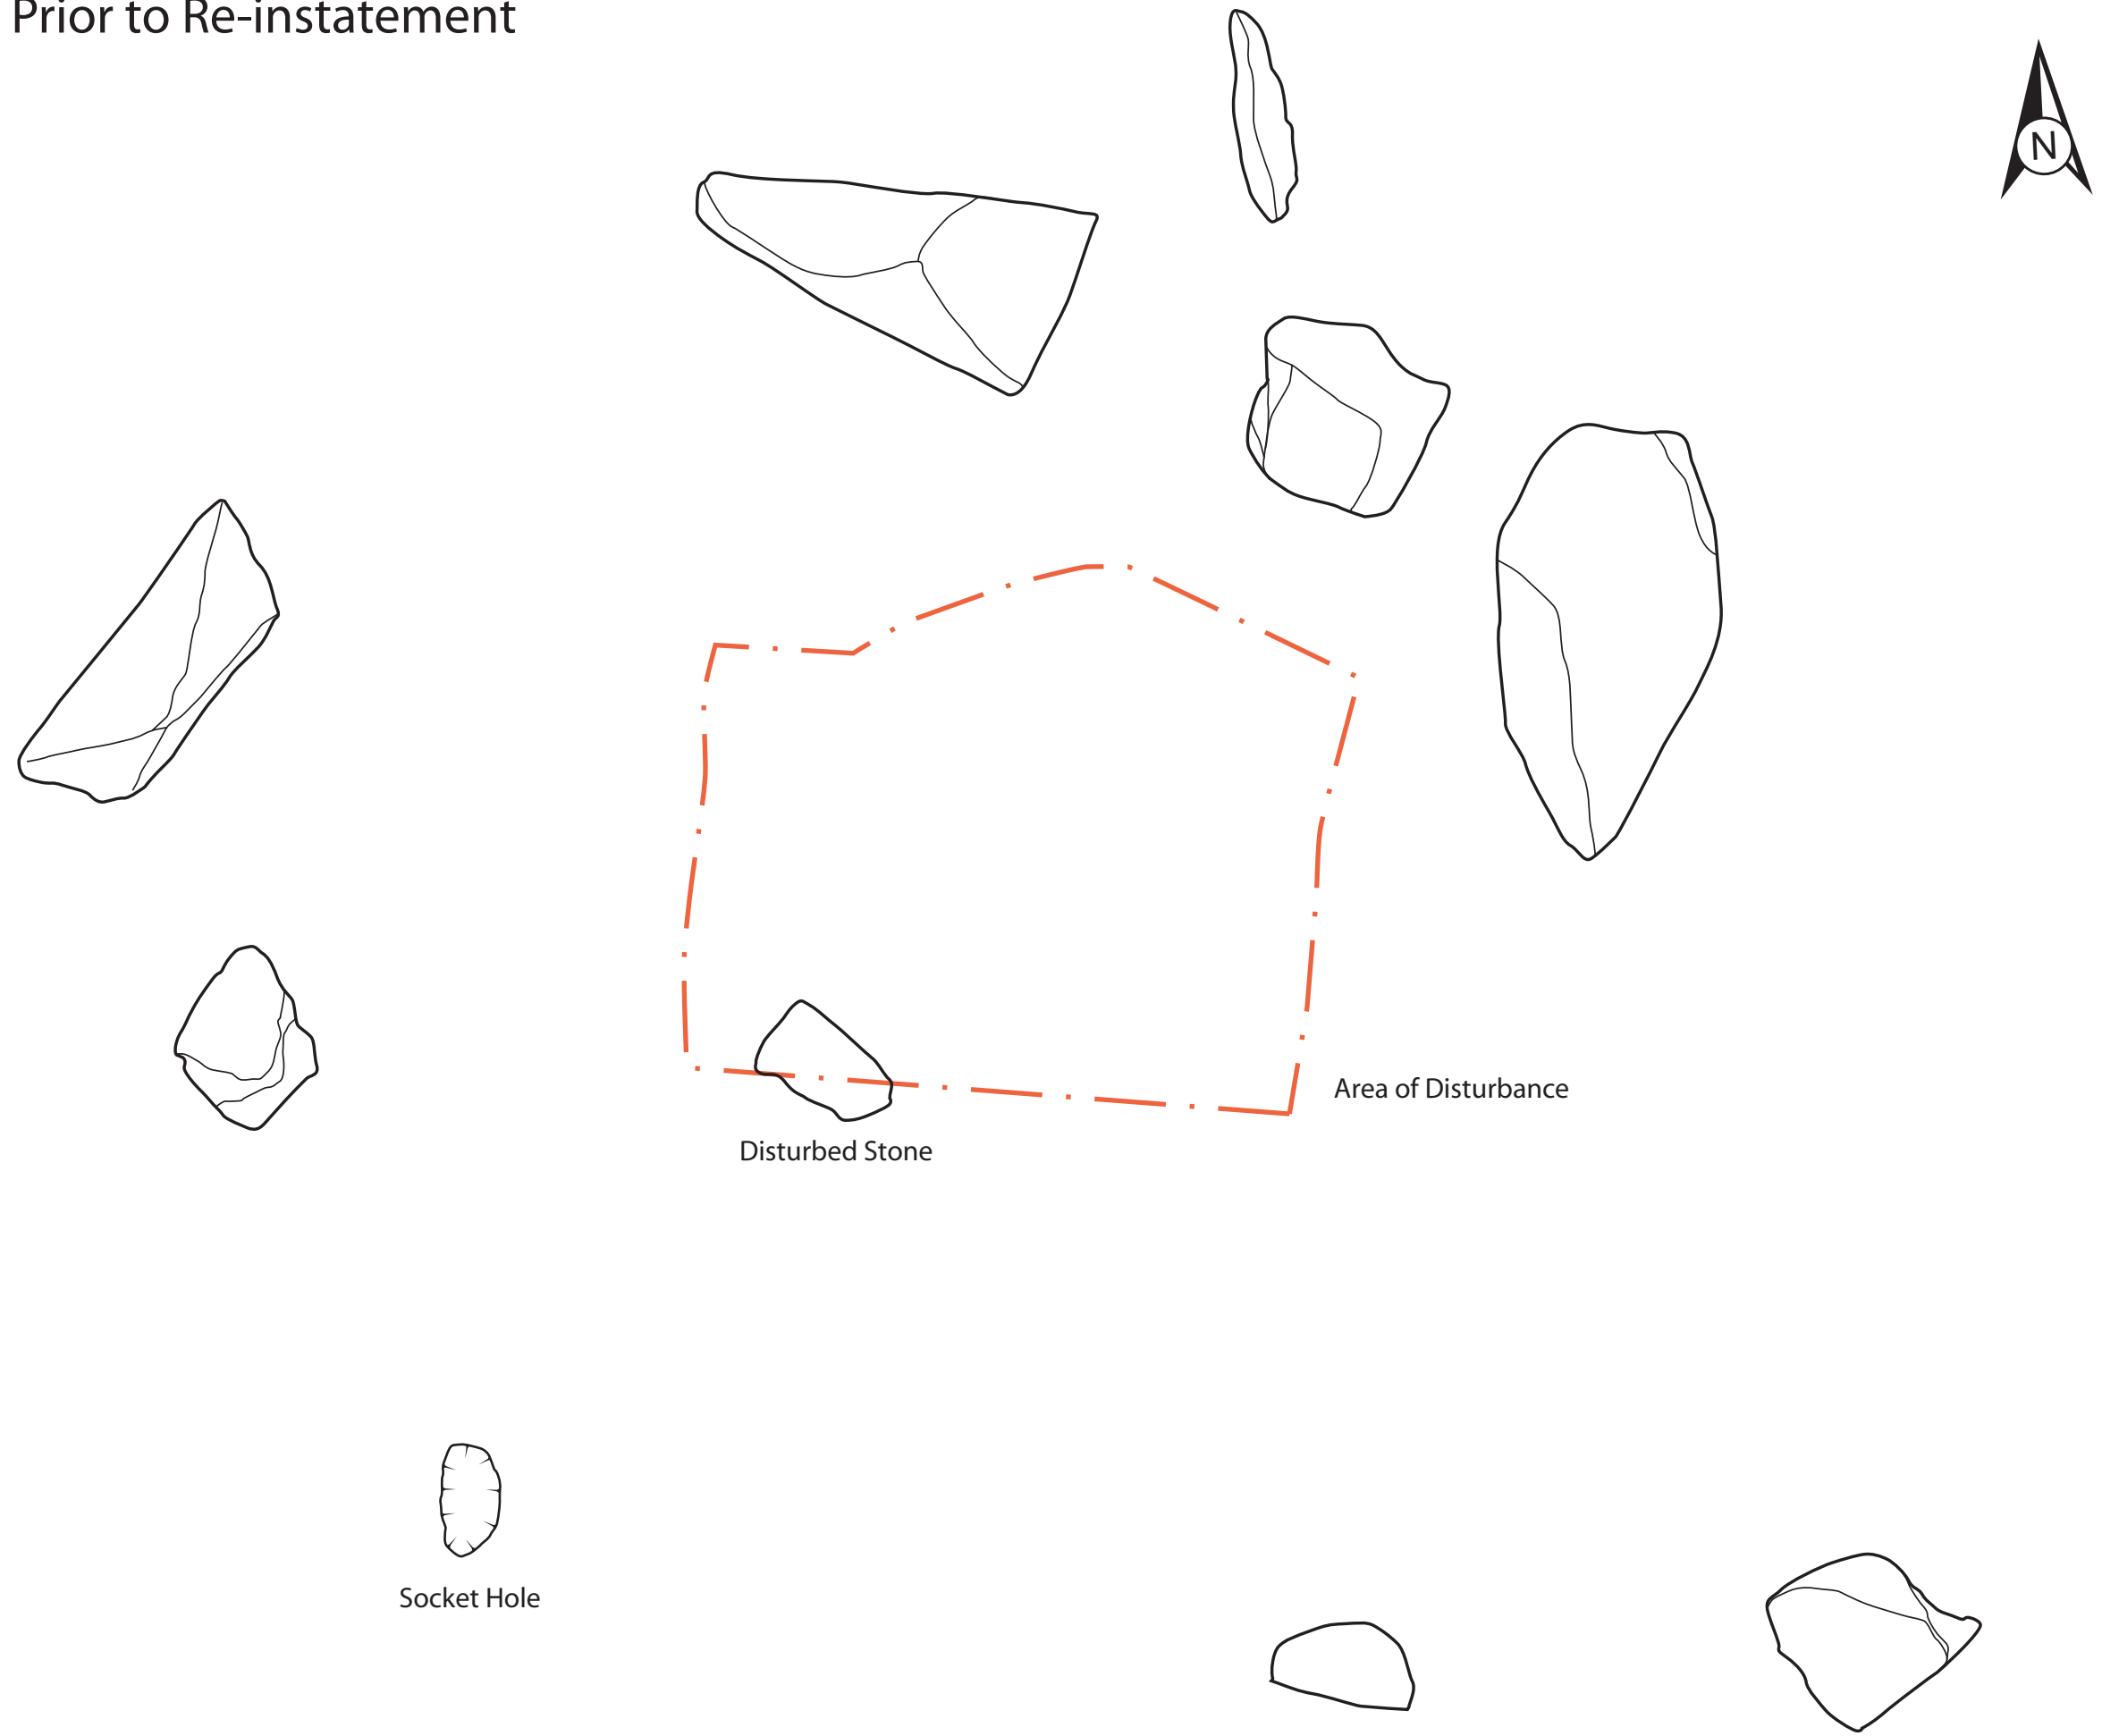
Figure 2: Nine Stone Rig Prior to Re-instatement

- 4.2.1 The evaluation comprised the excavation of a single trench located across the position of the unauthorised groundworks within the SM. Although originally it was intended to excavate a 3.5 m by 3.5 m area, on initial excavation it was realised that the area of disturbance was much smaller. The outer edges of the area comprised simply turf redeposited on turf. For this reason the actual trench measured 2.8 m by 2.5 m.
- 4.2.2 On excavation, it was established that the area of disturbance measured slightly less than first thought, as much of the damage simply comprised redeposited turfs, overlying the existing turf. The actual area of excavation was therefore aligned north to south across the central area of the SM, and measured 2.8 m east to west by 2.5 m north to south (Figures 2 and 3). It was located within the
