Hollybrook Limited : Bath House Lofts

Planning Consent : Condition 5

21st September 2012

Archive Document

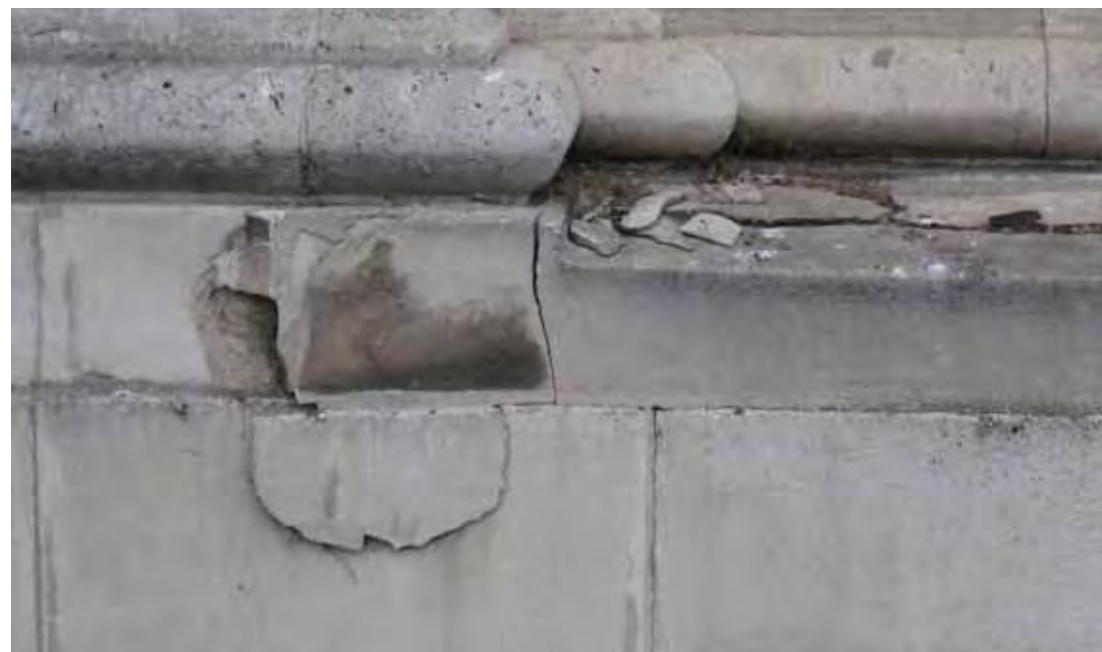
As noted previously the precast concrete facing material to the principal elevations is deteriorating in a number of locations. Within the larger blocks, the steel rebar hoops integral to their design and construction is sitting too close to the front face. As it gets damp the resultant corrosion expands the rebar and forces off the concrete facing.

We suspect that the steel hoops were 'thrown' into the moulds, and that their weight in the larger stones dropped them too near what was to become the external surface. If we were forming such a cast today, spacers and a two part mould would overcome such problems.

The stabilising process to repair the elements is outlined in the LBC Condition 3 document, which is being submitted with this one.
