Bothwell Parish Church, Bothwell, South Lanarkshire

Interim Archaeological Watching Brief Report

AOC 22563

28th February 2014

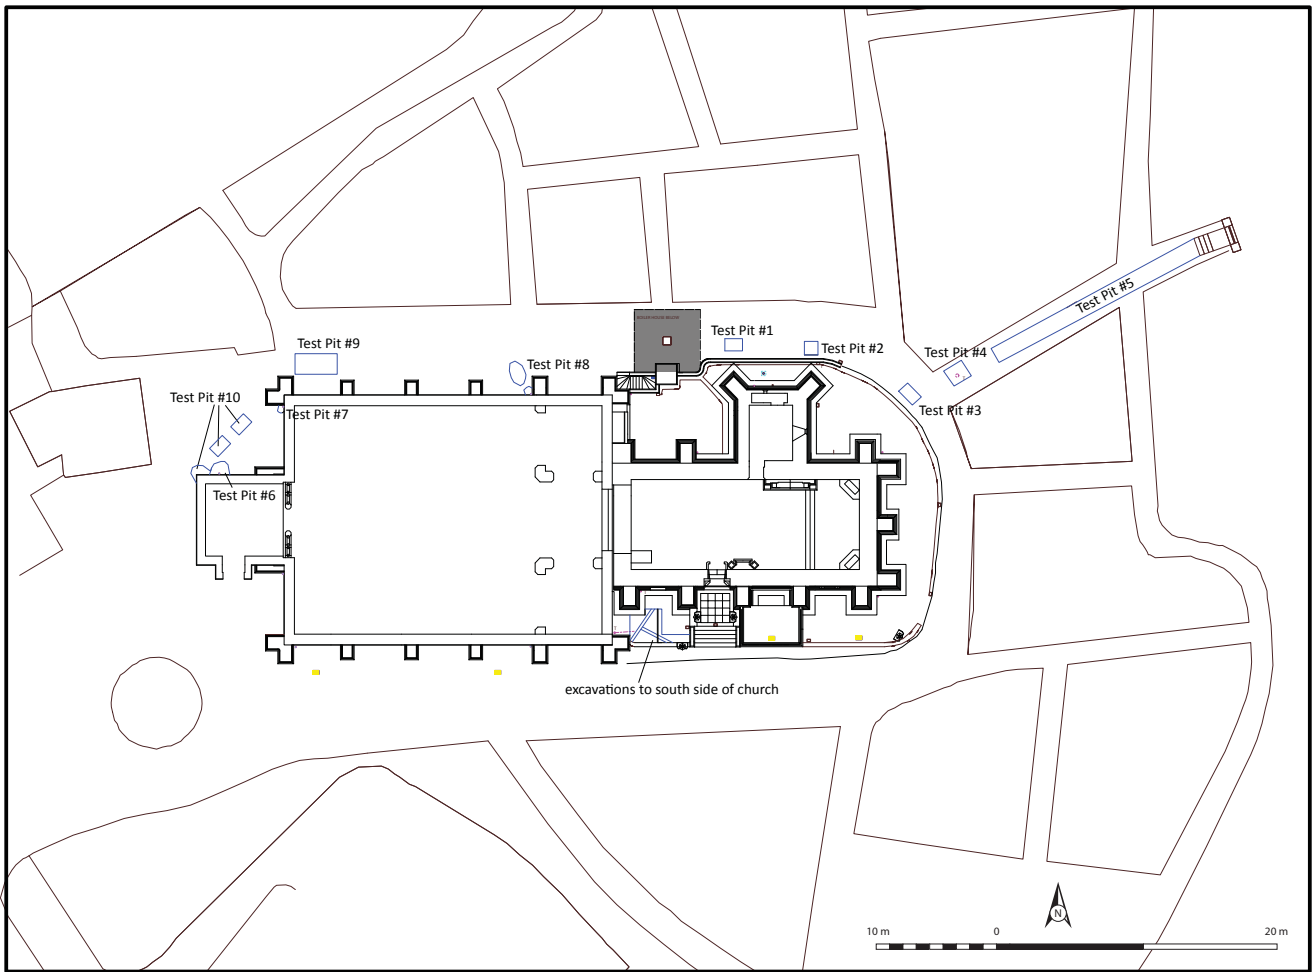
Figure 4: Site plan showing areas subject to watching brief

- 4.3 The next phase of investigations took place to the main pathway to the north of the church (Figure 4). Several small investigation holes were part machine and part hand-dug to identify where the main existing service lay. In both test pits (and indeed, in this area of the church pathway) there was a general sequence of stratification which included a small gravel path (009) set on levelling layers of made ground (010), (011) & (012). This overlay the characteristic compacted yellow re-deposited clay layer (013) within which were found disarticulated human remains (Plate 5). Test Pit #1 identified a small dump of bones (Find #4) together with a small shard of white glazed pottery (Find #5). In Test Pit #2, more disarticulated bone was found in deposit (013) including a skull and neck bones (Find #6) (Plates 6 & 7). To the east side of Test Pit #2 at a depth of 1.50m, a small area containing bone associated with degraded wood was located, within context (014). It was located within a very mixed dark fill beneath the compacted clay (013), so possible pre-dated this deposit. On closer inspection, this was highly likely to form part of a much larger confined burial (018) and the decision was swiftly made to leave the remains *in situ* and abandon the test pit (Plate 8). Test Pit #3 was located to the north-east end of the church, and contained similar stratigraphy, but no human remains were found. The existing service pipe was located to the north corner.

- 4.8 Together with the test pits mentioned above, there was a series of boreholes investigated around the perimeter of the church (for position, see Figure 4). Only Borehole #3 brought up some disarticulated human remains (Find #7) and, again, these looked to have been re-deposited with the natural compacted clay layer (013) and found at a depth of approximately 2m. In Borehole #4, approximately 0.40m in depth, the machinery hit a deep layer of large mixed red and whitish brick layer which rested over the natural clay.

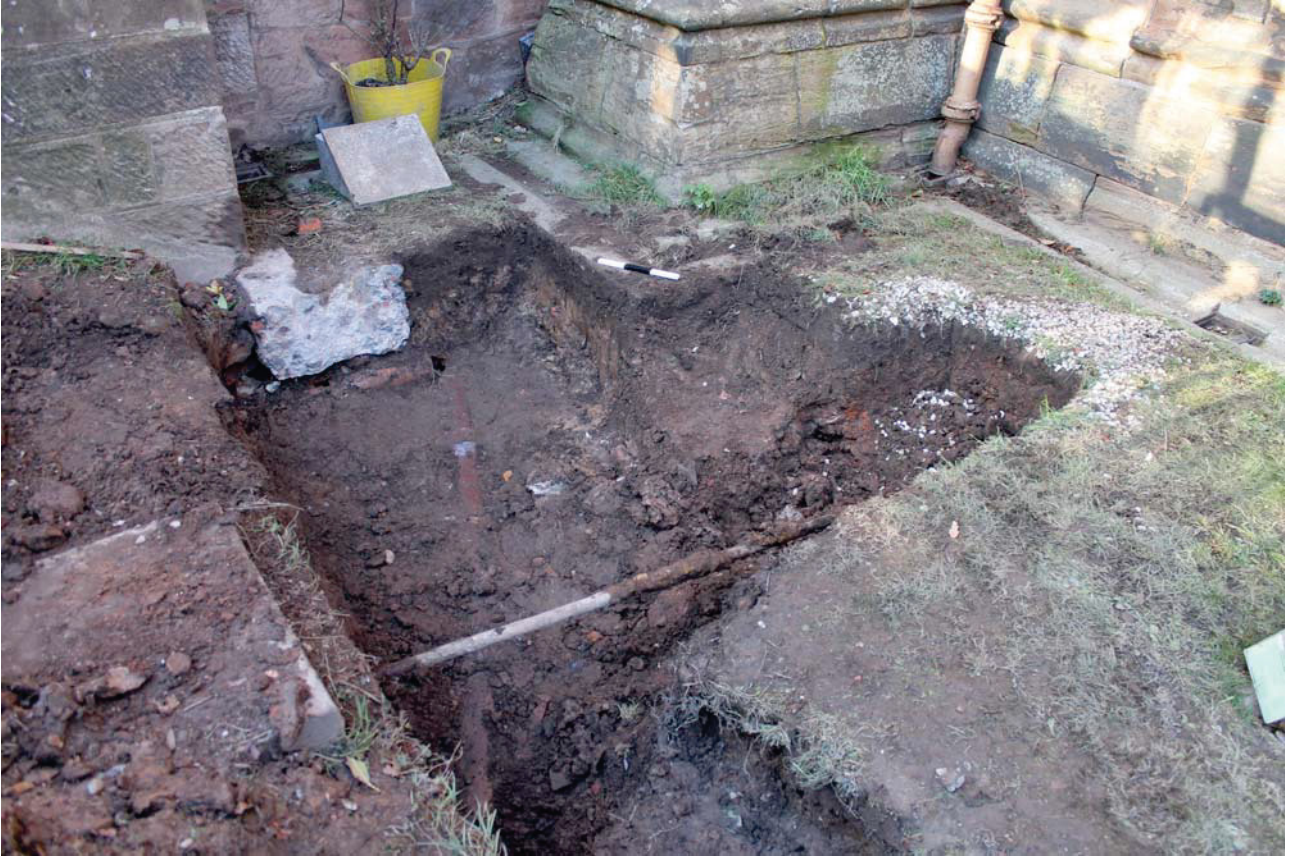
Plate 1: General view of excavations to the south side of the church from the south-west

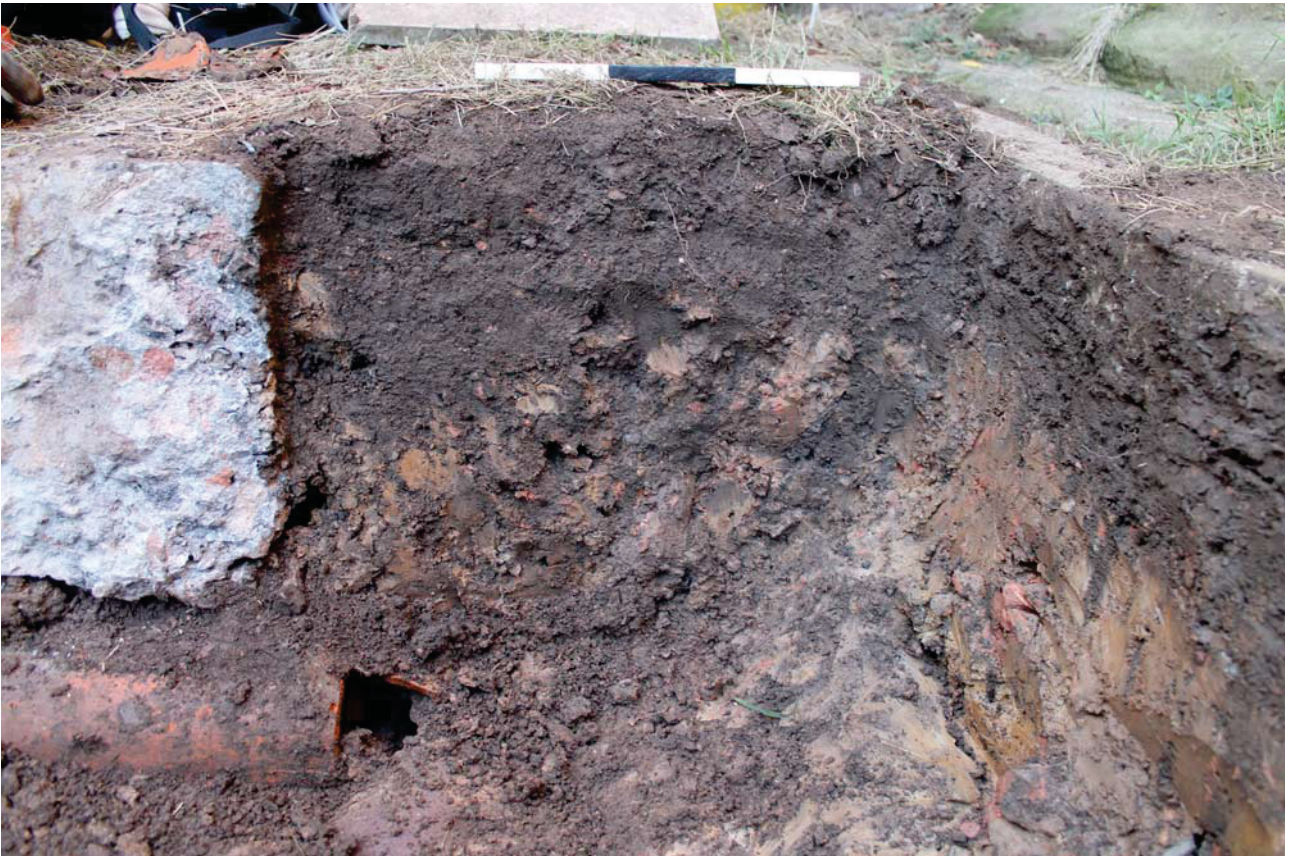
Plate 2: Detail of the east-facing section to excavations to the south side of the church, from the east

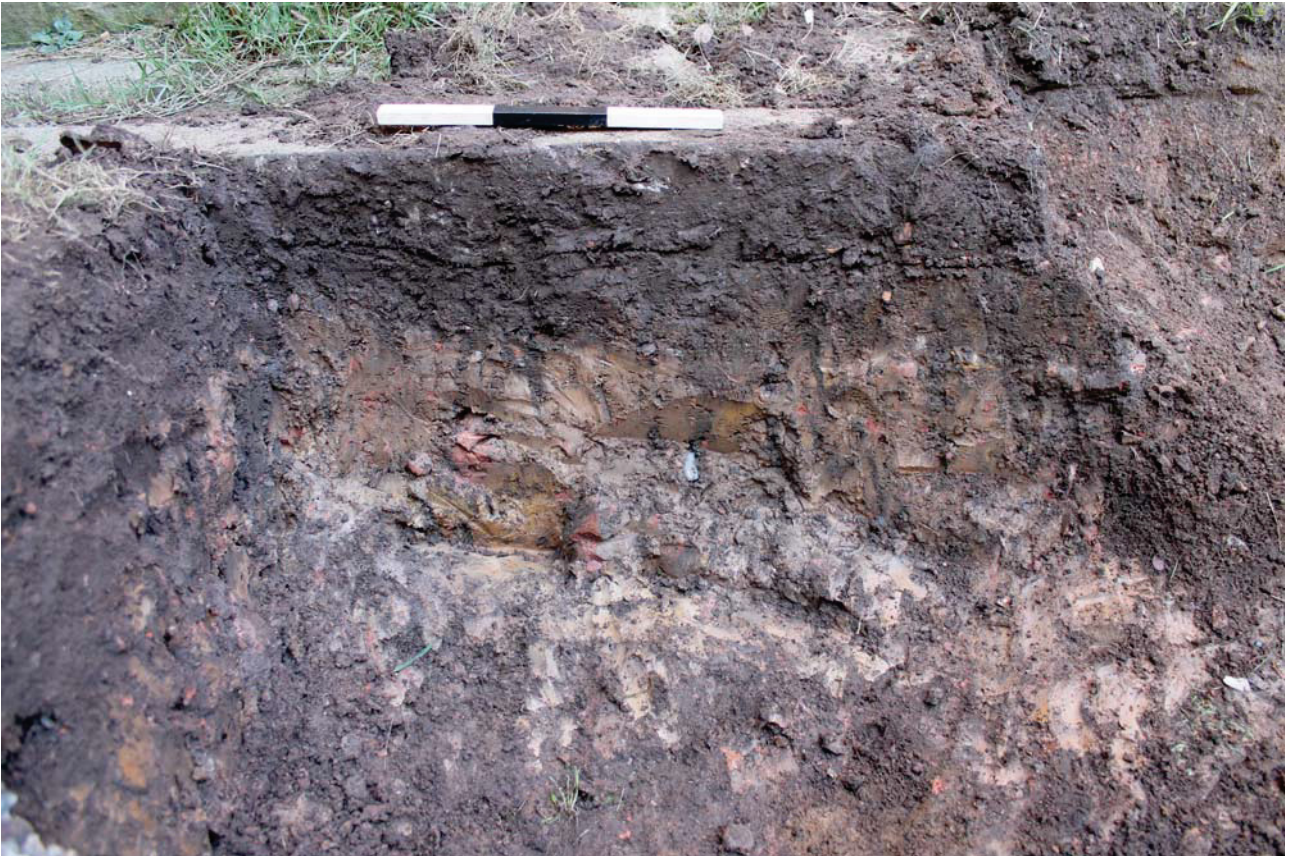
Plate 3: Detail of the south-facing section to excavations to the south side of the church, from the south

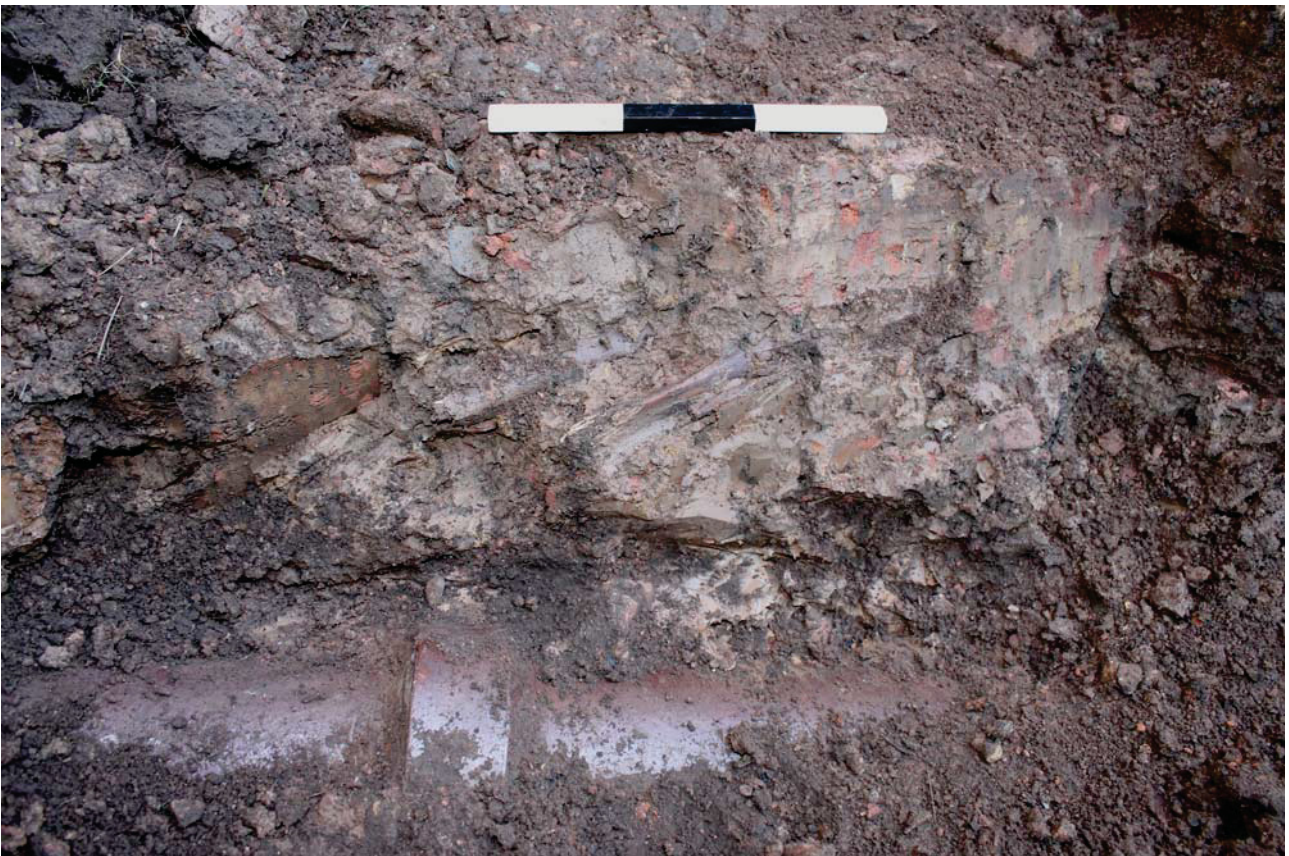
- 4.2 The initial excavations were undertaken to the south side of the church, which exposed two large (ca. 19th century) drainage pipes set within a compacted yellow clay layer (004). This lay beneath a dark brown subsoil (003) and over which was set the main concrete drain [002] which lay to the exterior wall of the church (Figure 4; Plates 1 - 3). Two urns were removed from these areas prior to excavation, which have been retained by Borthwick Parish Church for safekeeping. Within clay layer (004), there were also two discrete areas containing disarticulated human bone (Finds #1 & #2), which was likely disturbed at the time of the insertion of the drainage pipes there (Plate 4). An iron nail was also found in the assemblage (Find #3).

Plate 4: Detail of disarticulated human remains (Find #1) set into re-deposited clay layer (004) over ceramic pipe [007]

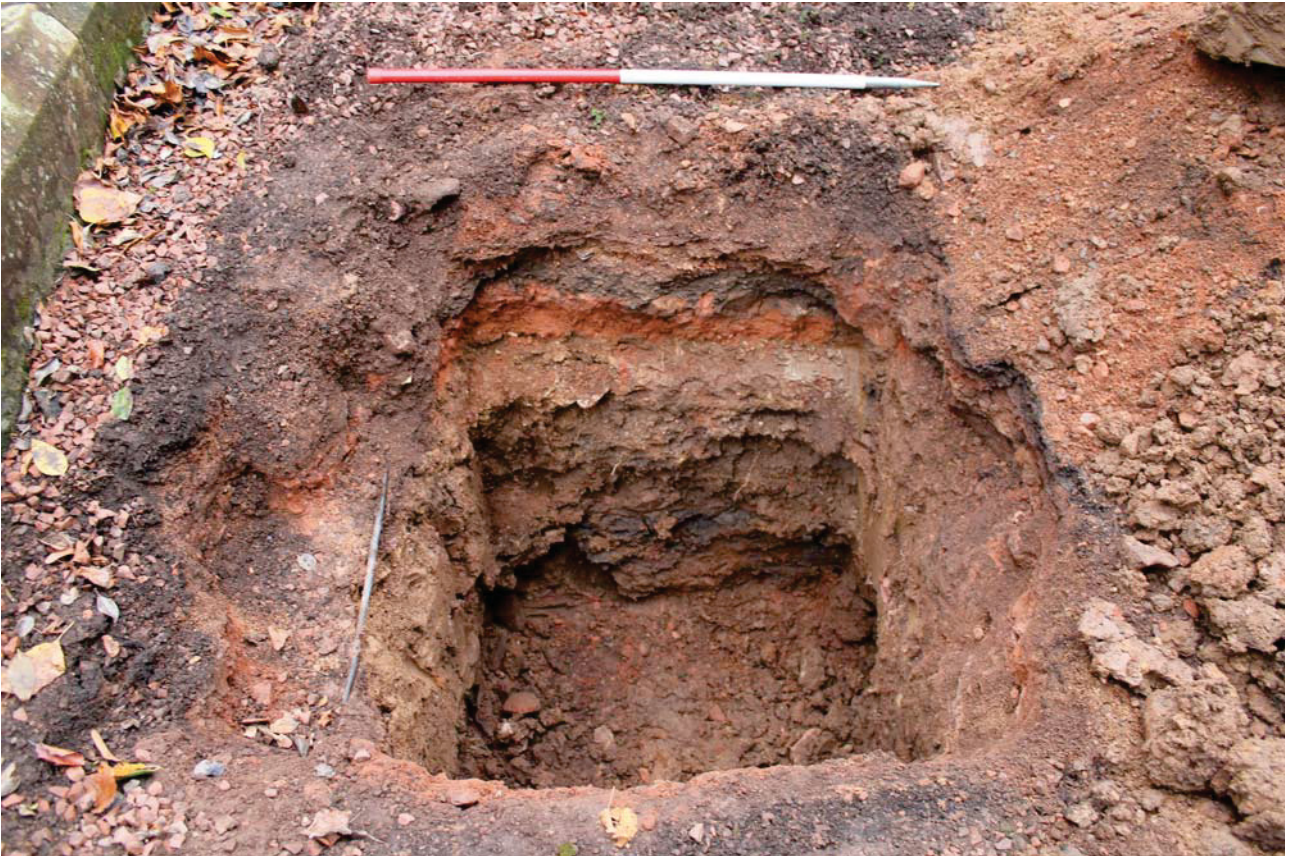
Plate 5: Detail of east-facing section of Test Pit #1, showing levelling deposits (010) - (012) to path (009) and re-deposited clay layer (013) beneath, from the east

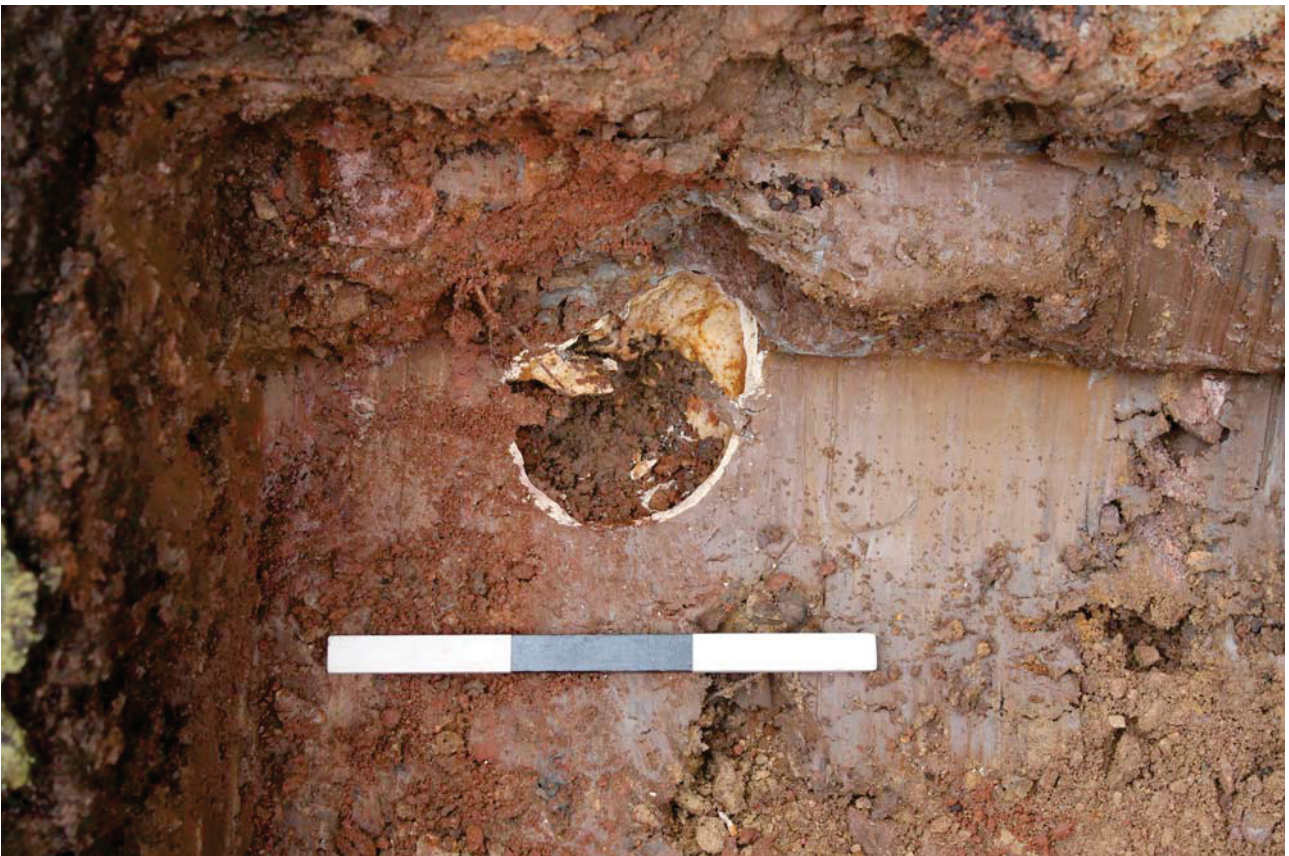
Plate 6: Detail of skull fragments located within compact re-deposited natural clay layer (013) from the east

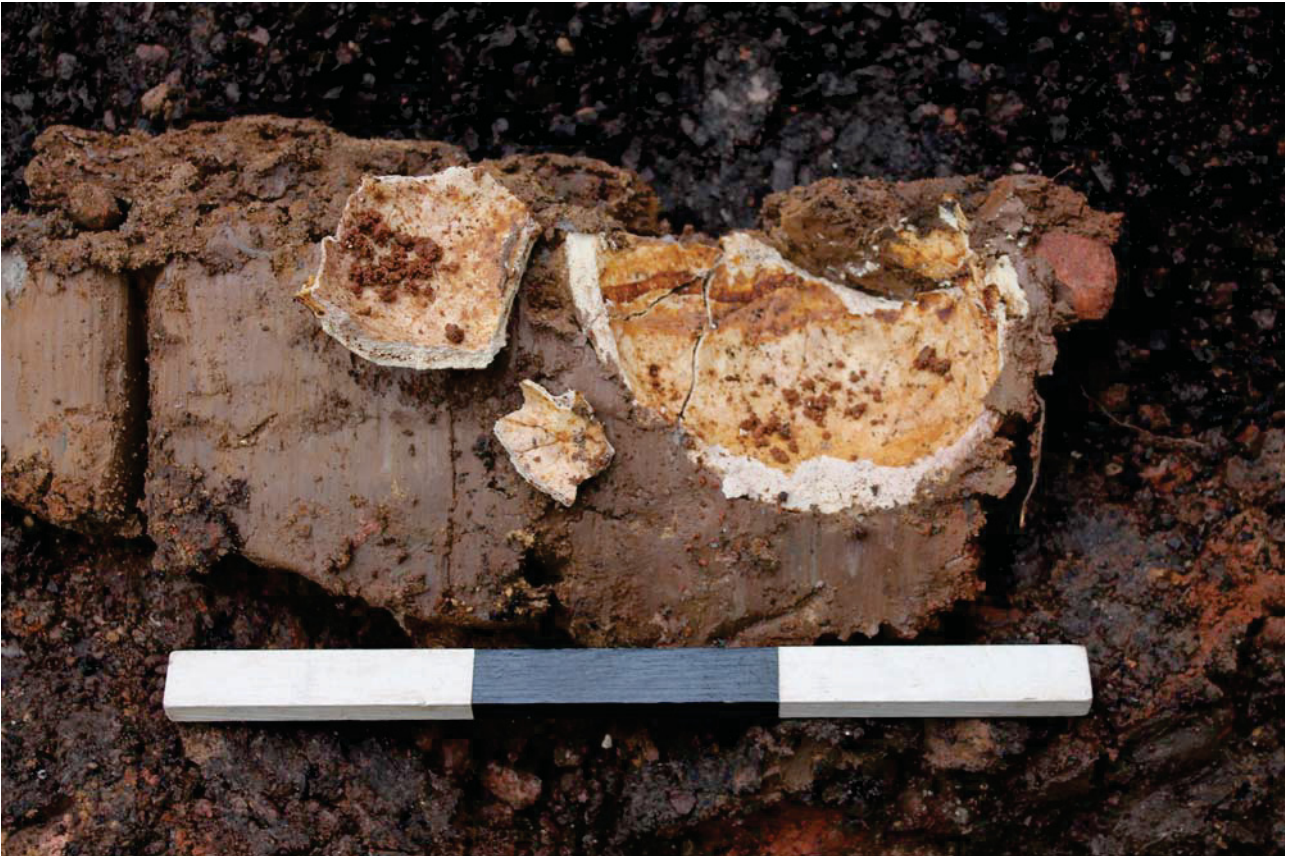
Plate 7: Detail of skull fragments removed from Test Pit #2, within compact re-deposited natural clay layer (013)

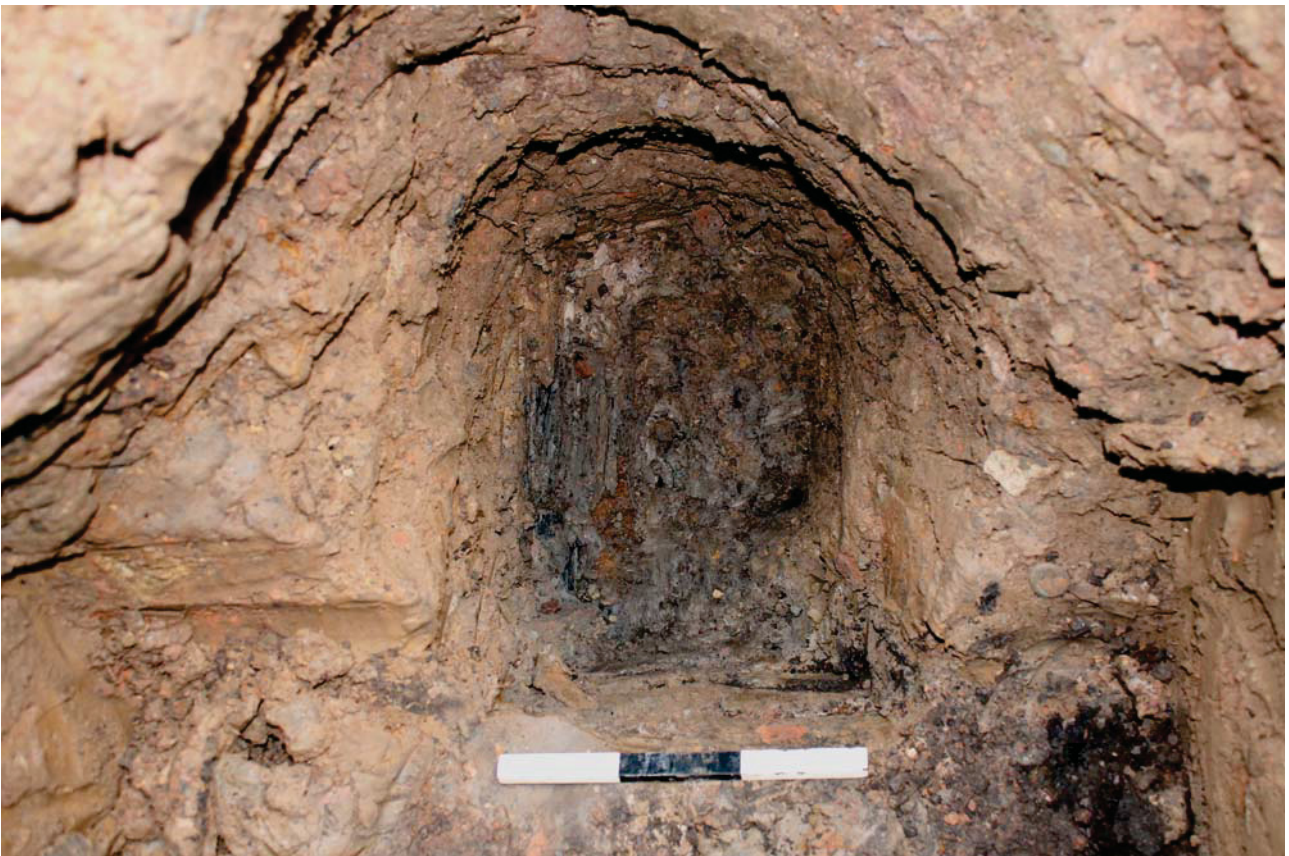
Plate 8: Detail of coffined burial (018) set within (014) within Test Pit #2

(018)	Coffined Burial	Coffined burial (only a very small part of which was exposed) to the base of Test Pit #2 about 1.50m below top of the pathway and beneath deposit (014), which became much more disturbed above the burial, which was left <i>in situ</i> .

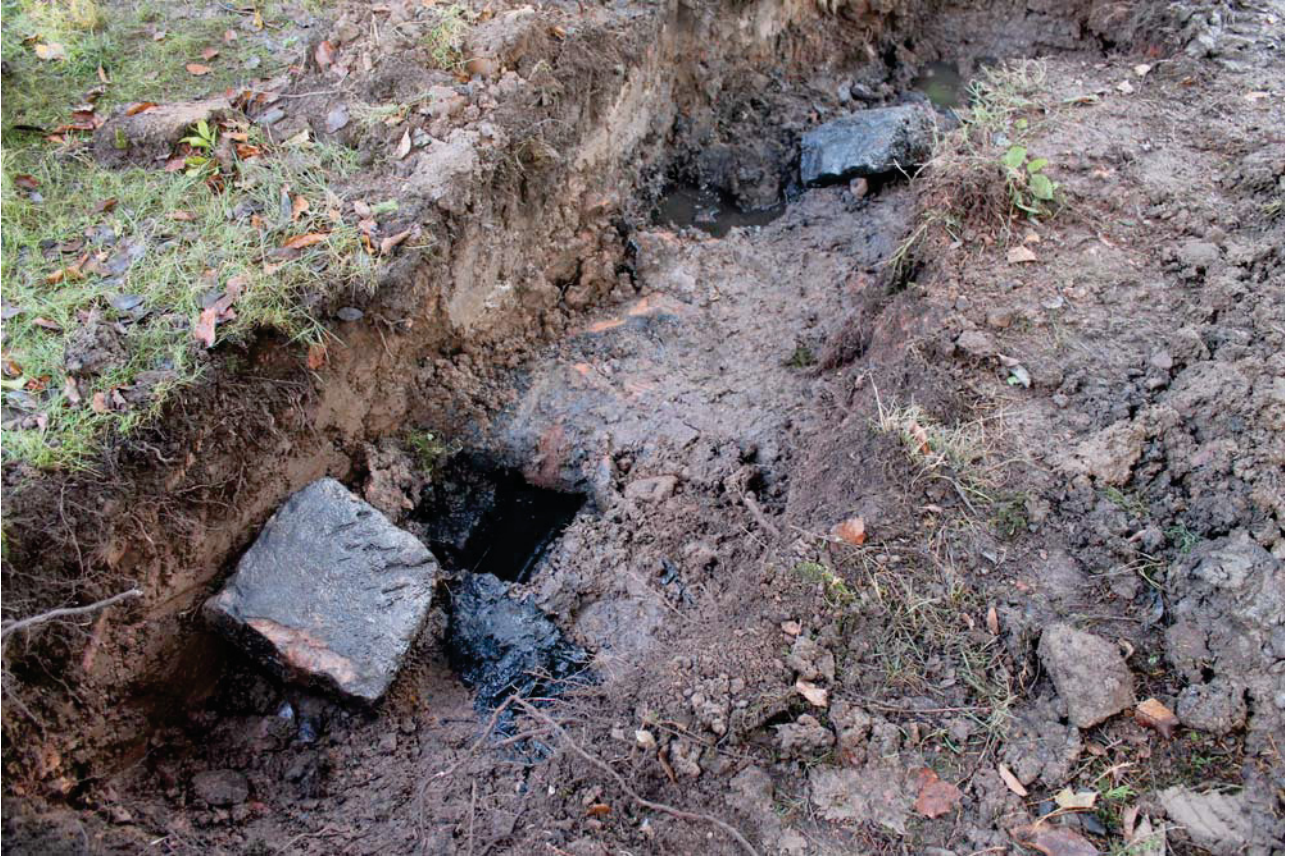
- 5.2 The stone culvert [026] at the east side of the churchyard is interesting and possibly identifies a very early drainage system for the church, possibly pre-dating the 19th century, although an exact date for this feature is uncertain. Drainage of some kind would have always been needed in this area of the church and, as such, could date from the earlier 14th century church, although, of course, drainage systems were always being updated over the centuries.

Plate 9: Detail of exposed stone culvert [026] from the west

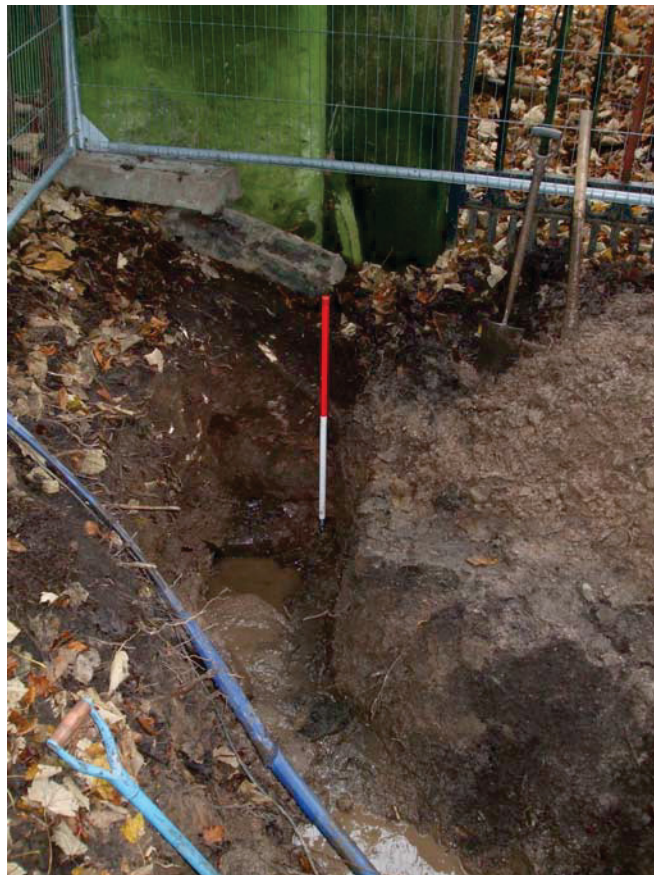
Plate 10: Detail of exposed stone culvert [026] adjacent to the east gate from the west

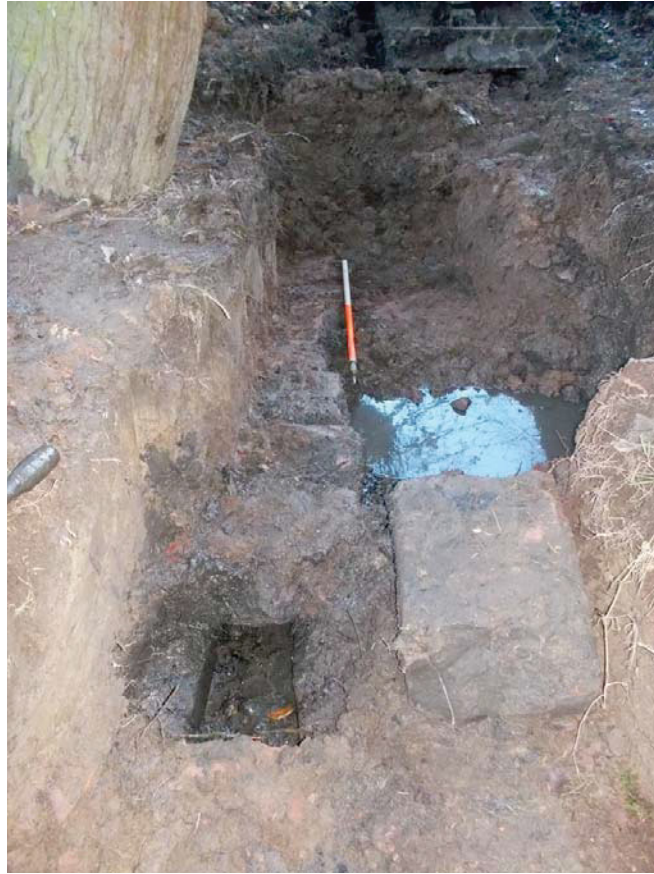
- 4.4 Test Pit #4 was excavated to the east side of the church at the beginning of the main path running eastwards to the outer boundary wall within the churchyard. This uncovered a series of ceramic pipes leader to the main sewer and went down approximately 2.10m. Test Pit #5 was then an extension in this area of the churchyard, which led from Test Pit #4 down to eastern side gate of the churchyard. A stone-lined drain was located here, which is possibly quite an early feature (Plates 9 & 10). The drain [026] was formed of large red sandstone blocks running roughly parallel and to the north of the main pathway. No human remains were found in the Test Pits #4 or 5. Test Pit #9 was excavated further to the west side of this to expose the culvert again (Plate 11).

Plate 11: Detail of exposed stone culvert [026] from the west
