Wester Housebyres, Melrose, Scottish Borders

Historic Building Recording Report

AOC 22447 31st March 2014

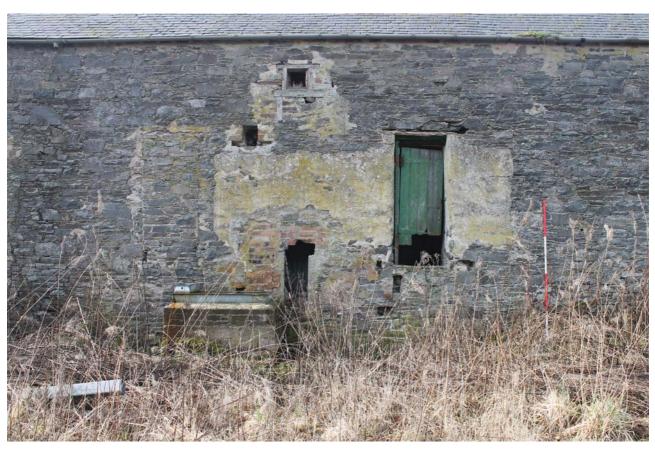
Plate 5: Barn A1, east elevation, detail of the openings and features associated with the water wheel from the east

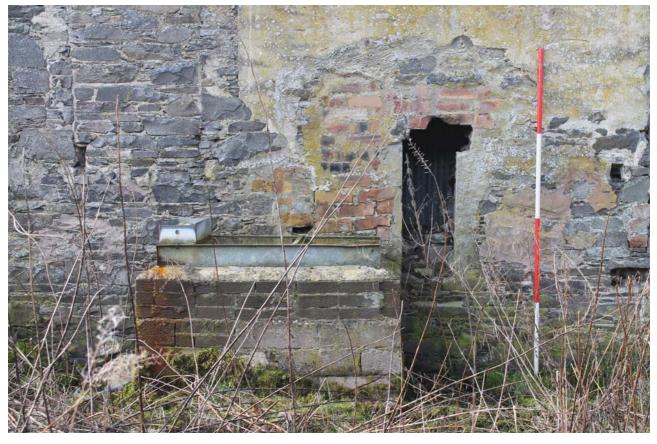
Plate 6: Barn A1, east elevation, detail of the small opening relating to the water wheel from the east

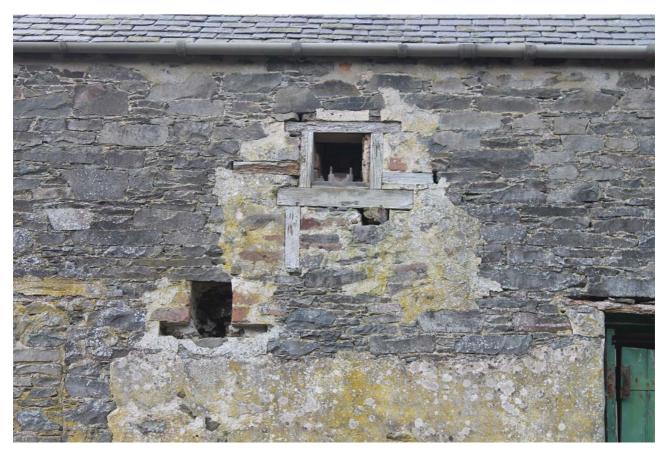
Plate 7: Barn A1, east elevation, detail of the bearing box associated with the water wheel and threshing machinery from the east

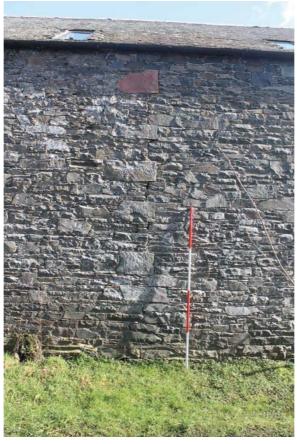
- 5.2.3 The west elevation to the south side has an opening to the north end with dressed sandstone surround (Plate 12). To the centre of this elevation, there is also what appears at first glance to be a phase line, marked by a line of larger stones with a straight junction between them. It is unsure, however, whether this forms an area of rebuild or not; there is not an equal feature on the opposing east elevation (Plates 13 & 14).

Plate 14: Barn A1, west elevation to the south side, detail of stonework from the west (?a phase line)

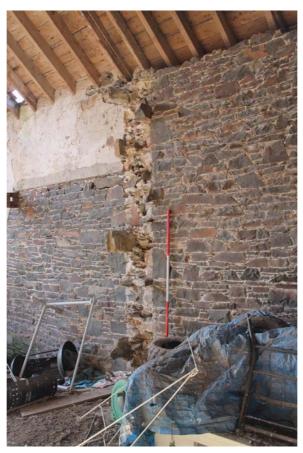
- 5.2.4 Internally, the barn consists of two spaces, A1/1 and A1/2 (Figure 7; Plates 15 & 16). However, originally the barn would have consisted of at least three separate spaces, as a broken-away stone partition wall exists to the south end in A1/1 (Plate 17). This barn is relatively open and has two openings to the east and west at the north end, the latter a much larger tractor entrance, probably enlarged from an original. The north dividing wall between A1/1 and A1/2 is a thick stone wall with two large openings (see Plate 16). The easternmost is set over a concrete step with a brick surround and is probably a later inserted entrance with a reinforced steel lintel above. The western entrance is a doorway through to the original threshing barn, although the surround has been re-done at a later date in brick and breeze-block.

Plate 17: Barn A1/1, detail of broken-away stone partition wall to the west wall, from the north-east

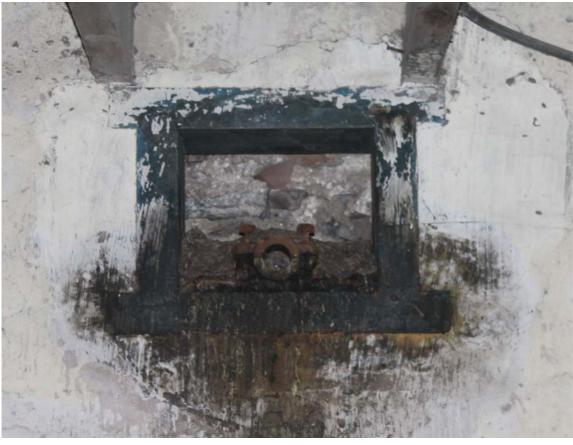
Plate 20: Barn A1/2, detail of bearing block on the east wall from the west

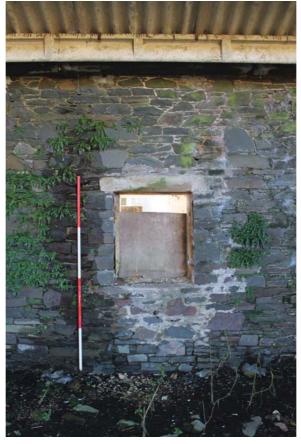
- 5.3.2 The north elevation is now located within a modern concrete barn, although was originally open to a cow yard. It is a very poorly preserved wall, no doubt exacerbated by the insertion of the concrete barn with heavy water and vegetation damage (Plates 30 & 31). It has three doorways into the pens with a window to the westernmost pen (Plate 32).

Plate 32: Barn A2, north elevation, detail of window in westernmost bay, from the north

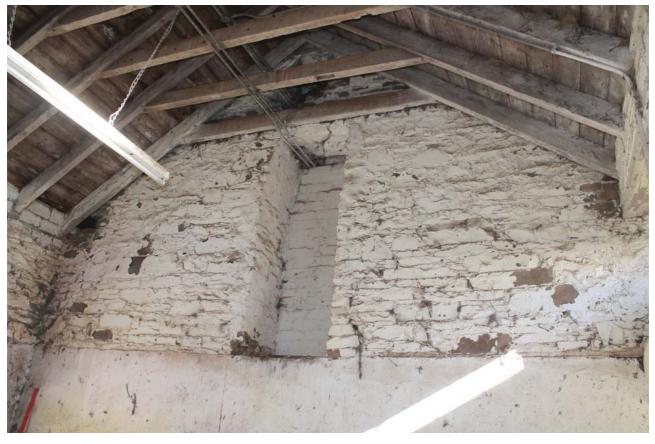
- 5.3.3 Internally, the space is divided into four separate pens separated by stone partition walls (Figure 7). Pen A2/1 to the east has doorways to both the north and south walls with a separate angled timber stall to the centre (Plate 33). Pen A2/2 also has doors to both ends, although the southernmost is the wider opening (2.53m). It has a timber stall and trough to the west side. Pen A2/3 is a much smaller pen, again with openings to both sides (Plate 34). The westernmost pen, A2/4, has a doorway to the south and a window to the north side (Plate 35). A concrete floor has been added to the west side and there is a small niche to the east wall. Set high in the dividing gable wall, also to the east side, is a bricked-up loading doorway for the loading and unloading of hay for the hay loft (Plate 36).

Plate 36: Barn A2/4, detail of the loading door from the hay loft in the east gable wall, from the south-west
