Buccleuch Church, 33 Chapel Street, Edinburgh Historic Building Recording Report

AOC 22983

27th March 2015

Historical Building Recording Report

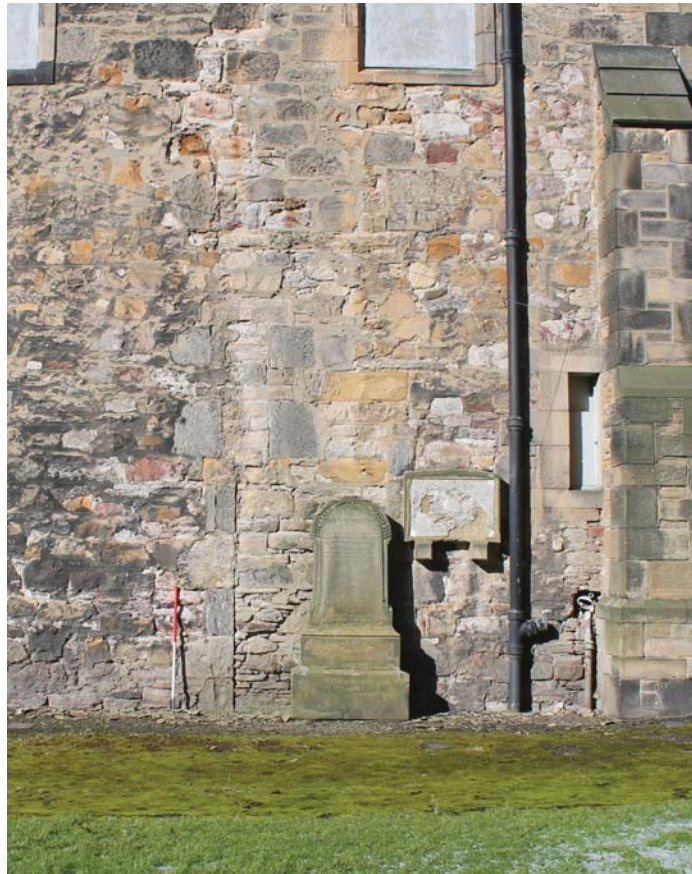
Plate 11: South-east elevation, detail of the blocked opening to the north-east side from the south-east

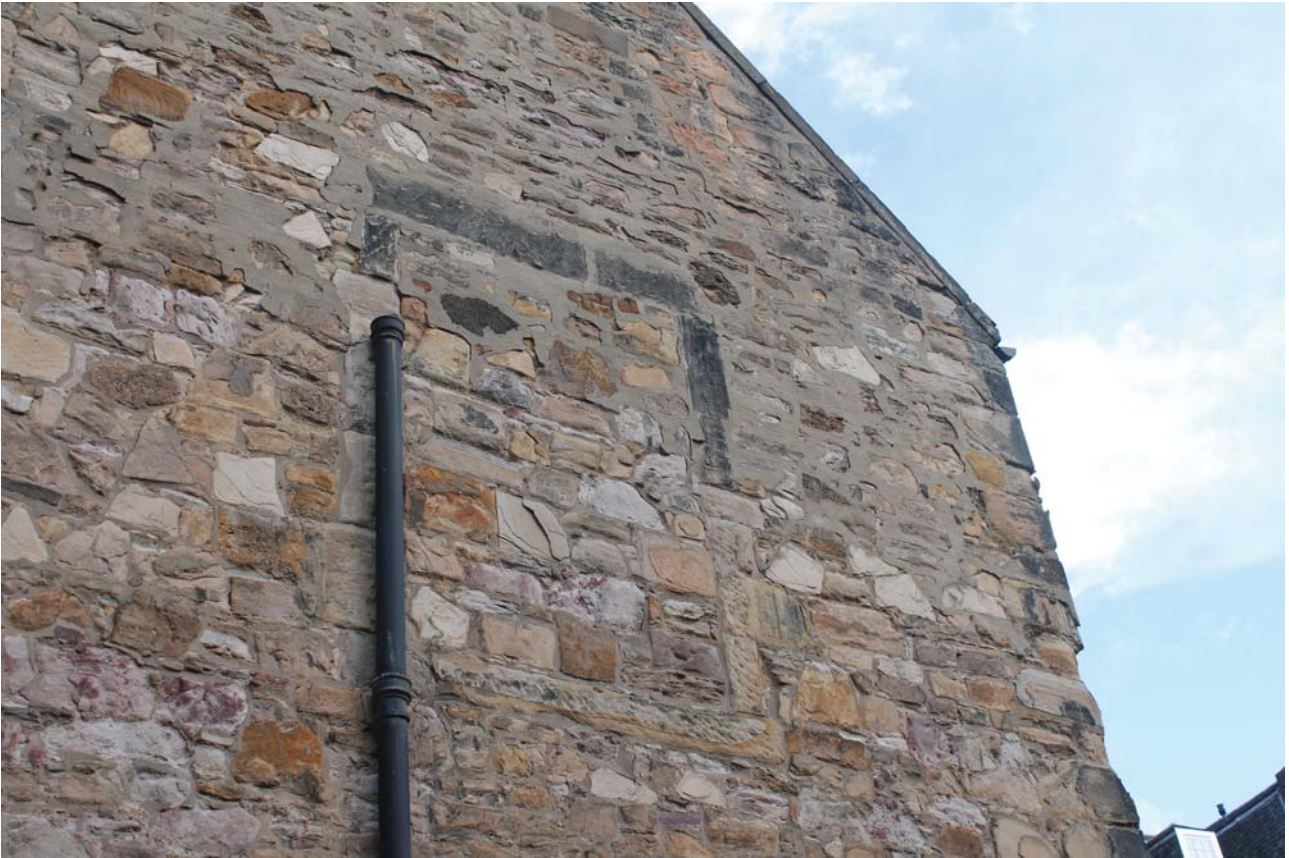
Plate 21: South-west elevation, detail of the blocked first floor window on the south-east side, from the west

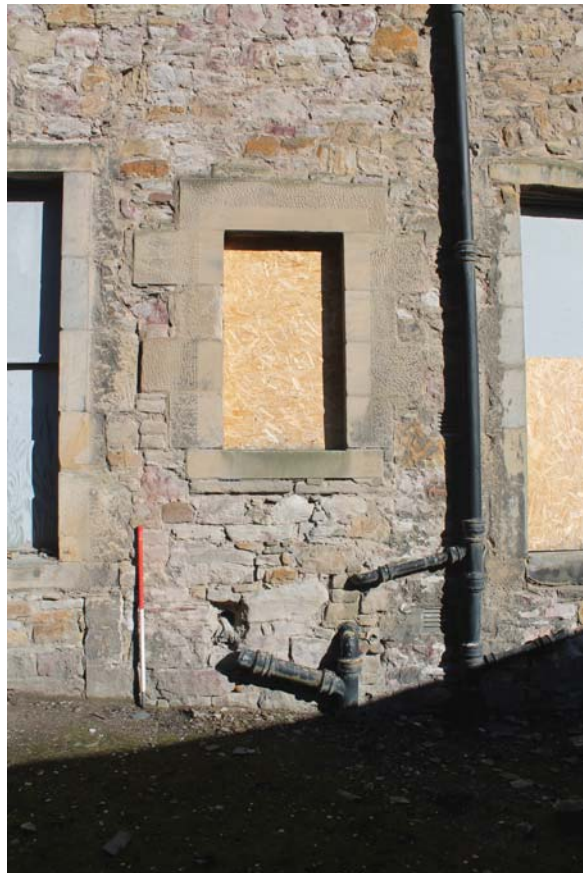
Plate 24: South-west elevation, detail of the main doorway to the north-west side showing the original blocked entrance from the west

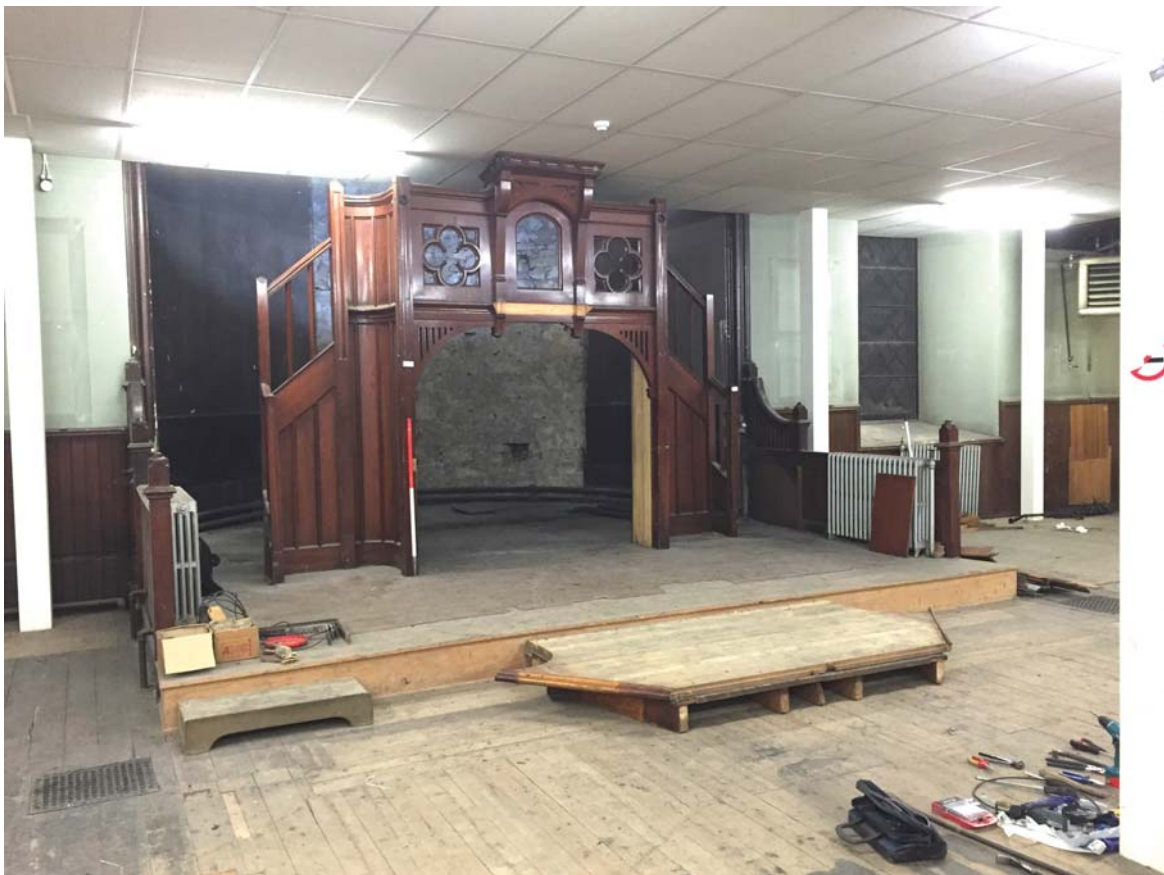
With the exception of the main front screen the organ was removed at both floor levels (Plate 86). Behind it, the stone rubble waling was partially exposed to the rear of the rounded bay and a clear levelling course was visible) (Plates 87 & 88). However, to the east and west sides, some decorative plasterwork was located, a red on brown with some gold (Plates 89 & 90). There was a small cavity below the organ area forming a small knee high crawl space, latterly used as a store, although originally there may have been the mechanisms for the operation of a larger or original organ. No other new features were identified after the organ removal to the first floor, the decorative plasterwork and exposed stone rubble walling ceasing to the level below the first floor windows (Plates 91 & 92).

Plate 86: Room 0/1, general view of screen in the north-west wall after the removal of the organ, from the south

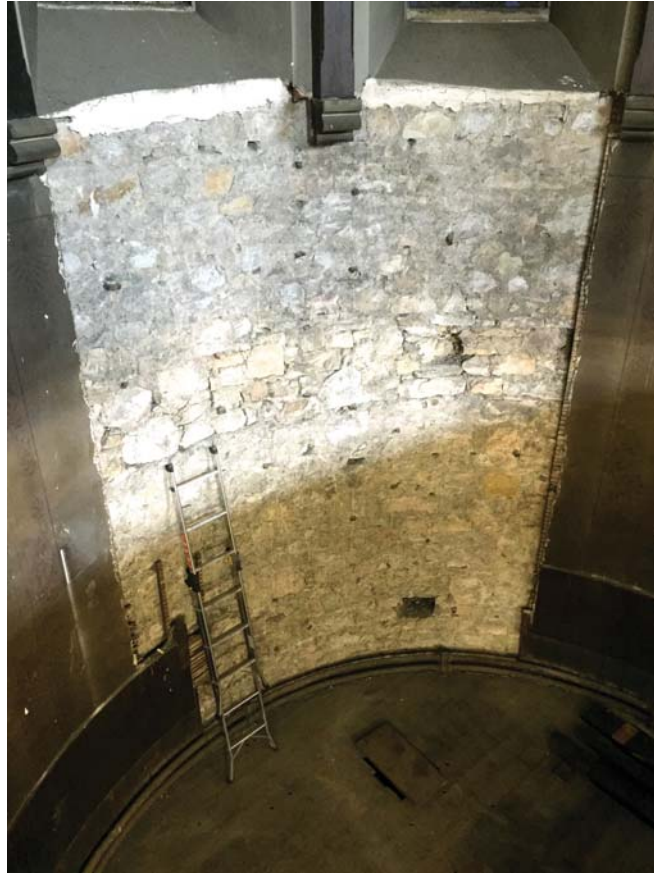
Plate 87: Room 0/1, general view of the exposed stone rubble wall looking down from Room 1/1 after the removal of the organ, from the south

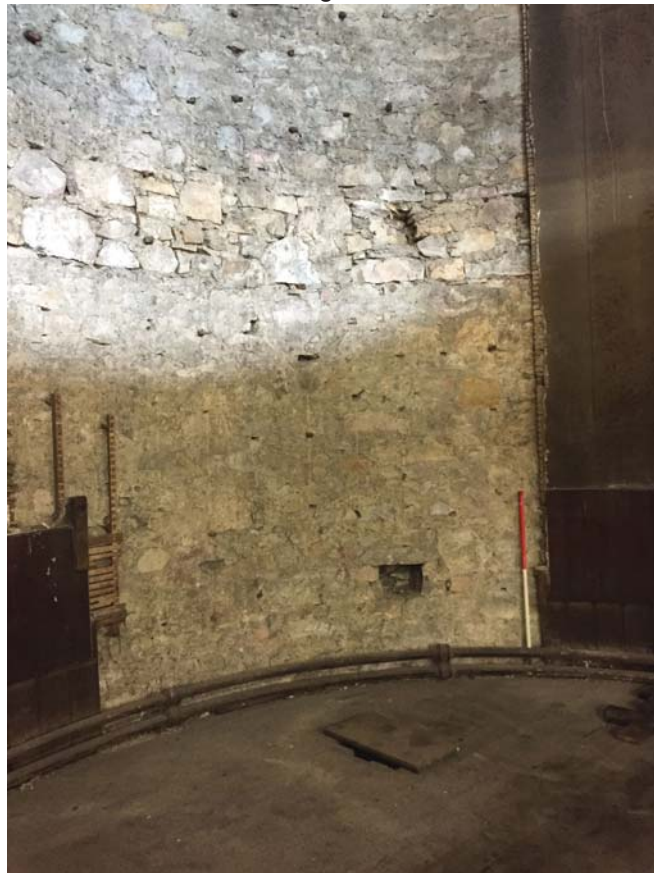
Plate 88: Room 0/1, general view of the exposed stone rubble wall after the removal of the organ, from the south

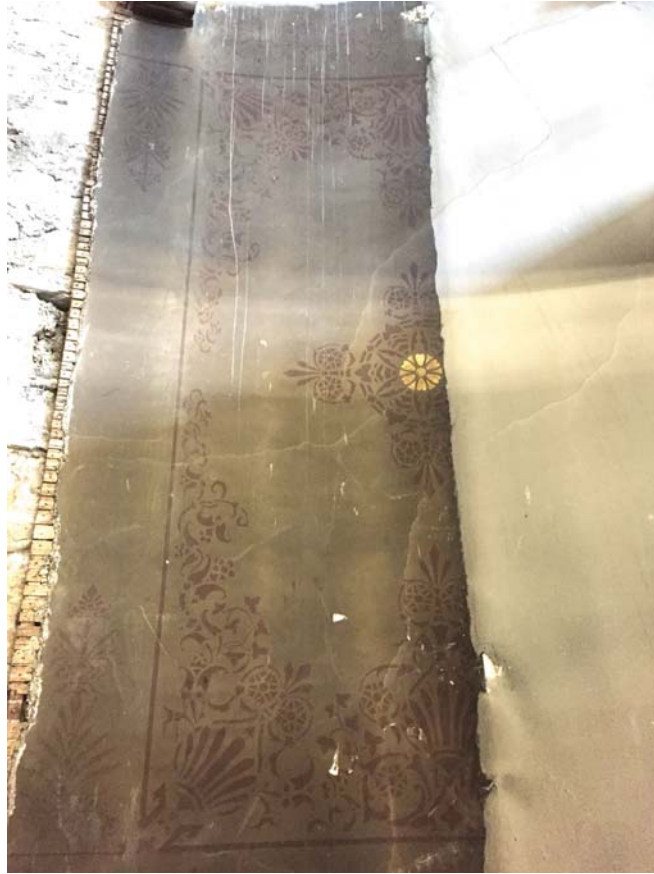
Plate 89: Room 0/1, detail of decorative plasterwork in the north-west wall after the removal of the organ, from the south

carved and still relatively intact; the screen is being retained. The decorative plasterwork looks worn and old and also looks to have been disturbed by the addition of the later organ, with the central area completely devoid of it and exposed to the stonework. Hence these decorative features may date to the Victorian period.

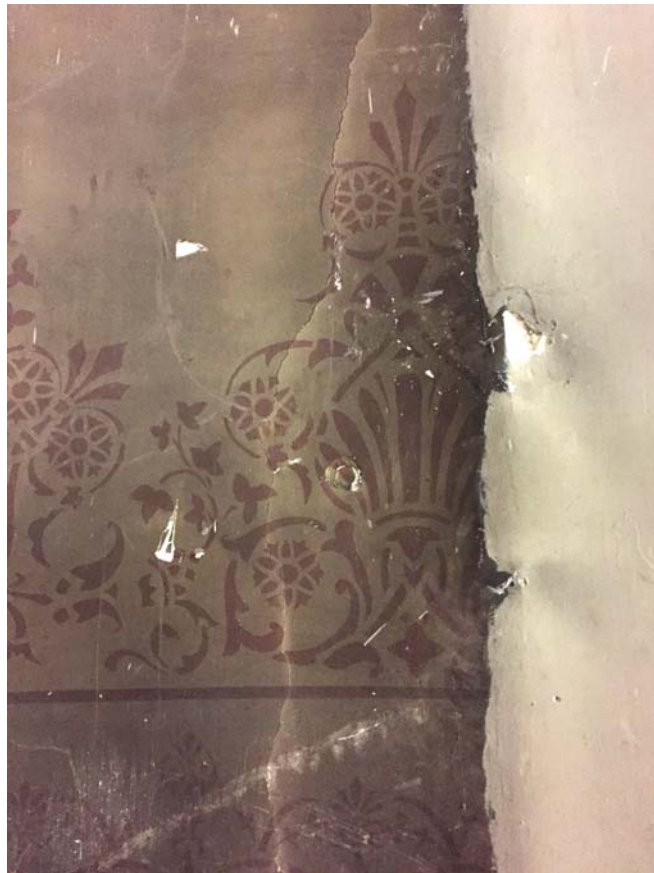
Plate 90: Room 0/1, detail of decorative plasterwork in the north-west wall after the removal of the organ, from the south
