# St Paul's Church, 4 Muirhouse Avenue, Edinburgh: Historic Building Recording Report

AOC Project: 23504

30<sup>th</sup> June 2016

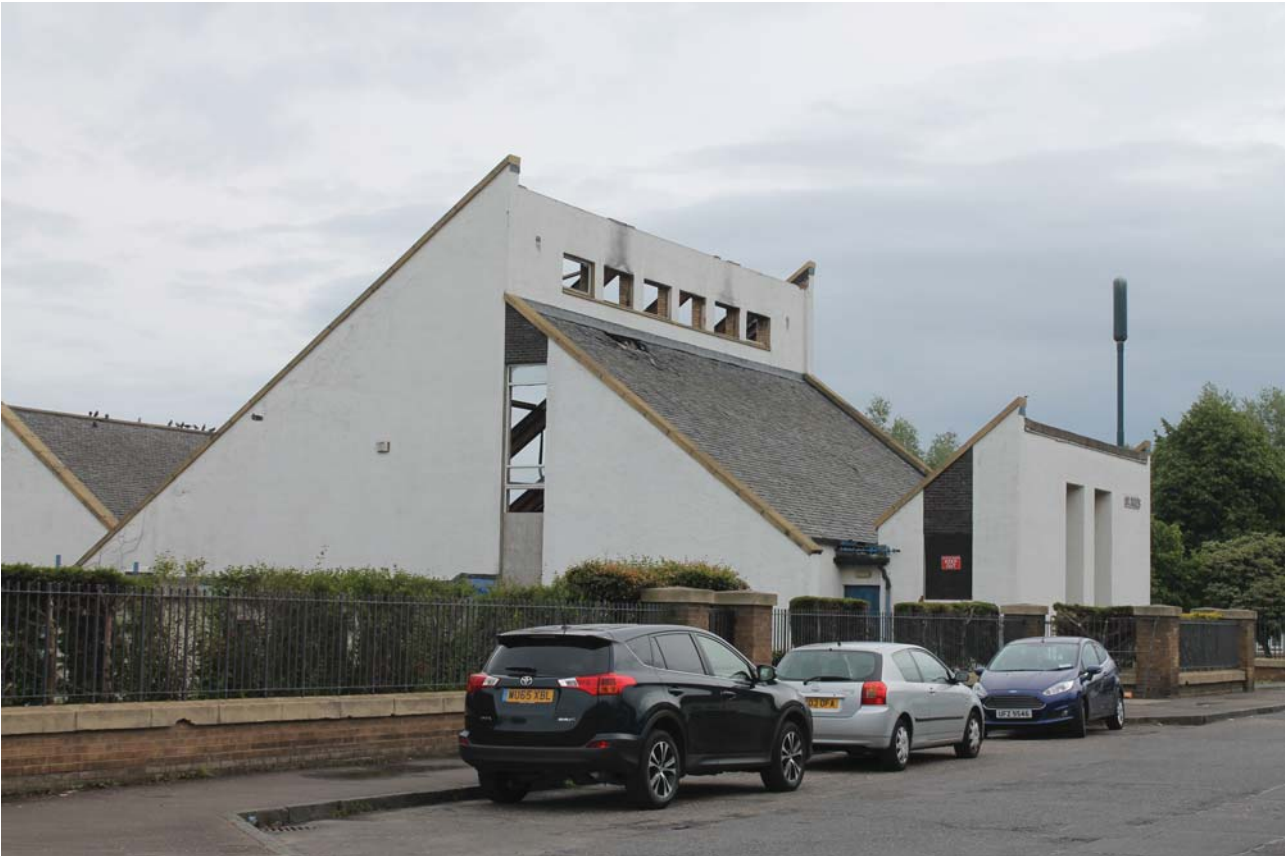
Plate 1: St Paul's Church, general view from the south-west

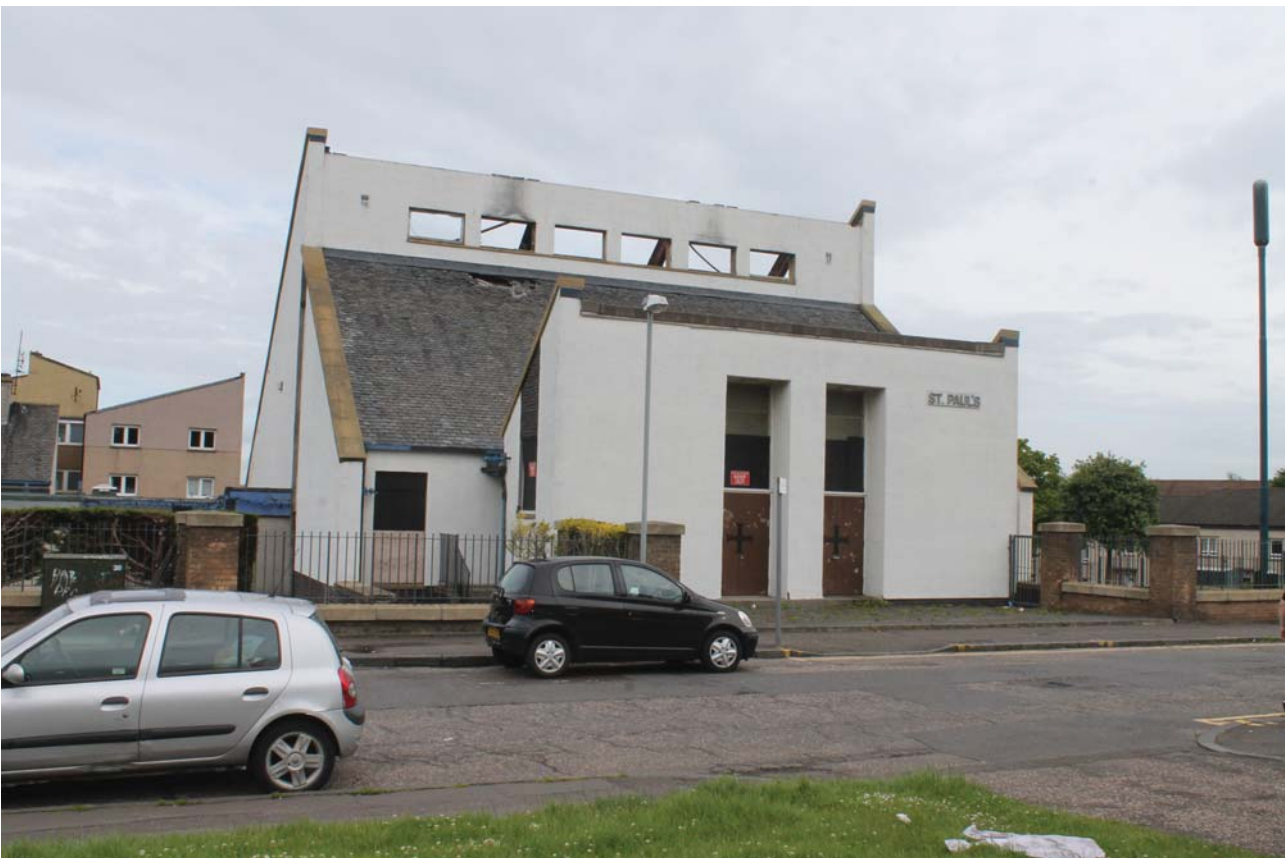
Plate 2: St Paul's Church, general view from the SSW

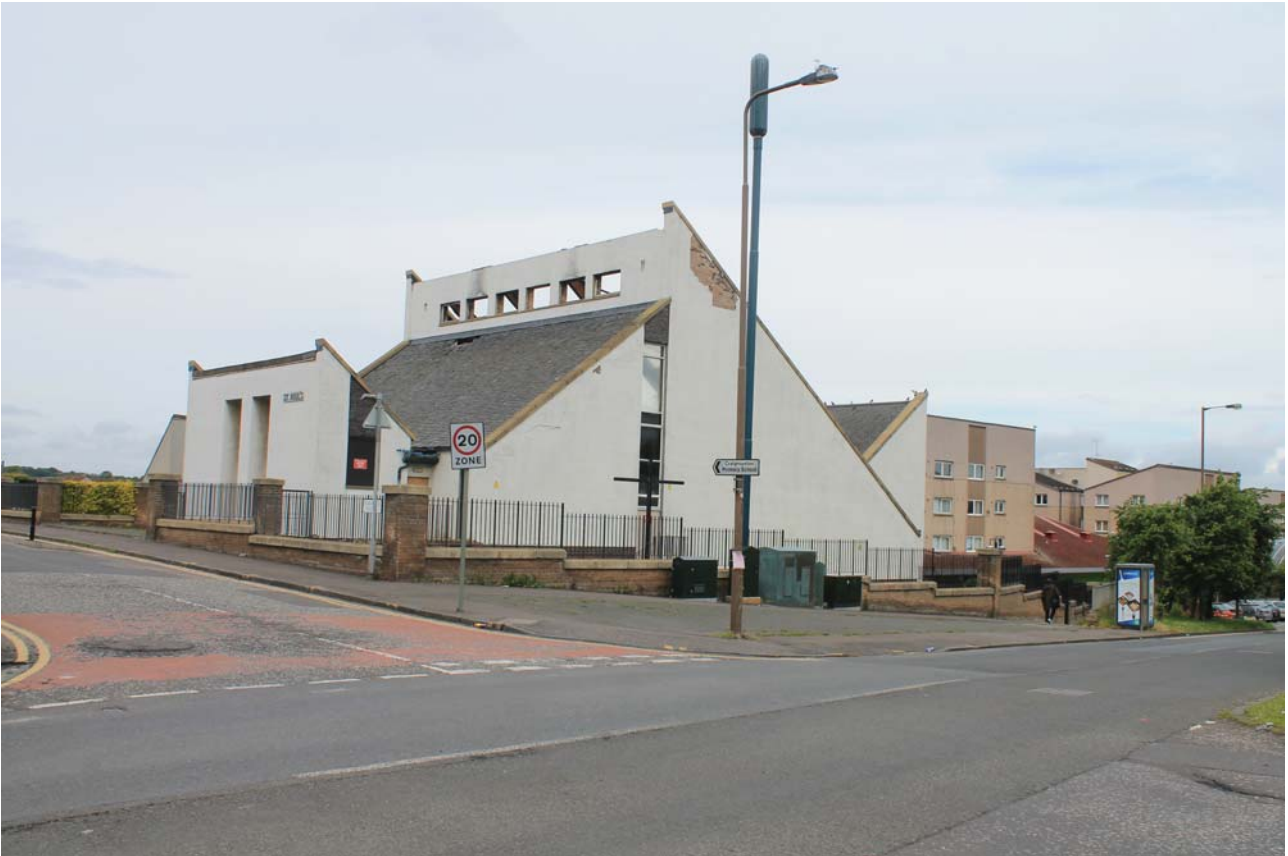
Plate 3: St Paul's Church, general view from the south-east

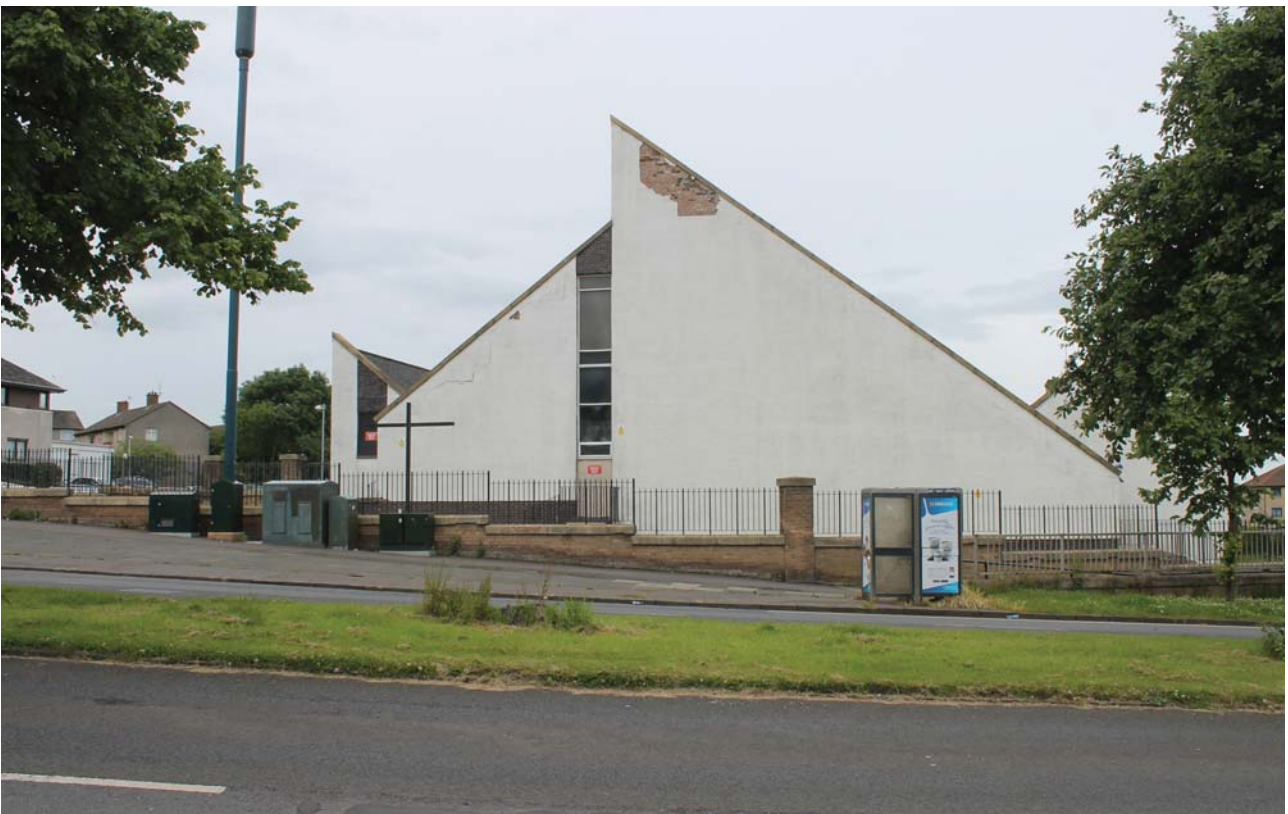
Plate 4: St Paul's Church, general view from the east

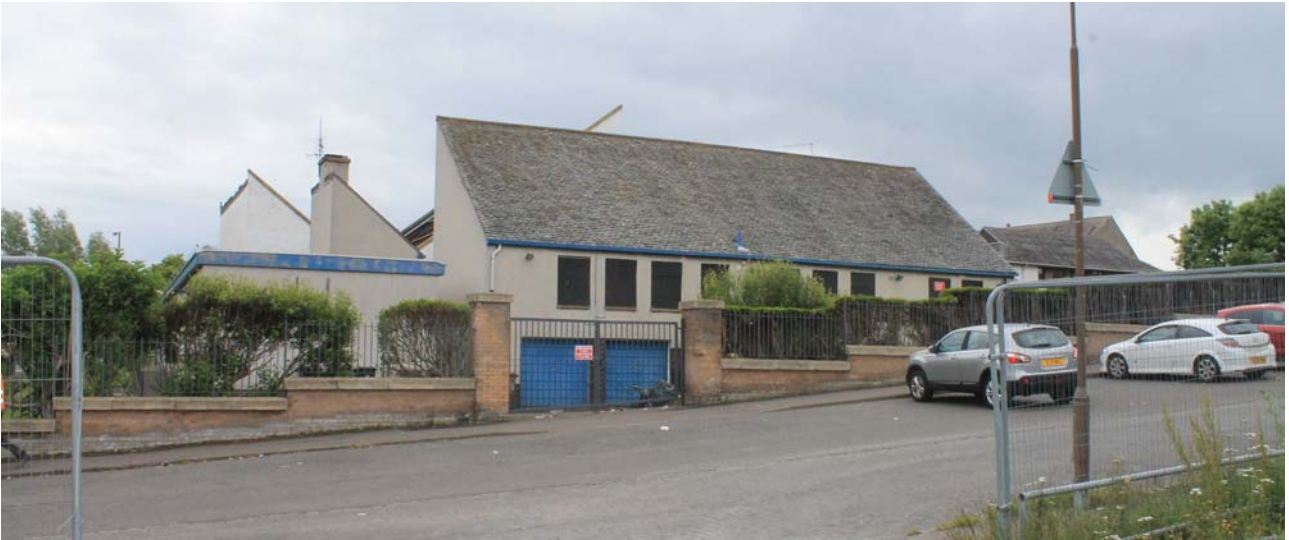
Plate 5: St Paul's Church, living areas, general view from the north-west

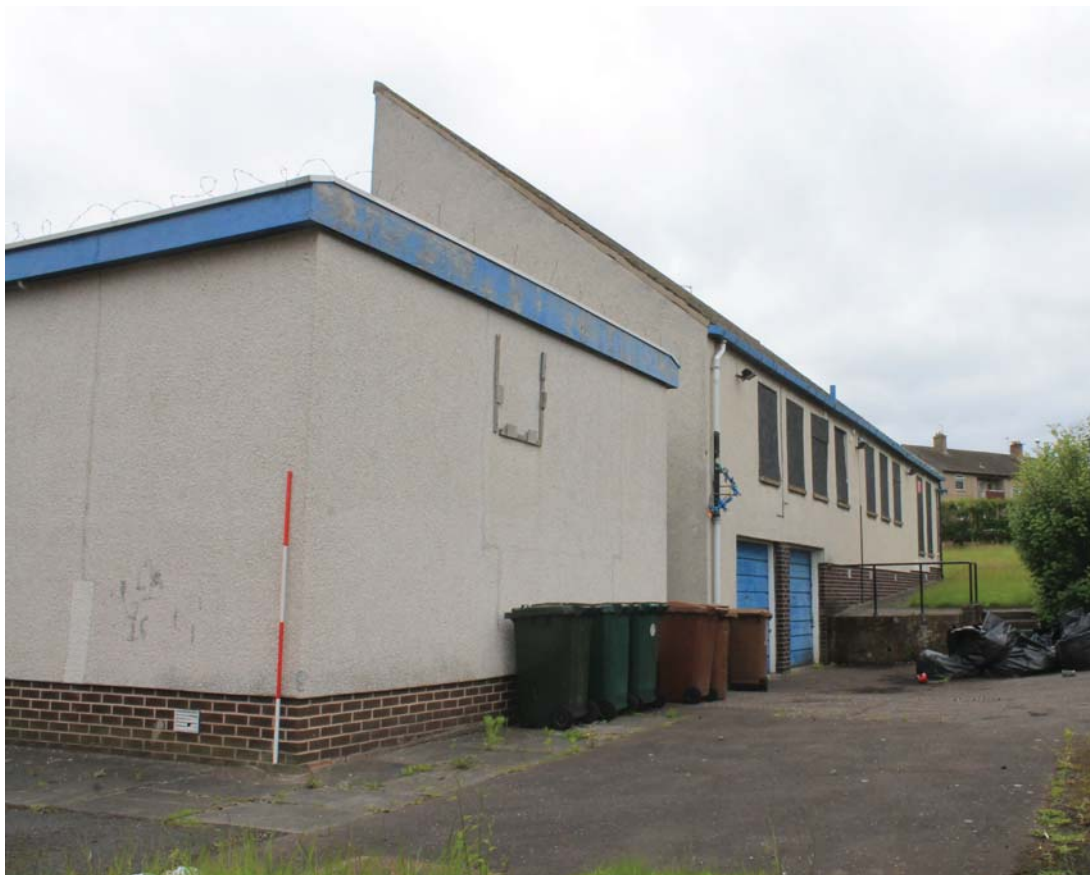
Plate 6: St Paul's Church, living areas and hall, general view of the west elevation from the north-west

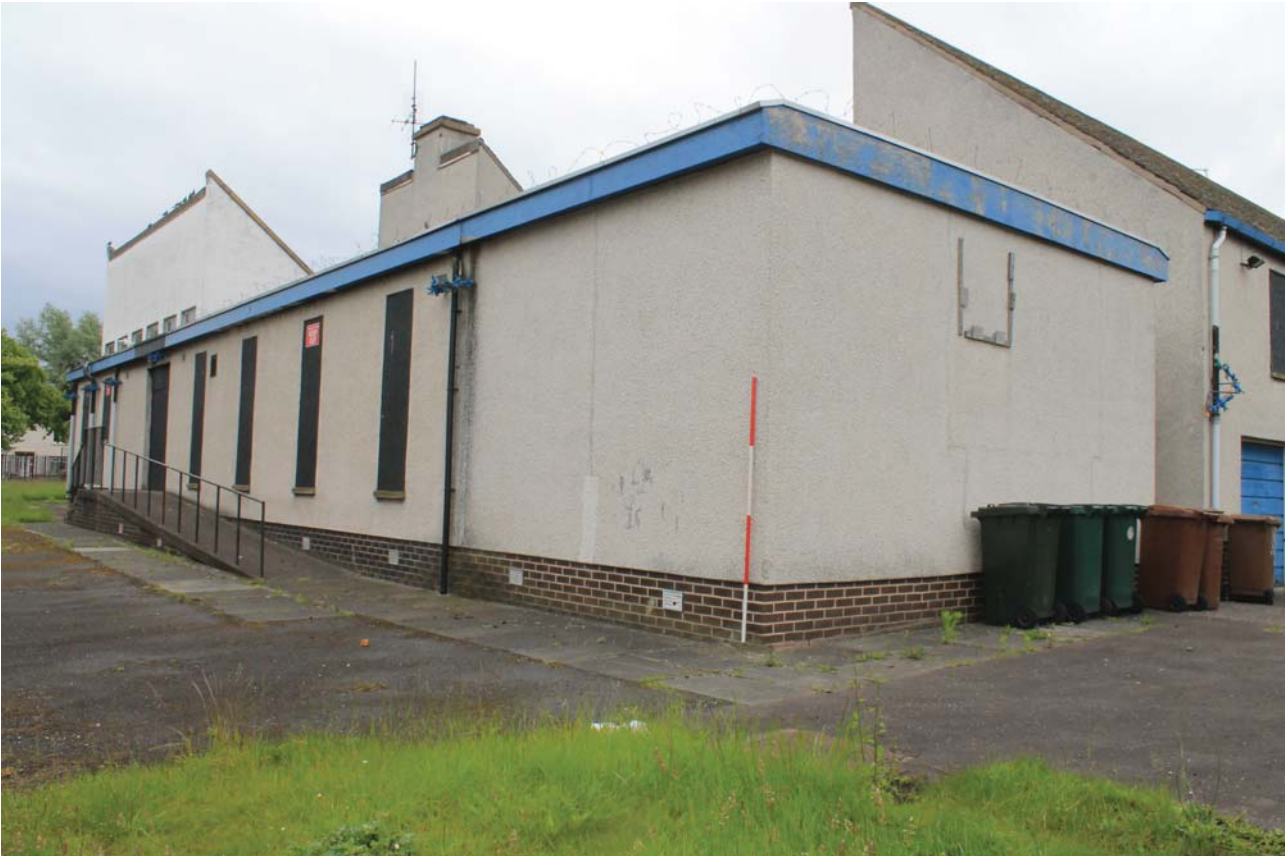
Plate 7: St Paul's Church, hall, general view of the north elevation from the north-west

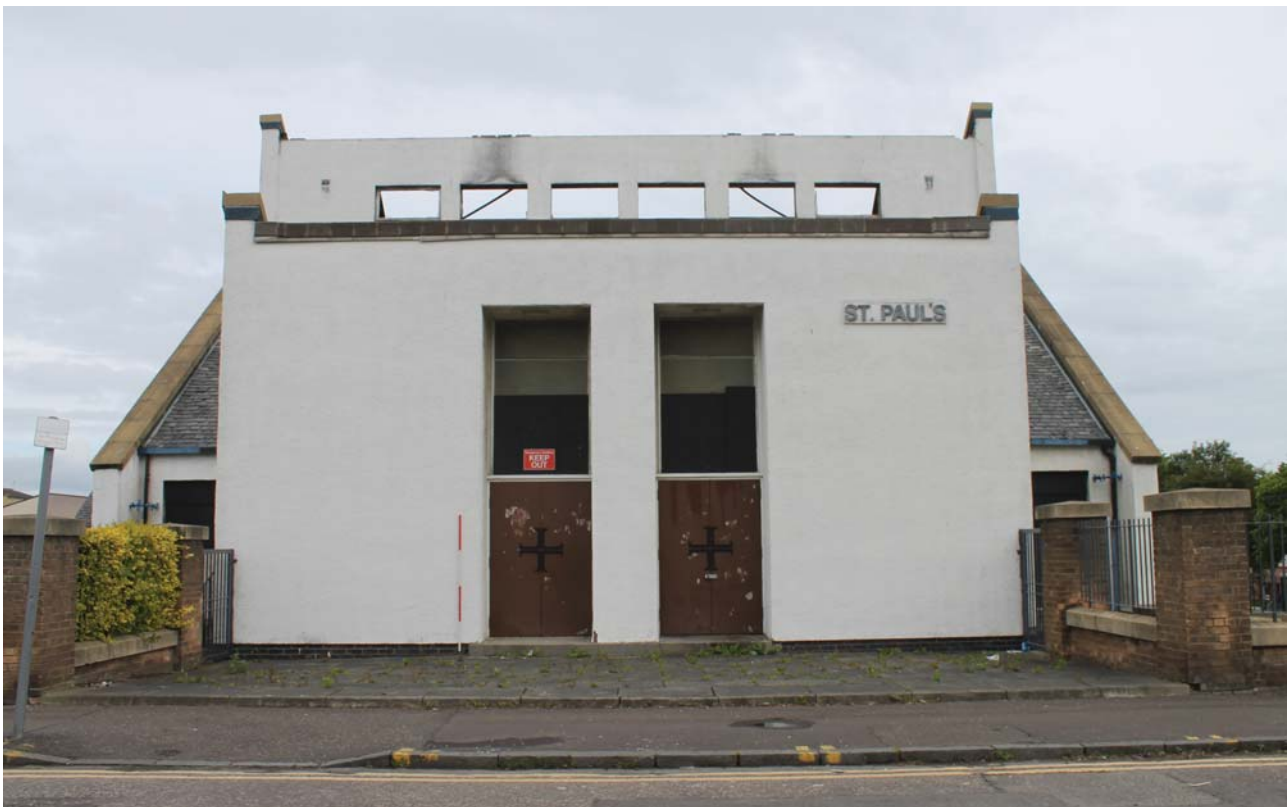
Plate 8: St Paul's Church, detail of the main entrance in the south elevation, from the south

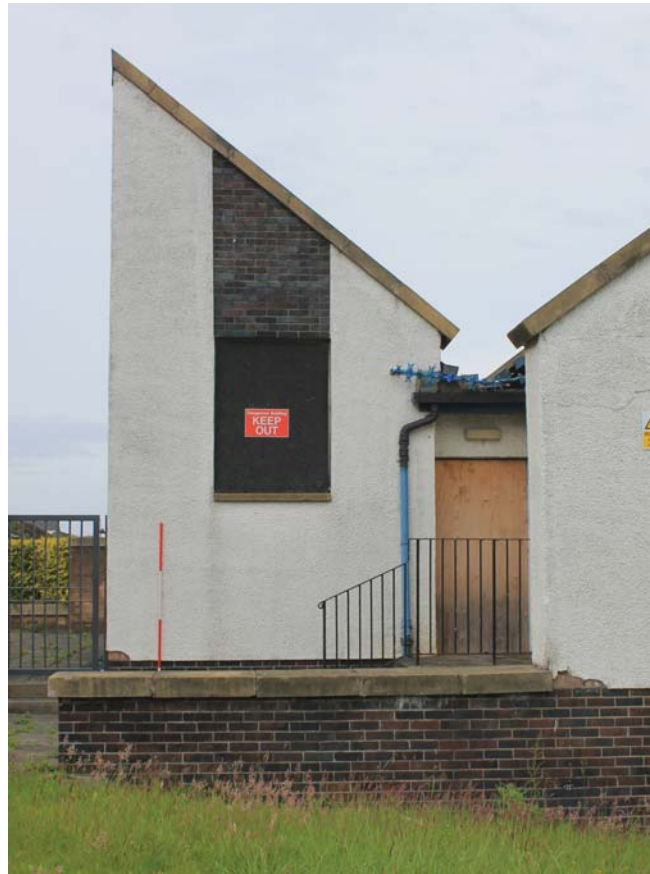
Plate 9: St Paul's Church, detail of the east-facing elevation of the main entrance from the east

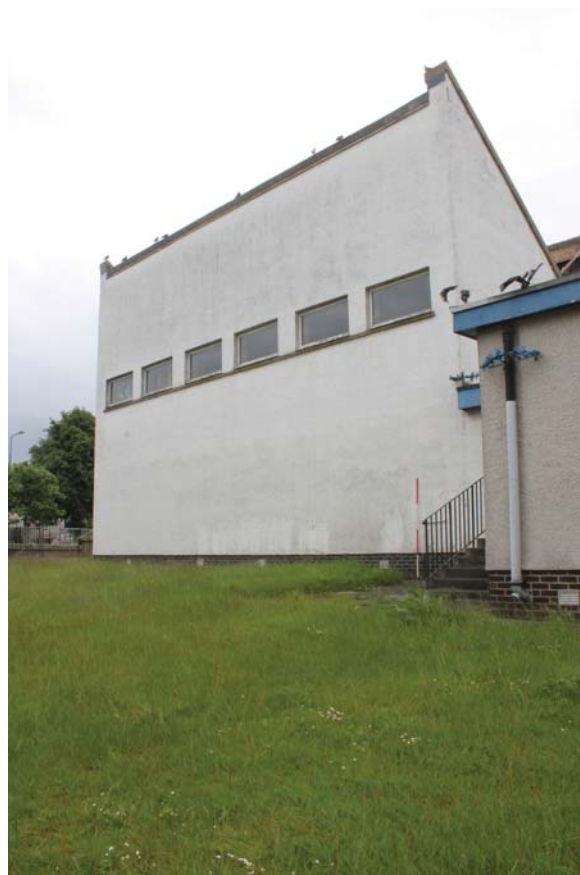
Plate 10: St Paul's Church, general view of the north elevation from the north-west

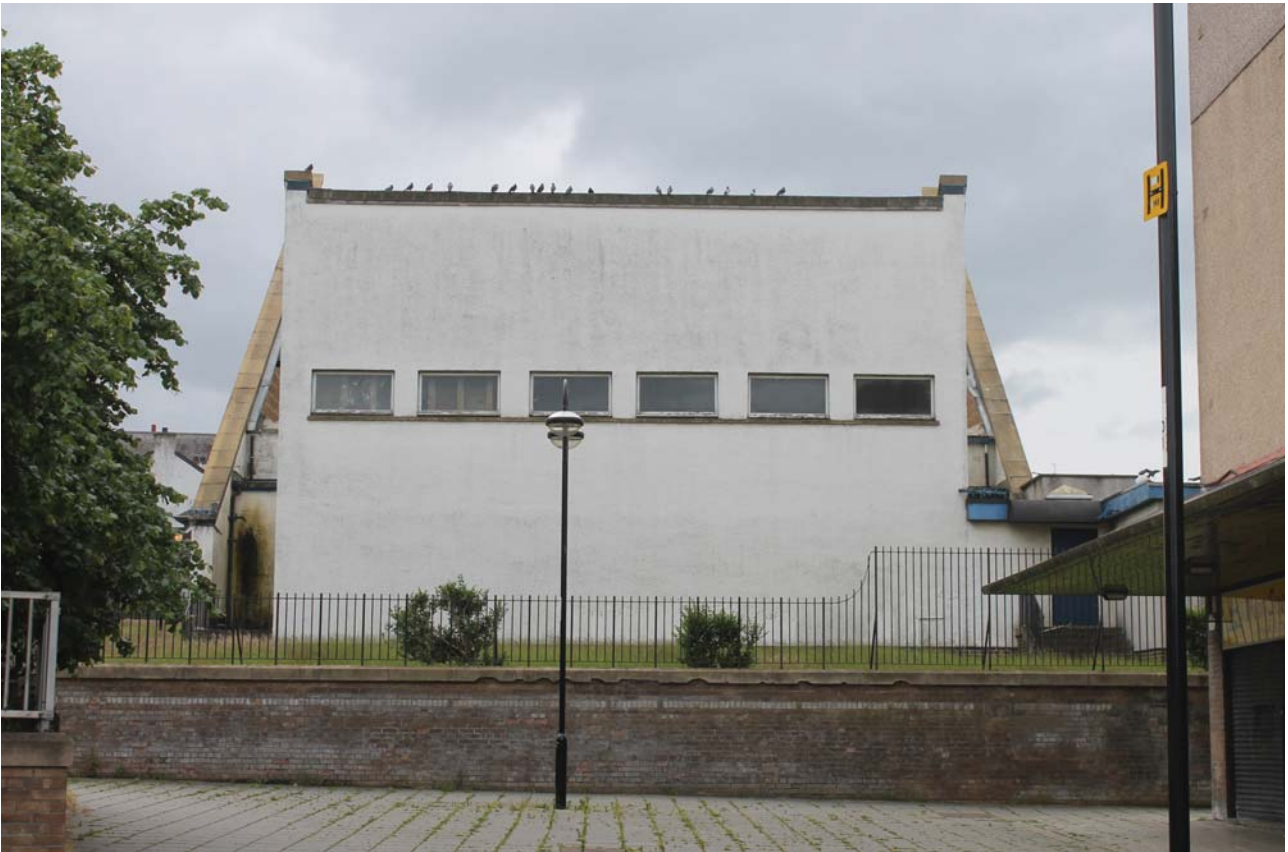
Plate 11: St Paul's Church, general view of the north elevation from the north

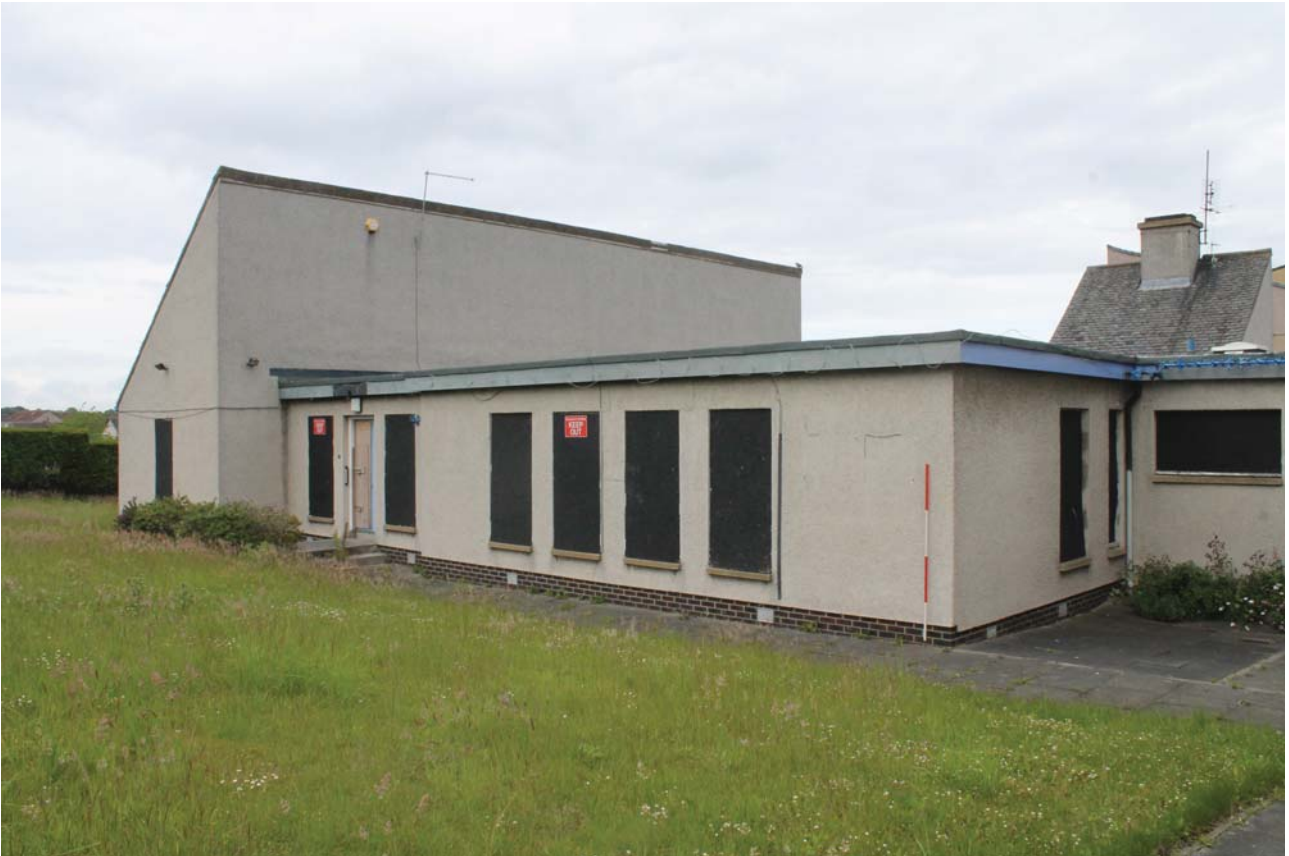
- 5.2 The west side of the church consists of a number of bedrooms, studies, bathrooms, kitchen, sitting room and hall, all centred around an off-set courtyard (Figure 3). It is largely a flat-roofed single storey block, although the steeply pitched half-roofs were echoed here with a half pitch to the west wing (Plate 13) and a smaller half-pitch over the boiler room with a chimney (Plate 14).

Plate 13: St Paul's Church, living areas, general view of the southern block from the south-east

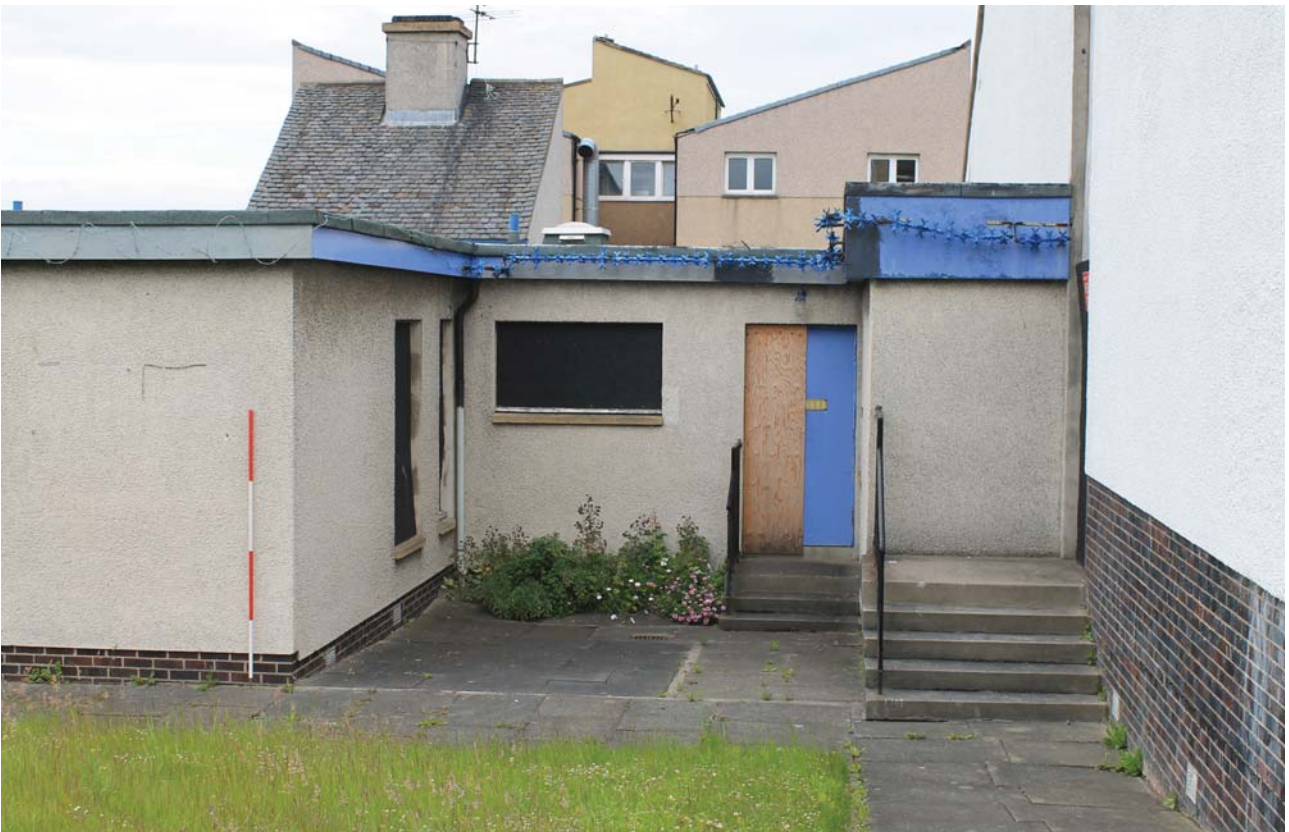
Plate 14: St Paul's Church, living areas, detail of the linking block between the church and the living areas (note half-pitched roof of the boiler house behind), from the SSE

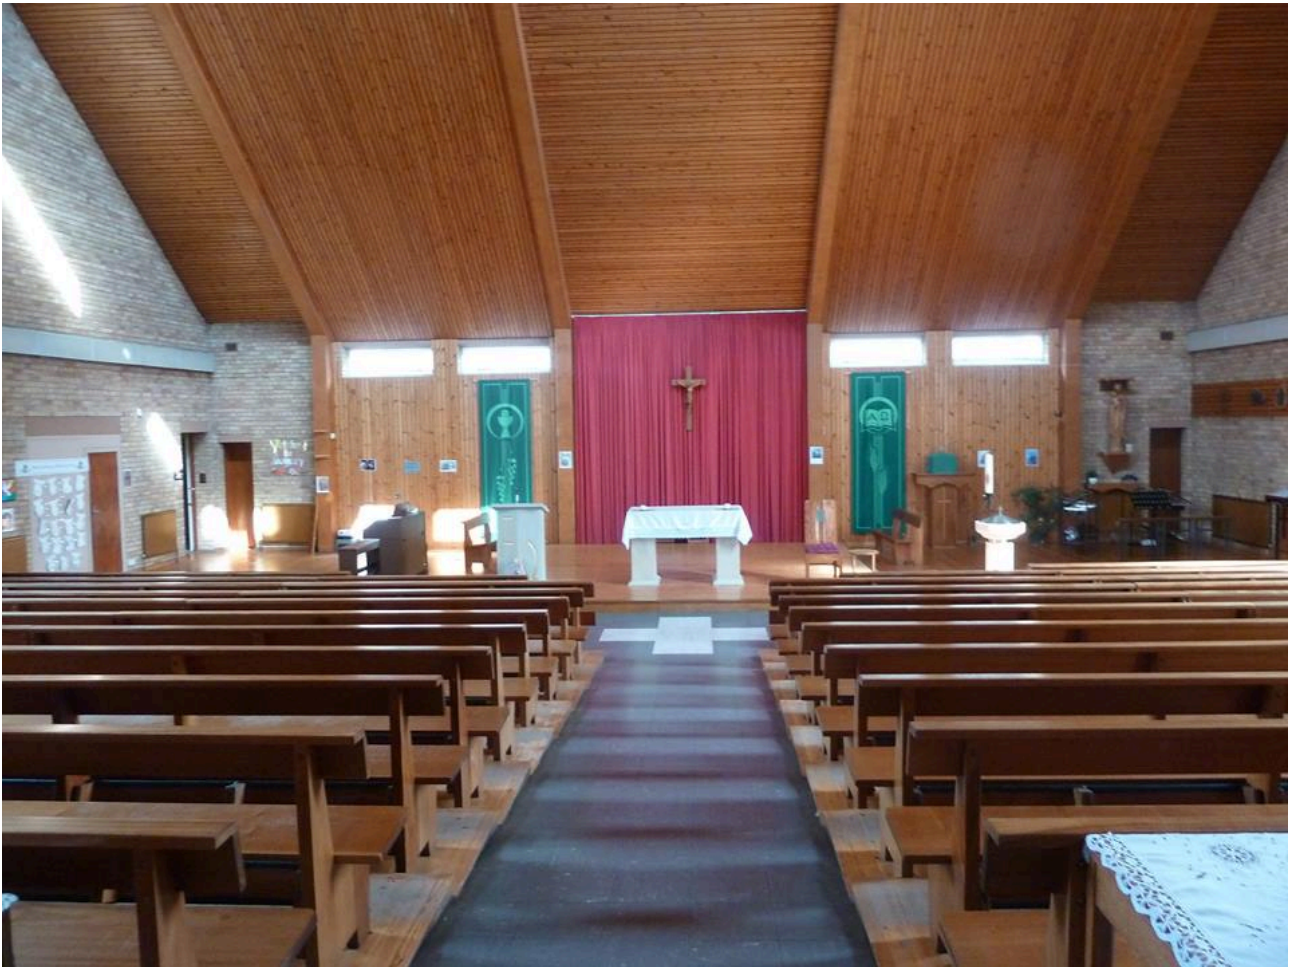
- 5.3 No access was made to the interior of the building during the on-site survey, as the interior has effectively been gutted after the 2014 fire. However, members of the community have kindly given permission to include a photograph of the interior of the church whilst it was still in use (Plate 15). It shows the building was bare to the brick walls to the interior with heavy use of pine timber panelling throughout.

Plate 15: St Paul's Church, general view of the interior of the main chapel before the 2014 fire from the east (© Lorraine McTigue)
