Waukmill house and steadings

Waukmill, Elgin, Moray

Historic Building Recording Report

AOC Project Number: 70217

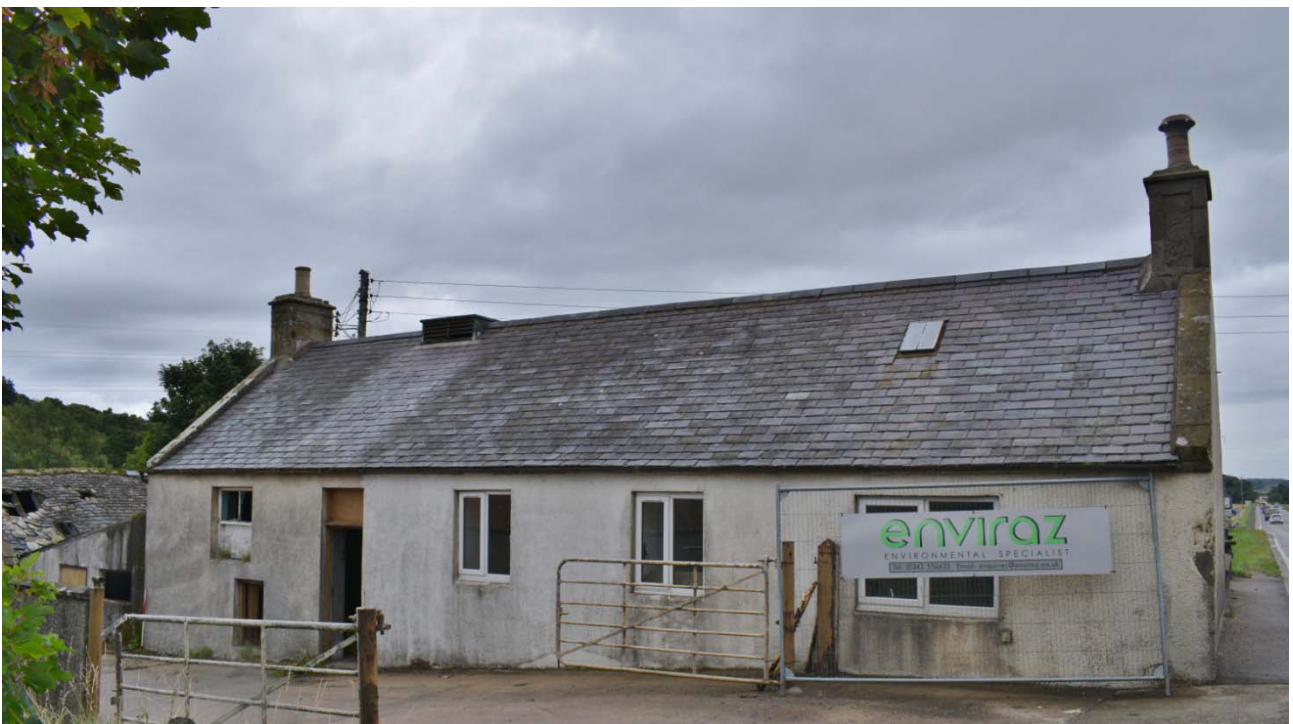
The northwest elevation (**Plate 3**) has three double casement windows to the southwest within A2. The outer windows are both splayed. To the northeast of the building, on the exterior of A1, there is a broken splayed window that is the same height as the others but located further from the ground due to the sloped ground condition. A small doorway is located below this, and a larger doorway – almost roof-height – is situated southwest of this. These are all within A1. A line of dressed bare stone (**Plate 4**) leads along the gable corner wall heads up the slate pitched roof to the stone and ceramic built chimneys, one on either gable end – the northeast of which is no longer in use and has no interior chimney architecture visible in A1. There is a small vent visible in the roof.

Plate 3: Oblique image of northwest elevation of D (left), A1 (centre) and A2 (right)

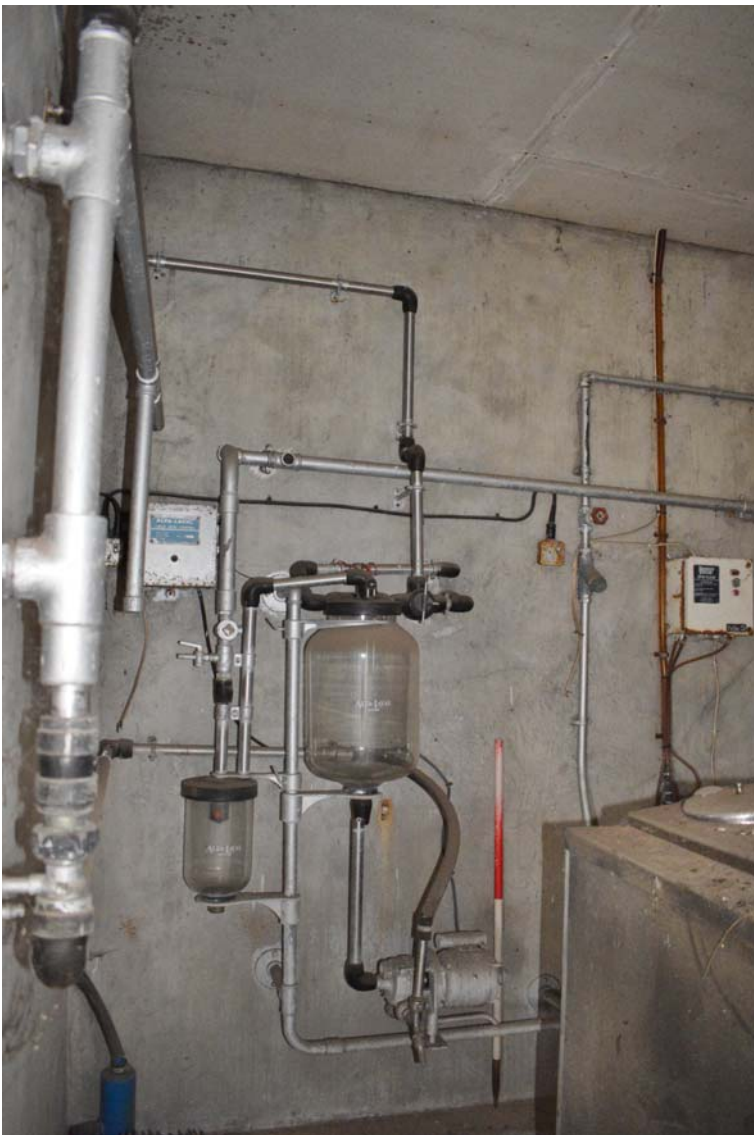
A single room measuring 5m x 5.8m northeast-southwest. The walls are rendered in concrete and the floor is poured concrete. A partition of bare concrete blocks one brick thick, and a continuation of the corridor wall in extension D, protrudes 3m into the room (**Plate 6**). The walls meet the ceiling at 3.95m, which comprises asbestos tiles. Two attic access hatches are visible. The room is full of pasteurisation equipment and limits some of the views of the walls (**Plate 7**). The attic could not be accessed for inspection.

Plate 7: Image of northeast interior wall of pasteurisation room A1, view blocked by debris

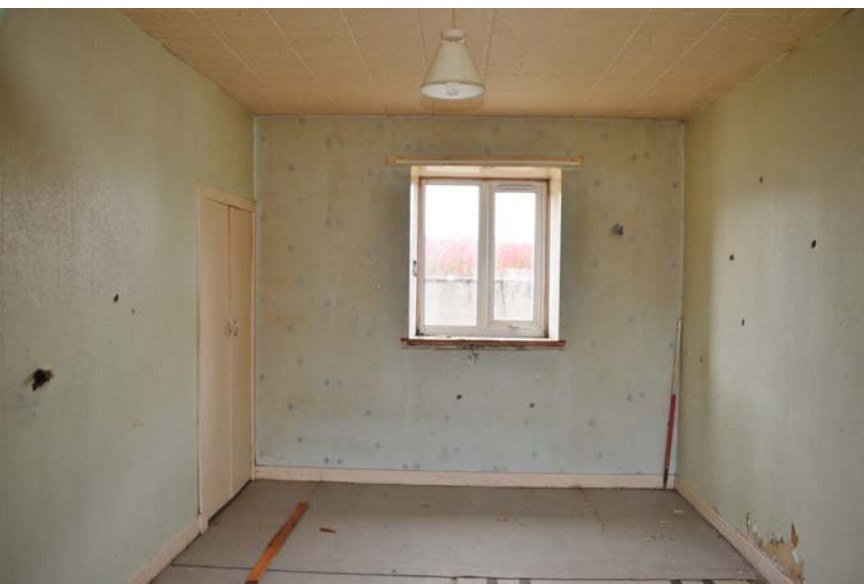
casement window in the northwest wall (**Plate 13**). Room 1 is the most northeasterly room, with a double casement splayed window in both the northwest and southeast wall. There is an inbuilt cupboard in the southwest wall (**Plate 14**). The interior is in good condition and the dwelling only recently vacated. The floors are generally bare wood and the walls have been wall papered. The building fabric of the walls is not evident from either the exterior or interior.

Plate 14: Image of northwest interior wall and window of room 3, A2

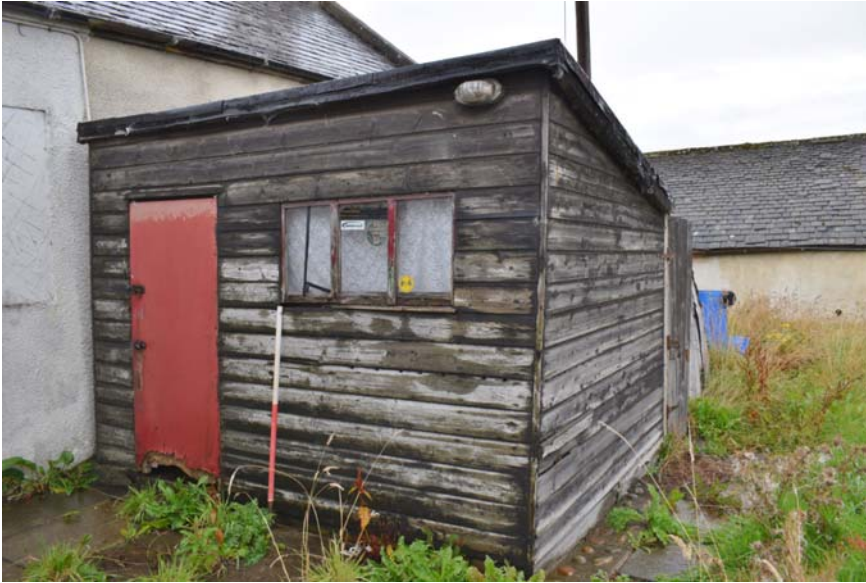
Evidently a former chicken coop, the shed is timber-built and of fairly modern origin (**Plate 15**). The structure does not have ground-penetrating foundations.

Plate 15: Image of shed A3, looking north

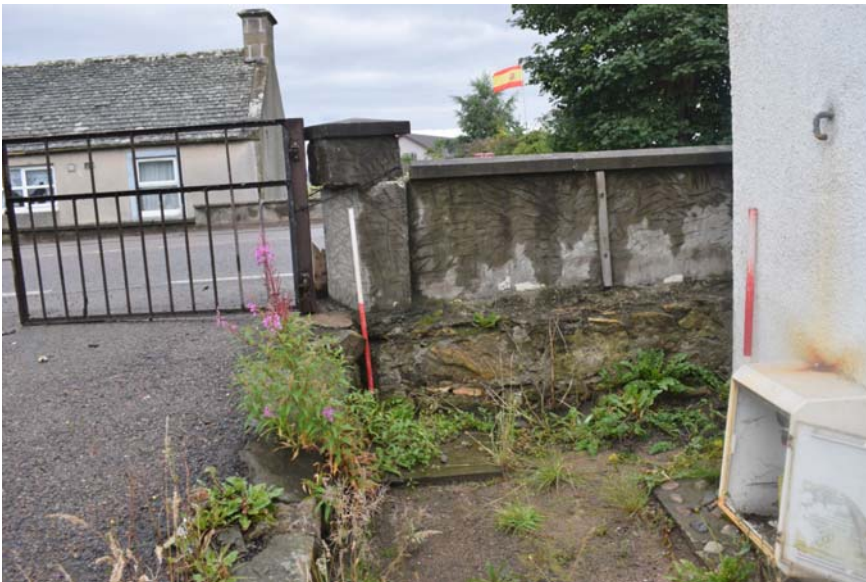
Part of a retaining wall is evident to the south of the cottage (**Plate 16**), to the northwest of the concrete access ramp that leads from the southeast side of the cottage to the road (**Plate 16**). It is notable to mention as it is constructed of dressed stone which may have been reused from earlier structures on the site.

Plate 16: Garden wall against main road on southwest gable end of A2, note the old stone

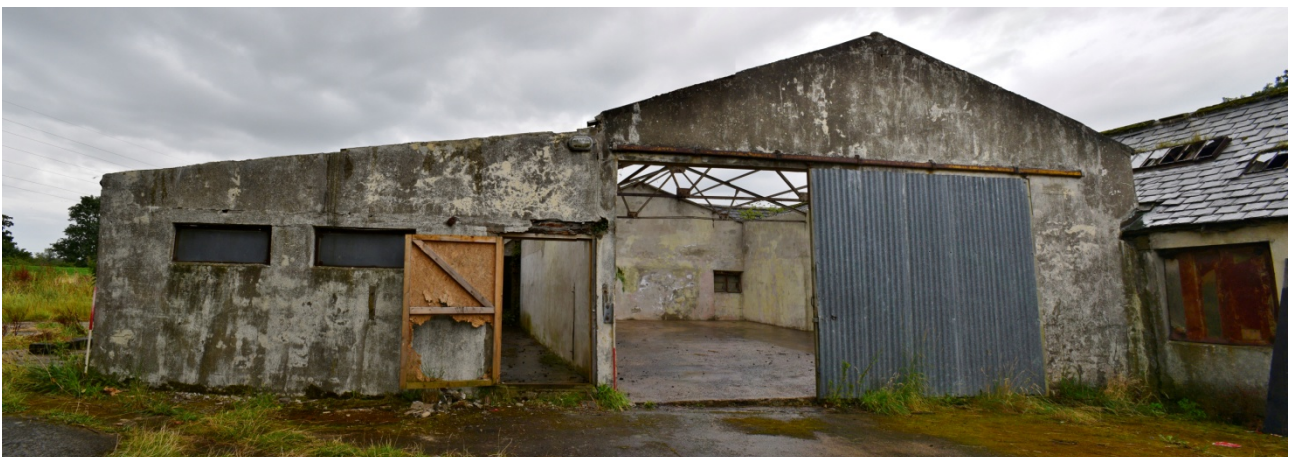
The northwest elevation consists of the plain northwest gable ends of B1, B2 and B3 (**Plate 17**). B1 contains a large corrugated iron sliding door to access the steading. B3 contains two small rectangular windows, similar to those found in building D, and a doorway access. B2 is a plain gable end with no features.

Plate 17: Image of northwest exterior wall of steading (B1 right, B3 left)

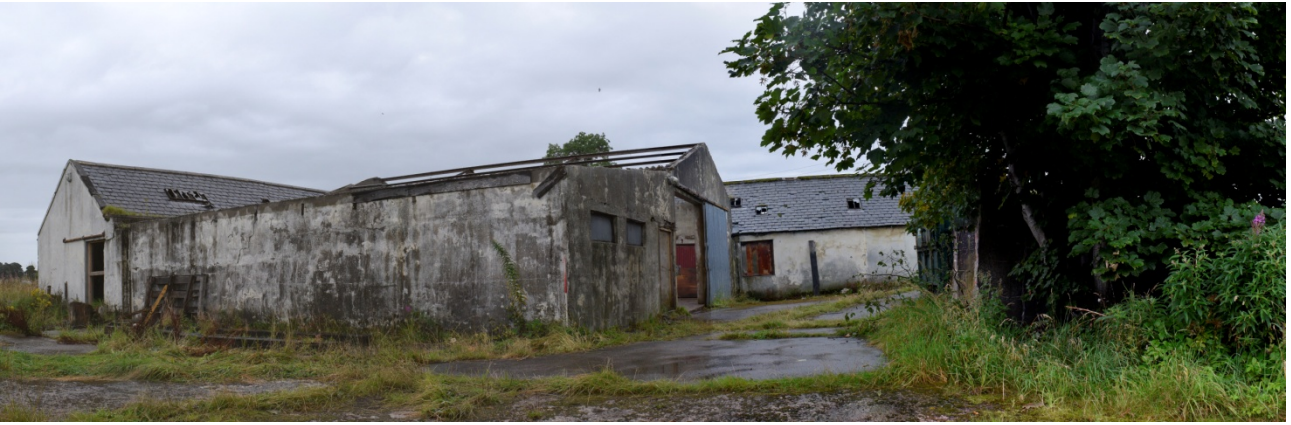
The northeast elevation consists of the gable end of the northeast-southwest aligned leg of B2, which has the remnants of a small sliding door to the right of the gable face (**Plate 18**). The northeast wall of B4 is also visible, a plain concrete block construction. From this projects a spur of bare concrete blocks supporting a large upright metal girder. The continuation of the northwest-southeast aligned leg of B2 can be seen running behind this, with five windows and two doorways – the most northwest of which is still in use whilst the other has been blocked up and is visible from the exterior by cracking in the harl.

Plate 18: Image of north corner of steading complex, looking south

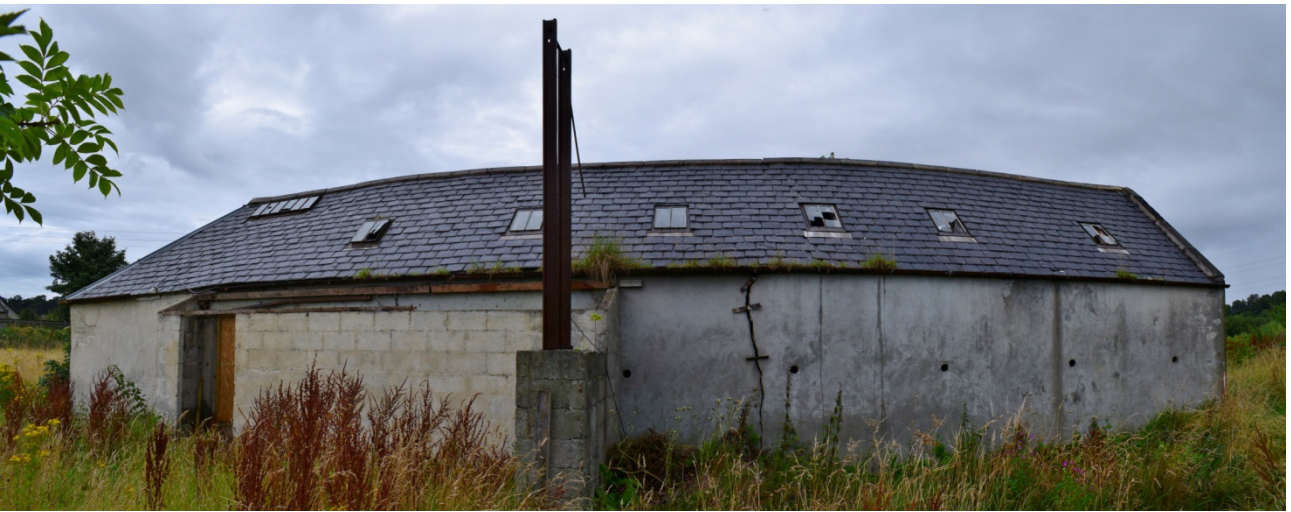
The southeast elevation depicts the southeast side of steading B2, showing a single access door to the southwest, enclosed within the concrete block-build addition of B4 (**Plate 19**). A large crack is visible in the centre of the wall which has been pinned with iron bolts. Six circular holes, presumably air vents, exist in a horizontal line mid-way up the wall of steading B2. Six equidistant and identical skylights occupy a central line across the roof, with an

Plate 19: Image of south exterior wall of steading B2, showing B4 to the left

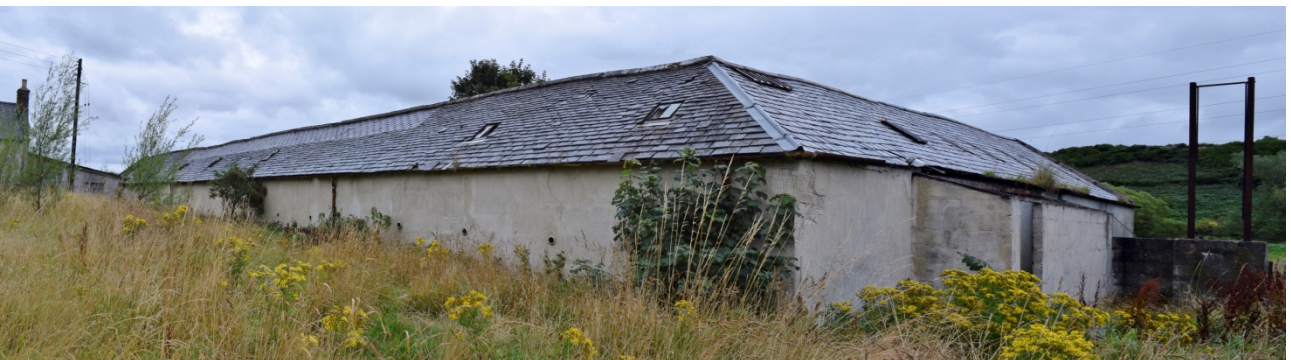
The southwest elevation shows the southwest wall of steading B2 and addition B4 (**Plate 20**). A further twelve ventilation holes exist in the same fashion as the northeast elevation within the B2 steading wall. The roof has a section of newer slating between the centre and northwest end, and six identical skylights – two towards the southeast end and four towards the northwest end. A single drainpipe exists at the centre of the wall face.

Plate 20: Image of south corner of steading B2

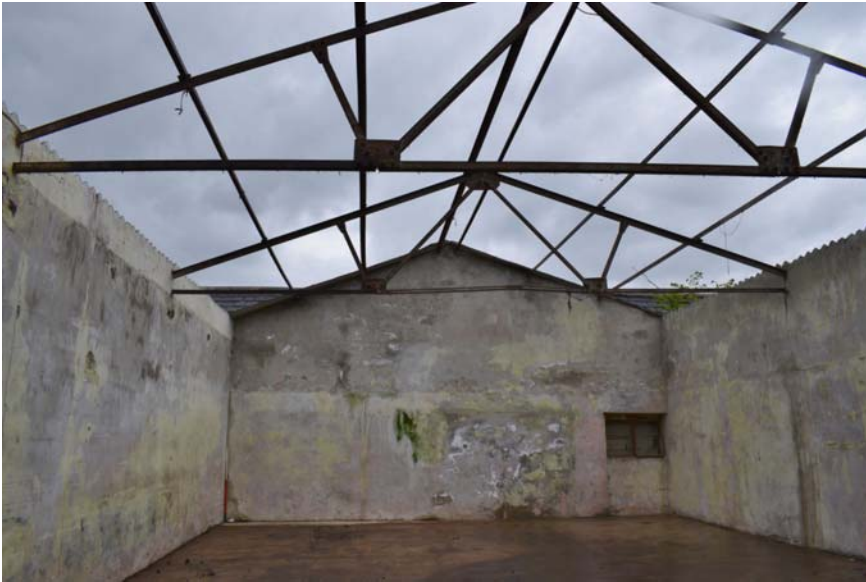
Measuring 12 x 8m northwest-southeast internally, this steading comprises three concrete block walls that abut onto the northwest and northeast wall of B2 (**Plate 21**). The interior of the walls have been cement rendered and the floor is poured cement. The building is unroofed but metal rafters still survive and indicate a pitched roof. The northeast and southwest wallheads are corrugated. Access is through a metal sliding door in the northwest wall. A second sliding door exists in the southeast wall, above which are visible dressed stone protruding from the cement rendered surface of the wall (**Plate 22**). The southeast wall contains a blocked up window that has been built into an old doorway. The general condition of this building is good however.

Plate 21: Image of southeast interior wall of steading B1

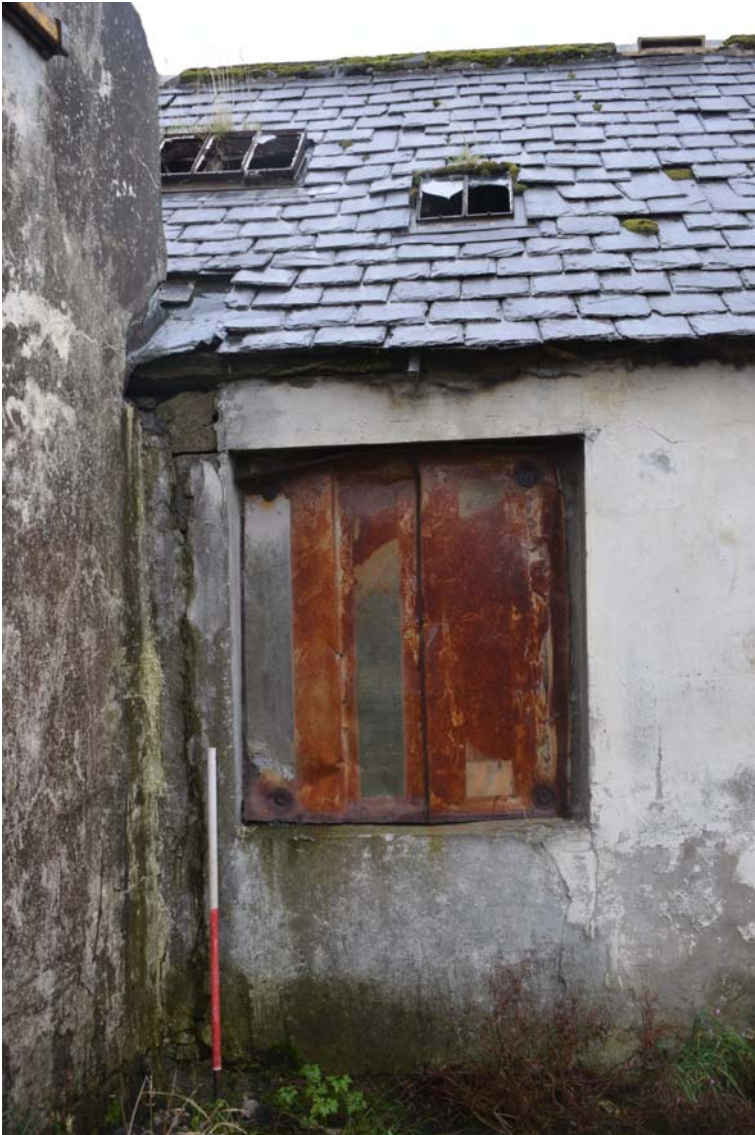
Plate 23: Image of adjoining B1 (left) and B2 (right), and window. Note the old stone within the fabric of B2, looking south southeast

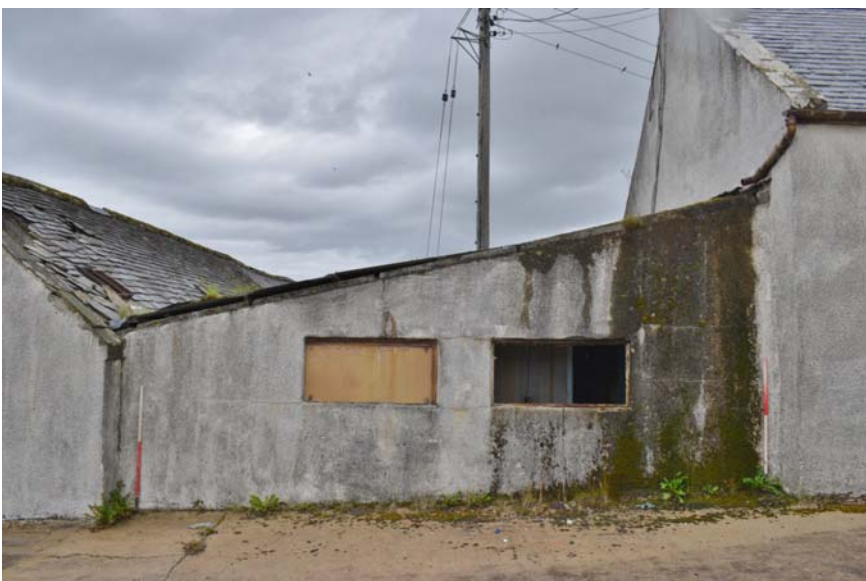
5.4.1 This extension joins the pasteurisation room A2 with steading B2 (**Plate 29**). It is constructed from concrete blocks, one brick thick, and the exterior has been harled. The interior wall faces of the extension have been cement rendered, and the floors are bare cement.

Plate 29: Image of northwest exterior wall of building (B2 left, A1 right)

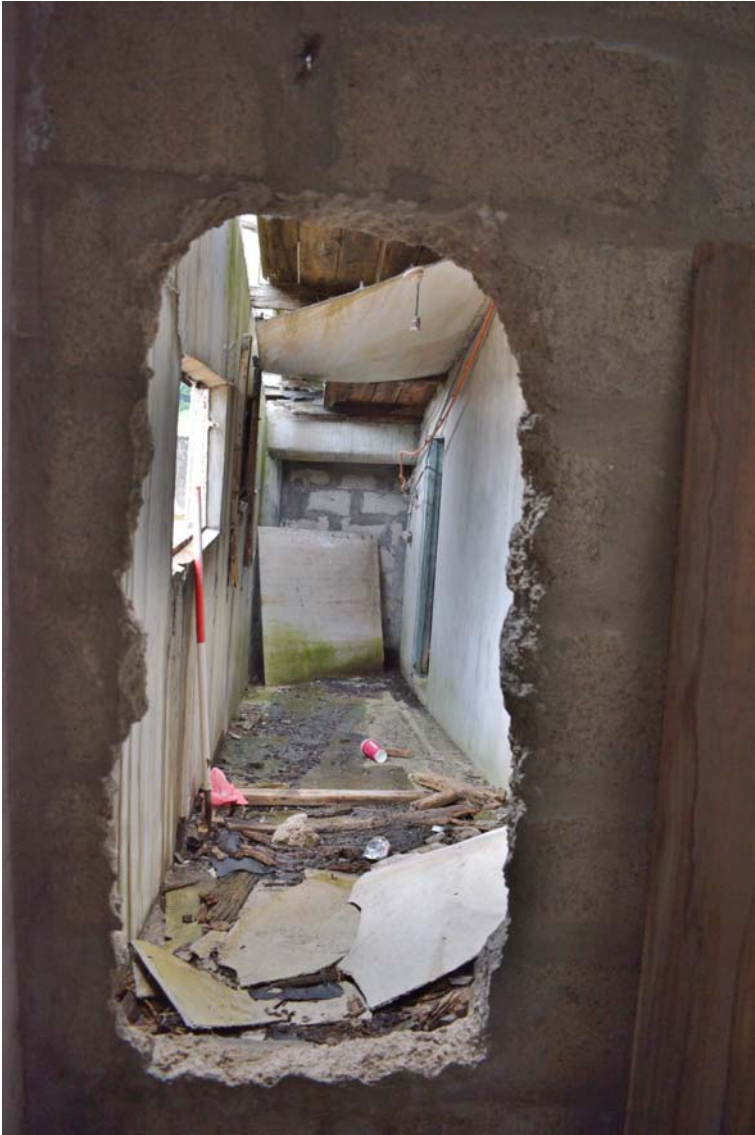
Due to the amount of asbestos within this particular building the archaeologist was prohibited from entering by asbestos clearance personnel. Observations were made from what the archaeologist could see from the open window, and with the assistance of the asbestos contractor who took photographs and gave dimensions of the rooms. The whole consists of a ramped access corridor that leads from steading to pasteurisation room and two plain windowless rooms adjacent to this, each accessed by a door. The northeast room is an electrics room, and the southwest room a bathroom. The access corridor has been blocked up with concrete blocks at either end where the doorways to steading and house would have been. A hole has been knocked through from the house (**Plate 30**).

Plate 30: Close up of hole in northeast interior wall of A1, leading through to D

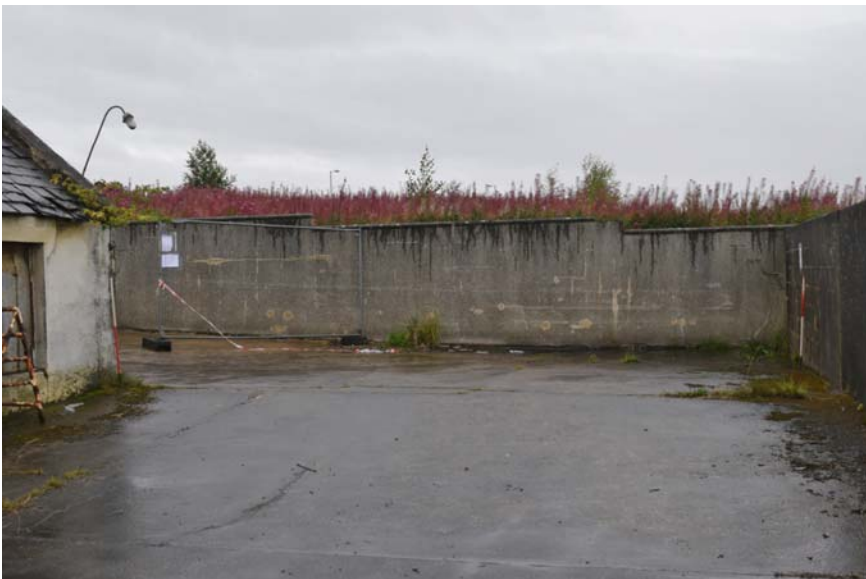
A cement rendered concrete block constructed wall, 0.2m wide and ranging between 1.5 – 2m tall, with coping stones on top (**Plate 33**). The wall proceeds from the roadside in a southwest-northeast alignment and is stepped in a declining fashion as it continues downhill. It runs along the back of the northwest-southeast aligned walls that make up building C.

Plate 33: Image of wall passing structure C (far right), looking northwest
