67 Lauriston Farm Road Edinburgh, Photographic Survey & Archaeological Evaluation: Data Structure Report

AOC Project: 23946
Planning Ref.:15/03373/FUL
17th November 2017

67 Lauriston Farm Road, Edinburgh: Photographic Survey & Archaeological Evaluation Data Structure Report

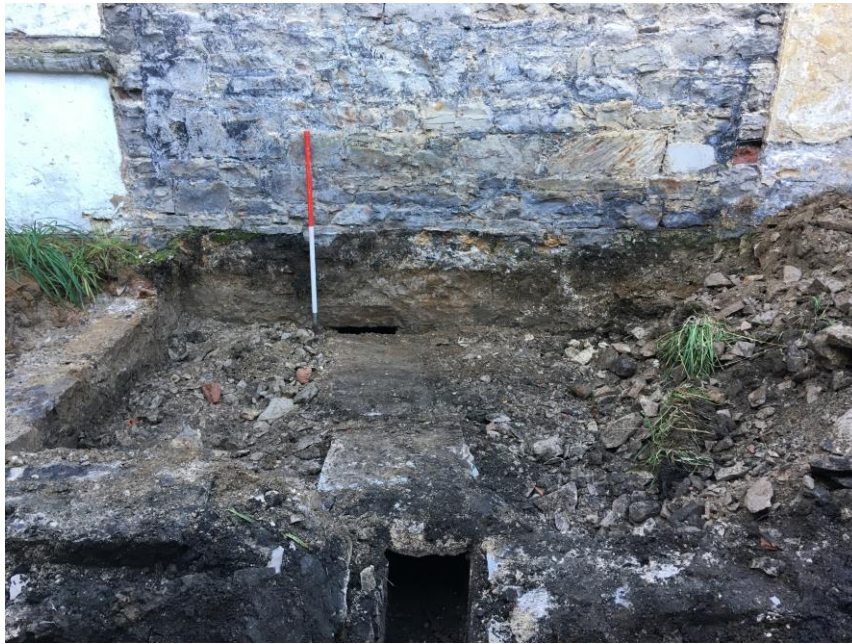
Plate 1: General view of stone lined culvert [5003] in Trench 5

- 4.3 Trench 5 exposed a stone lined culvert [5003], orientated north/south and curving to the north-west, continuing under the north wall of the barn and the farmhouse to the south (Plate 1). The foundations of an east/west internal stone wall [5004] was identified built over the culvert. The foundation of a single internal brick wall [5005] extending north/south, was also observed and abutted the internal stone wall [5004] and the north wall of the farmhouse. A square metal box drain [5006] was noted alongside this. The features were cut in a light orange brown slightly sandy clay natural subsoil.

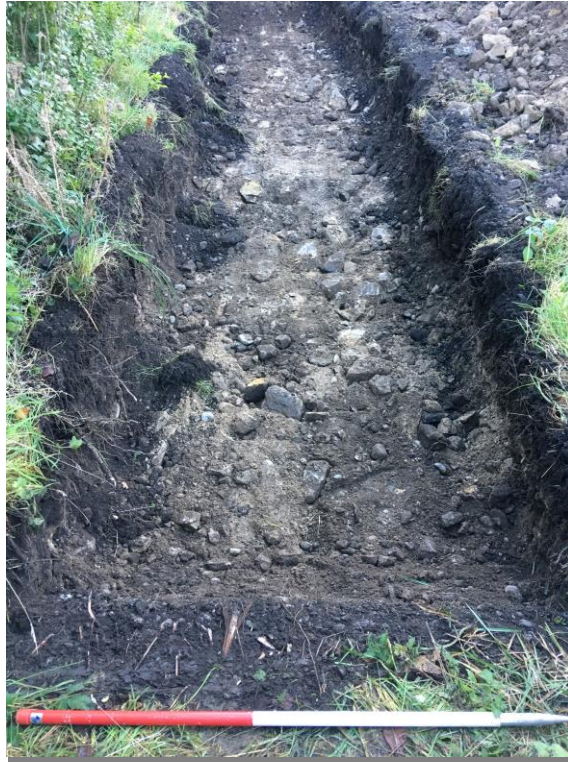
- 4.4 The stone-lined culvert [5003] observed in Trench 5 continued NNW in Trench 6 [6003] at a depth of about 1m below ground level. The topsoil was of a dark greyish brown clay silt loam, 0.20m in depth, over a made ground of sandstone and lime rubble (Plate 2)

Plate 2: General view of Trench 6

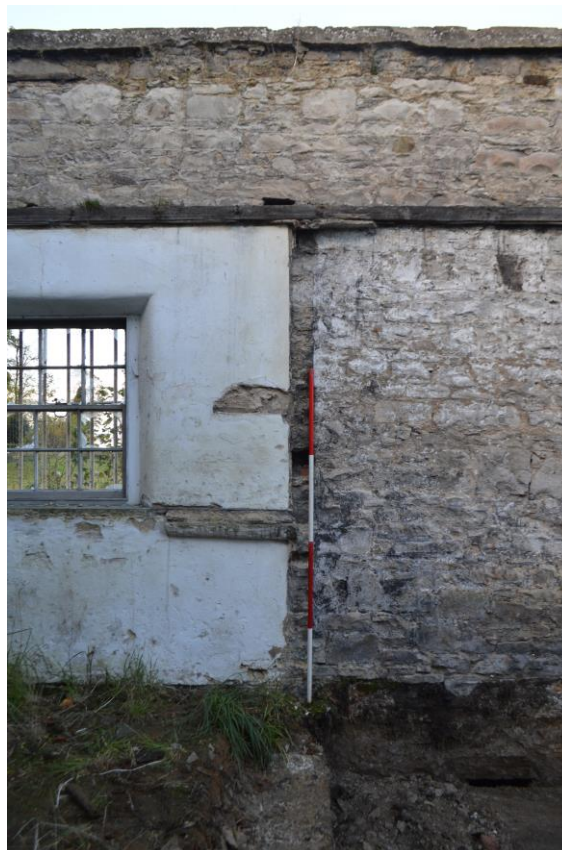
- 4.7 Some of the original features of the barn survive in the south-facing elevation, including the remains of a former vertical partition (Plate 3) and two horizontal timber beams. The foundation of the vertical partition was uncovered during the excavation of Trench 5. An east/west internal wall extends from the east-facing elevation of the farmhouse, possibly creating a former room in the north-west corner (Plate 4).

Plate 3: South-facing elevation of the barn

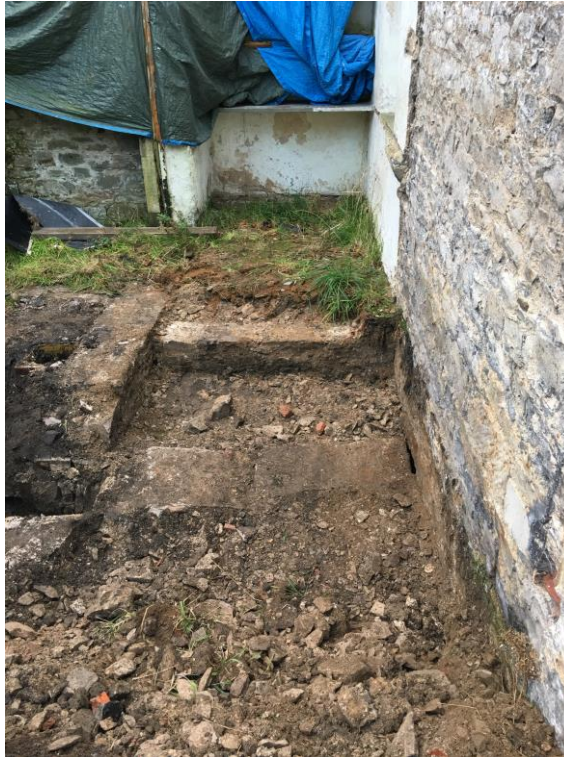
Plate 4: General view of the barn from the east

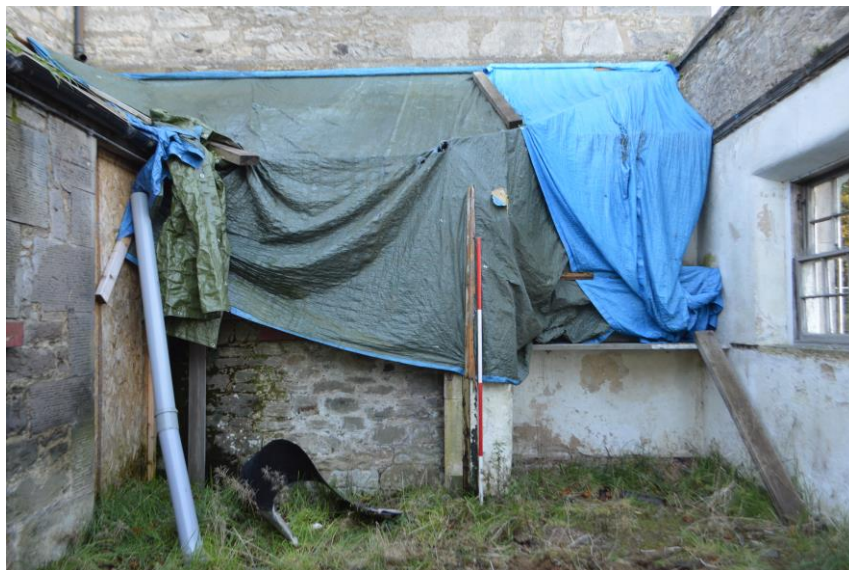
- 4.8 The area directly to the south of the east/west internal wall is indicated on the historic mapping as an open area, possibly a courtyard. This area appears to have been enclosed to the south and west by the external walls of the farmhouse, its sloping tiled roof, gutter, doors and windows having survived (Plate 5).

Plate 5: General view of the barn from the east
