# Haymarket Terrace, Edinburgh Watching Brief Data Structure Report

# Haymarket Terrace, Edinburgh Watching Brief: Data Structure Report

**AOC Project No:** 24001

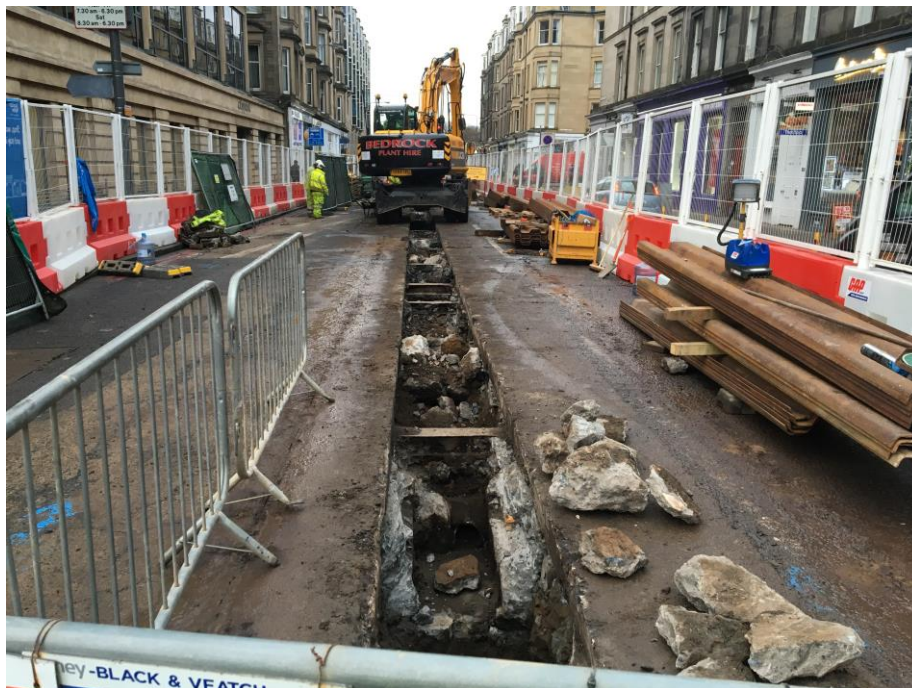
4.2.1 The excavation of Phase 3 started from the eastern most extent of the development area and continued westward along Haymarket Terrace. The initial 1-1.5m consisted of made-ground [003] which included an E-W ceramic drain, services and N-S metal beams encased in concrete at a depth of 0.3m (Plate 1). The made-ground overlay a mid orangey-brown clay-silt mixed with darker greyish-brown clay-silt subsoil [004]. Natural boulder clay, [000] was reached at about 2m.

Plate 1 – N-S Metal beams encased in concrete

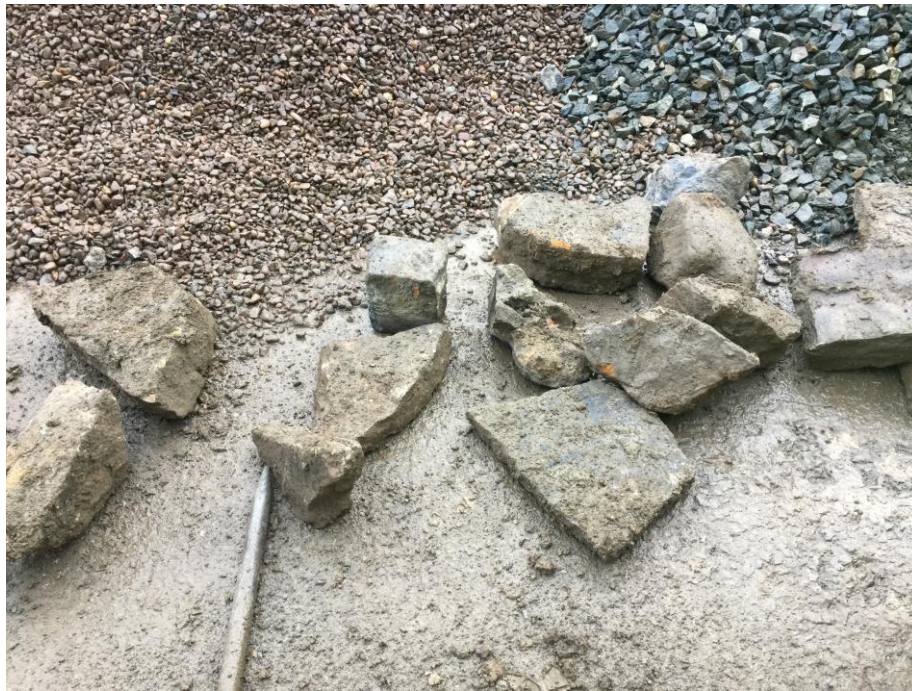
4.2.2 A BT Brick chamber was exposed at a depth of about 3m, with the area surrounding it visibly disturbed by modern activity. Large flagstones were observed at a depth of about 2m below street

level, within an organic dark greyish-brown clay silt deposit. It was mostly observed after being displaced with one flagstone still visible in the N-facing section (Plate 2).

**Plate 2 – Displaced Flagstone**

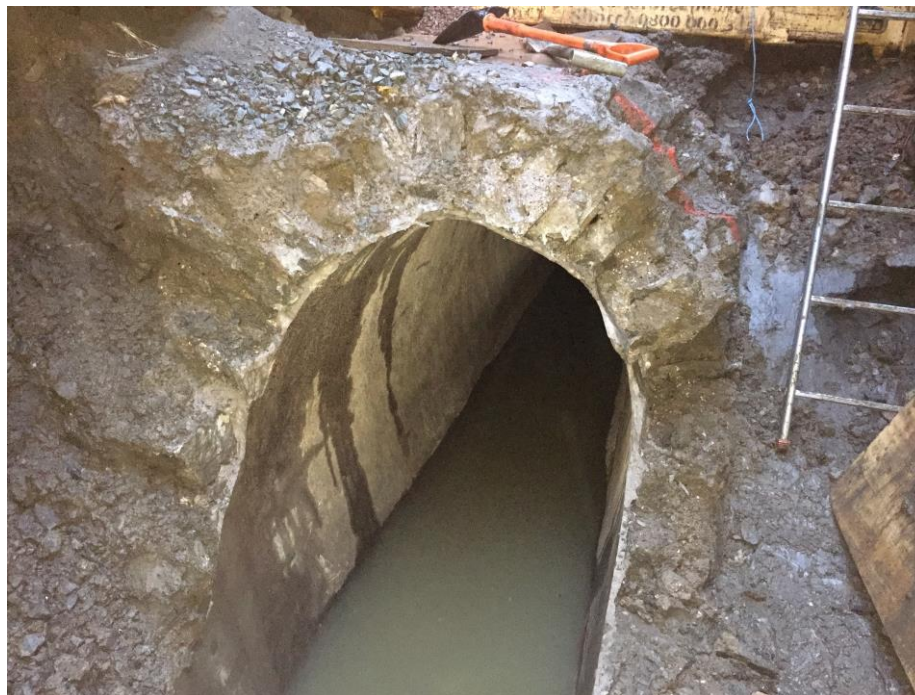
4.3.1 The excavation of Phase 1 started from the westernmost extent of the development area and continued eastwards along Haymarket Terrace. Excavation at the western end exposed a sandstone sewer [009] at a depth of 2m extending E-W the length of the opened section (Plate 3). The in-use sewer was made of sandstone blocks, 0.30m thick, with coarse concrete bonding. The interior measured 1.30m high and 1m wide.

**Plate 3 – Victorian sewer**

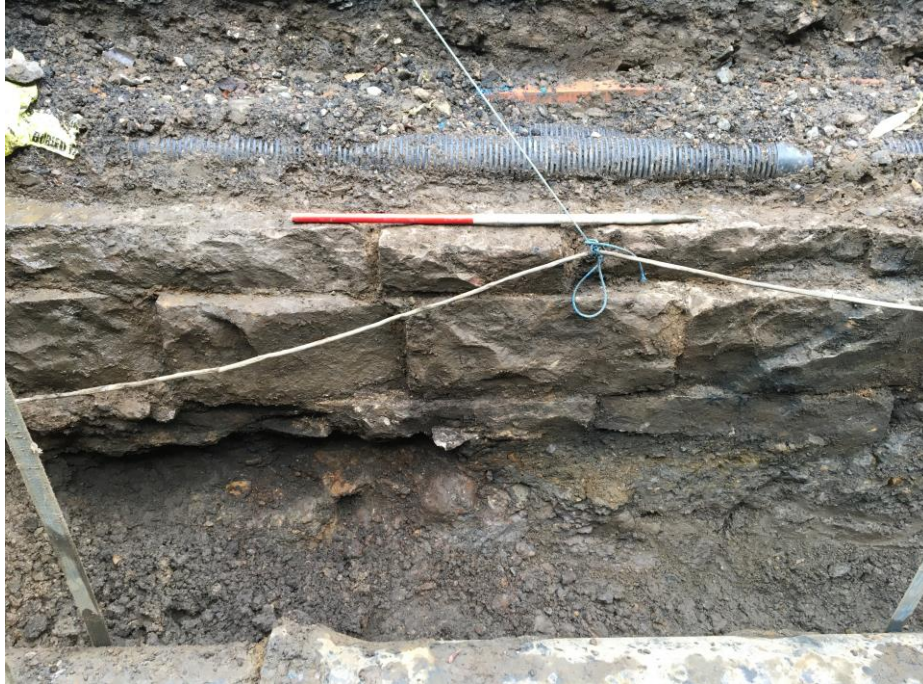
The S-facing sandstone wall [001] of a possible culvert was exposed 0.80m below the street level along the S-facing section of Box Trench 1 (Figure 2). The wall was visible for about 2.5-3.5m and was made up of 3 courses, 0.7m high in total with a sandy lime mortar bonding (Plate 4). The lowest course appeared to be a foundation, with a mix of slabs measuring 1m x 0.5m x 0.15m and smaller stones. The second course was made up of large angular blocks 0.8m x 0.5m x 0.32m. The upper course consisted of longer angular blocks 1m x 0.5m x 0.2m. The sandstone wall [001], was set over a dark grey-brown clay-silt deposit [002].

Plate 4 – Sandstone wall [001] in Box Trench 1

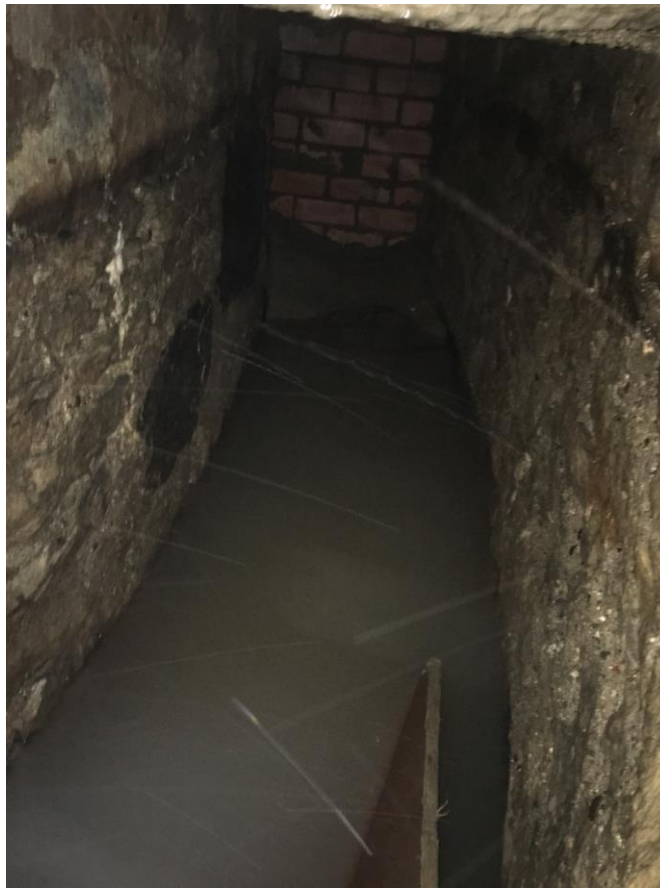
- 4.5.1 A culvert [008] was exposed in the NW corner of Box Trench 2, at a depth of 4m (Figure 3). It was set on an E-W orientation, but possibly turned north on both sides, joining up with a brick manhole further to the NE (Plate 5). The culvert was made up of mostly medium sized stones about 0.4m x 0.3m x 0.15m bonded with a lime mortar and an internal width of 0.7m. Up to 5-6 courses were exposed, although the full depth could not be determined due to the water level.

**Plate 5 – Detail of Culvert [008] showing brick manhole**

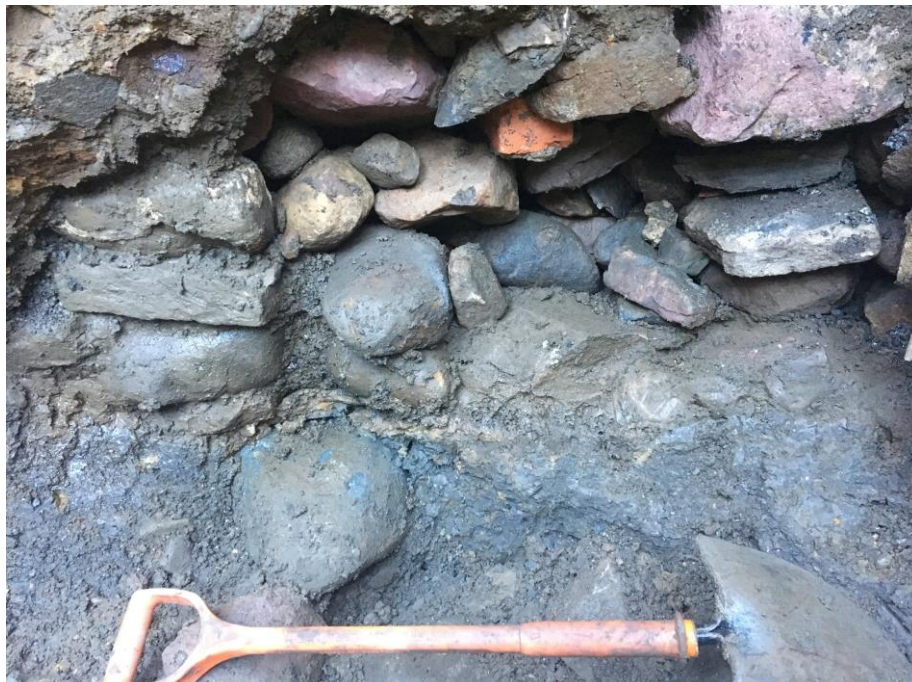
- 4.5.2 Along the W-facing section of Box Trench 2, the excavation revealed a 3 course wall [005], 0.45m high, with a sandy-clay bonding at about 1.65m below the street level (Plate 6). A rubble deposit of medium to large stones and occasional unfrosted bricks (006) was exposed south of the wall [005] with a possible second wall to the south of (006). A possible surface [007] was observed below (006) at a depth of 2.1m.

**Plate 6 – Detailed view of [005], (006) and [007]**
